Deterioration of Iowa Highway Concrete Pavements: A Petrographic Study

Paul E. Stutzman

December, 1999

Building and Fire Research Laboratory
National Institute of Standards and Technology
Gaithersburg, MD 20899

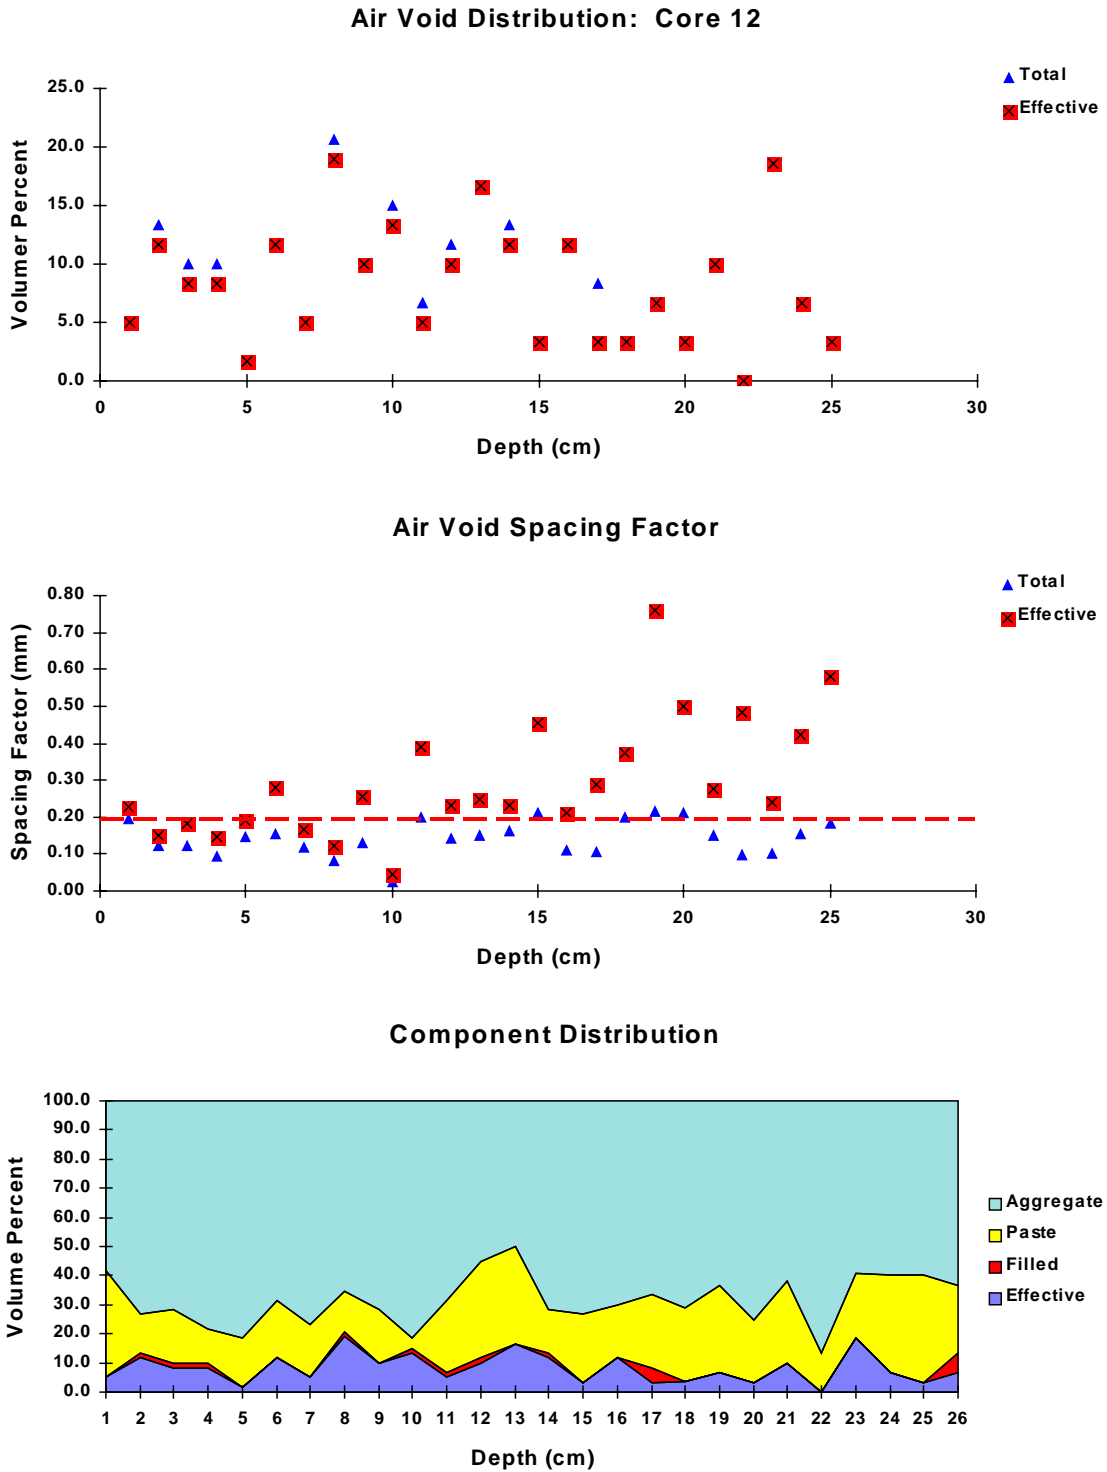
Figure 42. Core 12 air void volume and spacing parameters, and component distribution shows an increased degree of entrained air void filling with depth.

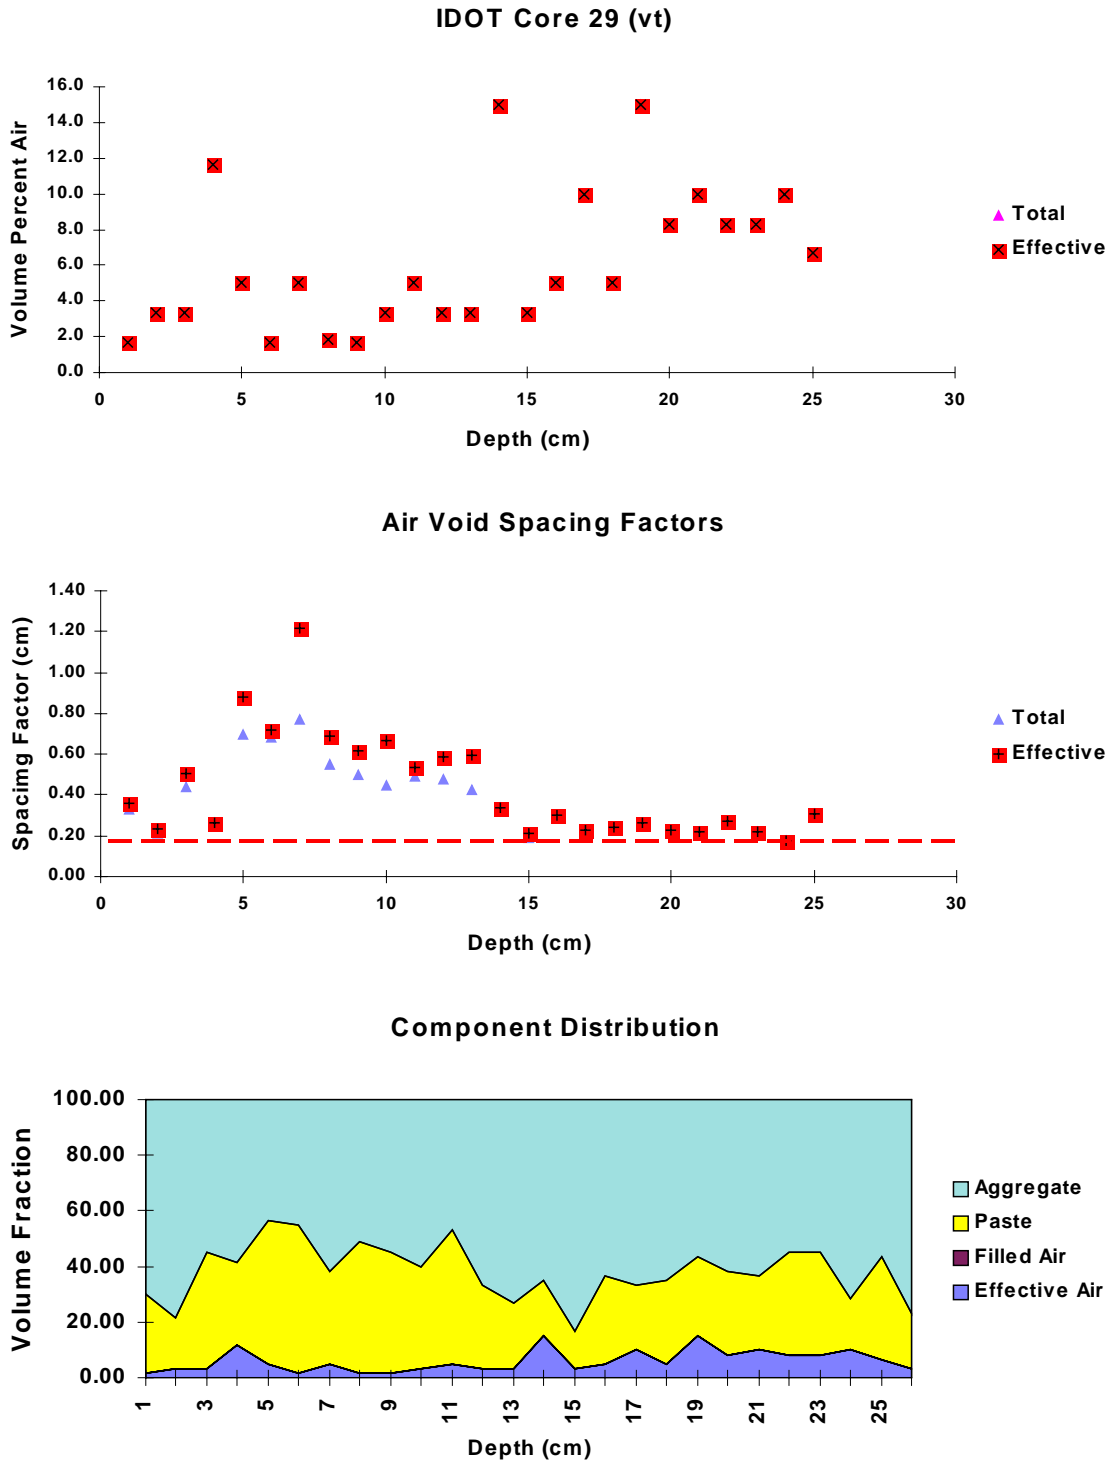
Figure 44. Core 29, centered on a well-defined vibration trail exhibits a significant increase in spacing factor in the upper half. This probably represents the zone of influence of the immersion vibrator probe. Note that the spacing factor is generally not satisfactory at any depth.
