**RECONNAISSANCE REPORT ON DAMAGE TO
ENGINEERED STRUCTURES DURING
THE MAY 1999 OKLAHOMA CITY TORNADO**

August 2002

Building and Fire Research Laboratory
National Institute of Standards and Technology
Gaithersburg, MD 20899-8611

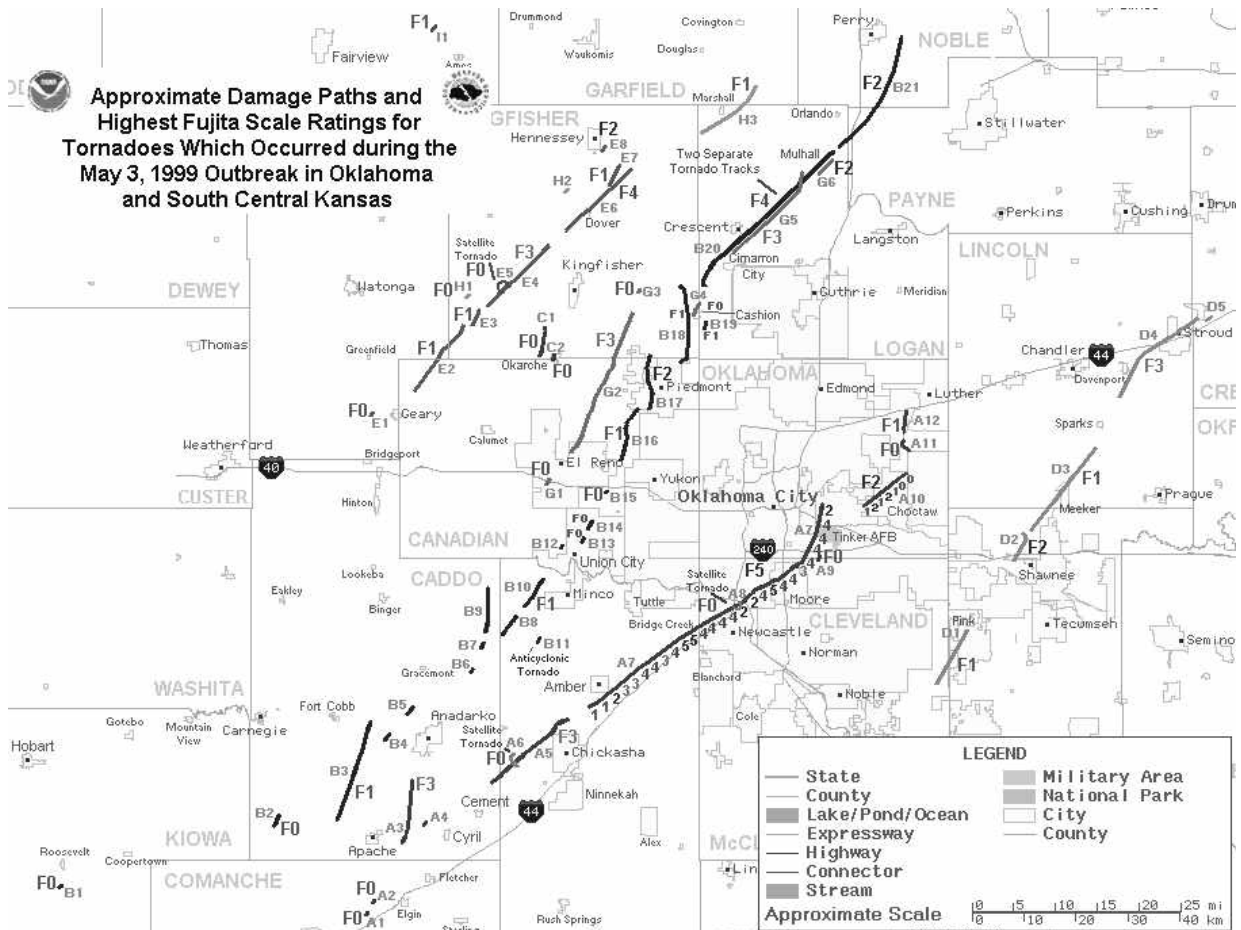
Figure 1-1. Map of Tornado Damage Paths and F-scale Ratings in the Vicinity of Oklahoma City, 01 July, 1999 Revision. (Courtesy of the NWS).

Weather Service identified the threat of tornadoes in the storm developing over the Midwestern US at 1:00 AM on 3 May 1999. The center issued the first tornado watch for the storm at 4:30 PM, and the first, weak tornado (A1 in Figure 1-1) was reported at 4:51 PM. During a ten-hour period that afternoon and evening, the National Weather Service Forecast Office in Norman, Oklahoma issued 116 warnings for tornadoes and severe thunderstorms.

Figure 1-1 shows a map of the tornado damage paths in central Oklahoma. The largest of these tornadoes (A7 in Figure 1-1), which passed through Oklahoma City, was rated as an F5 by the NWS. The other tornadoes were rated from F0 to F4. Table 1-1 lists the storm supercells identified by NWS, the number of distinct tornadoes that could be identified for each, the highest F-scale rating for tornadoes generated by that supercell, and the number of fatalities.

two storm cells (storms A and D), between Chickasha and Stroud, and including Southern Oklahoma City, Moore, Del City, Midwest City, and Choctaw. (In Figure 1-1 Chickasha is located near the bottom center of the map; Stroud is located near the mid right side of the map.) During the second flight, the team surveyed the damage caused by two additional storm cells (storms B and G), between Perry (near the top center of the map) and Union City (near the center of the map), including Mulhall, Crescent, and Piedmont. The observations from this survey were used to determine where the damage was heaviest and to locate significant structural damage that should be investigated more thoroughly.

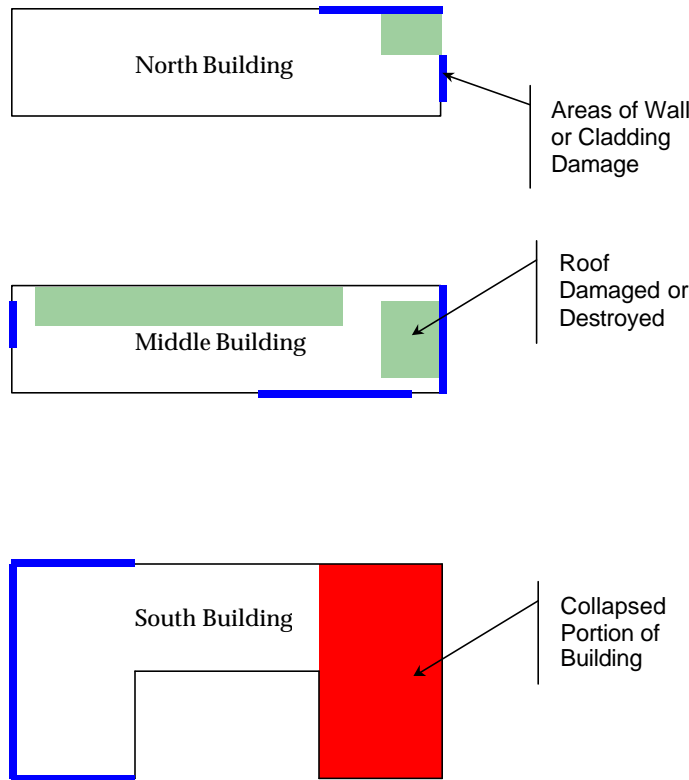
Figure 4-1: Simplified Plan View of Tinker Industrial Park

The tornado passed just south of the industrial park, causing the most severe damage to the south building, while the north building was the least damaged.

The south building was the newest of the three buildings. The main section had been completed less than one month before the tornado, and the foundation for an enlarged central section was under construction. The C-shaped portion, shown in Figure 4-1, was completed and the central and eastern portions were occupied. The structure and exterior of the western portion were complete, but the interior was still being finished.
