NISTIR 89-4061

AN ENGINEERING VIEW OF THE FIRE OF MAY 4, 1988 IN THE FIRST INTERSTATE BANK BUILDING LOS ANGELES, CALIFORNIA

Harold E. Nelson

March 1989

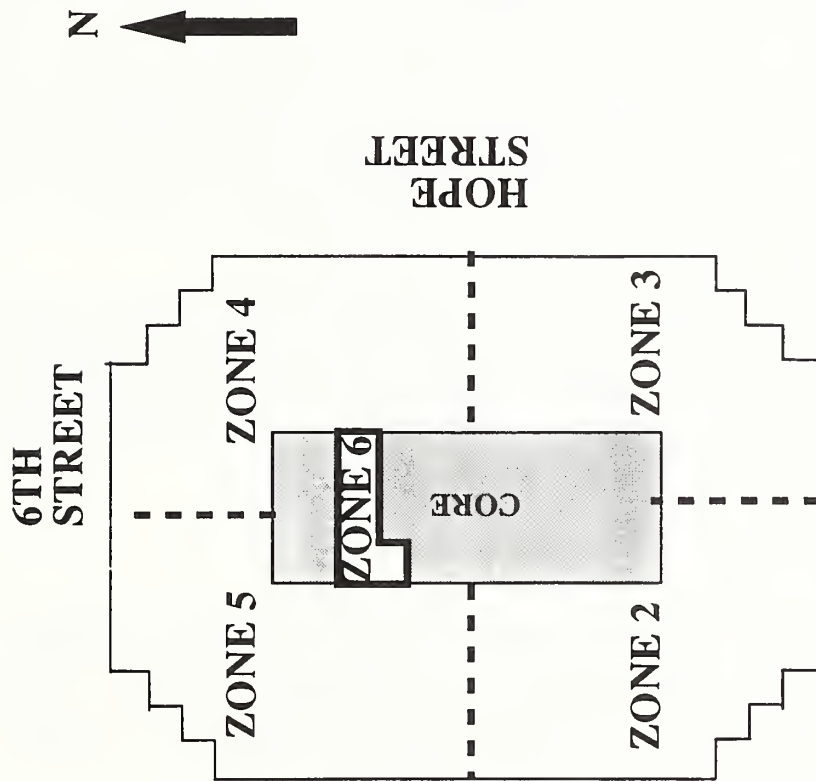
FIGURE 5. FIRE ALARM SYSTEM ZONES

The response of the smoke detectors was a principal source of data in recreating the fire. Each office floor has five smoke detector zones numbered zones 2 through 6. The layout is shown in figure 5. Zone 3 covers the area where the fire originated. Zone 6 is a special zone covering both the main elevator lobby and the small lobby in front of the freight elevator. There are smoke detectors located in the plenum space above the ceiling in zones 2-5. The smoke detectors in zone 6 are under the ceiling in the elevator lobbies and the freight elevator vestibule. In zone 3, there is one additional smoke detector located beneath the ceiling at the entrance door to the exit stair. That exit stair has a pressurized vestibule. In addition to the detectors described above, there were detectors connected to magnetic-hold opens for doors at each end of the 12th floor elevator lobby. These detectors, however, were reported as not connected to the fire alarm system.

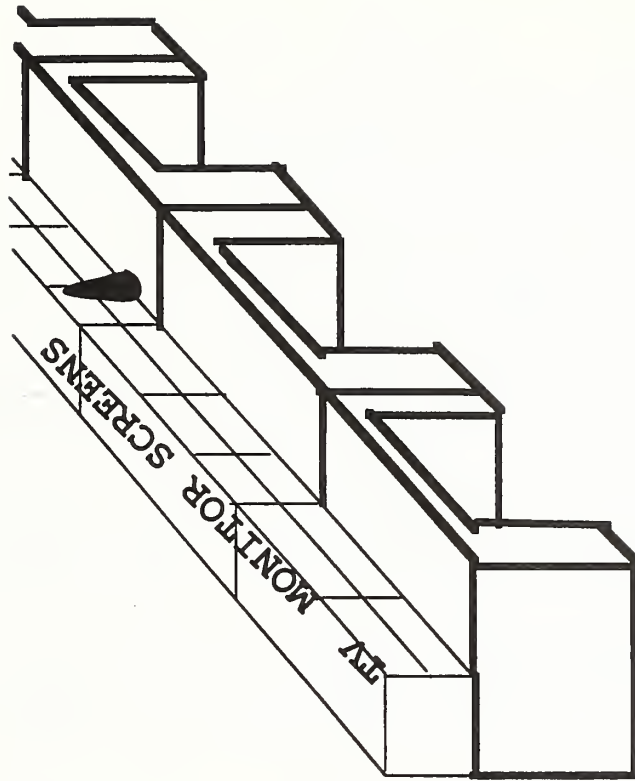
FIGURE 6. INITIAL FIRE ON A WORKSTATION

The fire trace discussed above indicates an open flaming fire of 10-20 kW approximately 3 minutes prior the 10:30 pm operation of the first smoke detector. The flame probably had a base about 6 inches in diameter and a height of about 18 inches. This is the start of analysis in this presentation. While figure 6 depicts the flame on top of the workstation it might actually have been on top of the workstation, under it, or between workstations.

12TH FLOOR ABOUT 10:25 - 10:27 A SMALL FLAME (<20KW) EXISTS INVOLVING SOME PART OF A WORKSTATION

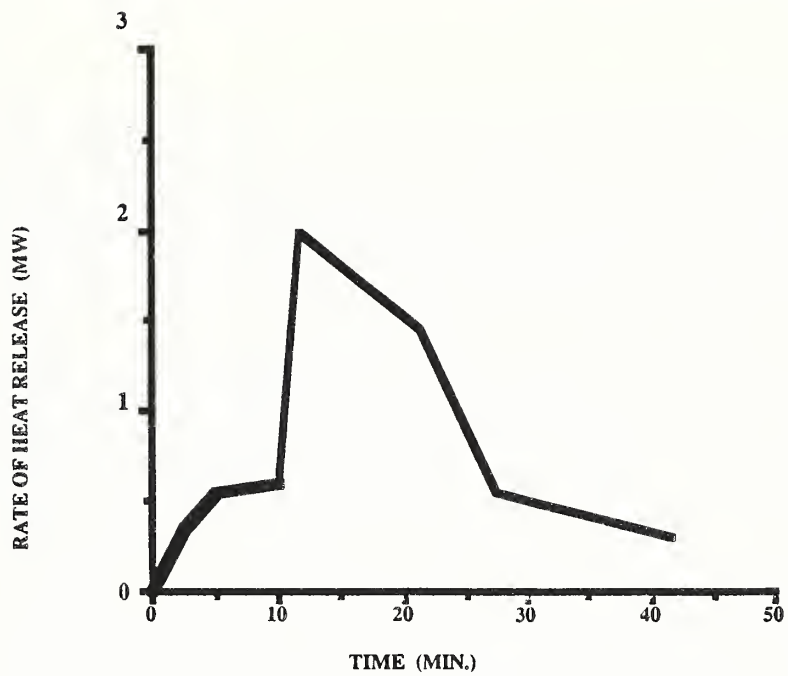
FIGURE 7. RATE OF HEAT RELEASE, TYPICAL COMPUTER WORKSTATION

The burning of the initial workstation is believed to have approximated that produced in a test of a computer workstation complex previously tested in the furniture calorimeter at the Center for Fire Research [6]. The rate of heat release curve used is shown in figure 7.

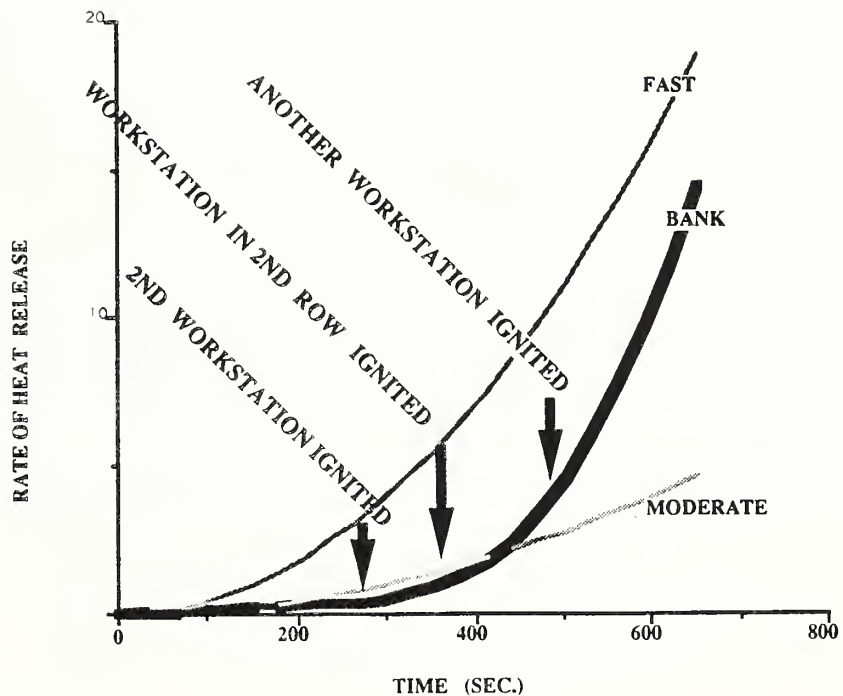
FIGURE 8. ESTIMATED FREE-BURN RATE OF HEAT RELEASE OF GROUPS OF WORKSTATIONS AS FOUND ON TRADING (12TH) FLOOR

Consequently, the growth rate assigned in analyzing subsequently ignited workstations was that used for a "fast fire" as described in NFPA 72E. The resultant free-burn fire growth curve, derived from calculating this spread as a series of individual radiant ignitions of workstations, is shown in figure 8. This curve is compared to both the fast and moderate fire growth curves of NFPA 72E.

The calculated burning rate starts out at a growth rate somewhat slower than that for the moderate curve but increases after several workstations are involved to a rate greater than the fast curve. Only the first 11 minutes of fire development is shown. As the fire approached that time the onset of flashover conditions and resulting fire environment rather than free-burn characteristics controlled the burning rate.

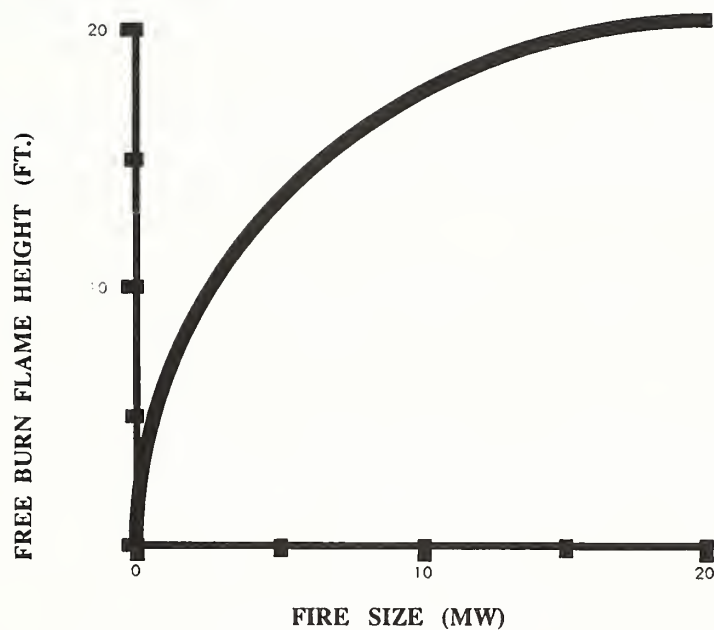
FIGURE 9. APPROXIMATE FREE BURN FLAME HEIGHT

As the fire grew, the fire base increased and the rate of heat release from the fire increased. Flame height is a function of rate of heat release and area of fire base. The theoretical free burn flame height from the fuel array presented by the rows of workstations peaked at about 18-20 ft. See figure 9. Since the ceiling was only 6-9 ft. above the fire (depending on whether the

fire was on the floor or the top of the workstation), the flame touched the ceiling when the rate of heat release was between 1/2 and 1 MW, (i.e. 5 1/2 to 6 1/2 minutes into the fire.) After the flame reached the ceiling, it extended along the ceiling spreading radially a distance about equivalent to that portion of the theoretical flame height cut off by the ceiling.

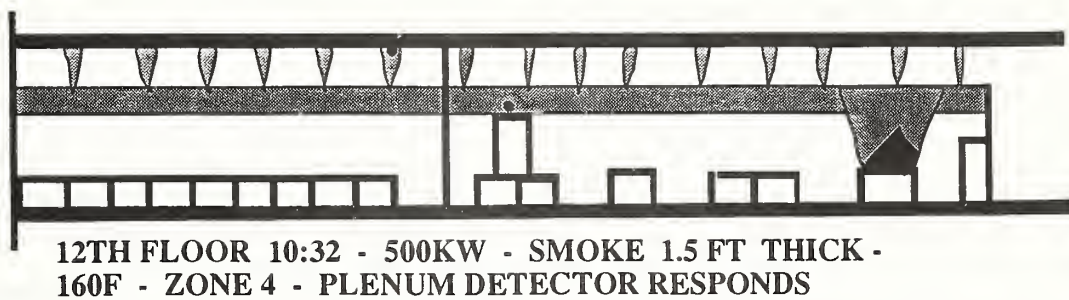
FIGURE 11. CONDITIONS AT 10:32 P.M.

The assumption of equal smoke conditions throughout the floor is, of course, incorrect. Temperature, if not depth of smoke is less at positions more distant from the fire source. Lower temperatures at locations more remote from the fire source reduce the rate of flow into the ceiling in those areas. As a first order assumption, it can be concluded that the zone that came in second (zone 4) was closer to the fire. Lacking any other information, this is a reasonable speculation. However, since zone 2 responds during the following minute, this speculation must be treated with caution.

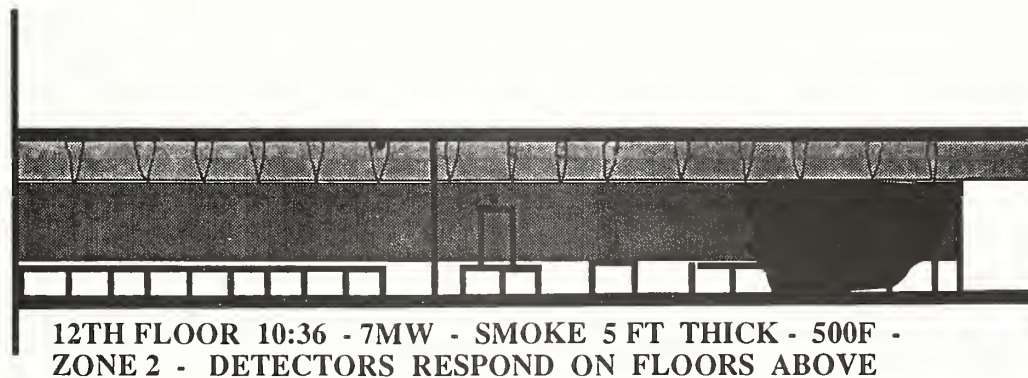
FIGURE 16. CONDITIONS AT 10:36 P.M.

Smoke from the plenum sweeps up through the return air shafts. During the next 2 minutes, smoke detectors respond for multiple zones on almost all of the floors between 12 and 32. These are the floors served by common return air shafts. (See figure 3.)

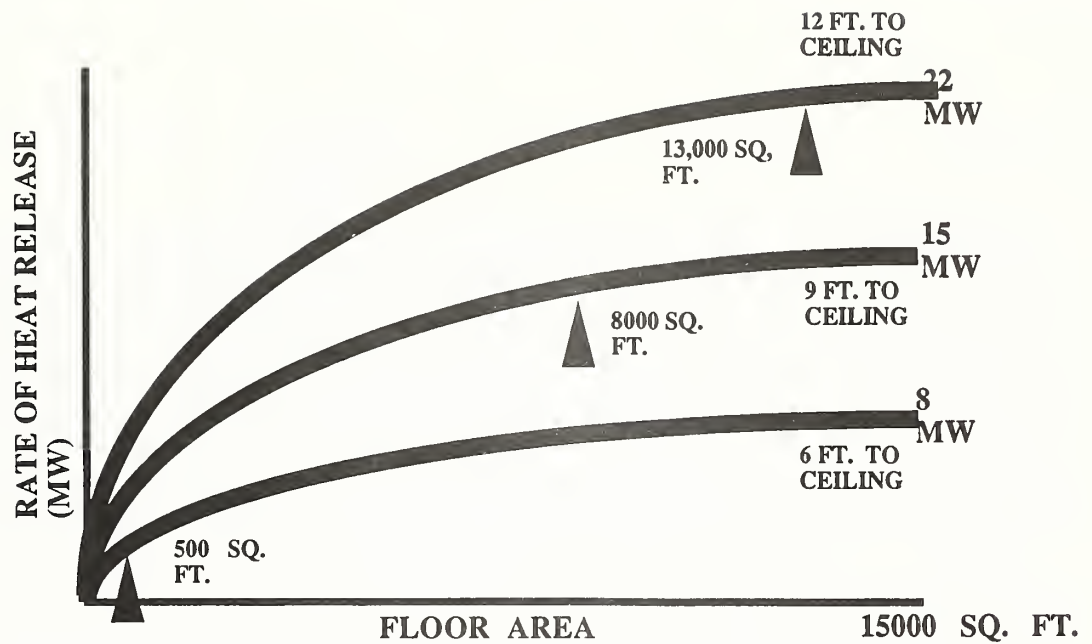
FIGURE 18. MAXIMUM FIRE SIZE IN A CLOSED SPACE AS A FUNCTION OF FLOOR AREA AND DISTANCE FROM FIRE TO CEILING

In a fast developing fire, key parameters include the area of the floor and the height between the base of the fire and the ceiling. The closer the base of the fire to the ceiling, the more likely that the fire will develop ceiling temperatures capable of causing flashover (thereby causing window breakage, resulting in a continuous air supply) before the smoke layer both reduces its oxygen level below that capable of supporting combustion and descends low enough to starve the fire. Where the base of the fire is further from the ceiling, the cooling effect of the entrained air slows down the development of ceiling temperatures. In such case a much larger floor area is necessary to provide a sufficient air reservoir to produce flashover temperatures in a closed space. The differences are shown in figure 18.

▲ DIVIDING POINT -- AT FLOOR AREAS LESS THAN THIS THE FIRE CONSUMES ENOUGH OXYGEN TO LIMIT FIRE DEVELOPMENT TO SMOKE TEMPERATURES LESS THAN 1112 F (600 C) - ABOVE THIS POINT THERE IS SUFFICIENT AIR ON THE FLOOR FOR THE FIRE TO CONTINUE TO HIGHER TEMPERATURES.

Further study to better relate these factors as well as fire growth rates and maximum fire size to flashover in closed space would be valuable. However, these calculations demonstrate a potential associated with open office arrangements with concentrated grouping of combustible work areas. Where such concentrations occur in spaces involving large floor areas and relatively low ceilings, there can be sufficient combustion air within the space to allow a developing fire to reach flashover conditions. This even if no additional air is introduced into the space.

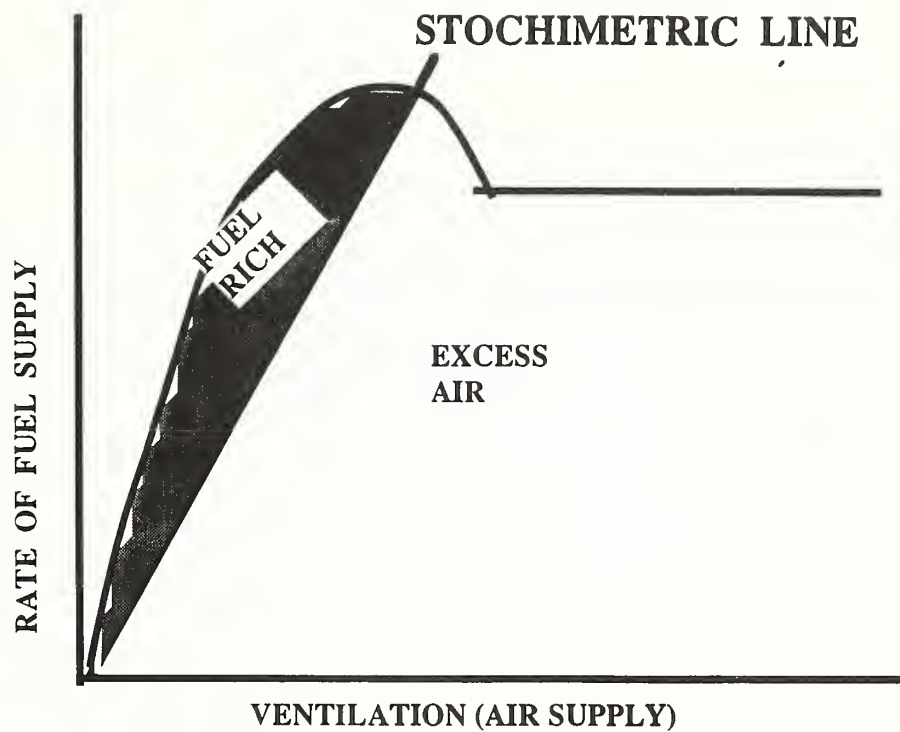
FIGURE 21. COMPARTMENT BURNING RATE THEORY

Figure 21 depicts the possible burning states of a fire in a compartment for a fixed amount of involved combustibles (i.e. fuel load.) The ventilation air supply represents the possible variation in window or door vents (or other features) that can be the source of air supply for the fire. For low ventilation the fuel produced can exceed the stoichiometric value. This depends on the degree of heat transfer from the fire and the compartment environment and the nature of the combustibles. As ventilation increases (e.g. windows break,) the same combustible fuel load can achieve different rate of fuel gas generation. Ultimately, in every vented compartment fire, this reaches a state in which excess air prevails. This fire undoubtedly experienced all aspects of this fire behavior. Before the windows broke and the initial oxygen was consumed, the fire on the 12th floor was to the left of the stoichiometric line as shown on figure 21. As the windows broke the fire state moved to the right of that line.

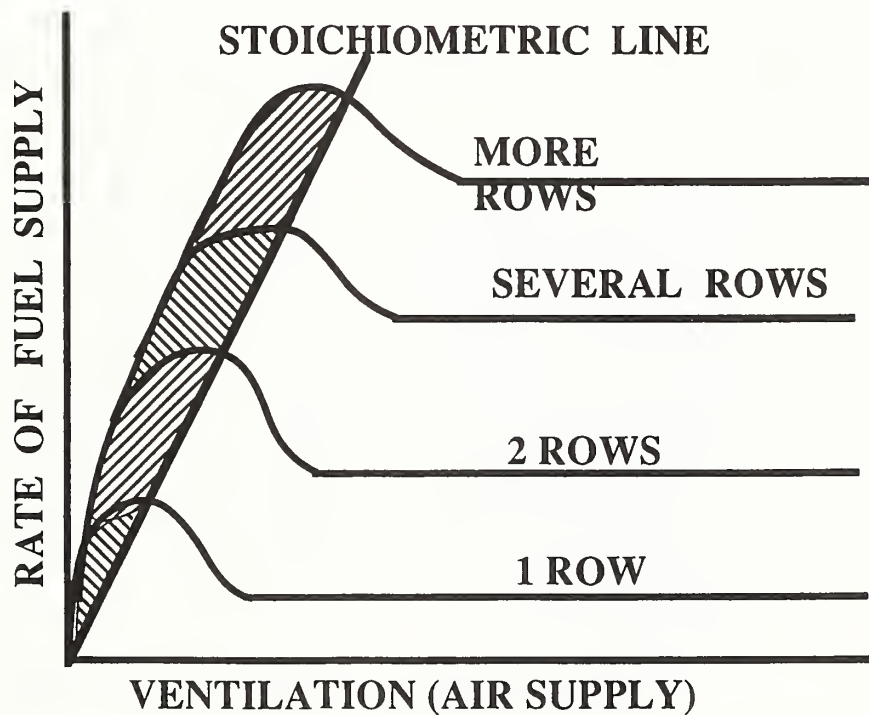
FIGURE 22. COMPARTMENT BURNING RATE THEORY APPLIED TO EARLY STAGES OF THIS FIRE

Figure 22 depicts a growing condition such as occurred in the bank building. As more and more fuel enters the picture, the required ventilation to move from fuel rich to air rich increases. It is believed that a condition stepping through these ranges probably occurred as the fire propagated around the 12th floor. Unfortunately, the lack of photographs or eye witness descriptions during the that period prevents confirmation.
