Lightning and Surge Protection of Photovoltaic Installations

Two Case Histories: Vulcano and Kythnos

François D. Martzloff

June 1989

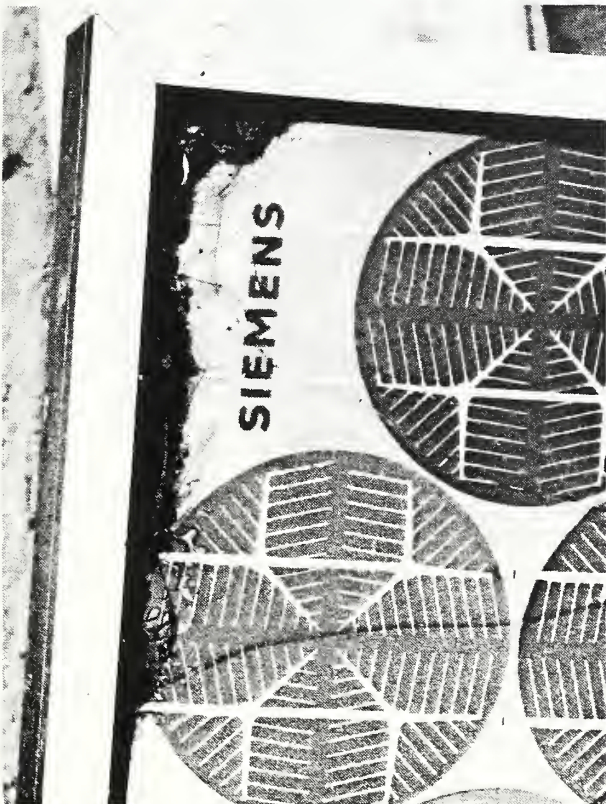
3-26 Detail of top left corner

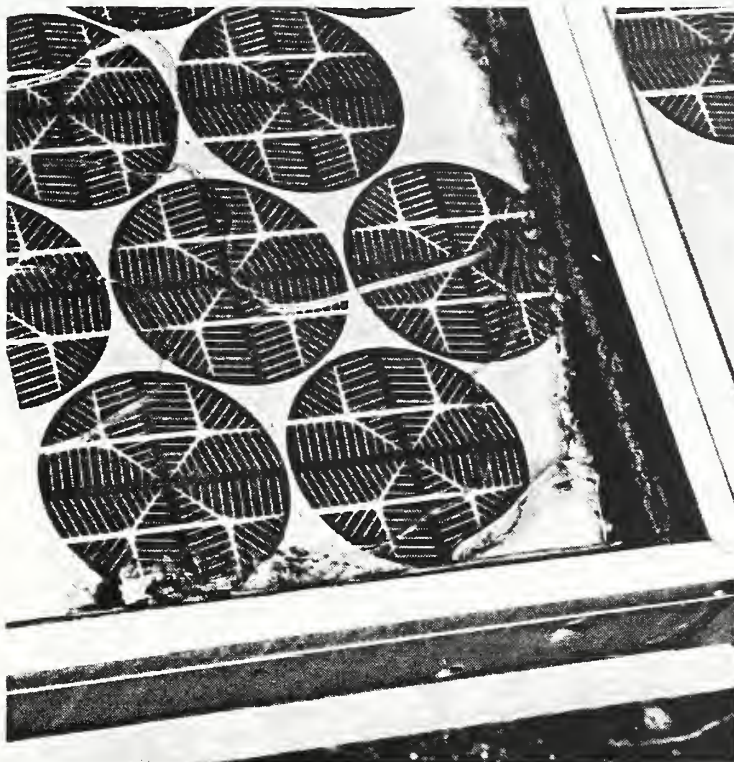
3-30 Detail of bottom right corner

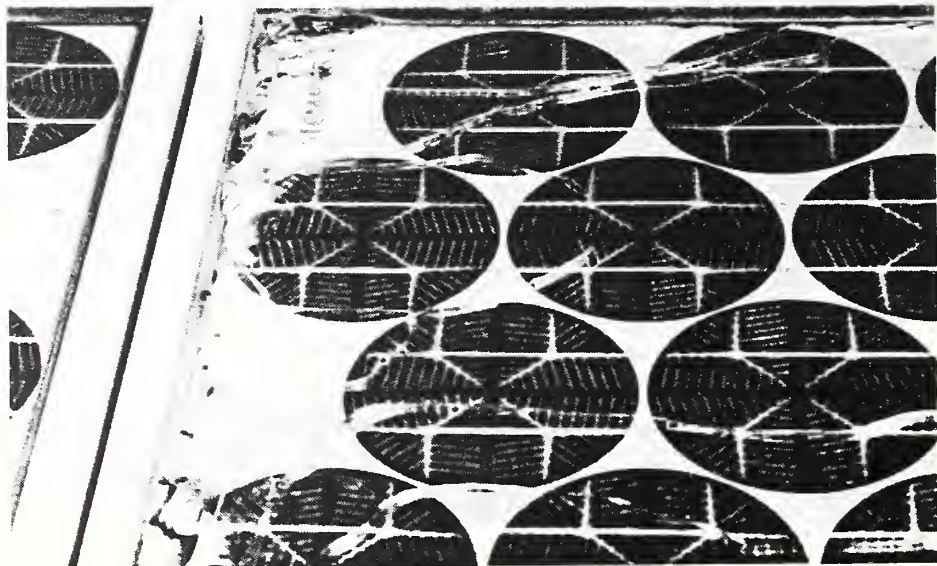
3-36 Detail of top left corner
