AIR QUALITY INVESTIGATION IN THE NIH RADIATION ONCOLOGY BRANCH

**Andrew Persily
W. Stuart Dols
Steven J. Nabinger
David A. VanBronkhorst**

**Sponsored by:
Division of Engineering Services
National Institutes of Health
Bethesda, Maryland**

August 1989

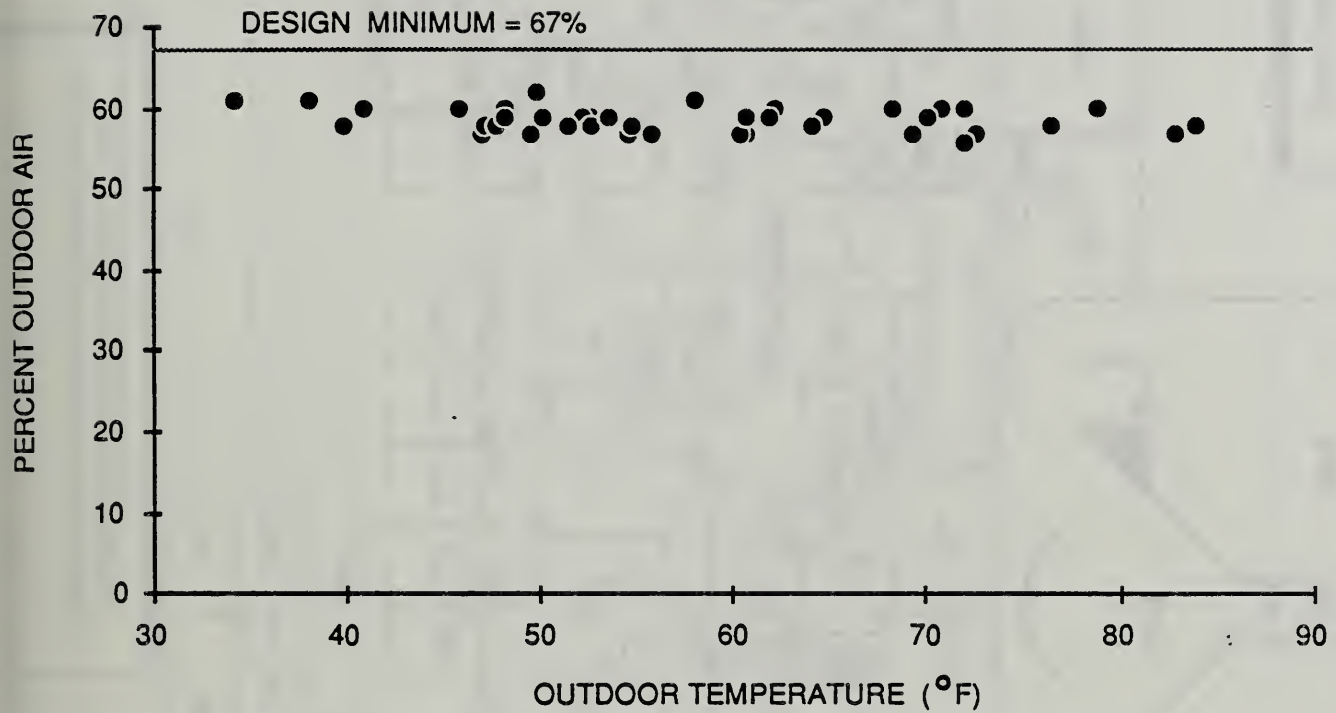
Figure 3.1 Percent Outdoor Air Intake vs. Outdoor Temperature

The calculated and design values of the percent of outdoor air intake are also given in Table 3.2, and there is essentially no variation in this percentage among the different test days. As discussed earlier, the amount of outdoor air intake is supposed to be at its design minimum of 67% when the outdoor temperature is greater than 50°F, with higher percentages being brought in when the outdoor temperature is below 50°F. The percent of outdoor air intake was measured over a range of outdoor temperatures using tracer techniques discussed earlier. The results of these measurements are shown in Figure 3.1, which is a plot of the

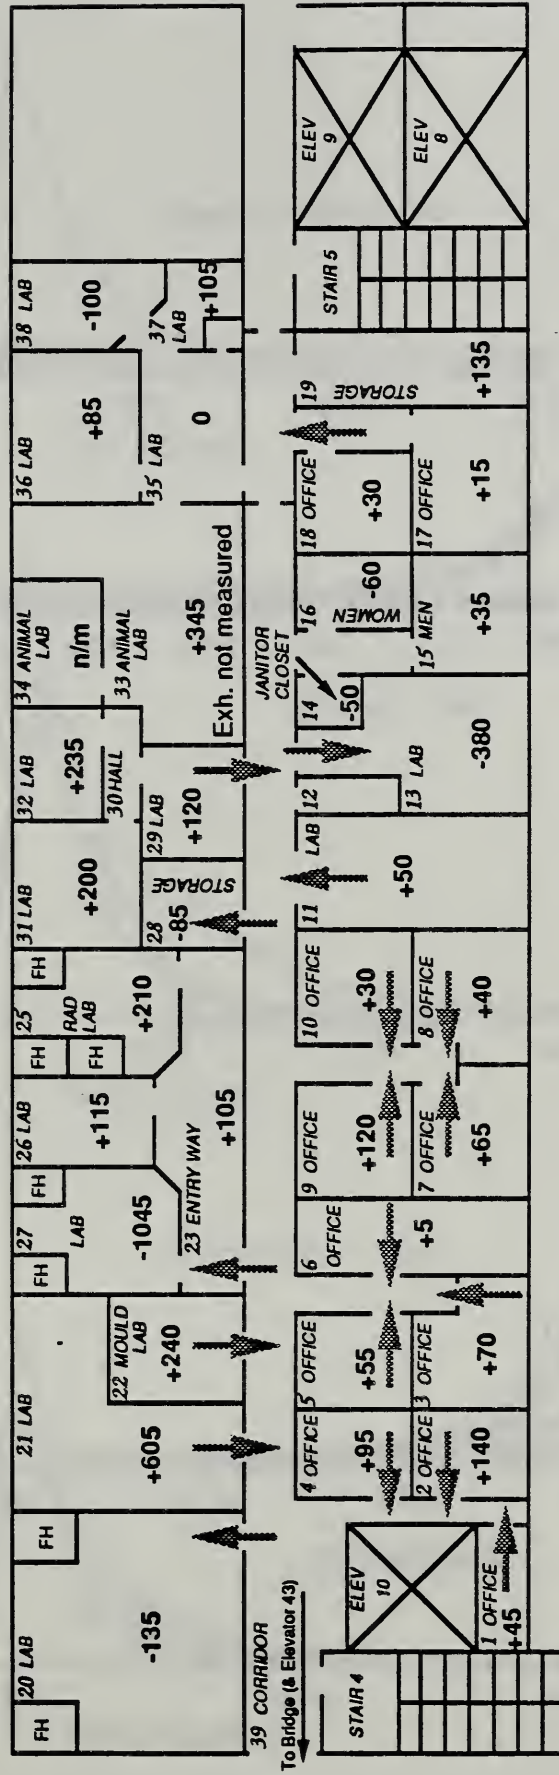
Figure 3.5 Measured Airflow Rates in Level 1B (Zone #4)

Table 3.8 lists the results of the ventilation airflow rate measurements in the rooms on Level 1B, and Figure 3.5 shows the net airflow rates for each room in schematic form. The measurement results that are at least 25% different from their design values are in bold type in the table. Several of the measured room airflow rates differ significantly from the design values, with a tendency towards the exhaust airflow rates being below design. On the east side of the floor, spaces 1 through 19, the exhaust flows are particularly low, especially in the southeast corner. Several of the laboratories have net airflows into the hall, resulting in the transport of contaminants to this common area and elsewhere in the building. The mould room (space 22, room 1B52) has an insufficient exhaust airflow rate, which is of particular concern given the substances used in this room. Many patients on the way to the Treatment Area use the 1B hallway and are exposed to whatever contaminants are flowing from these rooms into the hall.

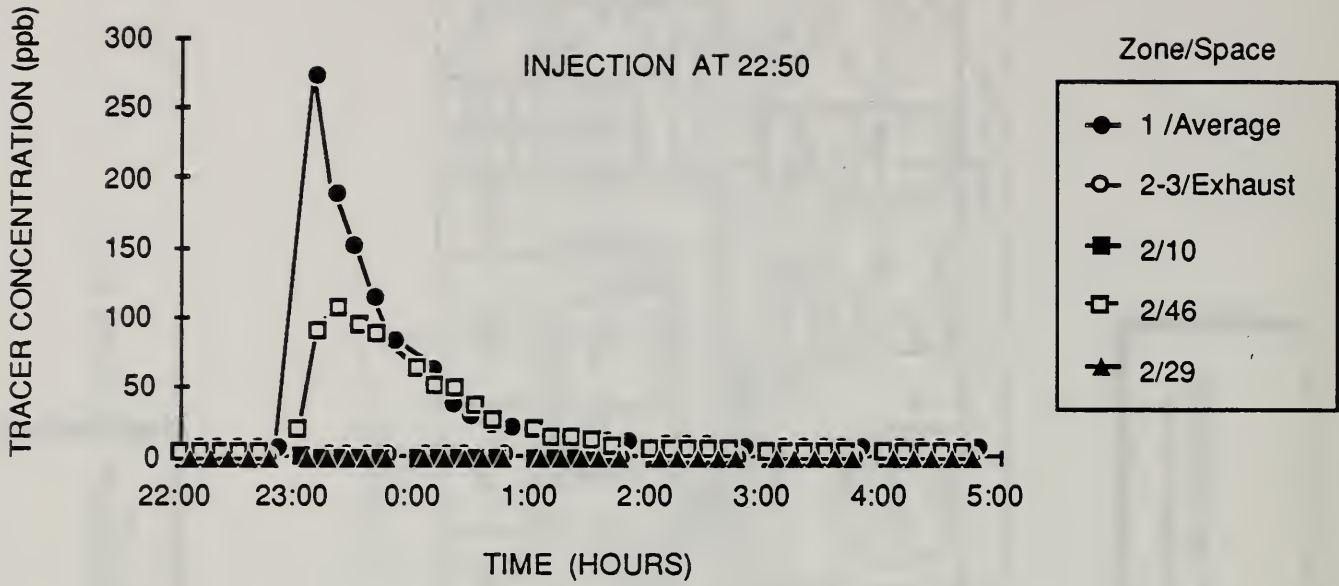
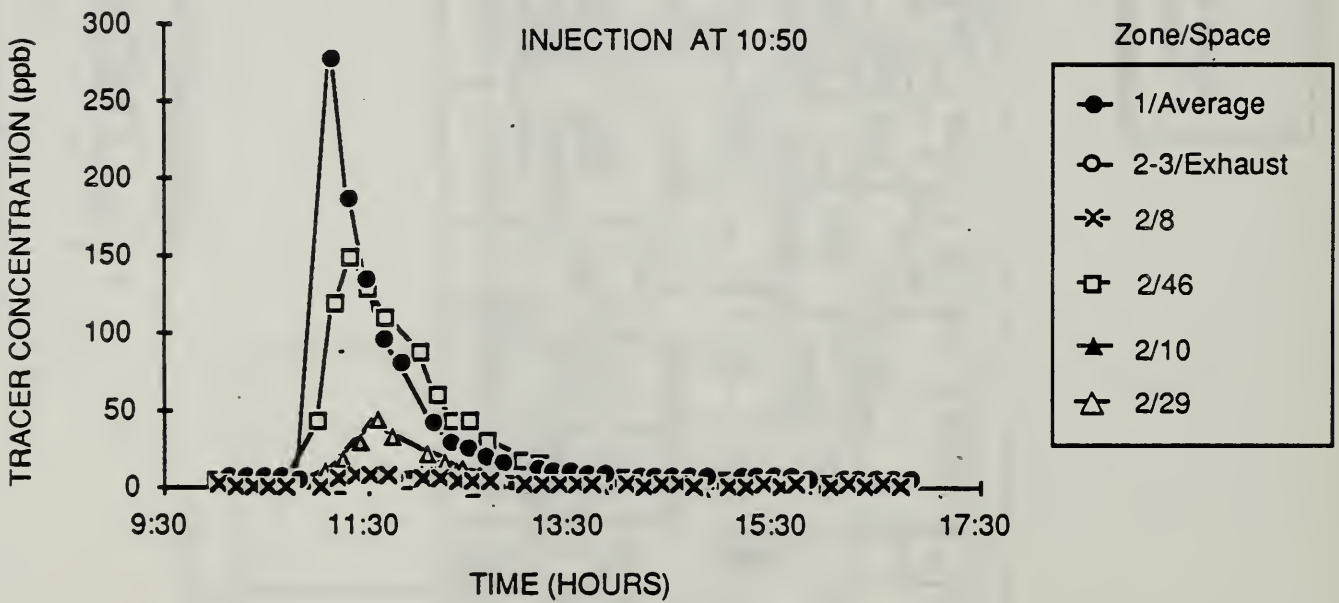
Figure 3.6 Tracer Gas Injection in Treatment Area

Air movement between the four zones of the ROB was examined by releasing tracer gas in one of the zones and monitoring the tracer gas concentration response in all of the zones using the automated tracer gas measurement system. Figure 3.6 shows the results for two tests in which sulfur hexafluoride was injected into the Treatment Area (Zone #1) supply air system. In the first test the tracer gas was injected during unoccupied hours, when most office and laboratory doors were closed. Other than the Treatment Area itself, characterized by the Zone #1 average concentration, the tracer is seen only at air sample location 2/46 in the hallway of Level B3B. (In these discussions, a sample location designation consists of a zone number and a space number or description separated by a slash.) All of the rooms on this level, and the exhaust duct which serves them, show no measurable tracer gas concentration. Though not shown in this plot, there was no tracer gas response on Levels B2.5B or 1B

The second plot in Figure 3.6 shows the results of an SF₆ injection into the Treatment Area during the day, when most of the office and laboratory doors to the hallway are open. Again we see tracer in the Level B3B hallway, but this time we also see a concentration response in several of the rooms on this level. The highest concentrations are in space 2/29, a laboratory for which the measured ventilation flows indicated that the ventilation of this space was dominated by exhaust. Therefore, air and tracer gas flows from the hall into this space. All of the other rooms shown in this plot have an excess of supply airflow relative to exhaust, and therefore they have relatively low tracer gas responses. Even though these spaces have an excess supply airflow, a small amount of tracer gas still gets into these rooms due to turbulence at doorways and other variations in the average airflow patterns. There was no measurable tracer gas response on Levels B2.5B (Zone #3) and 1B (Zone #4) in this second test, again indicating no significant airflow from the Treatment Area to these two levels. These two tests show that air moves from the Treatment Area to the Level B3B hallway, but not to Levels B2.5B or 1B. Whether air flows from the B3B hallway to individual rooms on this level depends on whether the door to the room is open and on the sign of the net mechanical ventilation airflow rate for that room.

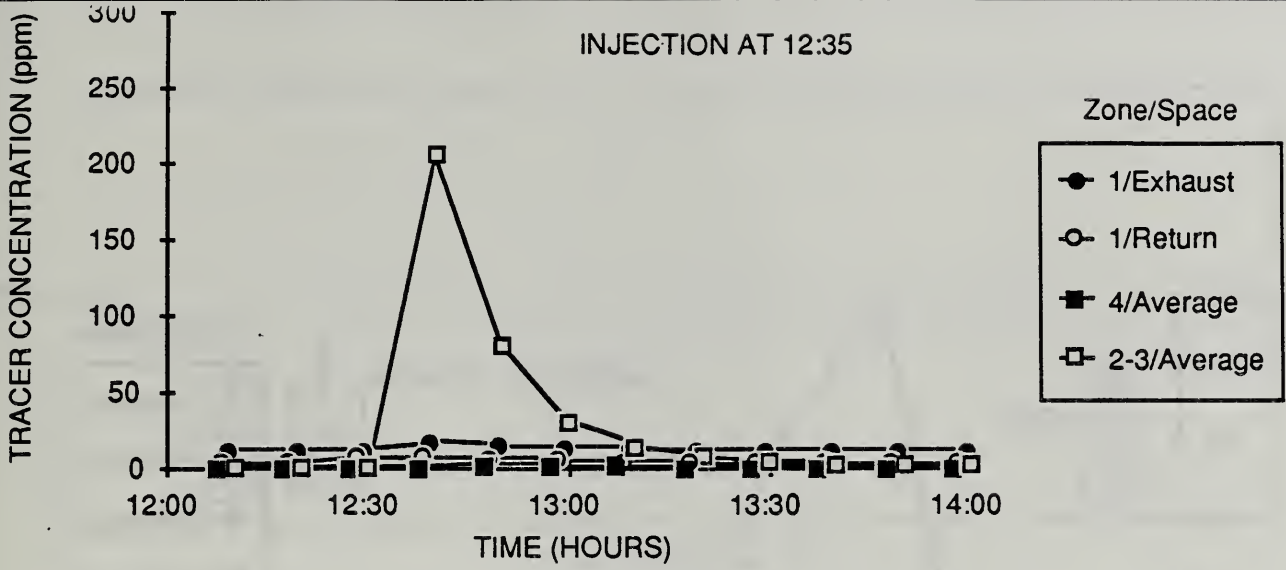
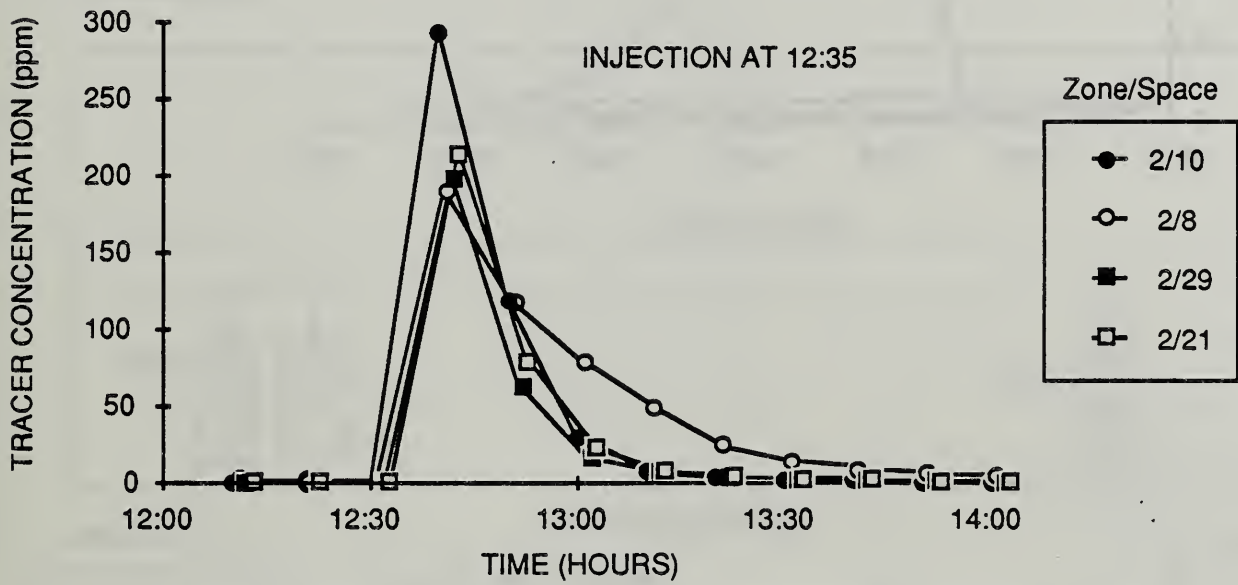
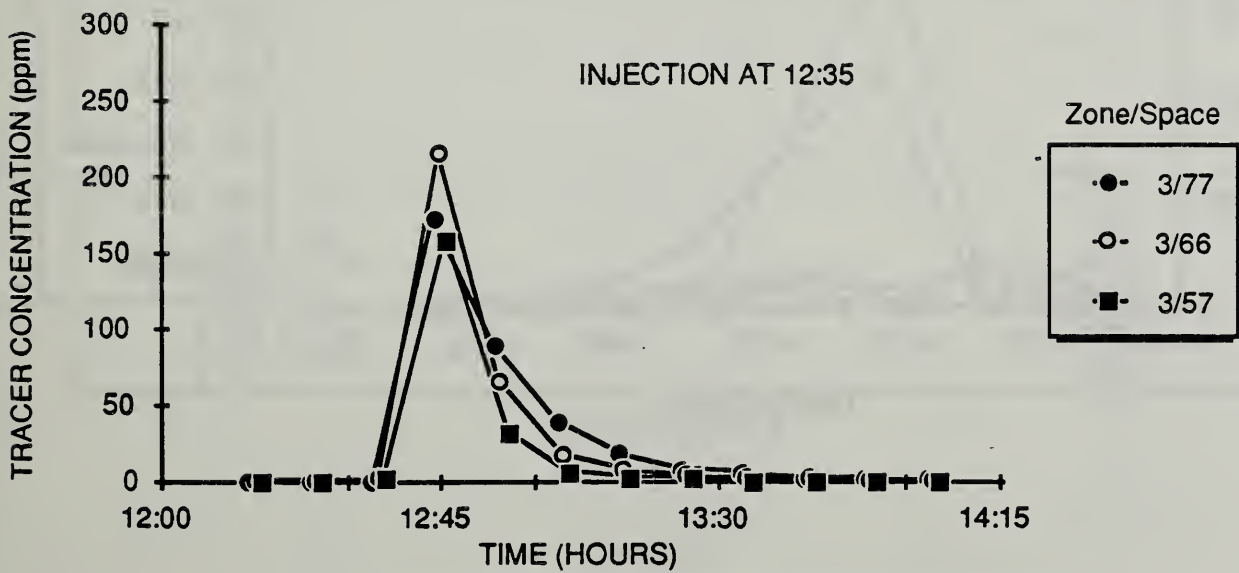
Figure 3.7 Tracer Gas Injection in Level B3B and B2.5B Supply Duct

The three plots in Figure 3.7 show the tracer gas response to an injection into the supply duct serving Zones #2 and #3. In the first plot we see that there is no response to this injection in either the Treatment Area or on Level 1B. The low, but constant, SF₆ concentration in the Treatment Area exhaust is due to a small SF₆ leak in one of the radiation treatment machines. The response to this injection in the individual rooms in Zones #2 and #3 are shown in the other two plots of Figure 3.7. These room responses are relatively uniform, indicating that the supply air is well distributed among the rooms.

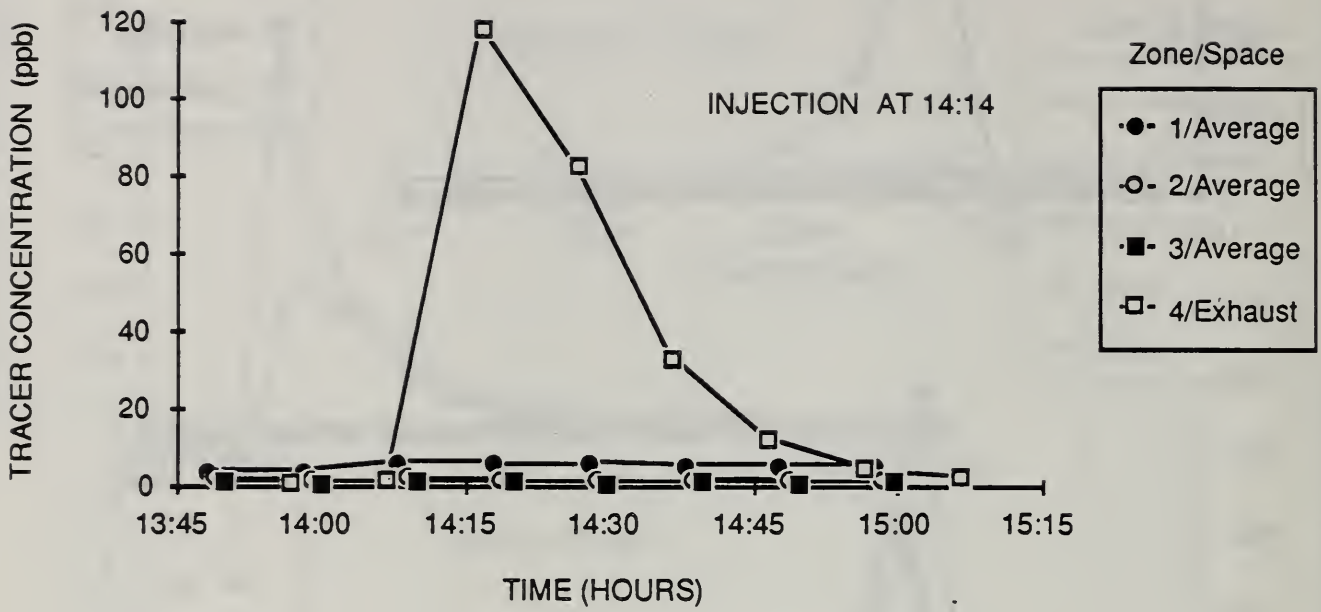
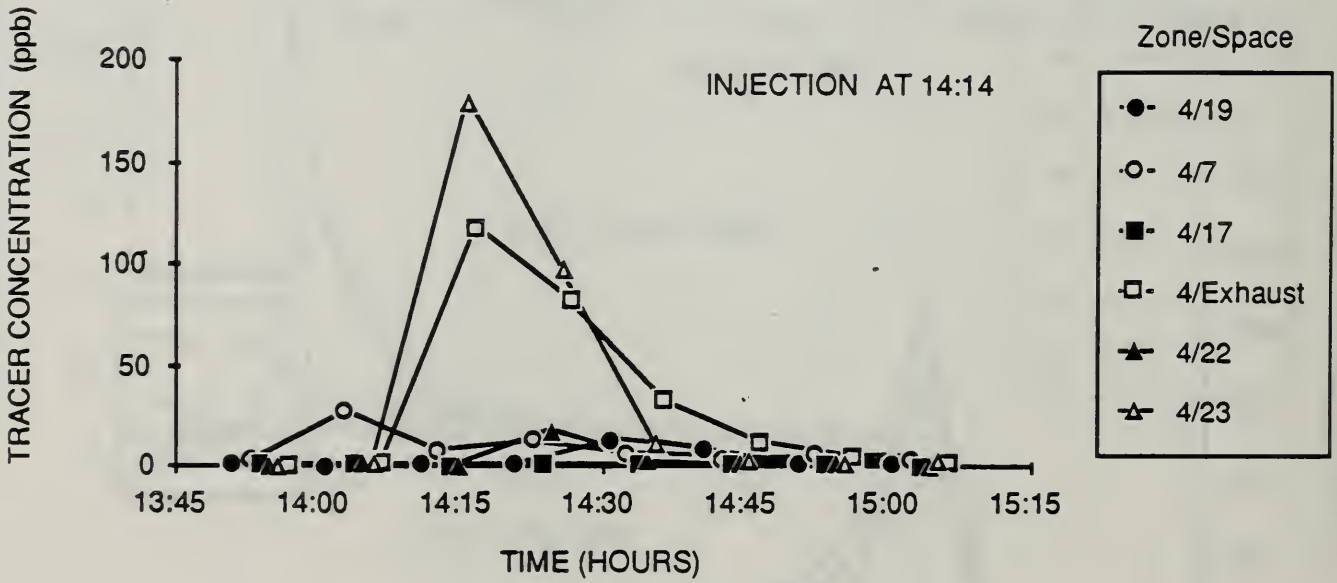
Figure 3.8 Tracer Gas Injection in 1B Hallway

Figure 3.8 shows the tracer gas response within the ROB to an injection into the hallway of Level 1B. The first plot shows that there is no response in any of the other ROB zones. The second plot shows the response in individual rooms on Level 1B. As expected, those rooms which have an excess of exhaust airflow relative to supply have more significant tracer gas responses than those which are oversupplied.

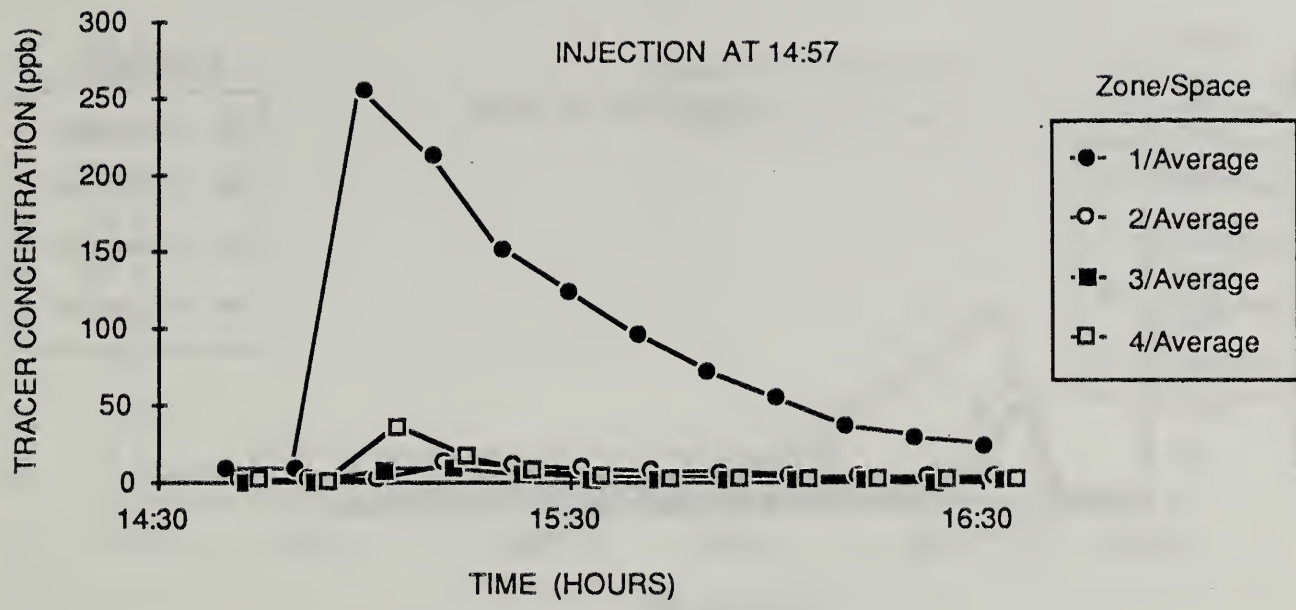
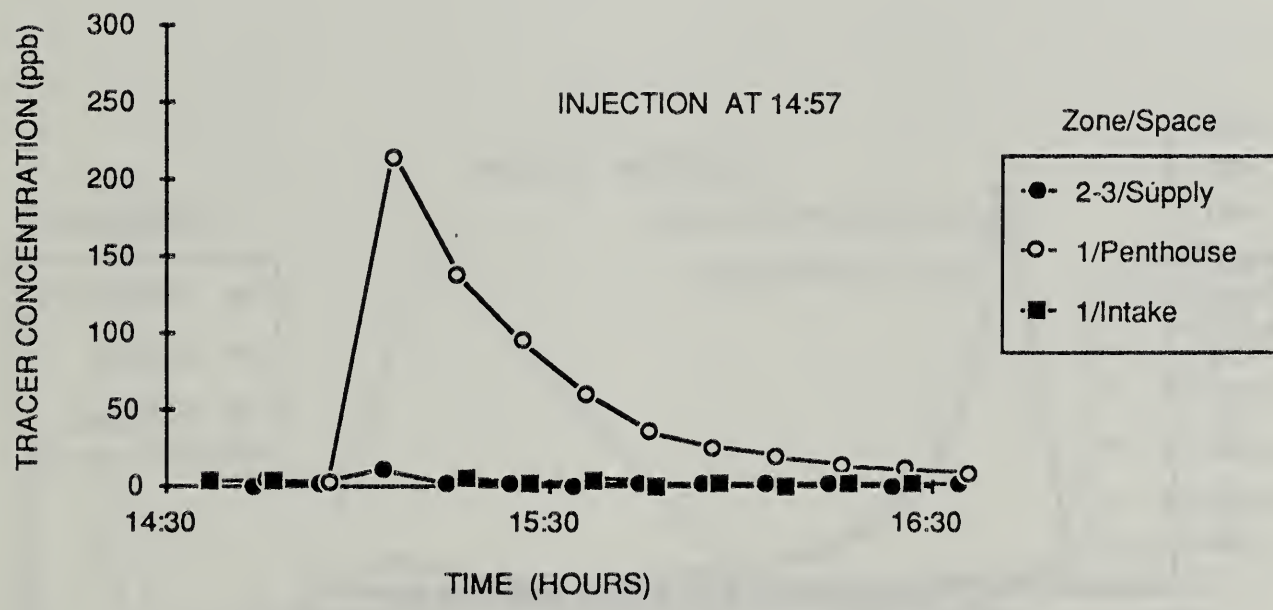
Figure 3.13 Tracer Gas Injection at Cafeteria Loading Dock

Figure 3.13 shows the tracer gas response to an injection at the cafeteria loading dock. The first plot shows a very strong response in the Treatment Area with a lesser response on Level 1B. Levels B3B and B2.5B exhibit even lower responses to this tracer gas injection. The second plot gives an indication of how the tracer gas gets into the ROB. This plot shows a very strong response in the Treatment Area mechanical room, but essentially no tracer gas in the Treatment Area air intake. Therefore the tracer gas is not getting into the Treatment Area through the air intake system. It is getting into the mechanical room, presumably through a ventilation grille for the penthouse located in the wall, near the exhaust grille. Once in the mechanical room, this air can get into the Treatment Area via leaks in the return air ductwork or other airflow paths. A small concentration response is seen in the supply duct serving Zones #2 and #3, indicating that some of this tracer gas is being entrained by the air intake of the supply fan serving these two zones.
