# NBS MONOGRAPH 158

## Corrosion and Protection of Steel Piles in a Natural Seawater Environment

This report describes the first eight years of a long term program in which twenty-three coating systems and five cathodic protection systems are evaluated on their ability to protect steel piles in offshore conditions. These systems are made up of nonmetallic coatings, metallic pigmented coatings, nonmetallic coatings on metal filled coatings, nonmetallic coatings on metallic coatings, metallic coatings, and cathodic protection on bare and coated piles.

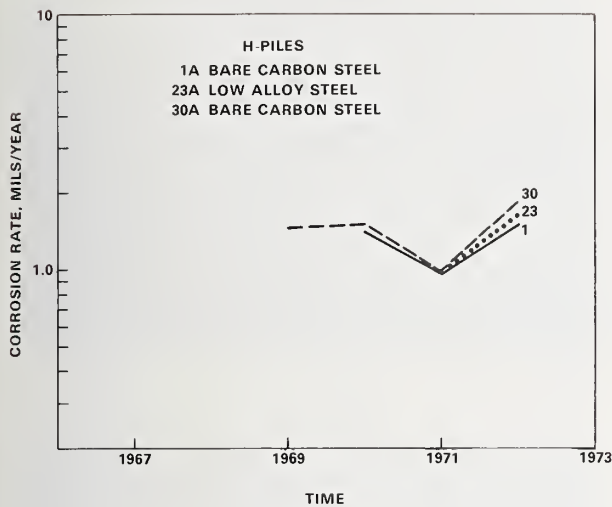
FIGURE 5

*Bare Piles*—After six years of exposure to the ocean, the corrosion of the bare piles has been extensive compared to that observed on the protected piles. These control specimens serve as a reference against which all protected piles are compared. Thus, they are important not only in their own right, but as standards of reference. The electrochemical measurements (fig. 5) indicate that their rate of corrosion has been fairly constant with time.

The last measurements of the A-piles were made in 1972 a few months before their removal for visual and physical inspection. Figure 5 shows that the corrosion rate of specimens 1A, 23A, and 30A was virtually identical in the four years the measurements were made. Specimen 23A is of special interest because it is a low alloy mariner steel. Their corrosion rate ranges from 1 to 2 mils per year (5 to 10 mdd<sup>2</sup>) for the entire area of the piles below the waterline. Electrochemical measurements were not made on 26A (pipe pile), or 31A.

All three of the uncoated carbon steel H-piles developed at least one perforation through the web in the splash zone. Specimen 23A, the low alloy steel H-pile, was not removed from the site and, therefore, physical measurements could not be made to verify the electrochemical measurements which indicate that its corrosion rate is essentially identical to that of 1A and 30A as shown in figure 5.

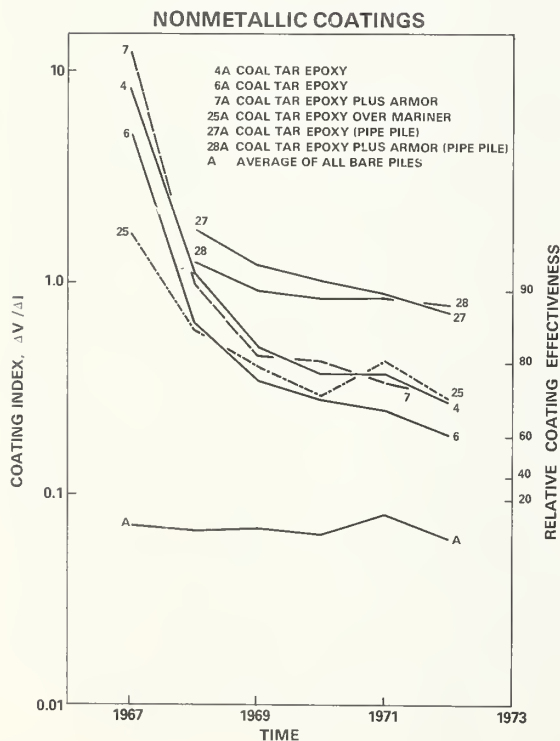
FIGURE 10

As a group, the coal tar epoxy paints have not performed as well as anticipated in the environment of this program. The electrochemical measurements made on the A-piles in the first five years are presented in figure 10. In this figure the coating index (electrical coating resistance) versus time is plotted. Thus, as the coating deteriorates more of the metallic substrate is exposed and the overall coating index drops. Similarly the relative coating effectiveness of the system drops. System 6, the polyamide-cured coal tar epoxy, appears to have deteriorated the most of the coal tar epoxies, but

The polyamide cured coal tar epoxy Systems 4, 7, and 25 are somewhat better than 6A and have a relative coating effectiveness of 70 in the same period of time as shown in figure 10. It is of interest to note that System 7, which has the aluminum oxide armor in the erosion zone, initially provided the highest degree of protection to the steel as indicated by the elec-

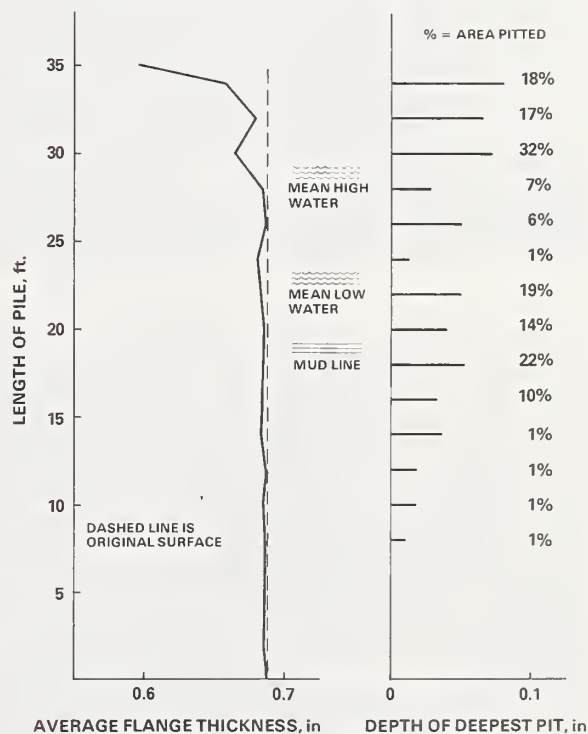
FIGURE 15

trochemical measurements. The physical measurements of these three piles are illustrated in figures 15, 16, and 17. The poor resistance of the coal tar epoxy coatings in the atmospheric and splash zones is well indicated in these drawings. Below the waterline, however, they have performed well. Pile 7A shown in figure 16 indicated that the armor coat did reduce the rate of coating deterioration in the erosion zone. Figure 18 is a photograph of the window in the atmospheric zone of pile 7A. Note the severe undercutting extending half the width of the pile. The window in the tidal zone, that zone between mean high water and mean low water, reveals only a slight amount of undercutting that extends 0.25 in (0.7 cm) as shown in figure 19. Pitting due to coating failure is evident. Below the mud line undercutting resistance is even better as shown in figure 20. Generally the coal tar epoxy looks good in this region.

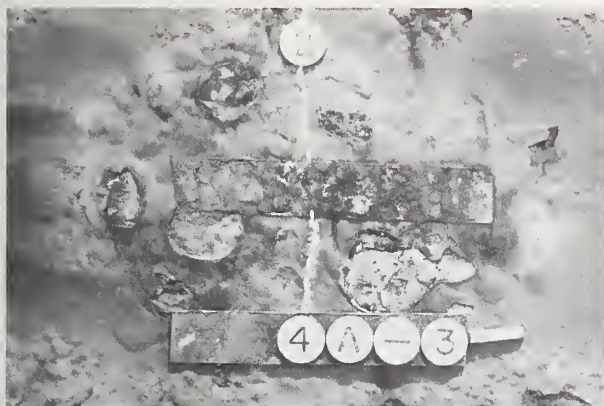
FIGURE 21

Pile 4A shown in figure 21 lacks the armor protection and has developed greater deterioration of the coating in the erosion zone as compared to pile 7A. The appearance of the window

in the atmospheric zone of pile 4A is similar to that of 7A after six years of exposure as figure 21 shows. In the tidal zone, however, the window on 4A has undergone considerable damage not readily seen in figure 22. Undercutting in this area extends almost 1 in (2.5 cm) beneath the coating. General damage to the coating in the surrounding area is also apparent. Below the mud line the coating is in excellent condition with practically no undercutting as shown in figure 23.

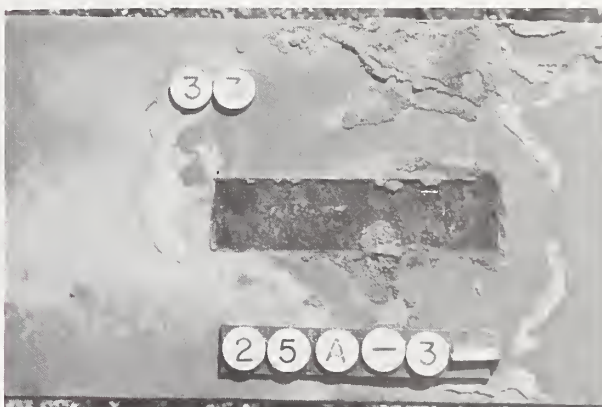
FIGURE 26

In the erosion zone, the coal tar epoxy on mariner steel, System 25, has not fared as well as the same coating on carbon steel (System 4A). Figure 17 indicates loss of metal at the flange in this area. Its pitting resistance below the mud line, however, is far better than any of the other similarly coated piles. Undercutting of the coating in the atmospheric zone is severe as illustrated in figure 24. Coating damage in the tidal zone is also very extensive (fig. 25). Below the mud line, however, figure 26 illustrates that the coal tar epoxy on mariner steel has not been undercut.

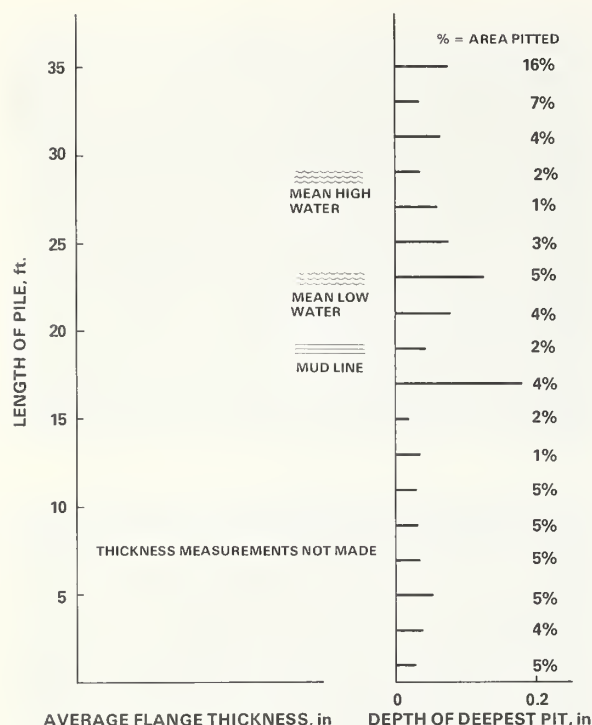
FIGURE 27

The physical measurements on the pipe piles consists only of pit depth measurements (figs. 27 and 28) as meaningful wall thickness measurements were not practical. These observations indicate that though there were fewer coating failures on the pipe piles, (% area pitted) as compared to the H-piles, the resulting pits were deeper on the pipe piles. The deepest pit in the erosion zone of 27A was almost 0.2 in (0.5 cm) deep. Undercutting of the coating on pile 27A extends about 2 in (5 cm) beyond the edge of the window as shown in figure 29, and is considered severe. In the tidal zone undercutting resistance is improved. Undercutting extends 0.5 in (1 cm) at the most (fig. 30). Figure 31 illustrates that below the

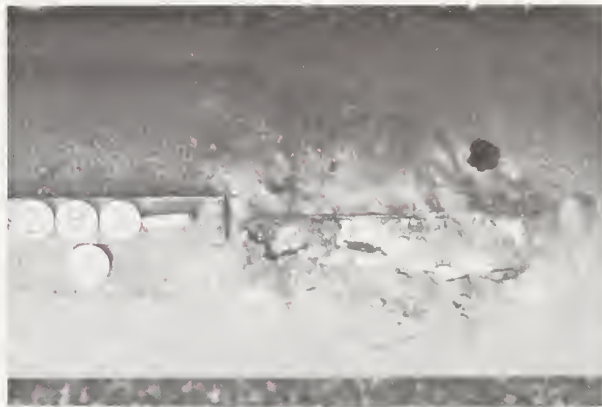
FIGURE 32

mud line, undercutting of the coating has progressed almost 1 in (2.5 cm) from the edge of the window. Coating delamination is also visible in this photograph. The windows in the coating on pile 28A are almost identical in appearance to those on 27A. In the atmospheric zone deterioration is extensive (fig. 32). In the tidal zone undercutting of the coating is moderate (fig. 33) with some mechanical damage visible. Below the mud line undercutting has progressed at least 1 in (2.5 cm) from the edge of the window (fig. 34).

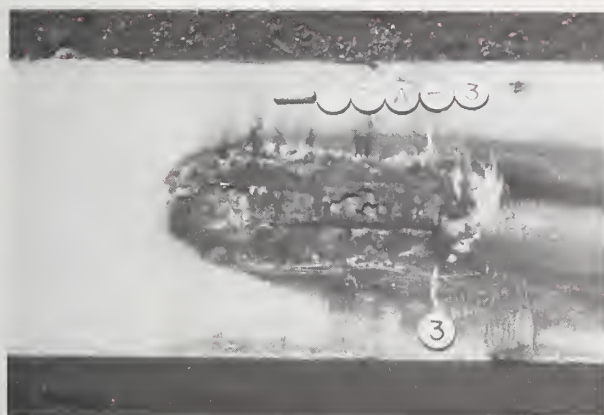
FIGURE 37

rosion observed on this system was just below the mean high water line with a rate of 0.15 mils per year (0.8 mdd). In the atmospheric zone, the window in the coating suffered only moderate undercutting as shown in figure 37 with a maximum penetration of 1 in (2.5 cm) or less. The same figure shows that the coating in the vicinity of the window is still in excellent condition. Most of the rusty color is surface staining of the coating. In the tidal zone (fig. 38) undercutting extends less than 0.25 in (0.6 cm) beyond the window. Some coating failure at the edge of the flange is visible in this photograph. Below the mud line undercutting was practically nonexistent as shown in figure 39. The dark globular material on the window is an adhering mud and sand mixture that apparently does not affect the phenolic mastic.

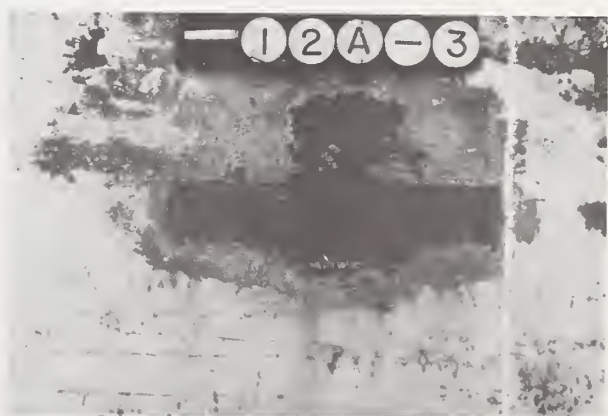
FIGURE 47

coating has been undercut almost two inches (5 cm) beyond the original edge of the window as shown in figure 47.

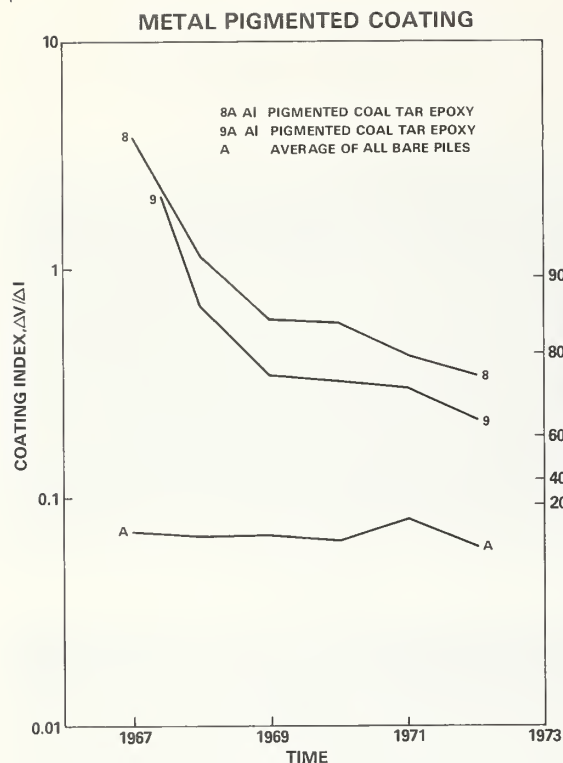
FIGURE 48

**Metal Pigmented Coatings**—Two aluminum pigmented coal tar epoxy coating systems (Systems 8 and 9) were included in the investigation. The electrochemical measurements on these two piles are illustrated in figure 48. From this figure one can see that the coating system on 8A has a relative coating effectiveness of over 70 while system 9A has slightly more than 60. The electrical resistivity of these two metal filled coatings is so high, that for all practical purposes they are nonconducting in the voltage ranges of our experiments. This is an important consideration as any conductivity through the film will affect the electrochemical measurements as will be pointed out later. The flange thickness measurements for pile 8A are illustrated in figure 49. This figure reveals that very little deterioration of the coating has taken place in the six years of exposure. Most of the damage to the coating has occurred in the erosion zone. The corrosion rate in this region has averaged less than 0.1 mil per year (0.5 mdd). The degree of pitting damage is

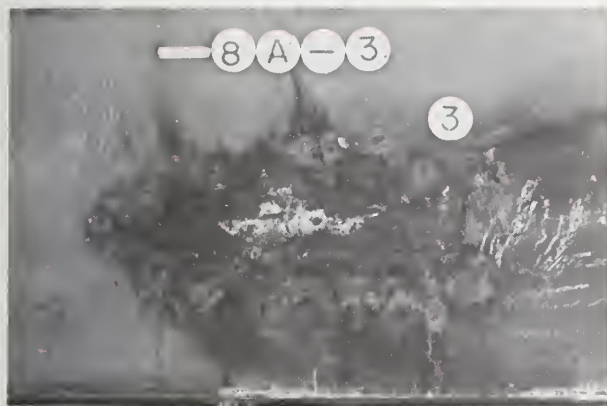
FIGURE 50

minor over most of the pile. In the atmospheric zone, undercutting of the coating extends less than 1.2 in (3 cm) beyond the original edge of the window as shown in figure 50. The same figure shows the otherwise excellent condition of the coating in the surrounding area. Most of the apparent damage is rust staining. In the tidal zone the coating at the edge of the window is in fairly good condition with only 0.1 in (0.2 cm) of undercutting as seen in figure 51. Some coating damage is visible in the surrounding area. Figure 52 is a similar window below the mud line which displays essentially no undercutting and no coating deterioration in the visible area.

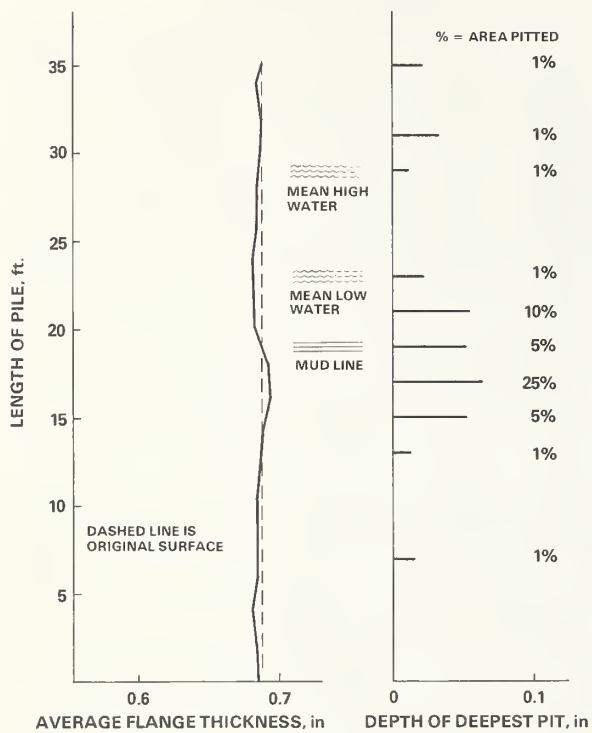
FIGURE 53

The second system of aluminum pigmented coal tar epoxy, System 9, has a film thickness that is 30 percent thinner than System 8. Specimen 9A has undergone more damage as the physical measurements illustrate in figure 53. Incomplete sandblasting of the surface during the cleaning process has caused the flange of specimen 9A in figure 53 to appear thicker in the erosion zone than it really is. The coating 1 in (2.5 cm) from the edge where the flange thickness measurements are made is in

good condition, but two or three inches (5 to 7 cm) from the edge, the coating had deteriorated as indicated by the pitting data in the same figure. The average corrosion rate over the entire surface of the pile is calculated to be slightly less than 0.2 mils per year (1 mdd). In the atmospheric zone, the coating window has produced undercutting extending about 1.5 inches (4 cm) under the coat as seen in figure 54. In the tidal zone, coating damage at the window is minor as can be seen in figure 55. Below the mud line undercutting has extended as much as 2 in (5 cm) under the paint system as shown in figure 56. Coating breakdown at the edge of the flange is also visible in this photograph. In general, both aluminum pigmented coal tar epoxy substrates have performed fairly well, although the thicker film, System 8A, has performed somewhat better in the six years of exposure.

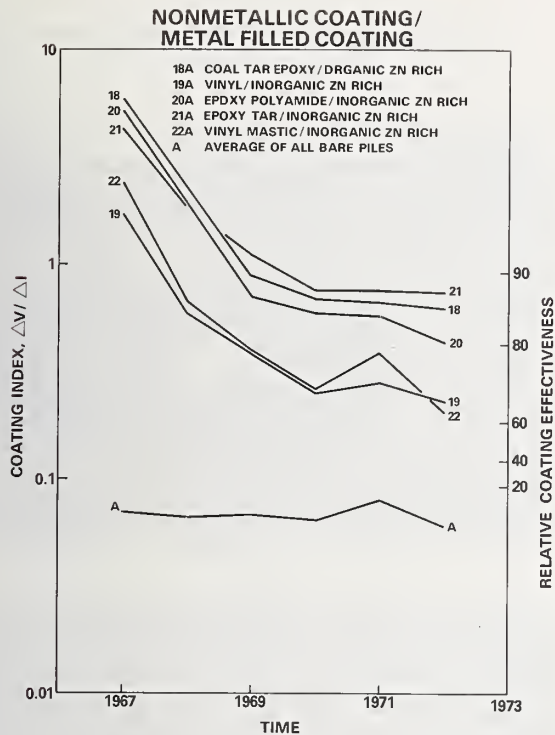
FIGURE 57

of these coatings. System 18, coal tar epoxy over zinc rich organic primer, is maintaining a relative coating effectiveness of 85. At the same time System 20, epoxy polyamide over zinc rich inorganic primer, has a relative coating effectiveness of 80. The coal tar epoxy over zinc rich inorganic primer, System 21, also has a relative coating effectiveness of 85. The relative coating effectiveness of these three systems may actually be slightly better than indicated by the electrochemical data. The reason being that as the overcoat erodes away or fails from some other cause, the electrically conducting metal filled undercoat is exposed. This undercoat may be protecting the steel very well, but because of its low electrical resistance it displays a lower coating effectiveness (coating index) than it really has.

Attention is again directed to figure 57 which illustrates the electrochemical data for the nonmetallic coatings on metal filled coatings. Systems 18, 20, and 21 have been described. The remaining systems in this category are piles 19A (vinyl over zinc rich inorganic primer), and 22A (vinyl mastic over zinc rich inorganic primer).

The electrochemical data indicate that Systems 19 and 22 are very similar in their deterioration and degree of protection as figure 57 illustrates. The relative coating effectiveness

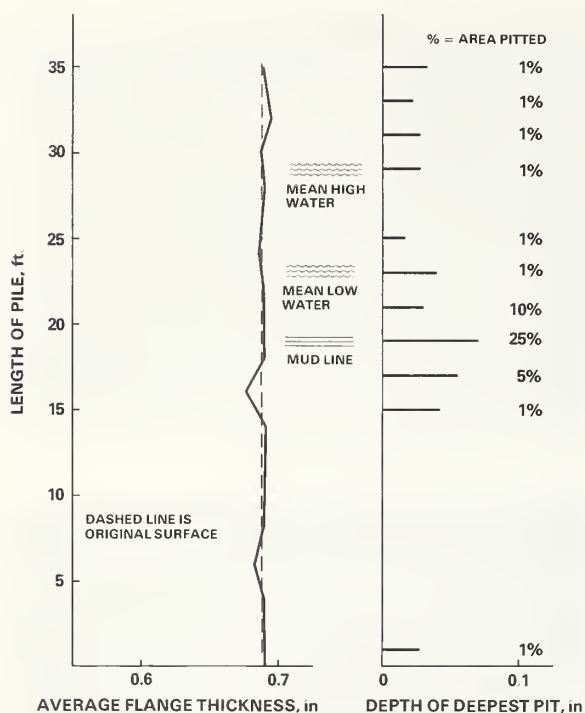
FIGURE 62

System 20A has also shown good resistance to the ocean exposure as illustrated by the physical measurements of figure 62. In this case some deterioration has occurred at the erosion zone, but with insignificant attack below the mud line. The coating was not completely removed in some areas which accounts for the flange appearing thicker than it was originally. This certainly indicates that the coat was still protecting in these areas. The average corrosion rate for this pile was considerably less than 0.1 mil per year (0.5 mdd). Undercutting resistance has been very good in all zones. The window located in the atmospheric zone developed less than 0.5 inches (1.2 cm) of undercutting as shown in figure 63. General pitting can be seen in the surrounding coating. Figure 64 illustrates the excellent appearance of the coating in the tidal zone. Below the mud line undercutting resistance is also very good, however, some blistering is visible in the coating in the adjacent areas (fig. 65).

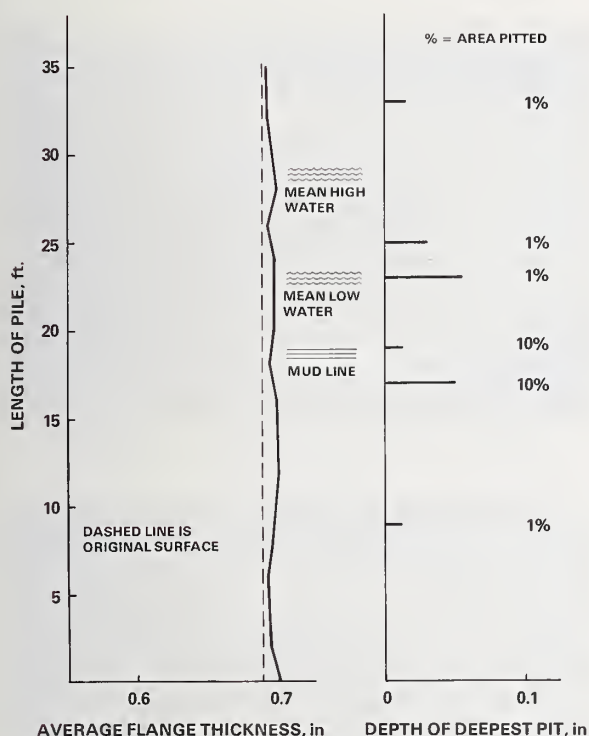
FIGURE 66

System 21 has displayed unusually good resistance to deterioration in the offshore exposure as shown in the physical measurements of figure 66. Incomplete sandblasting has led to the data showing the flange to be thicker than it was originally. As mentioned before, this clearly indicates that there was no metal loss in these areas. Thus, pile 21A is in excellent condition after six years of exposure. The amount of pitting is minor as the same figure shows. Undercutting of the coating in the atmospheric zone has been moderate with damage extending about 0.6 in (1.5 cm) beyond the window as seen in figure 67. The coating in the surrounding area is in excellent condition. In the tidal zone undercutting is of minor consequence and extends less than 0.1 in (0.2 cm) as illustrated in figure 68. Below the mud line there was no measurable undercutting of the coating as shown in figure 69. Mechanical damage to the edge has removed some of the coating.

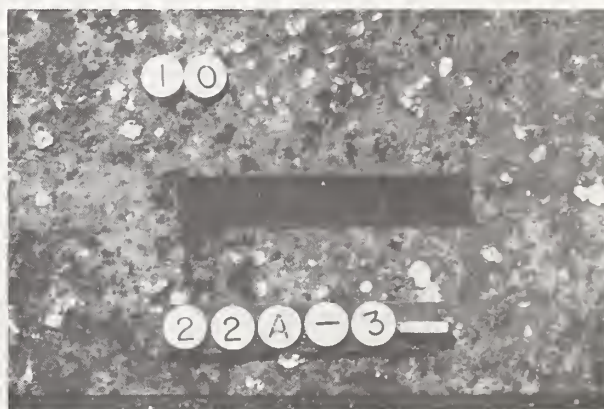
FIGURE 76

There is very little attack in the atmospheric zone. Undercutting in this area is less than 0.1 in (0.2 cm) as shown in figure 75. In the tidal zone general deterioration of the coating has taken place, but with very little actual metal loss. This is illustrated in figure 76. Undercutting here is also less than 0.1 in (0.2 cm). Below the mud line undercutting extends about 0.2 in (0.5 cm) beyond the window as figure 77 shows. Notice the blistering of the coating in the surrounding area. The overall average corrosion rate for pile 22A is less than 0.25 mils per year (1.4 mdd).

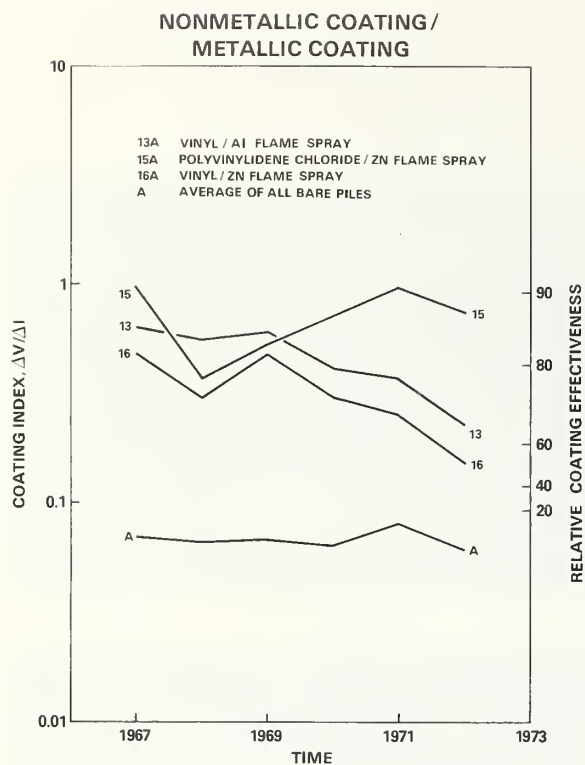
FIGURE 78

The vinyl over zinc flame spray system, pile 16A, has undergone the most deterioration of the topcoated metallic coating systems. The relative coating effectiveness of 16A is about 50 percent as figure 78 illustrates. After the top coat began to fail during the first year of exposure, the flame sprayed zinc protected the piling for a short period. Soon after, however, the system started to deteriorate steadily. It is of interest to note that the total coating thick-

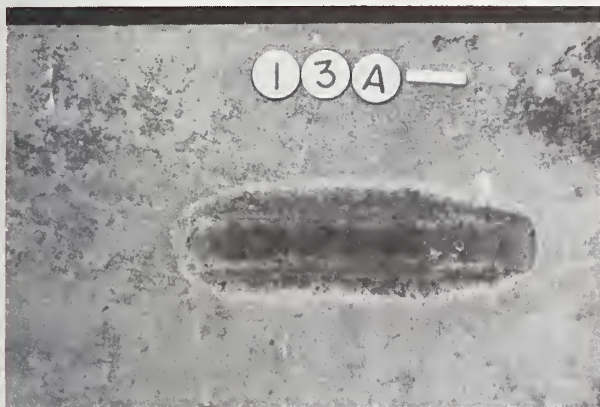
FIGURE 80

been less than 0.05 mils per year (0.3 mdd) for the six years of exposure.. In the atmospheric zone, the coating is in excellent condition. Corrosion damage extends slightly less than 0.5 in (1.2 cm) from the edge of the window as shown in Figure 80. Undercutting of the coating at the window in the tidal zone is too slight to be measurable, however, general coating failure is visible as figure 81 shows. Though the coating has obviously deteriorated below the mud line (fig. 82), there has been little subsequent attack to the steel pile. Damage to the coating at the window extends about 0.1 in (0.2 cm).

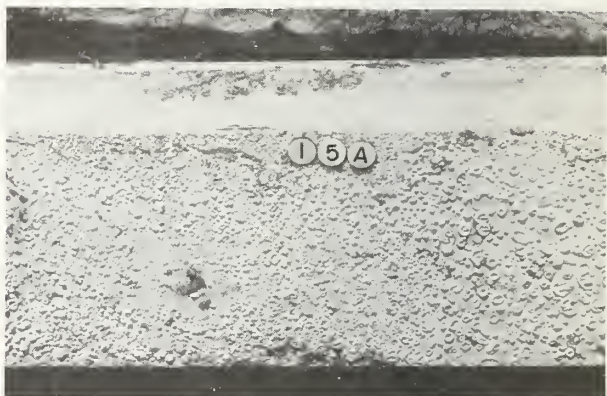
FIGURE 85

loss is small and uniform over the surface of the pile. Similarly, pitting is scattered and of minor consequence. The average corrosion rate for the entire pile is about 0.1 mil per year (0.5 mdd). There were no windows in the coating of this pile. The following photographs are included to display its appearance in areas similar to those seen for the other pilings. The coating in the atmosphere is in very good condition with only minor damage in a few areas. Unfortunately the photograph of this area is of such poor quality that it will not be shown. In the tidal zone the nonmetallic coating is badly blistered as figure 84 shows, but the piling is still being protected by the zinc. Top coat blistering extends into the area below the mud line as figure 85 illustrates, but corrosion damage to the pile is minor.

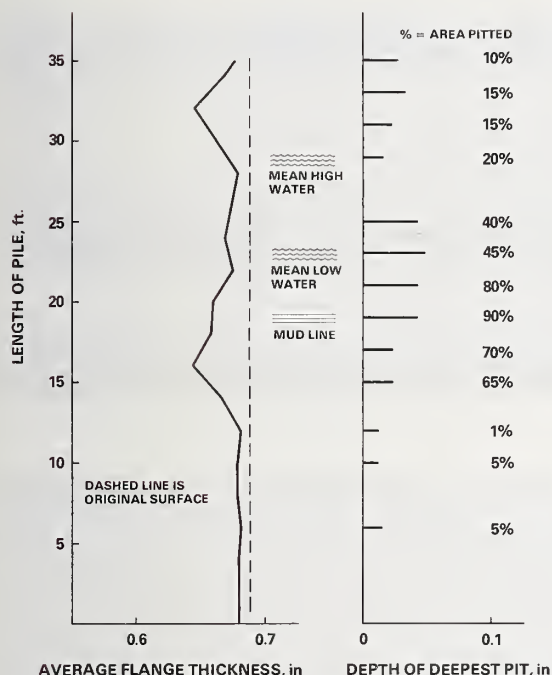
FIGURE 86

ness of this system is about 50 percent less than that of pile 15A. Corrosion damage to the steel pile in the form of general corrosion and pitting has been extensive as the plot of the physical measurements in Figure 86 illustrate. The average corrosion rate for the entire pile is about 1.5 mils per year (8 mdd). In the atmospheric zone coating failure was severe as figure 87 shows. The window in the coating is barely visible. In the tidal zone failure was also extensive as shown in figure 88. Figure 89 illustrates the condition of the piling below the mud line where it has fared somewhat better than in other zones. With such complete failure of the coating, evaluation of the undercutting is of no consequence and, therefore, is not attempted.

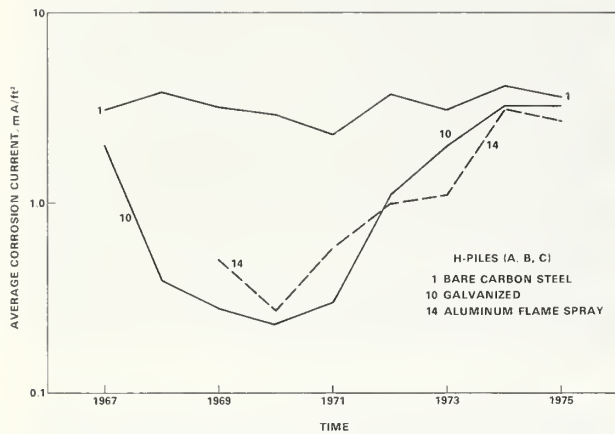
FIGURE 90

The flame sprayed aluminum system, pile 14A, is similar to pile 10A in its electrochemical behavior as indicated in figure 90. It too shows an increase in corrosion which is approaching that of bare steel as the aluminum deteriorates. The flange thickness measurements, figure 95, reveal some metal loss in the erosion zone, and practically no pitting anywhere. In the atmospheric zone the aluminum flame spray coating appears in excellent condition with the exception of the corrosion damage extending almost 1 in (2.5 cm) from the window shown in figure 96. In the tidal zone the coating is also in excellent condition (fig. 97) with minor damage extending from the window. From the mud line down, however, damage is more extensive. Figure 98 illustrates the window in this region with coating damage over most of the visible surface.

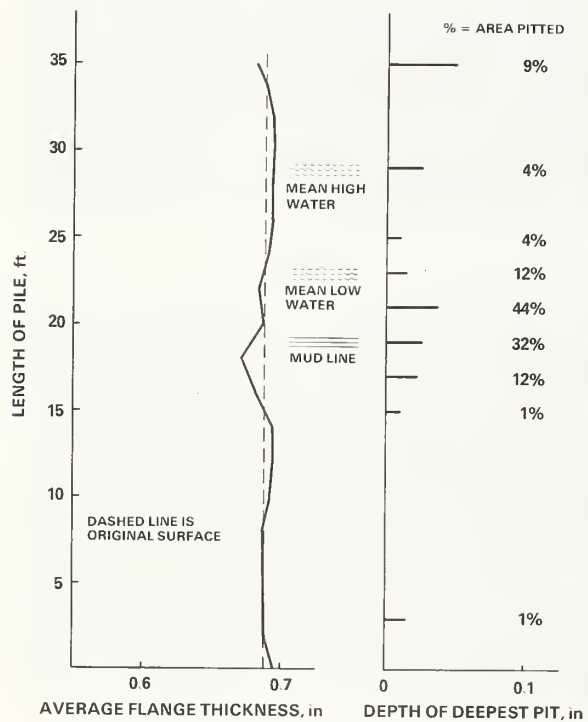
FIGURE 91

The results on the bare carbon steel piles are shown for reference as was done in all illustrations of electrochemical data. The corrosion current indicates that the bare steel corroded at a relatively uniform rate with time while the corrosion of the galvanized pile, 10A, has changed considerably in the same period. During the first three years, the corrosion current decreases by a factor of ten. Thereafter it increased steadily until now, eight years later, it is approaching the corrosion of the bare carbon steel pile. This data on the galvanized steel is made up of information from piles A, B, and C, two of which are still at the offshore site. Figure 91 illustrates the physical measurements on pile 10A. The pile shows some

corrosion in the atmospheric zone and considerable corrosion in the abrasion zone. The average corrosion rate for the pile is less than 0.15 mils per year (0.8 mdd). There are no windows in this system, but photographs are included for information. Above the high water line, coating failure is in the form of pits as figure 92 illustrates. In the tidal zone pitting continues along with some undercutting of the coating. A small section of coating was easily separated from the substrate as figure 93 shows. Below the mud line the coating was very thin or altogether missing in some areas as figure 94 illustrates.

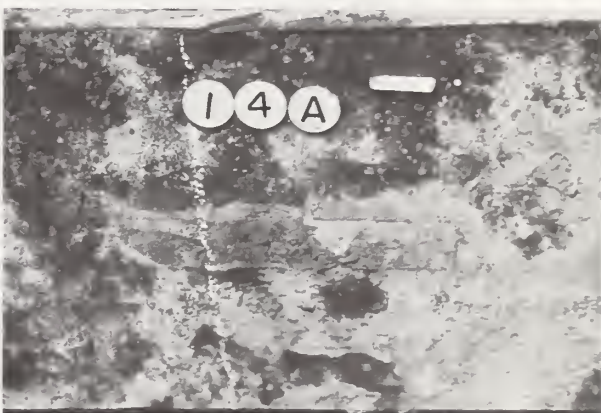
FIGURE 98

*Sealed flamesprayed aluminum*

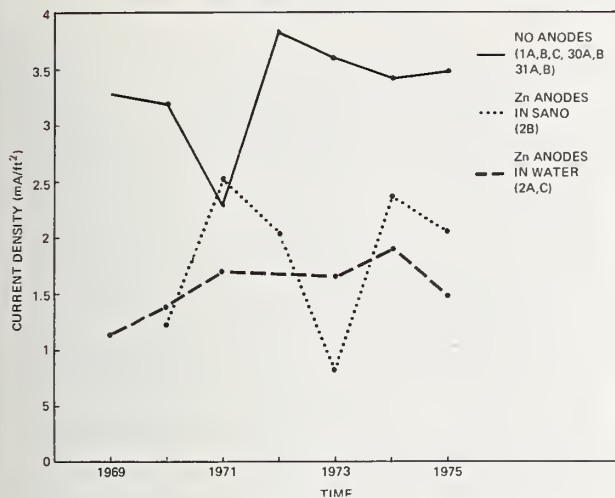
FIGURE 99

The average corrosion current densities of several bare steel piles and the average protective current densities of steel piles with zinc anodes are plotted in figure 99. The protective current density of the protected piles represent both the galvanic current as well as local action current on the anodes. The local action current was not directly determined but it has

As seen in figure 99, the protective current densities of the zinc anode protected systems are less than those of the unprotected piles. It appears that there is not very much difference in the protective current densities provided by the anodes in the water and buried in the sand over the 6 year period (1970 to 1975). More time will be required to determine any real differences.

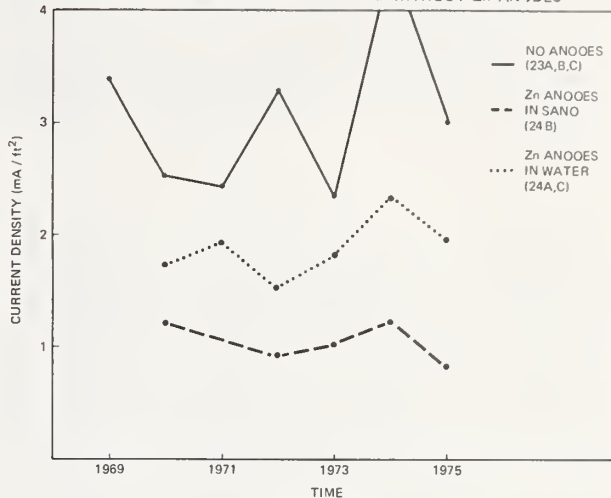
FIGURE 101

In the case of mariner steel, however, the protection current density of the zinc anodes buried in the sand, over the 6 year period, is definitely less than the current density of the zinc anodes exposed to the water (fig. 101).

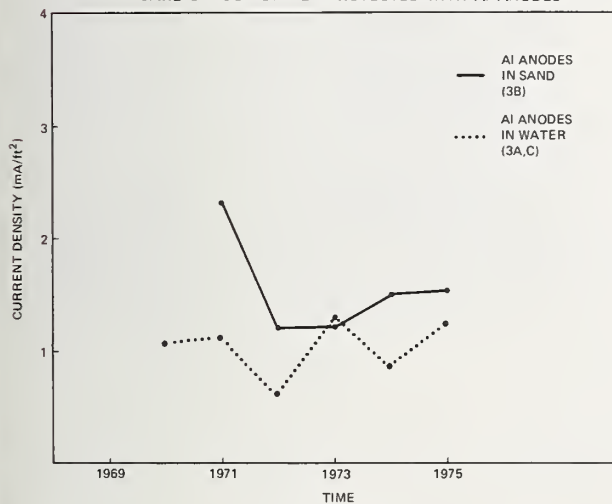
FIGURE 100

Aluminum anodes in the sand appear to be less effective than the anodes in water in protecting the steel (fig. 100).

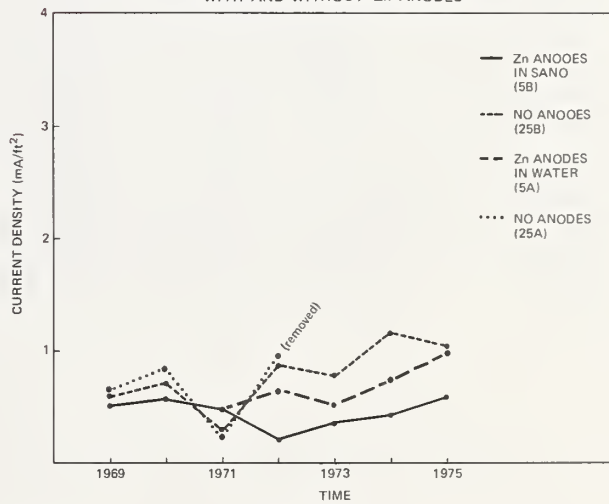
FIGURE 102

The coal tar epoxy coated piles, with zinc anodes in the sand appear to be more effective (from a galvanic current standpoint) than the coated piles without cathodic protection except for one year (1971). For the piles with windows (5A and 25A), there was little discernible differences for two years (1971, 1972) between the piles with anodes in the water and the piles without anodes (fig. 102).

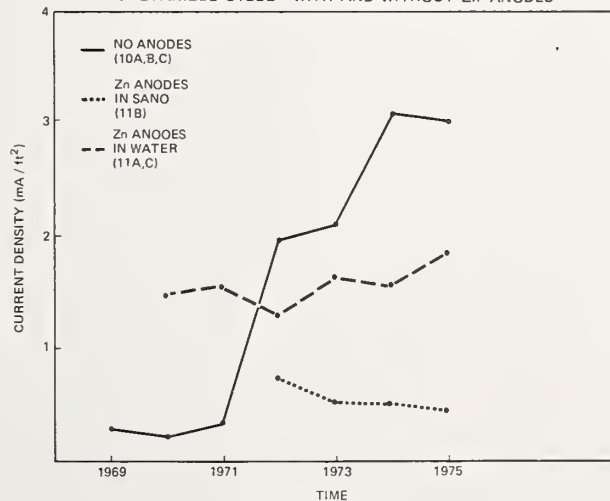
FIGURE 103

A comparison of the galvanized pile, with zinc anodes (System 11) and without zinc anodes (System 10), is shown in figure 103. Only a portion of the curve for the protective current density of the galvanized pile is shown. From 1973 to 1975 the curve represents the averages on piles B and C. Initially (1967) the average corrosion current density on piles A, B, and C was quite high and then decreased to very low values for 1967-1971 (fig. 90). The protective current density is very low for the zinc anodes buried in the sand and appears to be steadily decreasing with the passage of time. The protective current density for the zinc anodes in the water is about 3 times higher and appears to be increasing with time.
