**NIST NCSTAR 1-3**

**Federal Building and Fire Safety Investigation of the  
World Trade Center Disaster**

**Mechanical and Metallurgical  
Analysis of Structural Steel**

September 2005

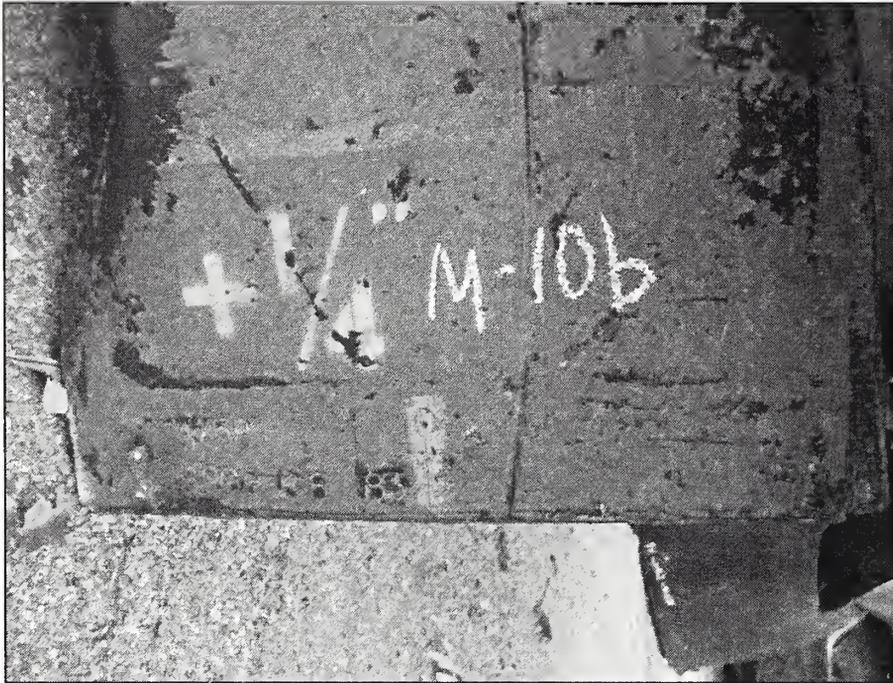
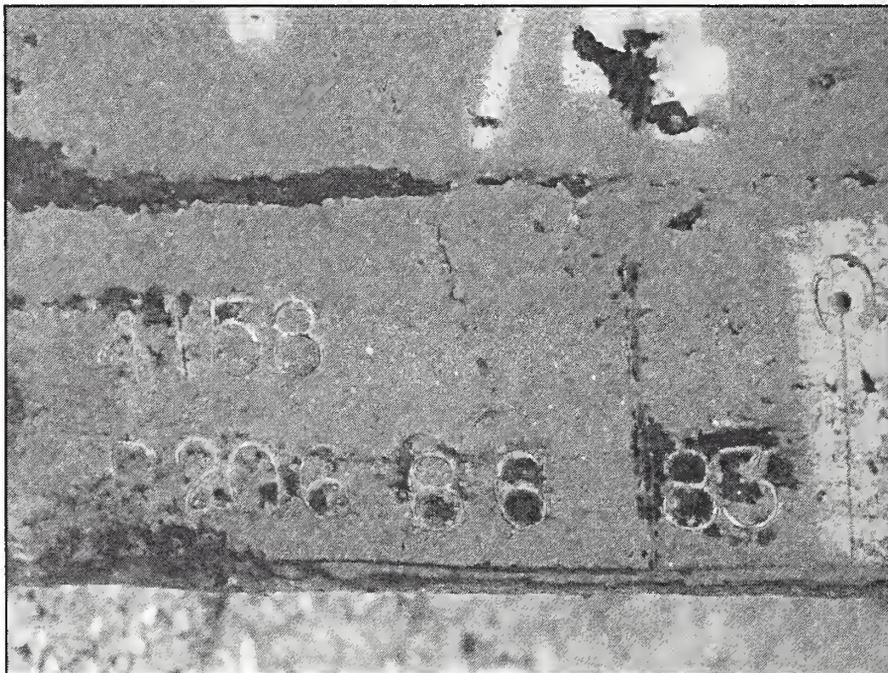
**Figure 5–1. Example of stampings on the interior base of the middle column for each panel. Shown here on panel M-10b are the stampings “B206 86 83,” indicating that it is from WTC 2, column number 206, spanning floors 83 to 86.**

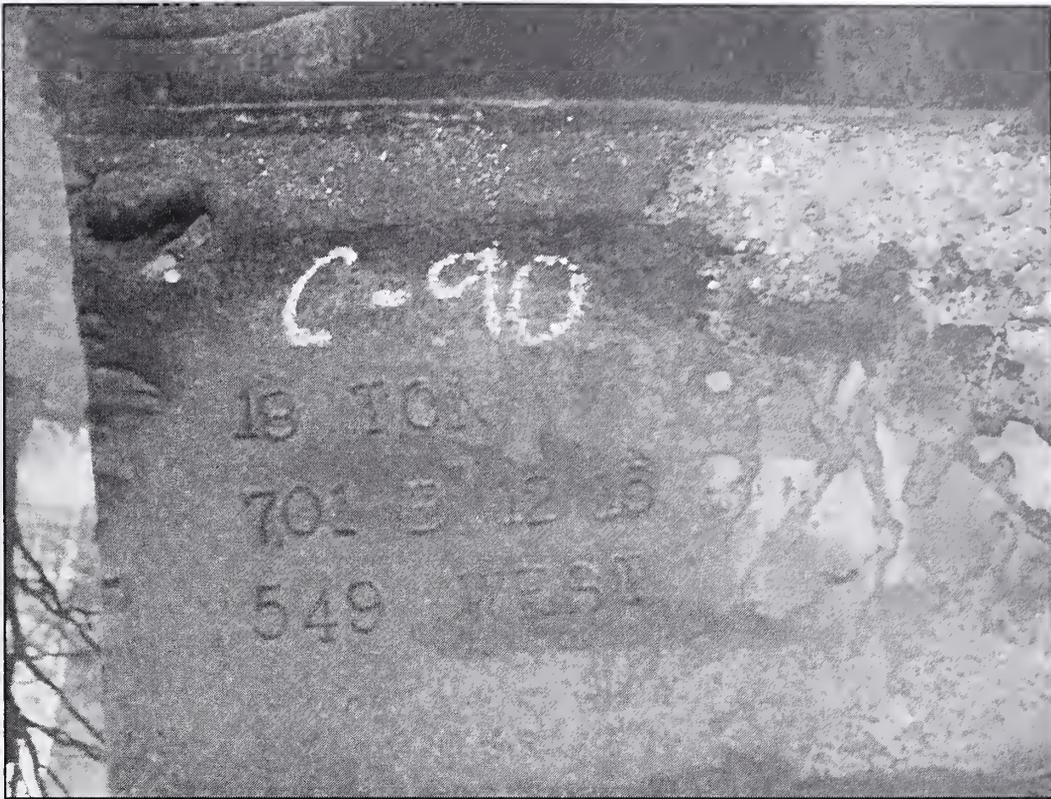
**Figure 5–2. Example of stampings placed on one end of a core column. Shown here on sample C-90 are the stampings “18 TON, 701 B 12 – 16, 549 WEST,” indicating that it is from WTC 2, core column number 701, and spans floors 12 to 16. Also indicated are the approximate weight of the piece (18 tons) and the derrick division <549> that was to lift it into place.**

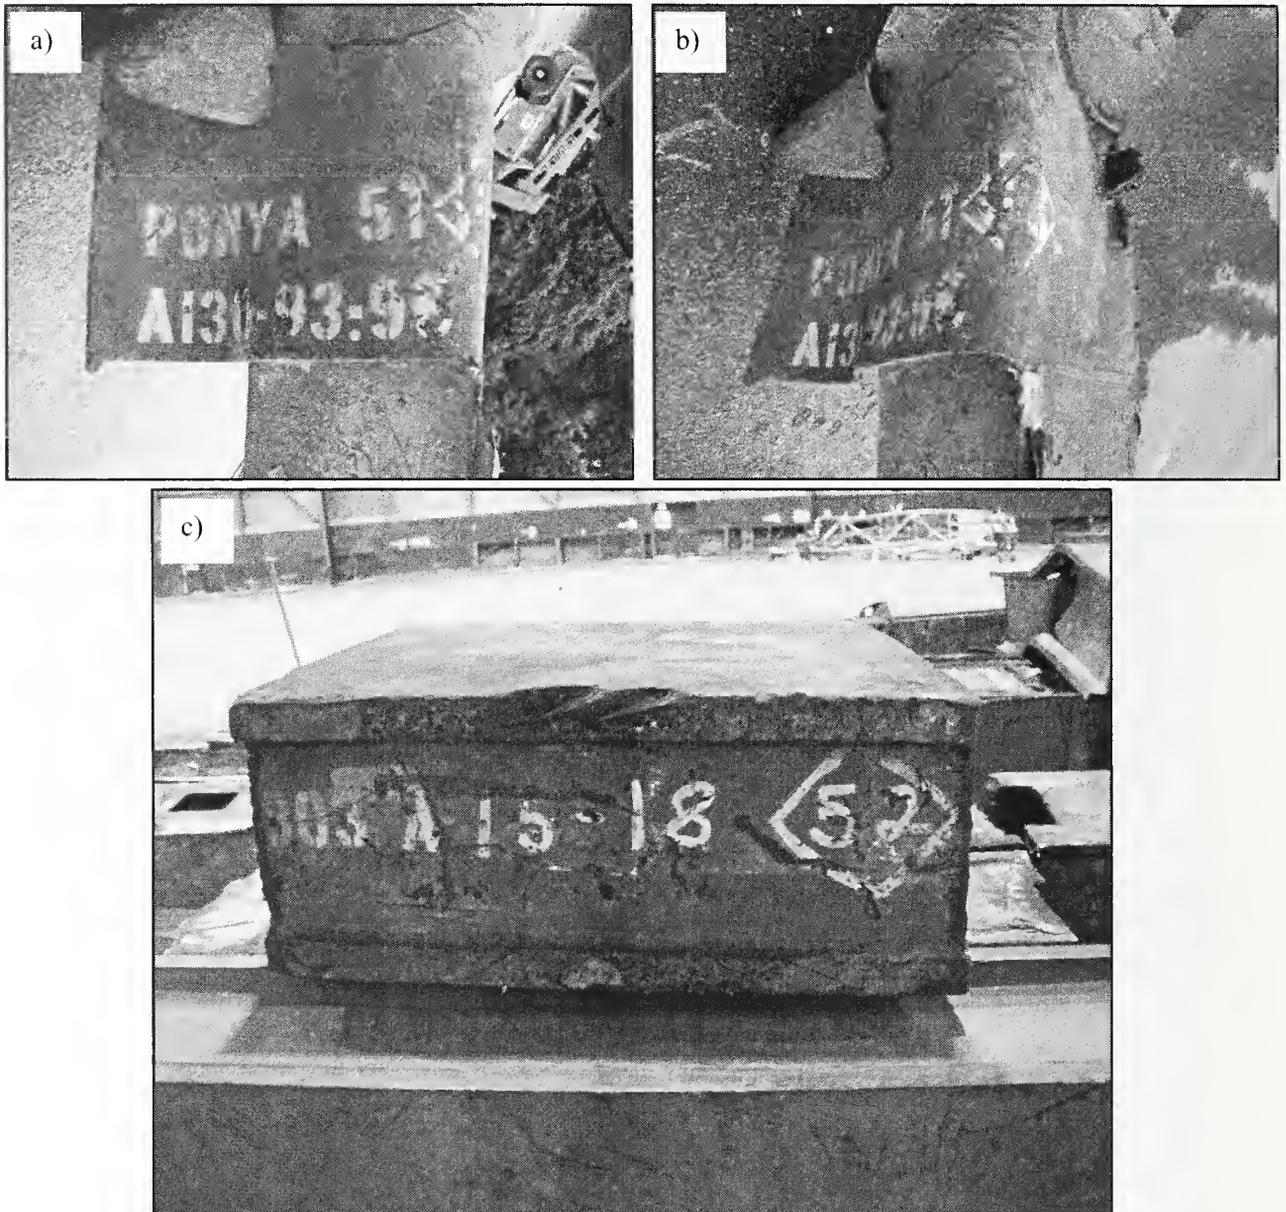
Also seen in Fig. 5–3a are two other markings, “5T” and “<63>”, found on the exterior panel sections. These markings are the estimated piece tonnage (1 ton equals 2,000 lbs, or approximately 907 kg) and erector’s derrick division number, respectively. This information was also stamped on some of the core column pieces, see Fig. 5–2. The erector, Karl Koch Erecting Co., Inc., assigned derrick divisions 47 through 70 for WTC 1 and derrick divisions 547 through 570 for WTC 2 (PONYA 1967). Each division was assigned to a specific area of the building and shared one of four cranes with other nearby derrick divisions. For example, a single crane may have lifted pieces from derrick divisions 65, 67, and 69. Several derrick divisions that hoisted the specific columns for both buildings have been identified, based on derrick numbers found on structural elements with positive identification, providing additional information to help identify partially identified panels (NIST NCSTAR 1-3B).

**Figure 5-3. a) and b) Characteristic stenciling found on the lower portions of the exterior column panels for sample M-27. Markings indicate this piece was in WTC 1, column number 130, spanning floors 93 to 96. Also seen are two other indicators, “5T” and “<63>,” indicating the estimated piece weight in tons and erector’s derrick division number, respectively. c) Characteristic stenciling found on core column for sample B-6152-1. Markings indicate this piece was in WTC 1, column number 803, spanning floors 15 to 18 with a derrick division number of <52>.**

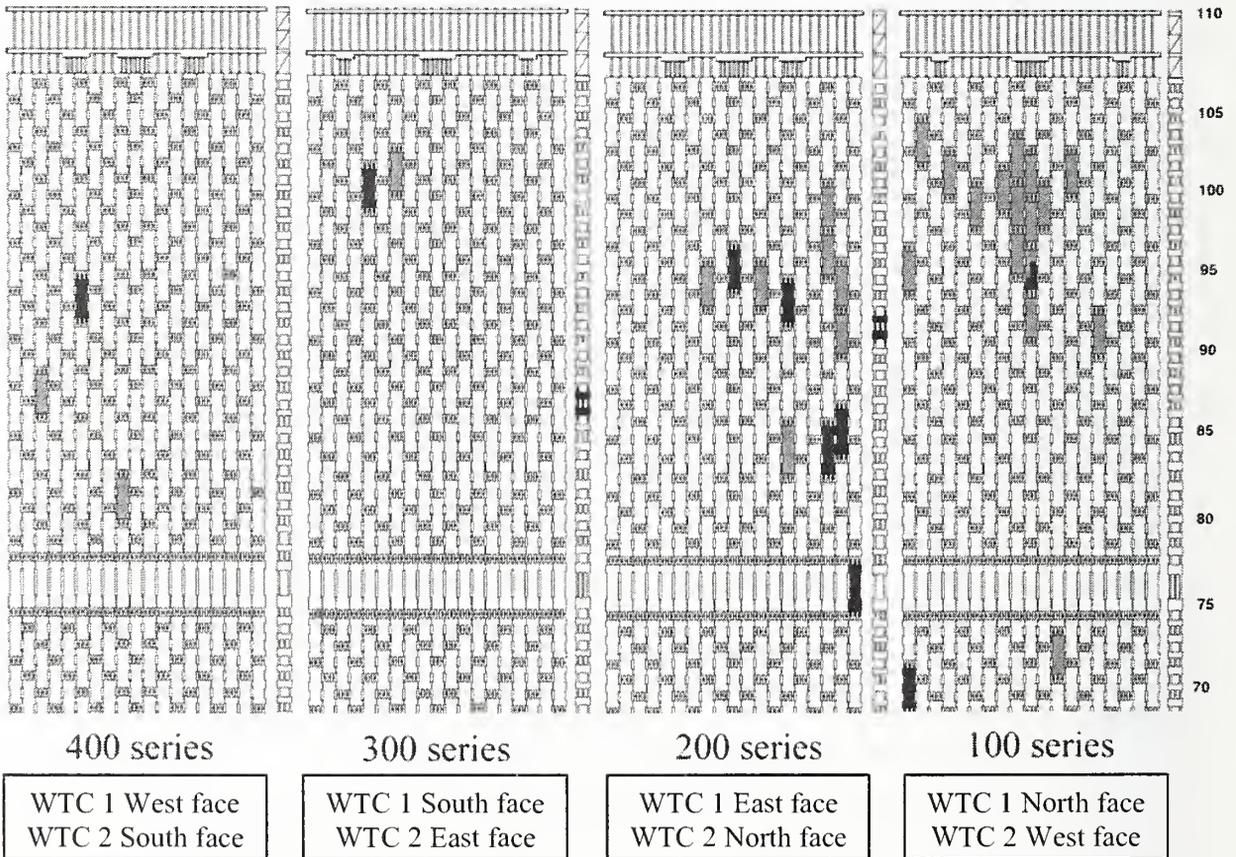
**Figure 5–4. Location of the exterior panels recovered from the top third of the WTC towers. Recovered WTC 1 panels are shown in light shading/green and WTC 2 panels are in dark shading/blue.**

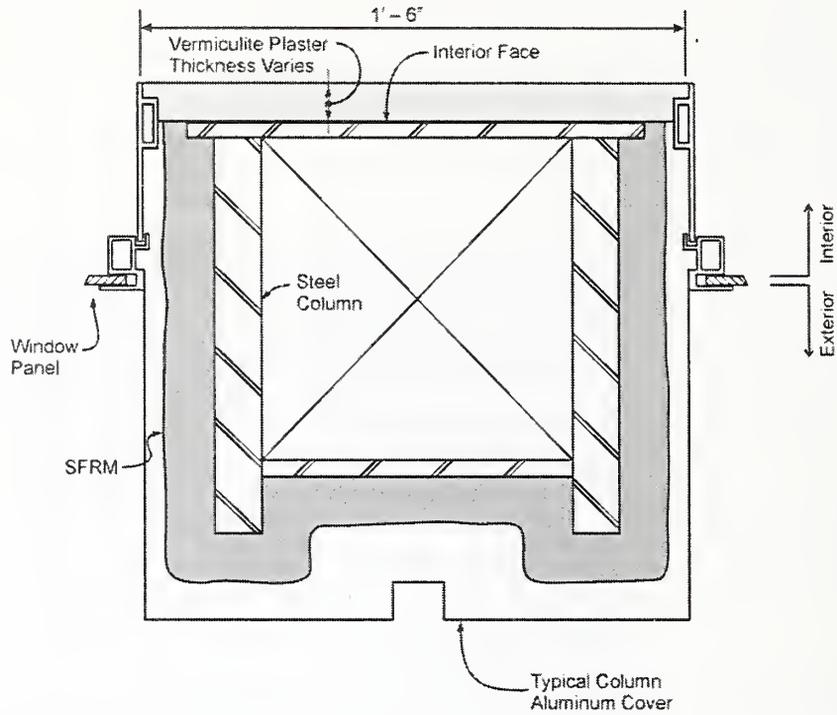
The north face of WTC 2 contained the exit holes for some of the debris from the collision of the aircraft. This debris consisted of aircraft components, building contents, and possibly structural parts of the building. This debris impacted the interior of the north wall, blowing out windows, damaging exterior columns and removing aluminum exterior panels and SFRM from the columns.

A broad region of the north face of WTC 2, spanning columns 230 through 259 and the 79th through 82nd floors, had the exterior aluminum panels and SFRM damaged or removed due to debris impact from within the building. In particular, a rectangular region consisting of columns 239 through 249 on floors 79 through 81 was found to be completely free of aluminum panels, and the best observations of SFRM damage were made here (Fig. 6–10). Red arrows indicate where the SFRM was dislodged from the outer web between the protruding tips of the flanges. This determination was made using this image and other higher resolution images. The appearance of white linear features on the edge of the columns, at this angle of solar illumination, shows the absence of at least some, if not most SFRM from the center region of the outer web of the column. In contrast, column 246 (green arrow) shows bright contrast

**Figure 6-6.** Diagrams showing how the fireproofing was to be applied to the exterior columns, and the exterior aluminum panels were attached to the window frames.

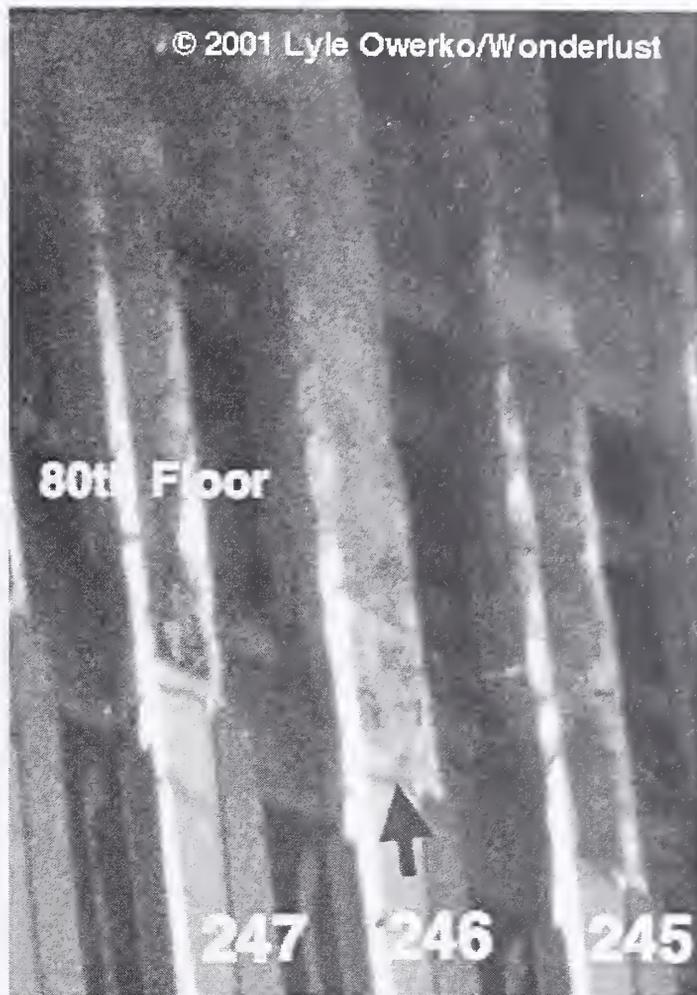
Figure 6–7. Fireproofing that had been applied to the exterior columns. The depression formed by the outer web and the flange tips are completely filled in with fireproofing at the arrow. North face of WTC 2.

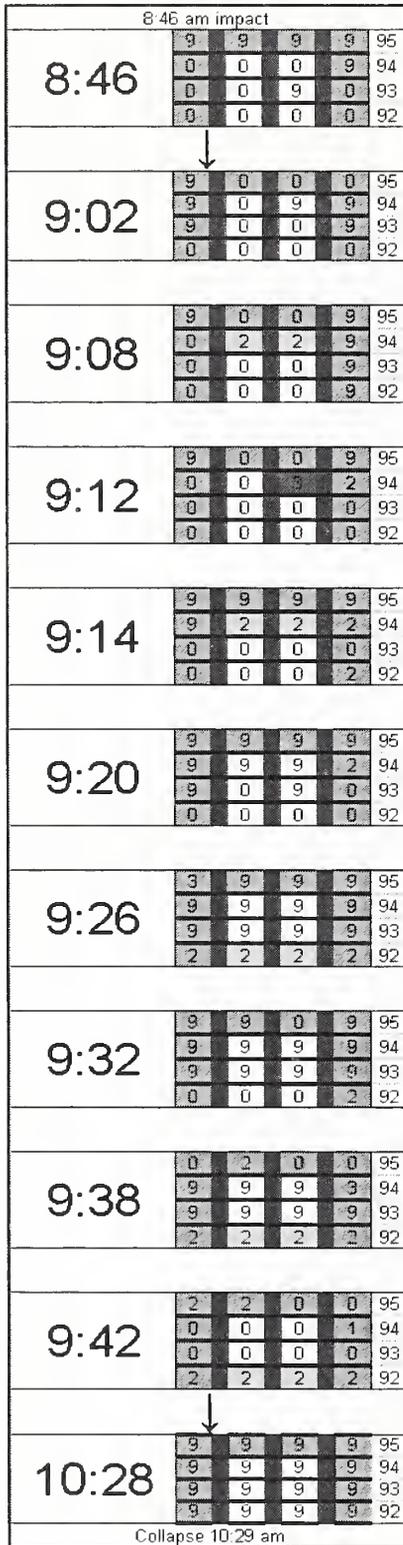
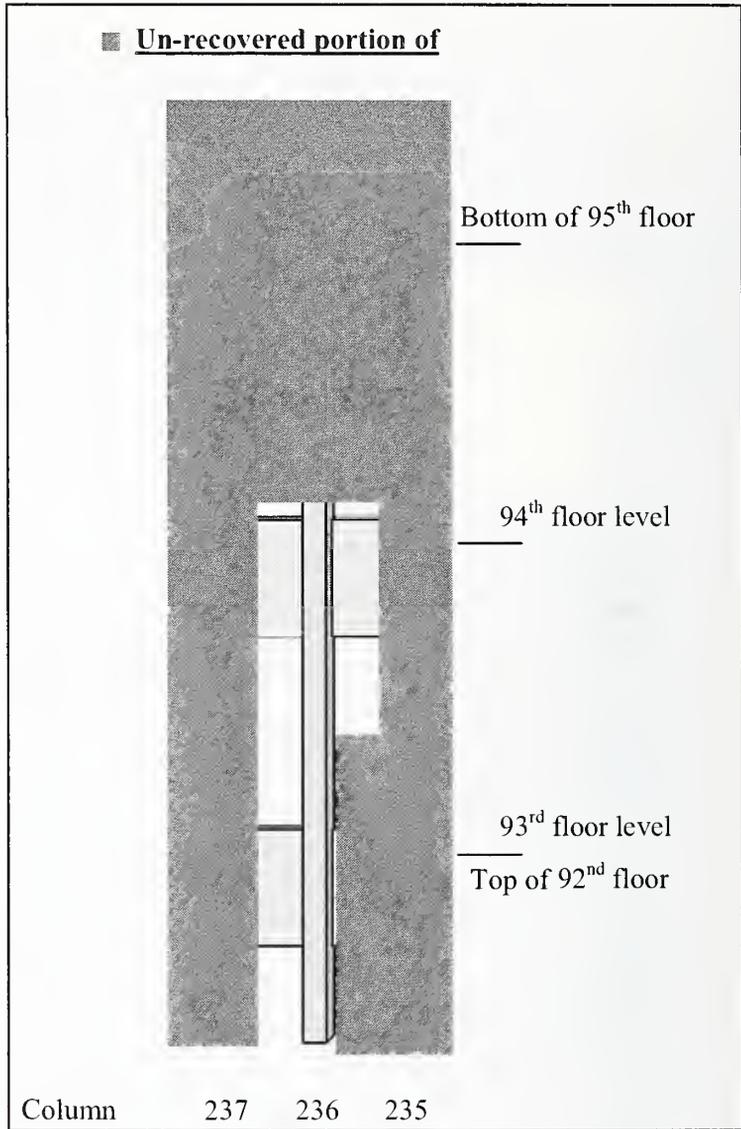
**NIST Name:** K-2  
**Panel ID:** A236: 92-95  
**Panel location:** WTC 1, East face

**Figure 6-13. Time-fire exposure map for panel K-2 (A236: 92-95). Fire can be observed on the 92nd and 94th floors of the panel.**

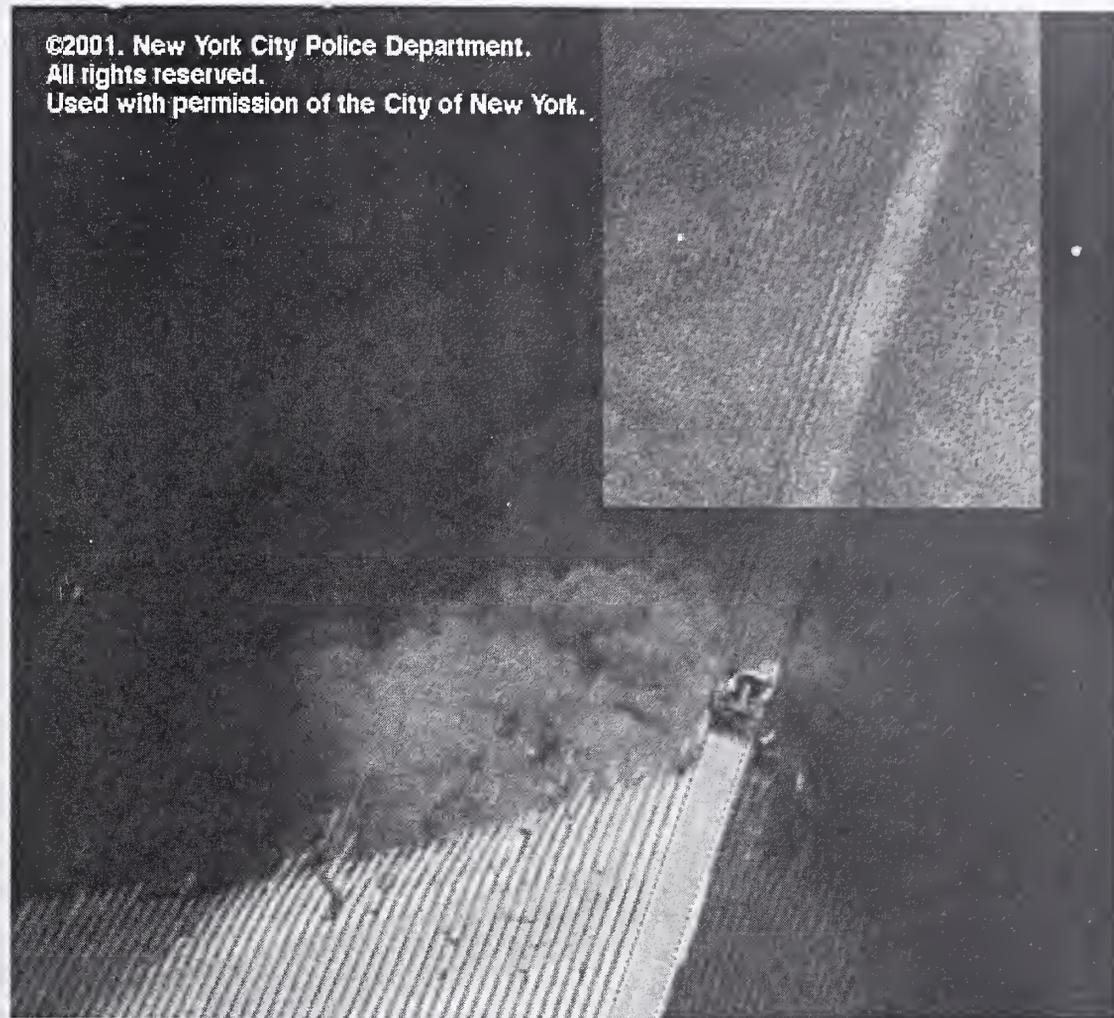
**Figure 6–21. Northeast corner of WTC 2, several seconds before collapse. The corner shows no distortion of the type in the previous figure, implying that the distortion accompanied the collapse and did not precede it. The region in the upper right is enhanced for visibility.**

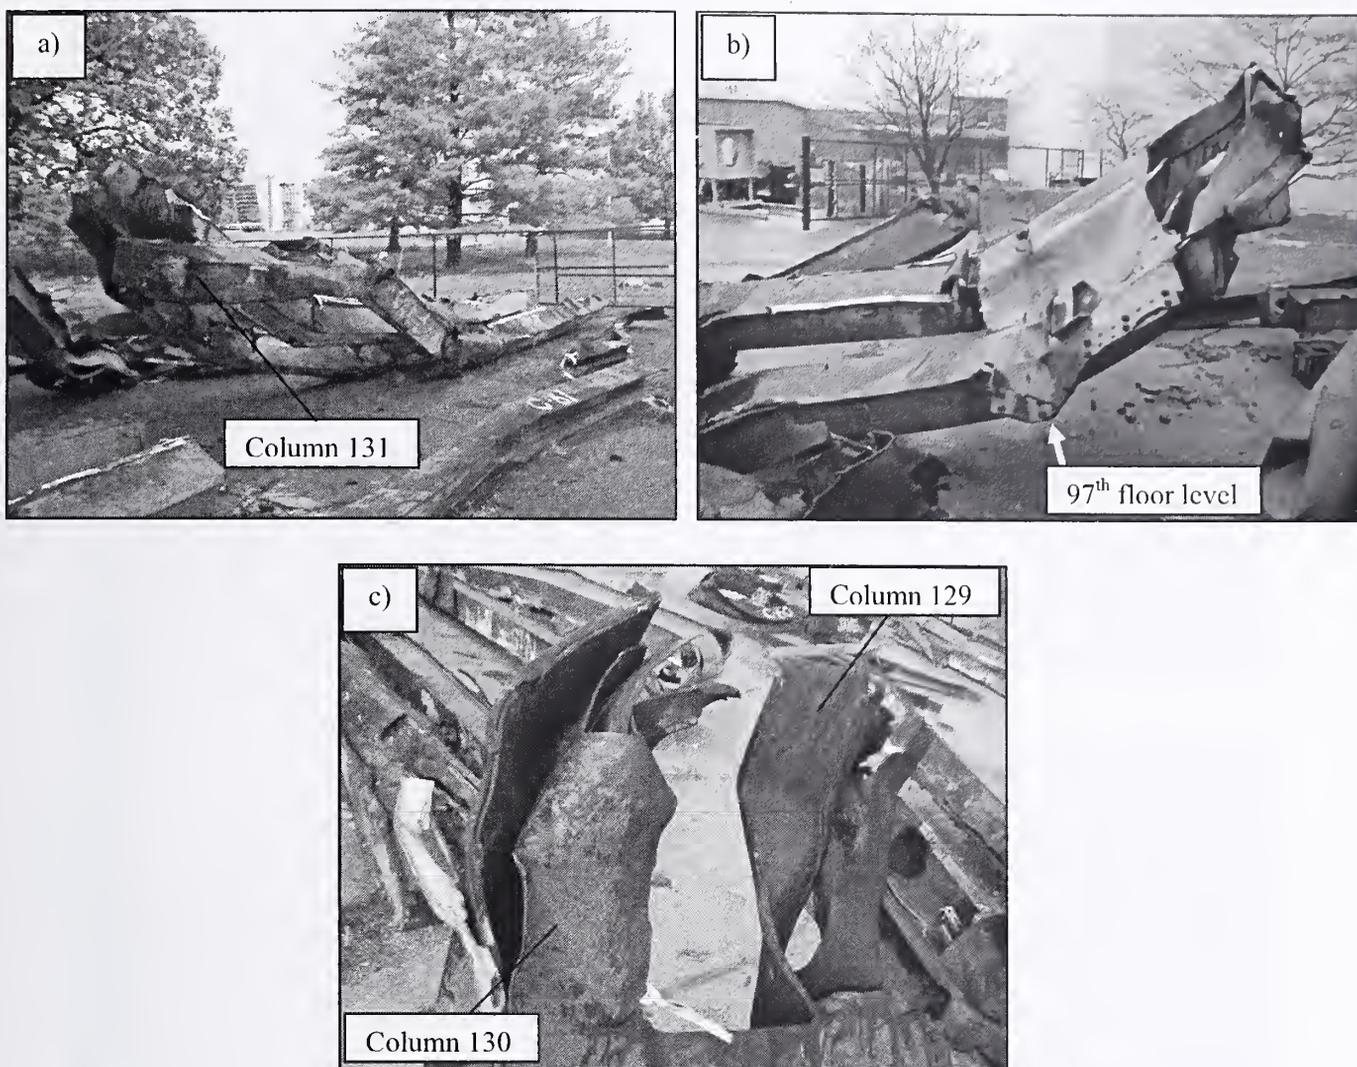
Panel M-2 (WTC 1, column line 130, floors 96 to 99) was struck by the upper part of the airplane's fuselage and the vertical stabilizer of its tail. In the photographic images (Fig. 6-1 [top]), the condition of the panel appeared remarkably similar to its as-recovered condition, Fig. 6-22a. The damage observed on the recovered panel was largely a result of the impact. The lower part of all three columns was bent into the building with the 97th floor concrete slab acting as a fulcrum point, Fig. 6-22b. Also, the lower end plates of columns 129 and 130 were ripped off with column plate fracture occurring near welds with to the butt plates, Fig 6-22c. This gave the columns a "splayed" appearance. The end plate for column 131 was still intact, and the lower portion of the column was relatively undeformed. In the pre-collapse images, the lower portion of this column is also bent inward just below the 97th floor spandrel; however, it was bent back out sometime during or after the collapse.

Damage to the lower portion of panel M-2 (WTC 1, column line 130, floors 96 to 99) was clearly associated with impact, which led to the missing endplates for columns 129 and 130. The inner and outer web plates of both columns have thinned in this area due to plastic deformation, Fig. 6-23a. The fracturing of the plates propagated as a 45 degree slant crack, oscillating between positive and negative 45 degrees with respect to the normal of the plate. The necking (thinning) of the outer web plate, plotted in Fig. 6-23b, indicates significant ductility, even at the high-strain rates associated with impact. Large buckles were observed on both flanges for columns 129 and 130 with some splitting occurring in the base material of the flanges (Figs. 6-24a and 6-24b) and spandrels (Fig. 6-24c). However, the welds found near this bending point remained intact (Fig. 6-24d).

Figure 6-22. a) Overall view of panel M-2 (A130: 94-97). Bottom of panel is on the left-hand side of the picture and the outside of the panel is facing down, b) major bend in panel located at the 97th floor level, and c) splayed bottoms of columns 129 and 130.

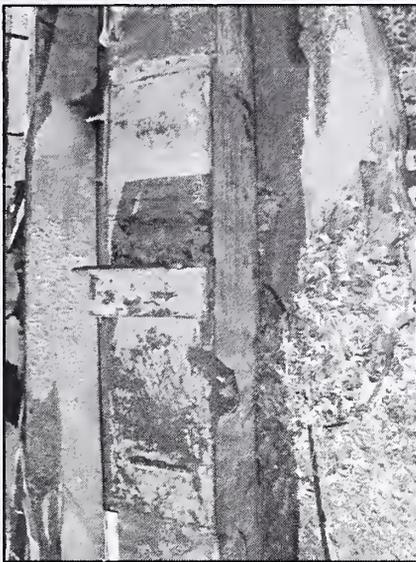
**M2-C1T**

Column 131, 99<sup>th</sup> floor

Failure mode: Type 4a, fracture of spandrel

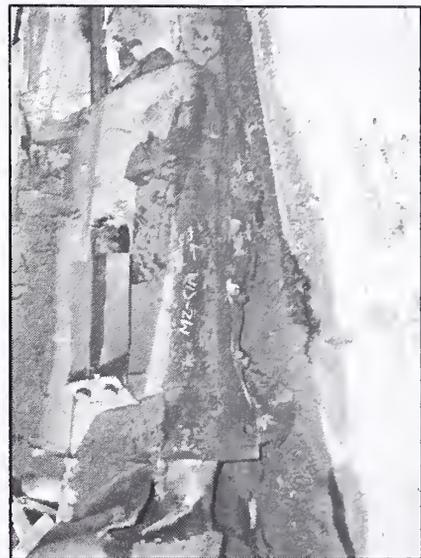
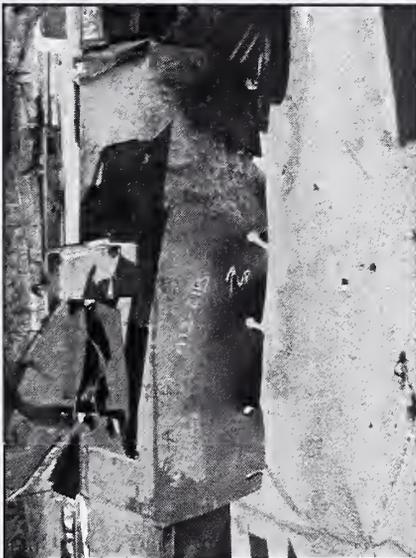
**M2-C1B**

As the entire panel M-2 (A130: 96-99) was recovered, all six spandrel connections were available for inspection. From pre-collapse photographs, it appears that both connections located on floor 97 failed upon impact of the airplane. Both failures were associated with tearing of the bolt holes (Fig. 6-25); the connection associated with column 131 had bolt hole tear out, and the connection nearest column 129 still retained the splice plate without the neighboring spandrel plate. The connections associated with floor 99 appeared intact, and failure may have occurred upon collapse. Those connections located on the 98th floor were obstructed by smoke, and the condition could not be determined prior to collapse. Their failures were associated with bolt hole failure, as well as fracture of the spandrel plate.

Failure mode: Type 3, mixed mode of fracture and bolt hole tear out, portion of spandrel from S9-C3B still attached

Column 131, 97<sup>th</sup> floor

Failure mode: Type 1a, bolt hole tear out

**Figure 6–25. Photographs of recovered spandrel connections from sample M-2 (A130: 96-99).**

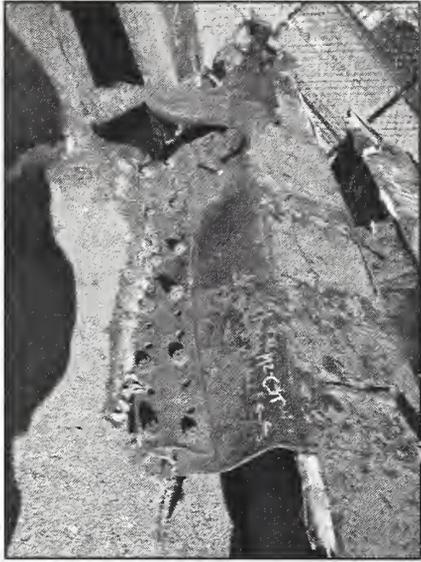
**M2-C3T**

Column 129, 99<sup>th</sup> floor

Failure mode: Type 1b, bolt hole tear out

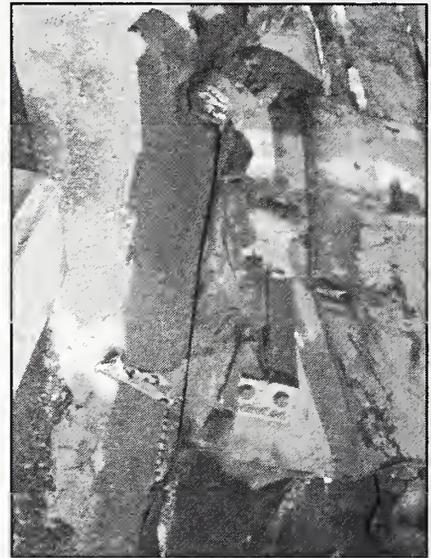
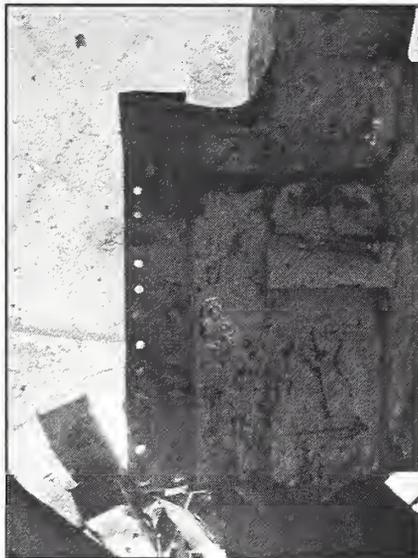
**M2-C3B**

Failure mode: Type 1a, bolt hole tear out

Column 129, 97<sup>th</sup> floor

Failure mode: Type 1b, bolt hole tear out

**Figure 6–25. Photographs of recovered spandrel connections from sample M-2 (A130: 96-99) (continued).**

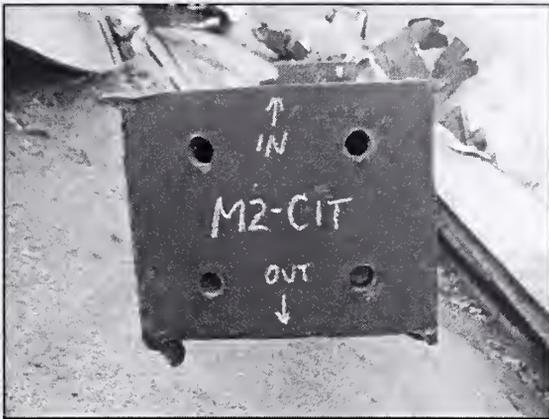
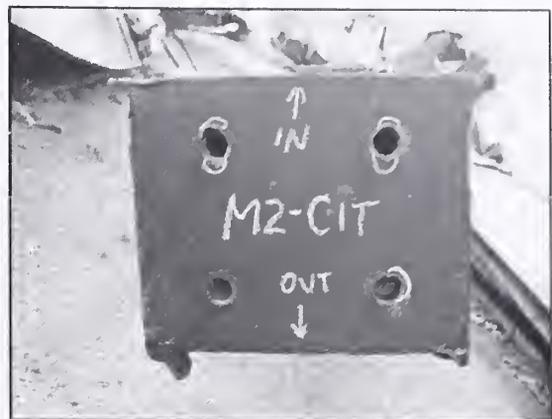
M2-C1T  
WTC1  
Col 131  
F199

**Figure 6–26. Photographs of recovered end plate connections from sample M-2 (A127: 97-100). Both ends of column 131 had bolt failure that resulted in deformation of the bolt holes in the end plates.**

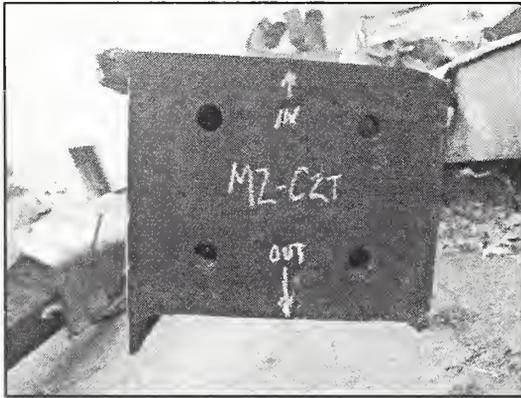
M2-C2T  
WTC1  
Col 130  
F1 99

No change in bolt hole shape

**Figure 6–26. Photographs of recovered end plate connections from sample M-2 (A127: 97-100). The upper end plate experienced bolt hole failure. The bottom end plate of column 130 was ripped out upon impact of the airplane. Failure was found to be a mixture of fracture in the base plates (portion of the flange/web still attached to the end plate) and clean separation of the end plate from the flange/web (complete flange/web recovered with internal weld bead visible) (continued).**

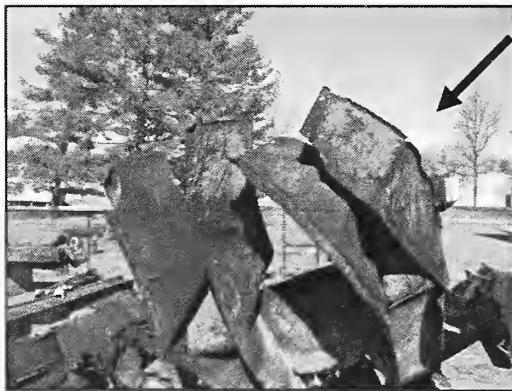
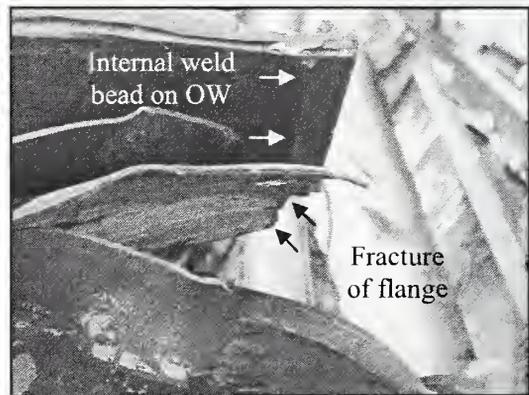
M2-C2B  
WTC1  
Col 130  
F1 96

The state of the recovered bottom portion of columns 129 and 130 was nearly identical to the condition after the impact for panel M-2 (A130: 96-99). Both end plates were ripped completely out of the column, Fig. 6-26. Failure was a mixture of fracture in the base plates (portion of the flange/web still attached to the end plate) and clean separation of the end plate from the flange/web (complete flange/web recovered with internal weld bead visible). Bolt hole deformation for column 131 indicated that the connection was broken by bending inward of the lower column of the connection. Finally, while bolt failure was observed at the 99th floor splice of column 129, it can be noted that some separation existed between the flange plates of the column and the endplate.

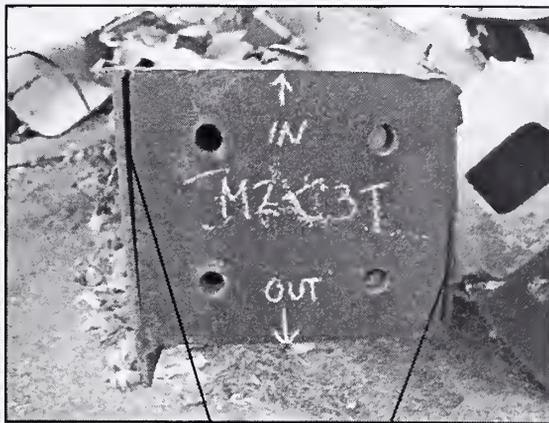
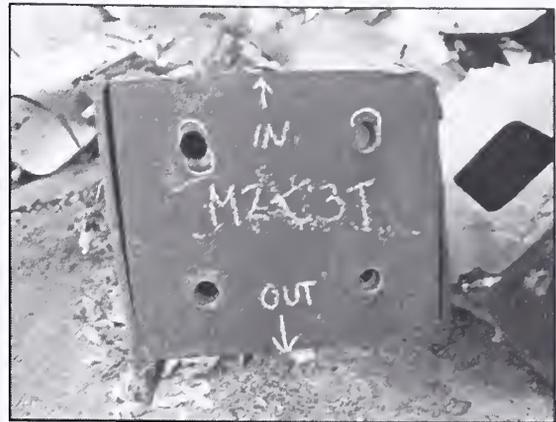
M2-C3T  
WTC1  
Col 129  
F1 99

Separation between flange plates and butt plate

**Figure 6–26. Photographs of recovered end plate connections from sample M-2 (A127: 97-100). The upper end plate experienced bolt hole failure. The bottom end plate of column 129 was also ripped out upon impact of the airplane. Failure was found to be a mixture of fracture in the base plates (portion of the flange/web still attached to the end plate) and clean separation of the end plate from the flange/web (complete flange/web recovered with internal weld bead visible) (continued).**

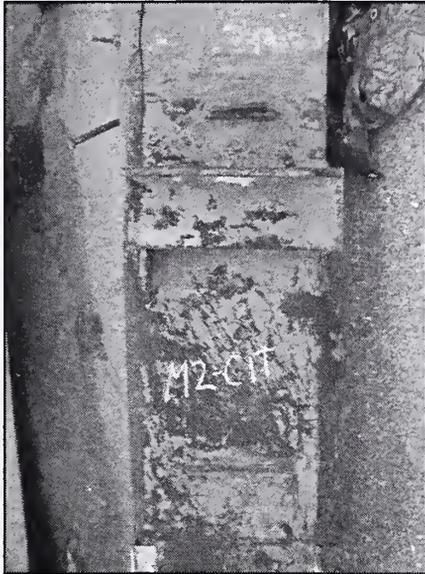
**M2-C1T (Co 131, Fl 99)**

Panel M-2 (A130: 96-99), Fig. 6–27, is shown as an example of perimeter wall truss connections. Of the six truss seats on the panel, four were damaged but intact (e.g., bending up/down, bolt hole failure), and the other two were completely ripped off of the column. The center column of this panel also had three gusset plates, used to anchor diagonal bracing straps to provide horizontal shear transfer between the floor slab and exterior wall, as well as out-of-plane bracing for the perimeter columns not directly supporting the floor trusses. Only portions of the gusset plates remained on the middle column of the panel with the diagonal bracing straps ripped from these plates.

1 standoff plate remains, seat and other standoff plate ripped off at welds;

Gusset plate with damper unit intact, bent up.

**Figure 6-27. Floor truss connectors for panel M-2 (A130: 96-99).**

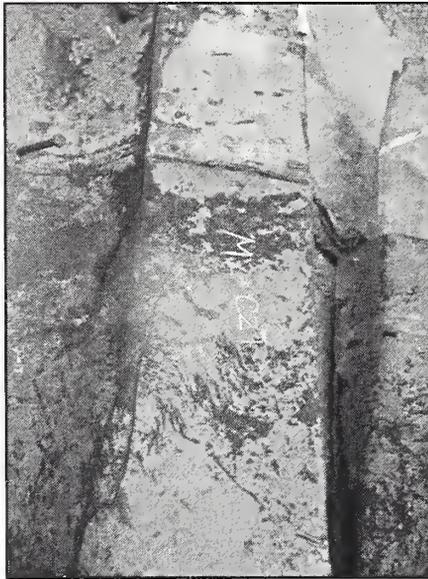
**M2-C2T (Co 130, Fl 99)**  
Type C  
Seat Detail: 5210  
Tab plate ripped off at weld.

**Figure 6–27. Floor truss connectors for panel M-2 (A130: 96-99) (continued).**

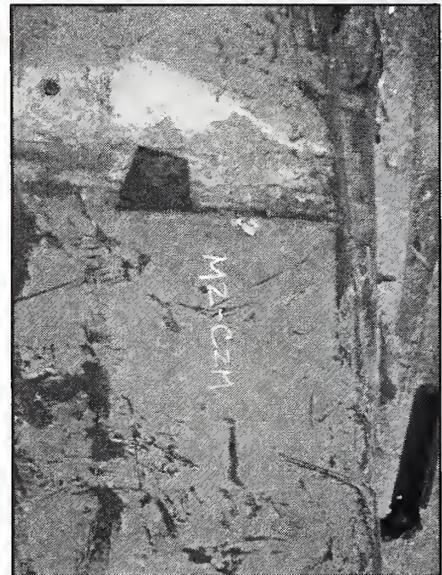
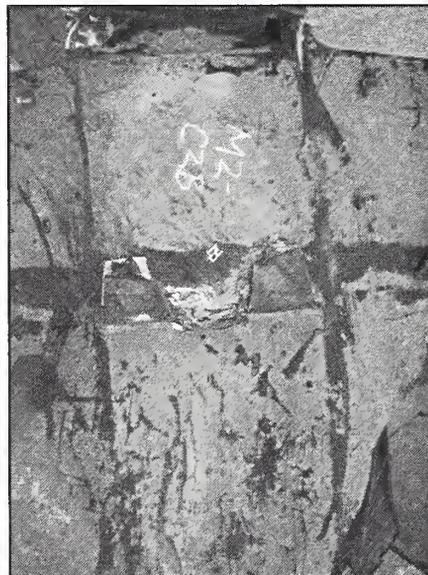
**M2-C2M (Co 130, Fl 98)**  
Type C  
Seat Detail: 5210  
Portion of tab plate remains, bent up.

**M2-C2B (Co 130, Fl 97)**  
Type C  
Seat Detail: 5210  
Tab plate remains, bent up.

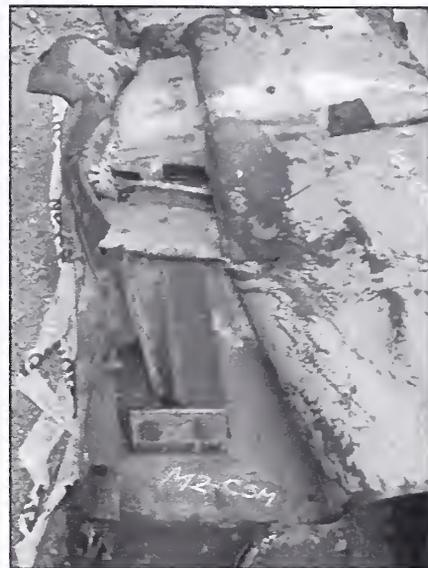
Type A  
 Seat Detail: 1411  
 Tab plate remains;  
 Seat intact, bent down, 1 bolt hole remains intact with bolt, other ripped out;

Type A  
 Seat Detail: 1411  
 Tab plate ripped off at weld;  
 Seat intact, bent down, 1 bolt hole remains intact, other ripped out;

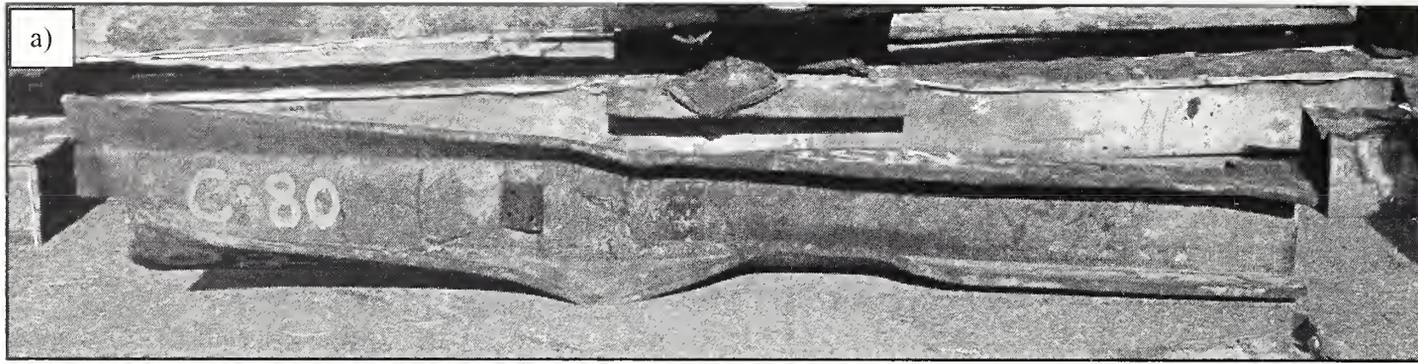
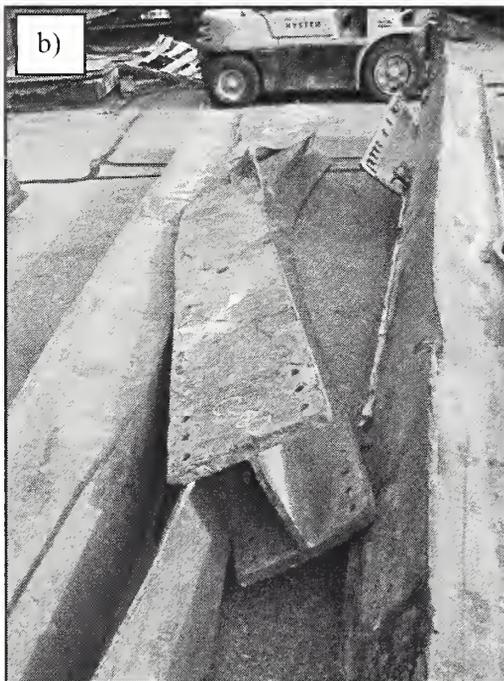
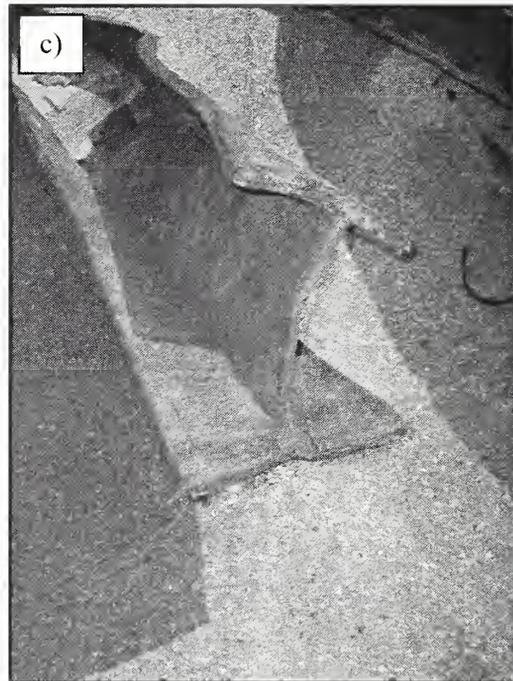
Sample C-80 (Fig. 6-30a), from WTC 1, was a 36 ksi wide-flange located in the middle of the second row of core columns along the north face. Only the lower third of the column was recovered (approximately 13 ft). The location of the column indicated that it did not sustain impact damage. Consistent with the column's position, modeling results indicated that this column was not in the path of the aircraft debris (NIST NCSTAR 1-2). Different failure modes were observed for each end (Figs. 6-30b and 6-30c). Bolt fracture occurred at the lower portion of the column (92nd floor region), while the upper portion of the wide-flange was torn through its section (near the 93rd floor region). No visible necking (localized reduction in area) was observed in the immediate vicinity of the fracture.

**Figure 6–30. Core column C-80 (603A: 92-95). a) Overall view of recovered column, b) view of connection in the 92nd floor region, failure as a result of bolt fracture, and c) torn end of column near the 94th floor region.**

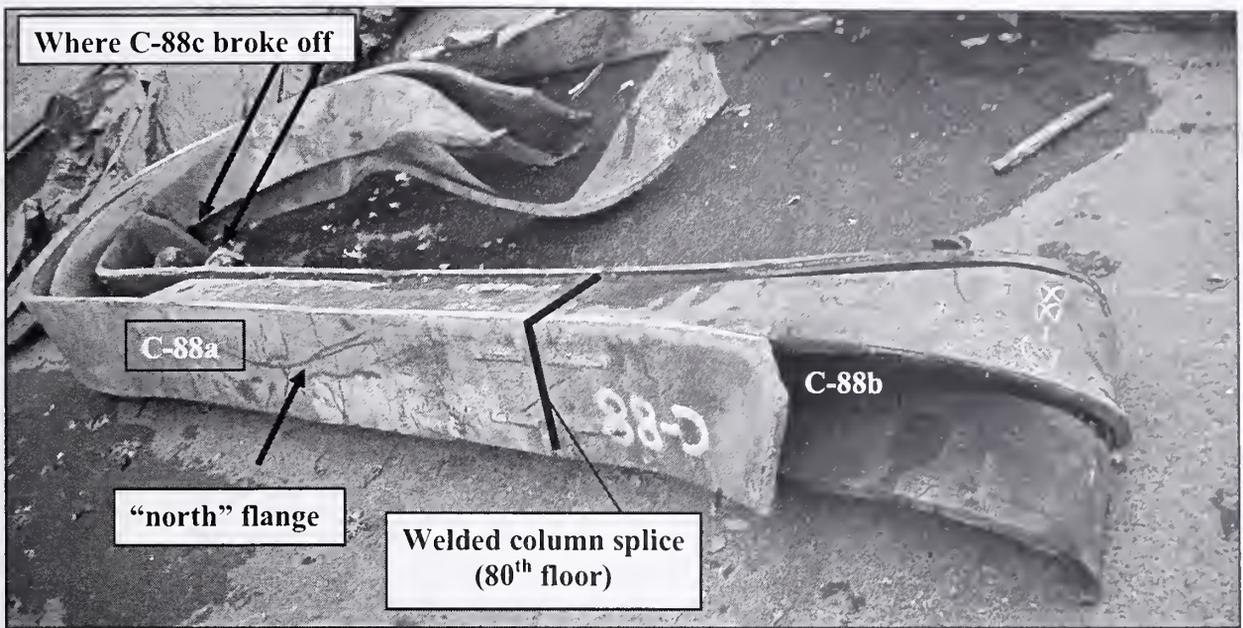
Core columns C-88a and C-88b, from WTC 2, were unique among the recovered core elements in that the columns were still connected at the welded column splice, Fig. 6–31. Both columns were 42 ksi built-up box columns with their shared splice in the 80th floor level. The lower 16 ft of C-88a was recovered (floors 80 through 82), whereas the upper 8 ft of C-88b was still attached (primarily within the 80th floor). The location of the column C-88b suggested that impact damage may have been sustained. Both webs and the “south” flange were severely bent to the east and had flame cut ends, Fig. 6–32. The bends occurred just below the connector for the channel associated with the 80th floor. The “north”

Figure 6–31. Overall view of recovered core columns C-88a (801B: 80-83) and C-88b (801B: 77-80).

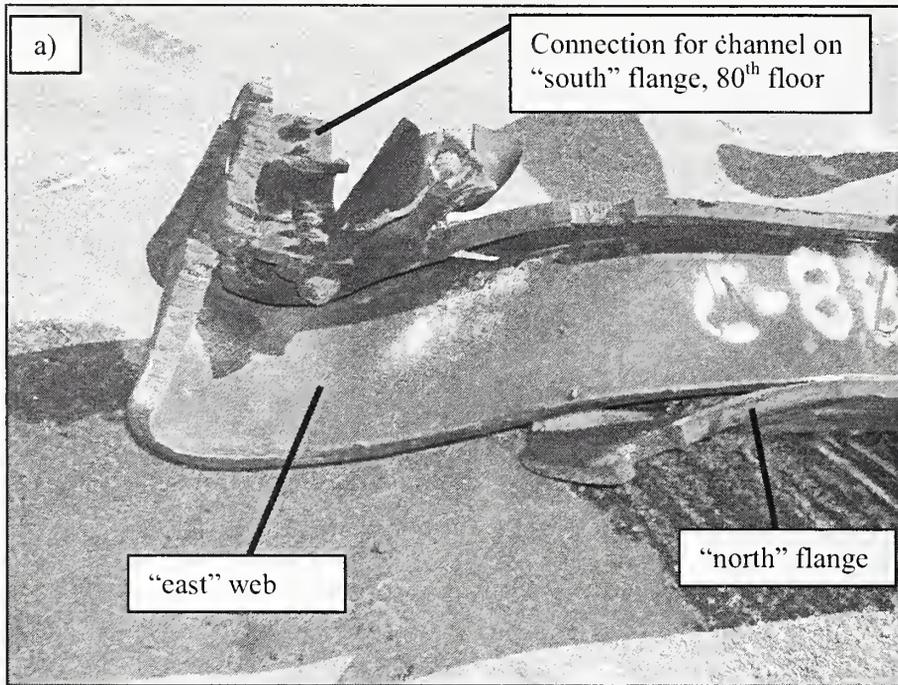
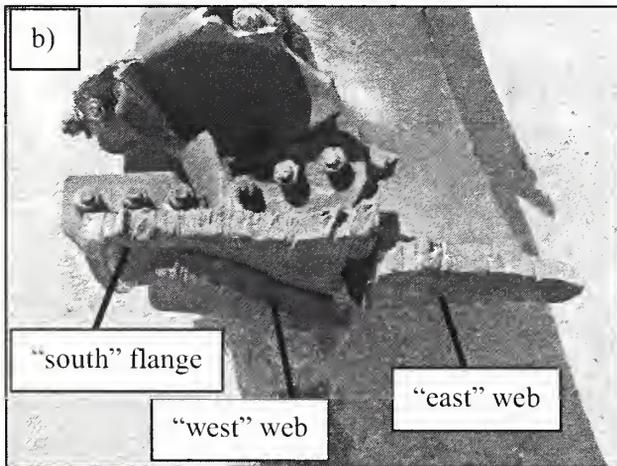
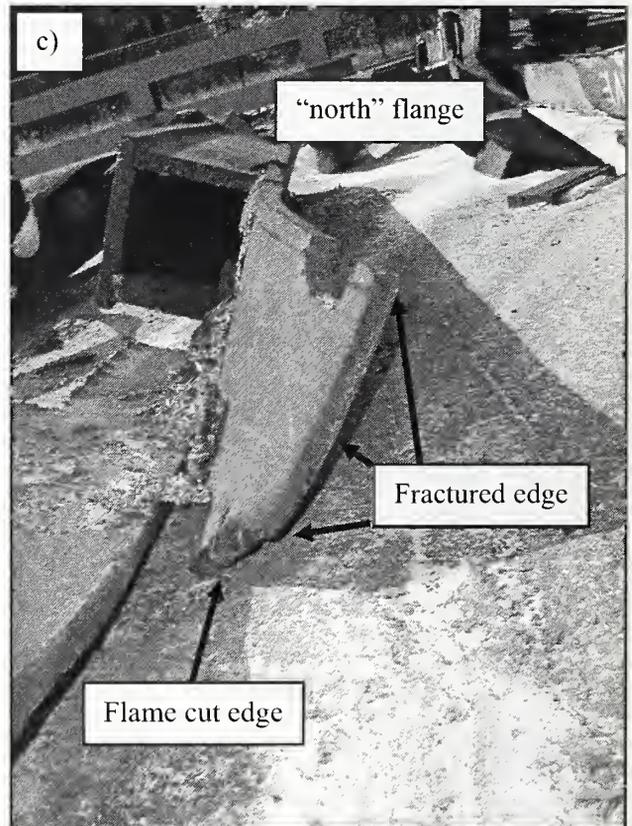
**Figure 6–32. Damage associated with core column C-88b (801B: 77-80). a) Overall view of failed end, b) bottoms of “south” flange and both webs bent towards the east just below the 80th floor level, ends were flame cut, and c) “north” flange bent towards the north, majority of plate was fractured with some flame cutting.**

flange had a less significant bend toward the north, with approximately 80 percent of the failed end of the plate as a fracture. There was no visible necking of the plate in the area of failure, with the remaining portion of the plate having been flame cut during the recovery effort. This flange was fractured roughly 2 ft below the splice in the 80th floor level. The fracture surfaces were too corroded for analysis. It was believed that the damage of the south flange and the two webs occurred during collapse of the building as the direction of bending was not consistent with the travel of the airplane. However, the damage to the north flange may have been a result of impact damage, as the severity and location of the plate failure was different from the other three plates of the column, and the direction of the bend was consistent with the travel of the airplane. The baseline analysis of the damage model indicated that this core column was not damaged as a result of the impact (NIST NCSTAR 1-2). However, another analysis with parameters set to increase the amount of damage indicated that impact damage was sustained. Core column C-88a did not sustain impact damage as (1) the damage (81st floor level) was above the floors of impact in this region (79th floor level), (2) the columns were bent downward indicating overloading of the column from above, and (3) the bending direction of the plates was opposite to the direction of the travel of the plane. This is also consistent with the modeling results (NIST NCSTAR 1-2).
