**NIST NCSTAR 1-3**

**Federal Building and Fire Safety Investigation of the  
World Trade Center Disaster**

**Mechanical and Metallurgical  
Analysis of Structural Steel**

September 2005

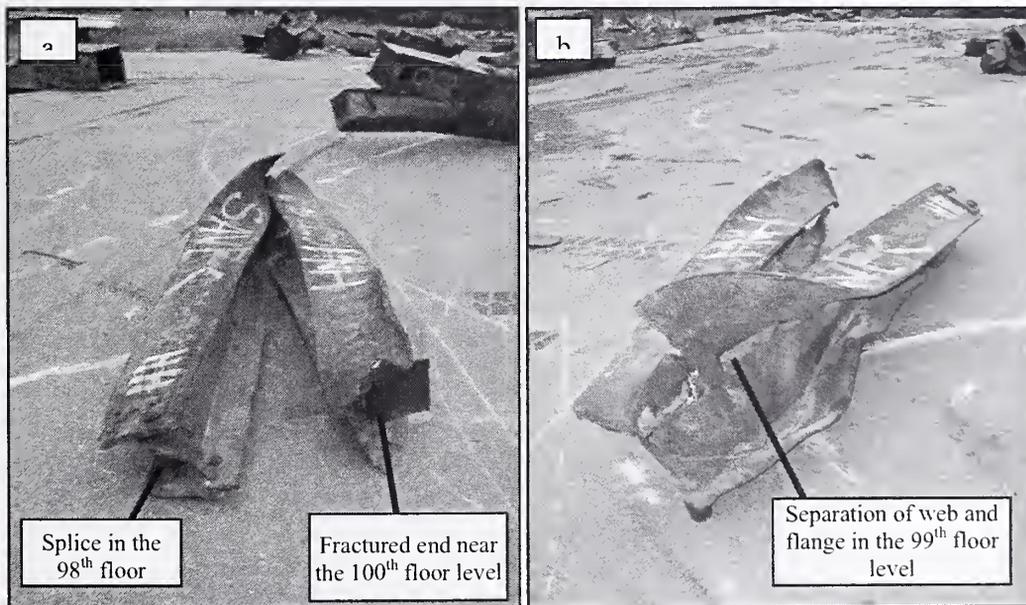
Aside from the three columns discussed above, only one other core column was recovered from within the fire region. Sample HH from WTC 1, Fig. 6–33, was a 42 ksi wide-flange positioned near the middle of the second row of core columns along the north face. The bottom half of the column was recovered (approximately 16 ft). The location of the column was such that damage could not have occurred during the impact. This was corroborated by the modeling results that indicated the core column was not hit during the impact (NIST NCSTAR 1-2). The failure mode of each end was different (Fig. 6–33a). Fracture of the plates used in the bolted connection occurred at the lower portion of the column (98th floor region), while the upper portion was torn through the material (100th floor region). Additionally, the sample was nearly bent in half (99th floor region), with complete fracture of one flange. Figure 6–33b shows that the flanges have become separated from the web in the region of the bend.

**Figure 6–33. Core column HH (605A: 98-101). a) Fracture at both ends and b) separation between flange and web in the 99th floor region.**

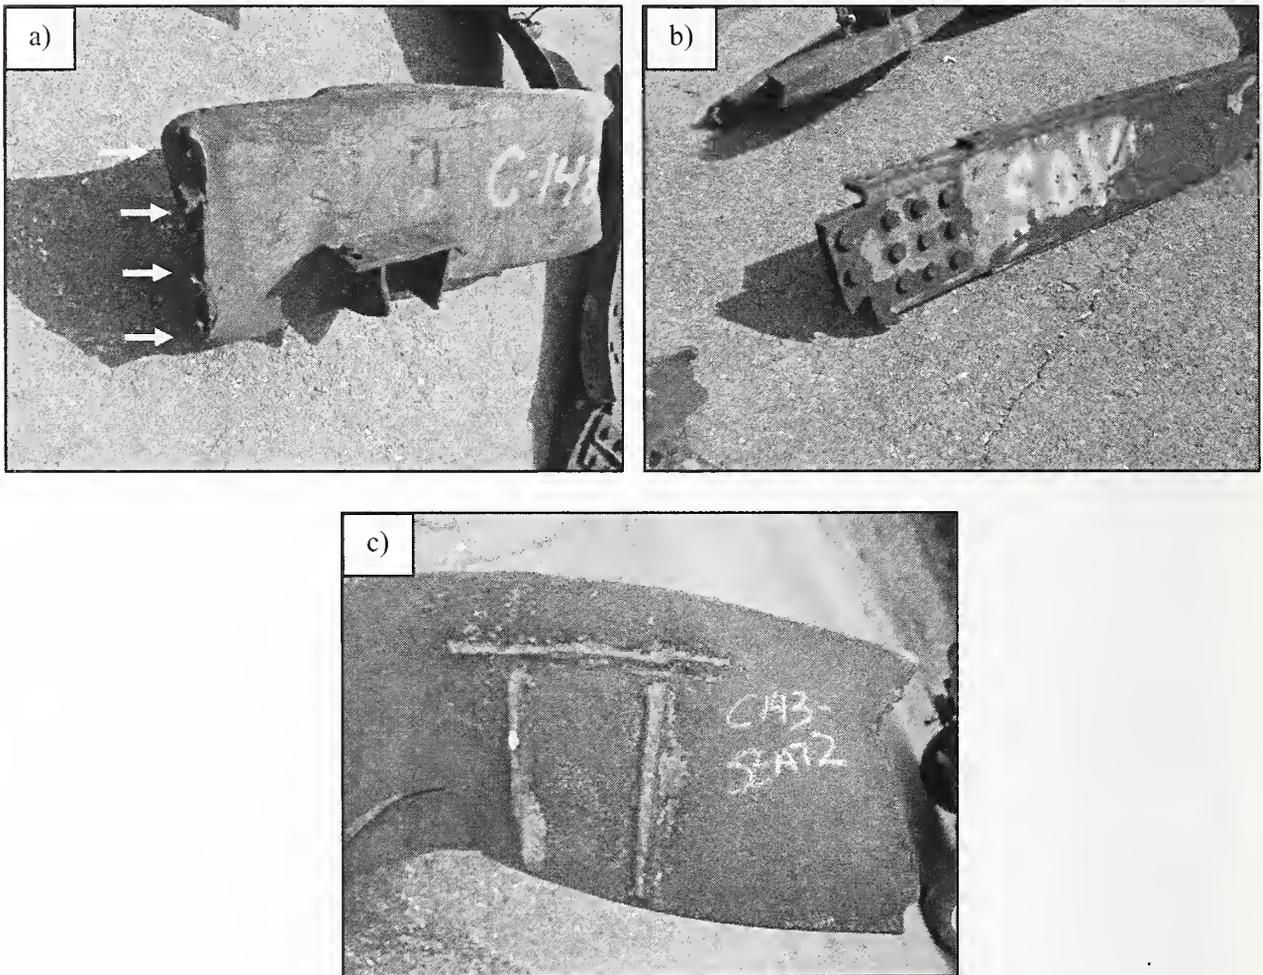
An analysis was conducted to evaluate the failure modes of the recovered channel material and the condition of the core truss seats. Of the 24 channels used to support the floor trusses, half failed at both ends within the channel itself, Fig. 6–34a, while the others failed at one or both of the end connectors, Fig. 6–34b. Twenty-one pieces of channel had seats or remnants of seats attached. Over 90 percent of the seats (31 total) were still intact with the majority of these somewhat deformed. Only two seats had been ripped completely from the channel at the welded joint between the seat and the channel, as shown in Fig. 6–34c. Half of the retained seats were observed to have both bolt holes still intact, while the other half had at least one bolt hole ripped out.

**Figure 6–34. Failure modes of core channels. a) Fracture through channel as indicated by arrows, b) failure associated with end connector, and c) seat ripped off at welded connection to channel.**

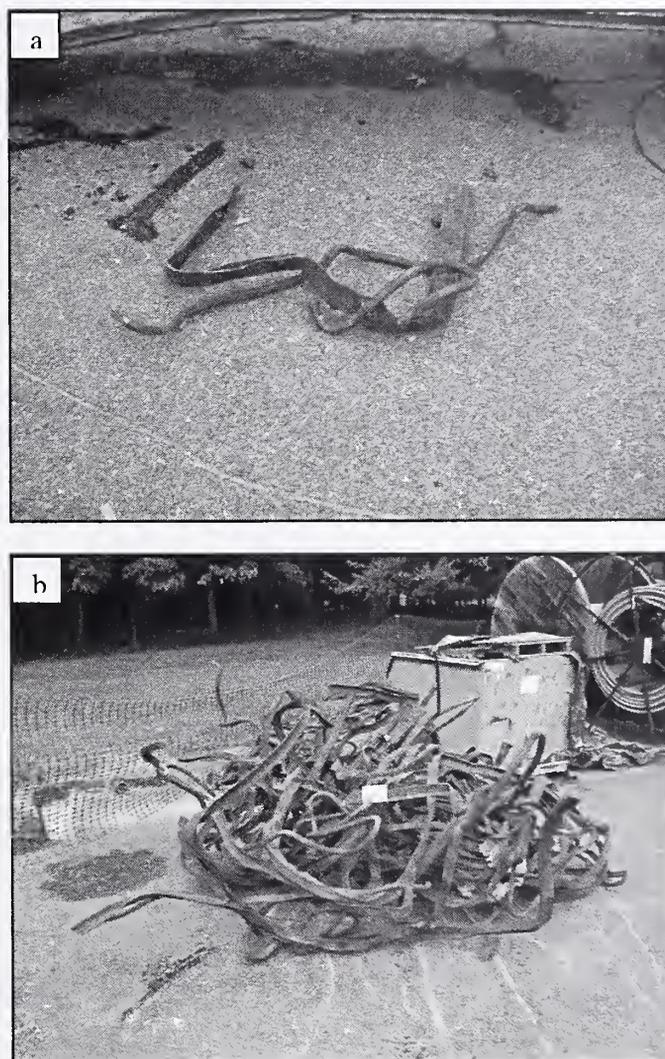
Samples received at NIST were either small sections (less than 3 ft to 4 ft in length) of chord and rod material (Fig. 6–35a) or large, entangled masses in the form seen in Fig. 6–35b. According to Structural Engineers Association of New York (SEAoNY) volunteer members involved in the recovery effort, it was necessary to “ball up” any truss pieces of significant size to facilitate removal from the WTC site and subsequent handling in the recovery yards. This was necessary since the primary and bridging trusses for a given floor were welded together into huge grids. During the collapse, these lightweight floor sections were severely damaged and could not be easily removed. Thus, it is unknown when specific damage features occurred. Further, it is likely that sections of multiple trusses were “balled” together and labeled as a single unit rather than that NIST labeled samples consisting of just one pre-fabricated truss unit.

**Figure 6–35. Examples of recovered floor truss material. a) Small sections of rod and chord (sample C-53) and b) “balled-up” sections of rod and chord (C-137f).**

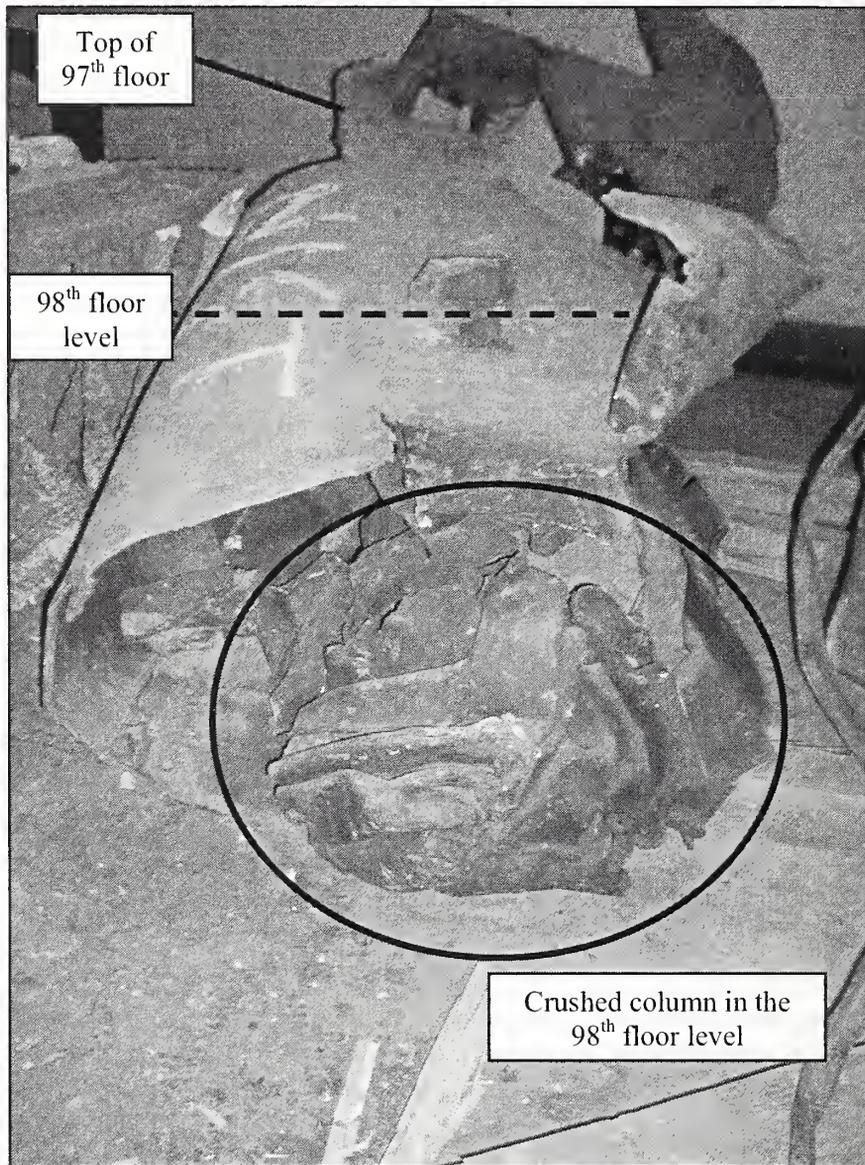
1. Panel K-1, WTC 1, column 210, flange and inner web of 98th floor region. Prior to the collapse of WTC 1, the panel was observed to have experienced varying degrees of fire exposure for a minimum of 31 cumulative minutes in this area. A unique feature of this panel is that the upper portion of the column was crushed while generally maintaining concentric axial alignment with the lower portion of the column, Fig. 6–36. This suggests that deformation occurred at the onset of collapse, while the lower portion of the column was still constrained due to the bolted splice (endplates).

**Figure 6–36. Crushed portion of column 210 in the area of the 98th floor (from sample K-1, A209: 97-100). Paint had mud cracking characteristic in this region.**

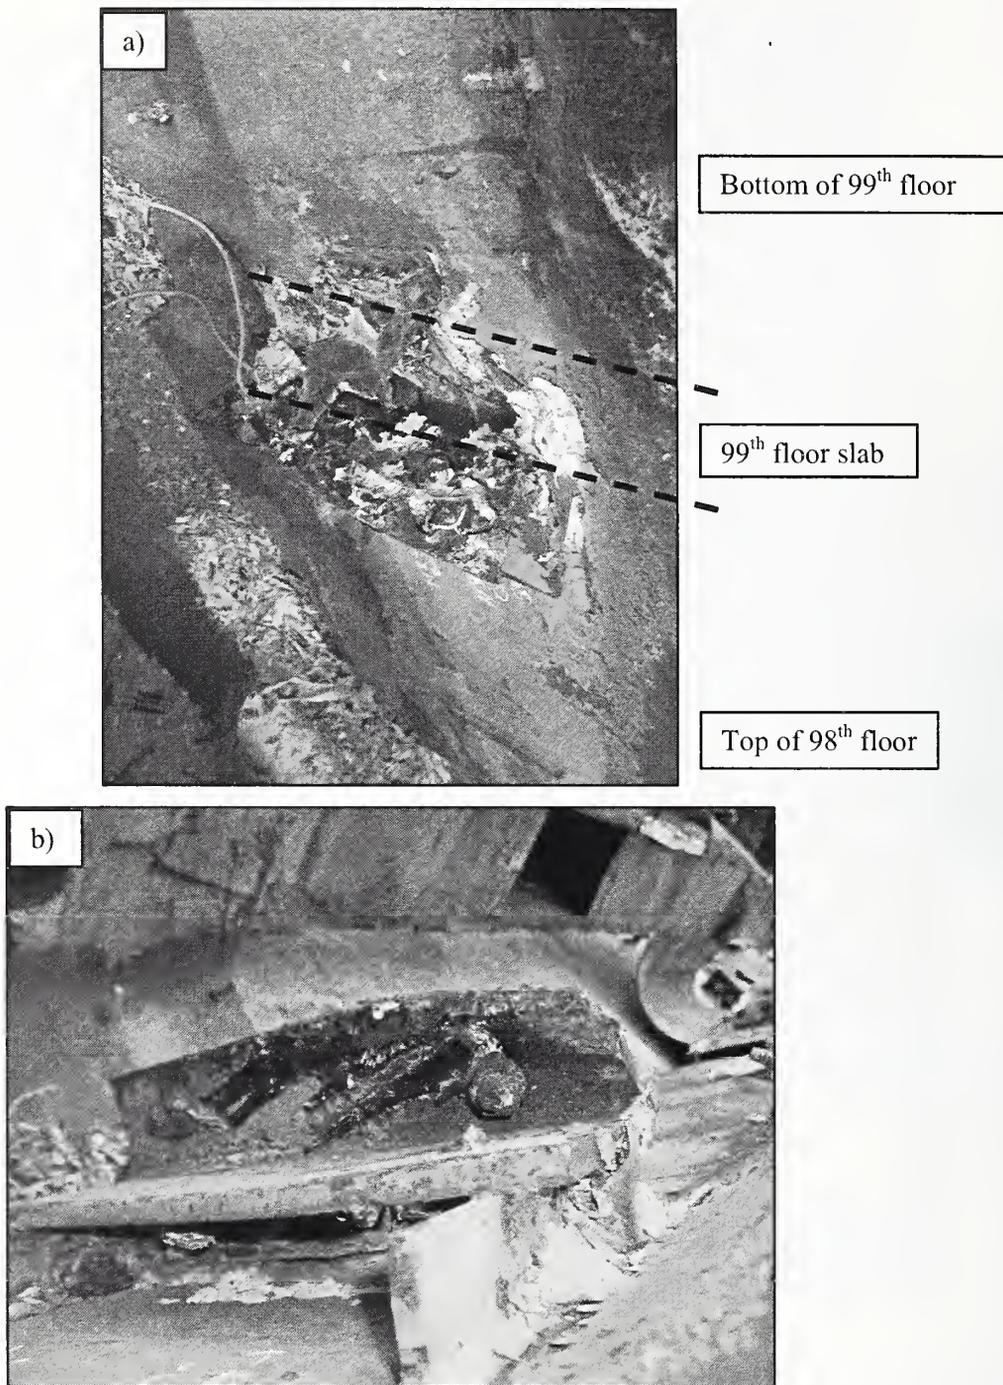
**Figure 6–38. Truss seat of the 99th floor on column 143 of sample N-8 (A142: 97-100). a) Top view showing the re-solidified black plastic with embedded papers, most likely a binder of some type and b) bottom view showing the drip pattern. It was unknown when the high-temperature excursion may have occurred.**

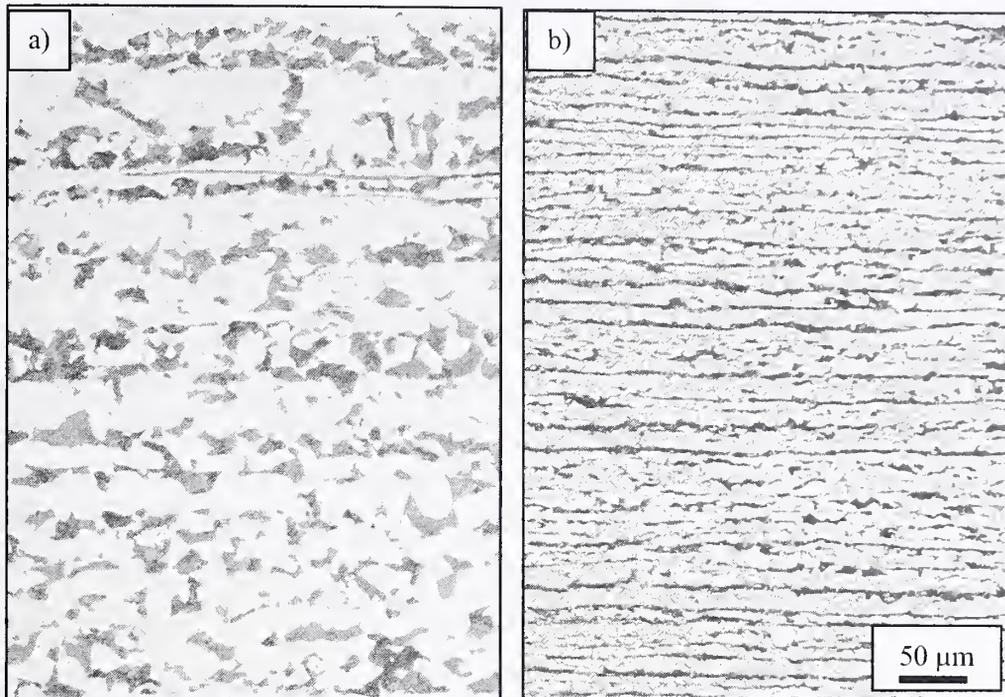
For the exterior panel sections, two different microstructural types were observed. Flange, web, and spandrel plates with specified minimum yield strengths less than 70 ksi were ferrite-pearlite (Fig. 8-1). Additionally, inner webs with  $F_y$  of 70 ksi and 75 ksi were ferrite-pearlite. For the Yawata produced plates (flange, outer web, and spandrel), this type of microstructure was expected given the measured plate thickness and specified minimum yield strength (refer to NIST NCSTAR 1-3A). Plates with  $F_y$  less than 70 ksi were typically hot rolled unless the following sizes were exceeded for a given  $F_y$ : 0.5" for 65 ksi, 1.25" for 60 ksi, and 1.5" for 55 ksi. For these specified plates, as well as those with minimum yield strengths equal to or greater than 70 ksi, "quenched-and-tempered" microstructures were observed (Fig. 8-2).

**Figure 8-1. Microstructure of ferritic-pearlitic WTC perimeter column flange plate steels. a)  $F_y = 45$  ksi (unidentified perimeter column with "45" flange stamping) and b)  $F_y = 60$  ksi (WTC 1, column 126, 97th floor).**

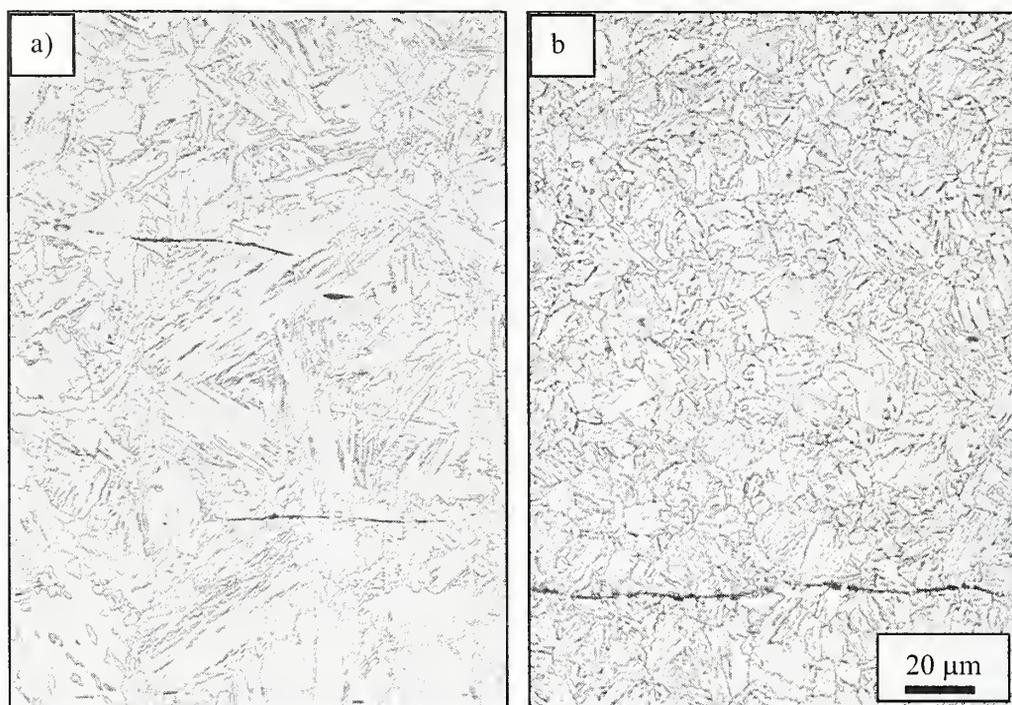
Microstructure varied within each of the two structure types, depending on product type, gauge, and strength level. Ferrite-pearlite steels had variations in ferrite grain size, ferrite grain shape, pearlite lamellar spacing, and banding of microstructural constituents with a change in specified  $F_y$  and gauge of the plate. Examples of these microstructures are shown in Fig. 8-1. Similarly, the quenched and tempered steels had variations with  $F_y$ . Plates with  $F_y = 70$  ksi had a coarse Widmanstätten morphology of ferrite with coarse cementite precipitates while the higher strength plates had what appeared to be a tempered martensitic structure, as shown in Fig. 8-2.

**Figure 8–2. Examples of “quenched and tempered” WTC perimeter column flange steel. a)  $F_y = 70$  ksi (WTC 1, column 224, 94th floor) and b)  $F_y = 80$  ksi (WTC 1, column 207, 89th floor).**
