NIST NCSTAR 1-3C

**Federal Building and Fire Safety Investigation of
the World Trade Center Disaster**

Damage and Failure Modes of Structural Steel Components

(Appendices A-G)

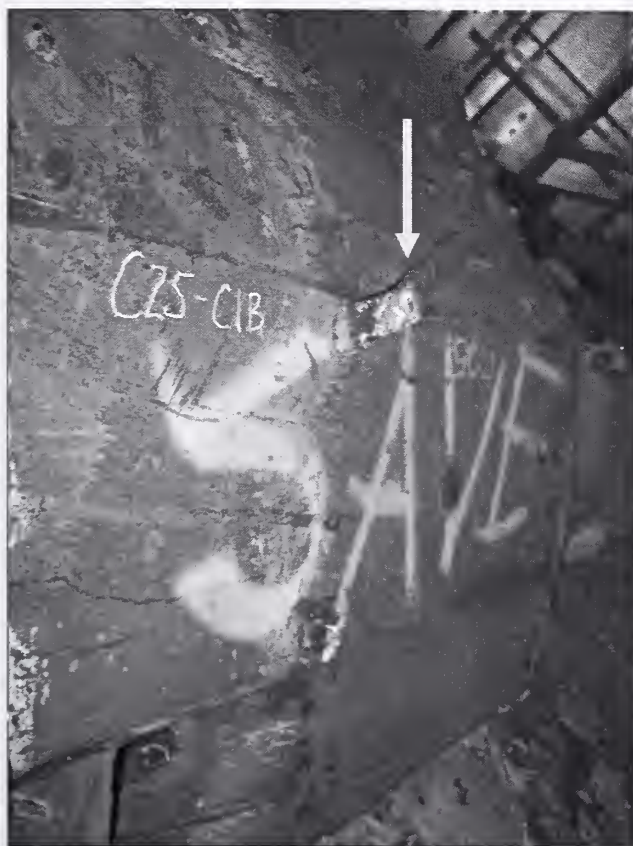
Connection C25-C1B

Portion of diagonal bracing straps remain attached to spandrel; welded directly to the spandrel.

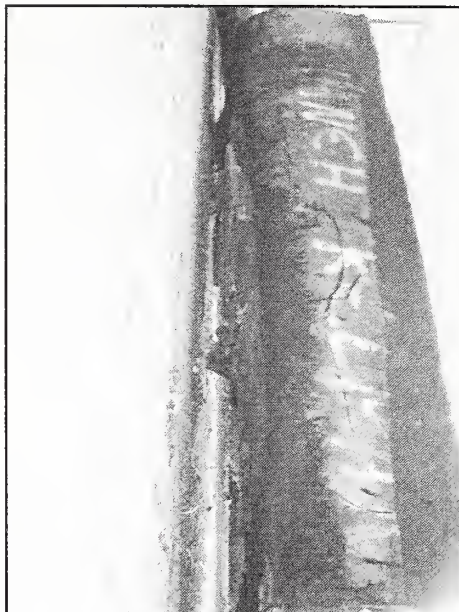
ASCE2-C3T (WTC 2, Col.329, Fl 43)

Gusset plate ripped completely out of spandrel;
Small seat intact, bent downwards, 1 bolt hole
intact, other ripped out;
No evidence of gusset plate for damper unit.

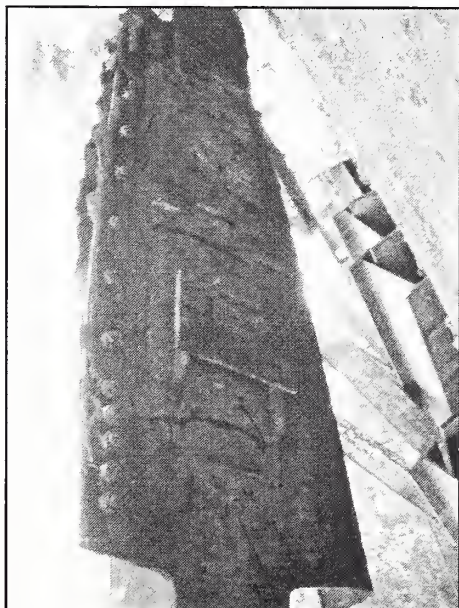
ASCE2-C3B (WTC 2, Col.329, Fl 41)

Portion of gusset plate remains;
Small seat intact, bent downwards, 1 bolt hole
intact;
No evidence of gusset plate for damper unit.

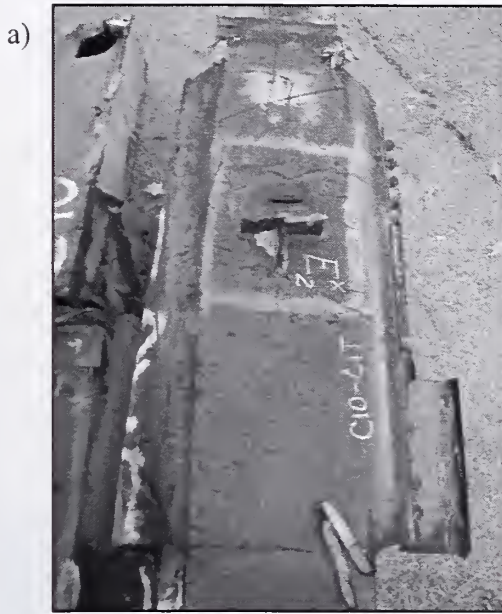
C10-C1T (WTC 1, Col.452, Fl 88)

Gusset plate ripped completely out of spandrel;
Small seat intact, bent downwards, 1 bolt hole
intact, other ripped out;
No evidence of gusset plate for damper unit.

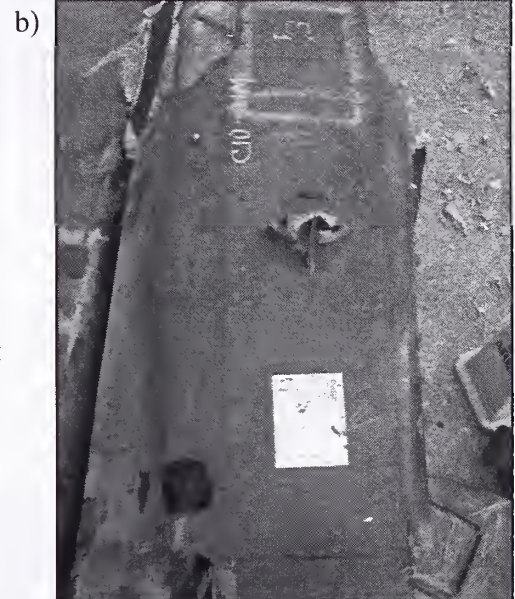
C10-C1M (WTC 1, Col.452, Fl 87)

Gusset plate ripped completely out of spandrel;
Small seat intact, corners bent downwards, 1 bolt
hole intact other ripped out;
No evidence of gusset plate for damper unit.

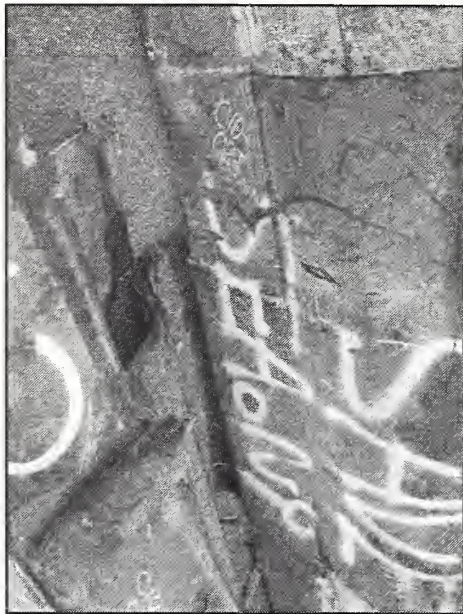
C10-C2T (WTC 1, Col.451, Fl 88)

2 1-inch portions of diagonal bracing straps remain.

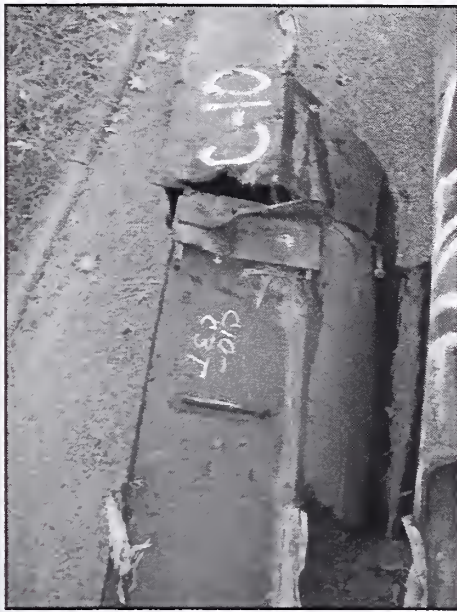
C10-C3T (WTC 1, Col.450, Fl 88)

Gusset plate ripped completely out of spandrel; Only 1 standoff plate remains, rest ripped off at welds; Gusset plate with damper unit intact, bent downwards.

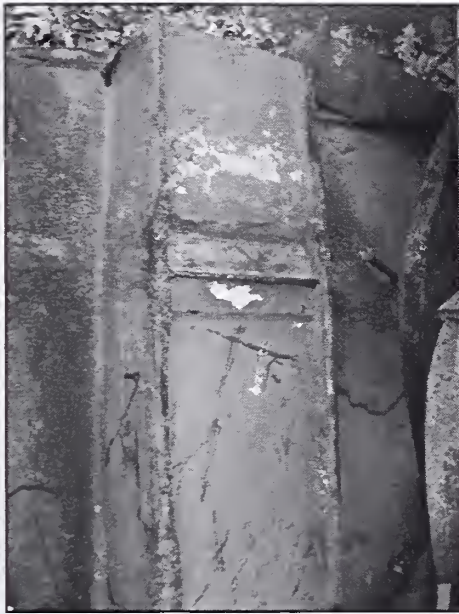
C13-C2T (WTC 2, Col.200, Fl 92)

Gusset plate ripped off at weld.

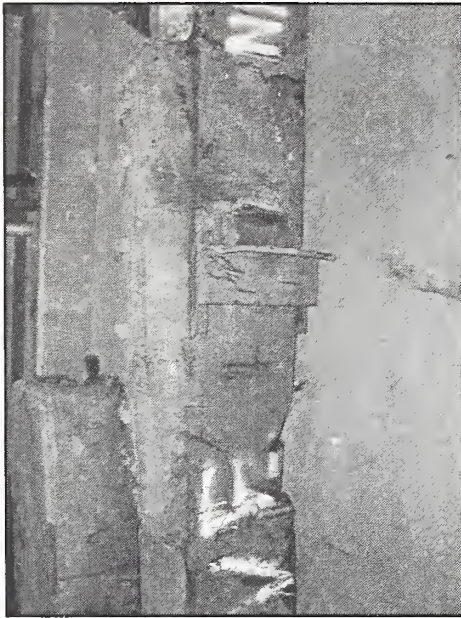
C13a-C3T (WTC 2, Col.159, Fl 92)

Gusset plate for damper unit ripped off at weld.

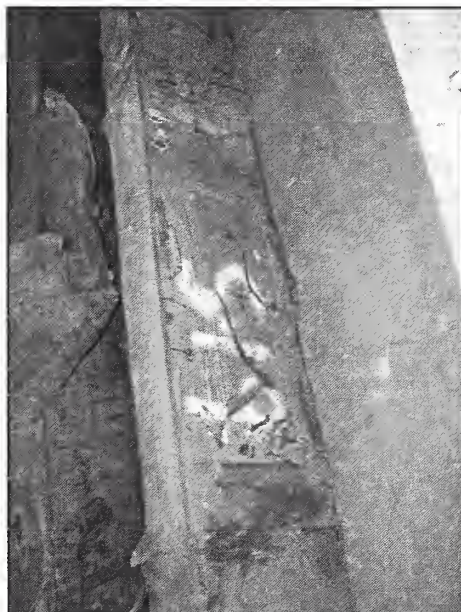
C13a-C3B (WTC 2, Col.159, Fl 91)

Gusset plate for damper unit ripped off at weld.

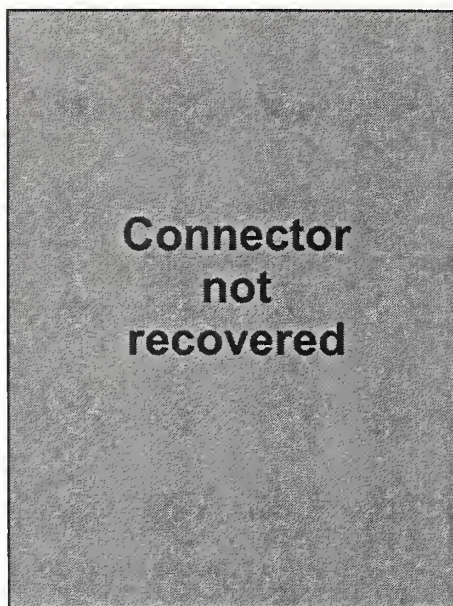
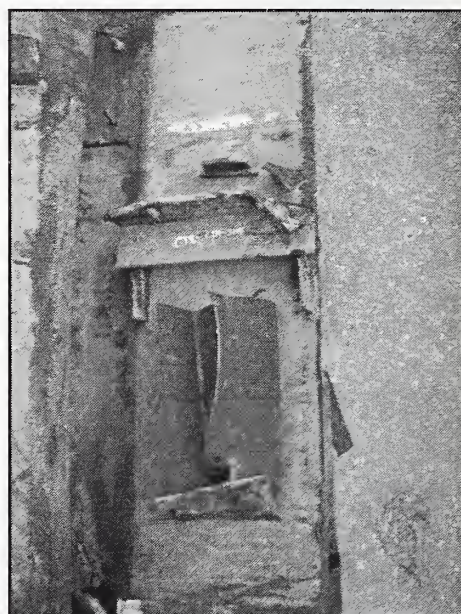
C18-C1M (WTC 2, Col.231, Fl 95)

Gusset plate intact;
Seat intact, both bolt holes intact, slight damage to one corner, bent downwards;
Gusset plate with damper unit intact, bent upwards.

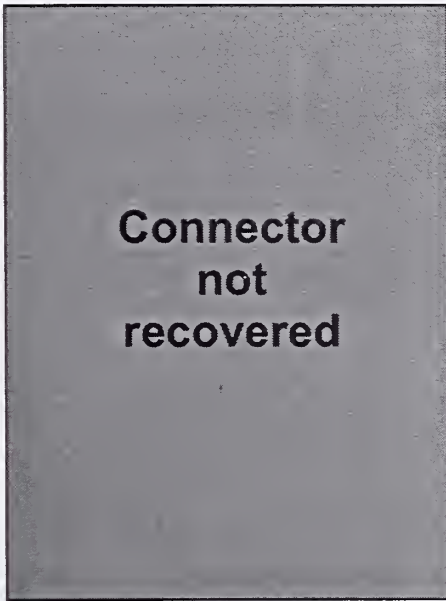
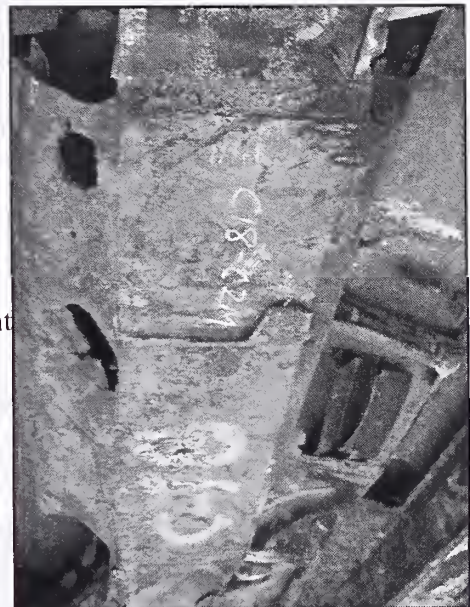
C18-C2M (WTC 2, Col.230, Fl 95)

Very small portion of large gusset plate remains, bent upwards.

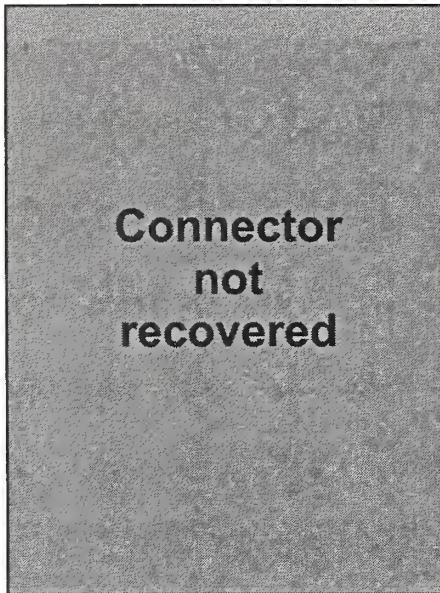
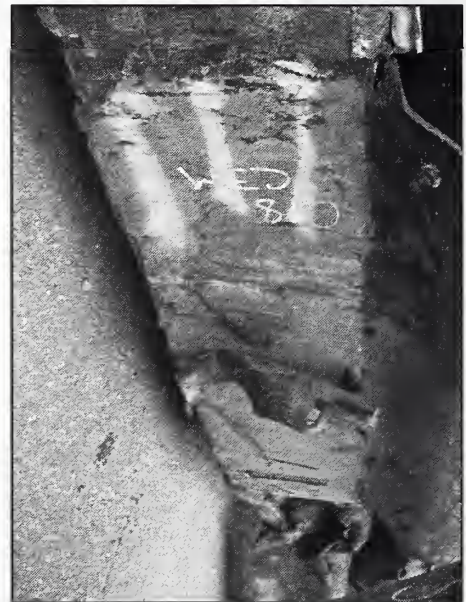
C18-C3M (WTC 2, Col.229, Fl 95)

Gusset plate intact, bent downwards;
Seat intact, bent down and in towards column, 1
bolt hole intact, other ripped out;
Gusset plate for damper unit ripped off at weld.

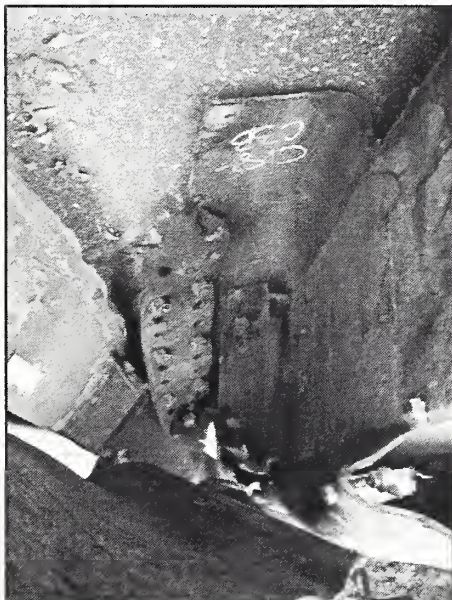
C18-C3B (WTC 2, Col.229, Fl 94)

Gusset plate intact;
Seat intact, both bolt holes intact with 1 bolt and nut,
some damage to corners;
Gusset plate with damper unit intact, bent downwards.

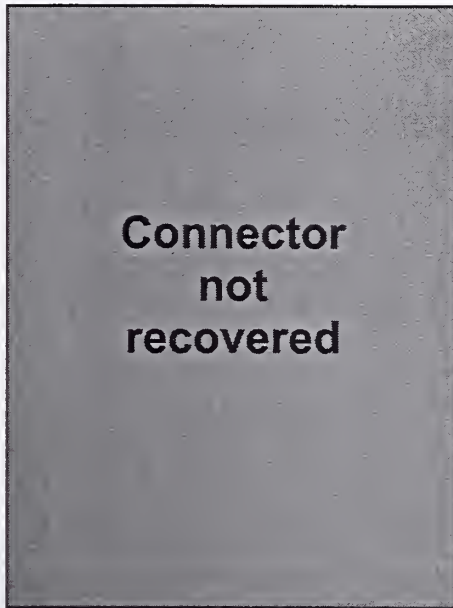
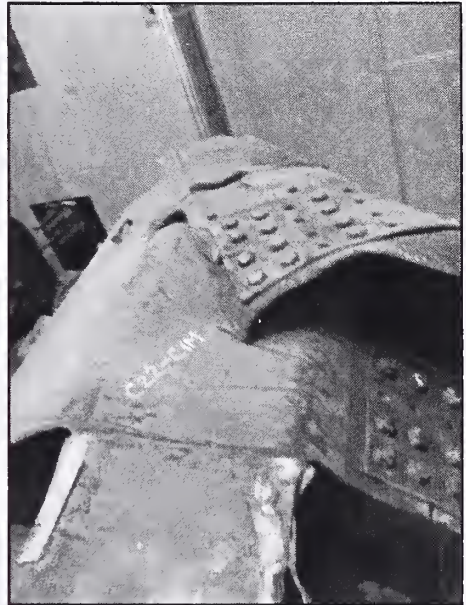
C22-C1M (WTC 1, Col.158, Fl 95)
Type C
Seat Detail: 5210

Large gusset plate ripped off at weld.

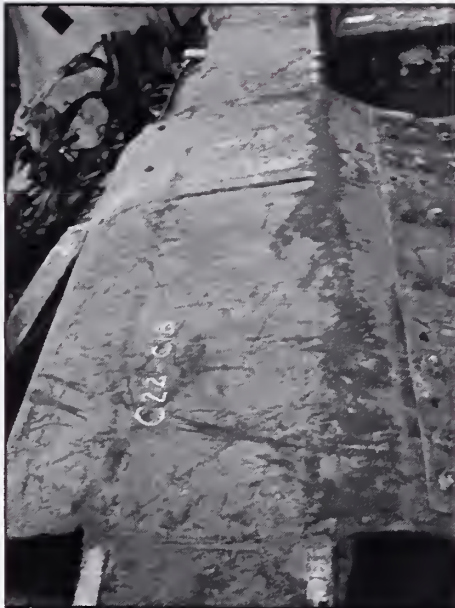
C22-C1B (WTC 1, Col.158, Fl 94)
Type C
Seat Detail: 5210

Large gusset plate ripped off at weld.

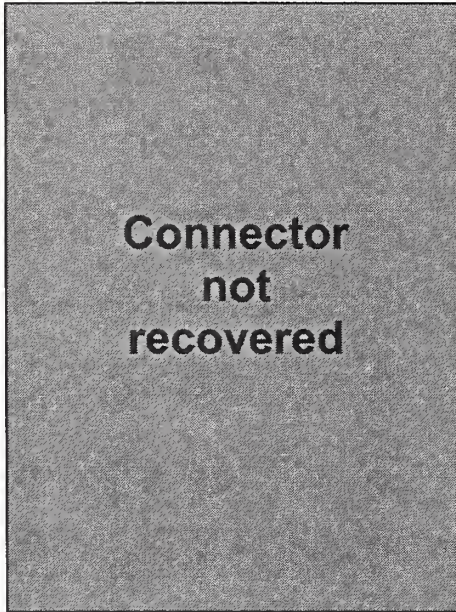
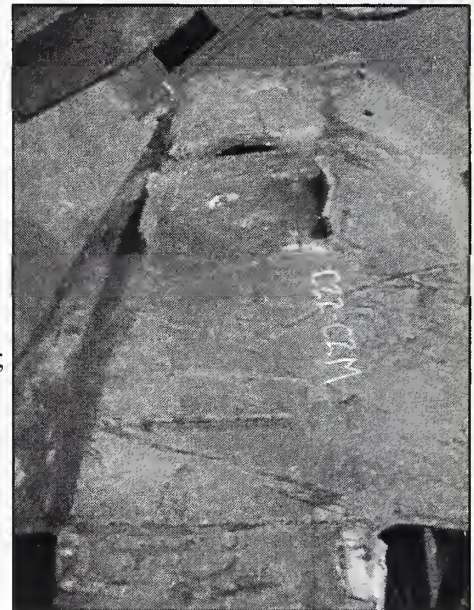
C22-C2M (WTC 1, Col.157, Fl 95)

Gusset plate ripped completely out of spandrel;
Only standoff plates remain, seat ripped off at welds;
Gusset for damper unit ripped off at weld.

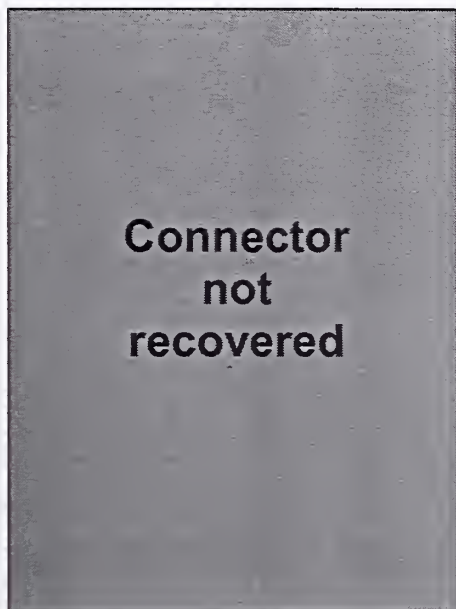
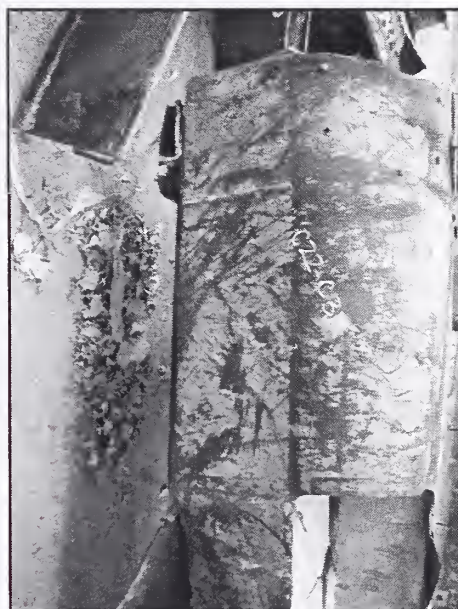
C22-C3M (WTC 1, Col.156, Fl 95)
Type C
Seat Detail: 5110

Large gusset plate ripped off at weld.

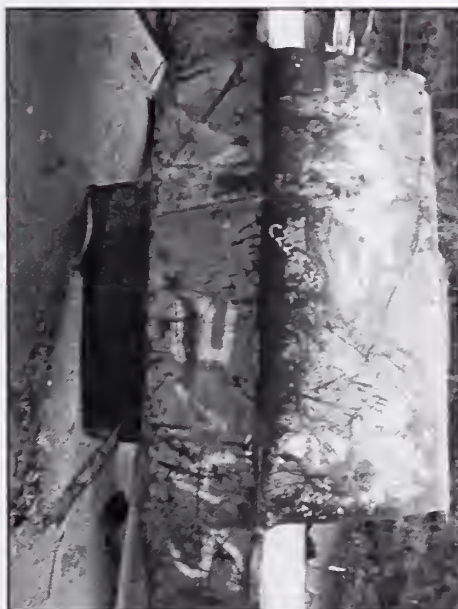
C22-C3B (WTC 1, Col.156, Fl 94)
Type C
Seat Detail: 5110

Large gusset plate ripped off at weld.

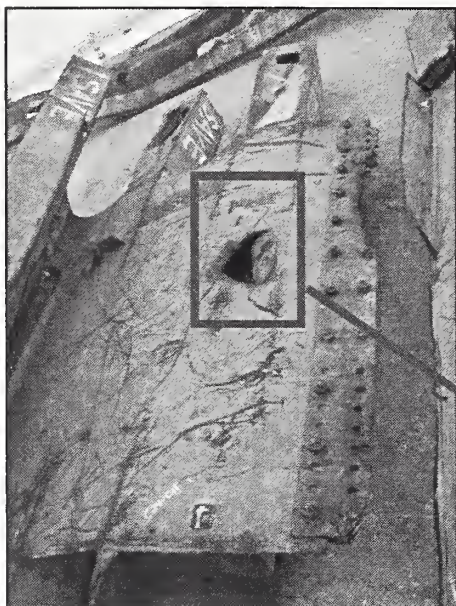
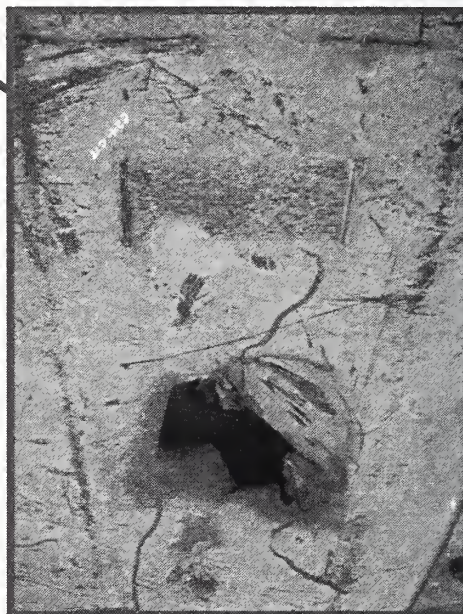
C24-C1T (WTC 2, Col. 204, Fl 77)

No evidence of gusset plate;
Seat that was welded directly to column (no shear plates) ripped off at welds;
No evidence of gusset plate for damper unit.

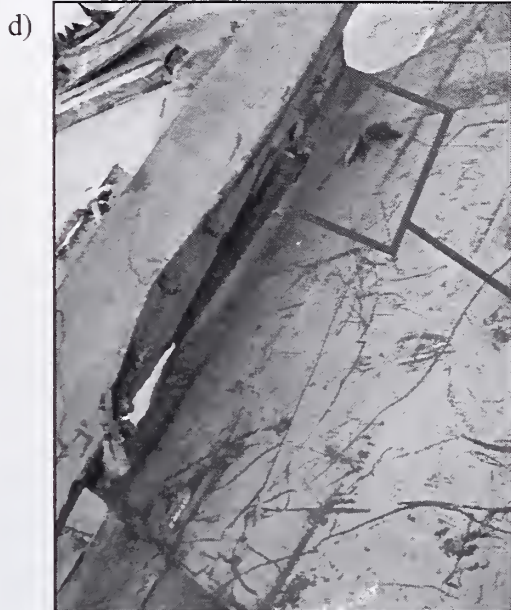
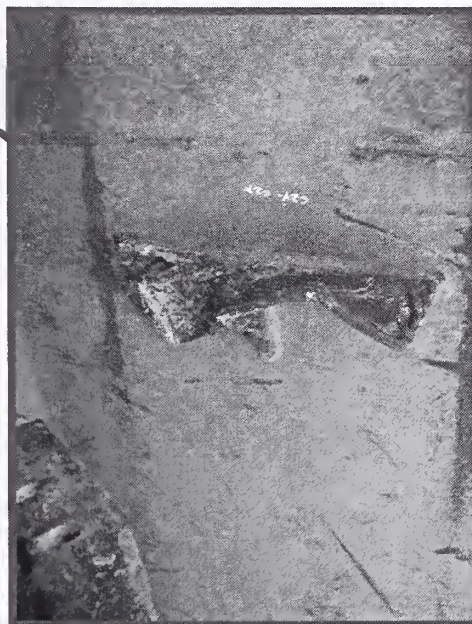
C24-C2T (WTC 2, Col.203, Fl 77)

Gusset plate with vertical support, torn and bent down wards.

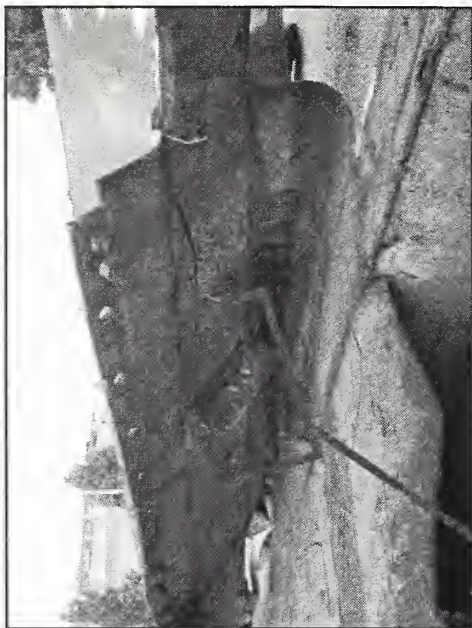
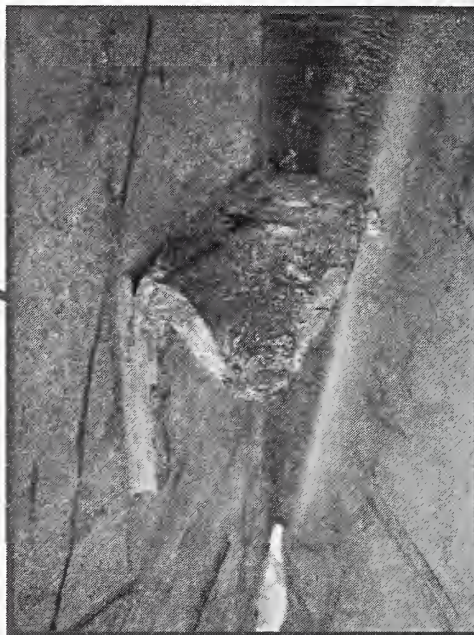
C24-C3T (WTC 2, Col.202, Fl 77)

Gusset plate for dampers ripped off at welds.

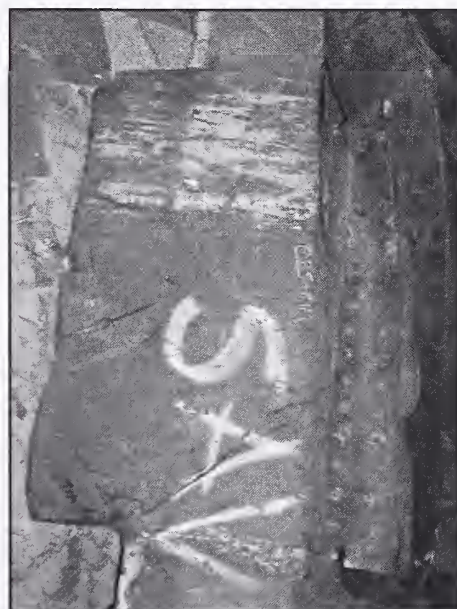
C25-C1M (WTC 1, Col.207, Fl 91)

1-in portion of diagonal bracing strap remains, other is ripped off at weld.

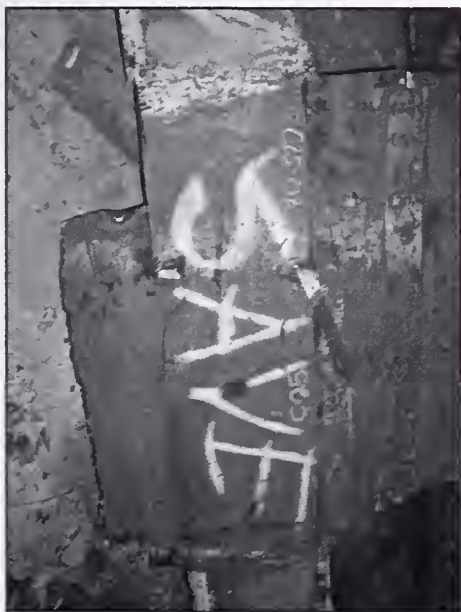
C25-C1B (WTC 1, Col.207, Fl 90)

1-ft and 1-in portions of diagonal bracing straps remain.

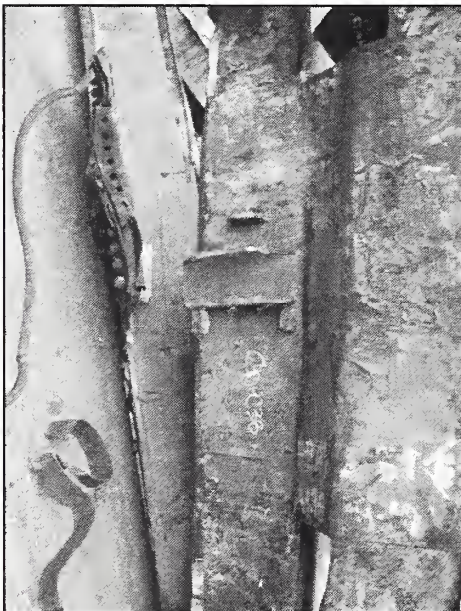
C40-C3B (WTC 1, Col.135, Fl 99)

Portion of gusset plate intact;
Seat intact, both bolt holes ripped out;
Gusset for damper unit ripped out at weld.

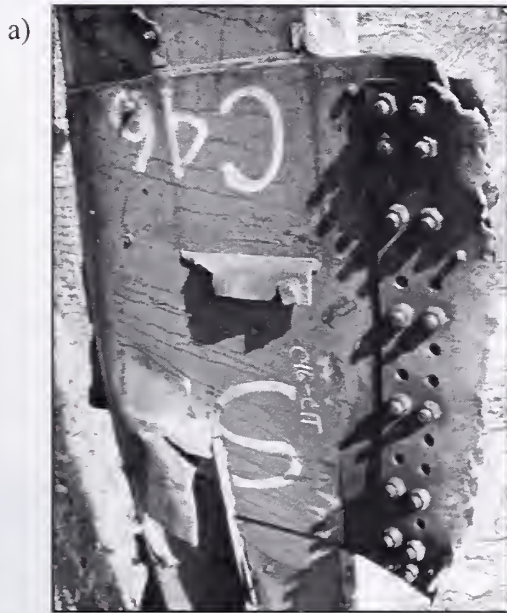
C46-C1T (WTC 2, Col.158, Fl 71)

Portion of gusset plate remains, bent downward.

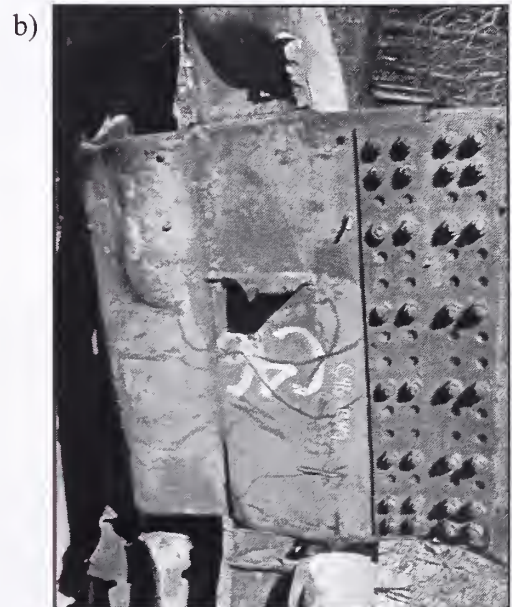
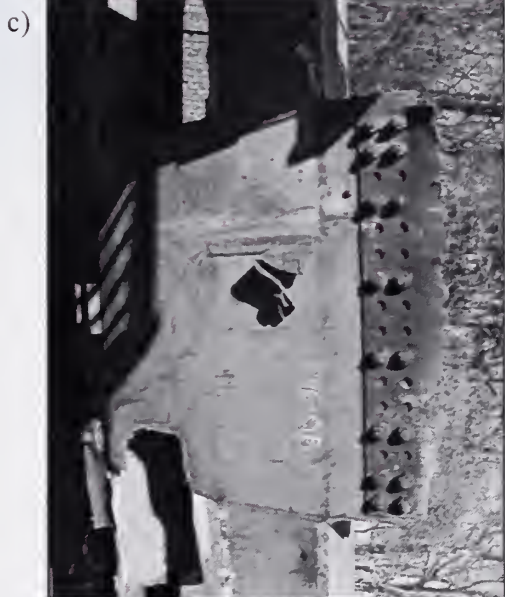
C46-C1B (WTC 2, Col.158, Fl 69)

Gusset plate remains, but half is ripped away from spandrel at weld, bent downwards.

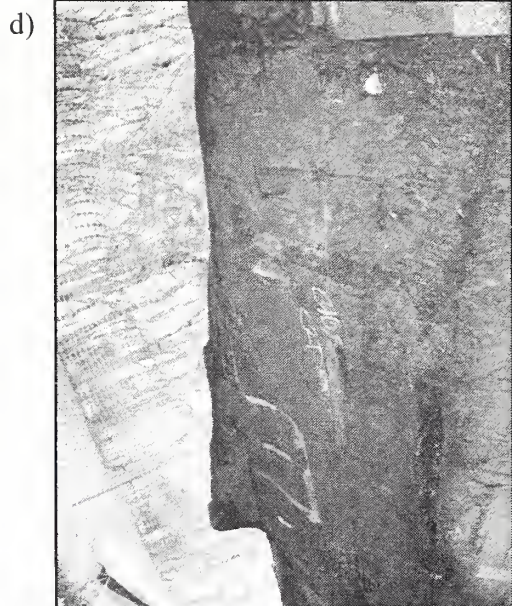
C46-C2T (WTC 2, Col.157, Fl 71)

Gusset plate intact;
Only portions of standoff plates remain;
Gusset plate for damper unit ripped off at weld.

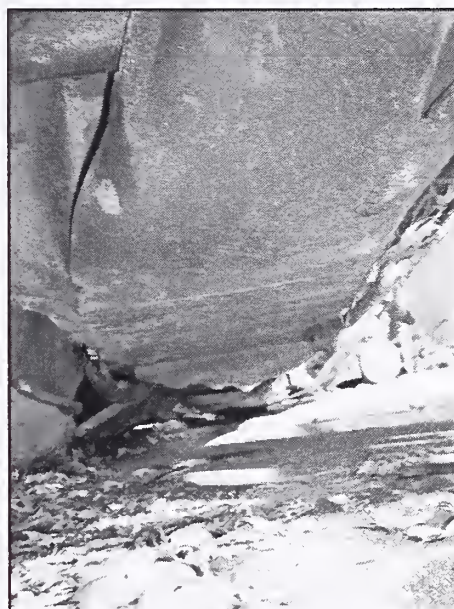
C46-C3M (WTC 2, Col.156, Fl 70)

Large gusset plate intact, bent downwards, 2 long diagonal bracing straps remain as well.

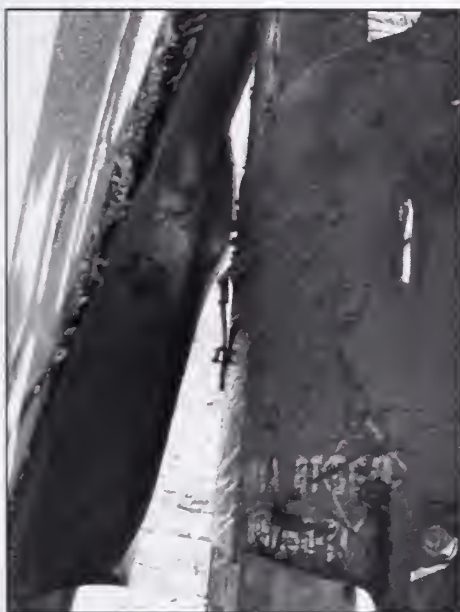
C46-C3B (WTC 2, Col.156, Fl 69)

Large gusset plate intact, bent downwards, 2 long diagonal bracing straps remain as well.

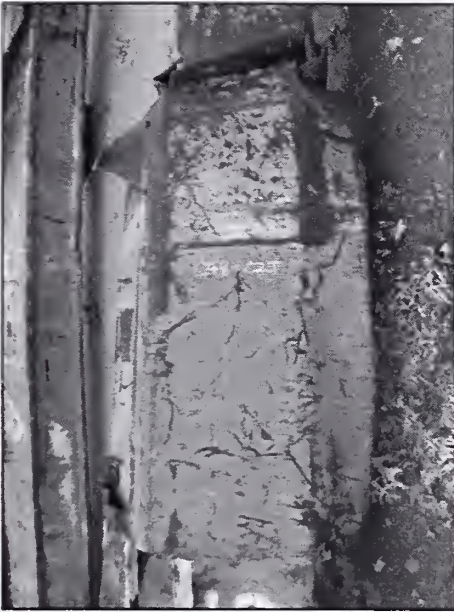
C48-C2T (WTC 2, Col.442, Fl 94)

Large gusset plate ripped off at weld.

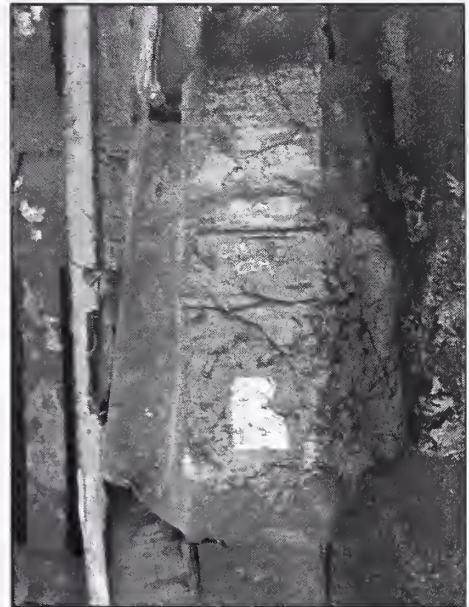
C48-C2M (WTC 2, Col.442, Fl 93)

Large gusset plate ripped off at weld.

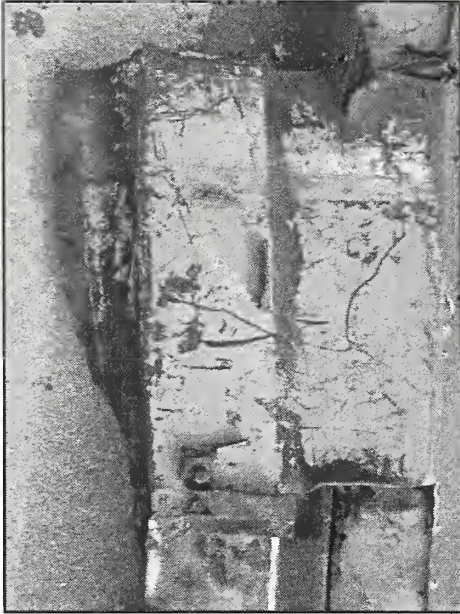
C48-C3T (WTC 2, Col.441, Fl 94)

Gusset plate intact;
1 standoff plate remains, rest ripped off at welds;
Portion of gusset plate with damper unit intact, bent downwards.

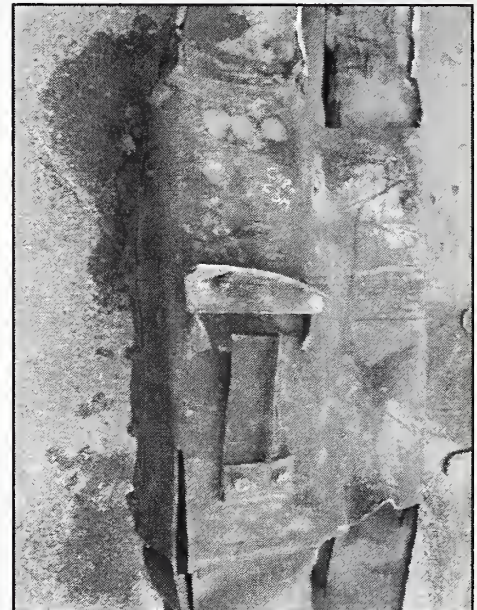
C48-C3M (WTC 2, Col.441, Fl 93)

Gusset plate intact;
Seat intact, bent downwards, both bolt holes intact,
1 with bolt and nut;
Gusset plate and damper unit intact, bent upwards.

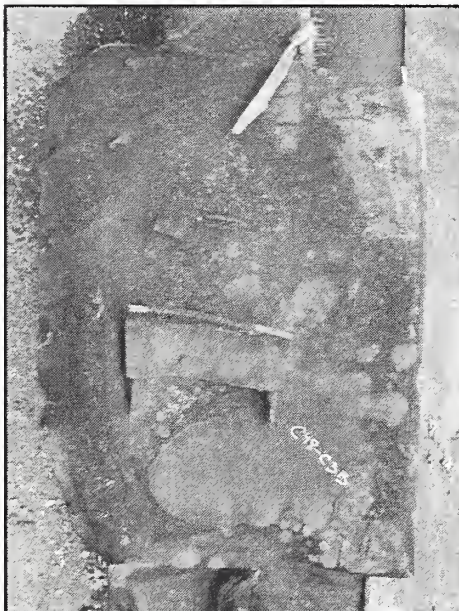
C48-C3B (WTC 2, Col.441, Fl 92)

Gusset plate intact;
Seat intact, bent in towards column, both bolt holes intact;
No evidence of gusset plate for damper unit.

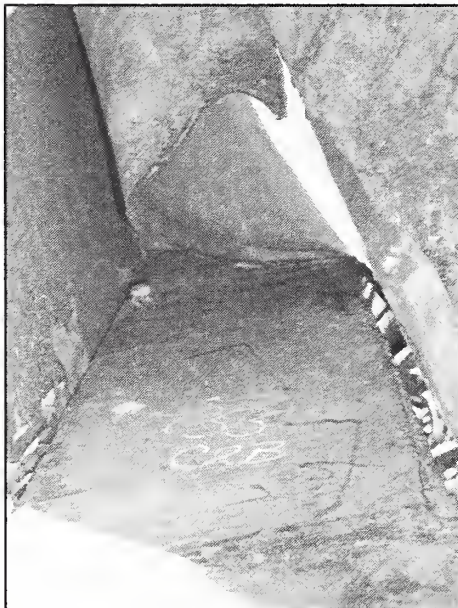
C55-C2B (WTC 1, Col.209, Fl 95)
Type D
Seat Detail: 5210

One diagonal bracing strap ripped off at weld, other
Has about 1 in left.

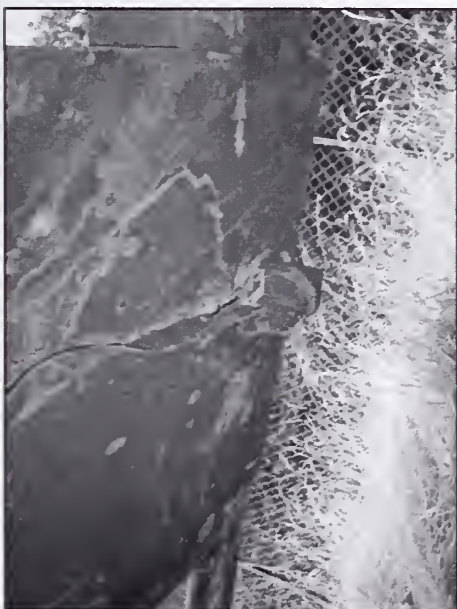
C89-C2B (WTC 2, Col.215, Fl 13)

No gusset plate, appears to have partial of 1 diagonal
bracing strap remaining;
Small seat intact, both bolt holes ok, small wide
flange section remains welded to seat;
No evidence of gusset plate for damper unit.

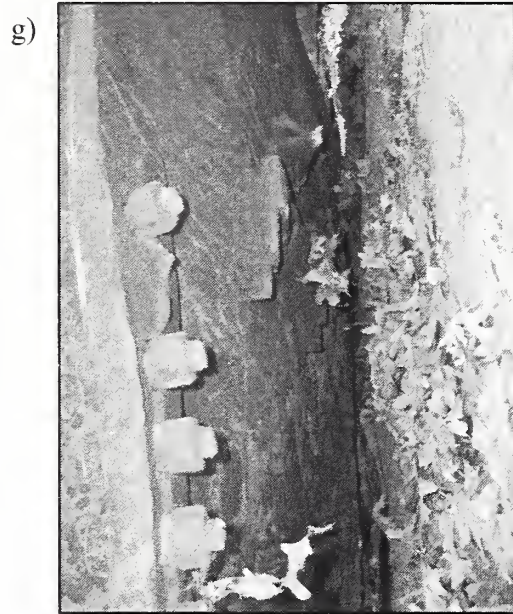
C89-C3T (WTC 2, Col.214, Fl 15)

Gusset plate ripped off at weld;
Standoff plates ripped off at welds;
Portion of gusset plate for damper unit remains,
damper units gone.

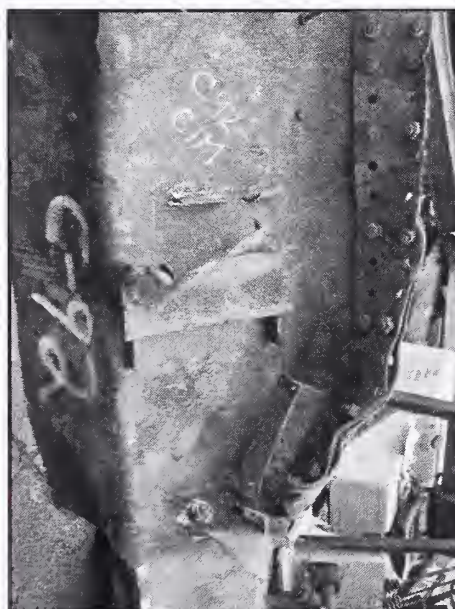
C92-C1M (WTC 2, Col.131, Fl 95)

Gusset plate with damper unit intact, half bent up.

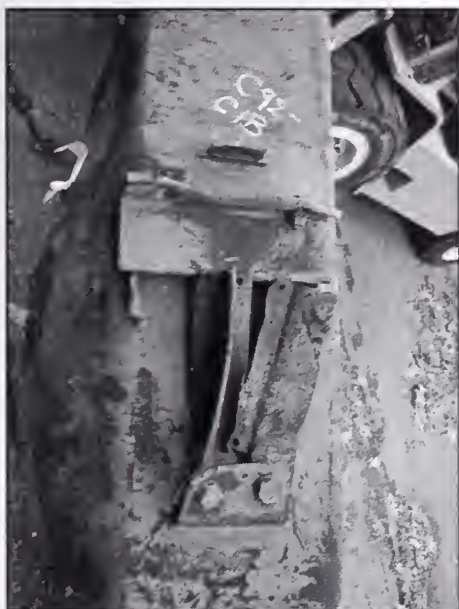
C92-C1B (WTC 2, Col.131, Fl 94)

Gusset plate with damper unit intact, bent up.

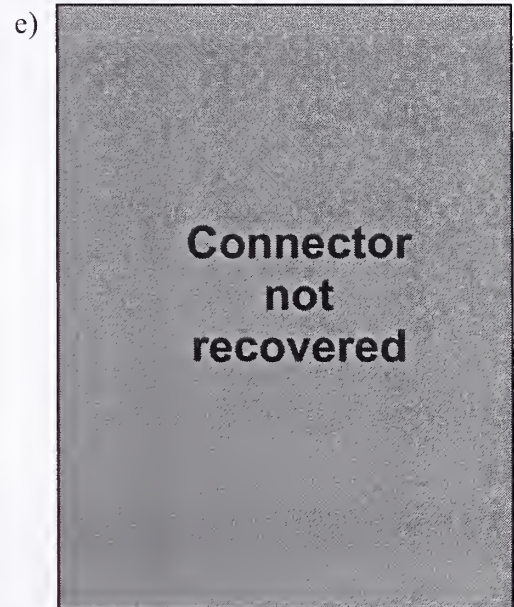
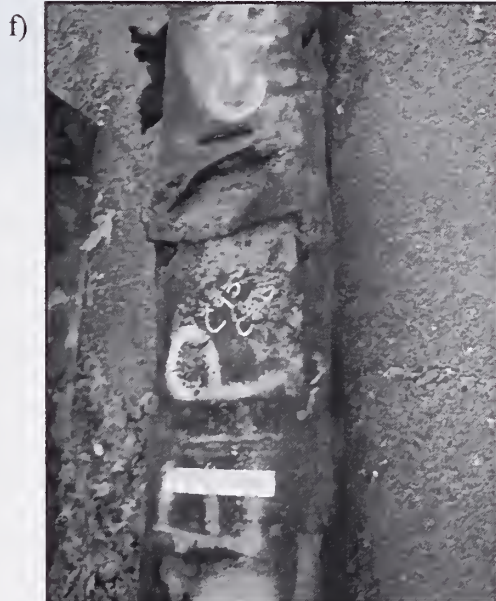
C93-C2B (WTC 1, Col.339, Fl 98)
Type A
Seat Detail: 1411

Gusset plate ripped off at weld;
Seat intact, pushed in and bent down, both bolt holes
ripped through;
Gusset plate for damper unit ripped off at weld.

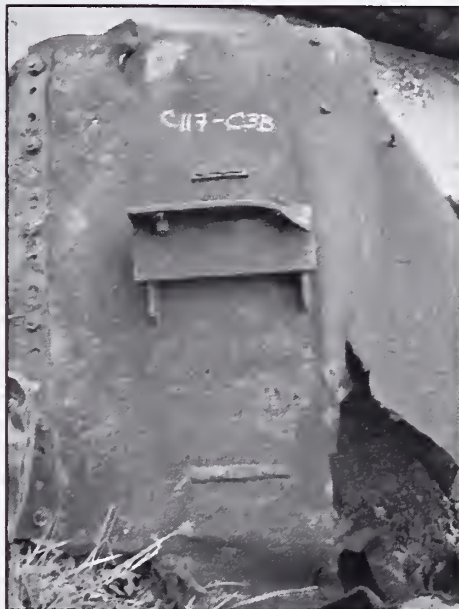
C117-C3B (Col.unknown, Fl 102)

Gusset plate for damper unit ripped off at weld.

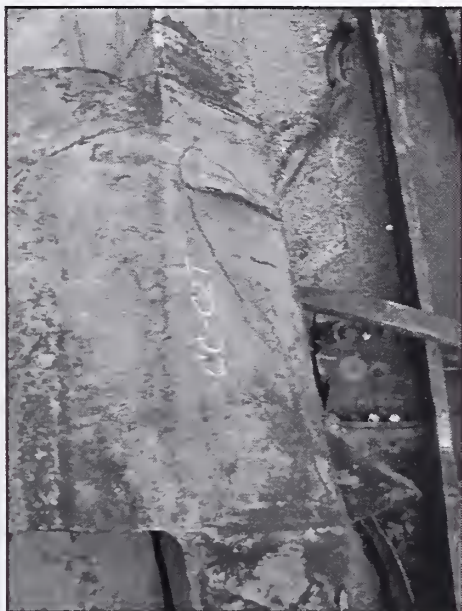
CC-C2T (WTC 1, Col.124, Fl 73)

Portion of large gusset plate remains.

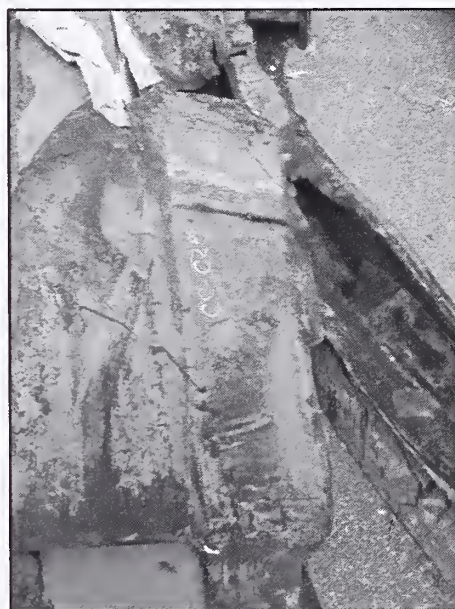
CC-C2M (WTC 1, Col.124, Fl 72)

Large gusset plate ripped off at weld.

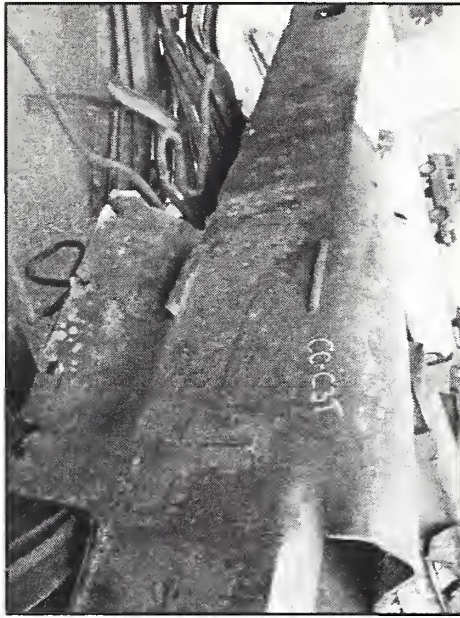
CC-C3T (WTC 1, Col.123, Fl 73)

Gusset plate ripped off at weld;
Standoff plates ripped off at welds;
Gusset plate for damper unit ripped off at weld.

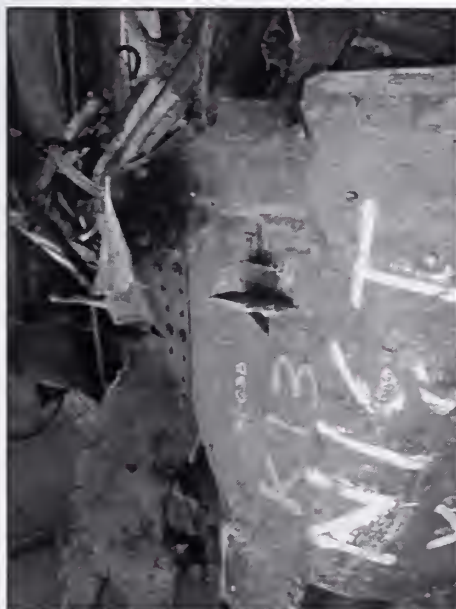
K1-C3B (WTC 1, Col.208, Fl 98)
Type B
Seat Detail: 5010

Gusset plate remains with shear bolt;
Small seat intact, 1 bolt hole intact, other is
covered by a welded plate;
No evidence of gusset plate for damper unit.

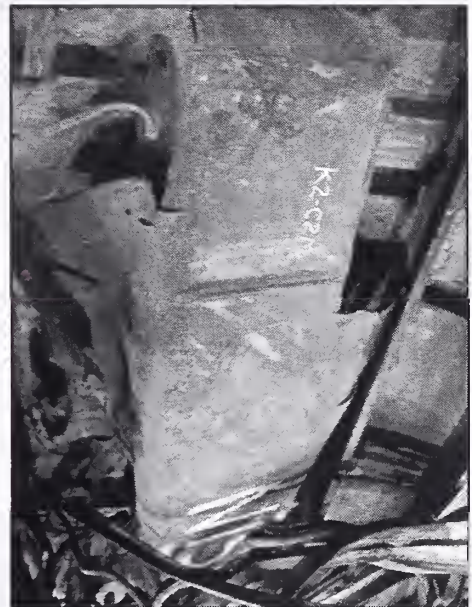
K2-C2M (WTC 1, Col.236, Fl 94)
Type C
Seat Detail: 5110

Gusset plate ripped off at weld.

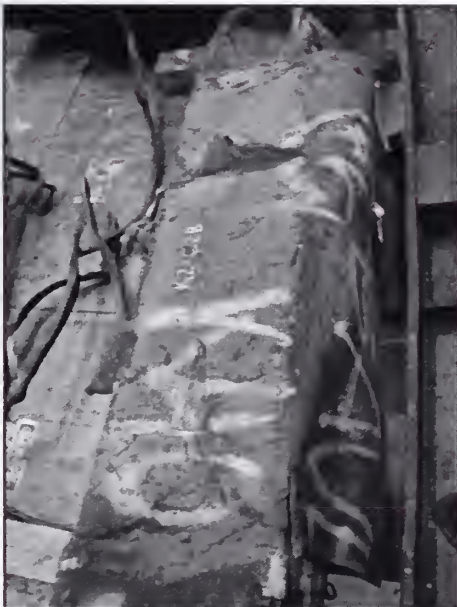
K2-C2B (WTC 1, Col.236, Fl 93)
Type C
Seat Detail: 5110

Portion of gusset plate remains.

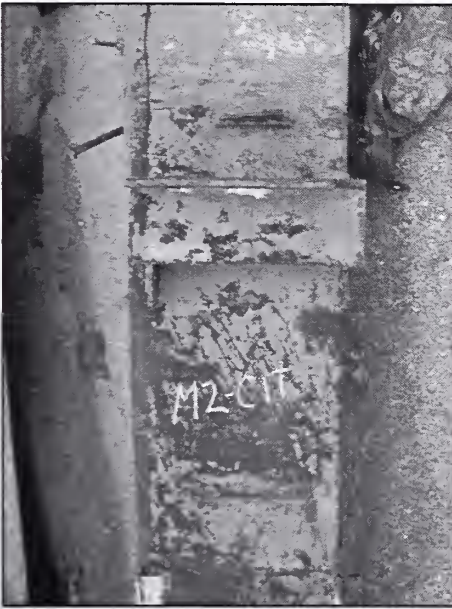
M2-C1T (WTC 1, Col.131, Fl 99)

Gusset plate remains;
Seat intact, 1 bolt hole remains intact, other ripped out;
Gusset plate for damper unit ripped off at weld.

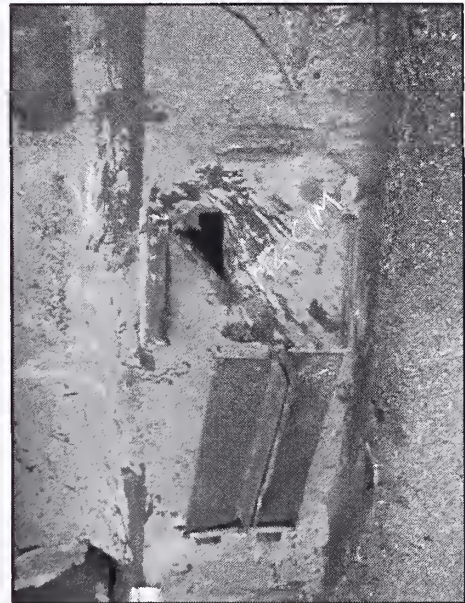
M2-C1M (WTC 1, Col.131, Fl 98)

Gusset plate intact;
1 standoff plate remains, seat and other standoff plate ripped off at welds;
Gusset plate with damper unit intact, bent up.

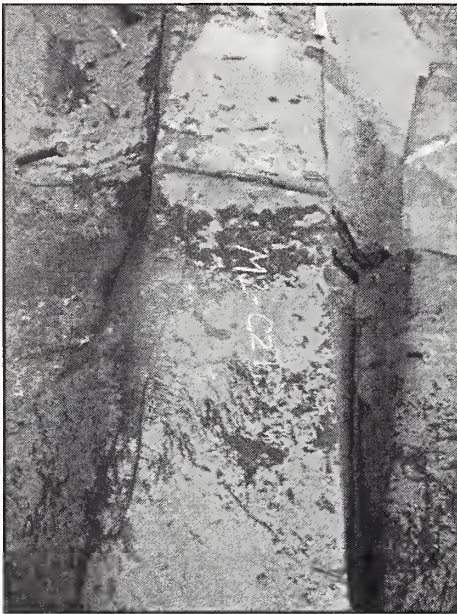
M2-C2T (WTC 1, Col.130, Fl 99)

Gusset plate ripped off at weld.

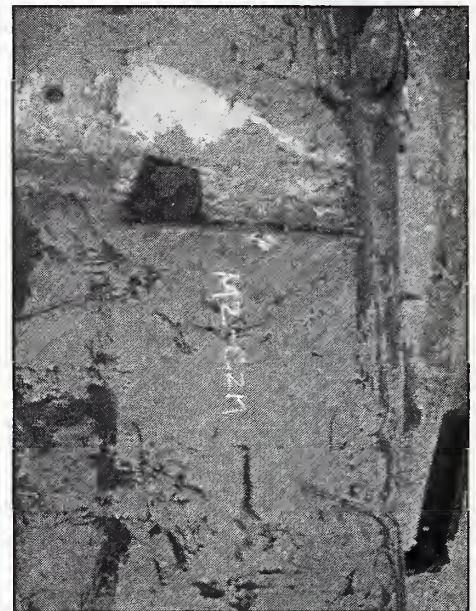
M2-C2M (WTC 1, Col.130, Fl 98)

Portion of gusset plate remains, bent up.

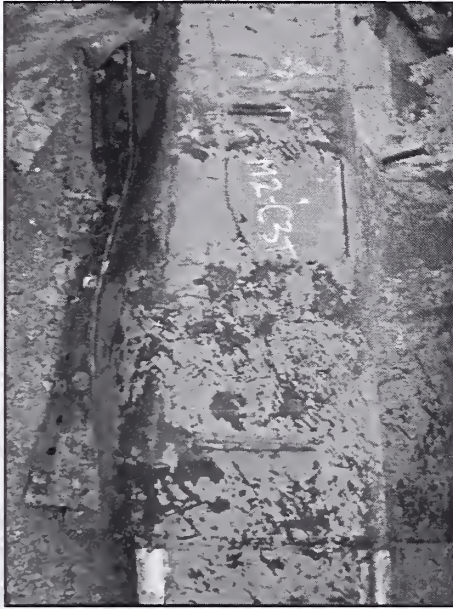
M2-C3T (WTC 1, Col.129, FI 99)

Gusset plate remains;
Seat intact, bent down, 1 bolt hole remains intact
with bolt, other ripped out;
Gusset plate with damper unit intact, bent up.

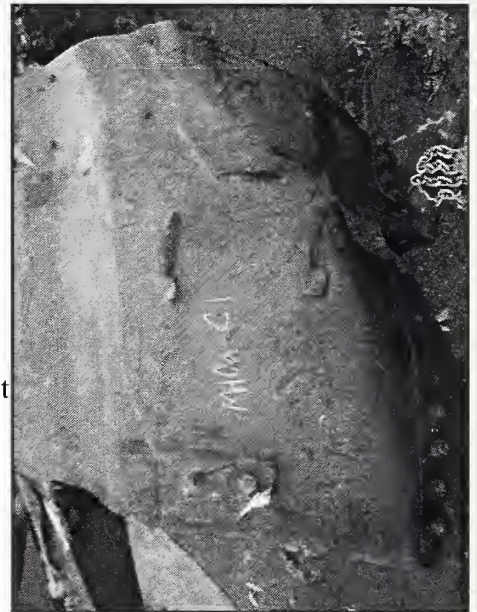
M10a-C1M (WTC 2, Col.210, Fl 84)

Gusset plate ripped completely out of spandrel;
Only portions of standoff plates remain;
Gusset plate with damper unit intact, partially ripped at
weld, bent downwards, portion of 1 damper remains.

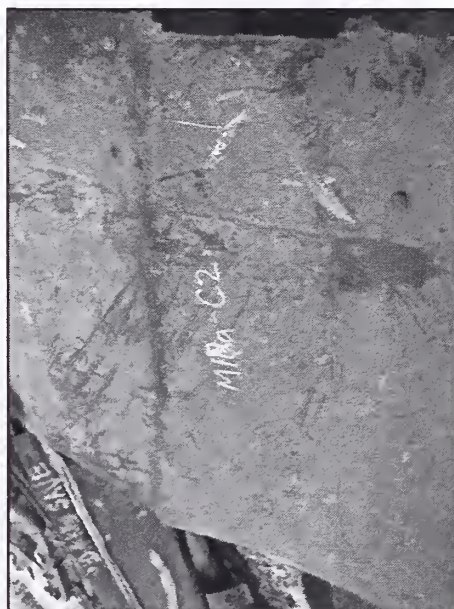
M10a-C2M (WTC 2, Col.209, Fl 84)

Both diagonal bracing straps ripped off at weld.

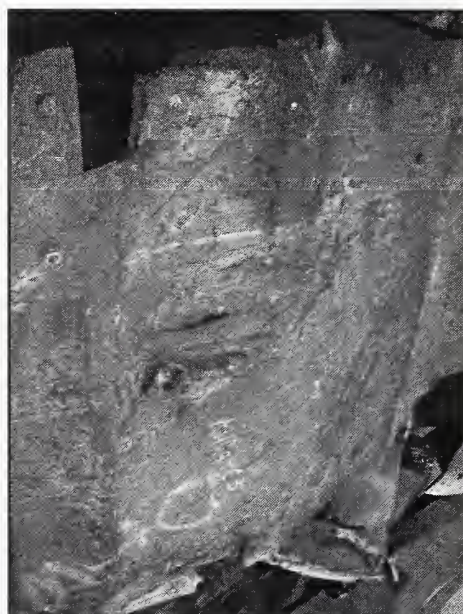
M10a-C3M (WTC 2, Col.208, Fl 84)

Gusset plate ripped completely out of spandrel;
Small seat remains, highly deformed, bent
downwards, 1 bolt hole intact;
No evidence of gusset plate for damper unit.

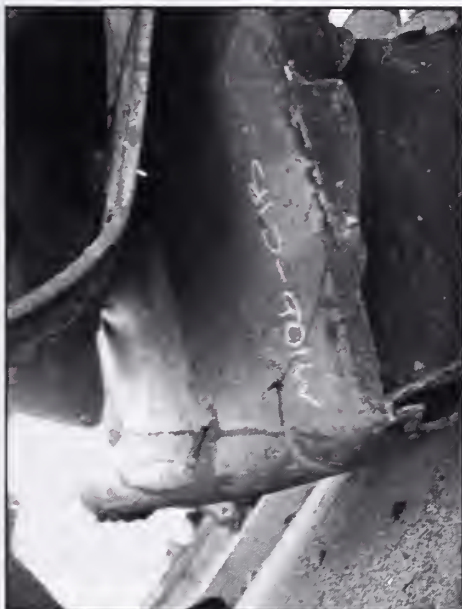
M10b-C1B (WTC 2, Col.207, Fl 84)
Type D
Seat Detail: 5110

Both diagonal bracing straps ripped off at weld.

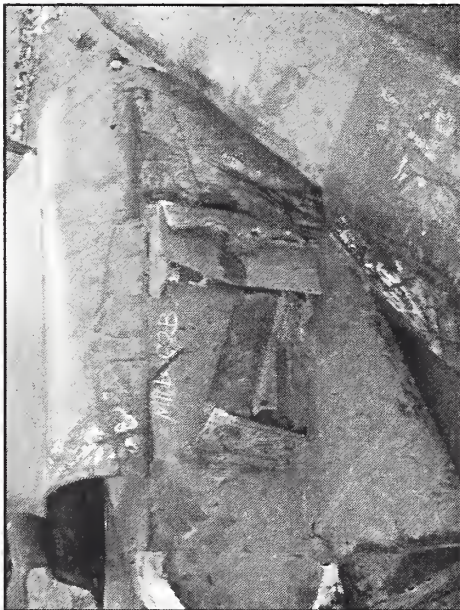
M10b-C2B (WTC 2, Col.206, Fl 84)
Type A
Seat Detail: 1212

Gusset plate ripped completely out of spandrel;
Seat intact, bent in towards column and downwards,
only 1 bolt hole intact, other ripped through;
Gusset plate with damper unit intact, bent upwards.

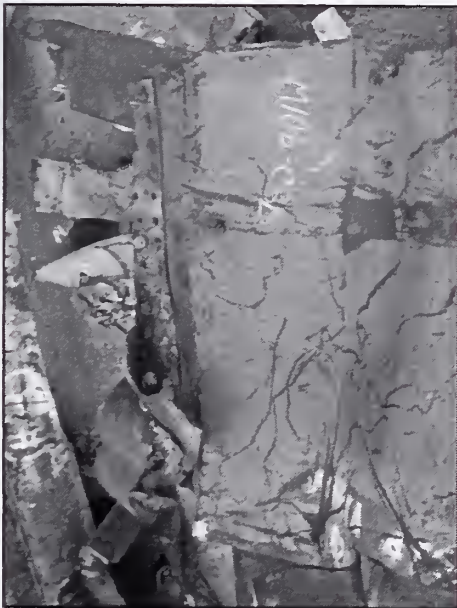
M10b-C3B (WTC 2, Col.205, Fl 84)

1-in portion of diagonal bracing strap remaining,
other ripped completely out of spandrel.

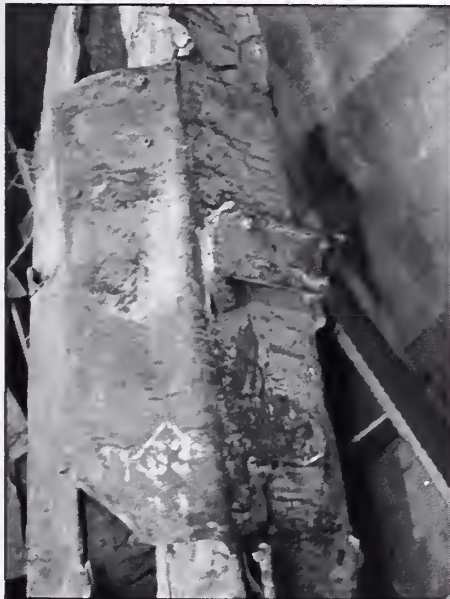
M20-C2B (WTC 1, Col.121, Fl 100)
Type A
Seat Detail: 1411

Gusset plate ripped completely out of spandrel;
Heavy seat intact, has additional stiffener, both bolt
holes intact, 2 bolts remain;
Gusset for damper unit ripped off at weld.

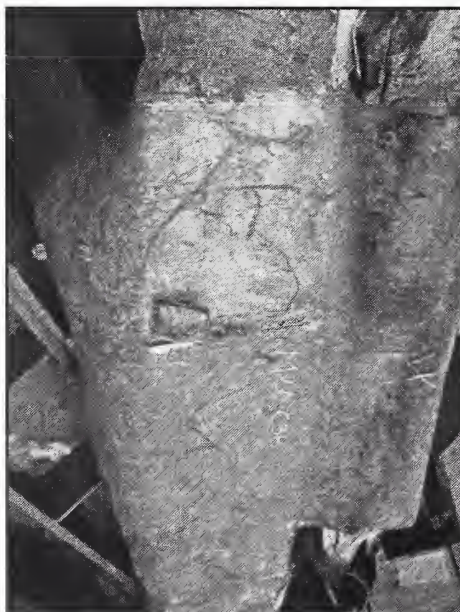
M20-C3B (WTC 1, Col.120, Fl 100)
Type C
Seat Detail: 5210

Portion of gusset plate remains, bent upward, rest
ripped off at weld.
