NIST NCSTAR 1-3C

**Federal Building and Fire Safety Investigation of
the World Trade Center Disaster**

Damage and Failure Modes of Structural Steel Components

(Appendices A-G)

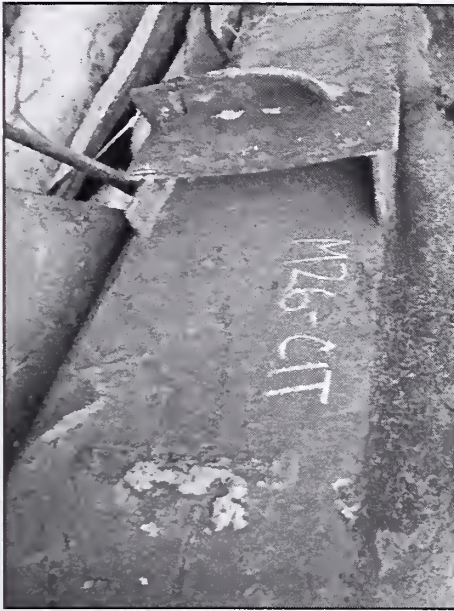
M26-C1T (WTC 1, Col.131, Fl 93)

Gusset plate ripped off at weld;
Seat intact, bent downwards, 1 bolt hole remains
intact, other ripped out;
Gusset for damper unit ripped off at weld

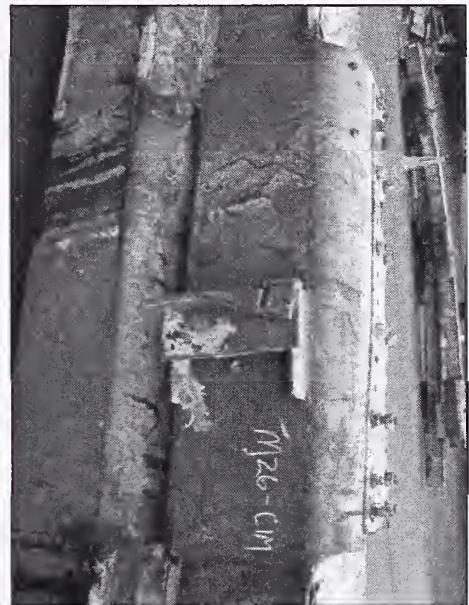
M26-C1M (WTC 1, Col.131, Fl 92)

Gusset plate ripped off at weld;
Seat intact, bent downwards, 1 bolt hole remains
intact, other ripped out;
No evidence of gusset for damper unit.

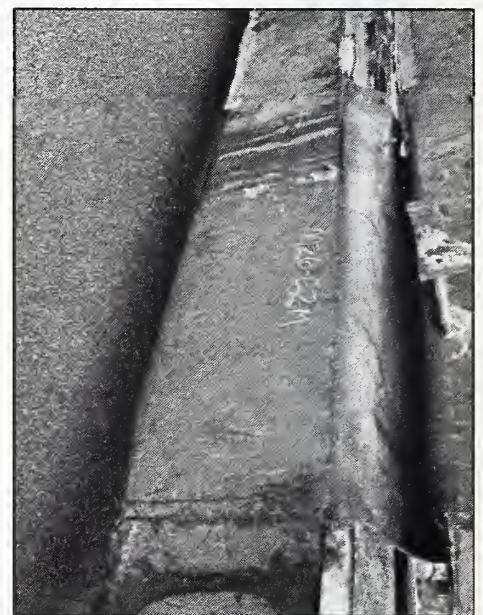
e)

Gusset plate ripped at weld.

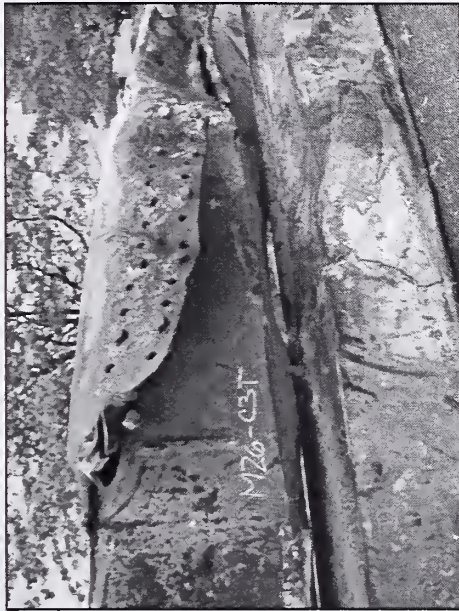
M26-C3T (WTC 1, Col.129, Fl 93)

Gusset plate remains;
Only standoff plates remain, seat ripped off at welds;
Gusset for damper unit ripped off at weld.

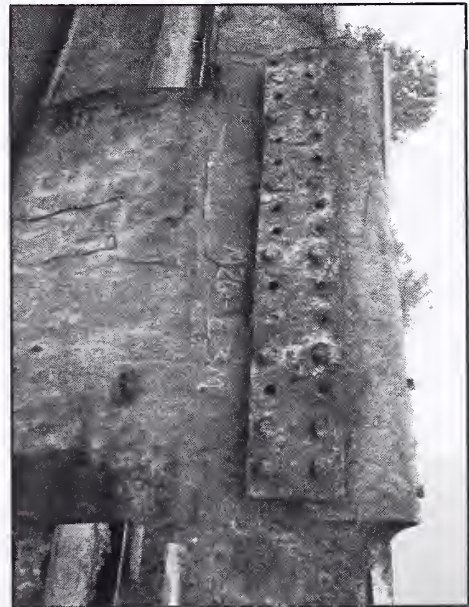
M26-C3M (WTC 1, Col.129, Fl 92)

Gusset plate remains;
Only 1 standoff plate remains, seat and other
standoff plate ripped off at welds;
No evidence of gusset plate for damper unit.

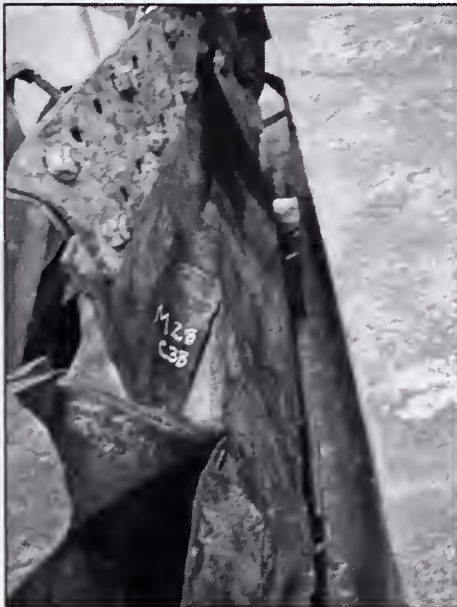
M28-C3B (WTC 2, Col.344, Fl 99)

Gusset plate ripped off at weld.

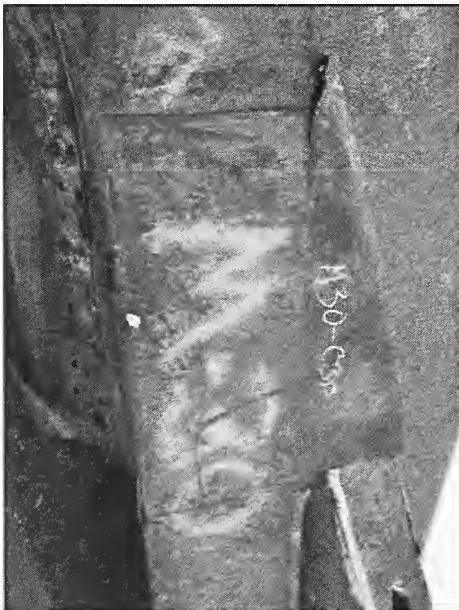
M30-C3B (WTC 1, Col.132, Fl 95)
Type C
Seat Detail: 5210

Gusset plate ripped off at weld.

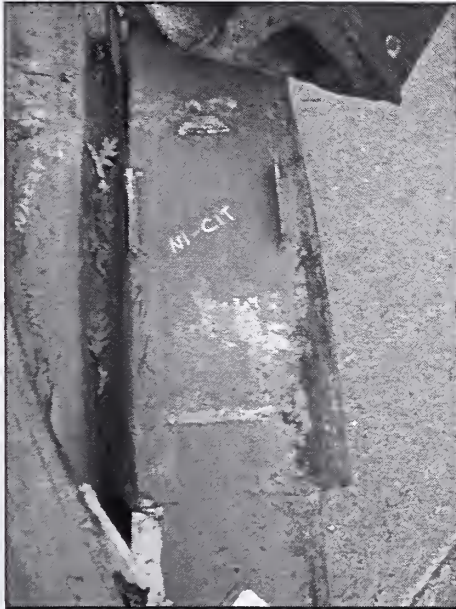
N1-C1T (WTC 1, Col.219, Fl 85)

Gusset plate intact;
Only standoff plates remain;
Gusset plate for damper unit ripped off at weld.

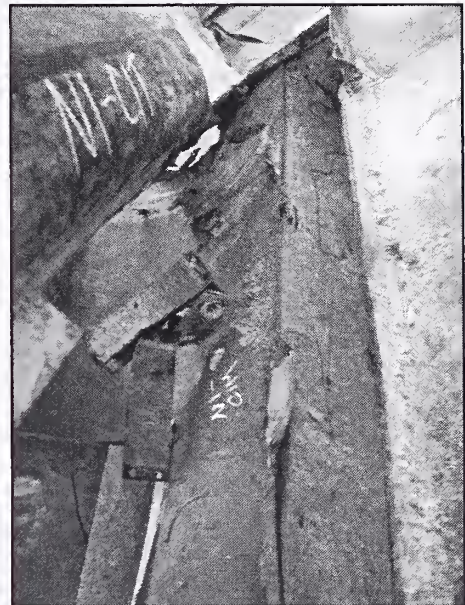
N1-C1M (WTC 1, Col.219, Fl 84)

Gusset plate remains;
Seat intact, bent downwards, both bolt holes intact;
Gusset plate with damper unit intact, bent downwards.

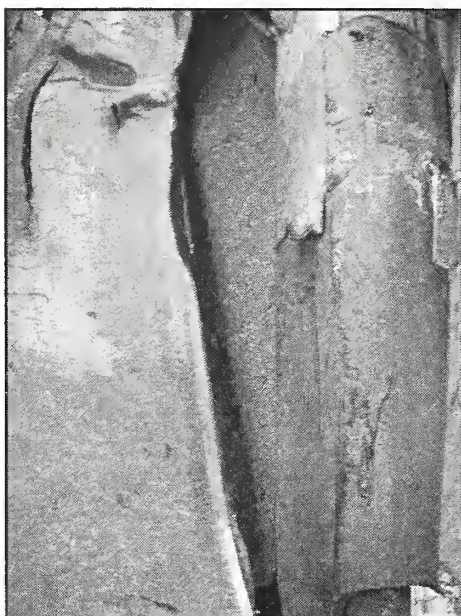
N1-C2T (WTC 1, Col.218, Fl 85)

Gusset plate remains, but half ripped away from spandrel at weld.

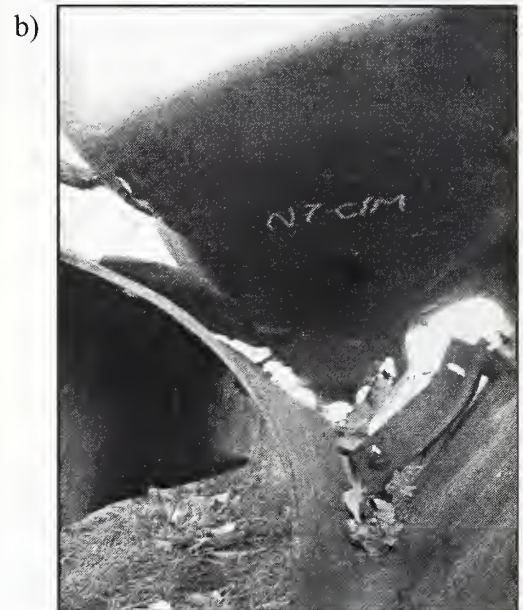
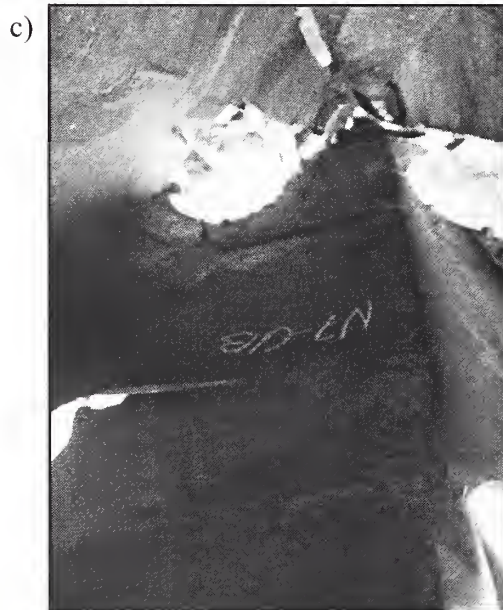
N7-C1B (WTC 1, Col.128, Fl 98)

Portion of gusset plate remains, bent downward.

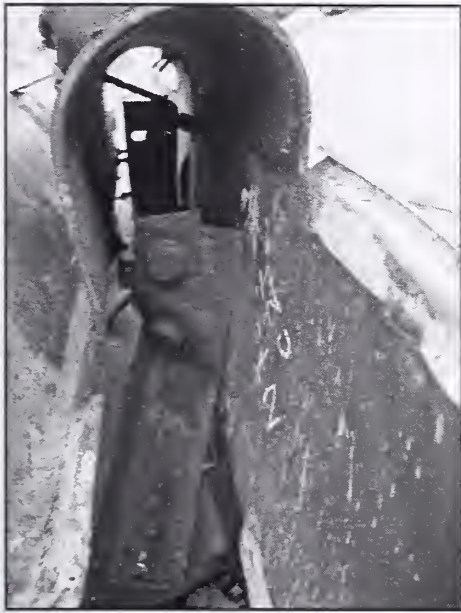
N7-C2T (WTC 1, Col.127, Fl 100)

Gusset plate with damper unit intact, bent upwards,
1 damper bent up, other bent down.

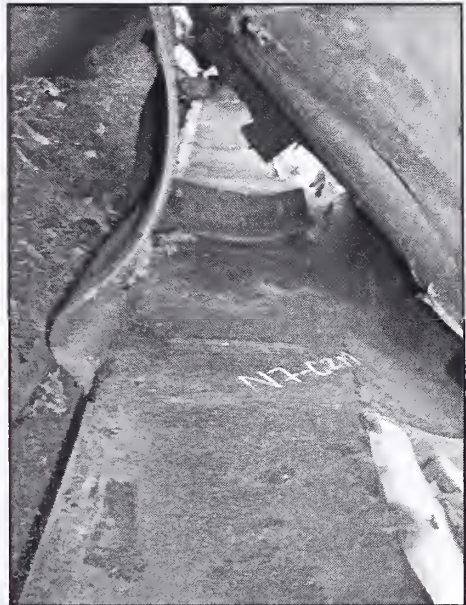
N7-C2M (WTC 1, Col.127, Fl 99)

Gusset plate ripped off at weld;
Seat intact, bent in towards column, both bolt holes
intact, 1 with bolt and nut;
Gusset plate for damper unit ripped off at weld.

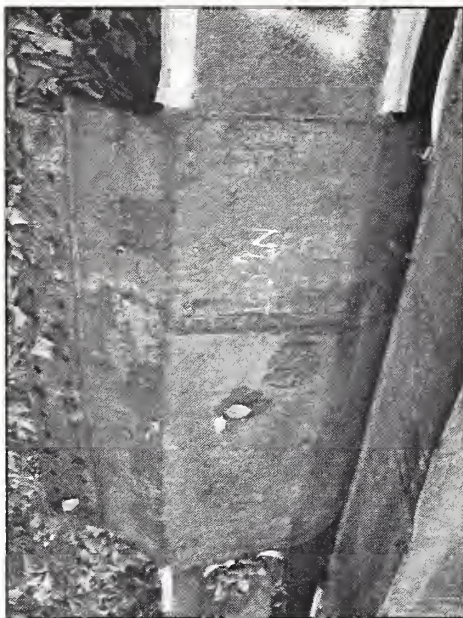
N7-C3T (WTC 1, Col.126, Fl 100)

Gusset plate ripped off at welds.

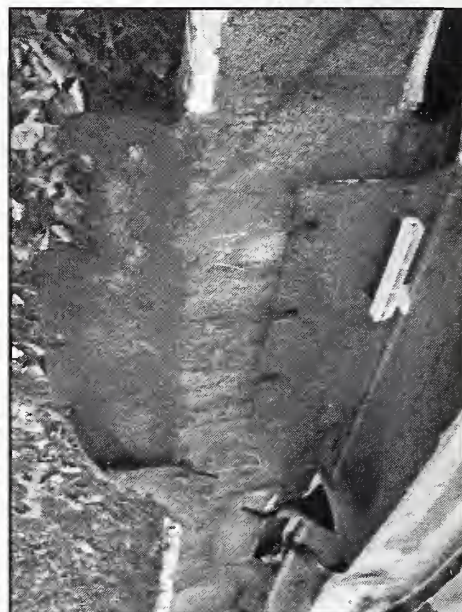
N7-C3M (WTC 1, Col.126, Fl 99)

Gusset plate ripped off at welds.

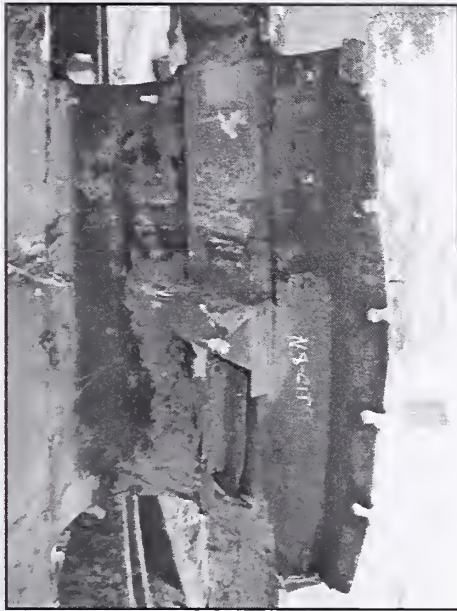
N8-C1T (WTC 1, Col.143, Fl 100)

Gusset plate intact;
Seat intact, partially bent downwards, both bolt
holes intact, 1 with bolt and nut;
Gusset with damper unit intact, bent upwards.

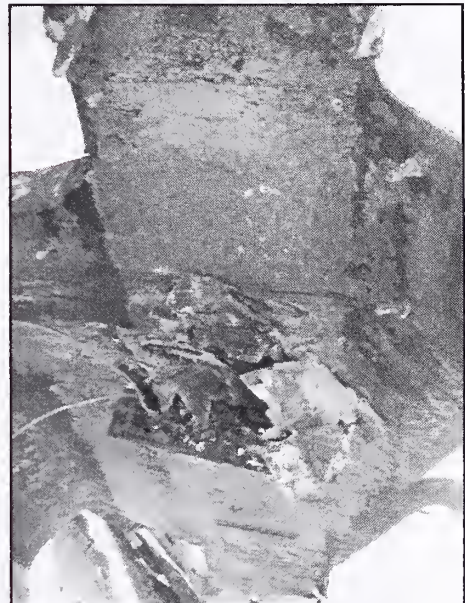
N8-C1M (WTC 1, Col.143, Fl 99)

Gusset plate intact;
Seat intact, partially bent downwards, both bolt
holes intact with bolts and nuts;
Gusset for damper unit ripped off at weld.

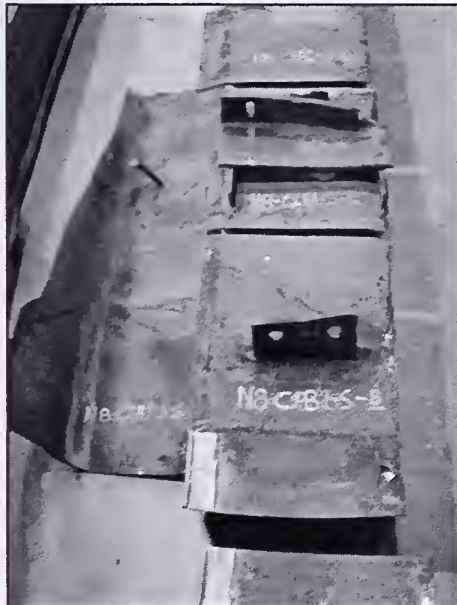
N8-C1B (WTC 1, Col.143, Fl 98)

Portion of gusset plate remains;
Seat intact, partially bent downwards, one bolt hole
intact, other ripped out;
Gusset plate for damper unit intact, bolt holes intact,
damper unit missing

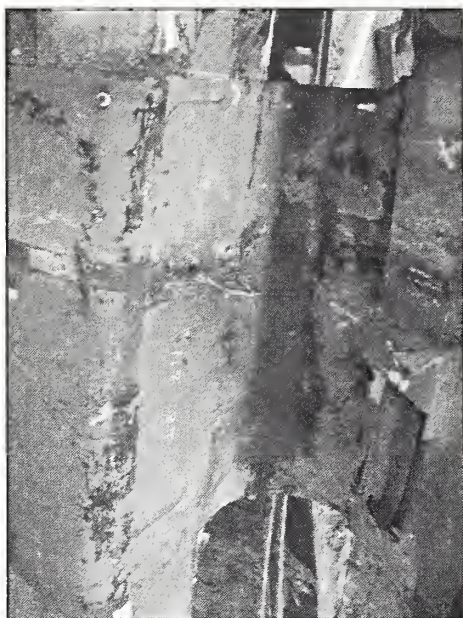
N8-C2T (WTC 1, Col.142, Fl 100)

Gusset plate intact with portion of diagonal bracing strap attached, bent downwards.

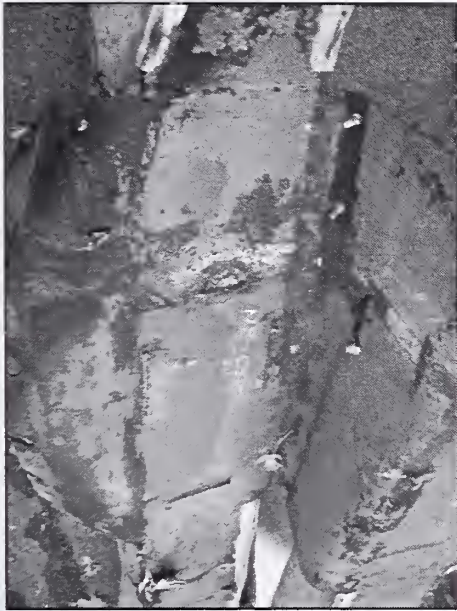
N8-C3T (WTC 1, Col.141, Fl 100)

Gusset plate ripped completely out of spandrel;
Seat intact, 1 bolt hole intact with bolt and nut,
other ripped out;
Gusset plate for damper unit ripped out at weld.

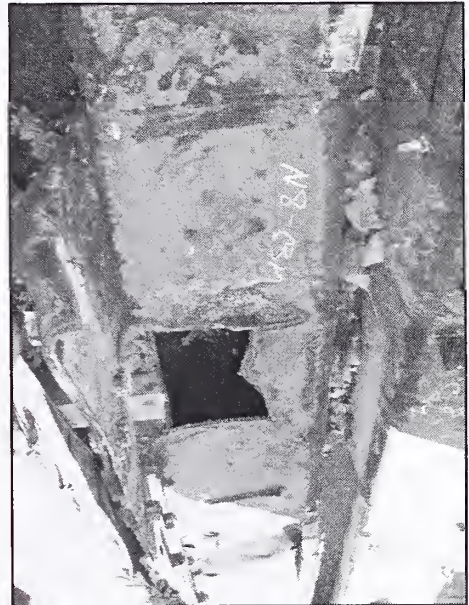
N8-C3M (WTC 1, Col.141, Fl 99)

Portion of gusset plate intact;
Seat intact, both bolt holes intact with bolts and nuts;
Gusset plate for damper unit ripped off at weld.

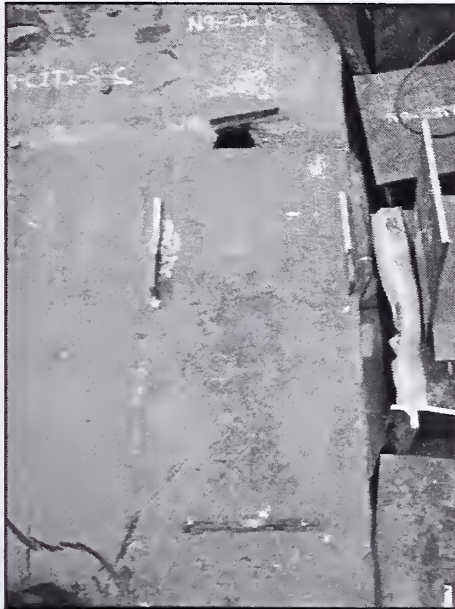
N9-C1T (WTC 1, Col.155, Fl 104)

Portion of gusset plate remains, ripped out of spandrel; Seat intact (removed by Boulder prior to picture), both bolt holes intact with bolts and nuts; Gusset for damper unit ripped off at weld.

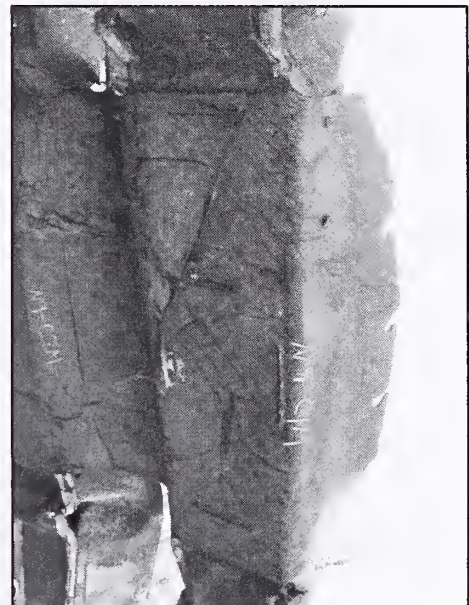
N9-C1M (WTC 1, Col.155, Fl 103)

Gusset plate ripped completely out of spandrel;
Only part of 1 standoff plate remains, rest ripped off at welds;

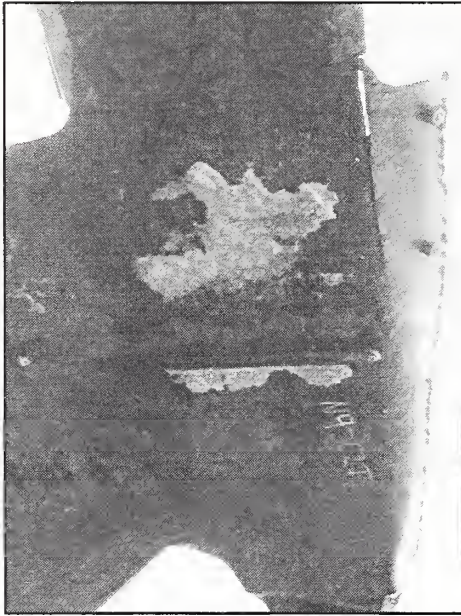
N9-C2T (WTC 1, Col.154, Fl 104)

Gusset plate ripped off at weld.

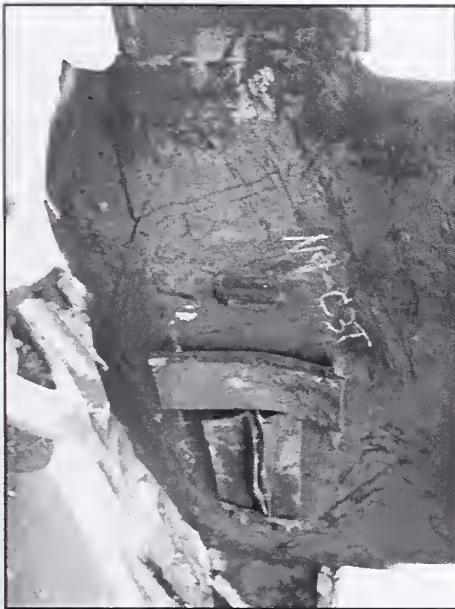
N9-C3T (WTC 1, Col.153, Fl 104)

Portion of gusset plate remains;
Portion of seat is left (vertical part attached to shear plates);
Gusset with damper unit intact, bent upwards.

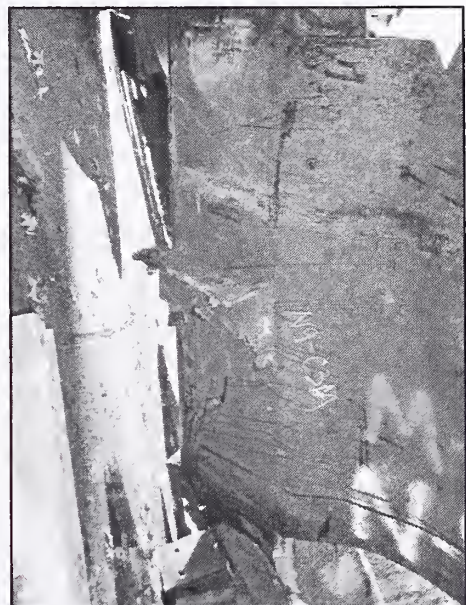
N9-C3M (WTC 1, Col.153, Fl 103)

Gusset plate ripped completely out of spandrel;
Seat intact, both bolt holes intact with bolts and nuts;
Gusset for damper unit ripped off at weld.

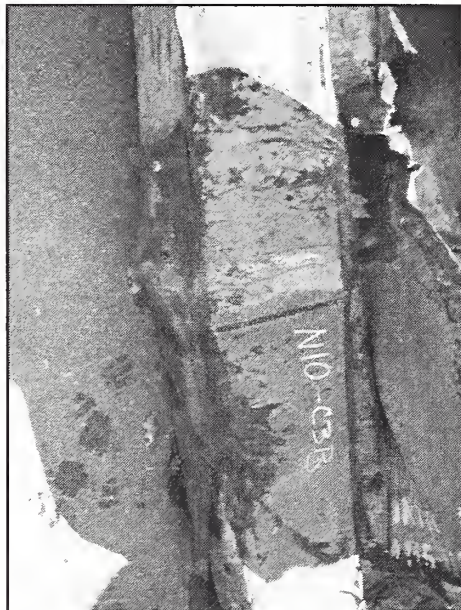
N10-C3B (WTC 1, Col.114, Fl 90)

Gusset plate ripped off at weld.

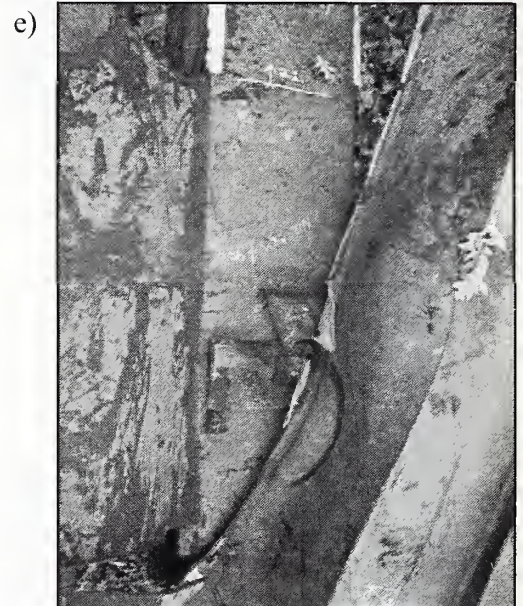
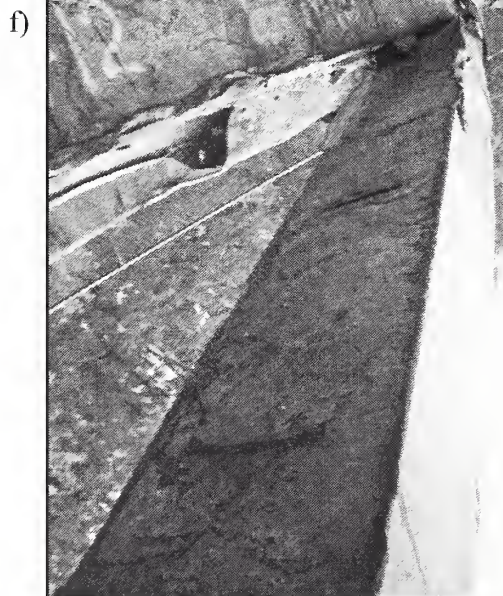
N12-C2B (WTC 1, Col.206, Fl 93)

Gusset plate intact, bent downwards;
Seat intact, bent downwards and in towards
column, one bolt hole intact, other ripped out;
Gusset plate for damper unit ripped off at weld.

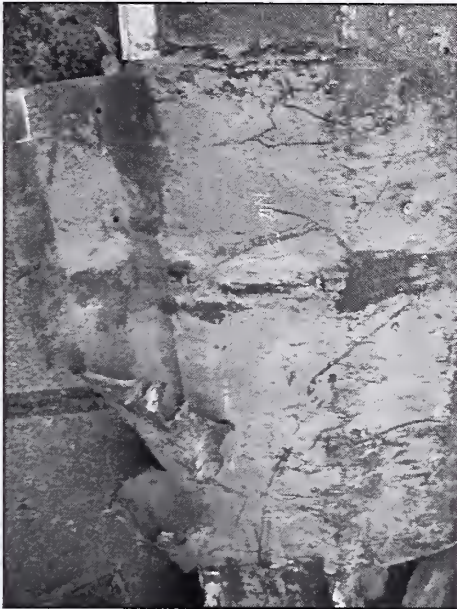
N12-C3T (WTC 1, Col.205, Fl 95)

2 1-in portions of diagonal bracing straps remaining

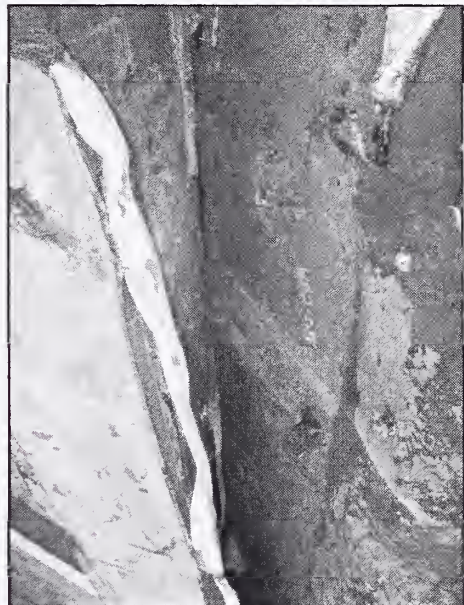
N12-C3M (WTC 1, Col.205, Fl 94)

2 1-in portion of diagonal bracing straps remaining.

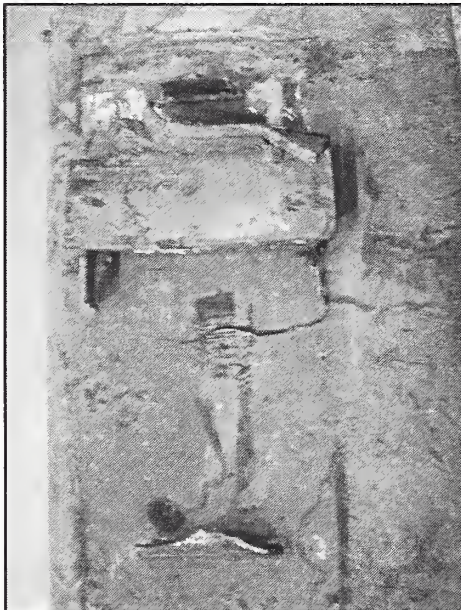
N13-C1B (WTC 1, Col.131, Fl 100)
Type A
Seat Detail: 1411

Gusset plate remains;
Seat intact, bent upwards, 1 bolt hole ripped but still
has bolt and nut, other completely ripped out;
Portion of gusset plate remains, bent upwards.

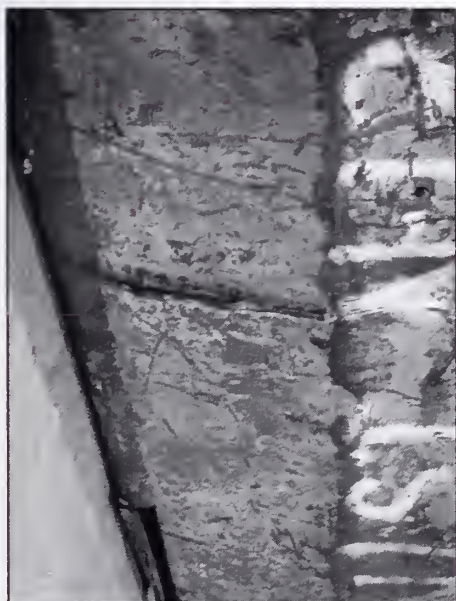
N13-C2B (WTC 1, Col.130, Fl 100)
Type C
Seat Detail: 5210

Gusset plate ripped off at weld.

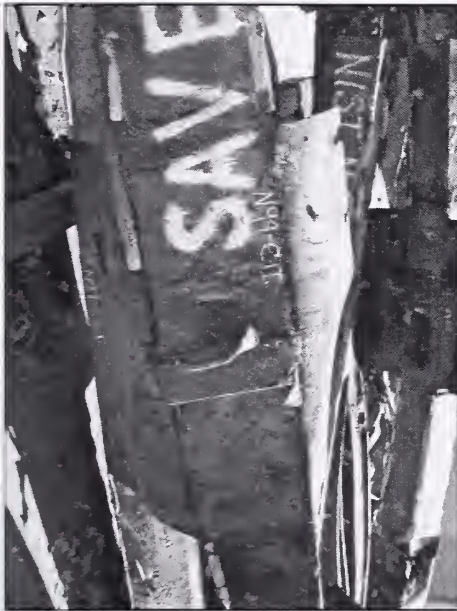
N99-C1T (WTC 1, Col.149, Fl 102)

Gusset plate intact;
Seat intact, bent upwards, both bolt holes ripped out;
Gusset for damper unit ripped off at weld.

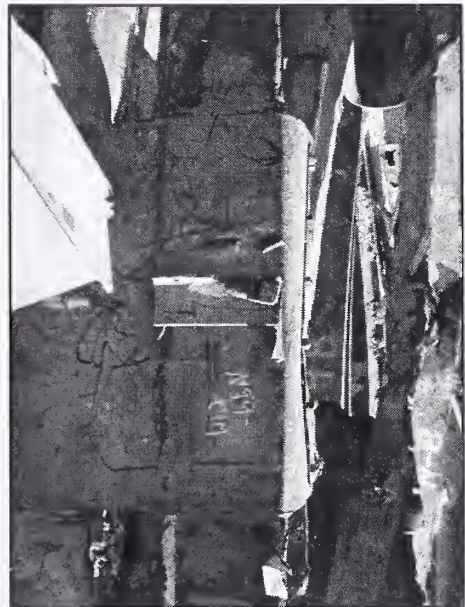
N99-C1M (WTC 1, Col.149, Fl 101)

Gusset plate ripped off at weld;
Seat intact, partially bent downwards, 1 bolt hole intact, other ripped through but bolt remains;
Gusset for damper unit ripped off at weld.

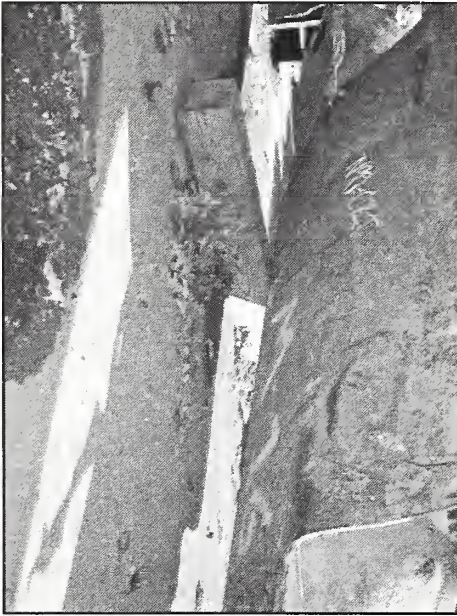
N99-C2T (WTC 1, Col.148, Fl 102)

Gusset plate ripped off at weld.

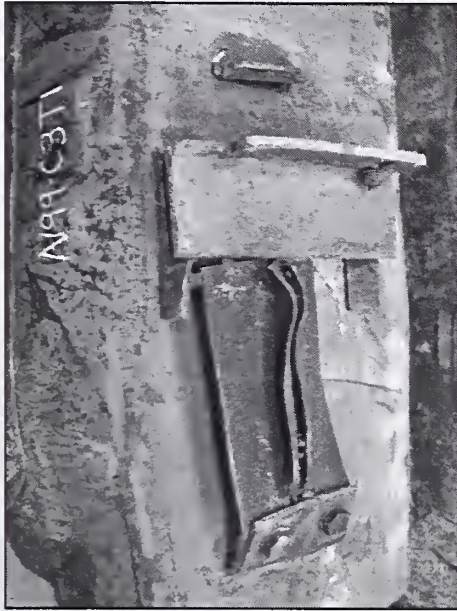
N99-C3T (WTC 1, Col.147, Fl 102)

Gusset plate intact;
Seat intact, 1 bolt hole intact with bolt and nut, other ripped out;
Gusset for damper unit ripped off at weld.

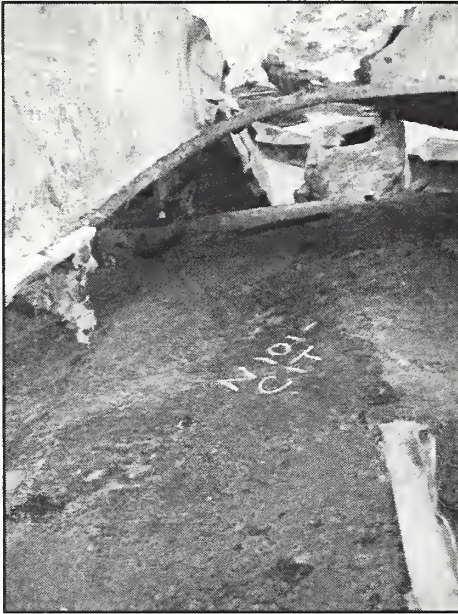
N101-C1T (WTC 1, Col.134, Fl 103)

Gusset plate ripped off at weld.

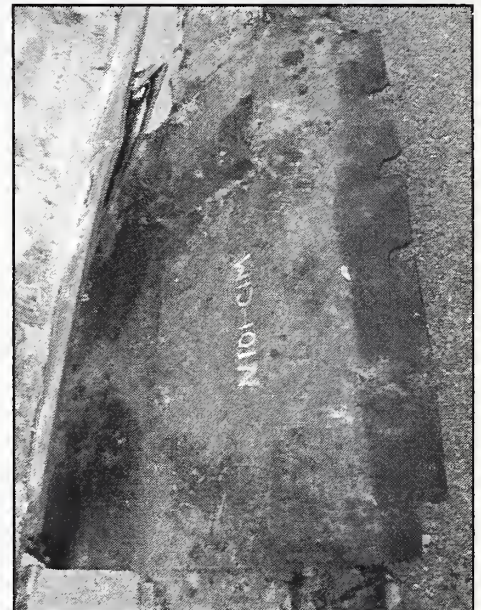
N101-C1M (WTC 1, Col.134, Fl 102)

Gusset plate intact with diagonal bracing strap attached, bent upwards.

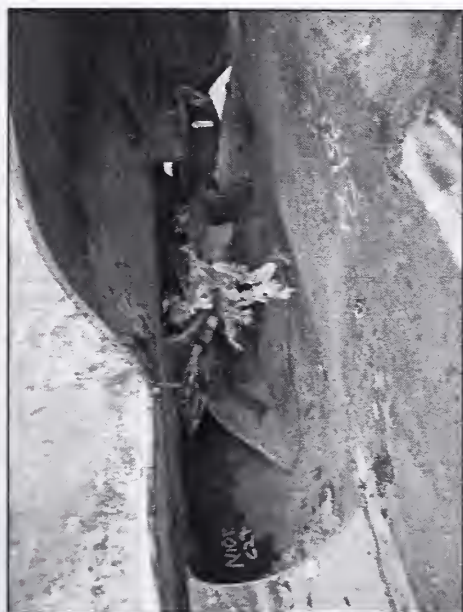
N101-C2T (WTC 1, Col.133, Fl 103)

Gusset plate ripped off at weld;
Seat intact, bent upwards, 1 bolt hole intact with bolt, other ripped through;
Gusset with damper unit intact, bent upwards.

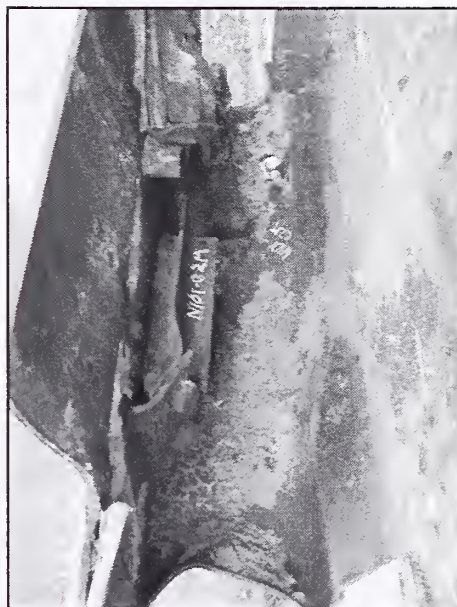
N101-C2M (WTC 1, Col.133, Fl 102)

Gusset plate intact, bent upwards;
Seat intact, both bolt holes intact with bolts and nuts;
Gusset with damper unit intact, bent upwards.

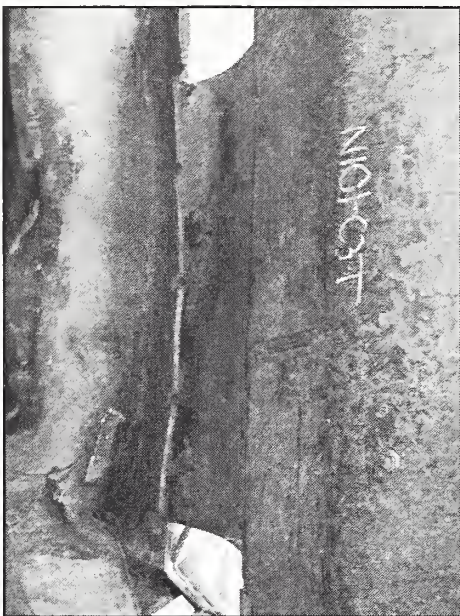
N101-C3T (WTC 1, Col.132, Fl 103)

Gusset plate ripped out at weld.

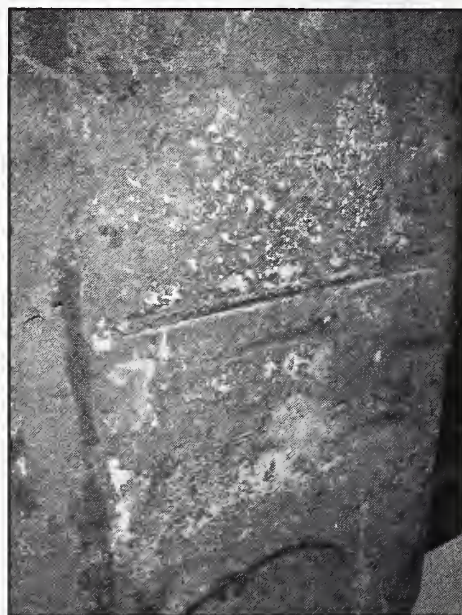
N101-C3M (WTC 1, Col.132, Fl 102)

Gusset plate ripped out at weld.

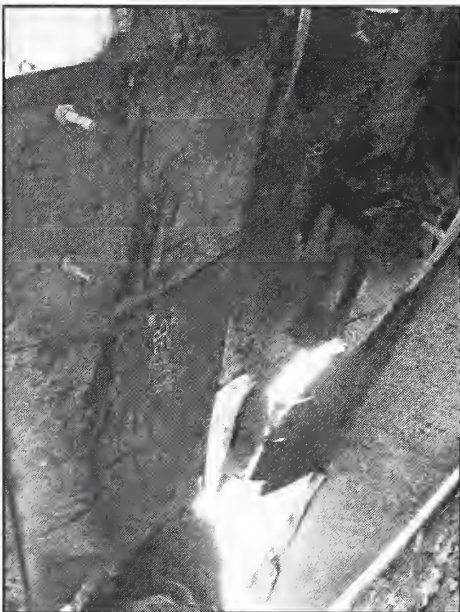
N101-C3B (WTC 1, Col.132, Fl 101)

Gusset plate ripped out at weld.

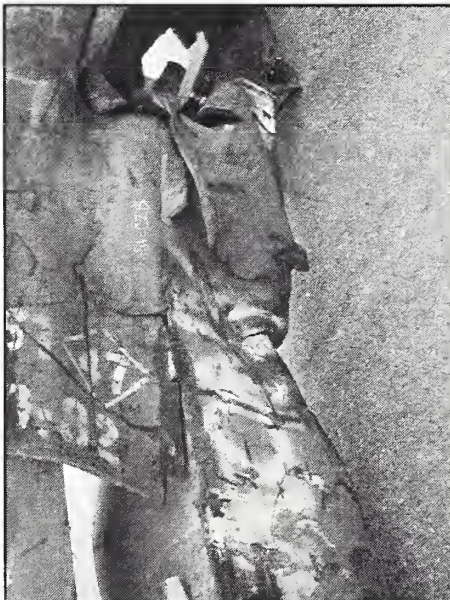
S1-C2B (WTC 1, Col.433, Fl 80)
Type A
Seat Detail: 1111

Gusset plate ripped off at weld;
Only 1 standoff plate remains, rest ripped off at welds;
Gusset for damper unit ripped off at weld.

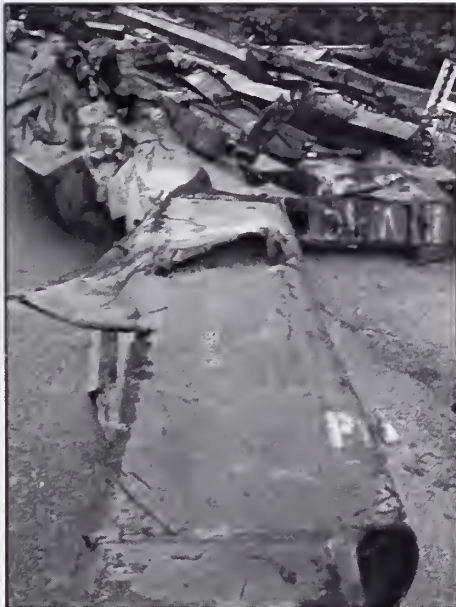
S1-C3B (WTC 1, Col.432, Fl 80)
Type C
Seat Detail: 5210

Gusset plate intact, bent downwards, with 2
diagonal bracing straps attached.

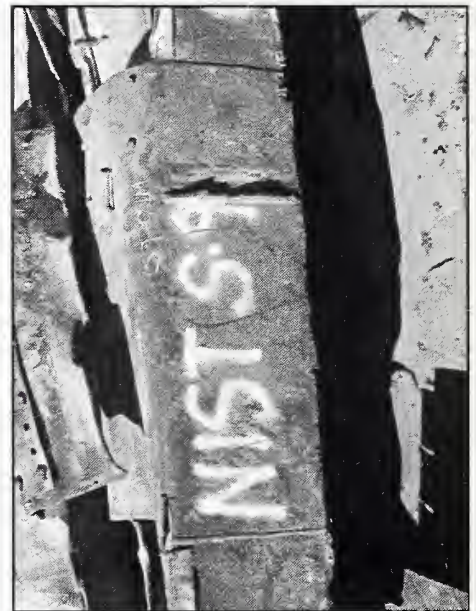
S9-C1B (WTC 1, Col.134, Fl 98)

Gusset plate ripped off at weld.

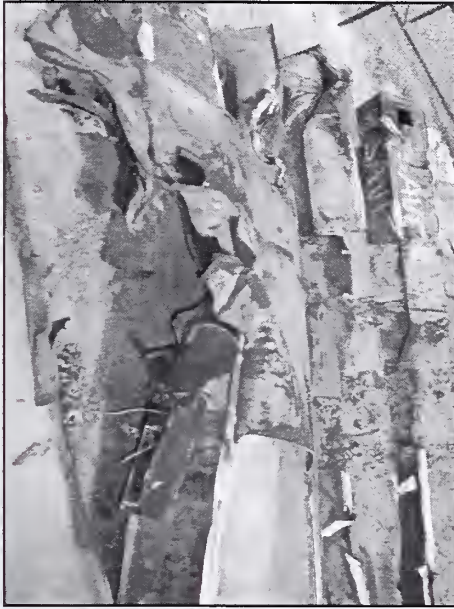
S9-C2T (WTC 1, Col.133, Fl 100)

Gusset plate ripped completely out of spandrel;
Standoff plates intact, seat ripped off at welds;
Gusset with damper unit intact, bent downwards.

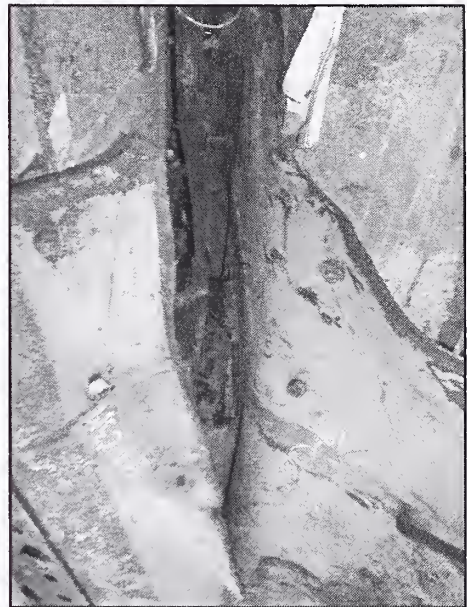
S9-C2M (WTC 1, Col.133, Fl 99)

Gusset plate intact;
Seat intact, bent in towards column, 1 bolt hole intact
with bolt and nut;
Gusset plate for damper unit ripped off at weld.

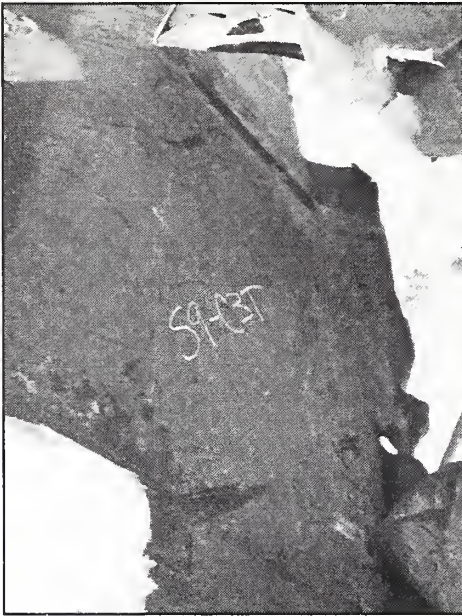
S9-C3T (WTC 1, Col.132, Fl 100)

Gusset plate ripped out at weld.

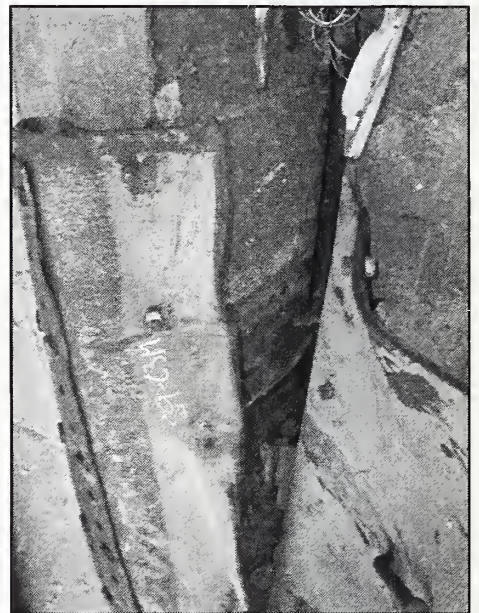
S9-C3M (WTC 1, Col.132, Fl 99)

Gusset plate intact with portion of diagonal bracing strap attached.

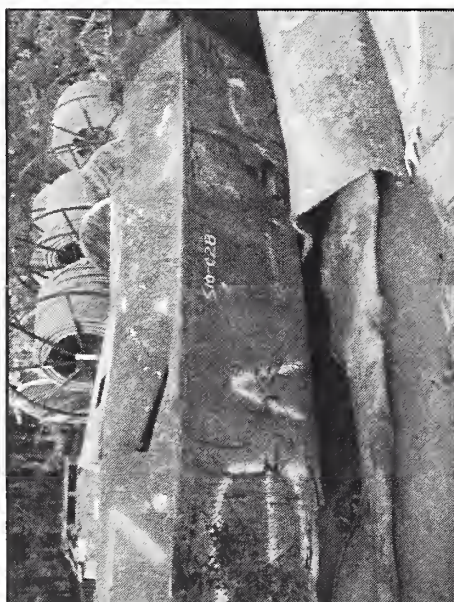
S10-C2B (WTC 1, Col.224, Fl 93)

Portion of large gusset plate remains, bent downwards.

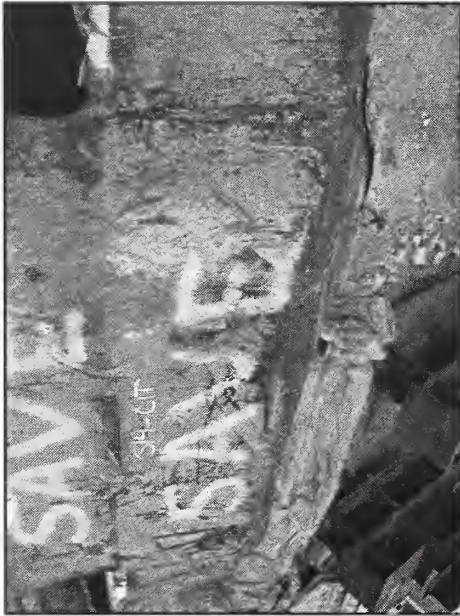
S14-C1T (WTC 2, Col.219, Fl 94)

Gusset plate with damper unit intact, bent upwards.

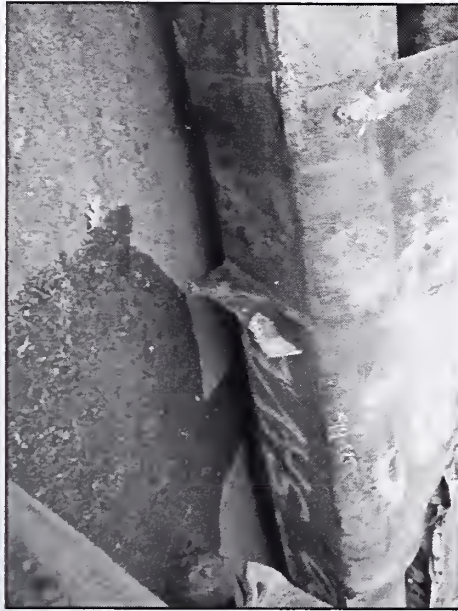
S14-C2T (WTC 2, Col.218, Fl 94)

Gusset plate intact, partially ripped at weld, with 2 diagonal bracing straps attached

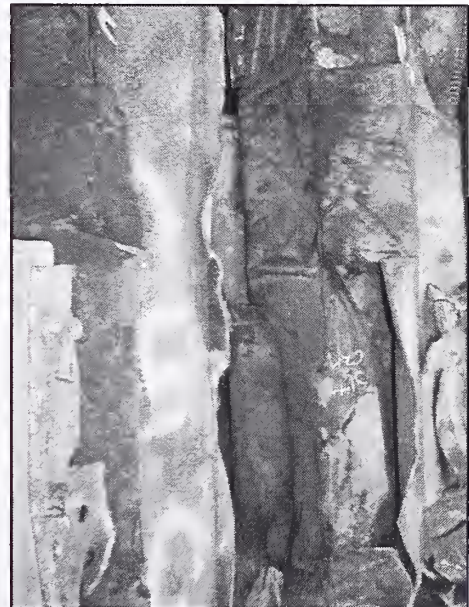
S14-C2M (WTC 2, Col.218, Fl 93)

Large gusset plate ripped off at weld.

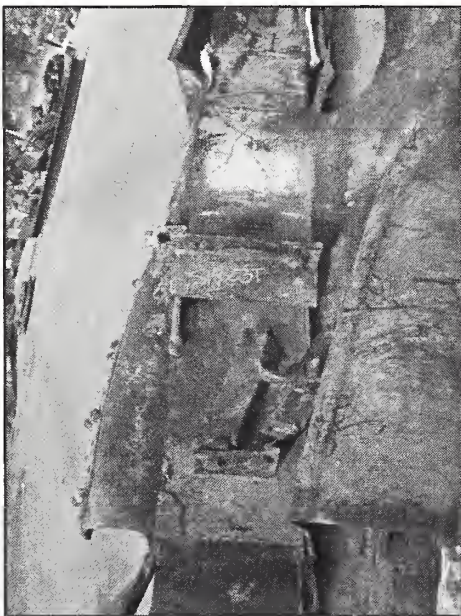
S14-C3T (WTC 2, Col.217, Fl 94)

Gusset plate for damper unit ripped off at weld.

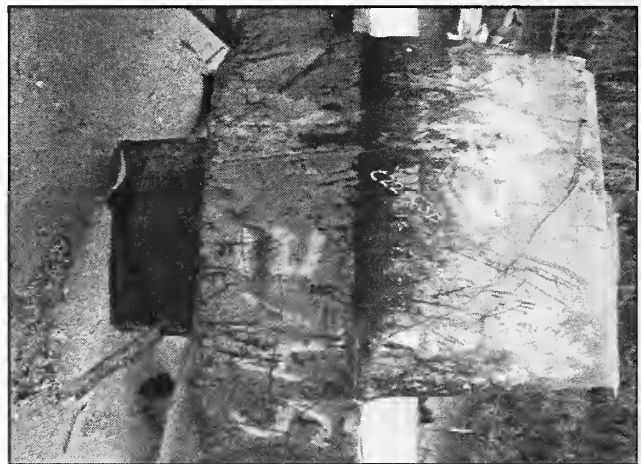
Seat 2: Both holes intact, both have bolts remaining, seat was bent

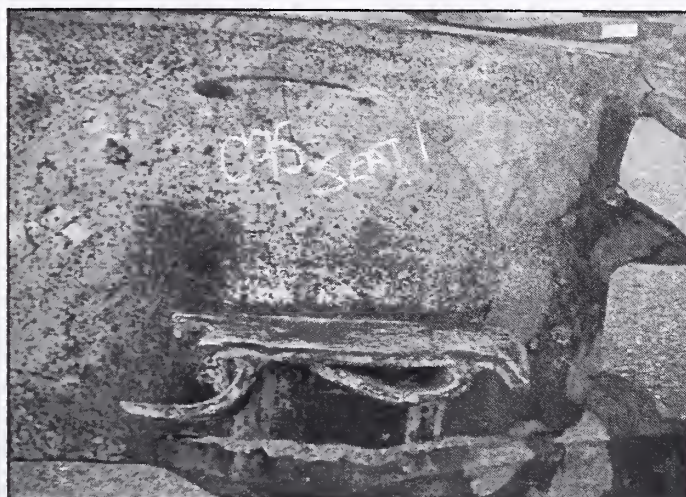
Figure C-2. Sample C-95, channel with one seat.

One seat with one hole intact, other ripped out, seat was bent

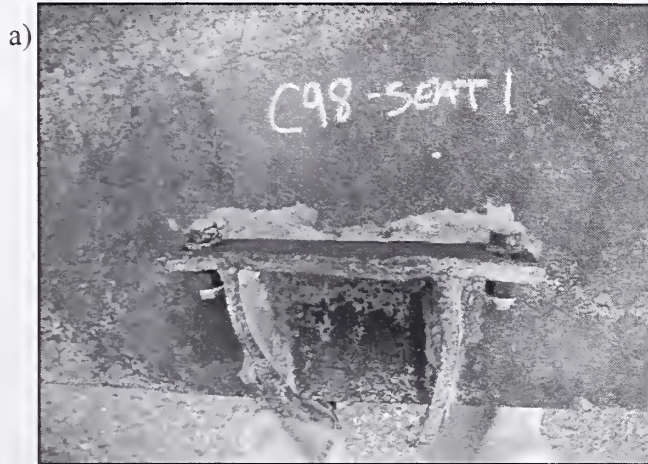
Seat 1: Both holes intact, both have bolts remaining, seat was bent

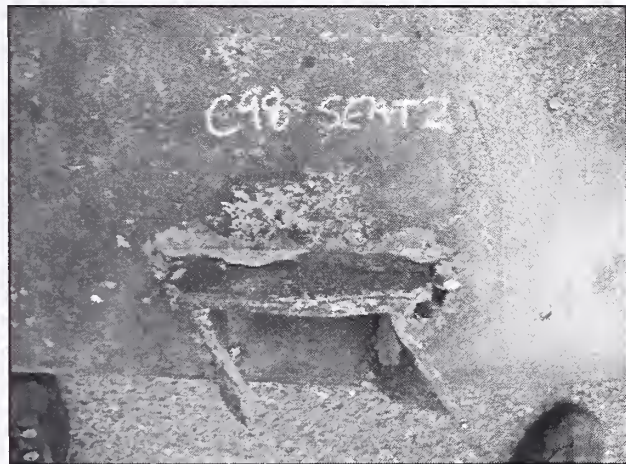
Seat 2: Both holes ripped through, one has bolt remaining, seat was bent

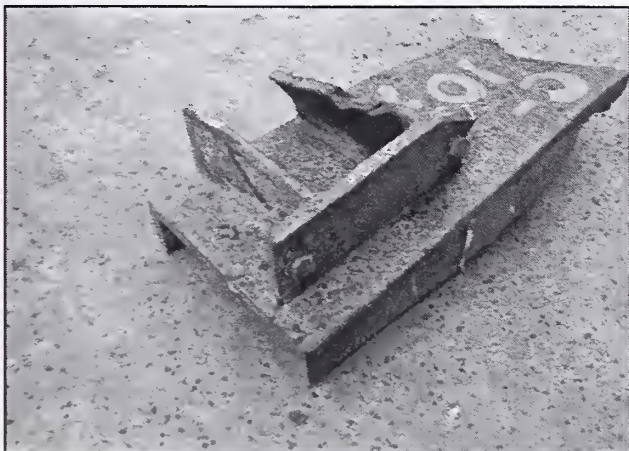
Figure C-7. Sample C-107, channel with one seat.

One seat with both holes intact, both
holes have bolts remaining

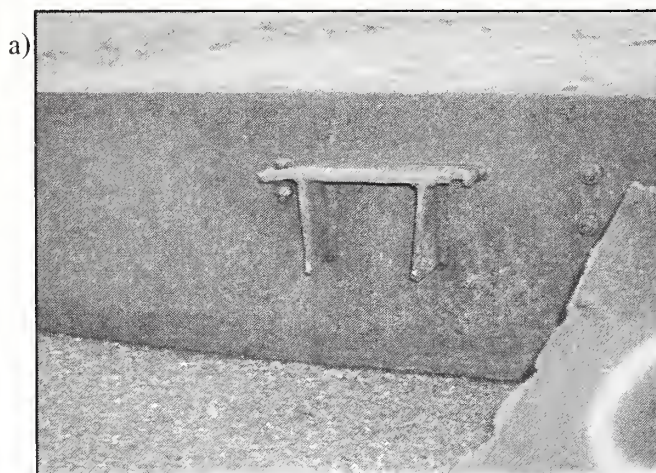
Seat 1: One hole intact with bolt, other ripped out

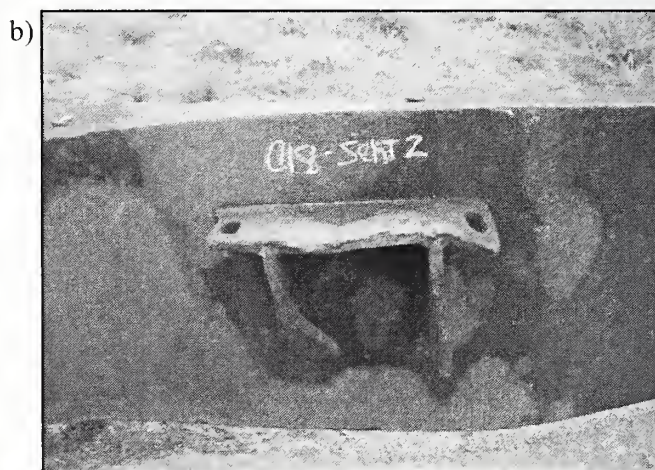
Seat 2: Both holes intact, seat was slightly bent

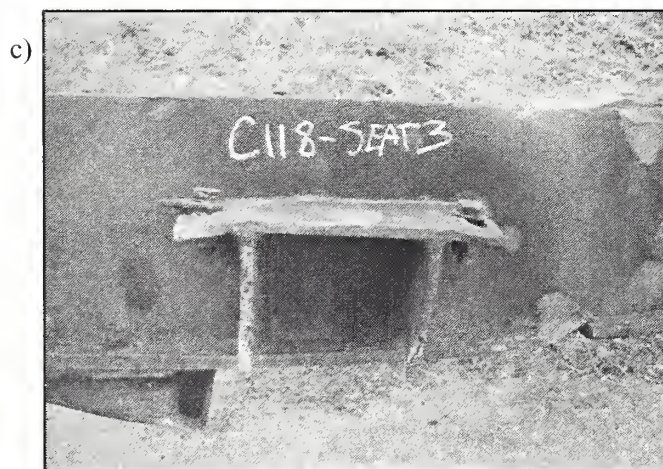
Seat 3: Both holes intact with bolts remaining

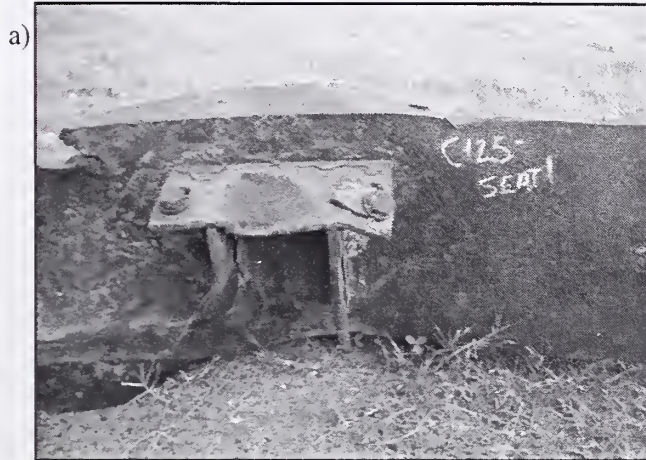
Seat 1: Both holes intact with bolts remaining, one has piece of angle attached, seat was bent

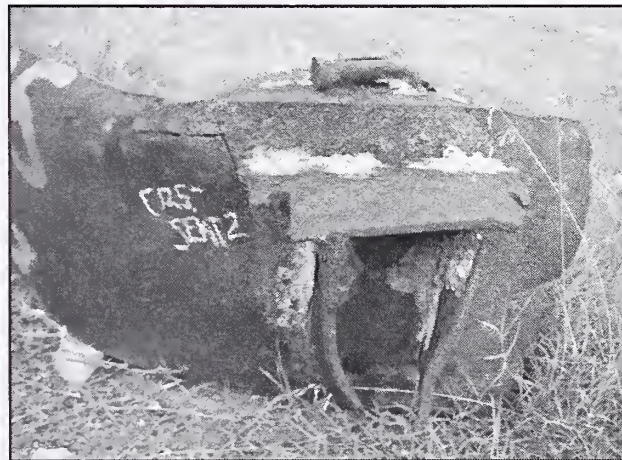
Seat 2: Both holes ripped out, seat was bent

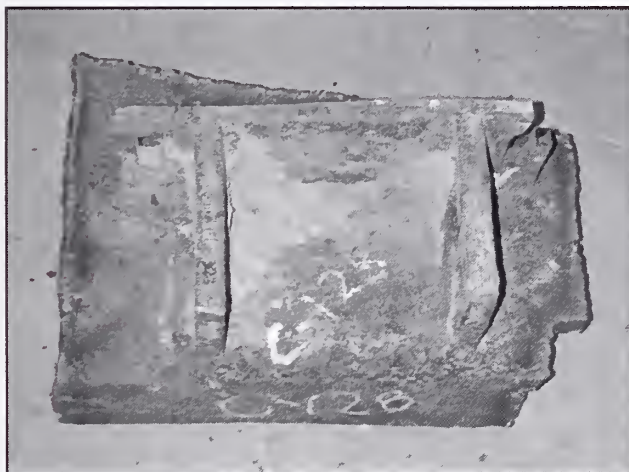
Figure C-10. Sample C-128, channel with one seat.

One seat with one hole intact with bolt, other is ripped out

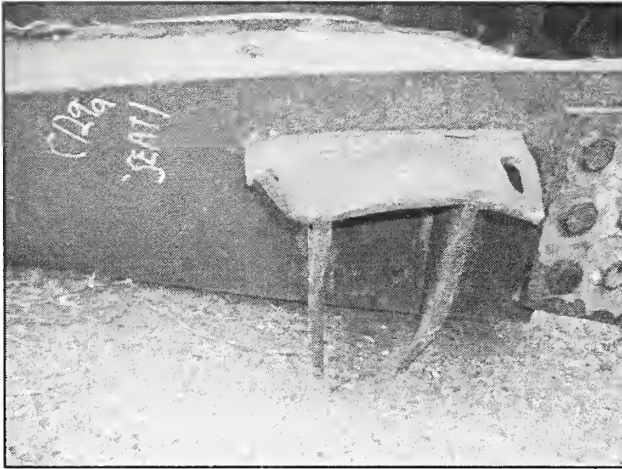
a)

Seat 1a: One hole intact, other ripped out, seat was bent

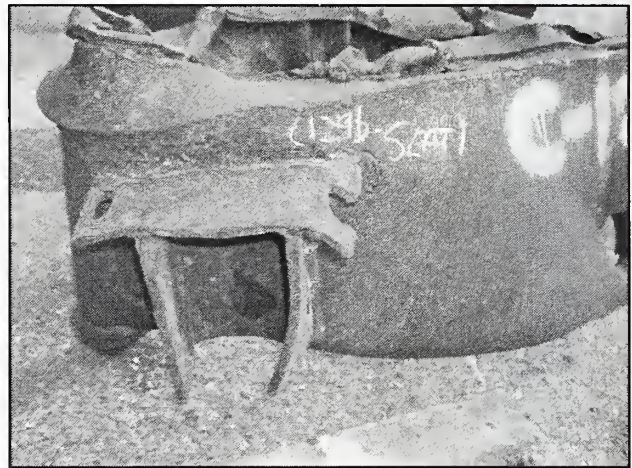
b)

Seat 1b: One hole intact with bolt, other is ripped out, seat was bent

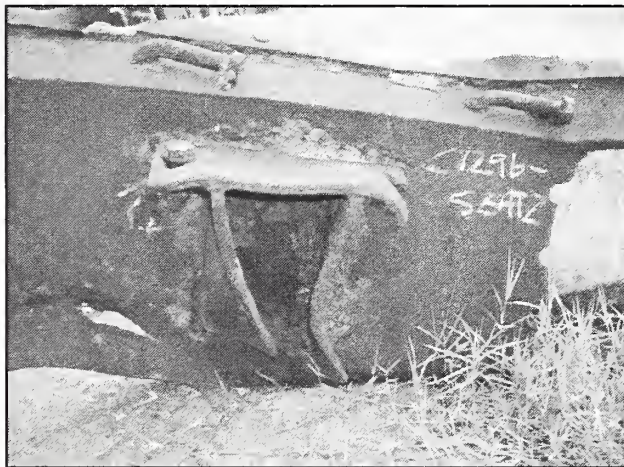
c)

Seat 2b: Both holes intact, seat was bent

Figure C-11. Sample C-129, two connected channels with three seats.

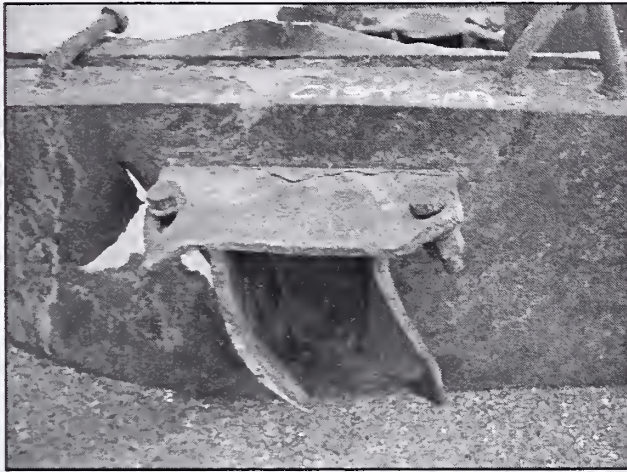
Figure C-12. Sample C-134, channel with one seat.

One seat with both holes intact, both holes have bolts remaining, seat was bent
