NIST NCSTAR 1-3C

**Federal Building and Fire Safety Investigation of
the World Trade Center Disaster**

Damage and Failure Modes of Structural Steel Components

(Appendices A-G)

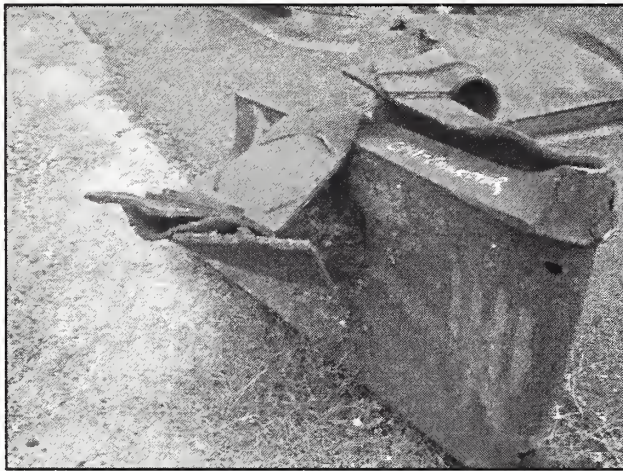
Figure C-14. Sample C-141, channel with one connector.

One connector

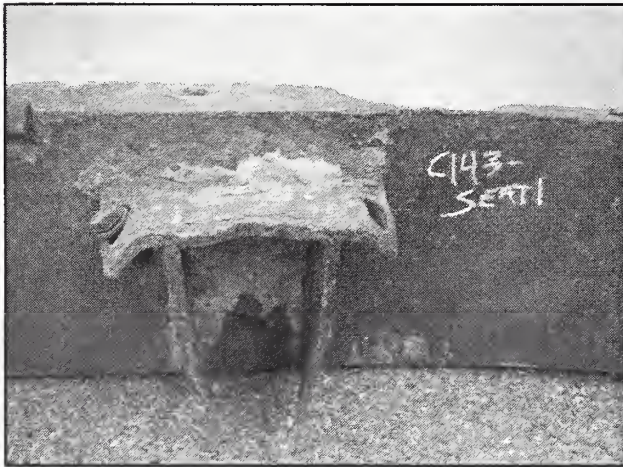
a)

Seat 1: Both holes intact, one has bolt remaining, seat was bent

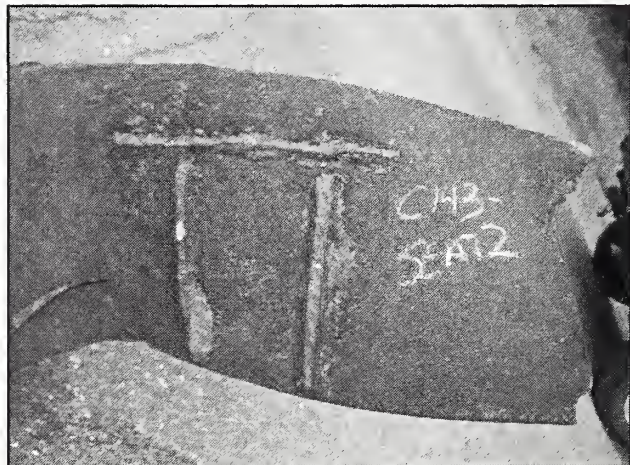
b)

Seat 2: Ripped off at the weld

Figure C-15. Sample C-143, channel with two seats.

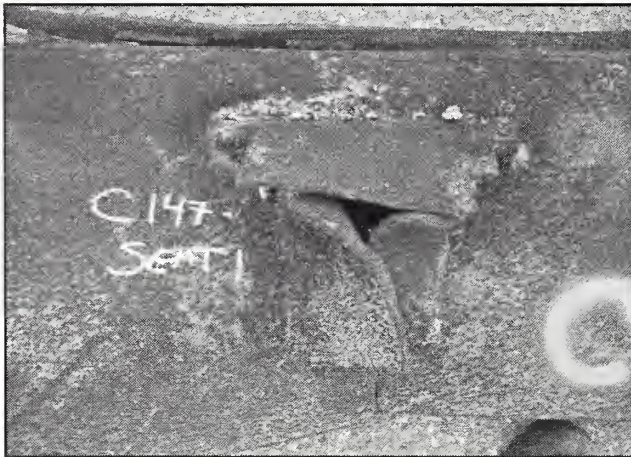
Figure C-18. Sample C-147, channel with one seat.

One seat with both holes ripped out,
seat was bent

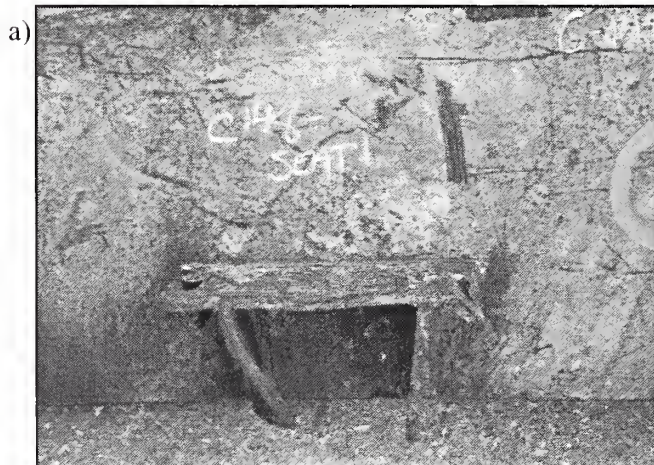
Seat 1: Both holes intact, one has
bolt

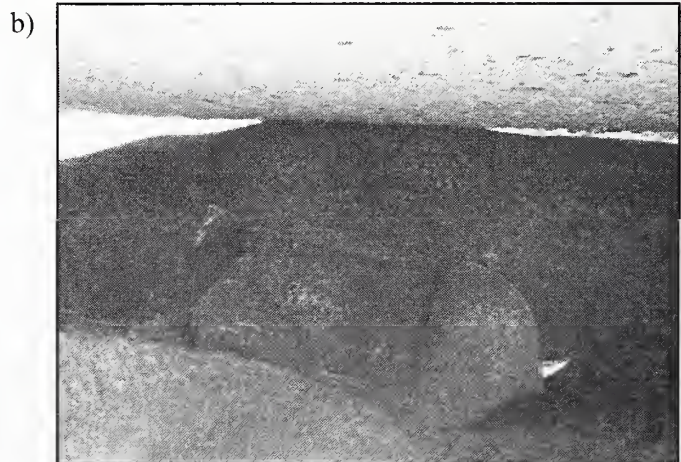
Figure C-19. Sample C-148, channel with two seats.

Seat 2: Both holes ripped out,
seat crushed

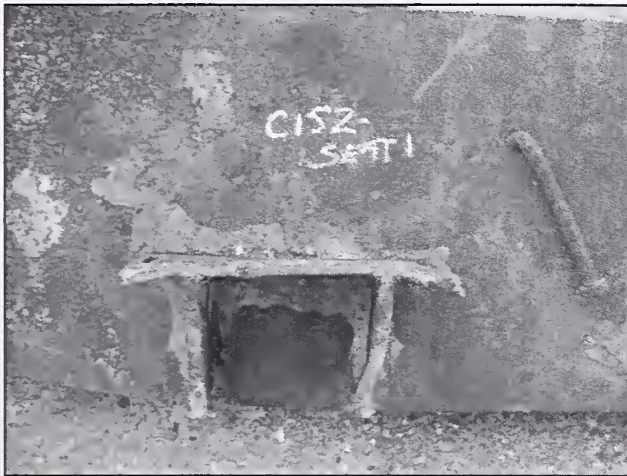
Figure C-20. Sample C-152, channel with one seat.

One seat with both holes intact

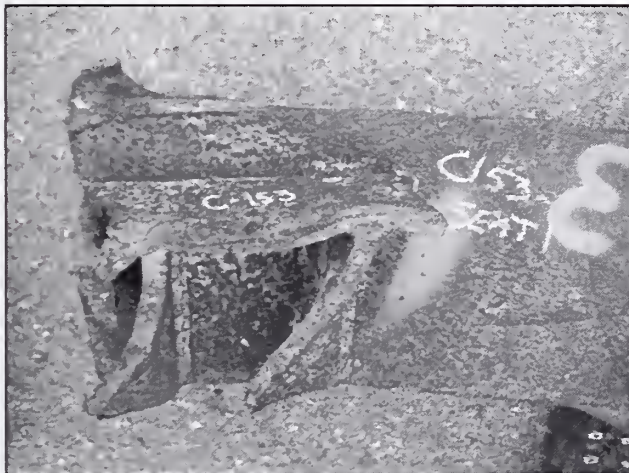
Figure C-21. Sample C-153, channel with one seat.

One seat with both holes
ripped out, seat was bent

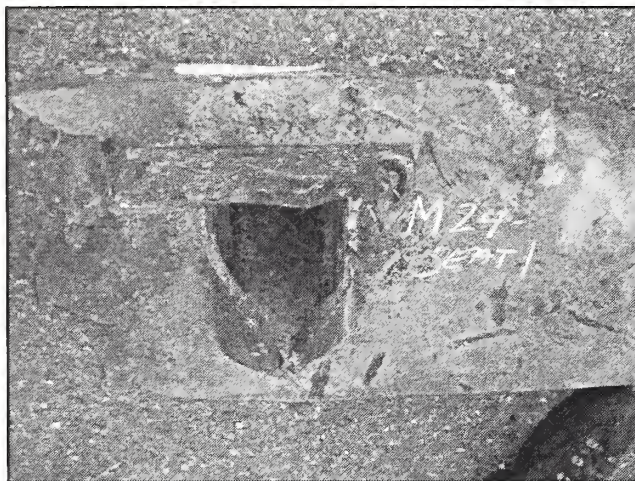
Figure C-22. Sample M-24, channel with one seat.

One seat with both holes intact,
seat was bent

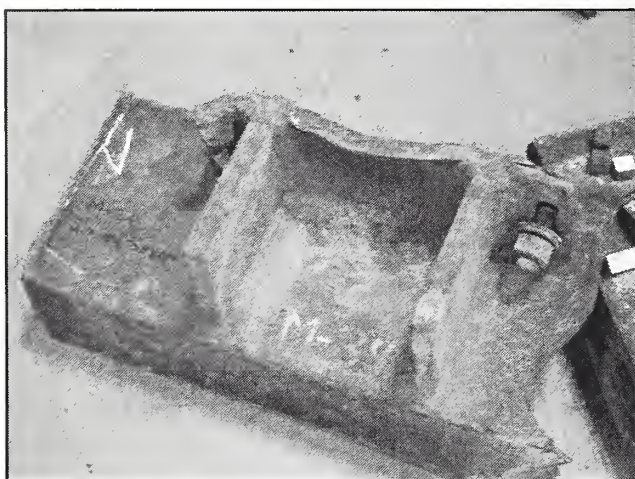
Figure C-23. Sample M-34, channel with one seat.

One seat with one hole intact with
bolt remaining, other was ripped out

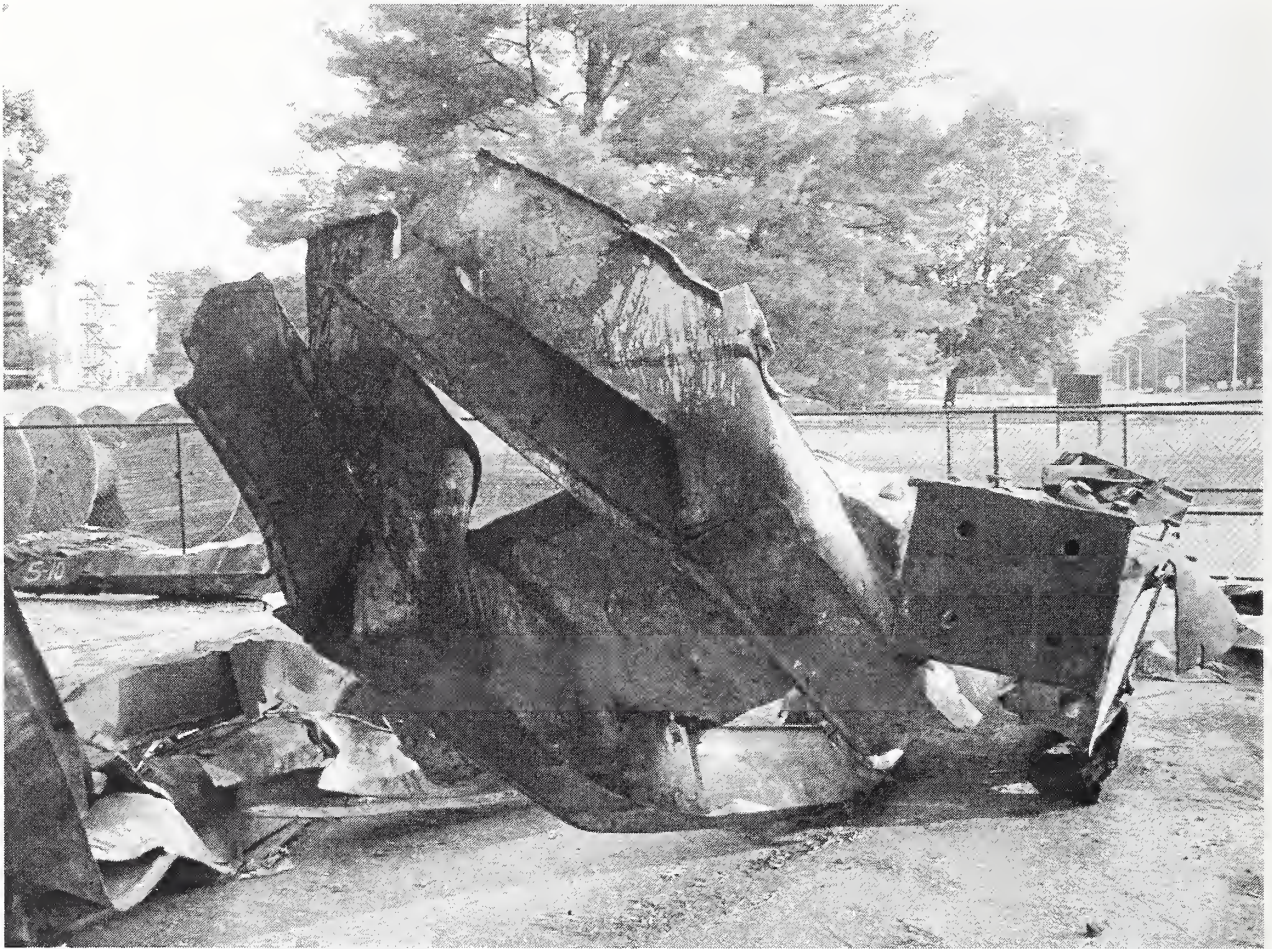
When viewed collectively, the observations on Pieces M-2 and M-27, particularly the observed apparent tensile stretching of some of the plates (as evidenced by necking down of the plates, described in Attachment A) that make up the column elements in these pieces, suggest that the columns in these panels may have resisted the aircraft impact in part by membrane tension behavior, in a fashion roughly analogous to sideways stretching of a rubber band held between two fingers. Likewise, certain observations of Pieces M-27 and M-30 can be viewed collectively; particularly the observed apparent transverse and longitudinal shear fractures in severed columns, to suggest that particular column elements in each of these panels resisted the impact of the aircraft through shear behavior. The difference between severed column elements that failed by shear, Figure 13, and column elements that failed by apparent membrane tension behavior, Figure 14, are readily distinguished on the basis of visual observation.

Figure 12. The extreme ends of the column elements in Piece M-2

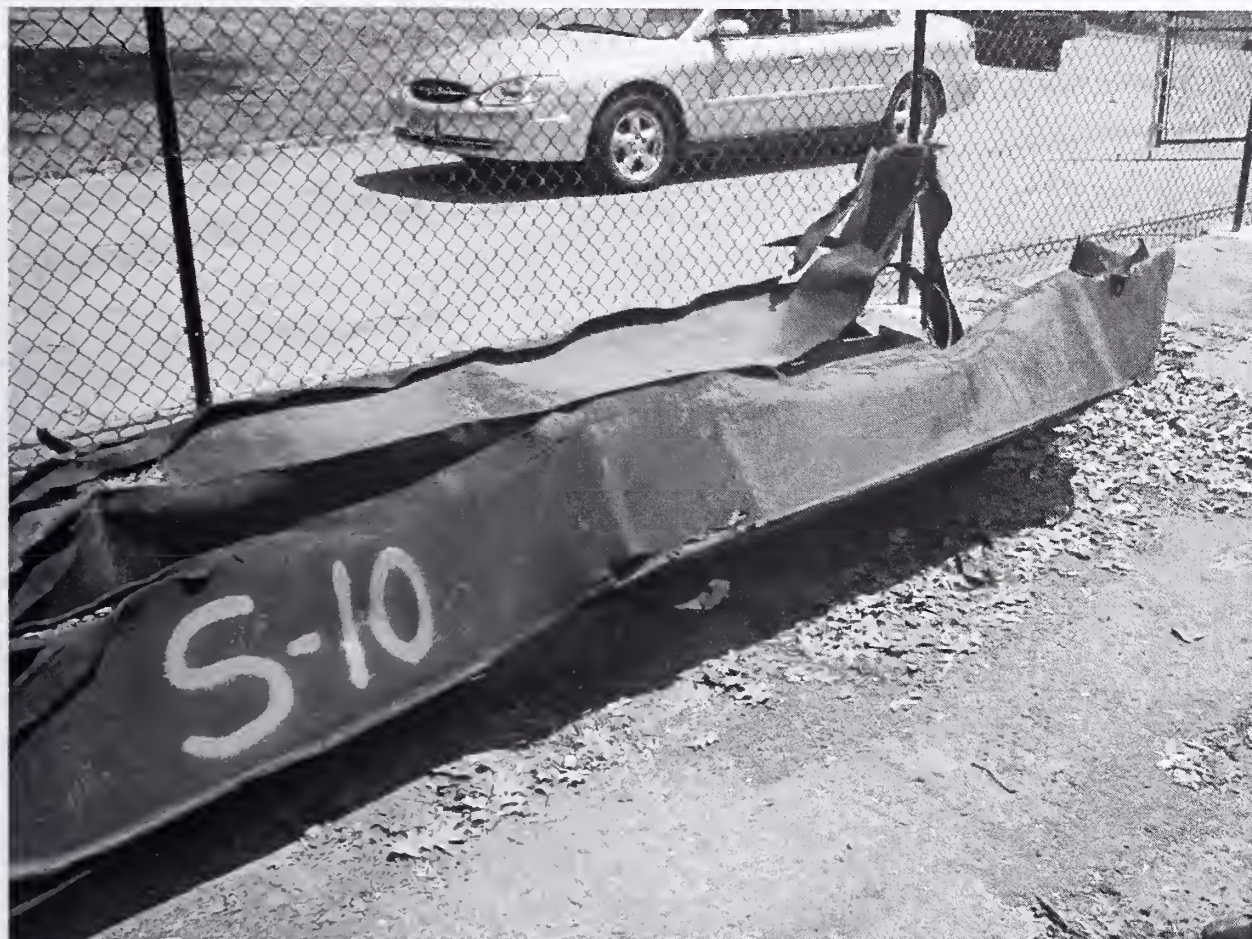
These judgments were based on visual observation of particular patterns of the presence or the absence of the visual effects of fire. The visual effects included: the presence and loss of primer paint; surface discoloration and intensity of rusting at the exposed steel; and localized distortion interpreted as possible local buckling caused by heat-related expansive strains. The last phenomenon is analogous to local buckling of exposed flanges of wide flange steel beams in structural steel floor framing beams exposed to fires. The primary pattern identified and relied upon was the presence of typically more than one visual indicator of possible fire effects on various surfaces of the individual column elements only at window openings, accompanied by the absence of these possible fire effects on the spandrel areas of the column panel. Figure 15 shows such a pattern on Piece S-10, where, from lower left to upper right in the figure, the first rusted area corresponds to possible fire effects at the 93rd floor window opening; the area of intact primer paint corresponds to the spandrel panel at the 94th floor; and the rusted remnant at the end of column corresponds to the bottom of the window opening at the 94th floor. Figure 16 shows a similar pattern on Piece M-4, where the inside faces of the column elements at the window opening exhibit possible effects of fire, while inside faces of the spandrel elements, and also the side faces of the column elements, do not exhibit these possible effects of fire. On some pieces, the observable pattern is much more subtle. Figure 17 shows the lower end of Piece K-2, where the possible fire effects are observed on the inside column face, concentrated at the head of window opening at the 92nd floor. On Piece K-2, it may be possible that the presence of the ceiling protected the spandrel area from exposure to fire.

Figure 15. Pattern of possible fire effects (absence of paint at left; presence of paint at right) observable on the side face of Column 224 of Piece S-10

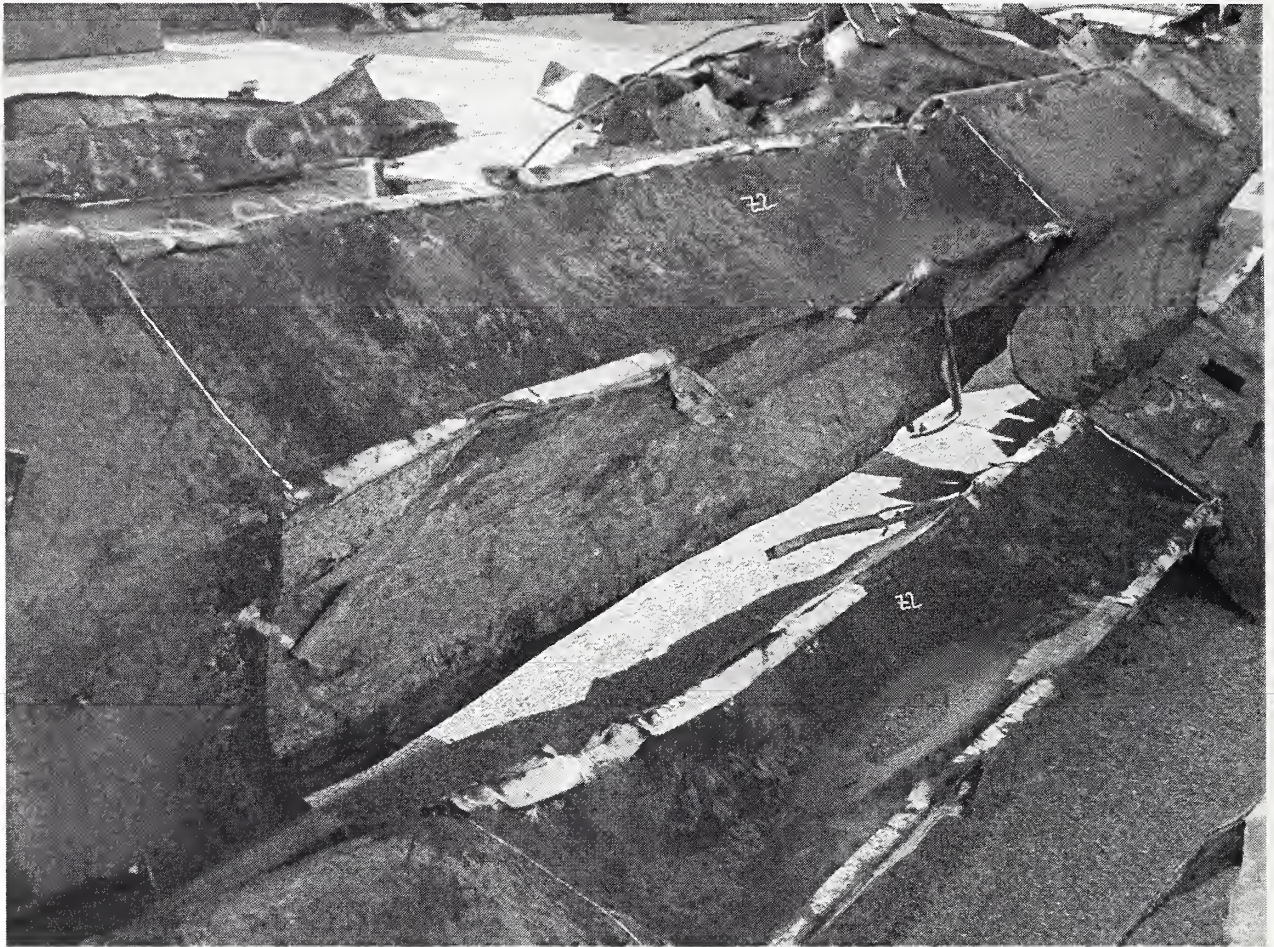
Figure 16. Pattern of presence and absence of possible fire effects on column elements of Piece M-4. Zones marked Z2 at middle are possible fire-affected areas at window openings. Spandrel plates above and below window openings appear unaffected by fire.

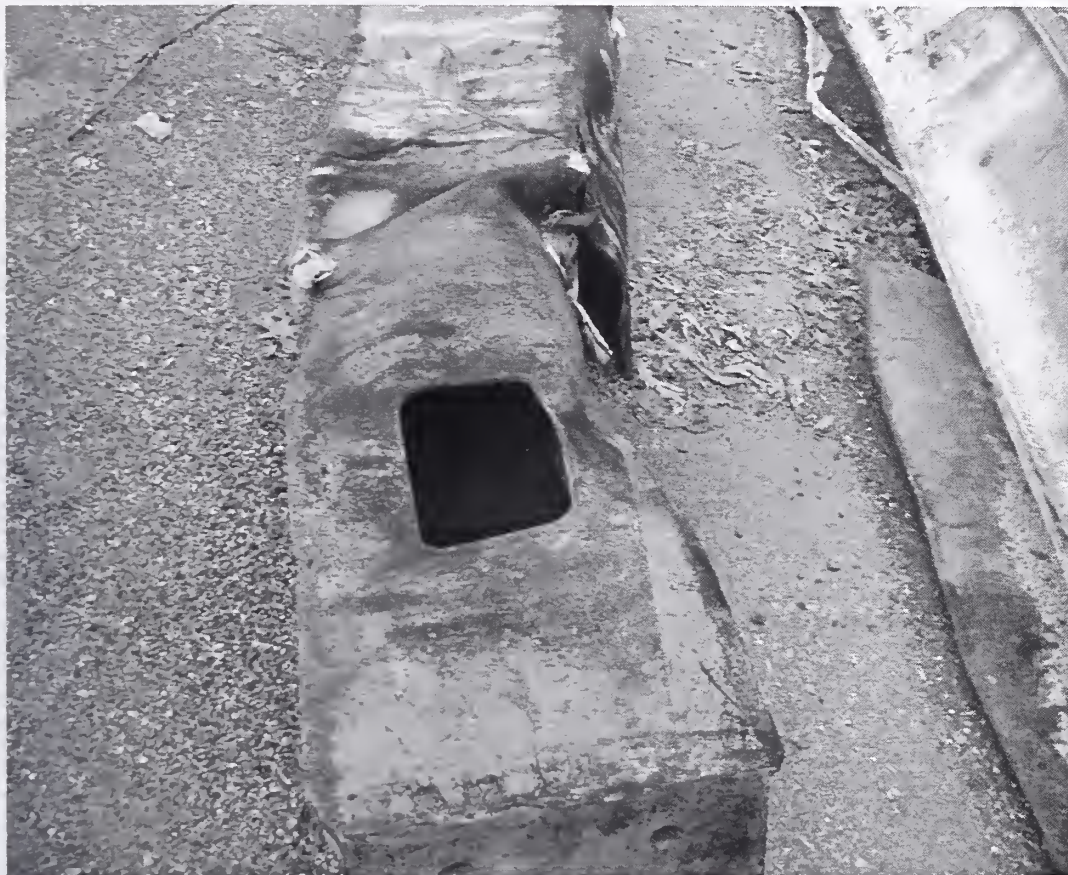
Figure 17. Possible fire effects on lower end of Piece K-2

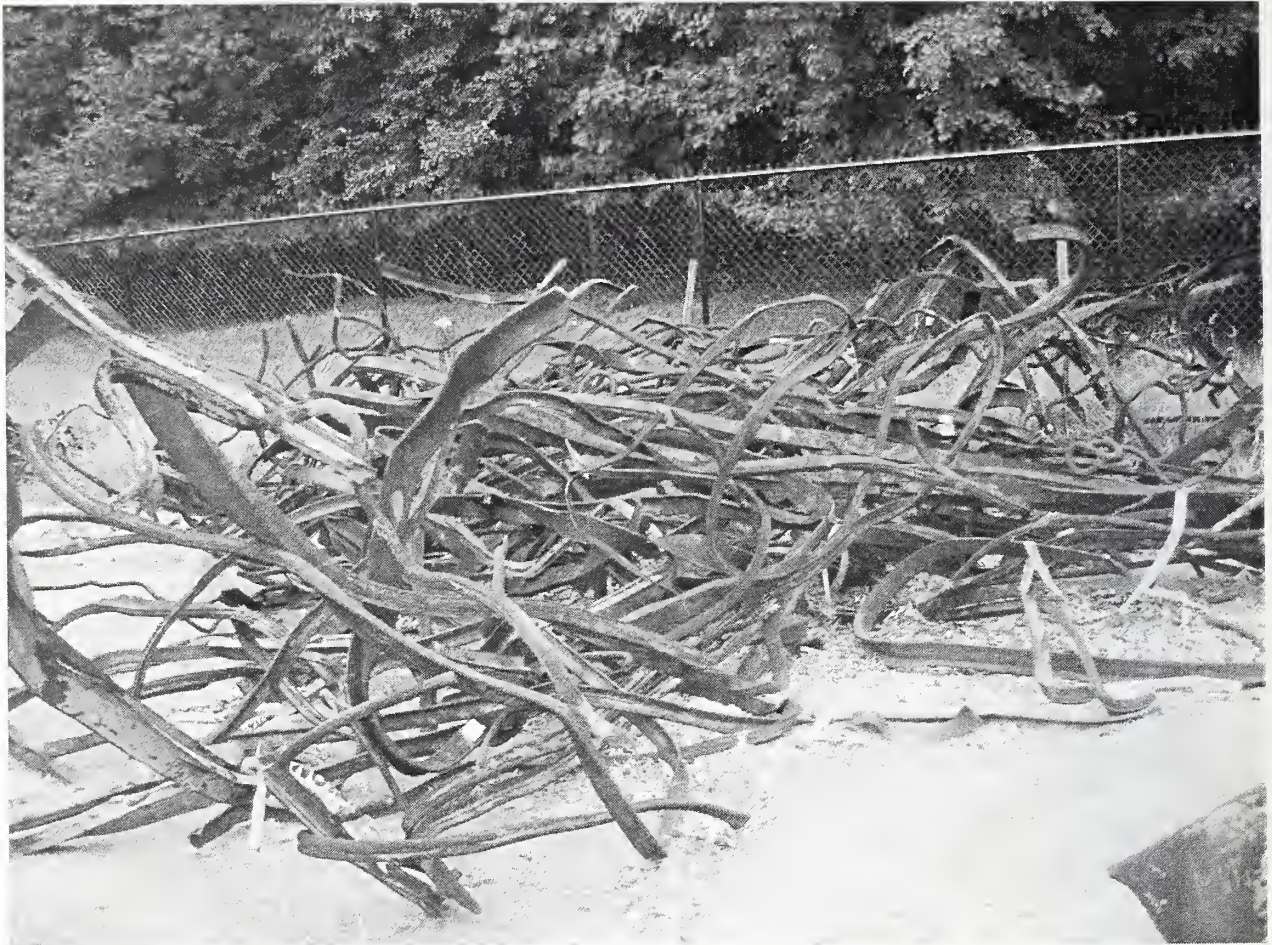
The recovered remnants of floor trusses recovered by NIST are severely distorted and the components from many individual trusses are intermingled into the same debris piles, Figures 18 and 19. It was impossible to determine whether the observed condition of the trusses was due to aircraft impact, fire following aircraft impact and before collapse of the tower, the collapse of a tower, fire in the debris pile following collapse, post-collapse recovery and salvage handling, or any combination of these extreme events. Our detailed observations may be found in Attachment B under Piece C-53.

Figure 18. General view of a portion of recovered floor truss material

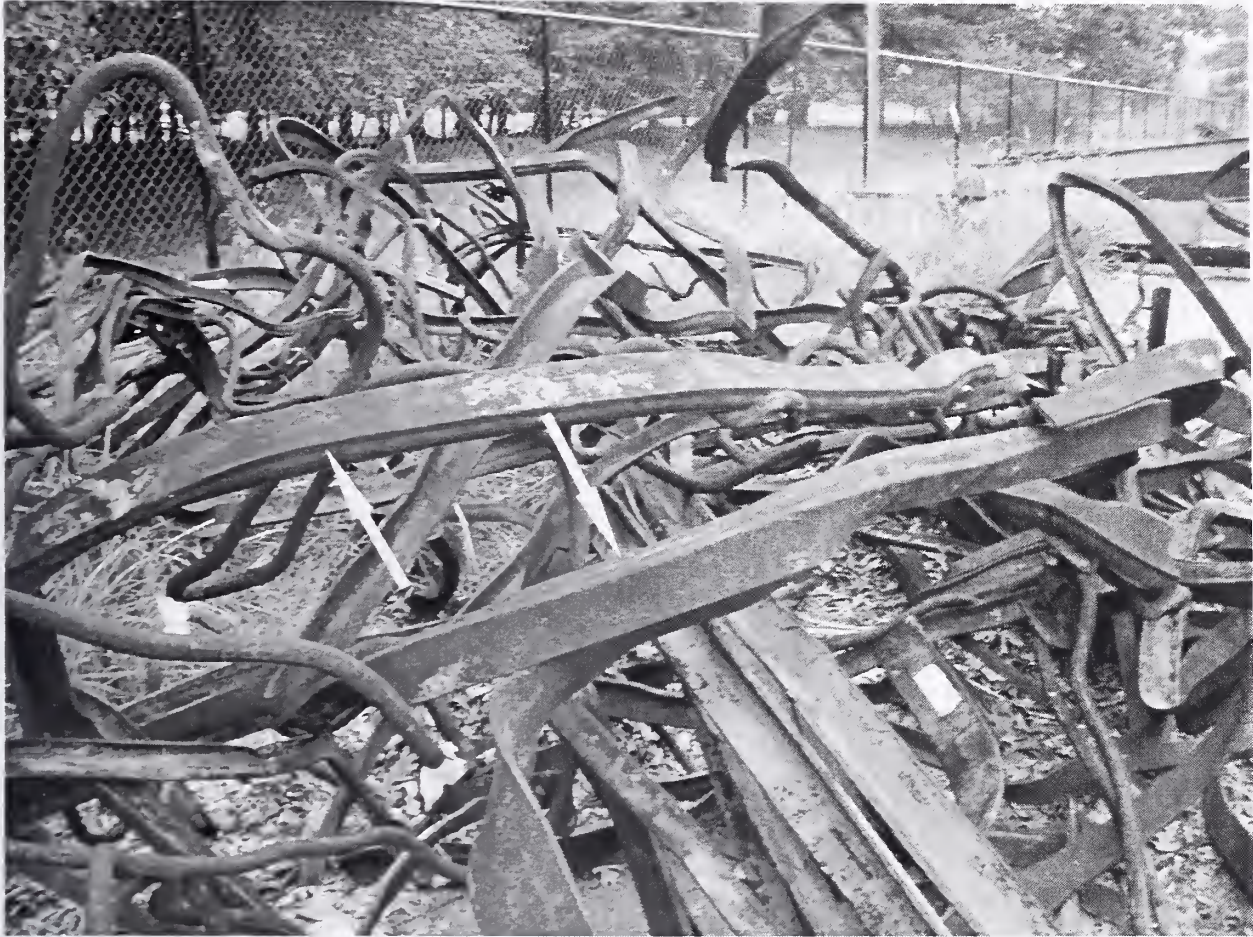
The rolled-steel angle shapes used in making the chords of the floor trusses exhibited a shallow, round rib running longitudinally on the vertical leg of the angle. This rib is visible on truss chords seen in Figure 19. This rib is a proprietary feature of floor trusses manufactured by Laclede Steel. The web-to-chord welds on the recovered truss remnants were observed to have been made by the electric resistance weld process, also typical of Laclede Steel trusses.

Figure 19. Close view of some recovered floor truss material. Arrows point to truss chords that exhibit longitudinal rib typical of floor trusses manufactured by Laclede Steel

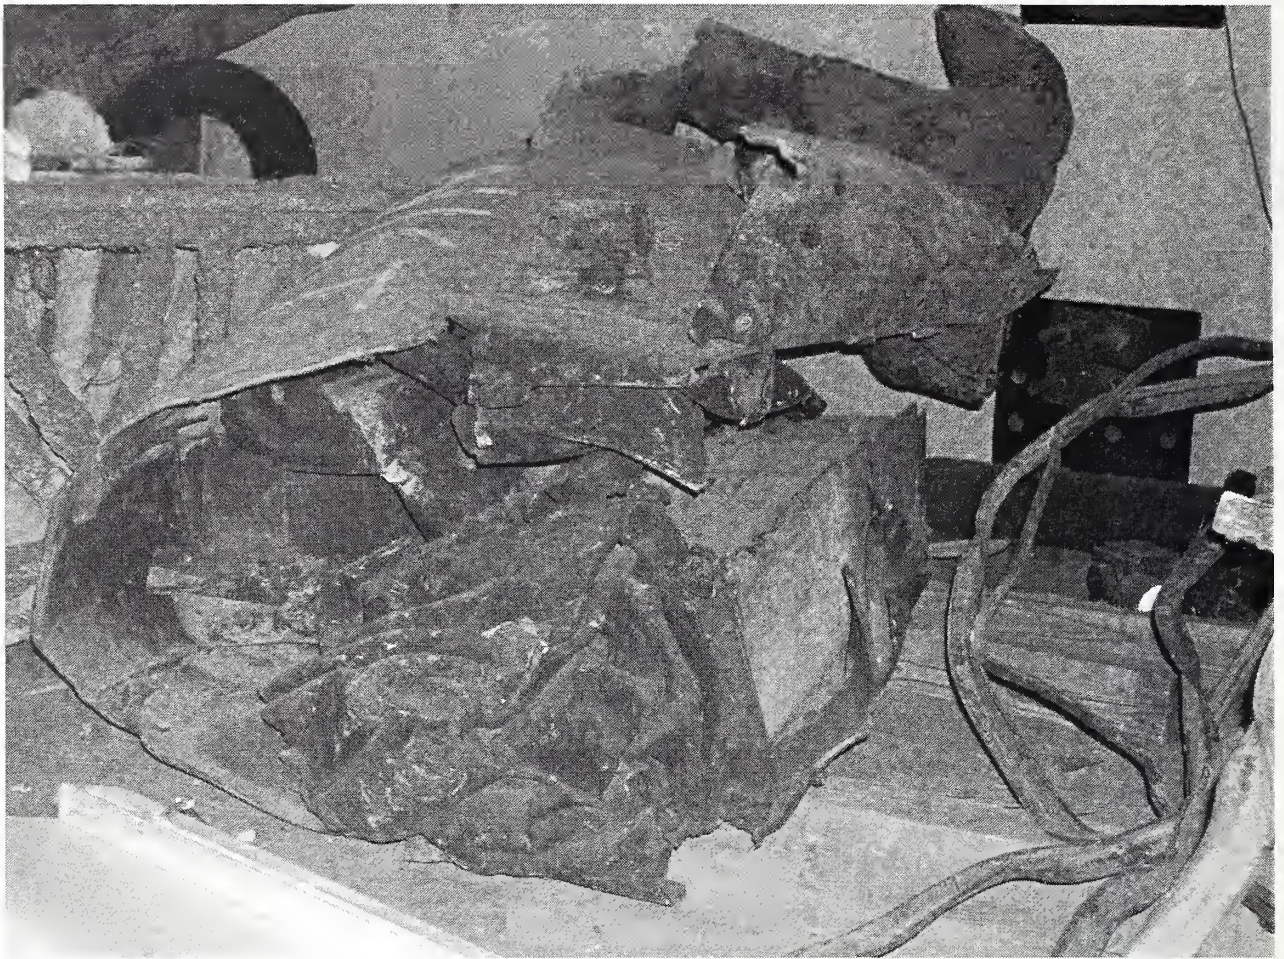
Of note is Piece K-1, shown in Figure 22 and further described in Attachment A. The piece is unique among the recovered steel in that the upper part of one column has probably collapsed in compression in an accordion-like manner. No other similarly-collapsed piece is found among the recovered steel at NIST that was surveyed. The accordion-like collapsed part of this column remains in general concentric axial alignment with the lower portion of the same column, which is relatively undistorted even after salvage and recovery operations. It cannot be readily distinguished whether this failure took place at a high or low rate of loading; whether elevated temperatures contributed to the observed condition; whether or not this failure occurred at about the time of collapse initiation; or if the observed condition is a result of impact as the piece fell to the ground.

Figure 22. Piece K-1, which has collapsed in compression

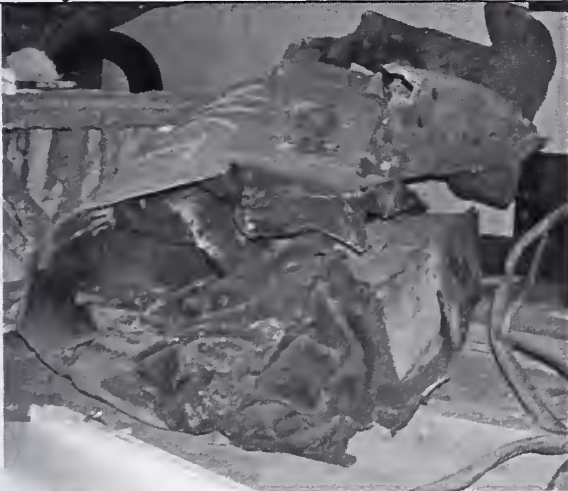
<p>Figure F-A-2a: Piece K-1 (also labeled K-13).</p>		<p>The piece is unique among the recovered steel in that Column 210 (the right-most of the three column, as viewed from inside looking out) has collapsed in compression in an accordion-like manner. No other similarly-collapsed piece is found among the recovered steel that was surveyed. The corresponding upper portions of Columns 208 and 209 are not attached to the recovered piece.</p> <p>While this piece is from floors in WTC 1 that were impacted by the aircraft, this piece is from the east building face (aircraft impact was on the north face). It is therefore unlikely that this piece has been directly impacted by aircraft.</p> <p>The accordion-like collapsed part of Column 210 remains in general concentric axial alignment with the lower portion of the same column, which is relatively undistorted even after salvage and recovery operations. It cannot be readily distinguished whether this failure took place at a high or low rate of loading, whether or not this failure occurred at about the time of collapse initiation; or if the observed condition is a result of impact as the piece fell to the ground. Further study of this piece in detail is needed in order to better understand how this type of collapse occurred.</p> <p>The lower portion of this piece is somewhat intact below the distorted portions of the columns. There are no significant visual indications of fire effects on the lower portion of this piece. However, given the sharp curvature of much of the bent steel in the collapsed portion of Column 3, there is the chance that that portion of Column 3 has been fire affected. Metallurgical examination can be used to determine whether or not the collapsed portion of Column 210 has been fire affected.</p>

<p>Figure F-A-2b: Piece K-1 (also labeled K-13).</p>

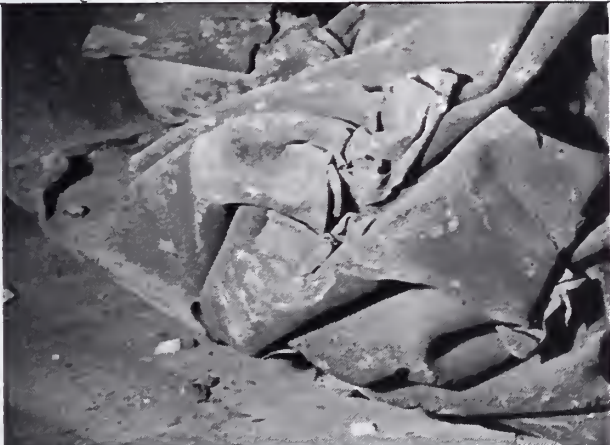
<p>Figure F-A-2c: Collapsed part of Column 210.</p>

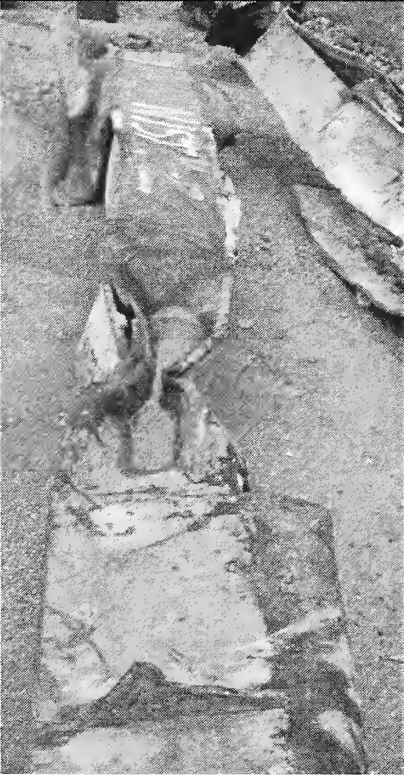
<p>Figure F-A-3a: General view of Piece K 2. Base of column is at bottom of photo.</p>		<p>Partial single column element from an exterior column panel on WTC 1. Piece recovered extends from column splice at 92nd floor to approximately base of windows opening at 94th floor. While this column is from floors where the aircraft impacted the structure, this column was not on the face of the building that was directly impacted by the aircraft.</p> <p>Distinct pattern of possible fire effects observed at windows at floors 92, 93 and 94 (loss of paint; significant section distortion), along with apparent protection of steel from fire effects at spandrels at floors 93 and 94. Pinching of column at 93rd floor window opening (Figure A-8) is most likely a result of post-collapse handling and recovery.</p>

<p>Figure F-A-3b: Closer view of column at 93rd floor window. Spandrel at 93rd floor is at bottom of photo.</p>

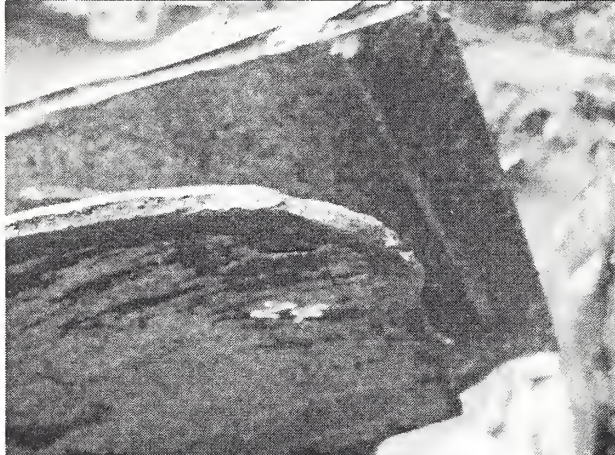
<p>Z4: Outside web plate of Column 2 (Figure A-12) is visibly constricted ("necked down") at vicinity of probable weld to column base plate. Probable cause is high rate of tensile loading due to aircraft impact. Similar effect was noticed on outside web plate of Column 1.</p>
Figure F-A-4d: Zone Z4.		<p>Z5, Z6: Fracture (Figure A-13) of flange plates at weld to column base plate at Column 2 exhibit a possible longitudinal shear failure instead of the tensile failure observed at Z4. Similar observation can be made for Column 1.</p>

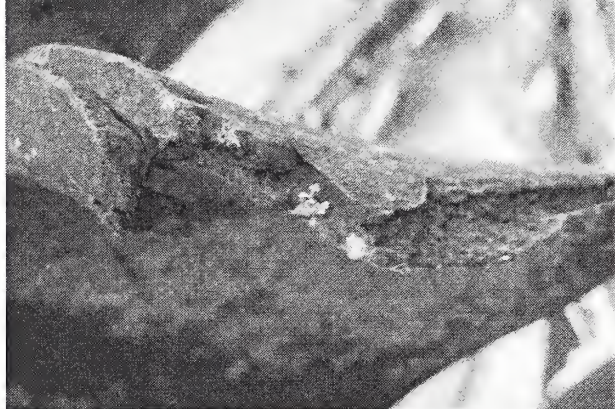
<p>Z7: Fragments of floor slab concrete (Figure A-14) with fragments of welded wire reinforcement and metal deck have been entrapped by bent-over connection plate element on Column C2. These are probable actual materials from the as-built 97th floor slab.</p>
Figure F-A-4e: Representative fracture at Zones Z5 and Z6.

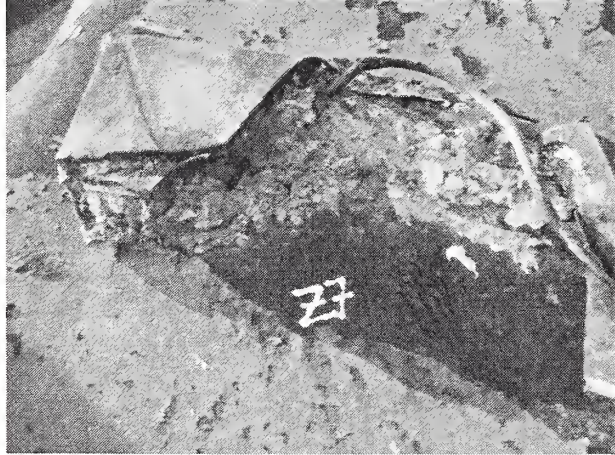
Figure F-A-4f: Entrapped concrete fragments.

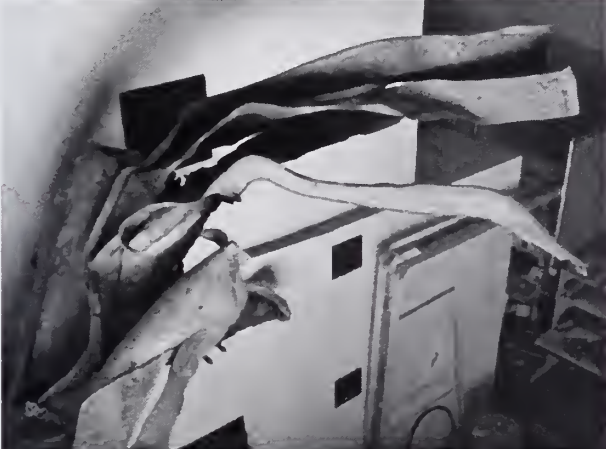
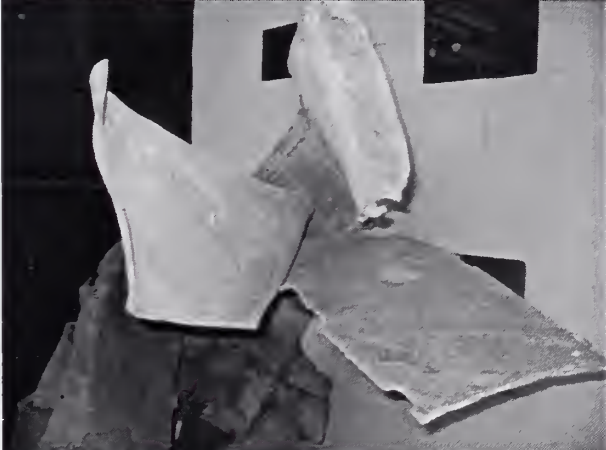
Piece ID Mark: M-27		By & Date: CP / JH / 30 July 2003	
Bldg: WTC 1	Column: 130	Floors: 93 - 96	Impact effects

<p>This exterior column panel from WTC 1 was directly impacted by the aircraft at its upper end. In the impact-affected area, the column elements have typically decomposed from their original four-sided, closed rectangular box shape into four ribbon-like, thin rectangular plate elements. It is likely that the welds at the corners of the box shape, originally joining the four face plates together, ruptured as a result of the aircraft impact. The rupture of these welds likely took place at a high rate.</p> <p>The middle column in the panel has been sheared off at the line between the top of the 95th floor window and the bottom of the 96th floor spandrel element. The fractures at the severed ends of the plates that make up this column element would likely have happened at a high rate of loading as a result of aircraft impact.</p>

<p>On the right column (as viewed from inside looking out), the inside face is severed at the top of the 95th floor spandrel element. The outside face, however, extends significantly longer to where it is severed. The outside face appears to be severed at a point beyond the top of the 96th floor spandrel, possibly at its original welded joint to the column end splice plate. The outside face has a very ribbon-like appearance. It is highly likely that this face has been subject to a high rate of membrane-like tensile loading due to the aircraft impact.</p> <p>This piece does not exhibit any significant indications of fire effects, as evidenced by mostly intact paint.</p> <p>This piece may warrant further study.</p>

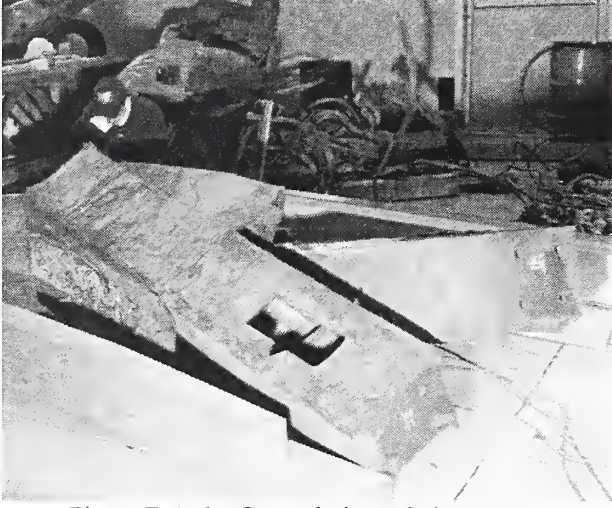
<p>Figure F-A-6a: General view of Piece M-30.</p>		<p>This piece is from an exterior column panel on WTC 1 that was directly impacted by the aircraft. The recovered piece consists of the lowest approximately three-quarter story of two column elements and a portion of the lowest spandrel element in the panel. Specifically, the recovered piece consists of fragments from Columns 132 and 133, extending from the column splice at mid-height of the 94th floor window to approximately the top edge of the 95th floor spandrel, and the 95th floor spandrel element, extending from the spandrel splice between Columns 131 and 132 to the edge of Column 133 that is towards the location of Column 134.</p>

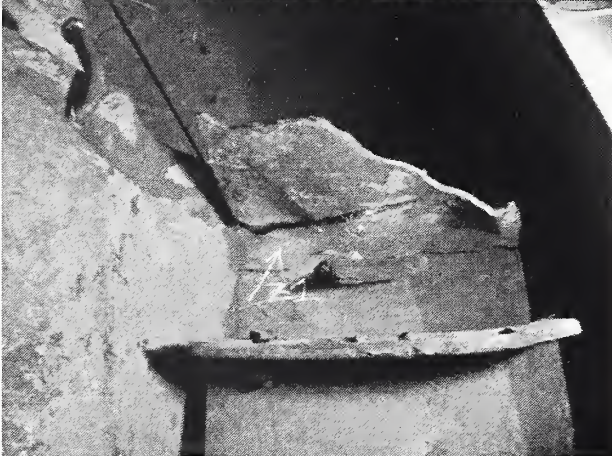
<p>Figure F-A-6b: Close view of severed Column 133 near the top of the 95th floor spandrel. Shown here the inside face of the column, along with the 95th floor joist seat on spandrel.</p>		<p>Column 133 was severed at approximately the 95th floor line, shown in Figures A-20 and A-21. The fractures of the column side faces occur along a line at the edge of an internal column diaphragm stiffener at this location. The side faces probably fractured in longitudinal shear along the edge of the internal stiffener. Remnants of the inside (marked Z1 in Figure A-20) and outside faces of the column extend above the stiffener diaphragm and are bent inward along edges of the stiffener diaphragm. The inside and outside faces probably fractured in tension. It is almost certain that these fractures were caused by the impact of the aircraft and therefore occurred at a high rate of loading.</p>

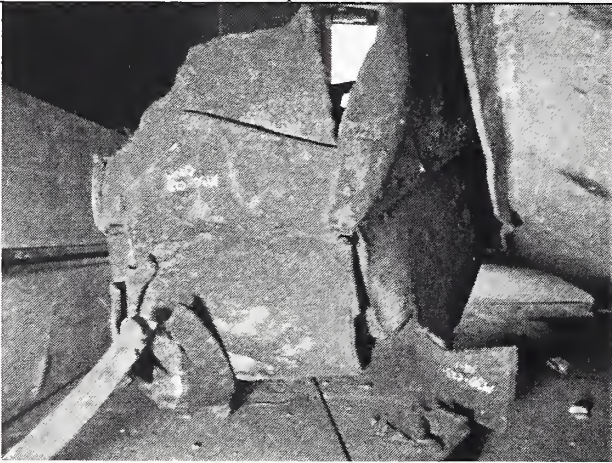
<p>Figure F-A-6c: Close view of severed Column 133, viewed as if looking down from above. Inside face of column is at top of photo.</p>

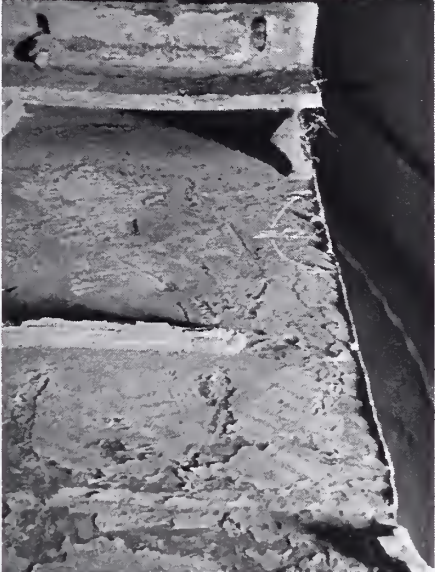
<p>The 95th floor spandrel plate has probably fractured in transverse shear along the right edge of Column 133. (This edge is marked Z2 in Figure A-22.) It is very likely that this fracture was caused by the impact of the aircraft and therefore occurred at a high rate of loading.</p>

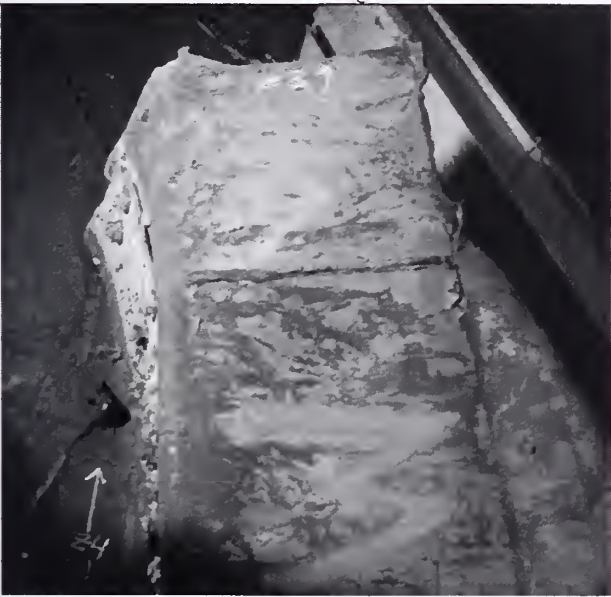
<p>Column 132 was also severed at approximately the 95th floor line, shown Figures A-23 and A-24. The severed edge is marked Z3 in Figure A-23. As with Column 133, the fracture of this column occurred generally at the location of an internal column diaphragm stiffener. It is almost certain that these fractures were caused by the impact of the aircraft and therefore occurred at a high rate of loading.</p>
	<p>Figure F-A-6d: View of severed 95th floor spandrel plate at edge of Column 133. Column 134 would have been to the right.</p>

<p>Figure F-A-6e: Close view of Column 132, showing sever at the top edge of the 95th floor spandrel. View here is of the inside face of the column and spandrel.</p>

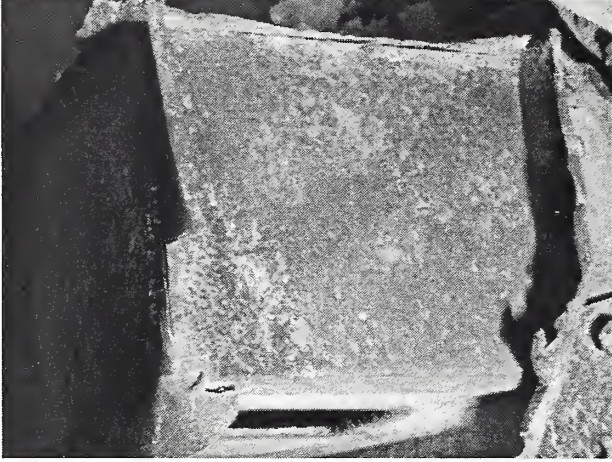
<p data-bbox="198 649 772 737">Figure F-A-6f: Close view of severed Column 132, viewed as if looking down from above. Inside face of column is at top of photo.</p>

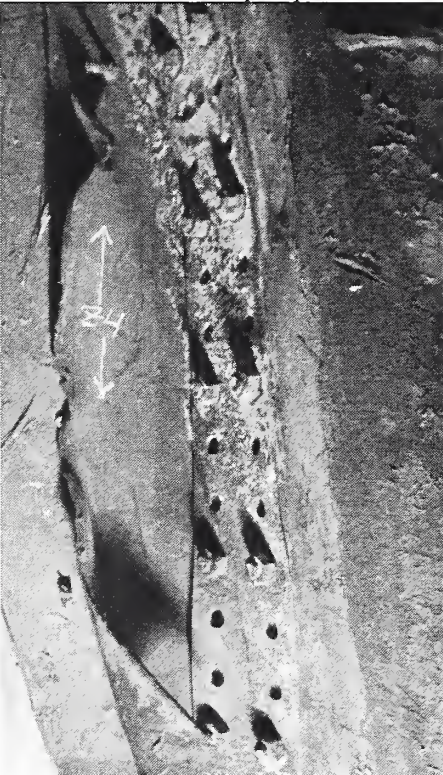
<p data-bbox="205 1508 765 1629">Figure F-A-6g: View of severed 95th floor spandrel plate to left of Column 132, showing spandrel connection bolts and connection plate. Column 131 would have been at left, and Column 132 is at right</p>		<p data-bbox="817 737 1425 1228">The 95th floor spandrel splice at the left of Column 132 was recovered with this piece. The recovered connection materials include bolts and connection plate. A fragment of the spandrel plate that extended from the splice to Column 131 was also recovered with this piece. The opposite edge of this additional piece, marked Z4 in Figure A-25, has a fracture surface that is inclined at 45 degrees. It is not certain that this fracture was caused by impact of the aircraft, because photographic evidence (FEMA 403, Figure 2-15) suggests that this segment of the 95th floor spandrel, although bent inward, may still be intact. Column 131 and the associated spandrel panel at the 95th floor were recovered as part of Piece M-27. There is a chance that the fracture surface that would mate to the fractured edge marked Z4 may exist on piece M-27.</p>

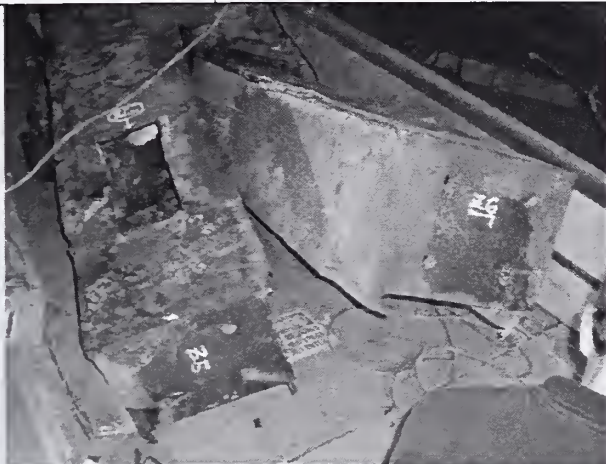
<p>Figure F-A-6h: View of column end plates on Piece M-30. Base of Column 132 is marked Z5 and base of Column 133 is marked Z6.</p>

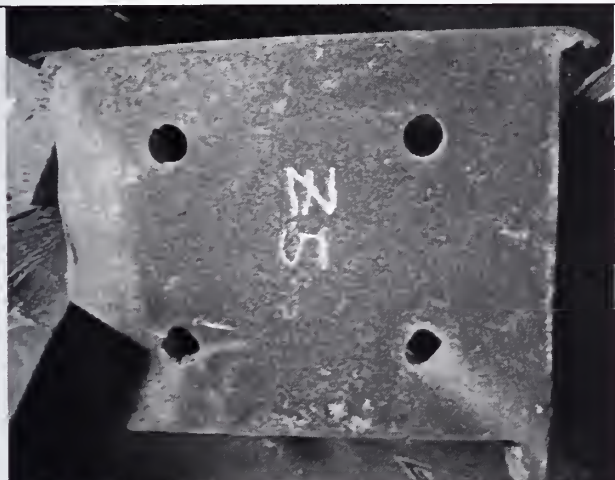
<p>Figure F-A-6i: Base of Column 132. Outside face is down.</p>

<p>Figure F-A-6j: Base of Column 133. Outside face is down.</p>	<p>CP / JH / 31 July 2003</p> <p>The bolt holes on the base plates for Columns 132 and 133, marked Z5 and Z6, respectively, show in Figures A-26, A-27 and A-28, were examined for hole elongation that might be related to the failure of the column splice bolts.</p> <p>On the base plate of Column 132, the two bolt holes nearest the outside face of the column exhibited elongation in a direction perpendicular to the outside face. The two bolt holes closest to the interior face exhibited insignificant elongation.</p> <p>On the base plate of Column 133, the direction of elongation of the bolt holes is consistent with the column twisting as the bolts were failing.</p>

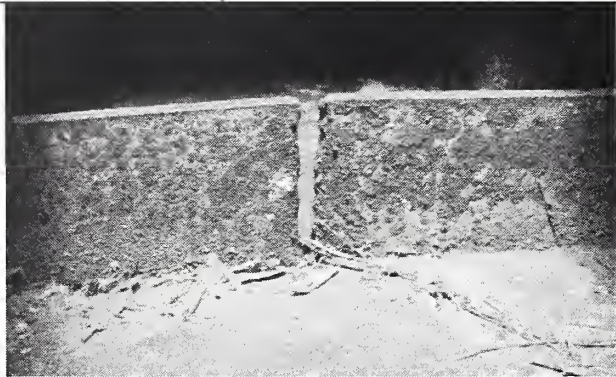
<p>Figure F-A-6k: Separation of rectangular bar found inside access hole at base of Column 132. The inside surface of the outside column face plate is at the bottom of the photo.</p>		<p>A unique separation, Figure A-29, was observed in a small rectangular bar found inside the rectangular access hole at the base of Column 132. The location was marked Z7 on the inside face of the column piece. The rectangular bar is believed to be an aid for fabrication used to support the column outside face plate at the proper position for welding. The bar appears to have ruptured, perhaps in tension, or has been flame cut.. It is not know if this condition is related to the impact of the aircraft into this piece, or is related to original fabrication.</p>

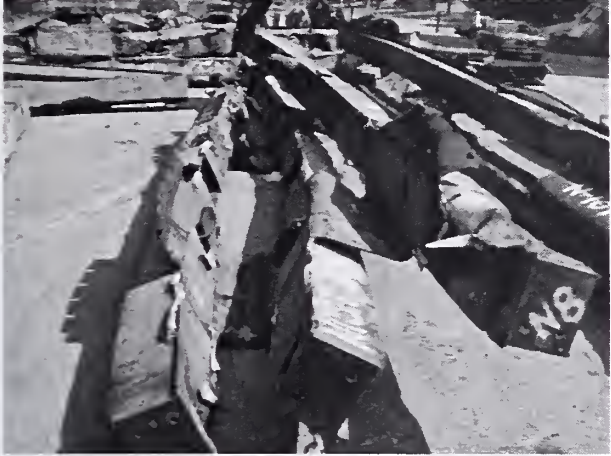
<p>Figure F-A-7a: Piece N-8.</p>		<p>Given location in structure, this exterior column panel was not affected by aircraft impact. Potential effects due to fire following aircraft impact were observed on columns as follows:</p> <p>Window at 97: Little or no fire effect Spandrel at 98: Little or no fire effect Window at 98: Some local buckling and some loss of primer paint indicative of possible fire effect Spandrel 99: Little or no fire effect Window 99: Some possible fire effect Spandrel 100: Little or no fire effect Window 100: Fire effect uncertain</p>

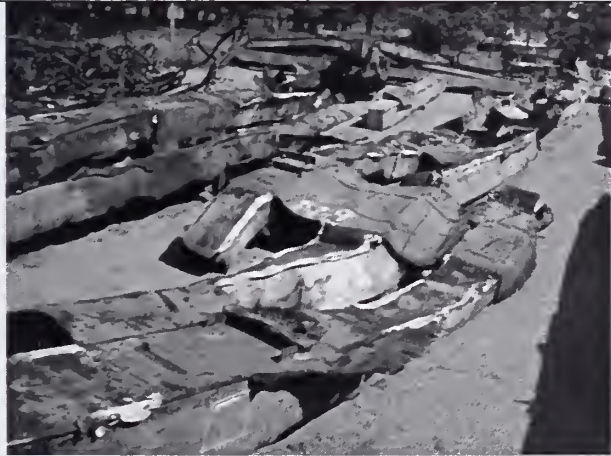
<p>Figure F-A-8: Piece N-9.</p>		<p>Given original location in building, this exterior column piece has not been affected by direct aircraft impact. Fire effect uncertain: some local buckling on inside faces of columns, along with moderate loss of paint, suggest possible fire effect. However, these visual features are not so pronounced so as to strongly indicate that these are effects due to fire.</p>
