NIST NCSTAR 1-3C

**Federal Building and Fire Safety Investigation of
the World Trade Center Disaster**

Damage and Failure Modes of Structural Steel Components

(Appendices A-G)

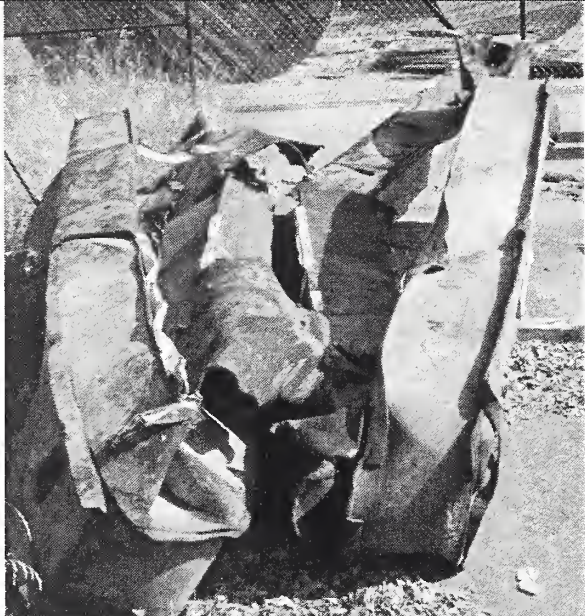
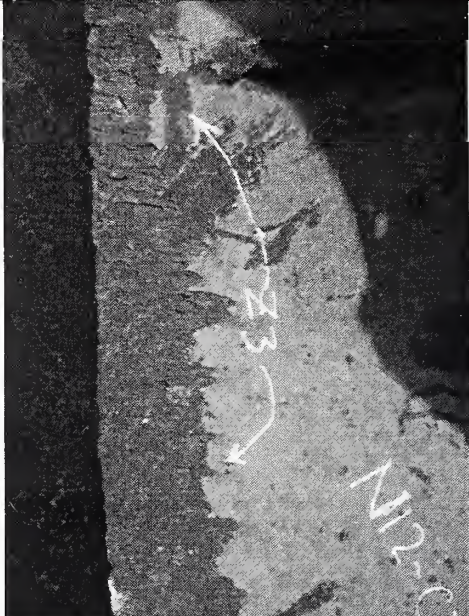
<p>Figure F-A-9a: General view of Piece N-12, showing fold in columns.</p>

<p>Figure F-A-9b: Fracture at column edge in 95th floor spandrel plate.</p> <p>While this piece is from the floors in WTC 1 that were impacted by the aircraft, this piece is from the building face to the left side (orientation of aircraft travel direction) of the impact face. It is unlikely that this piece has been directly affected by aircraft impact.</p> <p>The paint is missing from approximately the upper two-thirds of the inside faces of the columns adjacent to the 94th floor window openings. (The 94th floor window openings have been marked as Zone Z1.) This loss of paint is consistent with flames of an interior fire exiting through the window openings. Given proximity of this piece to the aircraft impact, it is likely that the observed loss of paint is due to fire following impact.</p> <p>Near the top of the window openings, the columns are severely distorted (marked as Z2 on the piece), suggesting a local buckle or local failure in the column at this location. The corner welds that join the column face plates together have typically ruptured at this distorted region.</p> <p>Similar patterns of loss of paint at window openings and probable local buckles in column elements at the top of window openings were also observed adjacent to the 93rd floor window openings. (The piece has become folded in half at the top of the 93rd floor window openings.) The 92nd floor, however, does not exhibit these patterns.</p> <p>The 95th floor spandrel plate was fractured vertically along the edge of the middle column. Fracture is through the parent material but has likely initiated at the heat affected zone of the weld. Fracture probably occurred during collapse.</p>

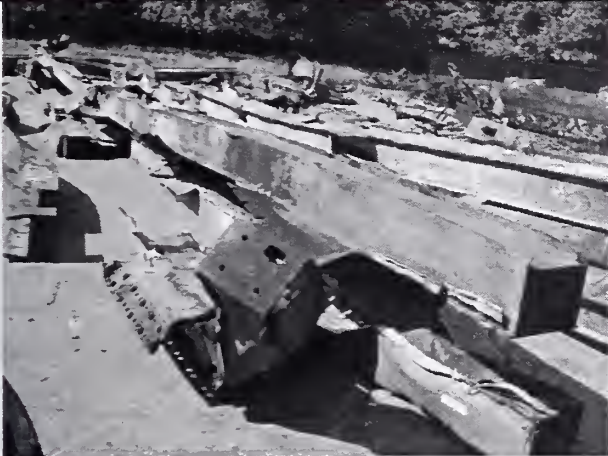
<p>Exterior column panel from face of aircraft impact on WTC 1, but from floor levels that are above the direct impact zone. Consequently, piece is presumably not affected by aircraft impact. Little or no effects of fire were observed on this piece.</p>	
Figure F-A-10: Piece N-101.

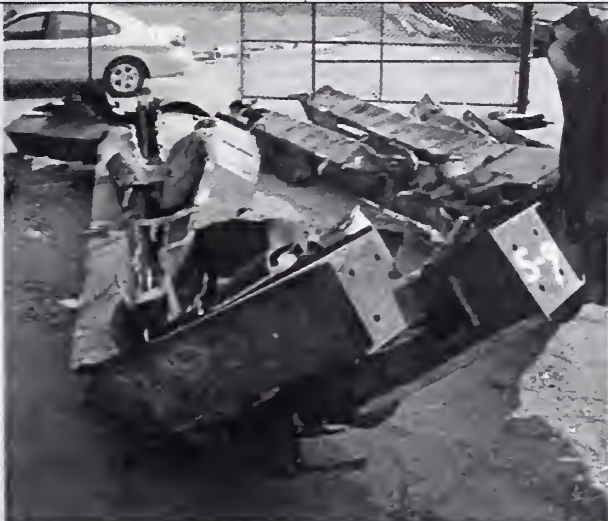
<p>This is an exterior column panel from above the aircraft impact zone of WTC1. Location suggests that this panel was generally intact following aircraft impact. The column splice connections at the bottom of this piece, however, were severed as a result of the aircraft impact. Other than at the 98th floor level, this piece exhibits little indication of fire effects. The fire immediately following the aircraft impact may have affected the faces of the columns adjacent to window openings at the 98th floor, as evidenced by loss of paint and the nature of the distortions in these faces of the column elements (Figure A-38). Apart from these areas, probable cause of observable distress in the remainder of the piece is collapse event, post-collapse events, or both.</p>

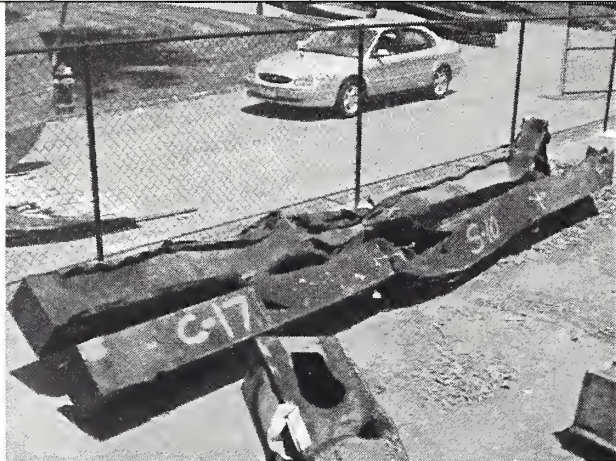
<p>Figure F-A-12a: General view of Piece S-10 (also labeled C-17).</p>		<p>This is a partial exterior column panel, consisting of approximately the lowest two-thirds (from column splice at the window opening at the 92nd floor through part of the column elements at the window opening at the 94th floor) of the second and third column elements (left to right, inside looking out) and associated fragments of spandrel panels at the 93rd and 94th floor lines. While this column panel is from floors where the aircraft impacted the structure, this panel was not on the face of the building that was directly impacted by the aircraft.</p> <p>The column panel exhibits distinct pattern of fire effects at windows openings. Zones of interest were identified on a side face of the middle column element as follows:</p> <p>Z0: Window opening at 92nd floor. Low to moderate paint remaining indicative of low degree of fire effects.</p> <p>Z1: Spandrel at 93rd floor line. Loss of paint and moderate distortions indicative of some fire effect.</p> <p>Z2: Window at the 93rd floor. Lack of paint and presence of pronounced distortions are indicative of significant fire effect.</p> <p>Z3: Spandrel at 94th floor line. Paint remains and distortions are relatively low, indicative of little fire effect.</p> <p>Z4: Window at 94th floor. Lack of paint and presence of pronounced distortions are indicative of significant fire effect. The column fragments end within this zone.</p>

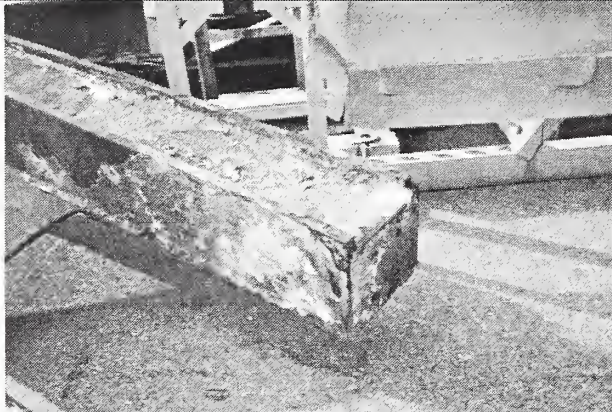
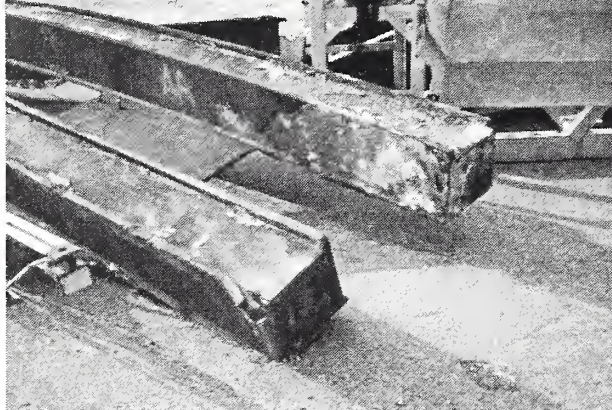
Piece ID Mark: AA		By & Date: RT / 25 July 2003	
Bldg: WTC1 or WTC2		Floors: unknown	
Column: unknown		<p>Two exterior box columns from one column panel with fire residue on the end of one column member. Because the residue is on the end plate of one member, it suggests that residue was deposited after the end plate was separated from its matching piece, meaning that residue deposit would have occurred after the collapse.</p>

Figure F-B-1a: End of one column on Piece AA.

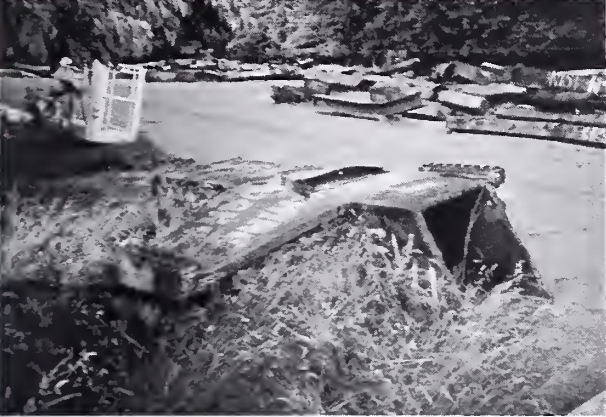
<p>Figure F-B-2a: General view of Piece B5004.</p>		<p>Low level tree haunch with a crack. The nature of the crack suggests that the crack initiated at the weld. Cracks of this nature are known to be a potential problem for welded joints in heavy pieces of fabricated structural steel. The crack probably occurred at the time the piece was fabricated, due to triaxial restraint of weld shrinkage during cooling of the original weld. It is our opinion that the crack was existent at the time of building collapse. The crack may have been extended during erection at the time of original construction.</p> <p>It is very unlikely that the crack was extended or enlarged as a result of aircraft impact or building collapse. It is also very unlikely that the presence of these cracks had any adverse effect on the performance of the building as it may relate to the aircraft impact, fire following aircraft impact, and initiation of progressive collapse. This is because the large compressive forces to gravity loads in the column due would tend to keep these cracks closed, even under loads associated with these extreme events.</p>

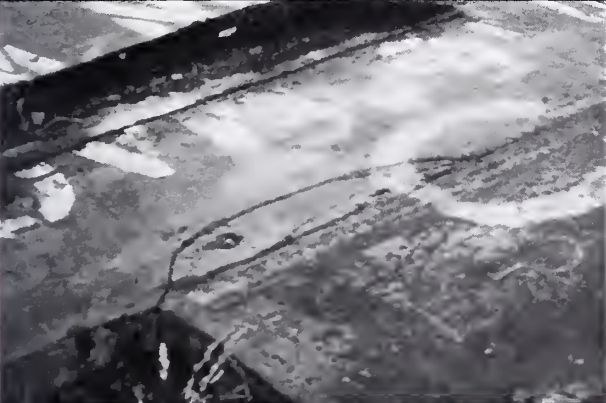
<p>Figure F-B-2b: View of crack observed on Piece B5004.</p>

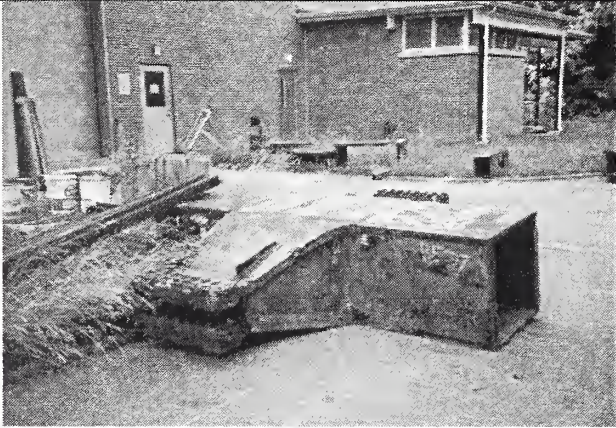
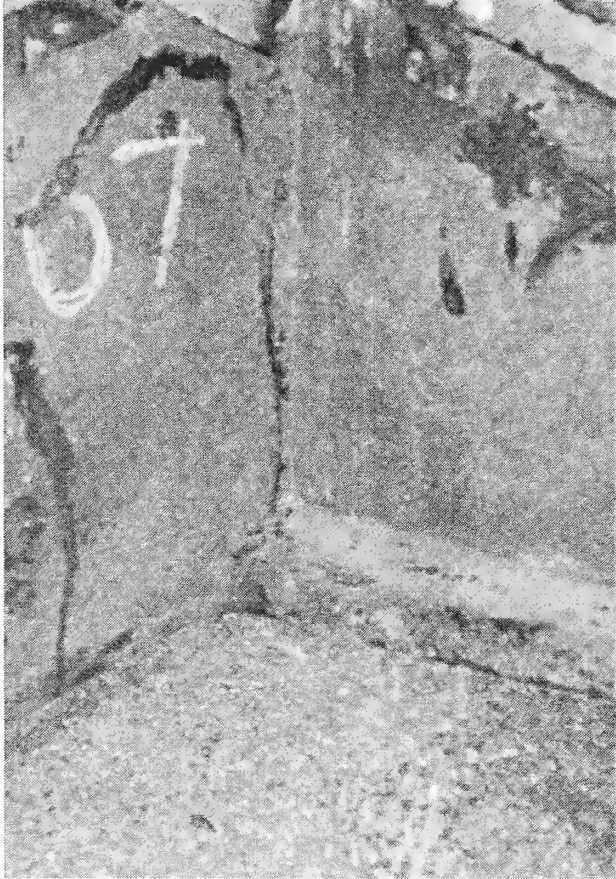
<p>Low level tree haunch with a crack. The nature of the crack suggests that the crack initiated at the weld. Cracks of this nature are known to be a potential problem for welded joints in heavy pieces of fabricated structural steel. The crack probably occurred at the time the piece was fabricated, due to triaxial restraint of weld shrinkage during cooling of the original weld. It is our opinion that the crack was existent at the time of building collapse. The crack may have been extended during erection at the time of original construction.</p> <p>It is very unlikely that the crack was extended or enlarged as a result of aircraft impact or building collapse. It is also very unlikely that the presence of these cracks had any adverse effect on the performance of the building as it may relate to the aircraft impact, fire following aircraft impact, and initiation of progressive collapse. This is because the large compressive forces to gravity loads in the column due would tend to keep these cracks closed, even under loads associated with these extreme events.</p>

Figure F-B-3b: View of crack observed on piece.

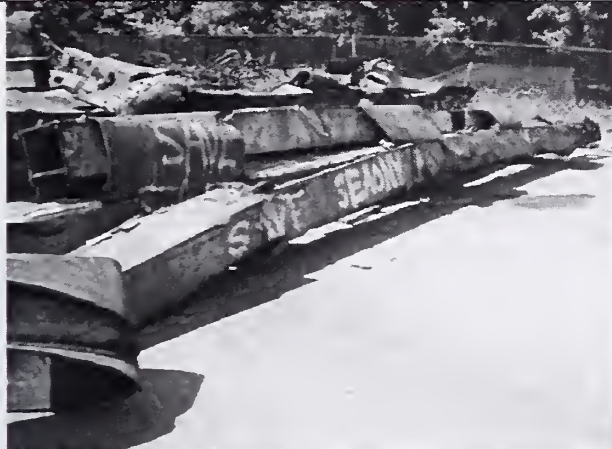
<p>Given the location in the building, this piece was not affected by aircraft impact. Visual indications of fire effect were not readily observed. Observed damage and distortions are probably due to collapse event and subsequent handling.</p>	
Figure F-B-4: Piece C-10.

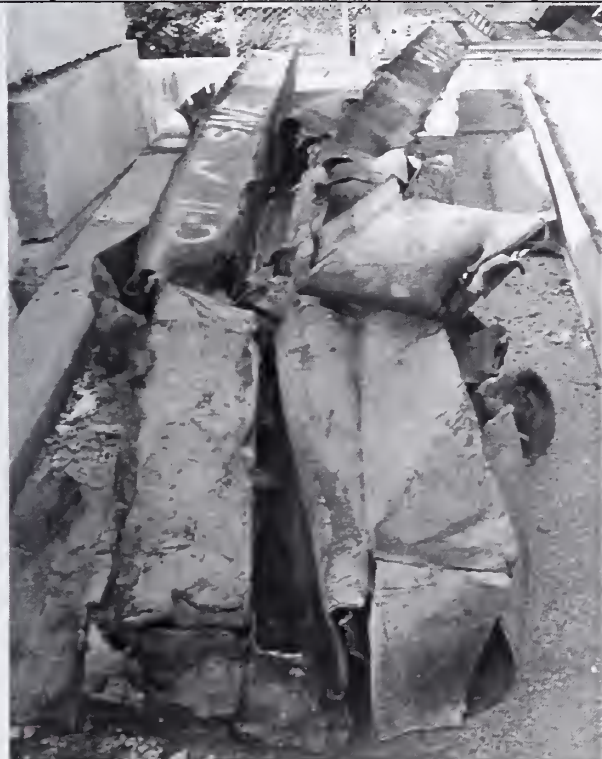
<p>Upper two-thirds of two columns from an exterior column panel. The thickness of the plates is consistent with having been located in the upper portions of one of the buildings. Indications of fire effects are present at the inside faces of the columns at the upper full window locations (between middle and top spandrel elements). Upper spandrel and column elements at the window location above the upper spandrel do not exhibit significant effects of fire.</p>	
Figure F-B-5: Piece C-11.

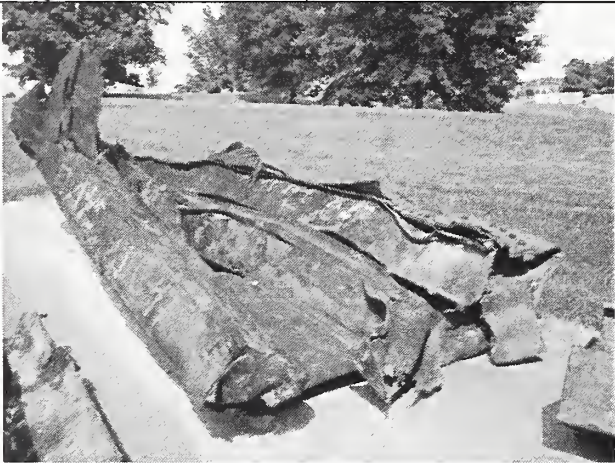
<p>Partially recovered exterior column panel from WTC 1 or WTC 2. General indications of fire effects widely distributed throughout piece. This observation suggests that the observed effects were a result of fire after collapse.</p>

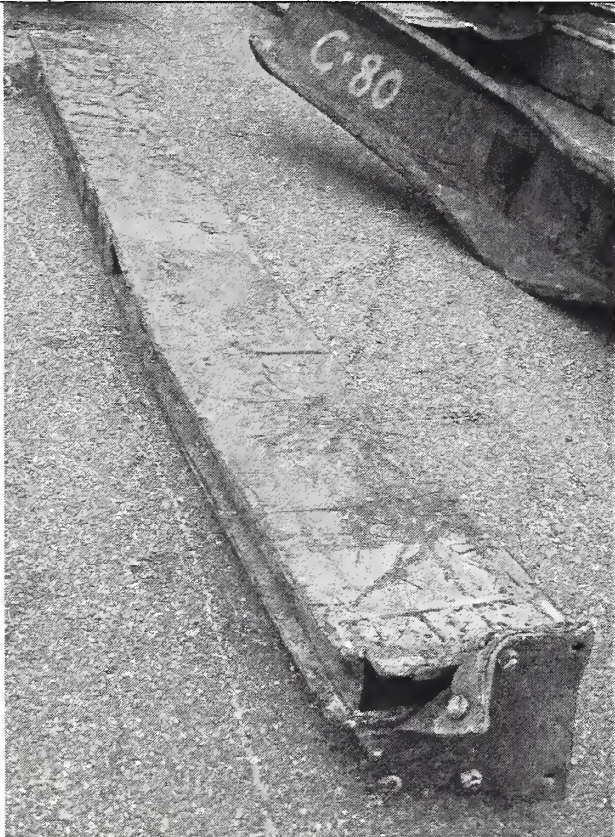
<p>Rectangular box beam shape. Connections at ends of the element indicate that this is a horizontally-spanning element. Concrete fragments were observed inside of the box beam. This concrete is well-bonded to the beam and conforms to the interior shape of the beam. This suggests that the concrete is probably from original construction.</p>

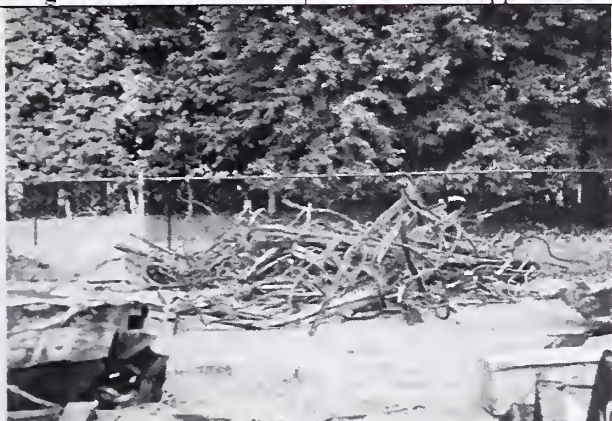
<p>Figure F-B-8a: General view of truss remnants.</p>		<p>Badly tangled remains of Laclede Steel open web steel trusses. The intermingling of the trusses suggests that this occurred during impact, collapse, salvage operations, hauling, storage, or any combination of these events. It is not possible to sort out what damage occurred when.</p> <p>Figures B-11 through B-18 show some of the connection joints within the truss members themselves. The trusses were fabricated with extensions of diagonal web members at the top chord panel points and at end bearing details that develop composite action with the concrete topping slab. As was typical for trusses and joists manufactured by Laclede Steel, the web elements are electric resistance welded to the top and bottom chord angles. Although the angles and web elements are severely distorted in the immediate vicinity of the panel points, the actual welded connections remain intact.</p> <p>Intact welds could be tested. These tests would provide a lower bound to the joist connection capacity. Small lengths of undistorted remnants of the chord angles and web rounds could be tested to provide the equivalent of mill test data.</p>

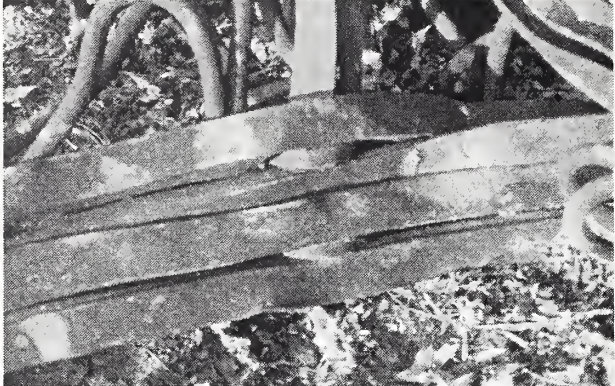
<p>Figure F-B-8d: Connections of truss diagonals to bottom chords.</p>	<p>(continued from previous page)</p>
  <p>Figure F-B-8e: Connection of truss diagonals to top chord.</p>	
  <p>Figure F-B-8f: Fracture of top chord at connection to diagonal. Note that welds are intact but that chord element has fractured.</p>

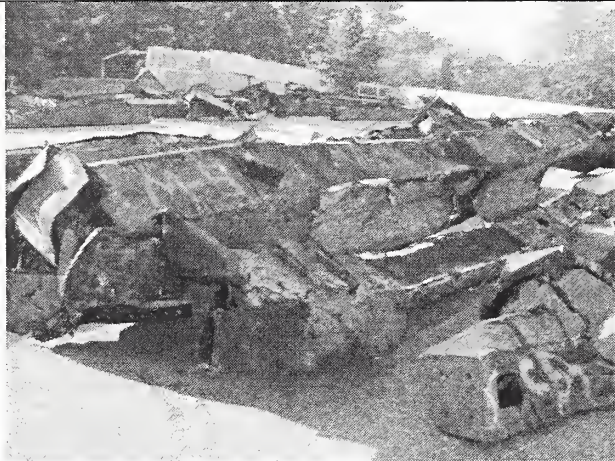
<p>Figure F-B-9a: Overall view of piece M-4.</p>		<p>This is an unidentified exterior column panel from WTC 1 or WTC 2. The recovered piece is a partial panel, consisting of approximately the upper one-half to two-thirds of the panel.</p> <p>This panel exhibits possible fire effects on the inside faces of all three columns at some window locations, as exhibited by loss of most paint and the presence of local buckling or “dishing” of the inside faces of the columns. The side faces and outside face of the columns exhibit little or none of these fire effects.</p> <p>Zones of interest were identified on the inside faces of two of the columns as follows:</p>

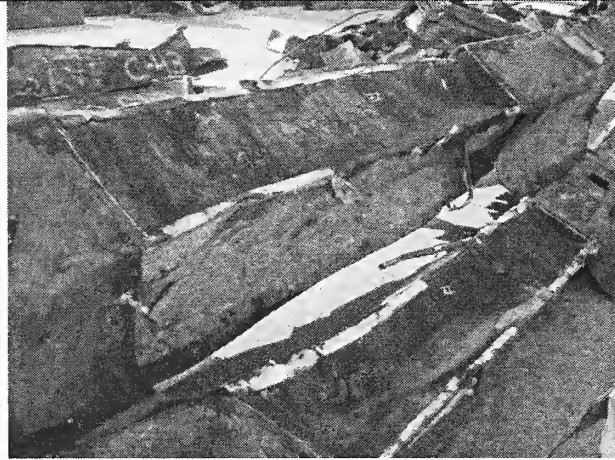
<p>Figure F-B-9b: Identified Zone Z2. Possible fire effects on inside faces of column elements at window location.</p>		<p>Z4: At window location just below the middle spandrel element. Loss of paint and severe distortions suggest possible fire effects.</p> <p>Z3: At spandrel section at middle of panel. Little or no visible indication of fire effects.</p> <p>Z2: At window location between middle and upper spandrel elements. Inside face of columns exhibit loss of paint and inward local buckling or dishing, both indicative of possible fire effects.</p> <p>Z1: At upper spandrel section. Little or no visible indication of fire effects.</p> <p>Z0: At window location above upper spandrel element. Little or no indication of fire effects.</p>

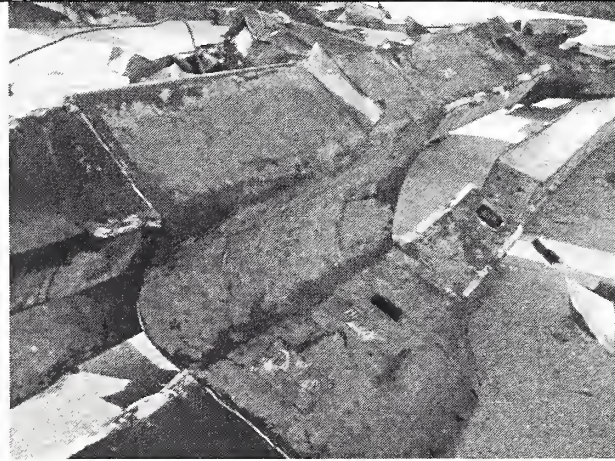
<p>Figure F-B-9c: Identified Zones Z1 and Z0.</p>

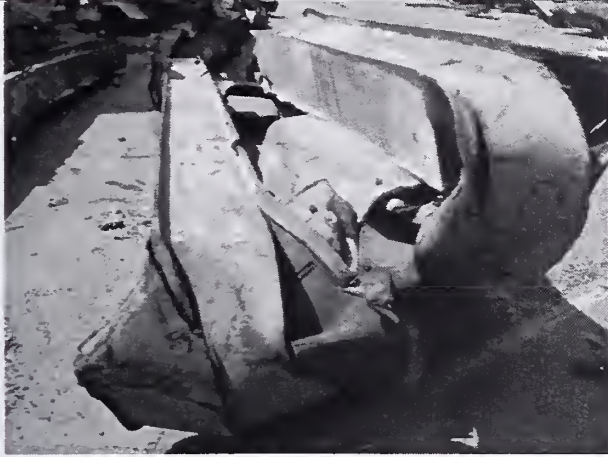
Piece ID Mark:	N-1	By & Date:	CP / 24 June 2003
Bldg: WTC 1	Column: 218	Floors: 82 - 85

<p>This column is from well below the aircraft impact zone. Panel is bent in half at about mid-length. No indication of fire effect. Given location in building, probable cause of observed damage and distortion is the collapse event and subsequent handling.</p>	
Figure F-B-10: View of piece N-1.

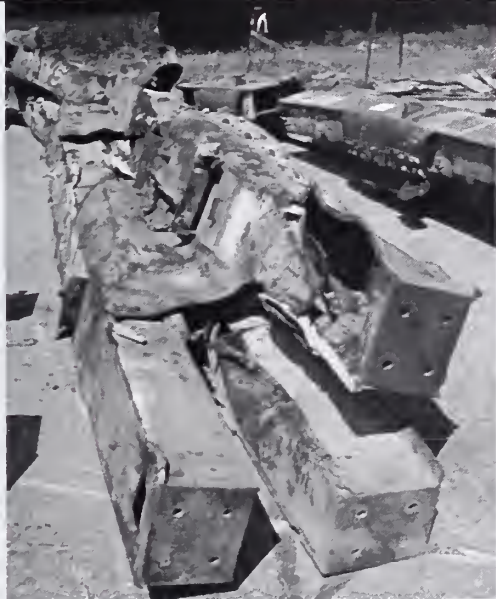
Piece ID Mark:	S-14 or C-20	By & Date:	
Bldg: WTC 2	Column: 218	Floors: 91 - 94

<p>Full exterior column panel from high floors in WTC 2, well above the aircraft impact zone for WTC 2. Possible fire effects observable at some locations on the piece. Given location of this piece in WTC 2, it is most probable that the observed fire effects are related to post-collapse fire rather than fire immediately after aircraft impact.</p>	
Figure F-B-11: Piece S-14 or C-20.

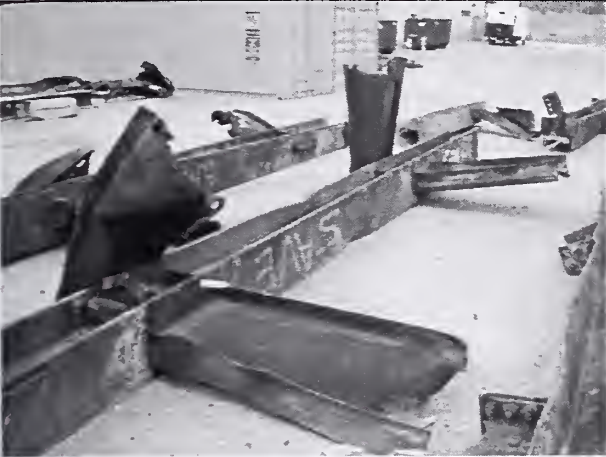
Piece ID Mark:	C-31 (also S-7)	By & Date:	CP & JH / 31 July 2003
Bldg: unknown	Column: unknown	Floors: unknown	Fire effects

<p>Figure F-C-1a: Piece C-31. Top of piece is at lower left; bottom of piece is at upper right.</p>		<p>Two-story wide flange column piece probably from a structure other than WTC 1 or WTC 2. The column piece itself is generally straight.</p> <p>The beam stubs framing into the flange on one side of the column (i.e., the beams are in the plane of strong axis column bending) are generally undeflected and remain in the plane of strong axis column and beam bending. The fractures at the free ends of these beam stubs suggest that these beam stubs have probably failed in tension generally directed along the longitudinal axis of the beam stub.</p> <p>The beam stubs framing into the opposite flange have been bent out-of-plane, extending in a direction generally perpendicular to the plane of strong axis beam and column bending. Examination of the column piece, including examination of column space at base of column piece, suggest that these beam stubs were bent out-of-plane during collapse. Examination of bolt hole distortions at the connection at the free ends of these beam stubs suggests that these connections also fractured in tension generally directed along the longitudinal axis of the beam stub.</p> <p>The outstand beam stubs appear to be fire effected.</p>

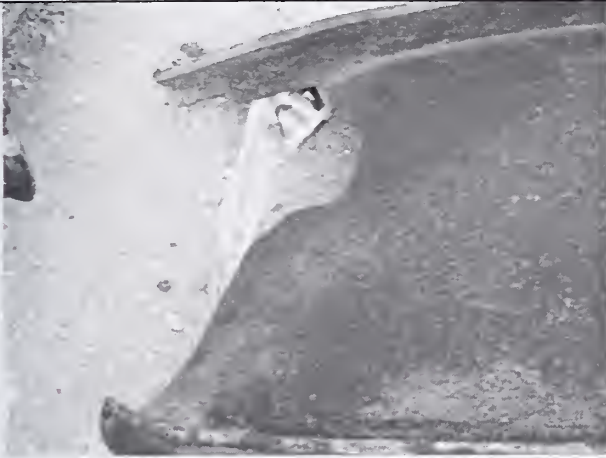
<p>Figure F-C-1b: Piece C-31. Fracture at end of beam stub that remains in-plane</p>

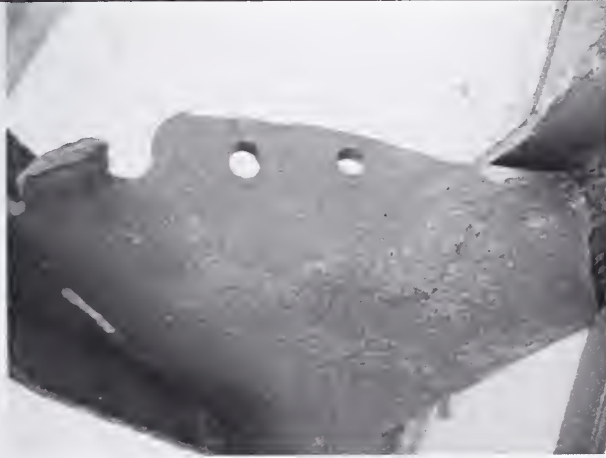
<p>Figure F-C-1c: Piece C-31. Fracture at end of a beam stub that is bent out-of-plane</p>

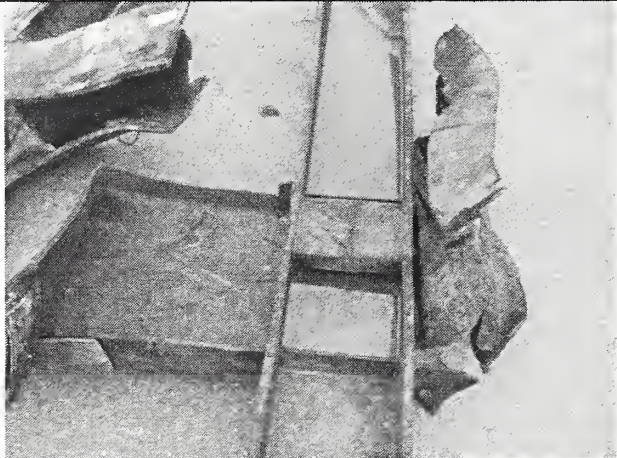
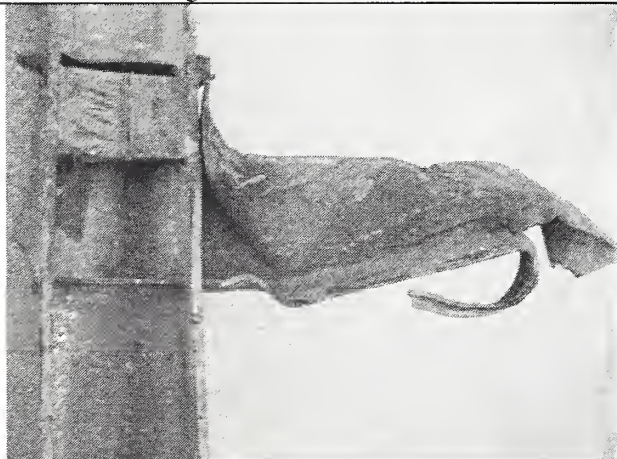
Piece ID Mark: C-42		By & Date: CP & JH / 31 July 2003	
Bldg: unknown	Column: unknown	Floors: unknown	Fire effects

<p>Figure F-C-2a: Piece C-42.</p>		<p>Two-story wide flange column piece probably from a structure other than WTC 1 or WTC 2.. The column piece itself exhibits a twist about its longitudinal axis. This column piece exhibits generally more distortion than other pieces reported in this appendix.</p> <p>The connections at the free ends of the beam stubs that frame into the column exhibit bolt tear-out failures. The bolt tear-outs are generally directed parallel to the longitudinal axes of the beam stubs, suggesting that the beam stubs were in axial tension at the time of tear-out.</p> <p>The outstanding ends of the beam stubs exhibit probable fire effects as evidenced by the character of the distortions at the outstanding ends.</p>

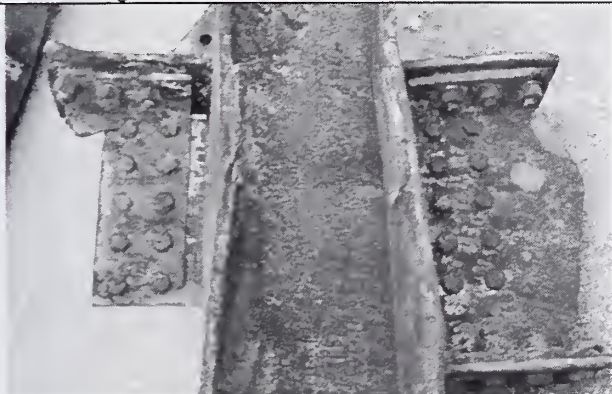
<p>Figure F-C-3b: Block shear fracture in Piece C-72 at left; probable tensile fracture at right.</p>

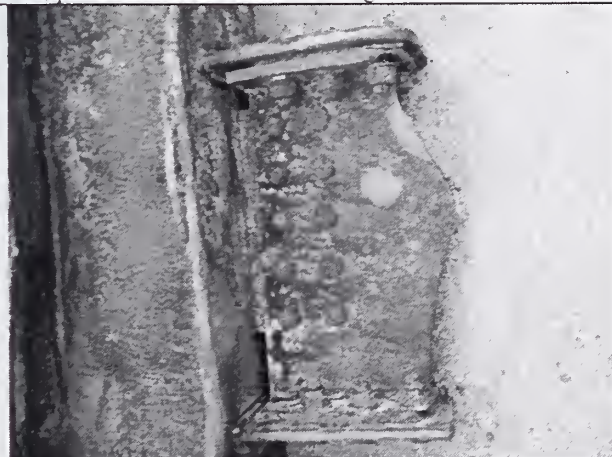
<p>Figure F-C-3c: Piece C-72 showing probable tensile fracture of beam through net section at connection to column.</p>

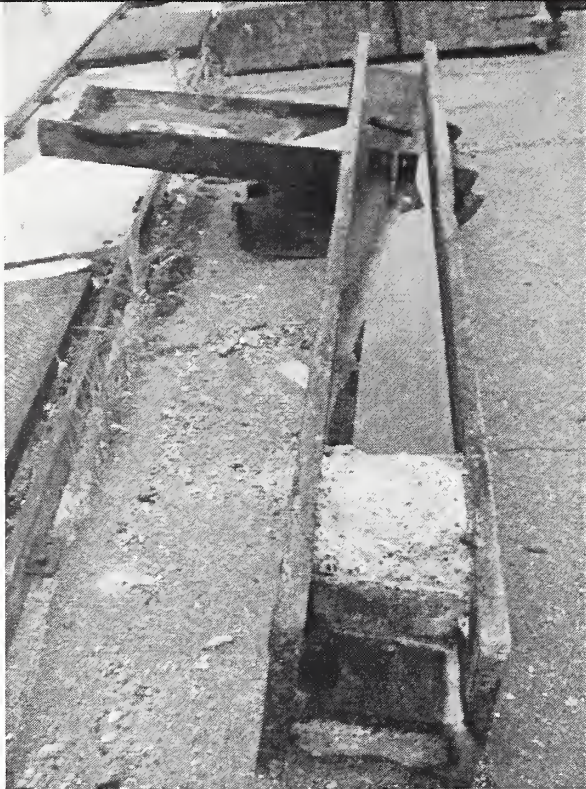
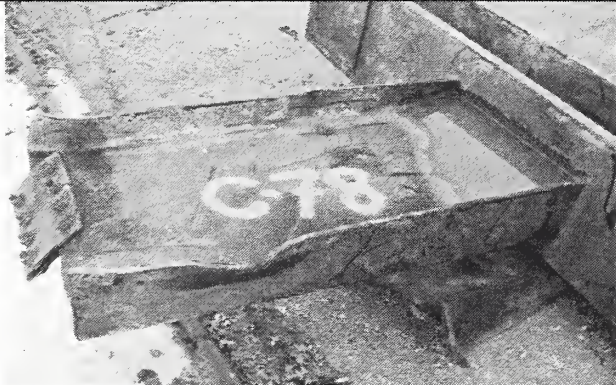
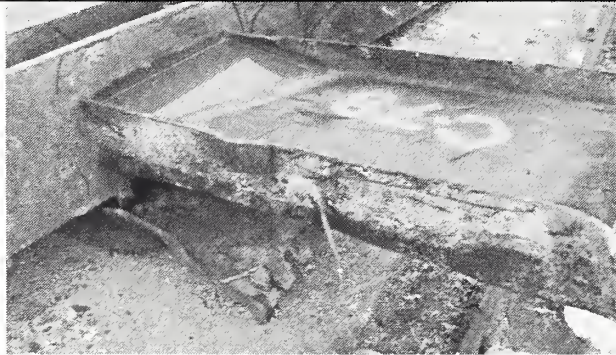
Piece ID Mark: C-78		By & Date: CP & JH / 31 July 2003	
Bldg: unknown		Floors: unknown	
Column: unknown

<p>One-story wide flange column piece probably from a structure other than WTC 1 or WTC 2. The column piece itself is generally straight.</p> <p>The connections at the free ends of the beam stubs have fractured due to bolt tear-out. The direction of bolt tear-out on the web of one of the beam stubs is parallel to the longitudinal axis of the beam stub, which is consistent with axial tension loading in the beam stub.</p> <p>No distinct indications of fire effects.</p> <p>This piece contains fragments of concrete trapped between the flanges and web of the column near its base.</p>

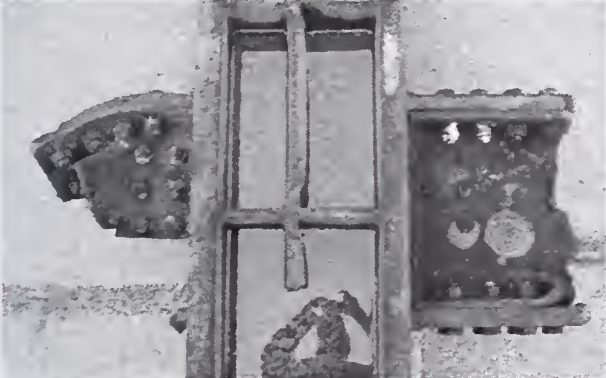
<p>Figure F-C-5b: Piece C-85, connections of beams to column.</p>

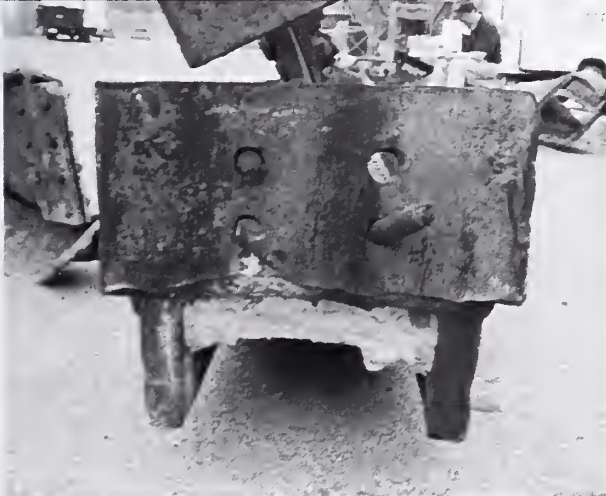
<p>Figure F-C-5c: Piece C-85, column connection plate at base of column</p>

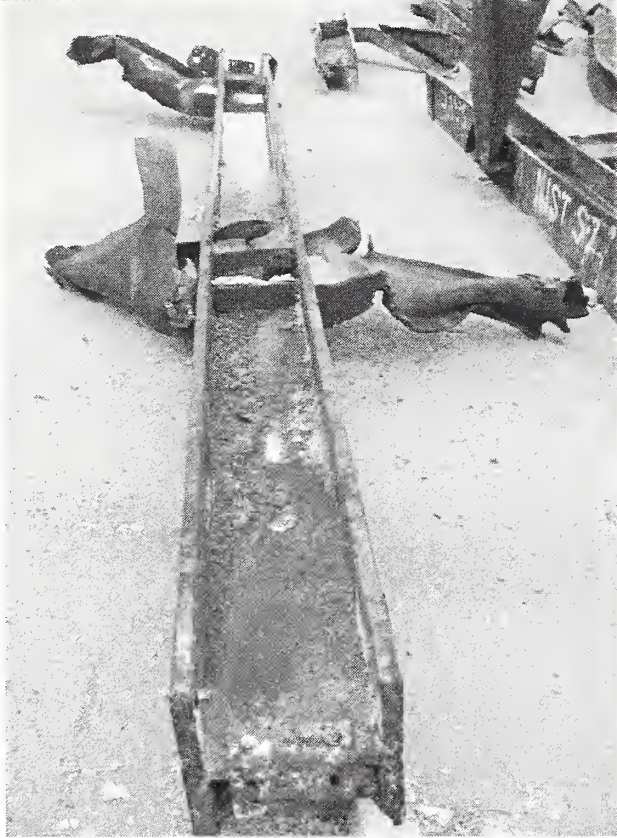
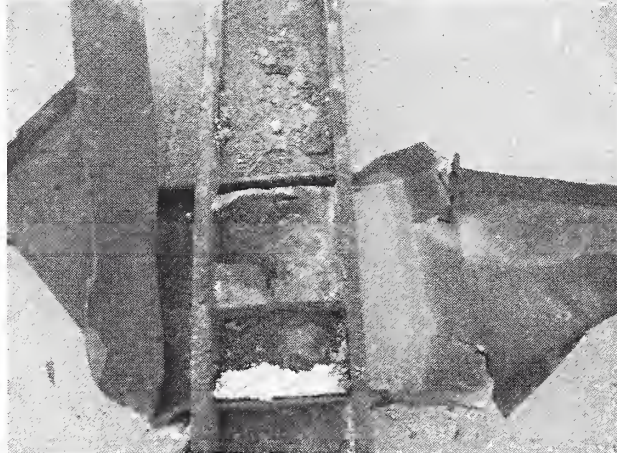
Piece ID Mark: M-11		By & Date: CP & JH / 31 July 2003	
Bldg: unknown	Column: unknown	Floors: unknown	Fire effects

<p>Two-story wide flange column piece. The column piece itself exhibits a very slight twist but is otherwise generally straight.</p> <p>The fractures of the connections at the free ends of the beam stubs suggest that the beam stubs were in axial tension at the time of failure.</p> <p>The outstanding ends of the beam stubs exhibit probable fire effects as evidenced by the severe distortions of the beam stub element.</p>

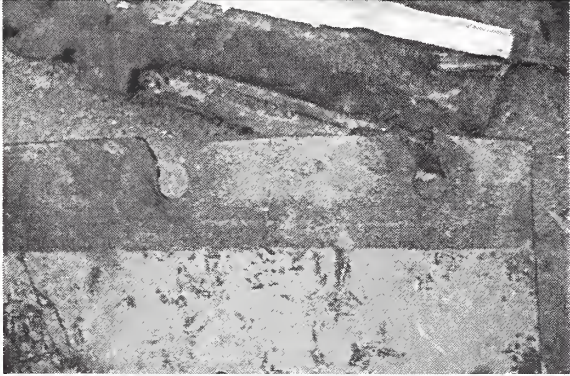
<p>Figure F-D-1a: Spandrel connection failure Type 1</p>	<p><u>Type 1</u> Edge-distance bolt tear-out from spandrel plate</p>

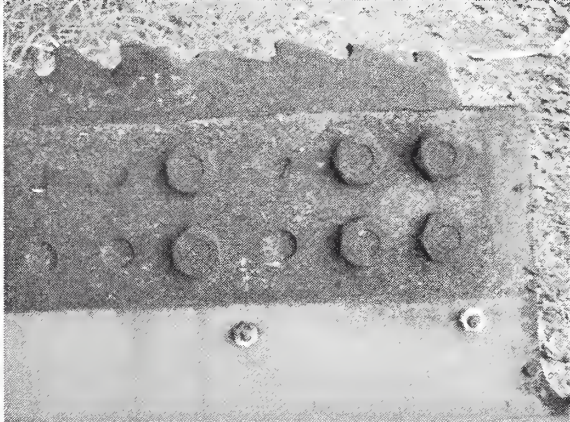
<p>Figure F-D-1b: Spandrel connection failure Type 2</p>	<p><u>Type 2</u> Edge-distance bolt tear-out from connection splice plate</p>

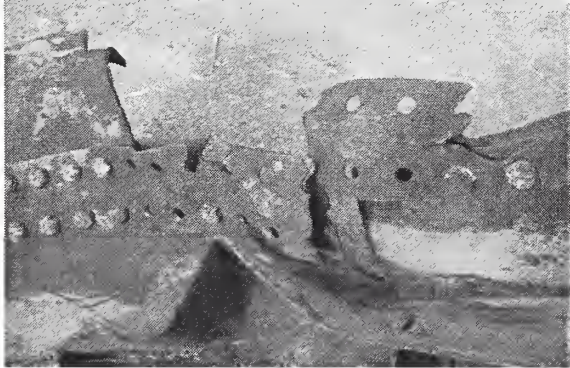
<p>Figure F-D-1c: Spandrel connection failure Type 3</p>	<p><u>Type 3</u> Combination of Type 1 and Type 2: Edge distance bolt tear-outs observed on both spandrel plate and splice plate</p>

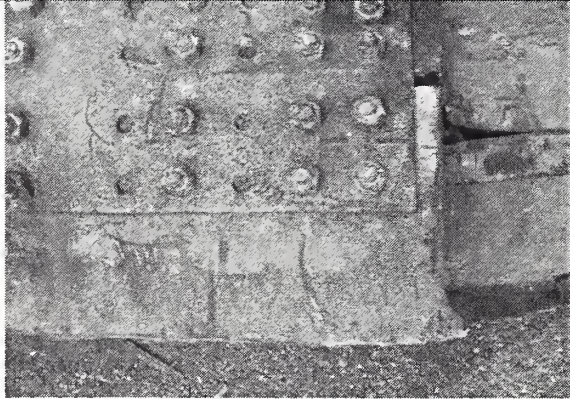
<p>Figure F-D-1d: Spandrel connection failure Type 4</p>	<p><u>Type 4</u> Fracture of spandrel plate away from splice plate connection</p>

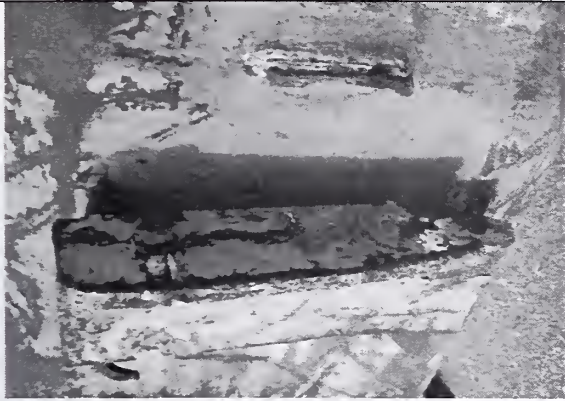
Figure F-D-2a: Seat failure mode Type 1

Seat assembly remains and at least one erection bolt is present in the seat angle

(In Figure D-2a, an erection bolt is present in the hole at the left.)

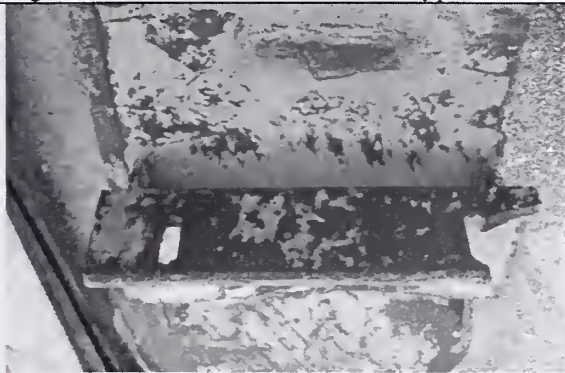
Figure F-D-2b: Seat failure mode Type 2

Seat assembly remains in place and at least one of the bolt holes for the in the seat angle has edge distance tear-out; no bolts are present

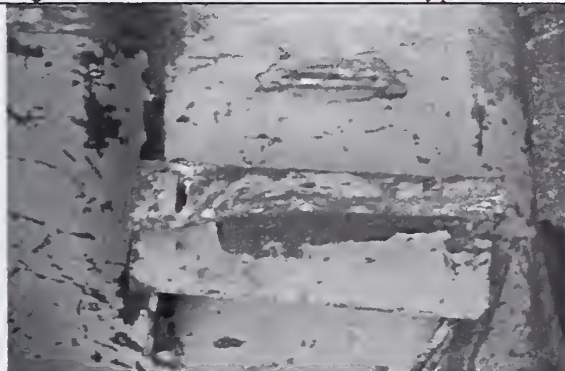
Figure F-D-2c: Seat failure mode Type 3

Seat assembly remains in place with no erection bolts present and no edge distance tear-outs of bolt holes in the seat angle

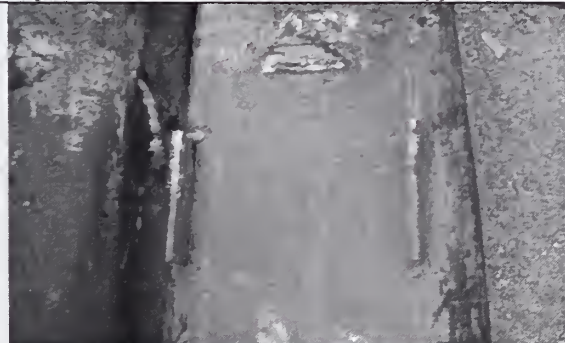
Figure F-D-2d: Seat failure mode Type 4

Seat assembly is missing and appears to have been sheared off where the stand-off plates are welded to the face of the column

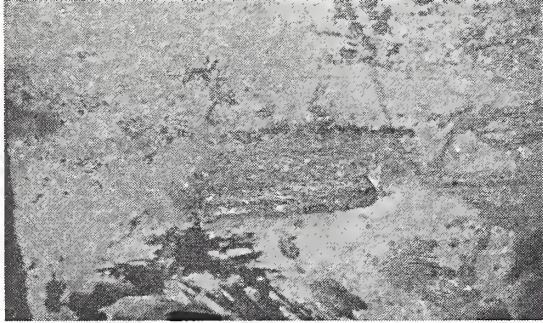
Figure F-D-3a: End gusset failure mode Type 1

Fracture of top plate through gross section away from weld to face of column

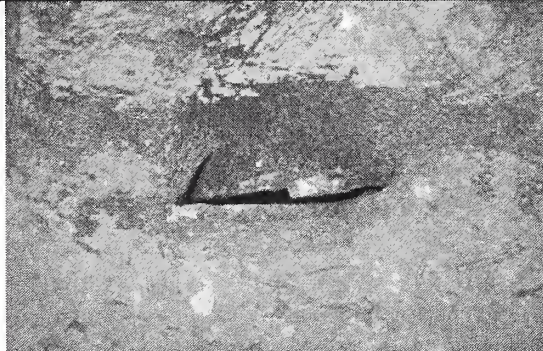
Figure F-D-3b: End gusset failure mode Type 2

Tear-out of top plate and weld from the parent material of the column face

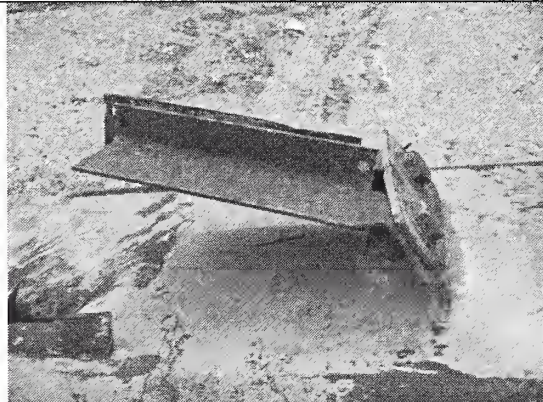
Figure F-D-4a: Damper connection failure Type 1

Remnants of the damper and its connection plate remain attached to column

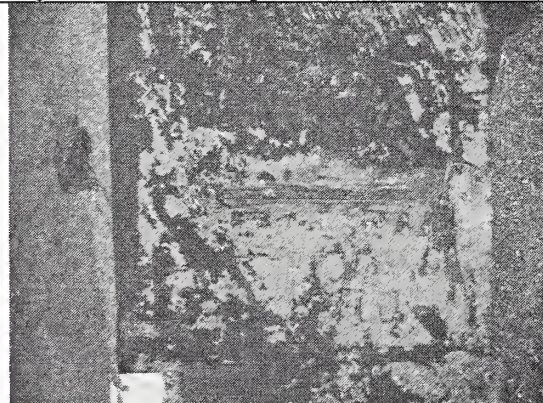
Figure F-D-4b: Damper connection failure Type 2

Damper and its connection plate are missing, typically fracturing at weld of connection plate to face of column
