NIST NCSTAR 1-5

Federal Building and Fire Safety Investigation of the World Trade Center Disaster

Reconstruction of the Fires in the **World Trade Center Towers**

September 2005

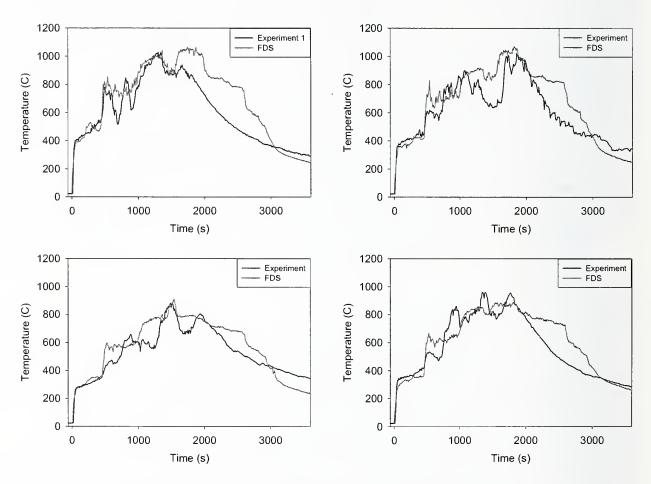
Figure 4–8 displays the upper layer temperature for Test 1 at four locations (clockwise from upper left: near window, between workstations, behind workstations, rear wall). The measured and predicted temperatures for all the tests were similar to those shown in Figure 4–8. Peak temperatures near the compartment opening were about 1,000 °C, decreasing to 800 °C at the very back of the compartment. The trend was captured in the simulations. The decrease in temperature was important because in the simulations of the WTC fires, the only basis of comparison was the visual observations of fires around the exterior of the buildings. It was important to demonstrate that the model not only predicted accurately the temperature near the windows, but also the decrease in temperature as a function of distance from the windows. The temperature predictions for the other tests were similar and are included in NIST NCSTAR 1-5E.

Figure 4–8. Upper layer temperatures at 4 locations, Test 1.

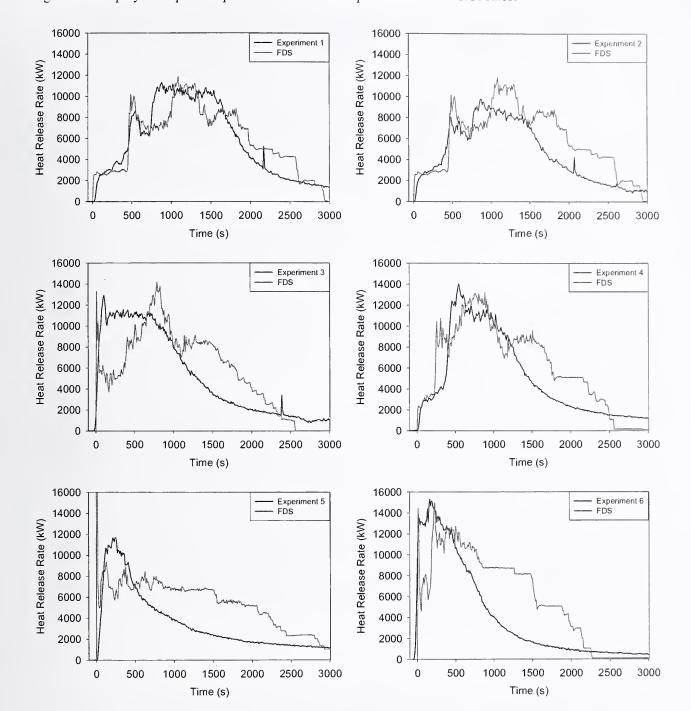
Figure 4-9. Heat Release Rates for multiple workstation experiments.

- The broad shapes of the predicted and measured heat release rate curves were similar. FDS tended to underpredict the pre-peak behavior, overpredict the long-time slower burning period, and thus run out of fuel sooner than the actual tests. These effects were likely due to the simplified modeling of the complex thermoplastic combustibles.
- The spike at the start of the simulations of Tests 3, 5, and 6 was associated with the burning of Jet A. In the FDS mixture fraction model, the fuel burned immediately upon mixing with air, while in the experiment some Jet A had been absorbed by the furnishings and required more time to burn.
- The predicted times to half combustion of the workstations were, on the average, three minutes longer than the measured times.
- The predicted burnout times were, on the average, five minutes longer than the measured times.

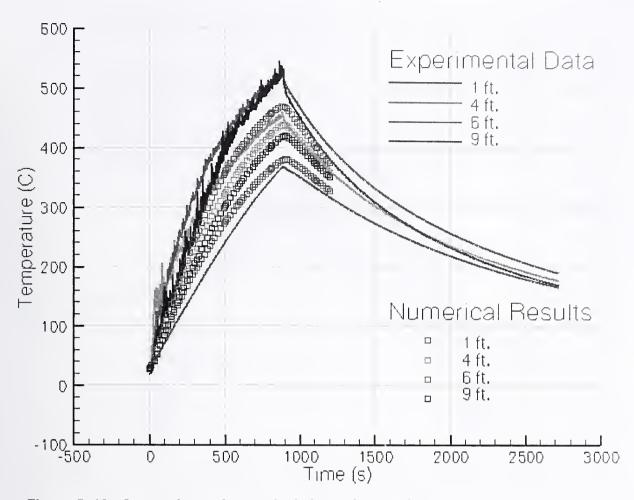
- The shape of the simulated time-temperature results was similar to the measurements.
- For most locations, the absolute difference between the numerical predictions and the experimental data was less than 20 °C at any time. The agreement for the east bar (further from the fire pan) was within 10 °C. This was well within the combination of experimental uncertainty in the temperature measurements and uncertainty in the FDS simulations. (There were some locations where the difference was as large as 100 °C due to FDS not precisely predicting the asymmetry of the fire plume. These regions are not a true test of the accuracy of the FSI. As noted earlier, for the WTC fires that were severe enough to cause structural damage, the fire had a far wider spatial extent, and the calculation results will be less sensitive to the exact location of the fire plume.)

Figure 5–10. Comparison of numerical simulations with measurements for the steel surface temperature at four locations on the west bar in Test 1.

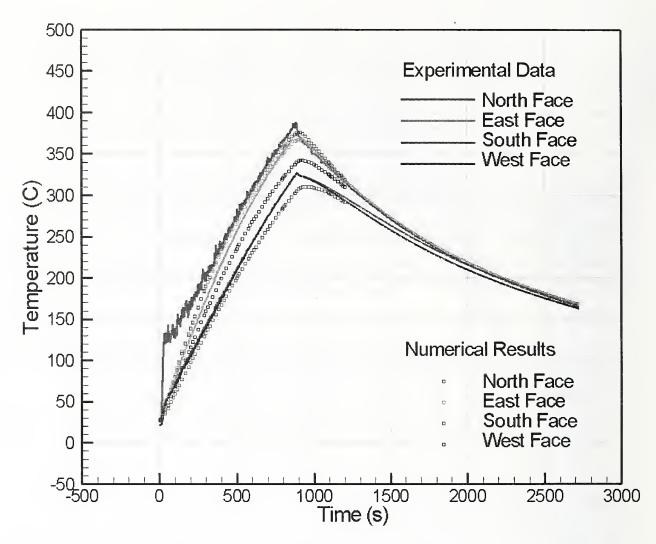
For most locations, the relative differences between the measured and simulated peak temperatures were less than 5 percent, although for some locations the differences were as large as 10 percent. The latter generally occurred just before the fuel flow was stopped at 900 s after ignition. These were all well within the combined uncertainty in the temperature measurements and in the FDS simulations. There was a very large disparity on the south face immediately after the start of the test when the temperatures were still relatively low, but the rate of temperature change was large. These results are discussed in terms of model and measurement uncertainty below.

Figure 5–11. Comparison of numerical simulations with measurements for the steel surface temperature at four locations 3.69 m above the floor on the column in Test 1.

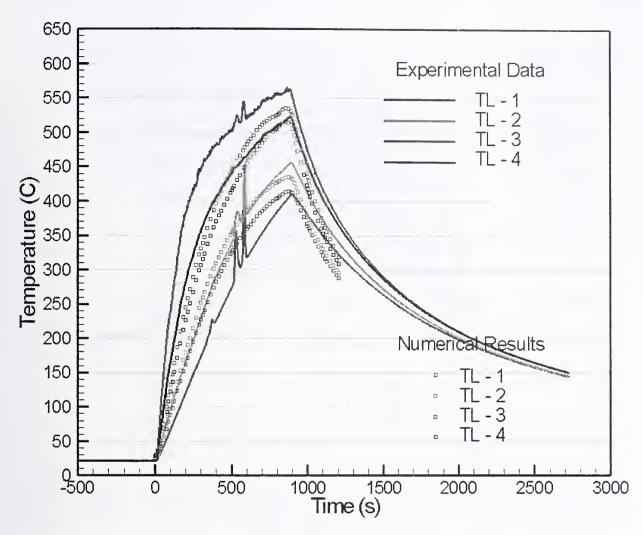
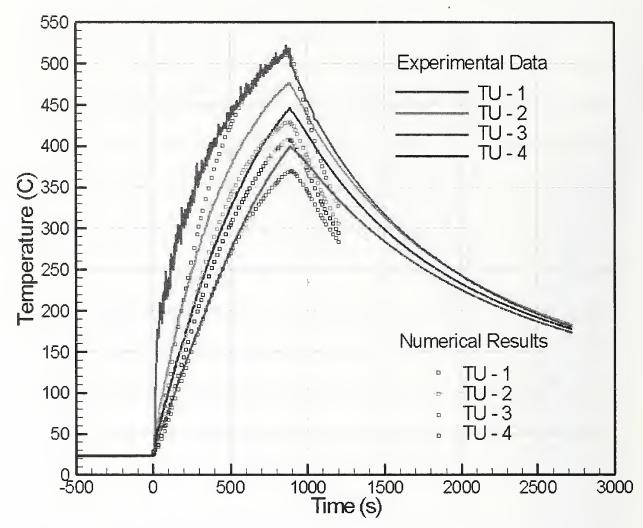
Figures 5–12 and 5–13 are representative of the comparison of calculated and measured temperatures on the surfaces of the north truss during Test 1. The four locations were along the length of the lower chord of the truss in Figure 5–12 and the upper chord in Figure 5–13. For most locations, the maximum difference between the measurements and the simulations was less than 10 percent, which typically occurred when the fuel flow was stopped. For a small number of locations, the difference was as large as 27 percent.

Figure 5–12. Comparison of numerical simulations with measurements for the steel surface temperature at four locations 2.89 m above the floor on the north truss in Test 1.

Figure 5–13. Comparison of numerical simulations with measurements for the steel surface temperature at four locations 3.70 m above the floor on the north truss in Test 1.

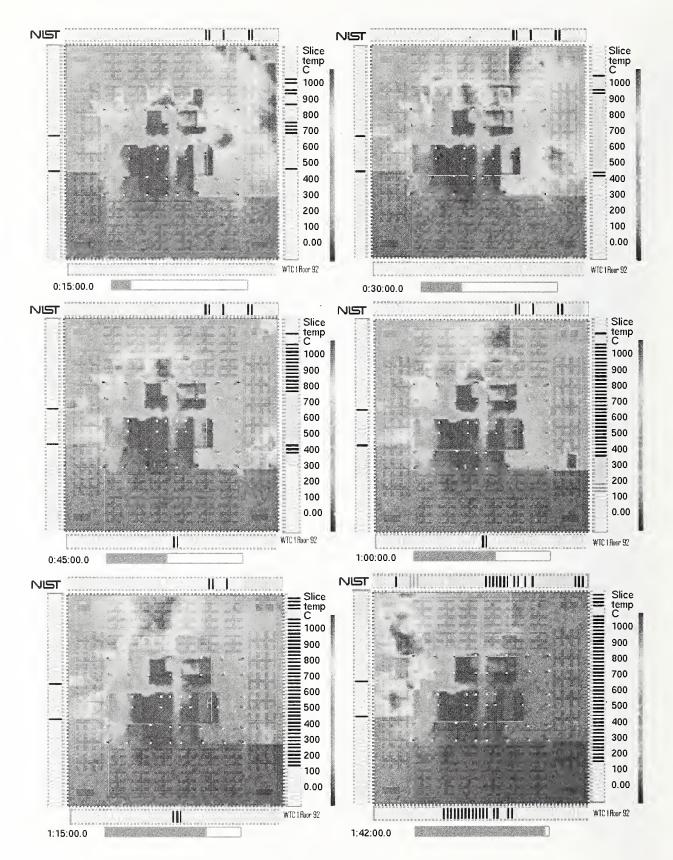
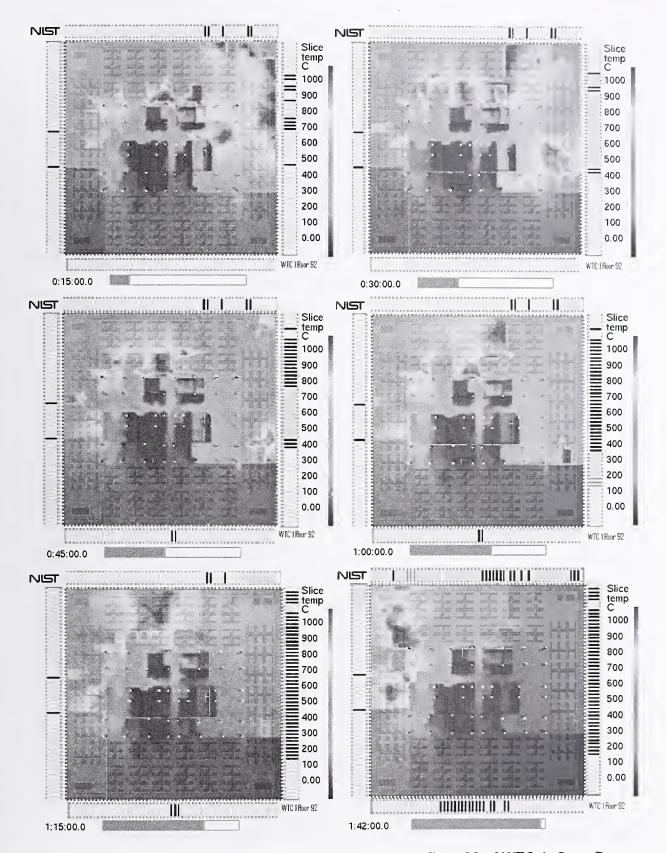
In the simulation, there was no damage on this floor other than window breakage. The ignition of jet fuel in the northeast corner and air from broken windows led to sustained burning of the contents in that corner. The combustibles were consumed about 45 min after the aircraft impact, and the fires moved south along the east face (where they were stopped by a partition) and west along the north side of the interior core. There was a wall that blocked the fires from spreading directly to the north face. Eventually, the simulated fires arrived at the north face about 15 min sooner than was observed in the photographs and videos. The fires never reached the south section of the floor because of various walls that obstructed their spread.

The general pattern of the simulated fires was consistent with the photographic evidence. However, the burning rates were faster than observed: the simulated fire in the northeast corner burned out faster than actually observed, and the simulated fire on the west grew faster. The actual fire on the east face moved slightly further to the south than in the simulation, suggesting that the wall location was incorrect or that the wall had been penetrated. If the latter, it was not clear what caused the fire to stop where it did.

Figure 6–1. Simulated upper layer temperatures on floor 92 of WTC 1, Case A.

Figure 6–2. Simulated upper layer temperatures on floor 92 of WTC 1, Case B.

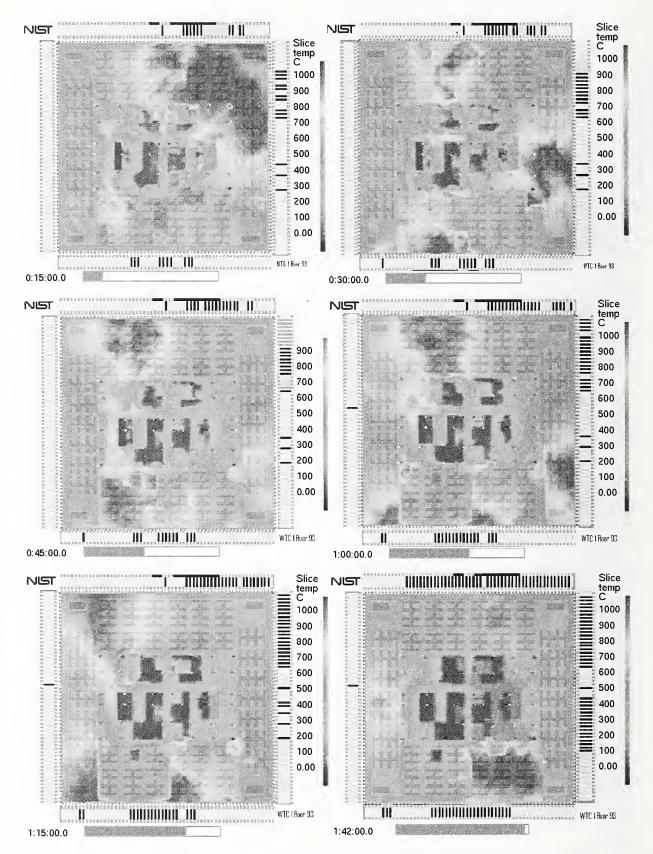
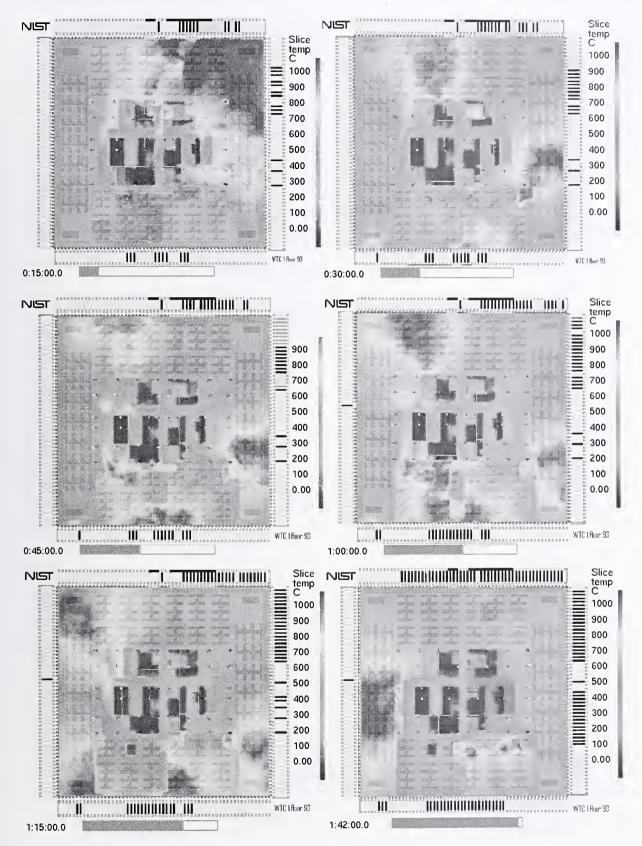
As on the 92nd floor, the simulated fires began in the northeast corner, just under where the left wing of the aircraft dripped jet fuel through the damaged floor slab from the 94th floor. Consuming the combustibles in the northeast in about 30 min, the fires moved west along the north face and south along the east face.

burning rate. The breaking of about 20 windows on the west side of the north face in the last 10 min indicated that there were interior fires or an overall build-up in the temperature of the gases. The observed window breakage along the south face in the last 10 min indicated the presence of a fire, but unlike the simulation, the fires had to have been away from the perimeter since they were not observed through the windows.

Figure 6–3. Simulated upper layer temperatures on floor 93 of WTC 1, Case A.

Figure 6-4. Simulated upper layer temperatures on floor 93 of WTC 1, Case B.

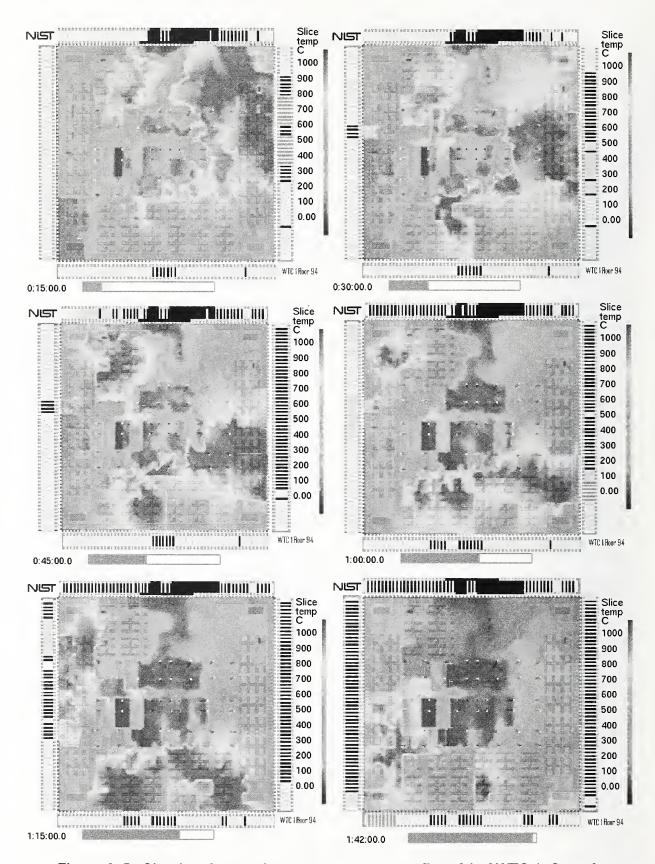
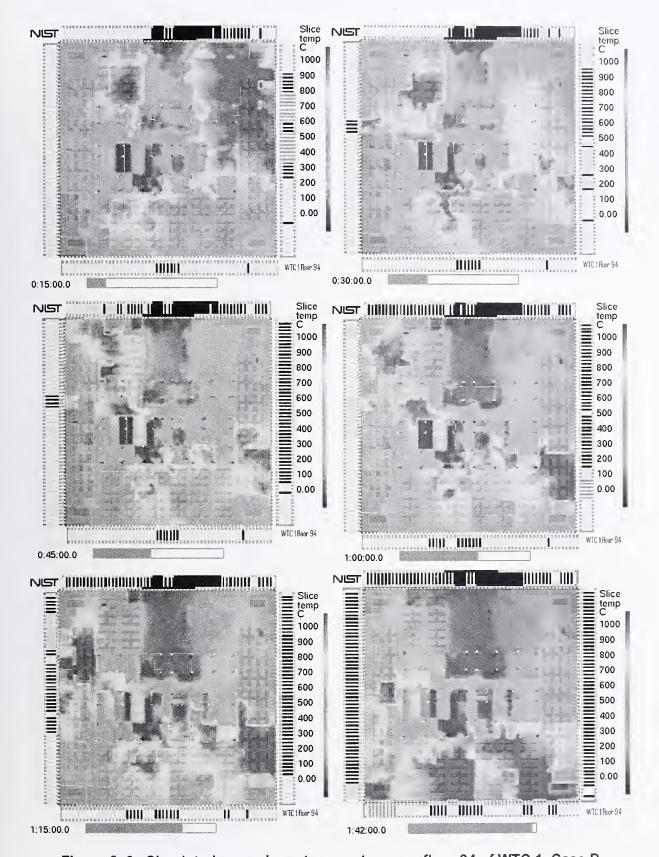
Floor 94 was directly impacted by the left wing of the aircraft, and a substantial amount of jet fuel was spread throughout the cast side of the floor. Initially, severe fires were observed on the east face, and then steadily spread around the floor, with the heaviest activity in the end being in the southwest quadrant.

The simulation captured the movement of the fires reasonably well. The simulated fires burned vigorously in the northeast quadrant for the first 30 min. Then for the next hour, the fires moved at roughly the same rate as the real fires clockwise toward the southeast and counterclockwise toward the southeast. In some areas, the simulation shows the burning to be too close to the windows. The late fire on the south face was not seen in the photographs and videos.

Figure 6–5. Simulated upper layer temperatures on floor 94 of WTC 1, Case A.

Figure 6–6. Simulated upper layer temperatures on floor 94 of WTC 1, Case B.

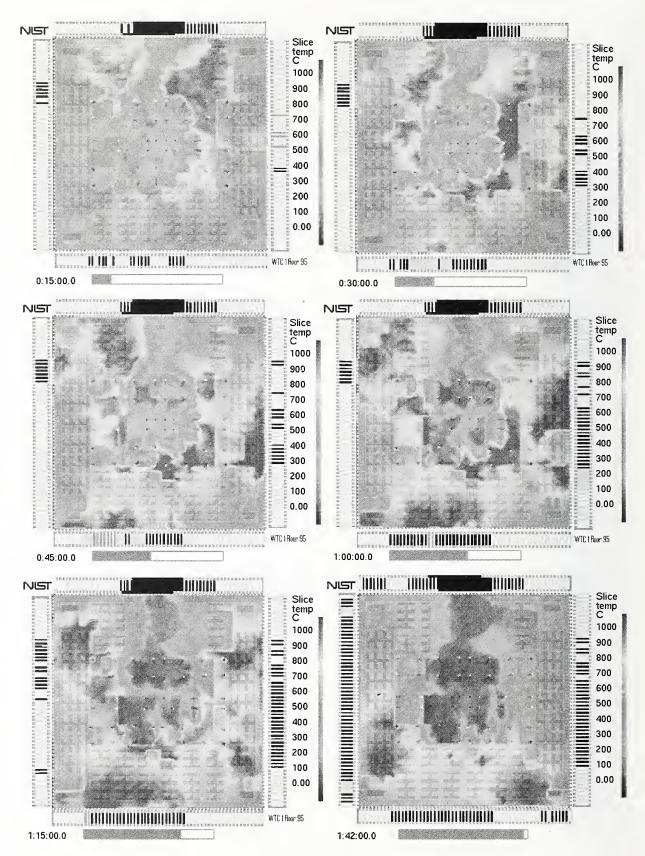
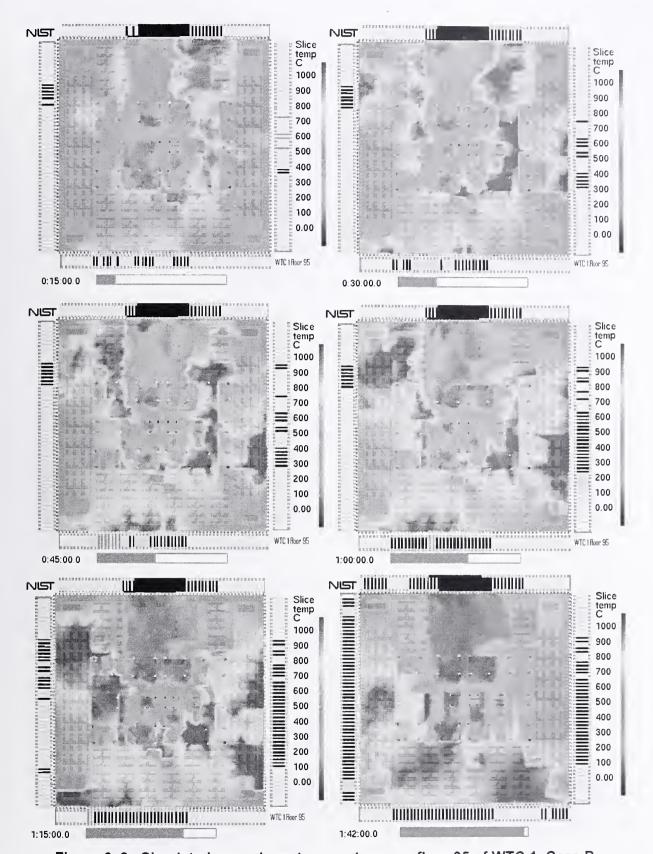
The simulated fires started around the center of the north face where the fuselage of the aircraft hit. The fires then followed the pattern of window breakage. There was substantial fire activity predicted in the building core due to the extensive wall damage (NIST NCSTAR 1-2). The simulations suggested that air rising through the core mixed with the oxygen-starved fuel gases that were accumulating on this floor because of the relatively light exterior damage away from the impact zone. However, there was no evidence to confirm or deny the existence of vigorous fire activity within the core.

Taking into account the tendency to simulate burning too close to the windows, the overall pattern of the fires is reasonably consistent with the observations. The fire on the north side of the building was growing just before additional windows break there. The same is true for the fire on the middle of the east side. The early fire simulated on the south side is consistent, but burns too long or too close to the broken windows.

Figure 6-7. Simulated upper layer temperatures on floor 95 of WTC 1, Case A.

Figure 6–8. Simulated upper layer temperatures on floor 95 of WTC 1, Case B.

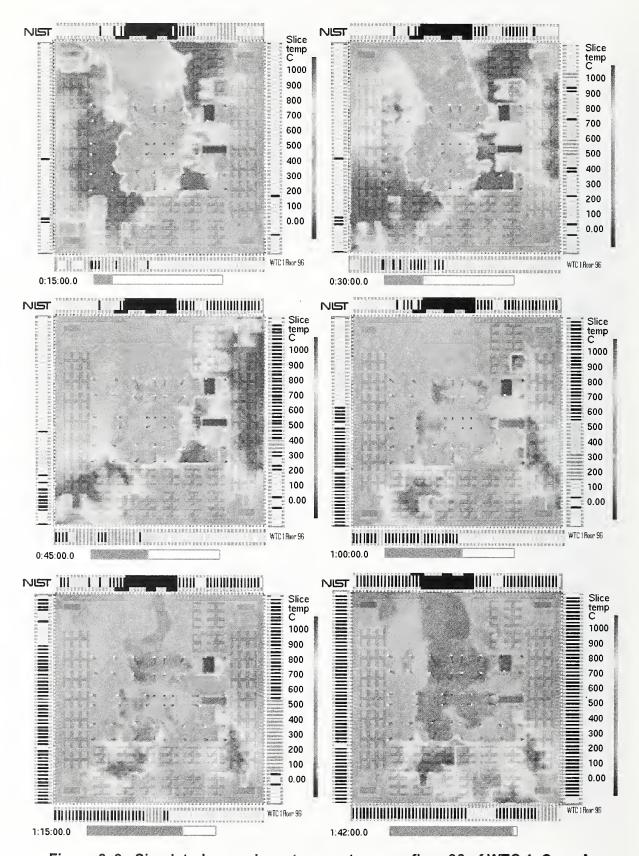
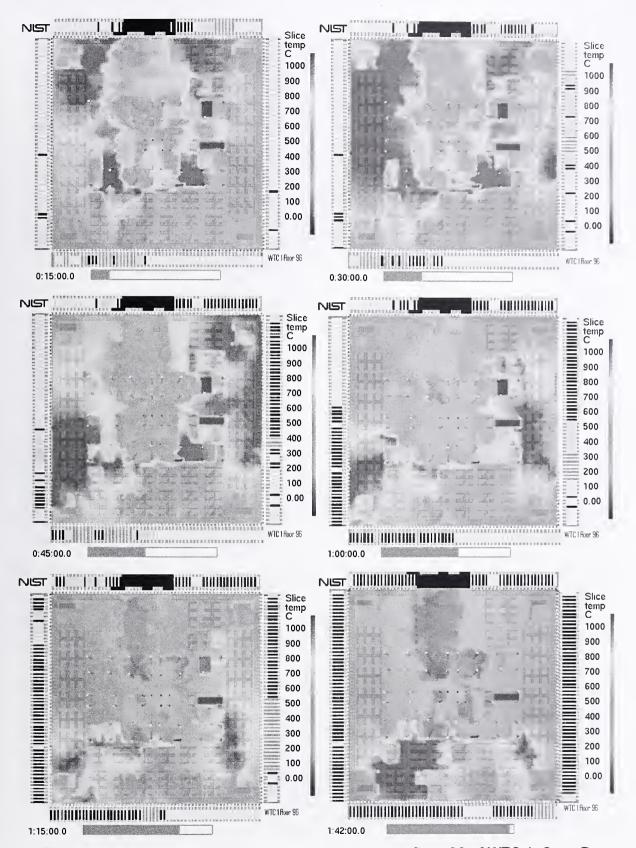
Floor 96 was directly impacted by the aircraft fuselage and inner wings. There was extensive damage to the core and internal walls. One simulated fire stared to the east of the impact hole, spread southward along the east side of the building, and turned the corner to the south face. This behavior mimics closely the behavior of the actual fire. By contrast, the simulation overestimated the extent of the fire on the west face. The visual observations suggested that this fire originated in the south, not the impact area. The simulation is a fair rendition of the observations on the south side of the tower beginning about 15 min to 30 min after the aircraft impact. The model captured the delayed movement of the fires along the south face due to the presence of office walls.

Figure 6-9. Simulated upper layer temperatures on floor 96 of WTC 1, Case A.

Figure 6–10. Simulated upper layer temperatures on floor 96 of WTC 1, Case B.

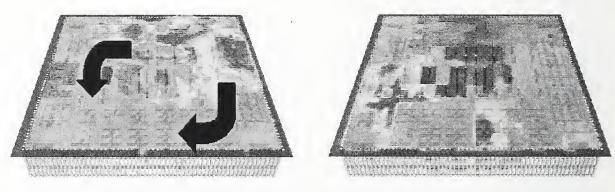
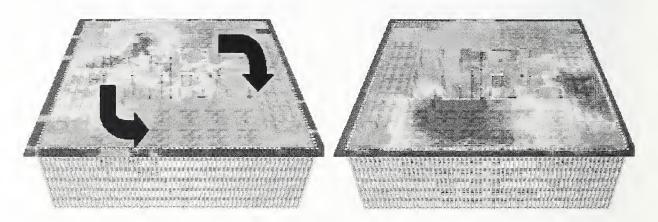
Figure 6-29. Direction of simulated fire movement on floors 94 and 97 of WTC 1.

In WTC 1, much of the fire activity was initially in the vicinity of the impact area in the north part of the building, then it spread around the east and west faces, and was last observed to be concentrated in the south part of the building at the time of collapse, as depicted in Figure 6–29.

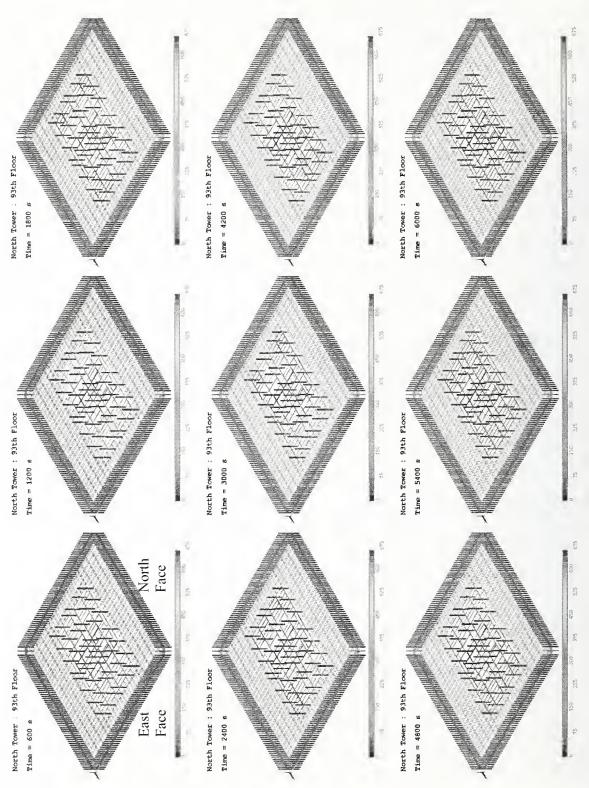
Figure 6-31. Thermal response of floor 93 of WTC 1, Case A.

There was no structural or insulation damage to the trusses, core beams, or perimeter columns on floor 92 or floor 93. Columns 504 and 605 were damaged structurally on floors 92 and 93, while column 705 was damaged on floor 93 only. There was no insulation damage to the core columns on these floors.

Since there was no insulation damage, the trusses and columns on floor 93 stayed relatively cool. The trusses had a mean insulation thickness of 2.2 in., which resulted in gradual heating of the entire floor system. The core beams were covered with 0.5 in. of insulation and, as a result, heated faster. This is illustrated by significant heating of the core beams at 1,800 s after impact. As the fire spread toward the south face of the North Tower, the core beams gradually cooled and showed relatively lower temperatures at 6,000 s after impact.

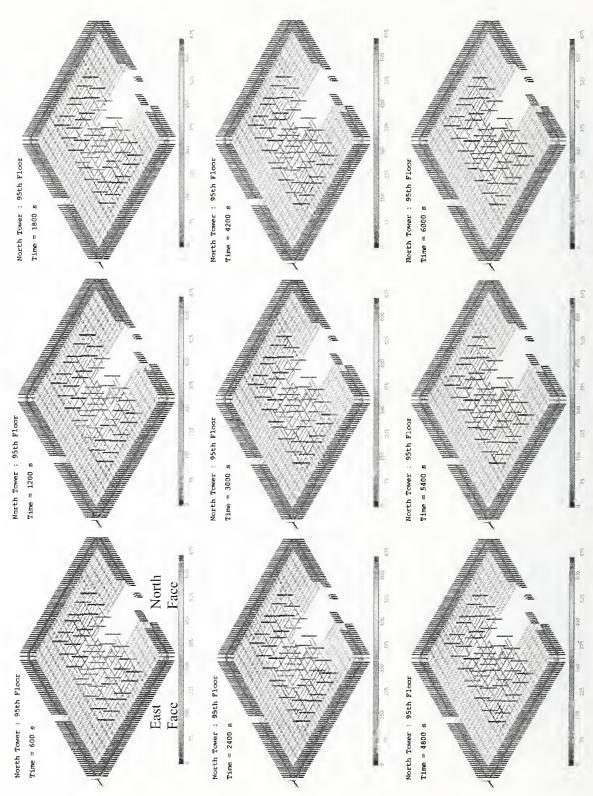
Figure 6-35. Thermal response of floor 95 of WTC 1, Case A.

There was extensive insulation damage to the trusses that supported the slab on the 95th floor, and those in the northeast heated rapidly. They cooled gradually as the fire moved southward.

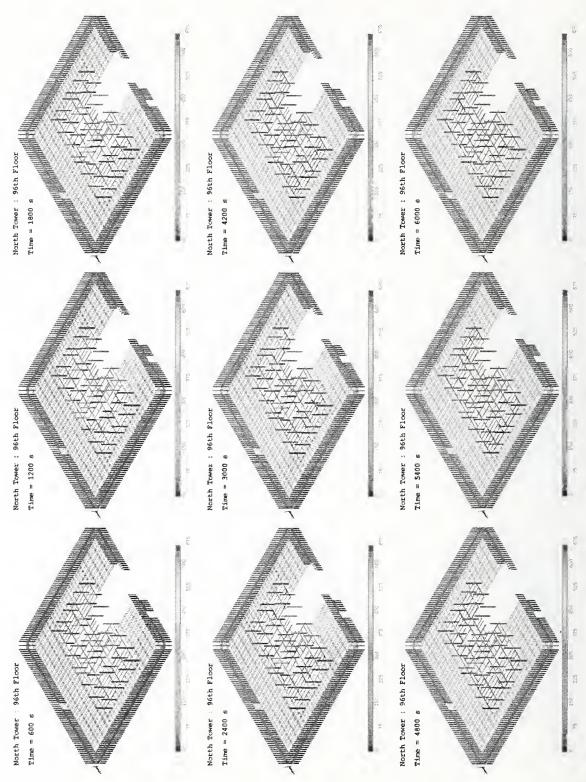
Figure 6-37. Thermal response of floor 96 of WTC 1, Case A.

The insulation-damaged trusses on the north face heated rapidly in the first 30 min after impact. They then cooled as the fire moved to the south. The fully insulated trusses at the west face only reached peak temperatures of approximately 150 °C.

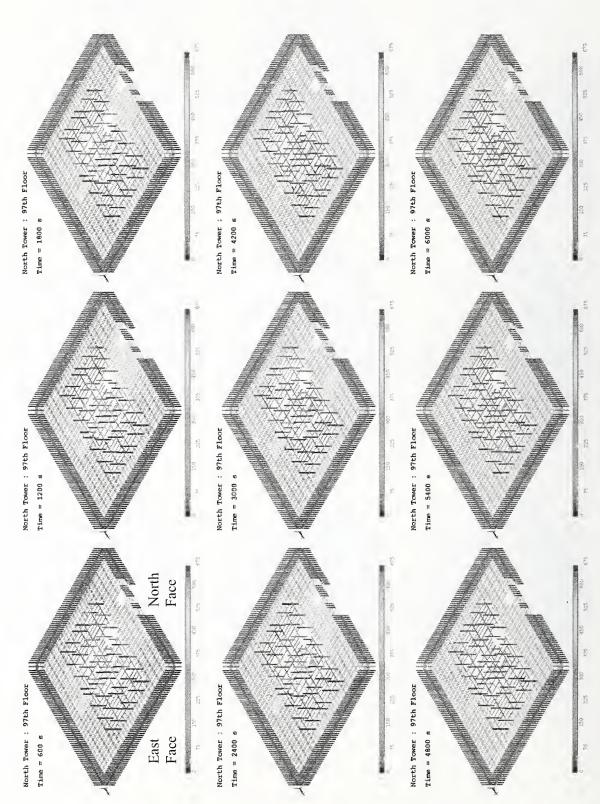
Figure 6-39. Thermal response of floor 97 of WTC 1, Case A.

The west side of the core on floor 97 suffered extensive insulation damage, and this resulted in heating up of the core columns. Core columns on the east side of the core have their insulation intact and as a result stay relatively cool.

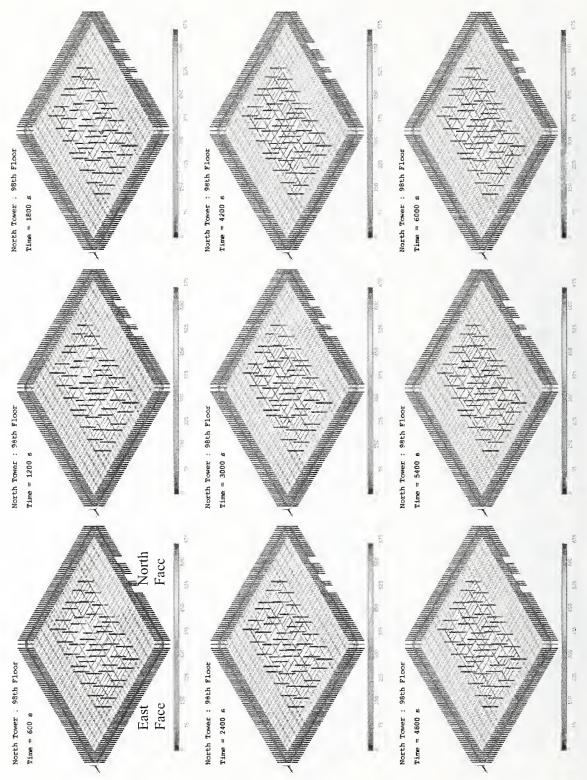
Figure 6-41. Thermal response of floor 98 of WTC 1, Case A.

For the core columns, wed observe higher temperatures on the west side, because of insulation damage and fire activity in this region. Some core columns indicated very high temperature below the concrete slab and relatively low temperatures above the slab. This was due to differences in insulation status and fire activity in the immediate vicinity of these columns on floors 97 and 98.

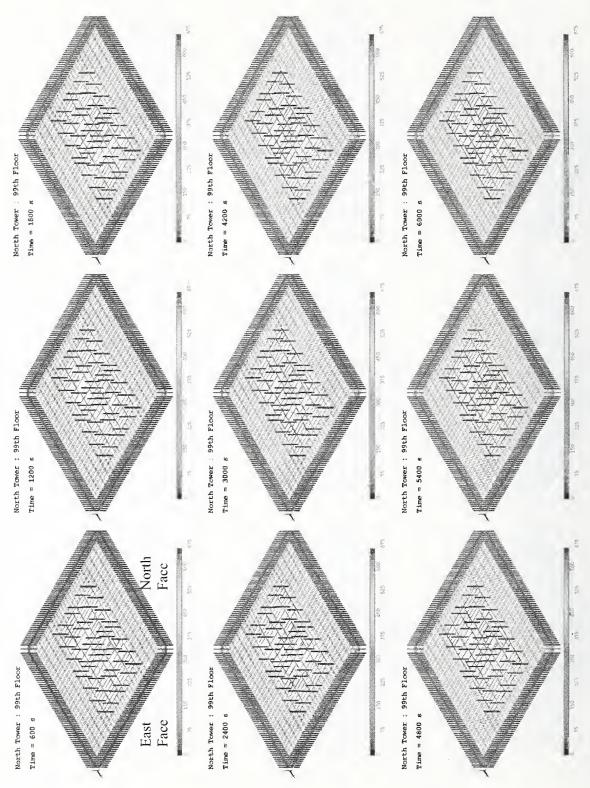
Figure 6-43. Thermal response of floor 99 of WTC 1, Case A.

There was no structural or insulation damage to the trusses, core beams, perimeter columns, or core columns. As a result, the structural temperature rises were modest.
