FAILURES IN WIRE BASKETS OF URETERAL STONE DISLODGERS

B. W. Christ

C. H. Brady

Engineering Metallurgy Section
Metallurgy Division

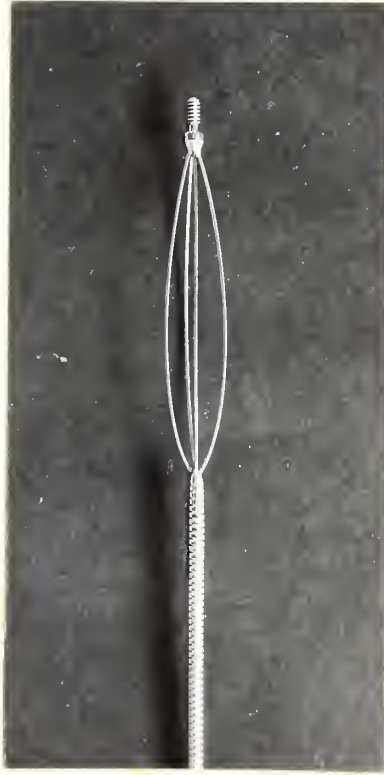
(a) IX
Unused stone dislodger, showing a portion of the flexible cable, the connector between flexible cable and basket wires, the basket wires, and the connector between basket wires and filiform tip. (Filiform tip is not shown.) Unit produced by Greenwald Surgical Co. for C. R. Bard, Inc.
