NATIONAL BUREAU OF STANDARDS REPORT

10 164

TEST AND EVALUATION OF THE PREFABRICATED LEWIS BUILDING
AND ITS COMPONENTS
PHASE I PART 2
FULL-SCALE BUILDING TESTS

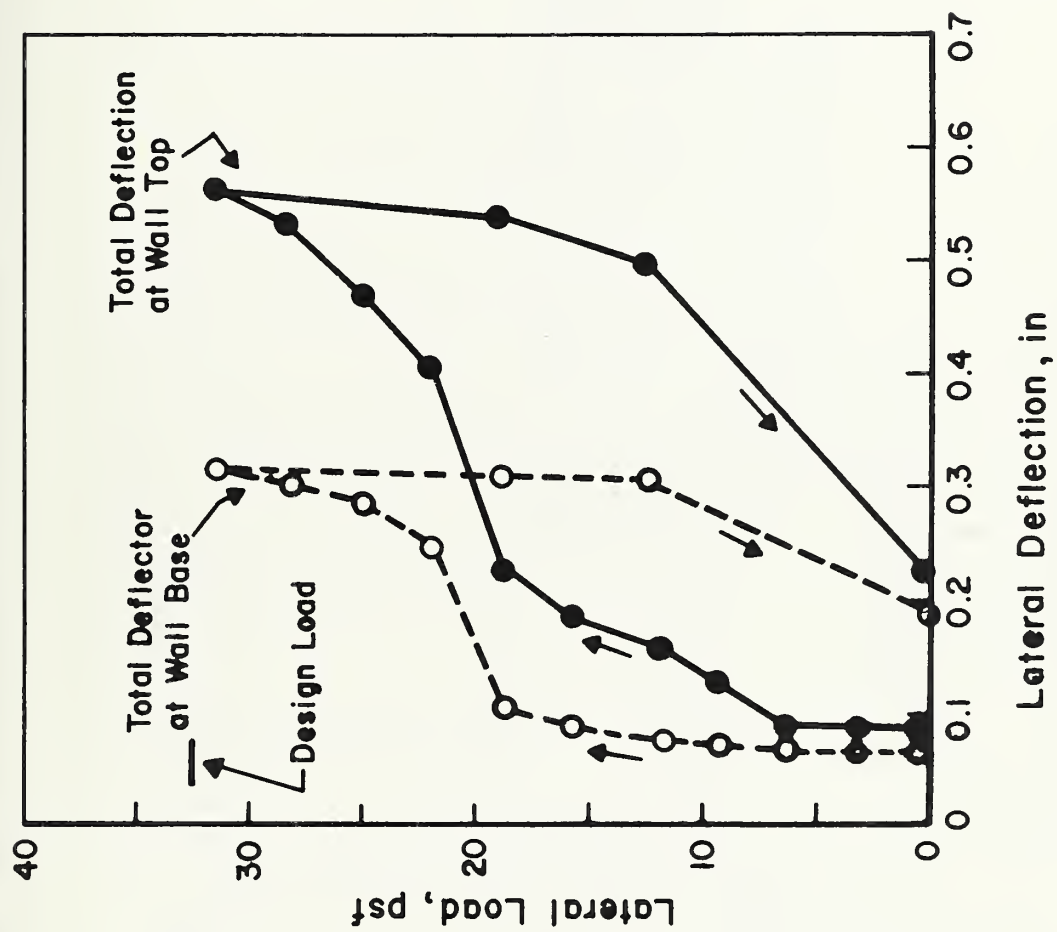
Figure 2.19 West wall lateral deflection at mid-length, racking test No. 1

A plot of lateral load versus midlength lateral deflection of the west wall eave and base is shown in figure 2.19. The total deflection at the base of the wall is shown dotted while the total deflection at the top of the wall is shown solid (total deflection with respect to the reaction floor). The load-deflection curves do not start at zero due to residual deflections obtained when cycling the load ten times to 15.7 psf. An undetermined portion of the residual deflections is due to slack in the building system. The base deflection in figure 2.19 is initially due to the deformation of the longitudinal "Eye" beams as shown in figure 2.18. Between 18.9 and 22.0 psf a bolt connecting the north floor panel to the "Eye" beam in the northwest corner of the building sheared. This accounts for the large base deflection of about 0.15 in during this load increment. Loading was continued up to 31.5 psf (0.97 design load) and the test was then halted. One full design load was not reached due to a small error in calibration of the load measuring transducer.

The total deflection at the top of wall (figure 2.19) reflects the base movement plus additional top movement. Net top wall deflections for all lateral gage points are shown in figure 2.21 and are discussed later. The net deflections were unaffected by the large base deflections.

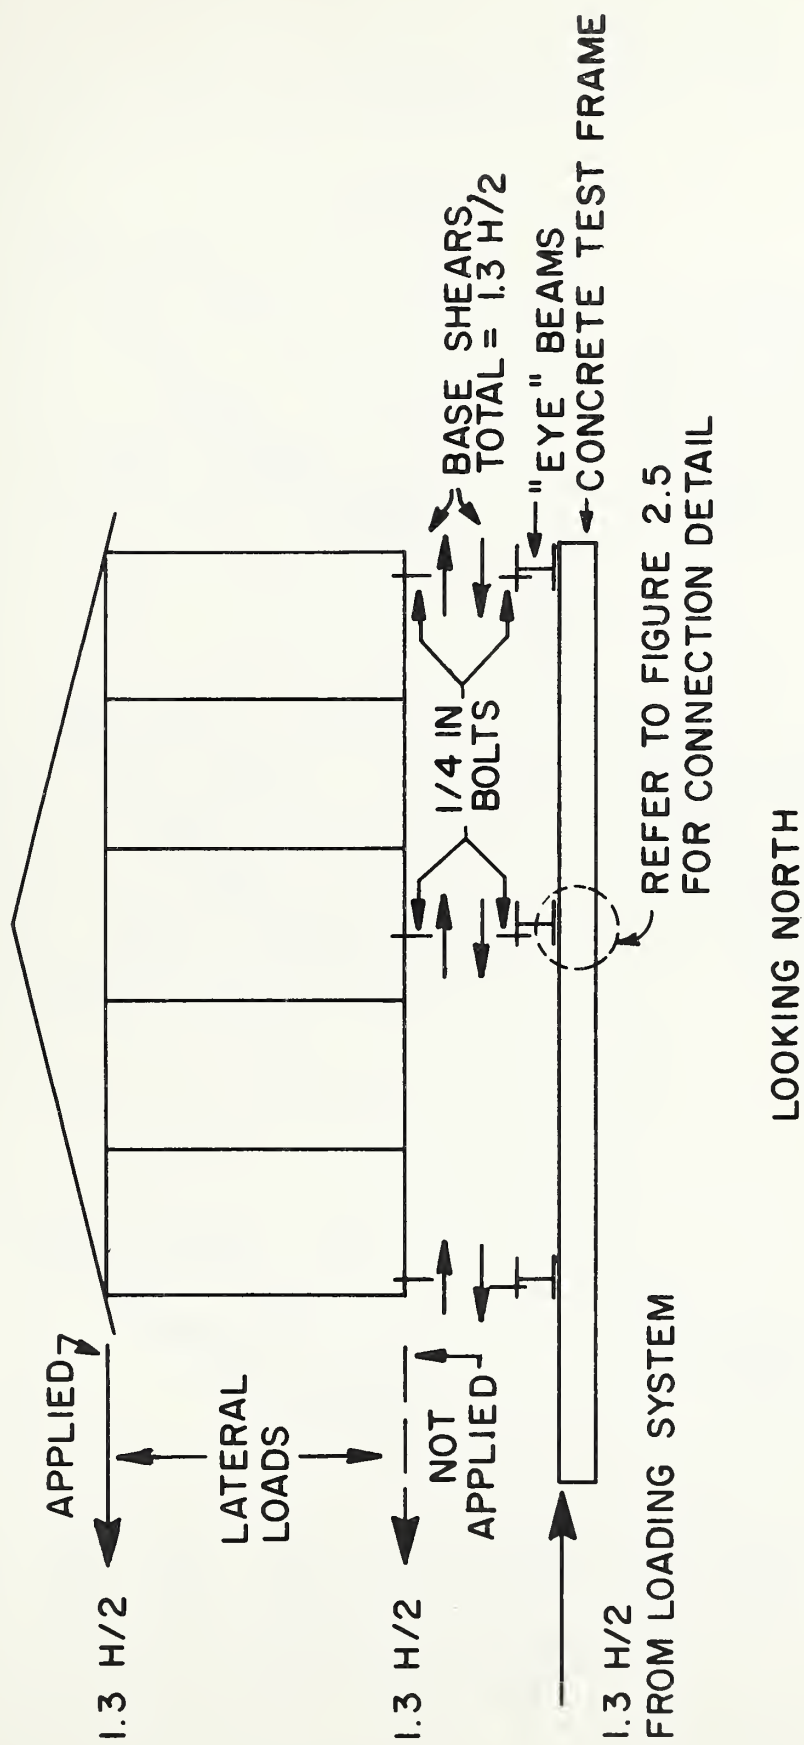
Figure 2.20 Free body diagram showing lateral loads and lateral reactions

A free body diagram for lateral forces is shown in figure 2.20. The lateral load is transferred into the "Eye" beam foundation by shear through the 1/4-in bolts (neglecting friction) attaching the floor panels to the "Eye" beams. Due to the relative stiffness of the side walls, end walls, and roof the lateral loads are transmitted by diaphragm action through the roof out to the end walls and then into the floor panels. These lateral loads are then transferred into the foundation "Eye" beams almost entirely by the 1/4-in bolts attaching the two end floor panels to the "Eye" beams. That is, almost all of the lateral load is carried by six-1/4 in bolts (three on each end of the building), assuming that no shear is transferred between adjacent floor panels. Note also that the base lateral load in figure 2.12c was not applied during this test so that the total base shear carried by the bolts in this test was only one half of what it would be under the wind load shown in figure 2.12a.

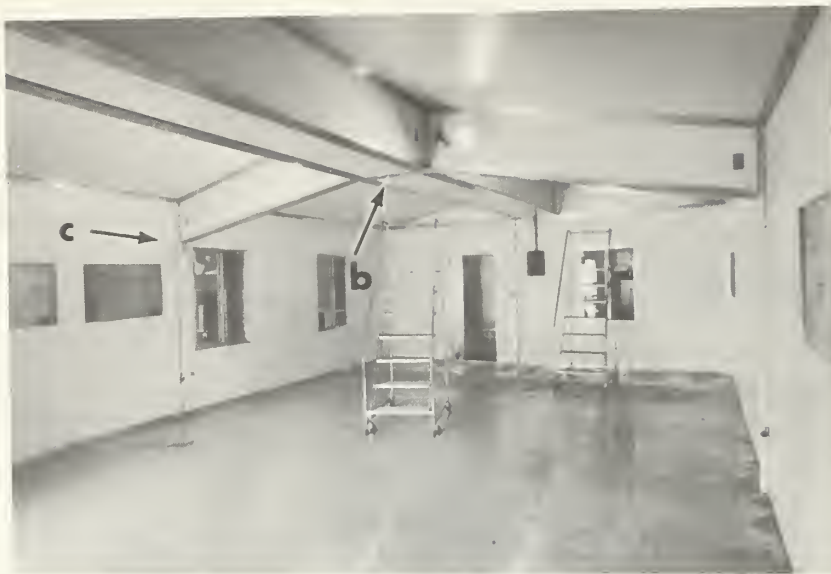
(a) General interior view before testing

Figure 2.33 Racking test No. 2
damage areas

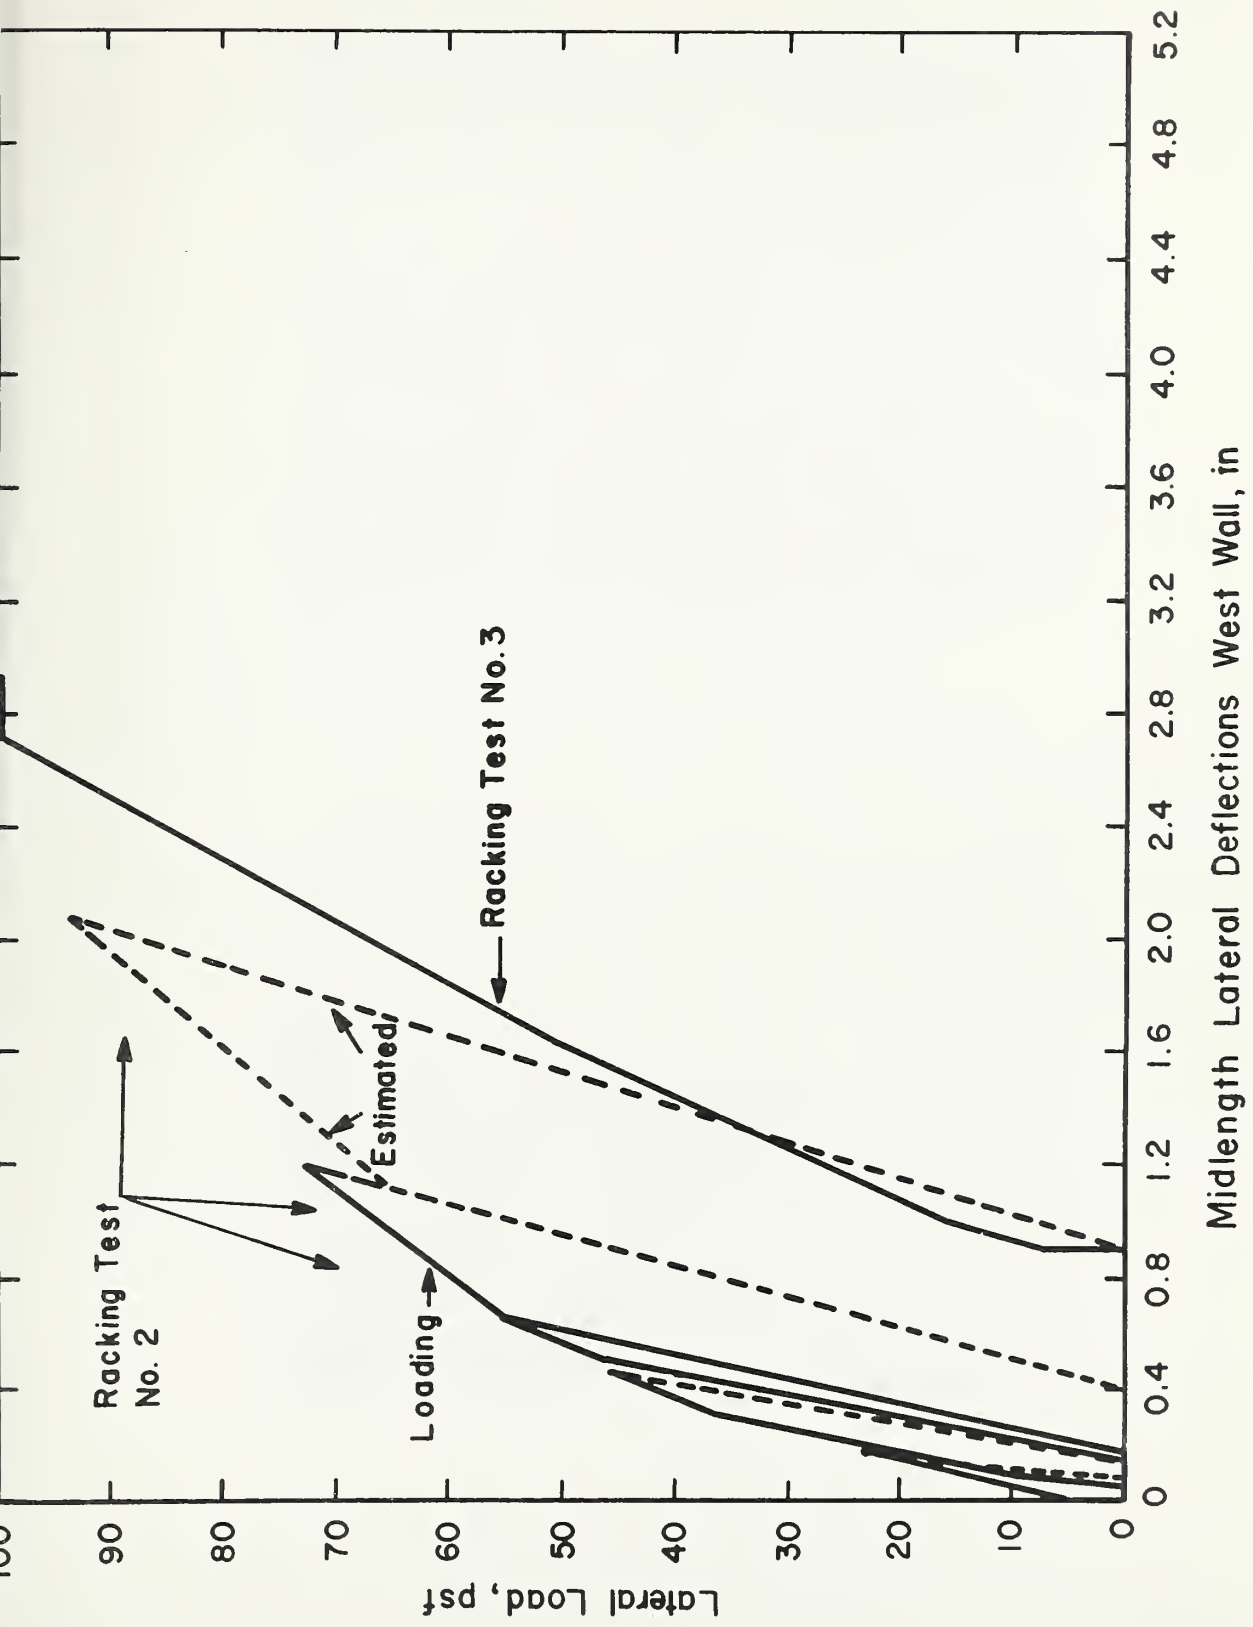
Figure 2.36 Midlength load-deflections for racking tests No. 2 and No. 3

The midlength west wall lateral deflection is shown in figure 2.36, considering the residual deflection from racking test No. 2. The load deflection data from racking test No. 2 is shown by a series of straight lines indicating only significant changes in the load-deflection curves. The zero position for racking test No. 3 is then assumed to be the unloaded position from cycle No. 6 of racking test No. 2. The load-deflection data for racking test No. 3 are shown by a solid line, also indicating only significant changes in the load-deflection response. The load-deflection response for racking test No. 3, indicated that the building was more flexible than it was during racking test No. 2. This is one more indication that the transverse beam fractured during racking test No. 2 (section 4.4). A view of interior damage after racking test No. 3 is shown in figure 2.37. The general interior view of the building before racking test No. 3 is shown in figure 2.37a with the major structural damage area identified by an arrow. A closeup of the damage is shown in figure 2.37b. As shown in figure 2.37b the rivets connecting the bottom extrusion to

Most of the load in the transverse beam is carried by the extrusions in bending. After the rivets sheared, the load was transferred into the aluminum skin which fractured due to stress concentration at the corner of the cut out. The fracture of the beam reduced the stiffness of the roof system and probably accounts for the flexible load-deflection relationship shown in figure 2.36 for racking test No. 3.

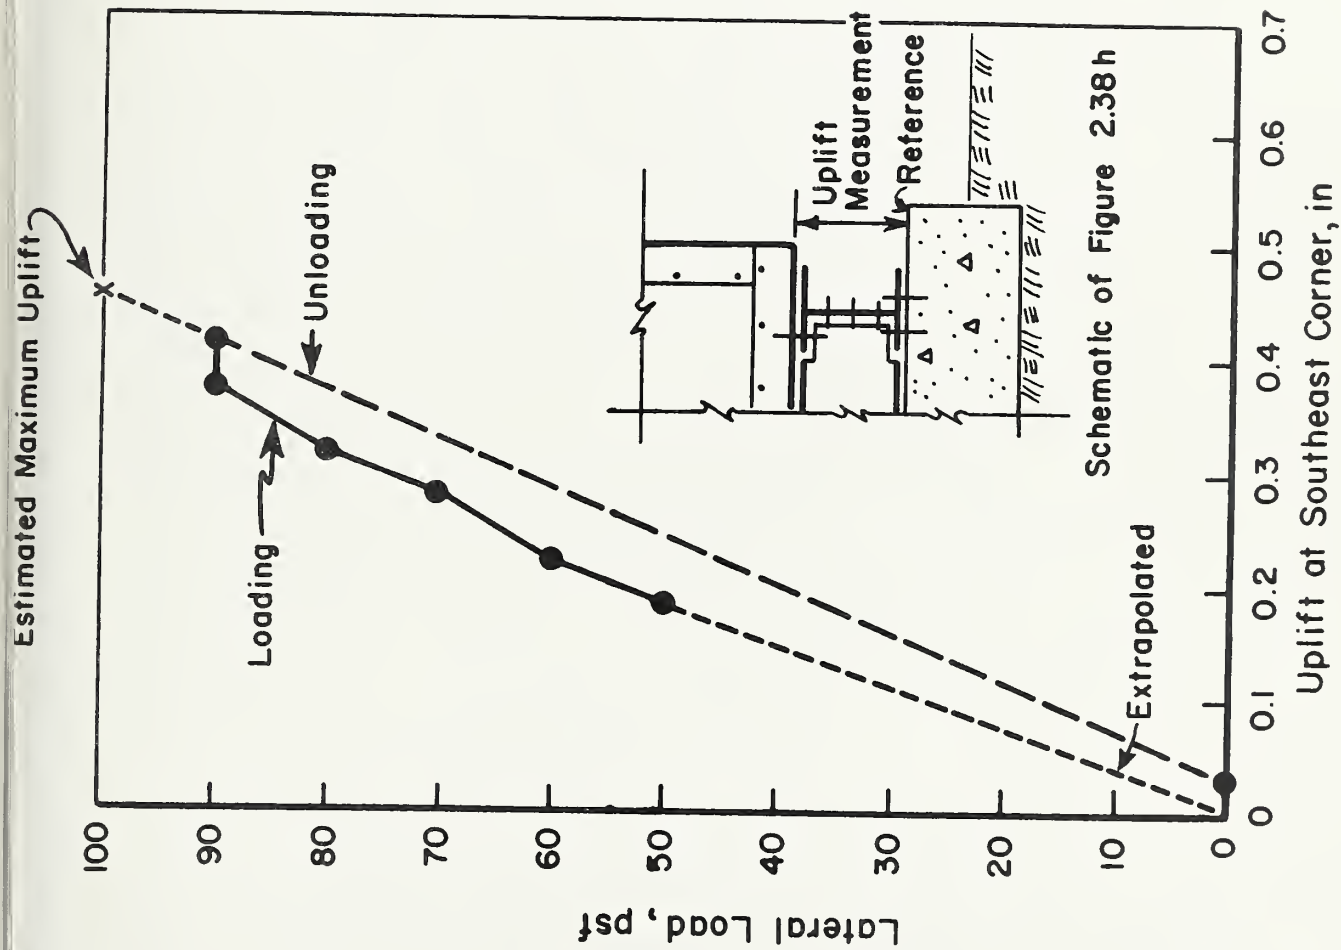
Figure 2.39 Load vs uplift at southeast corner

Uplift deflection was recorded at the base of the east wall (southeast corner of the building) after the test was underway. The uplift is shown in figure 2.38h. The data are shown in figure 2.39 by solid circles and connected by solid lines. The zero value was obtained by extrapolating the first two readings. Total deflection values were then obtained by using the extrapolated zero. The maximum uplift value was not obtained. An estimated value was determined by connecting the unloaded deflection with the last known deflection by a straight line and extending this line up to 100 psf.
