# NATIONAL BUREAU OF STANDARDS REPORT

10263

## REPORT ON THE INVESTIGATION OF CERTAIN DEFECTS AND DEFICIENCIES IN TRAILER-TYPE HOUSES ON KWAJALEIN ATOLL MANUFACTURED BY NORTHLAND CAMPS, INC.

Department of the Army  
Honolulu District, Corps of Engineers  
Fort Armstrong  
Honolulu, Hawaii

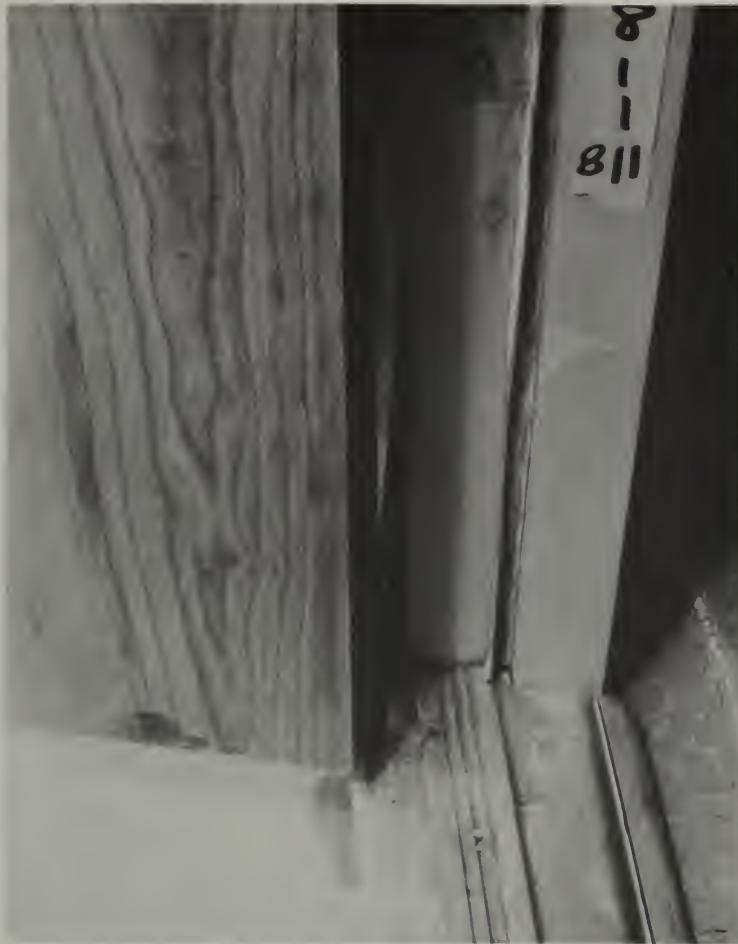
Figure 7. Weatherstripping on the hinged side of the door jamb showing the placement of the weatherstripping at midwidth of the threshold.

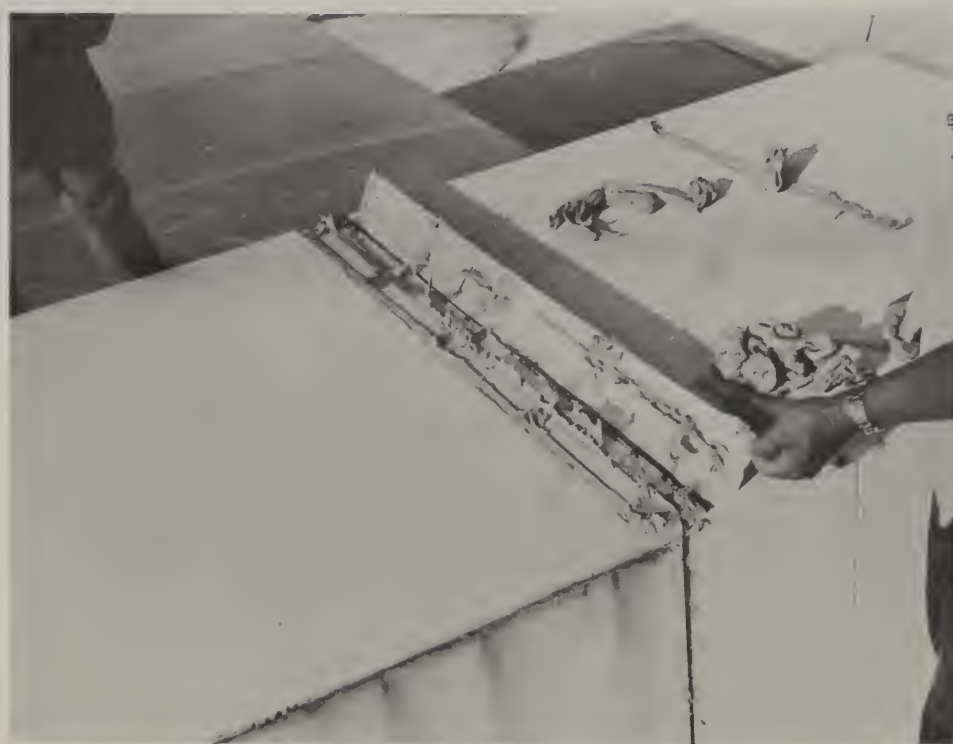
Figure 13. Joint cover and caulking of the top joints between the air conditioner and plenum cabinets.

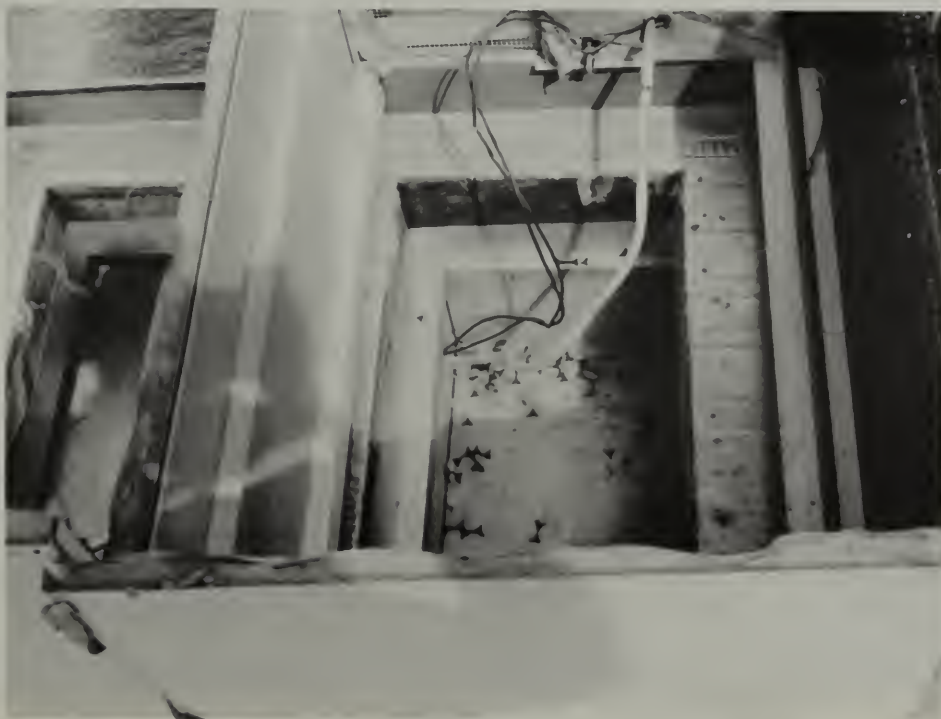
The vertical joints for the access panels were slip type with the male flange being on the access panel. This poor design feature allowed any water which might enter the joint to drain to the interior of the plenum. The lower left corner of figure 15 shows the construction of the vertical joints of the access panels.

Figure 15 . The supply and return openings and assembly of the plenum cabinet.

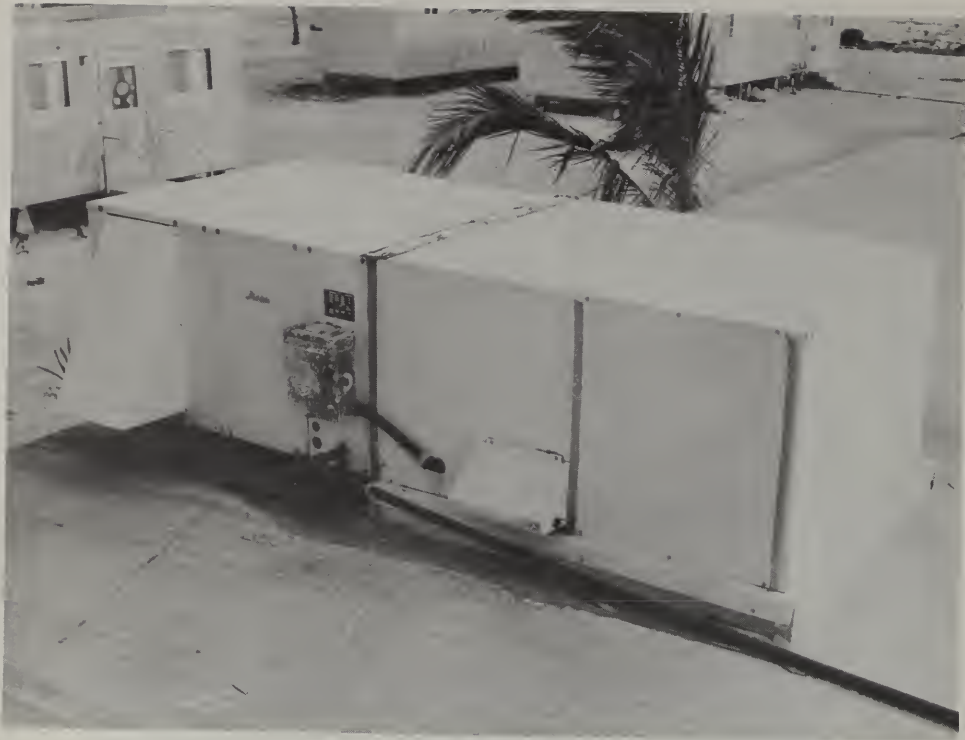
Figures 16 and 17 show typical installations. Figure 18 shows arrangement of the major elements of the air conditioner at house 915.

Figure 16. Typical air conditioner installation, right side.

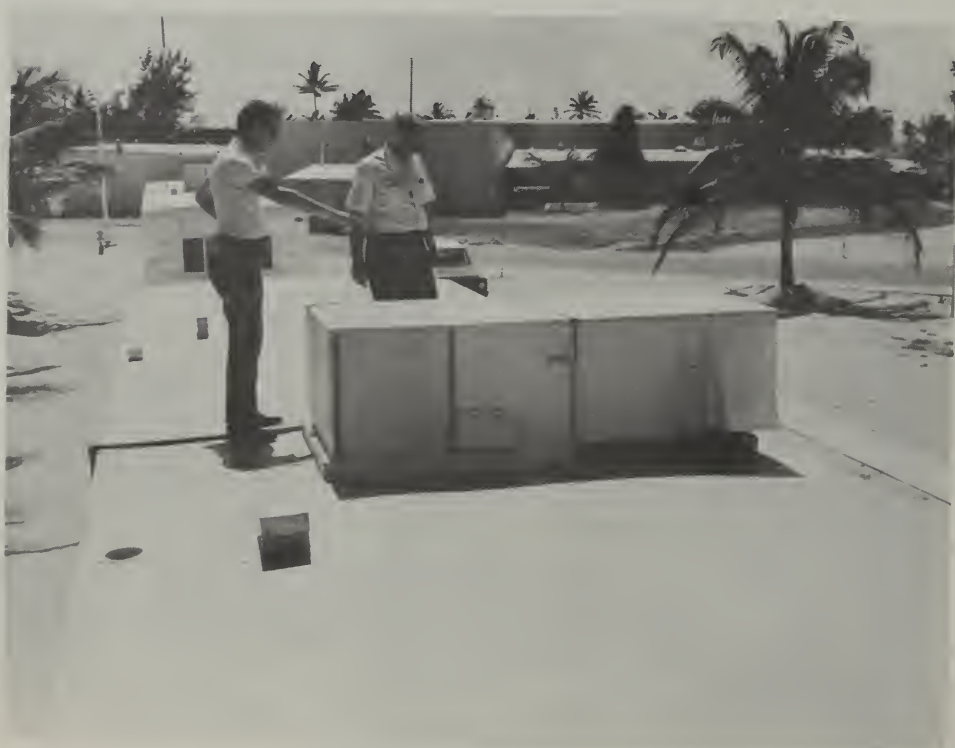
Figure 17. Typical air conditioner installation, left side.

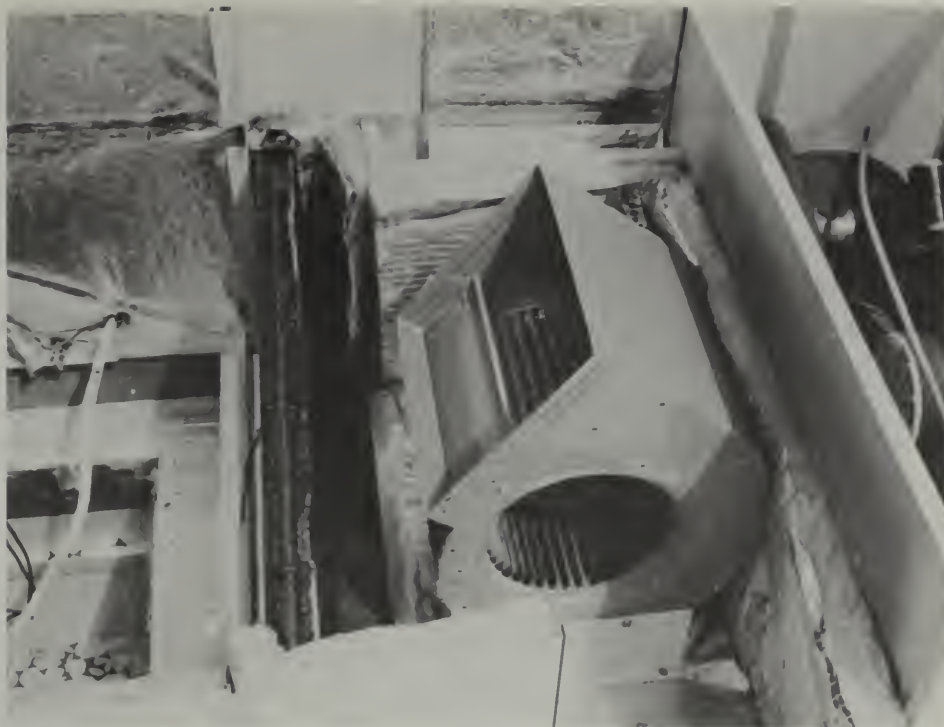
Figure 18. Interior of air conditioning unit showing left to right - return air opening, evaporator coil, evaporator blower and portions of the compressor and condenser fan.

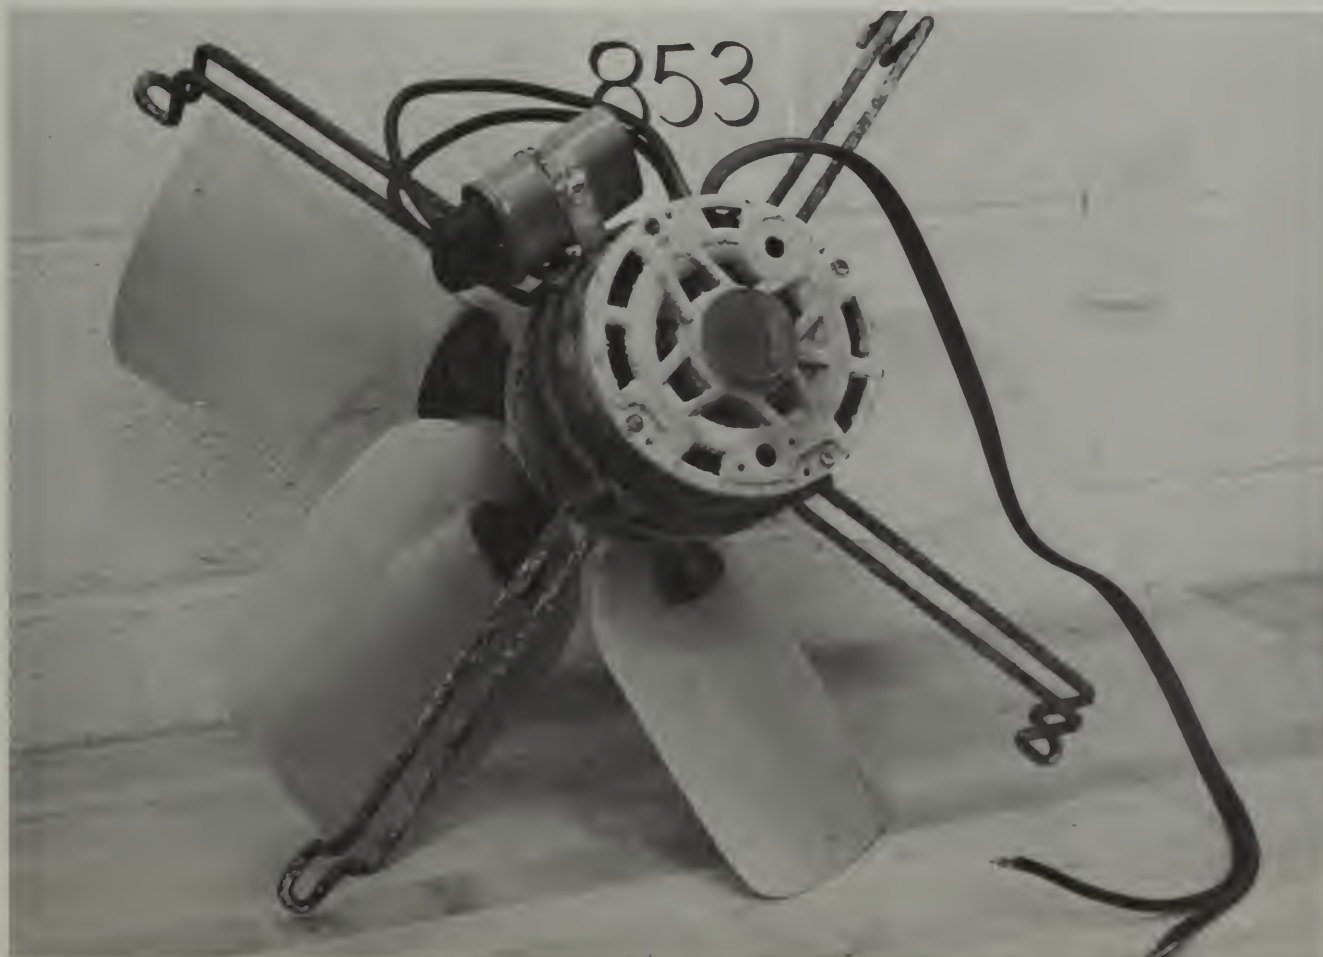
Each of the 31 BARD Mod. P36A air conditioners inspected contained a 5-blade, 20 inch diameter propeller-type condenser fan shaft-mounted on a 1/2 HP GE PSC (permanent split capacitor) motor, Model No. 5KCP39MG7626S. See figure 19. These motors were positively identified by the motor nameplate, if legible, and by the model number stamped on the rear bearing end cap. Figure 20 is a facsimile of a nameplate from one of these motors. Figure 21 shows the condenser fan and motor from house 915. The motor model number can be seen on the rear bearing end cup.

Figures 19 and 22 show respectively the condenser fan and motor from house 853, and the evaporator blower motor from house 915. All of the motors are identical.

Figure 19. Condenser fan, motor, capacitor, and mounting frame, removed from house number 853.

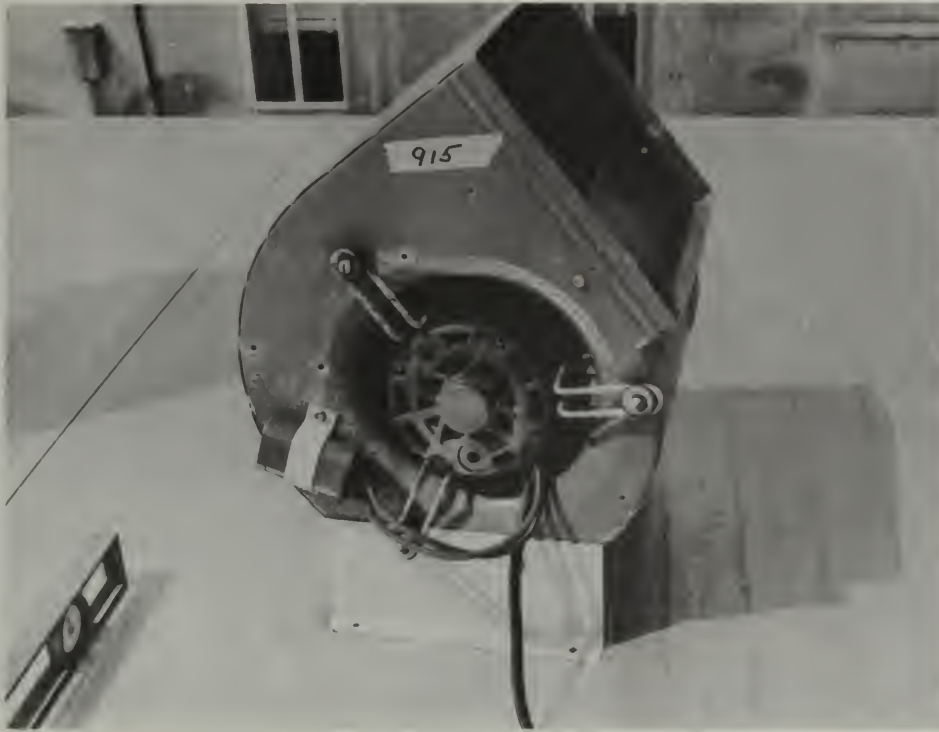
The evaporator centrifugal blowers also were powered by direct shaft mounting on the same model 1/2 HP GE motors, based on similar identification in a sampling of approximately 15 of the 31 inspected units. Figure 22 shows the evaporator blower and motor assembly removed from house 915.

Figure 22. Evaporator blower and motor assembly from house 915.

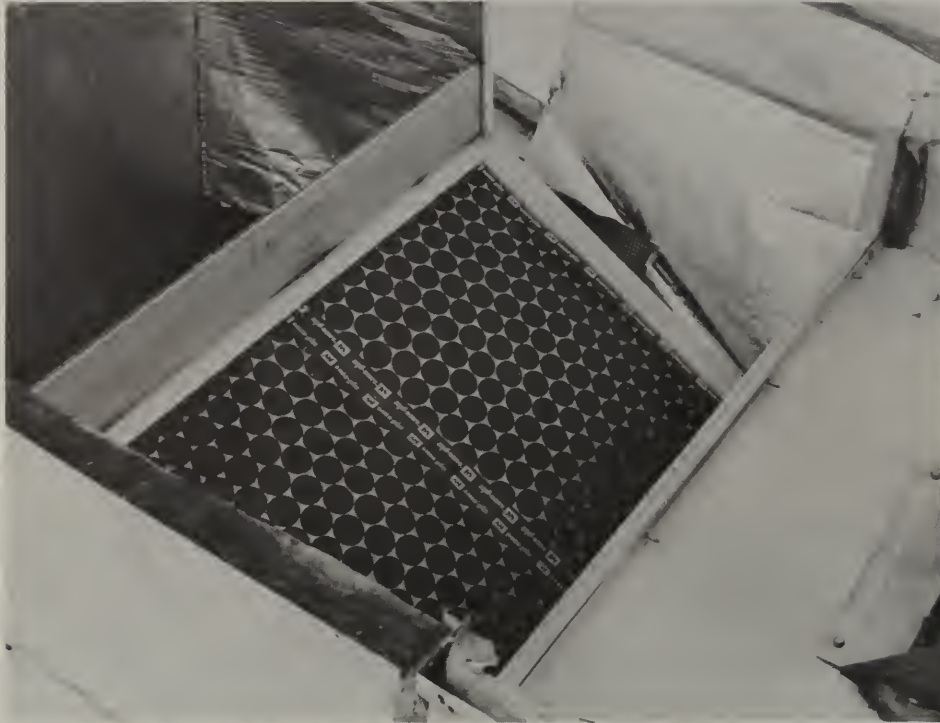
Placement of filters. In several units, the filters were still in place in the return air section of the plenum even though the filter was supposed to be mounted in the return air grille in the house. Figure 28, showing the unit being disassembled at house 808 for removal of motors, shows the filter in the return air plenum. Note the screen below the far end of the filter. This screen shows the location of the outdoor or make-up air inlets (one on each side). Removal of the factory-installed filter as shown permits the make-up air to enter the coil unfiltered.

Figure 28. Factory installed filter in return air section of plenum in house 808.

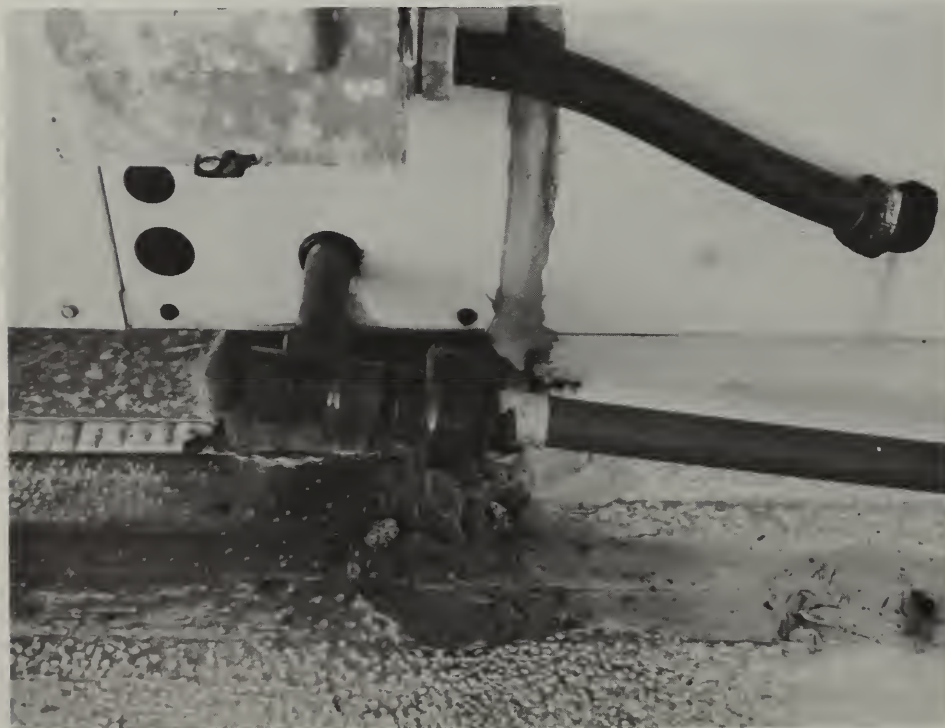
Condensate drain lines. These were not installed as a part of original installation. Prior to installation, corrosion damage and staining of the house roof and front wall occurred. Figure 32 shows drain line installation. Note corrosion of roof surface.

Figure 32. Condensate drain line leading from the condensate pan to ground level.

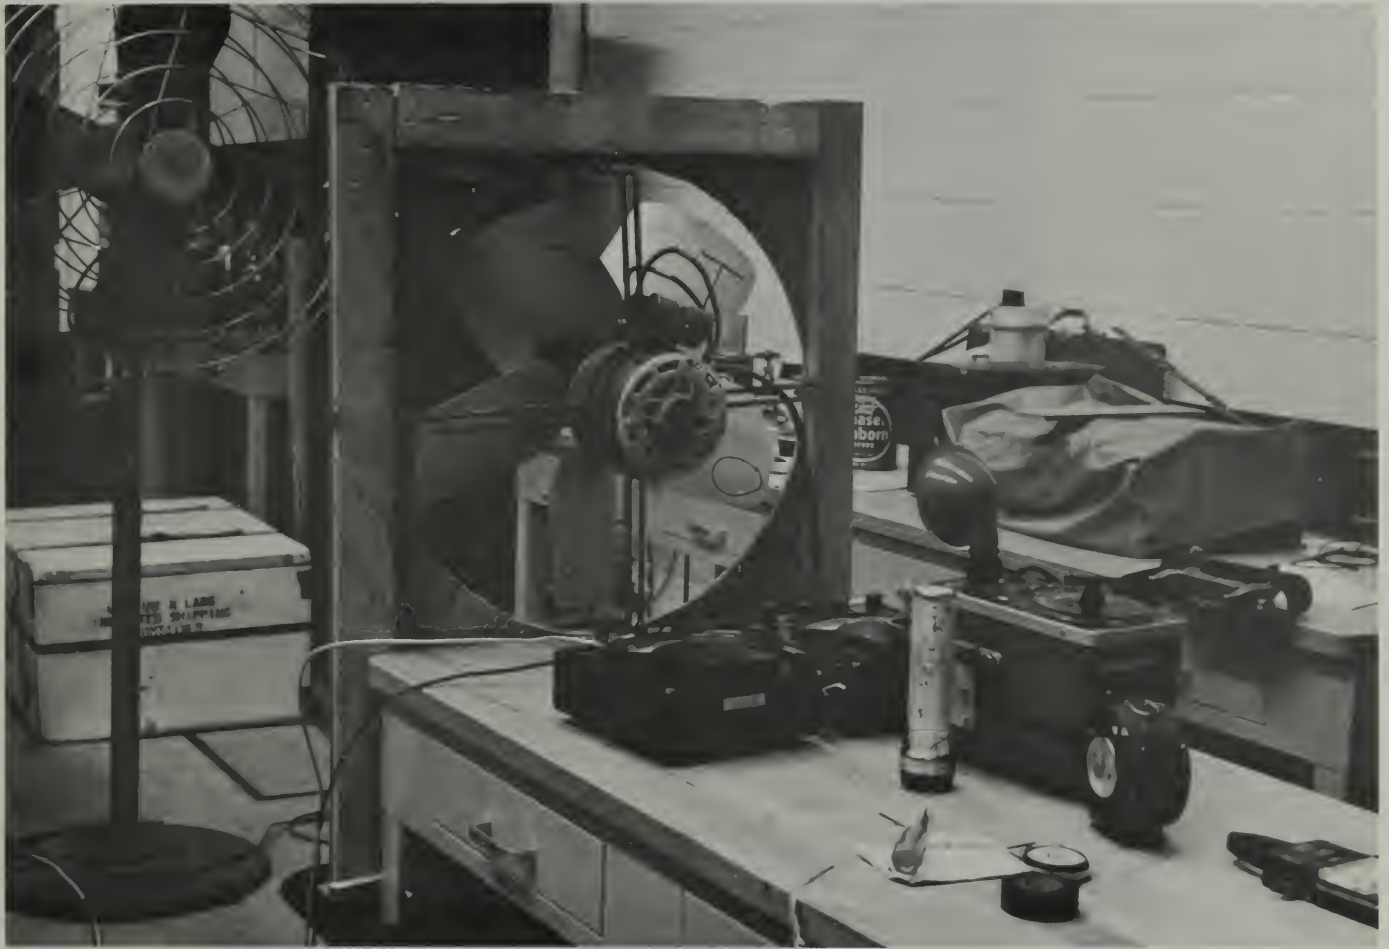
Motors numbered 853C and 915C were further tested operationally to determine effects of reverse windmilling on starting and running characteristics. Figure 33 shows how a pedestal-type fan was used to produce reverse windmilling at various speeds. It should be noted that the test setup did not duplicate the actual case in that no coil or housing of the actual unit was employed. It was intended only to produce reverse rotation rates. Depending on fan bearing drag, wind angle, etc., air speeds from 10 to 19 miles per hour were required to produce 200 rpm reverse windmilling in the test specimens. Motors were tested with good capacitors, shorted capacitors, and open-circuited capacitors. Normal locked rotor currents (shaft not able to turn) were:

Figure 33. Laboratory setup for measuring effect of reverse windmilling on starting and running capability of condenser fan motor.

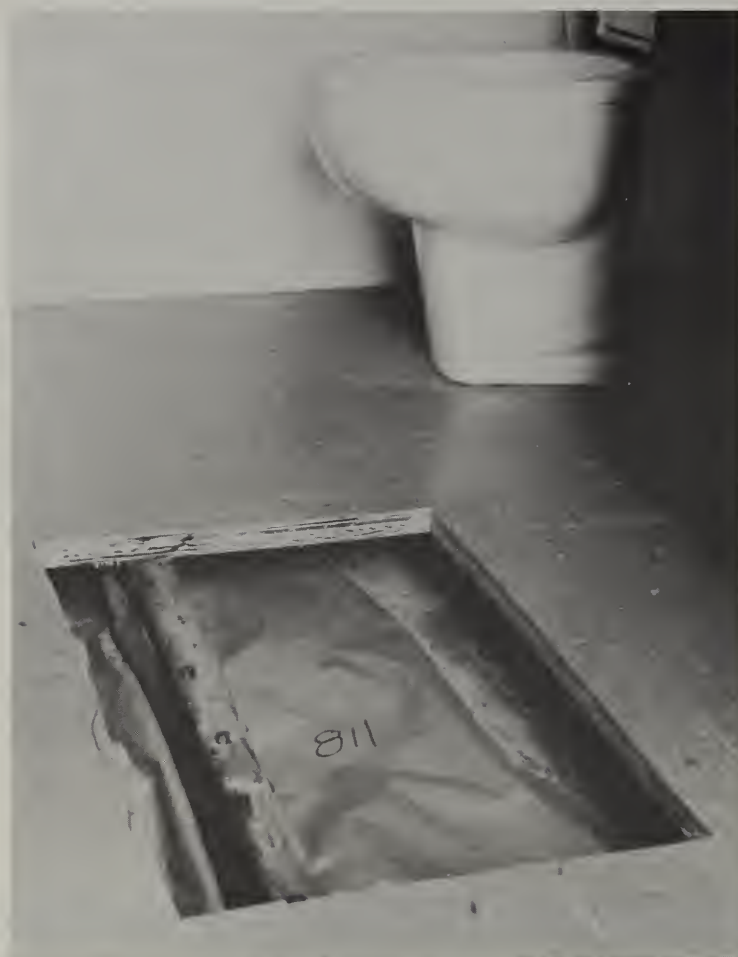
Sections of flooring (tile and subfloor) were removed on October 23 from houses 811, 954 and 896 as shown in figure 38 and shipped to the National Bureau of Standards for analysis. Results of this analysis are:

Figure 38. Floor sample removed from bathroom of house 811.
