# NATIONAL BUREAU OF STANDARDS REPORT

10 320

FIRE ENDURANCE TESTS OF UNPROTECTED WOOD-FLOOR  
CONSTRUCTIONS FOR SINGLE-FAMILY RESIDENCES

May 10, 1971

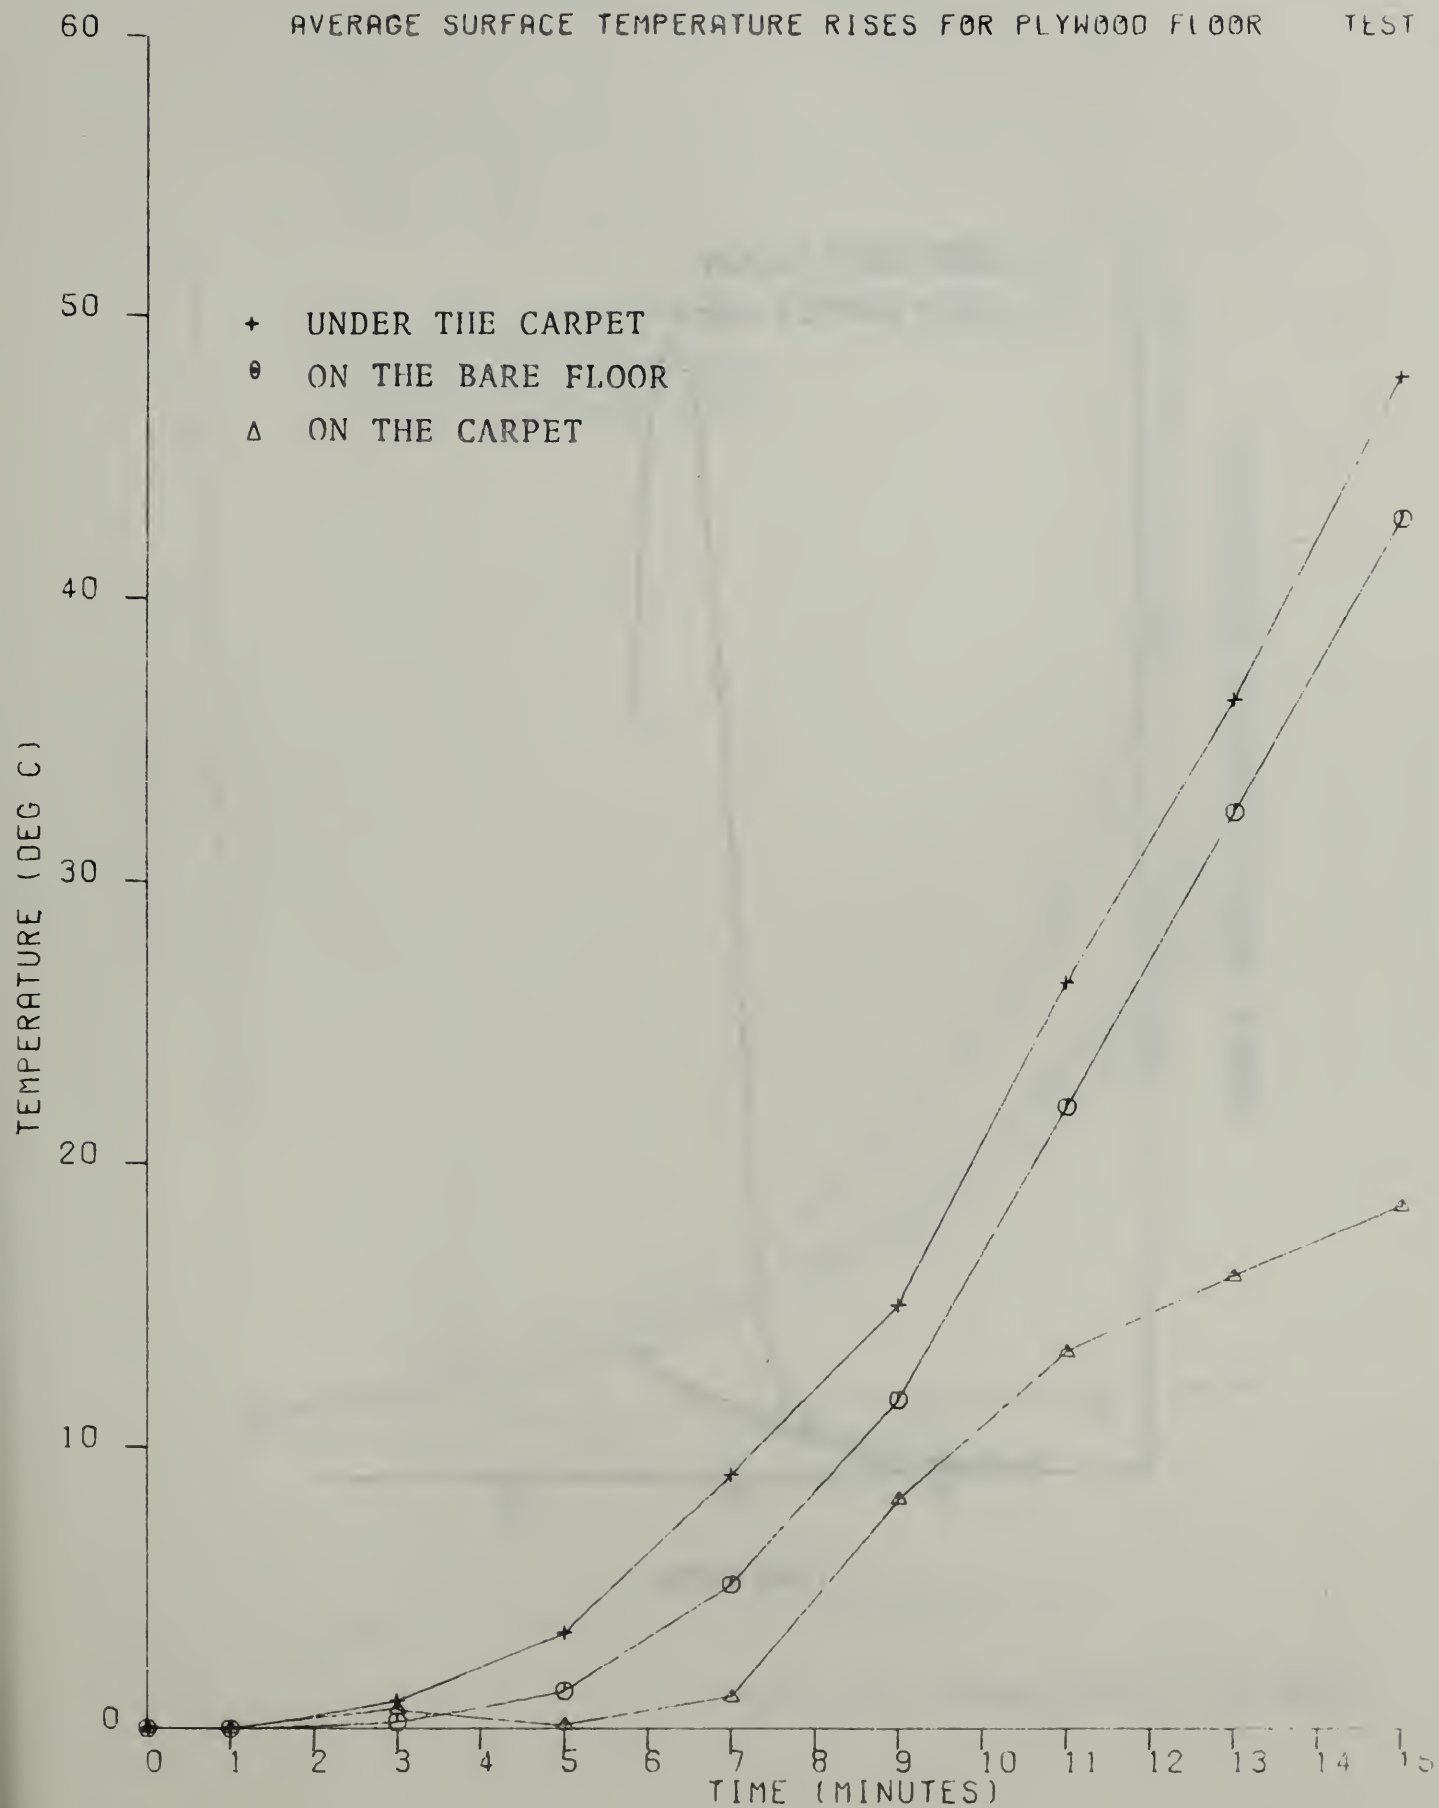
FIGURE 11.

The average temperature of the bare surface thermocouples was less than 75°C when the test was terminated after 15 minutes. On the carpet only one of the thermocouples exceeded 50°C, with a reading of 80°C. This thermocouple might have had a nail head directly underneath. The average temperatures of the bare floor and carpet are shown along with the average temperature beneath the carpet in Figure 11.

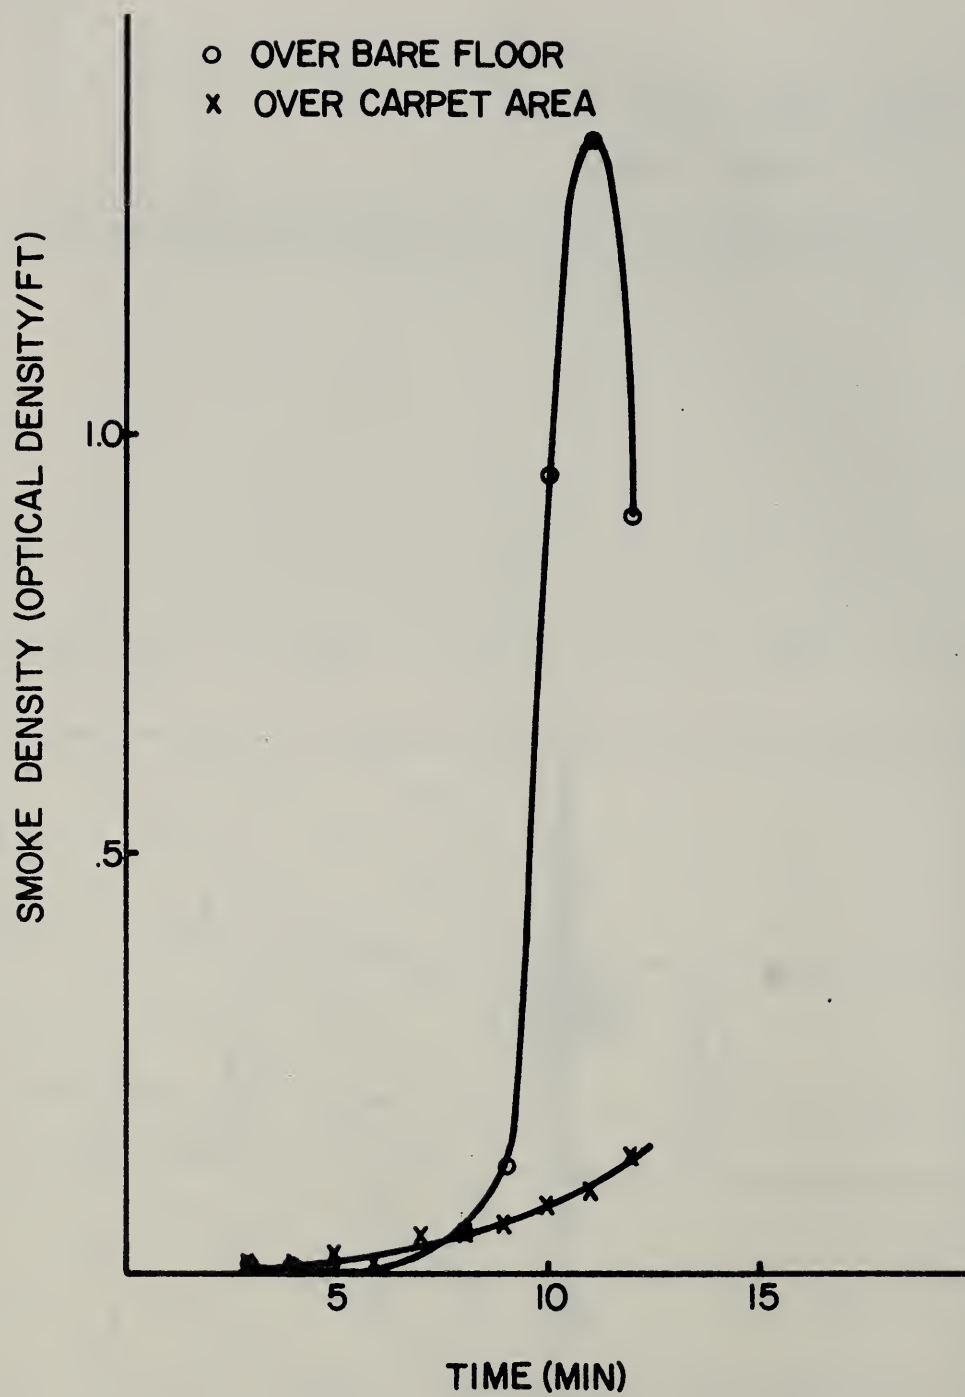
FIGURE 12. Smoke Density, Test #L-1

The smoke meter on the bare floor showed a sudden increase in smoke at about 9 minutes, which was more than 4 minutes before "flame through" was noticed. The smoke level indicated by the meter over the carpet was appreciably lower. The transmission of the smoke meters is given in table 1 Appendix II and Figure 12.

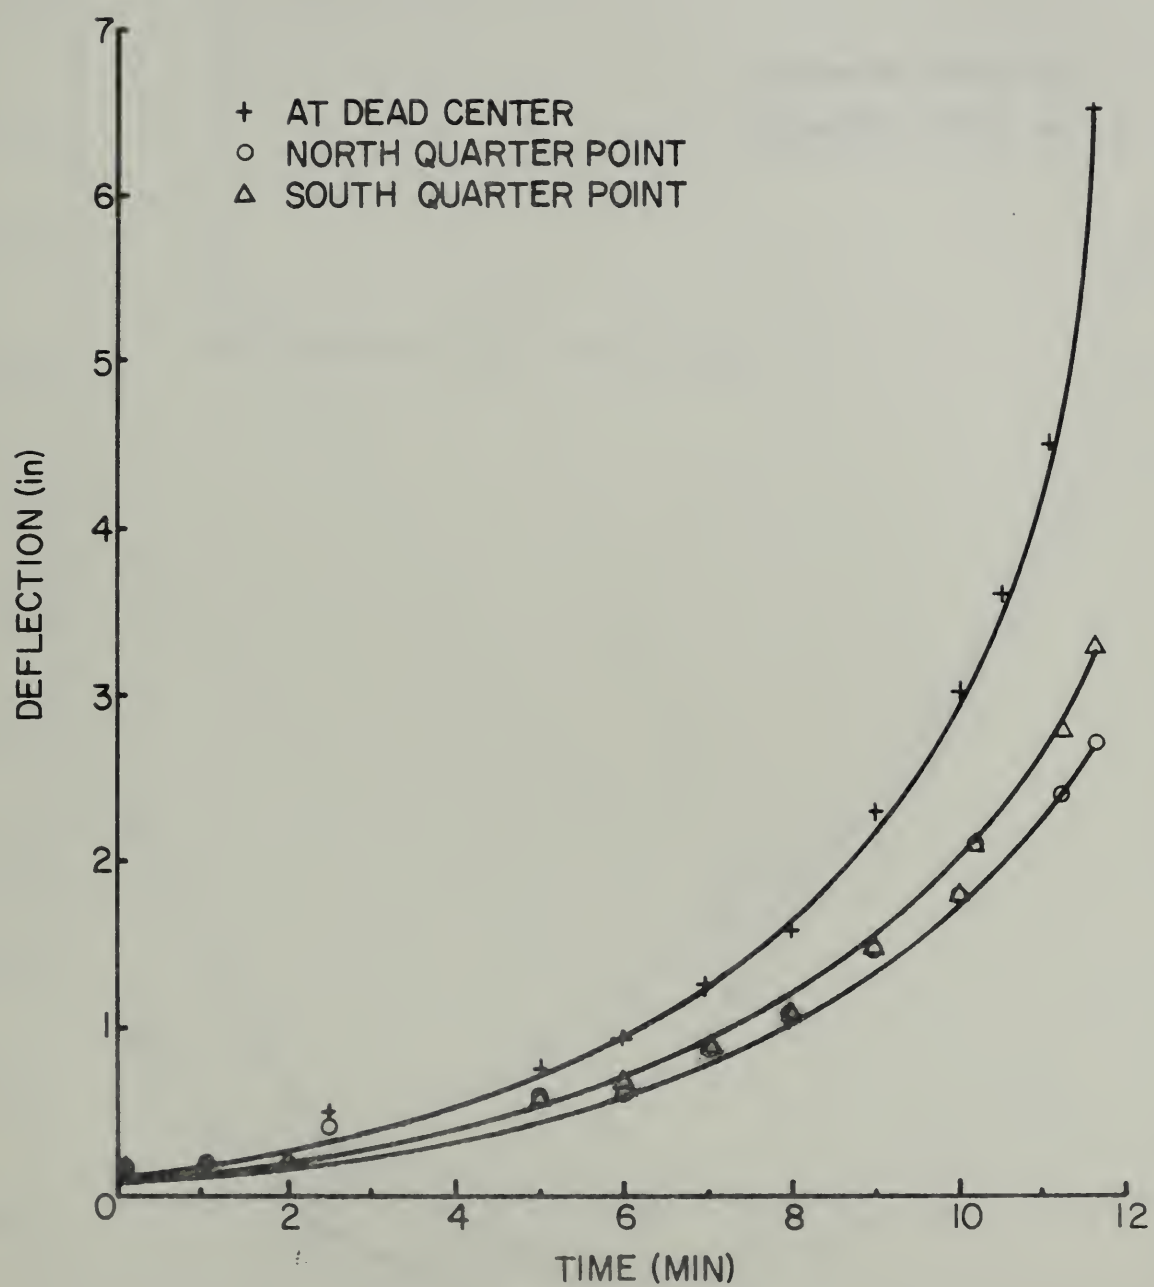
FIGURE 13. Deflection Measurements Test #L-1

The deflection increased steadily as shown in Figure 13. The deflection at the center of the floor was 6.5 inches at 11:38 when the load could not be maintained. The deflections are tabulated in table 2 Appendix II.

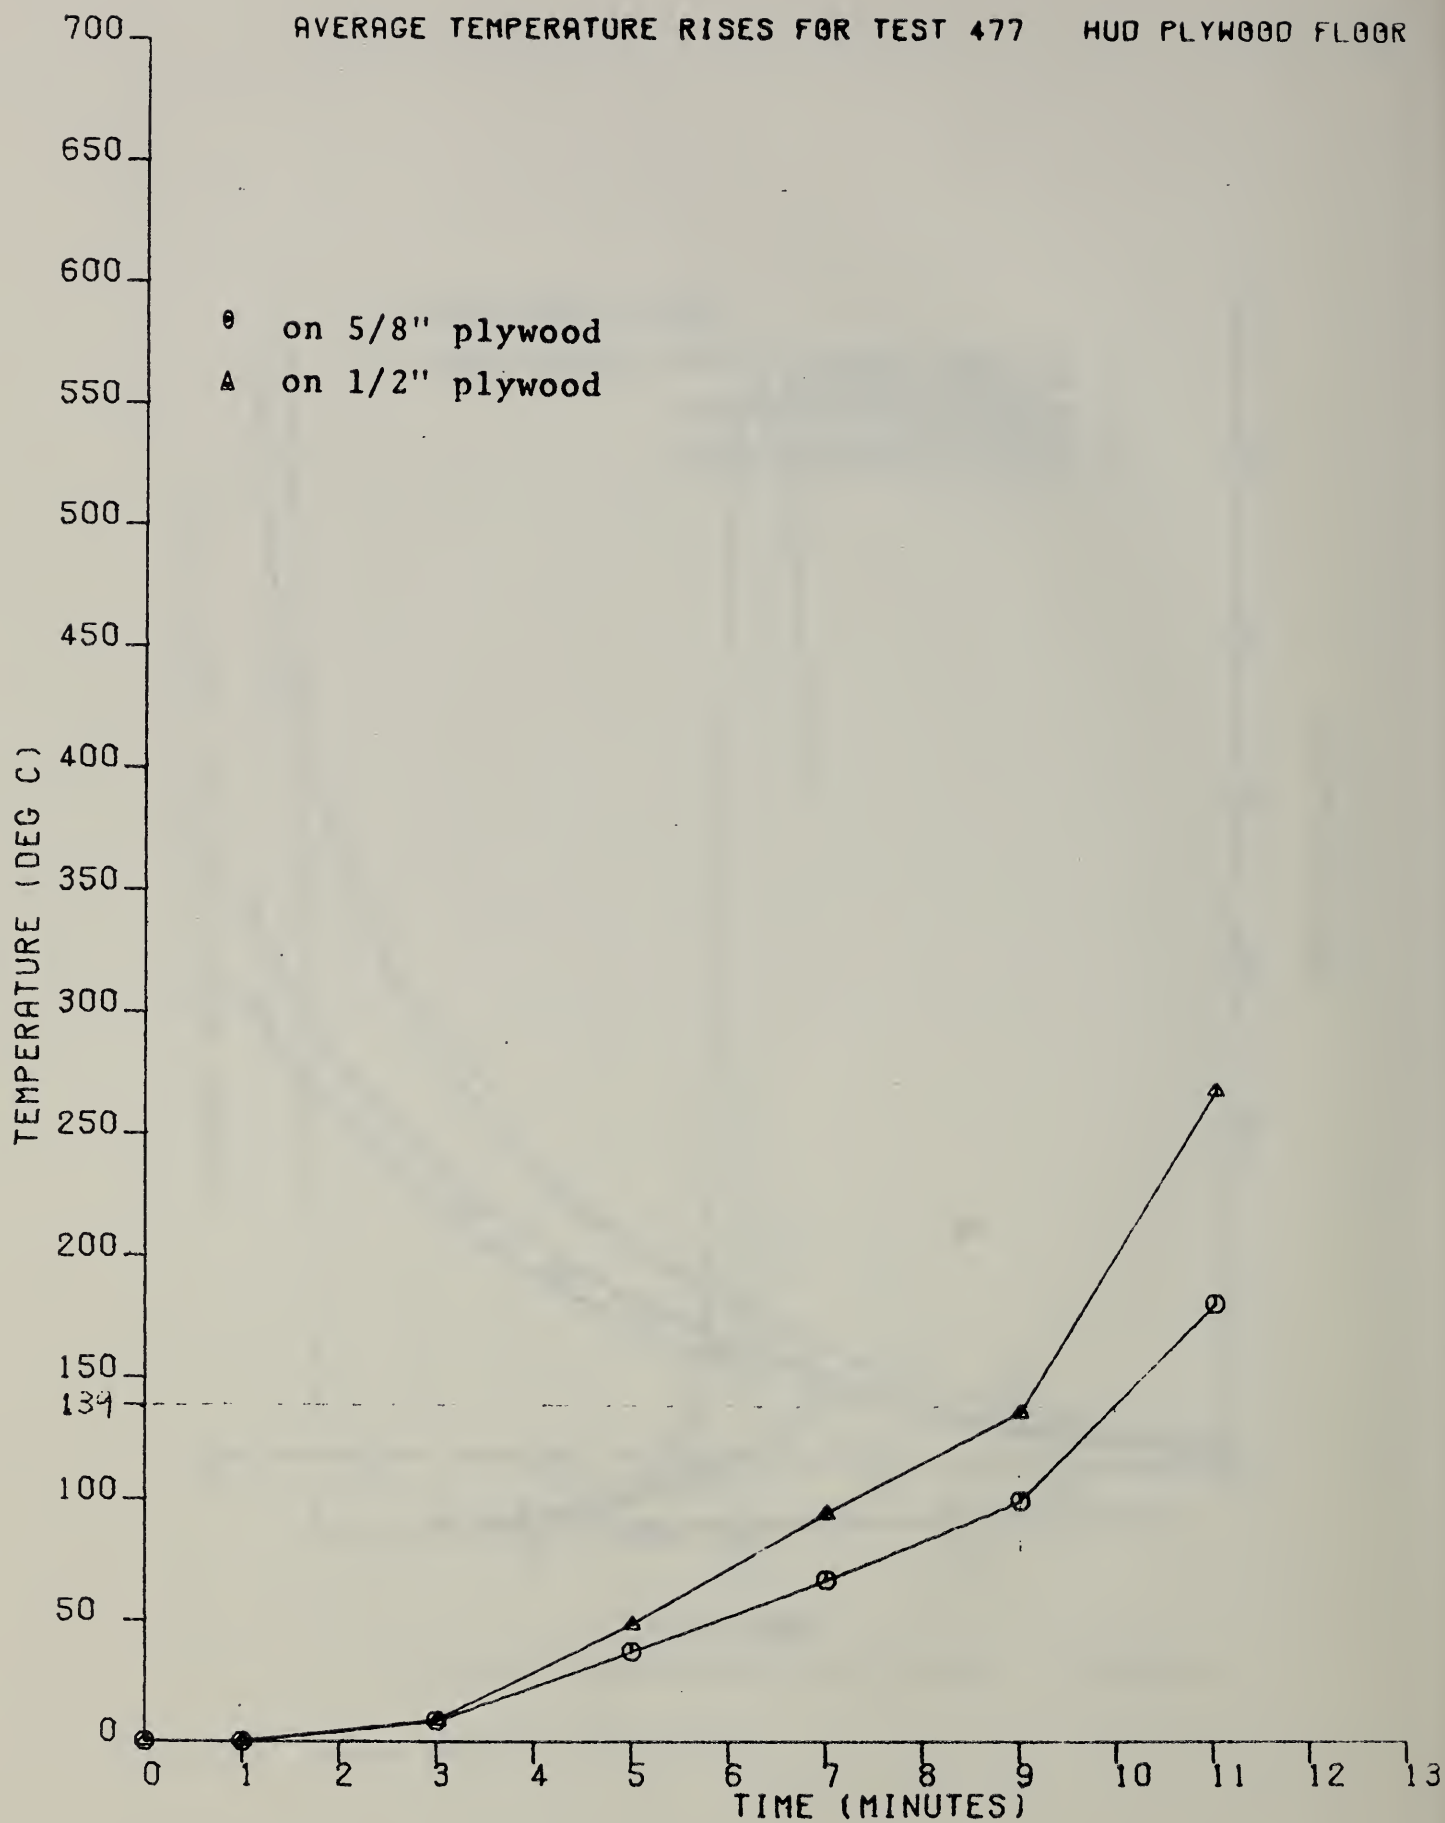
FIGURE 14.

Figure 14 illustrates average temperature rises on the unexposed surface. The temperature failure was 9 minutes for the 1/2" plywood floor and 10 minutes for the 5/8" plywood floor.

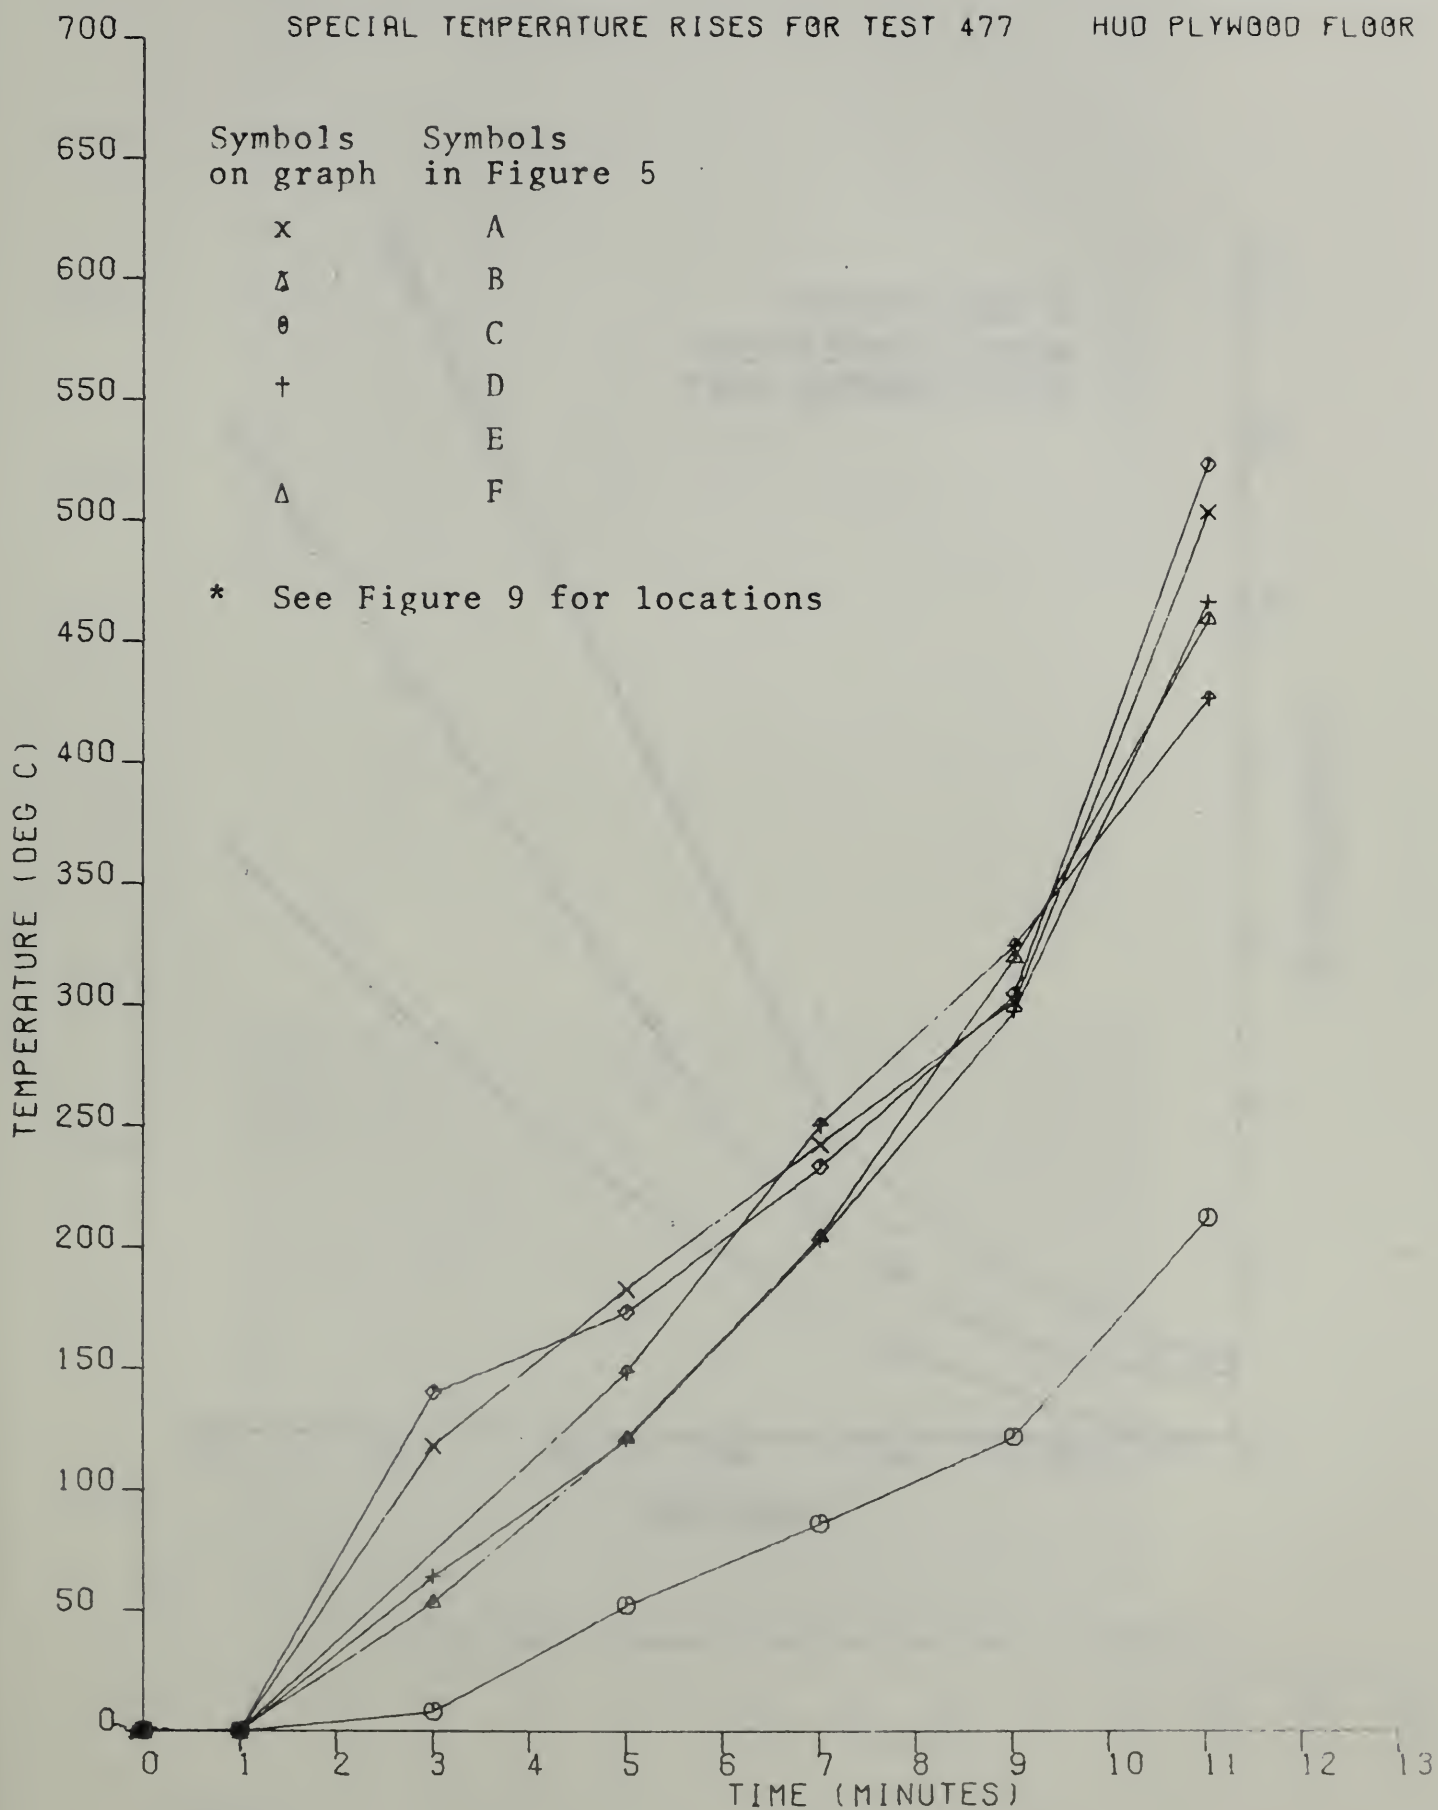
FIGURE 15.

Figure 15 is the temperature history of the 6 specially arranged thermocouples. The slow rise in temperature of thermocouple C illustrates the effectiveness of the blocking in protecting the joint.

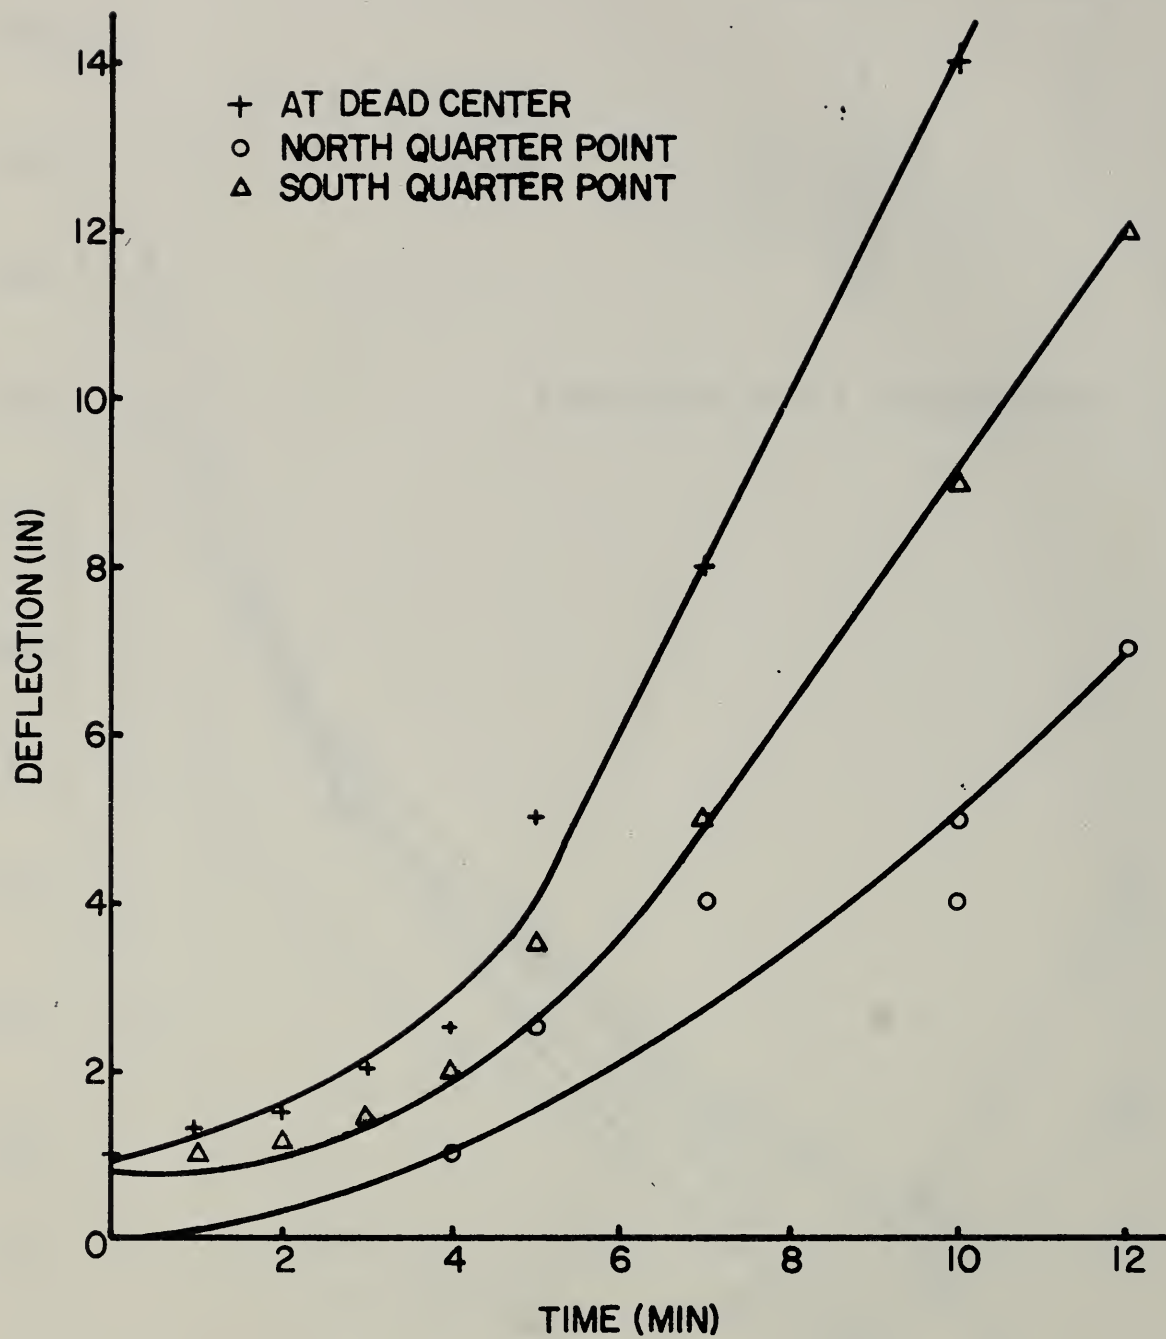
FIGURE 16. Deflection Measurements, Test #L-2

The deflections are tabulated in table 3 Appendix II and shown graphically in Figure 16.

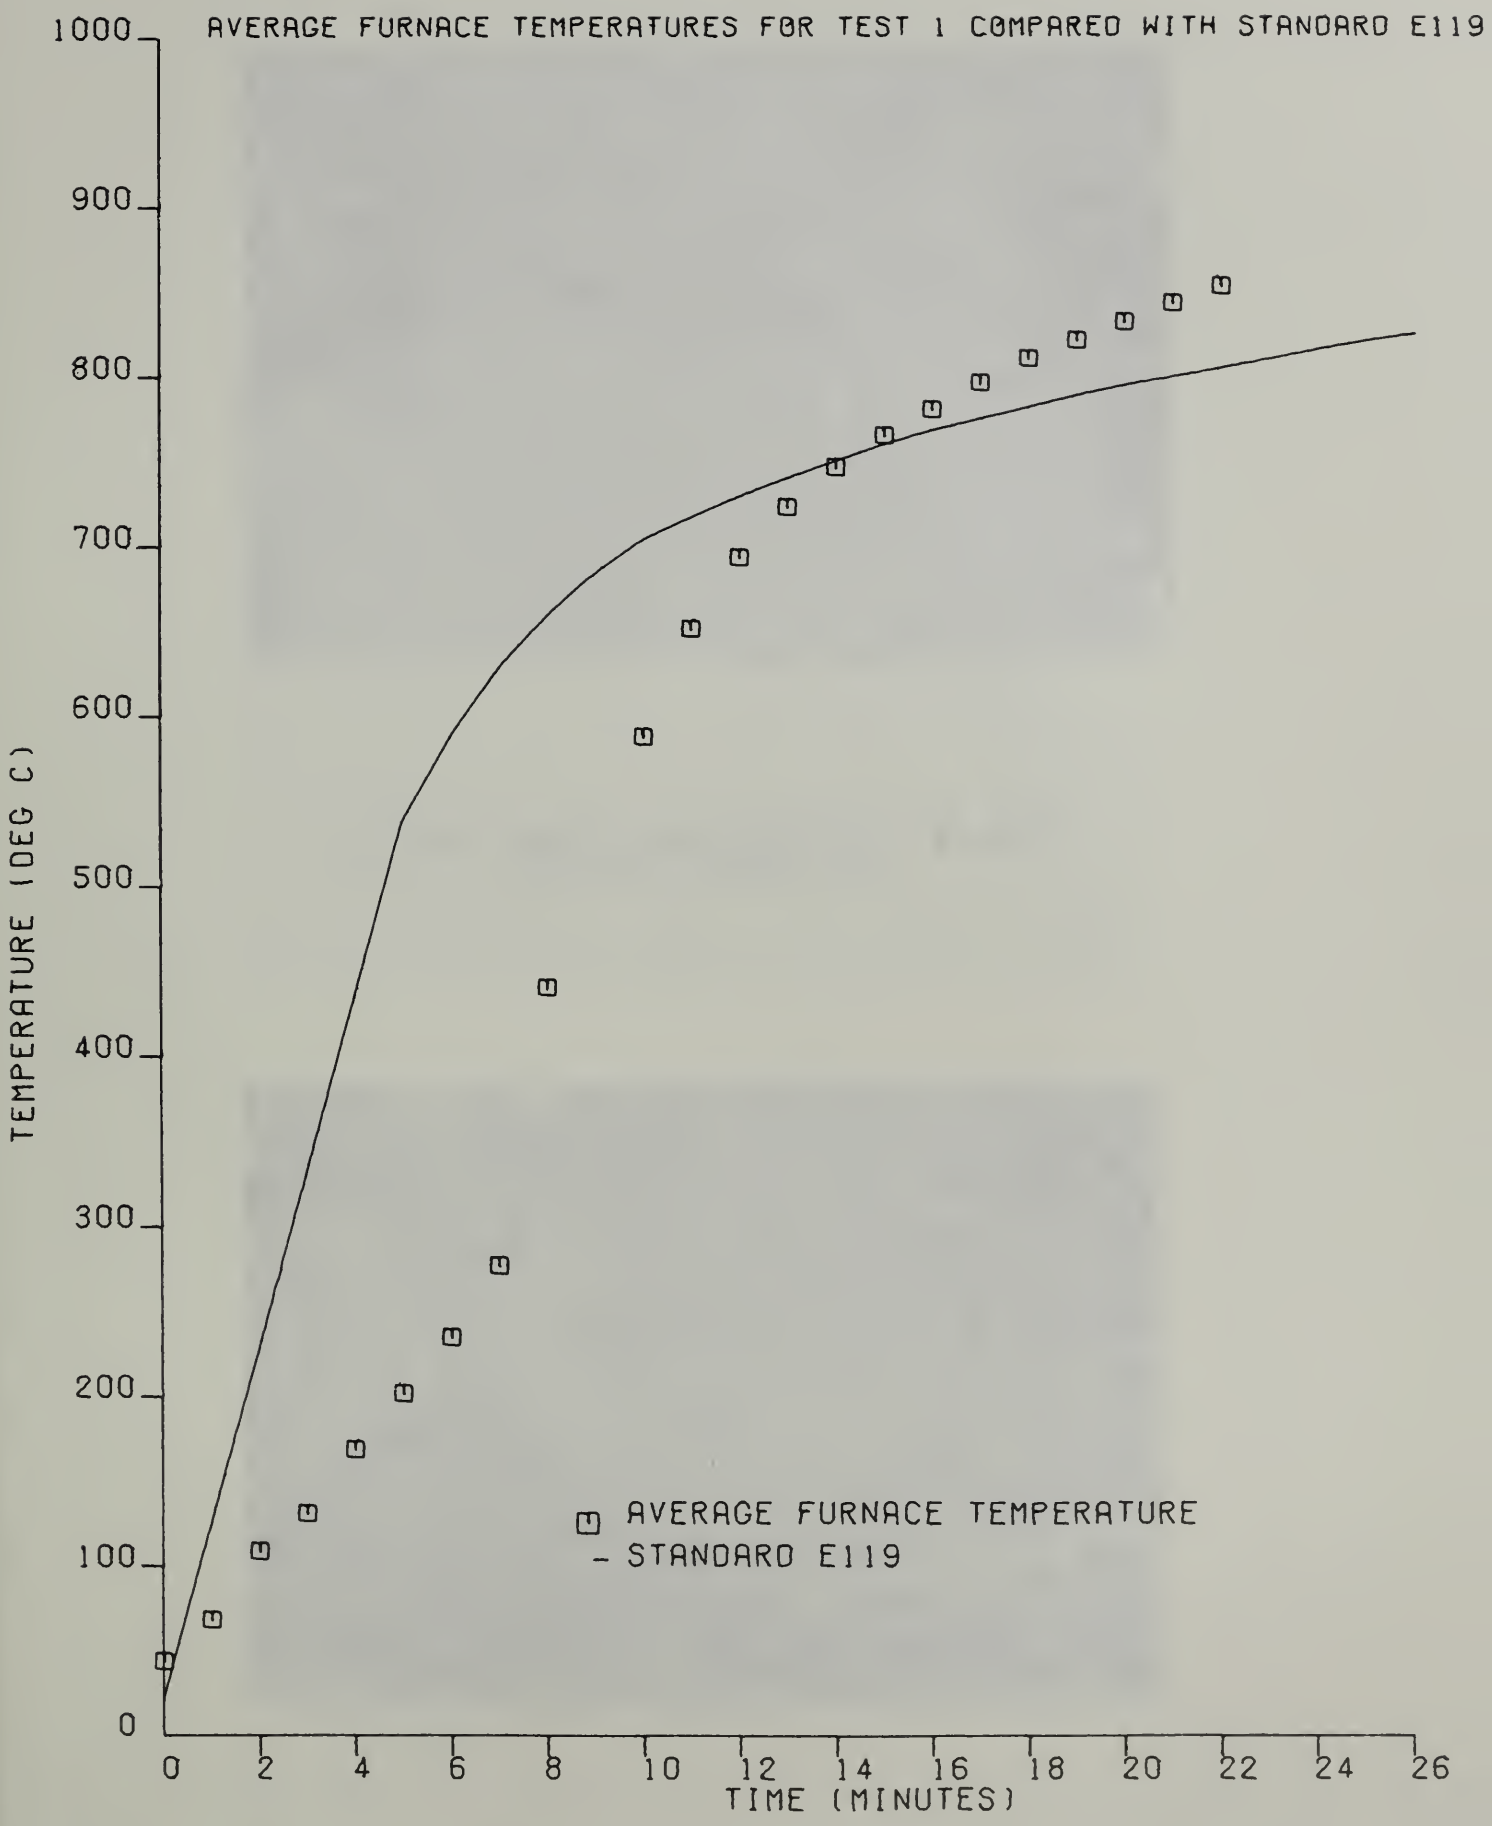
FIGURE 17.

Some difficulties with the furnace control occurred at the beginning of this test and so the furnace temperature-time curve was below the standard temperature-time curve (see Fig. 17). The corrected time of flame through, according to the correction formula stated in ASTM E119-69, was 18min:10sec. This compares quite well with the 17min:21sec of test #S-2 which was a duplicate of #S-1 excepting that a light load of 10 psf was applied to #S-2.

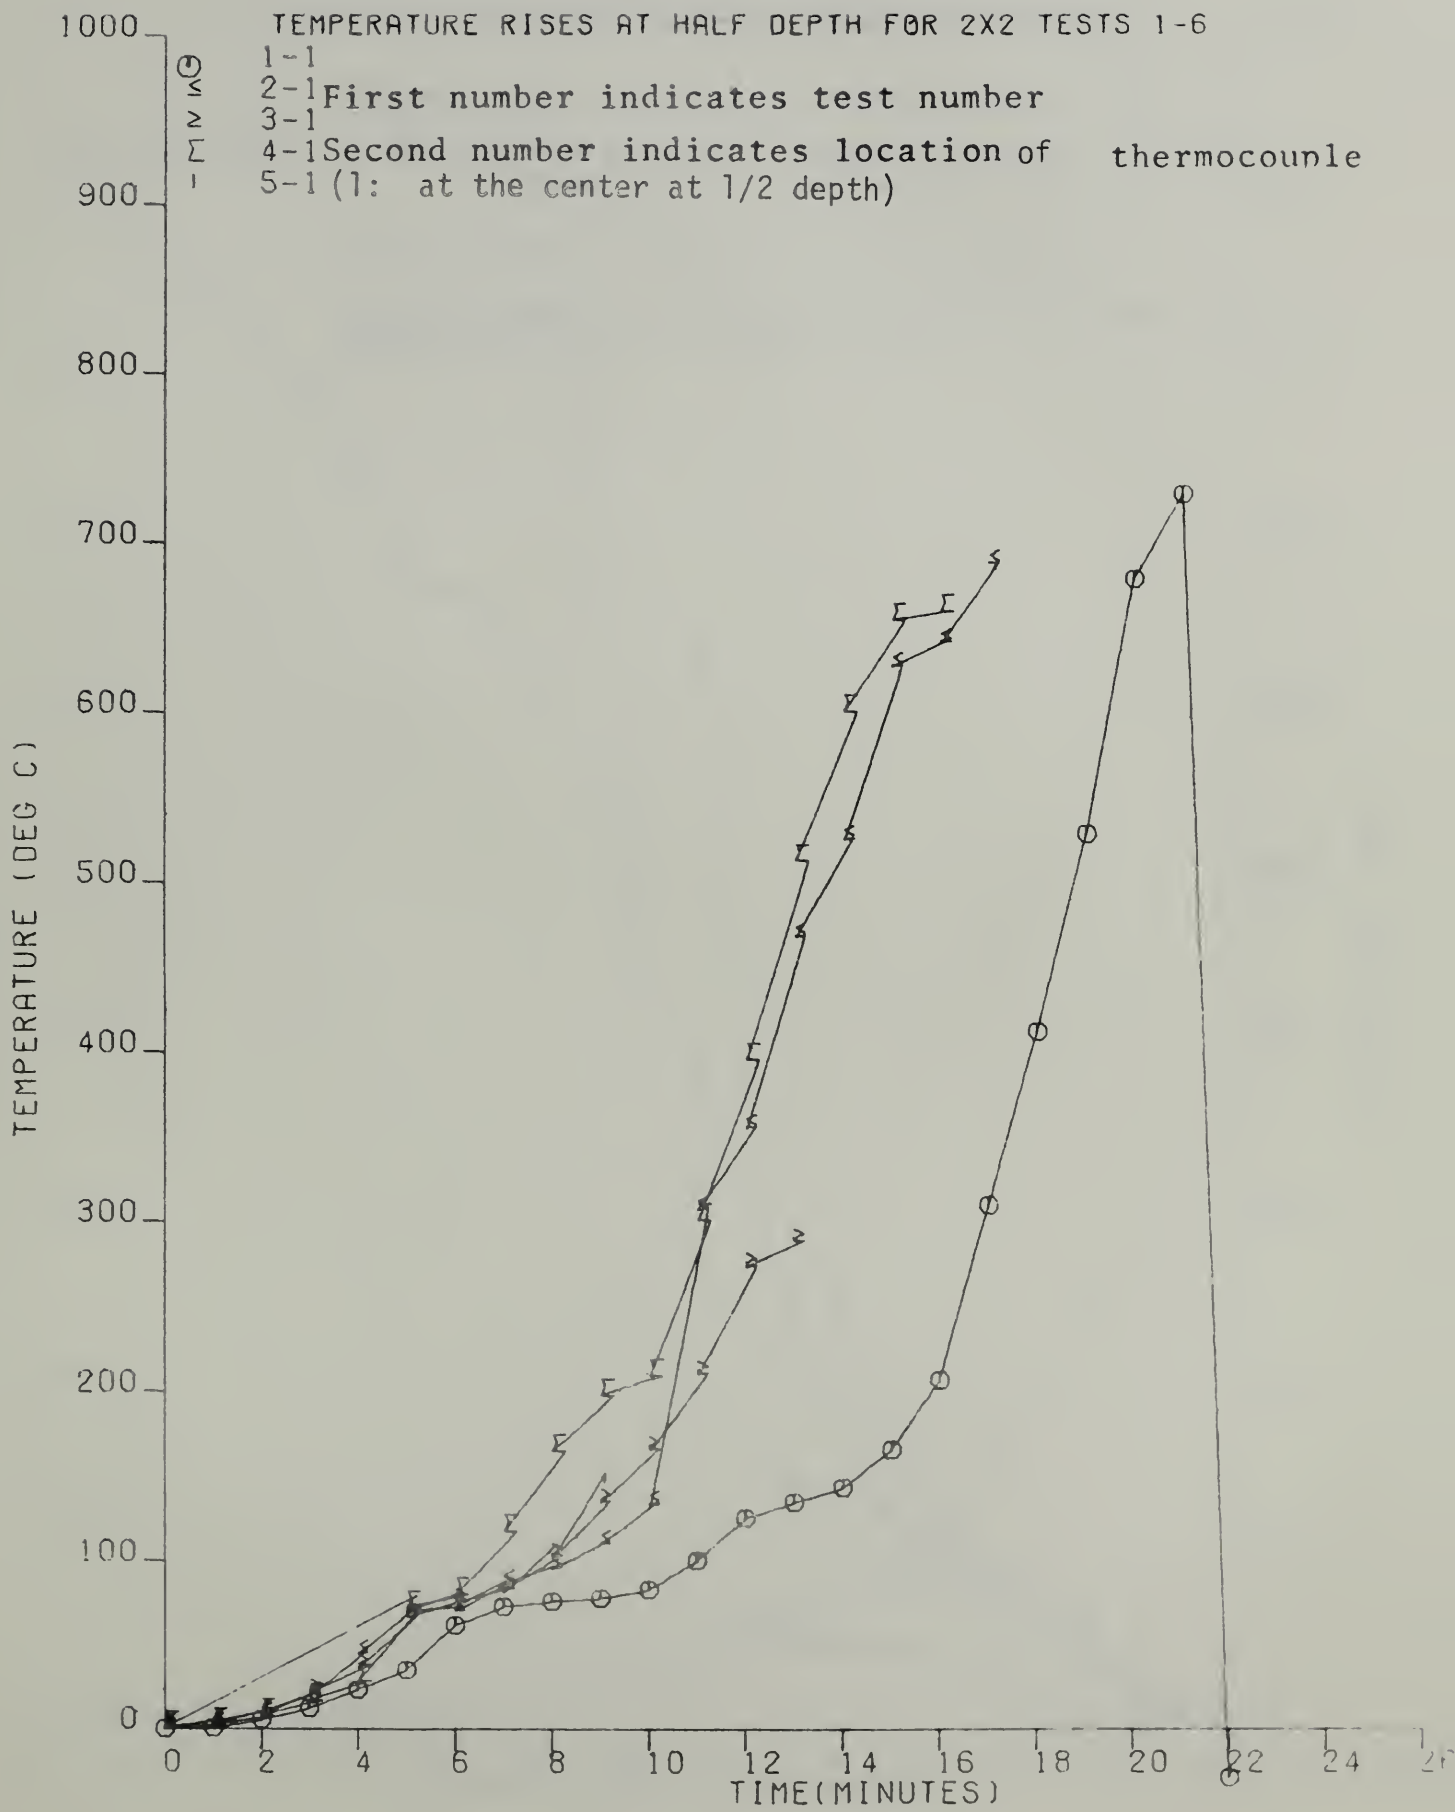
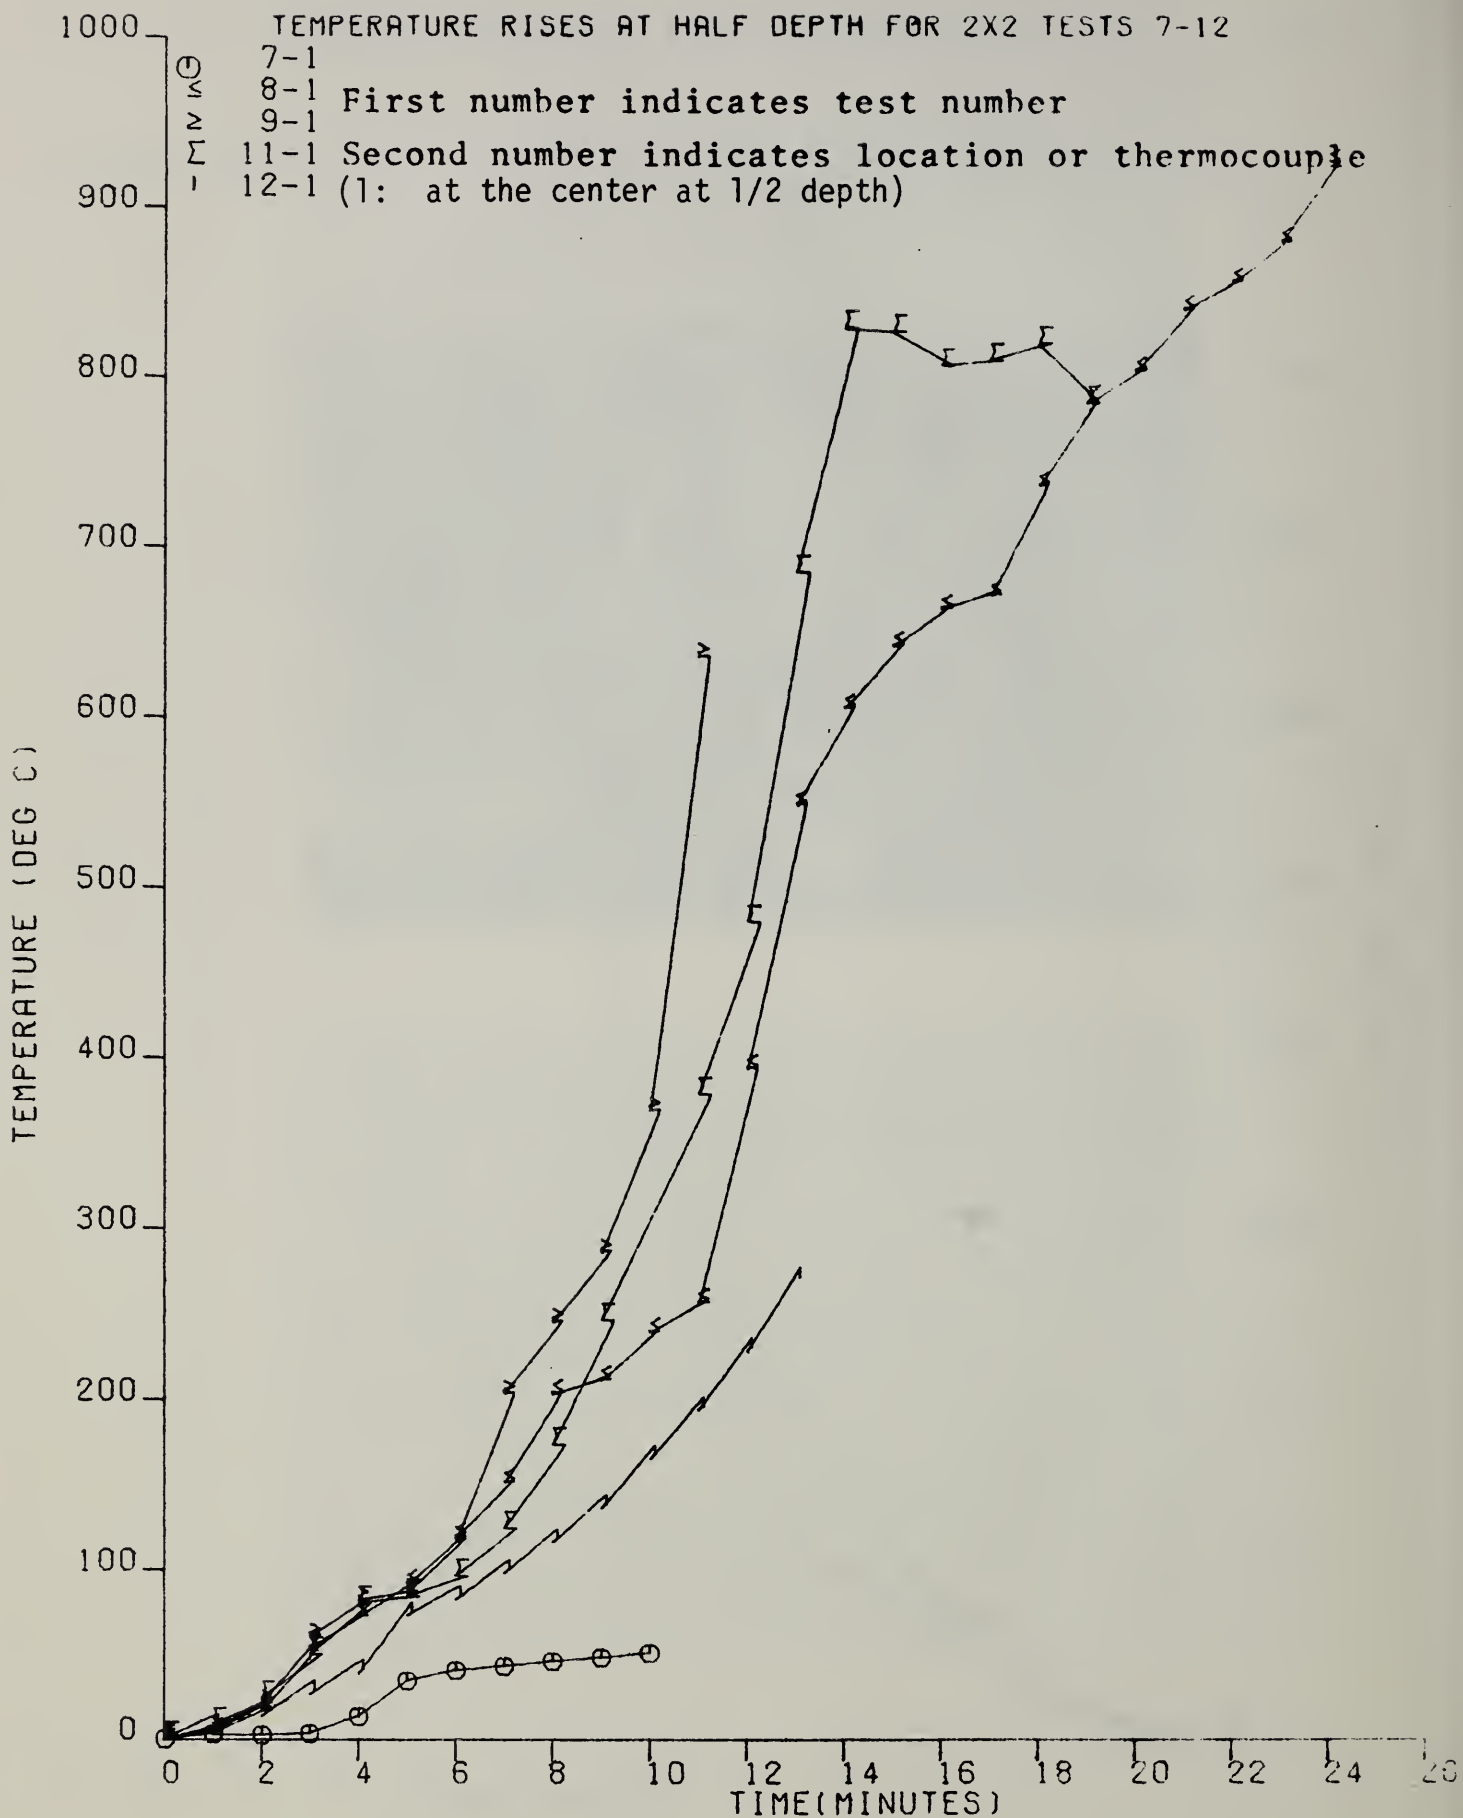
Figure 23 and 24 shows the temperature changes at half depth for the small scale tests. In Figure 24 the slope of curve 7-1 is flatter than the others, which is explained by the blocking under the joint protecting the joint from the fire.
