# NATIONAL BUREAU OF STANDARDS REPORT

10 320

FIRE ENDURANCE TESTS OF UNPROTECTED WOOD-FLOOR  
CONSTRUCTIONS FOR SINGLE-FAMILY RESIDENCES

May 10, 1971

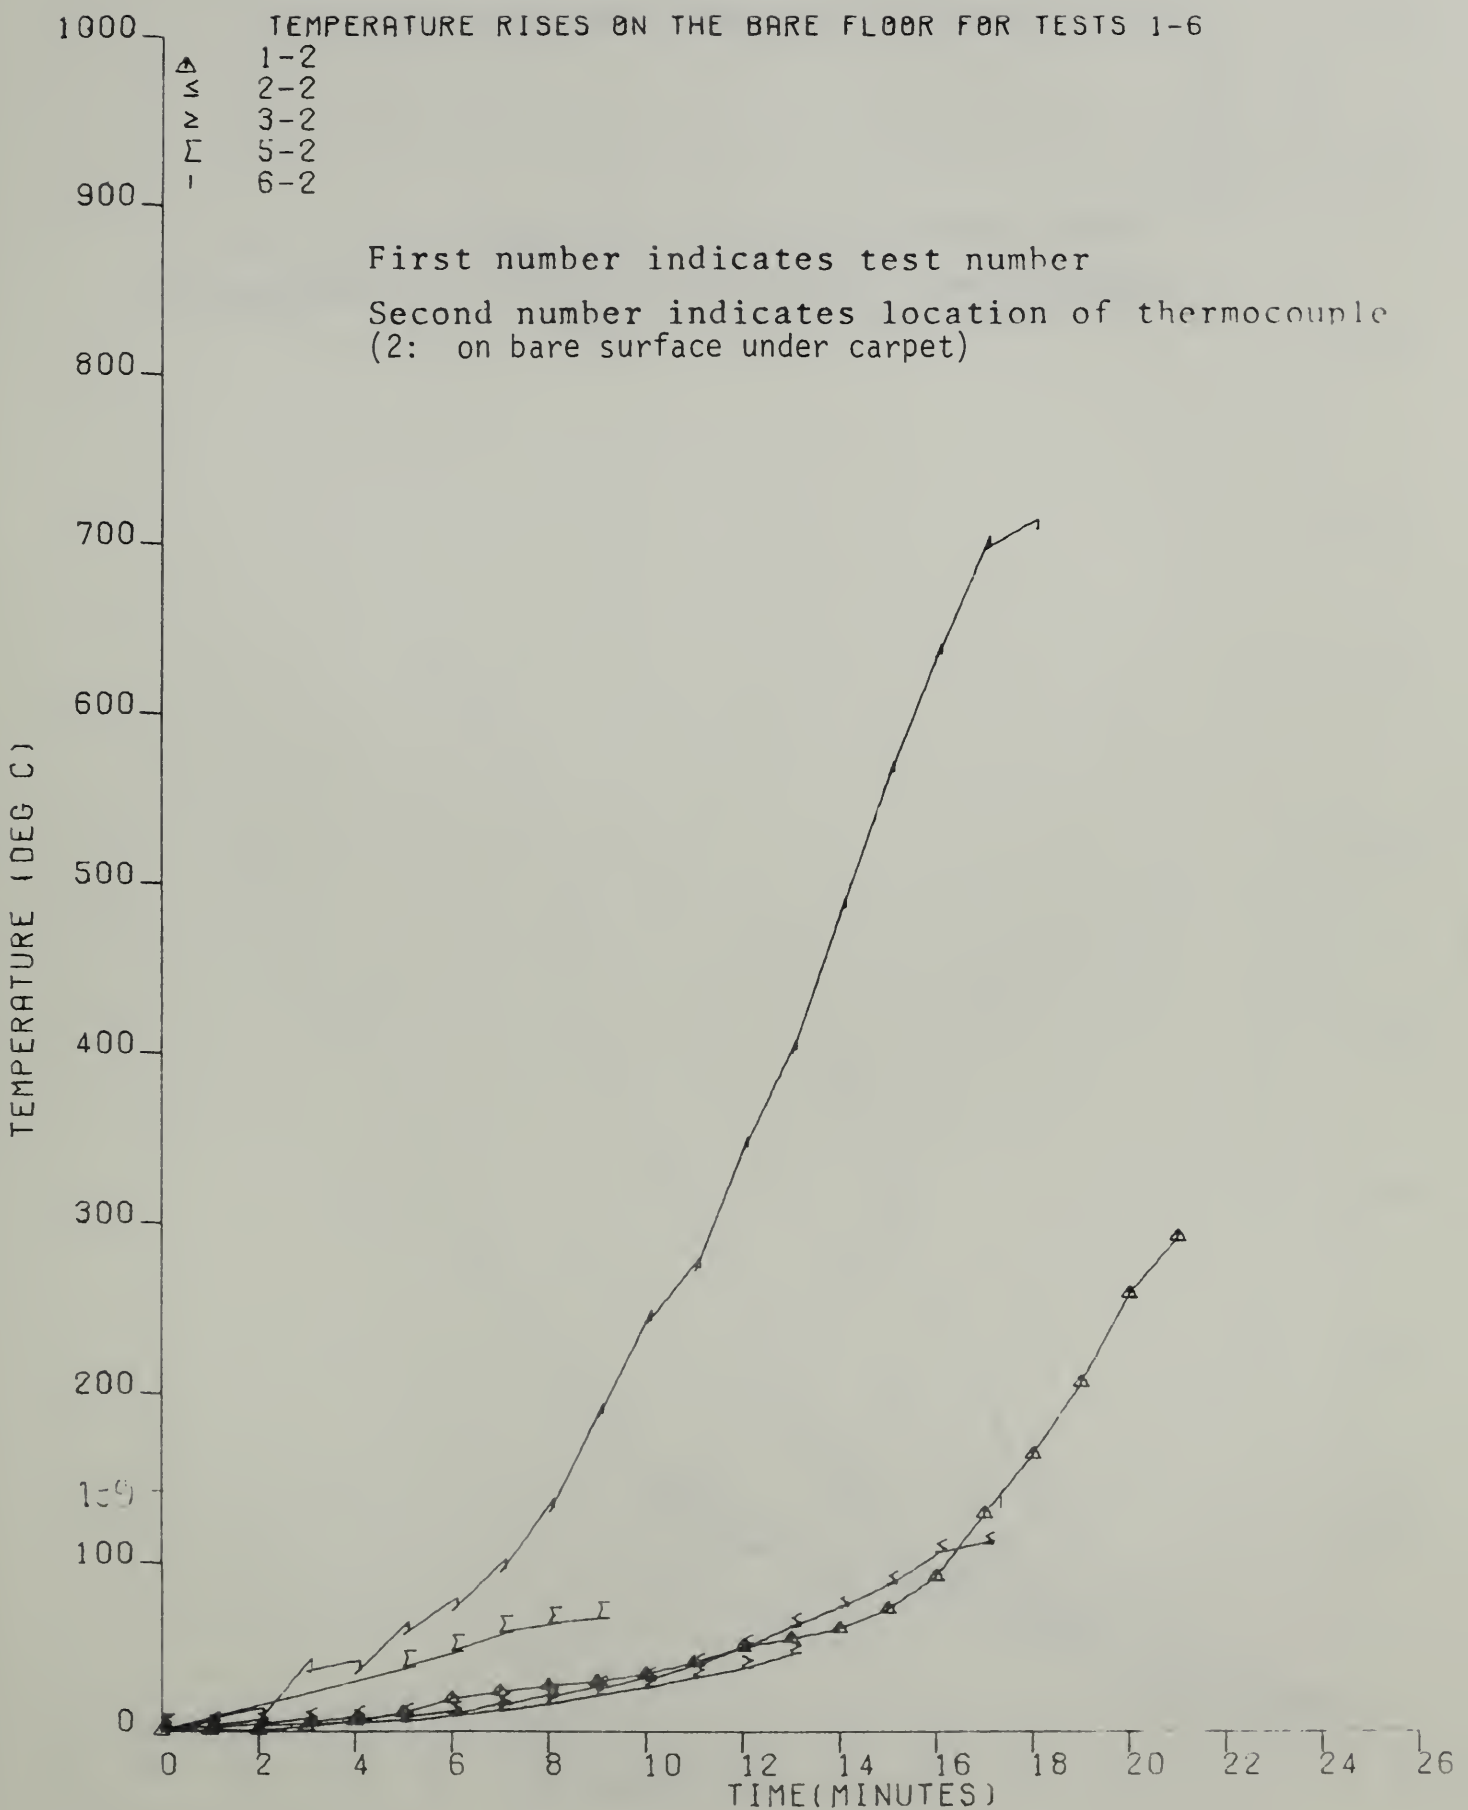
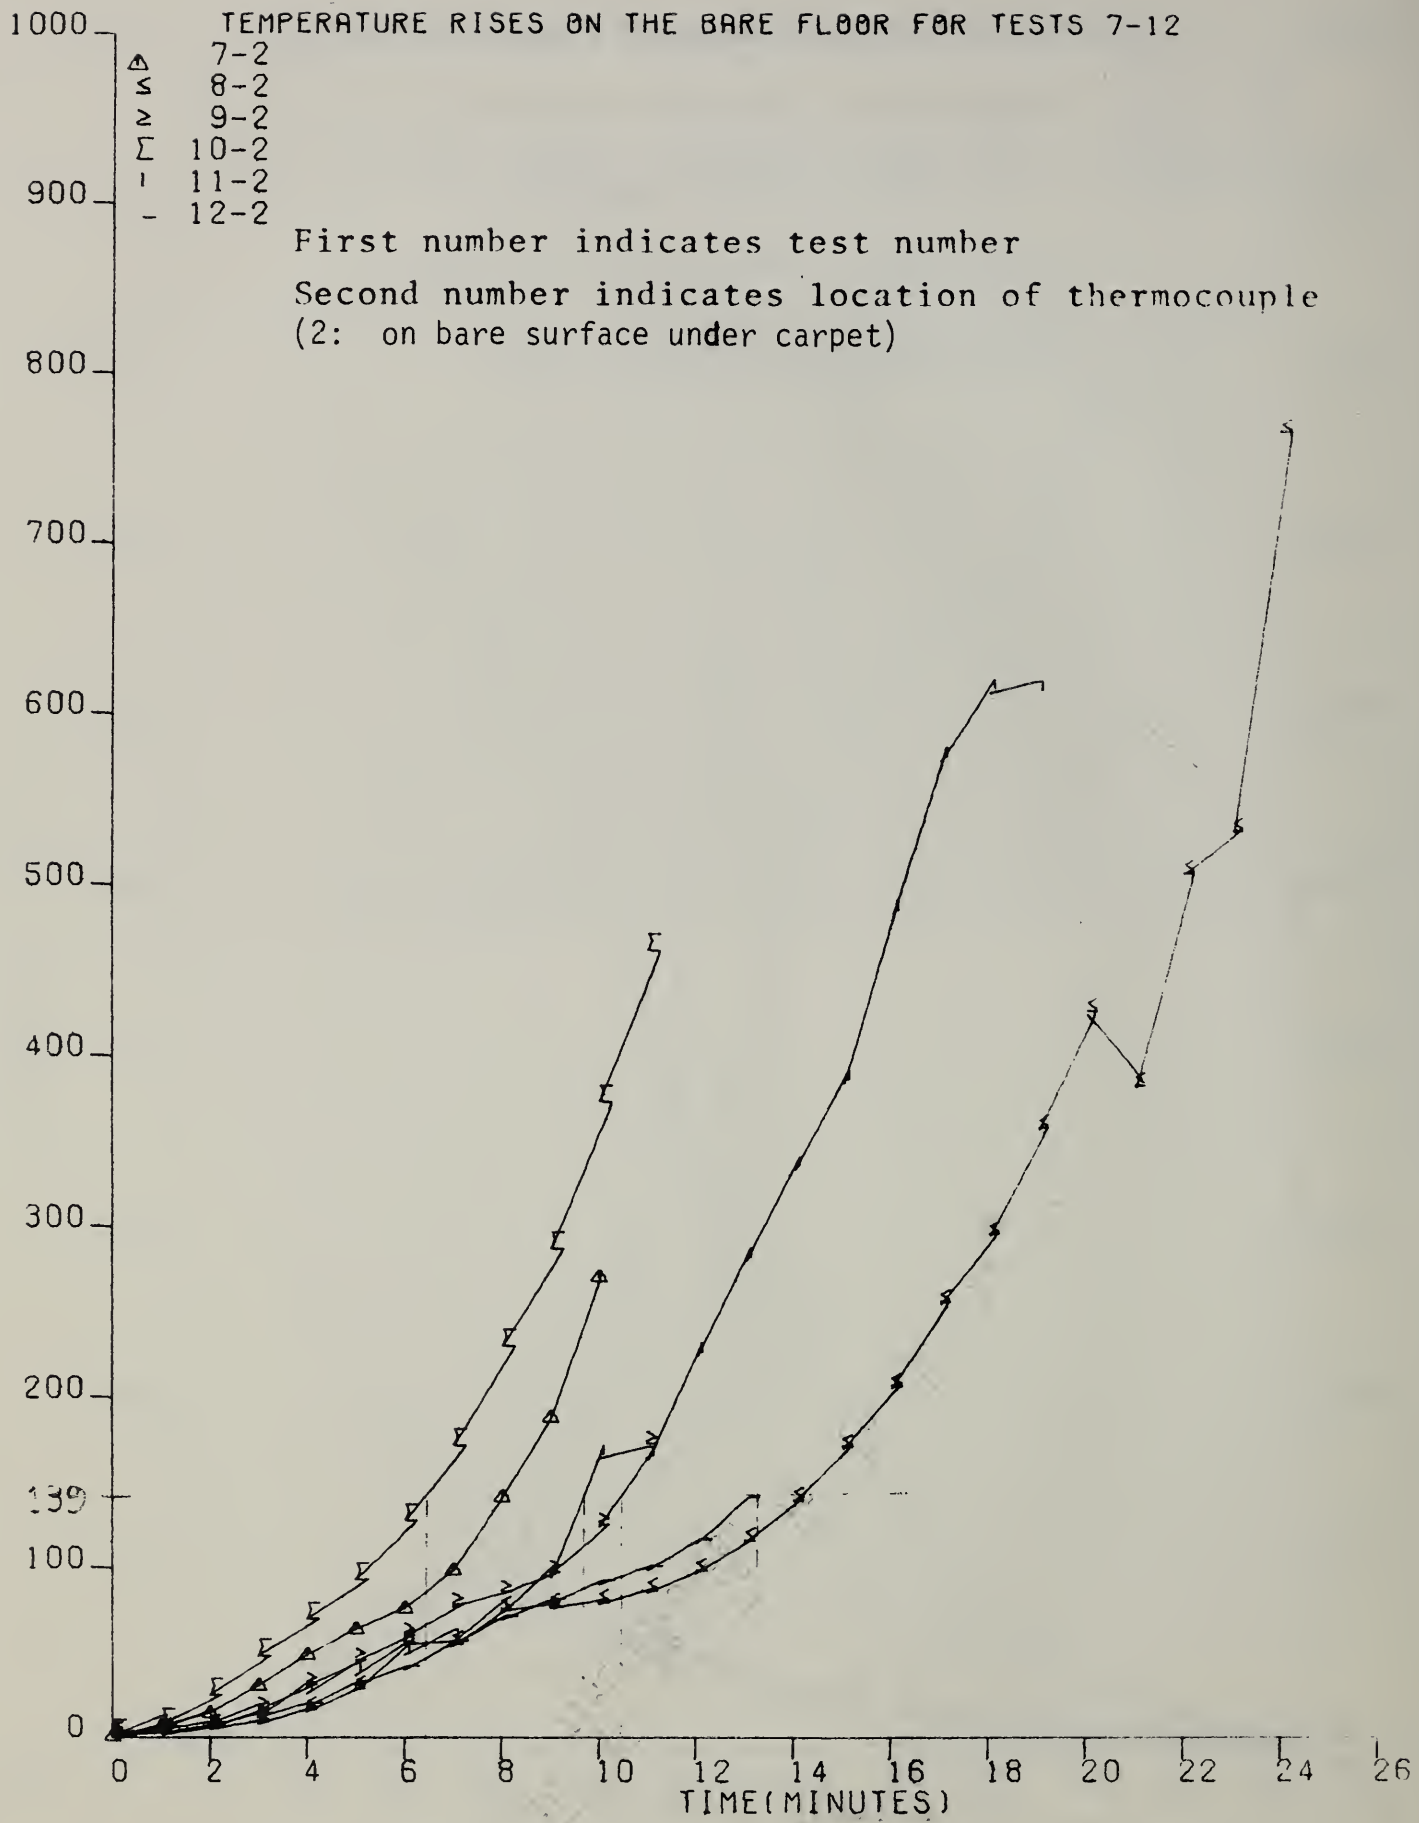
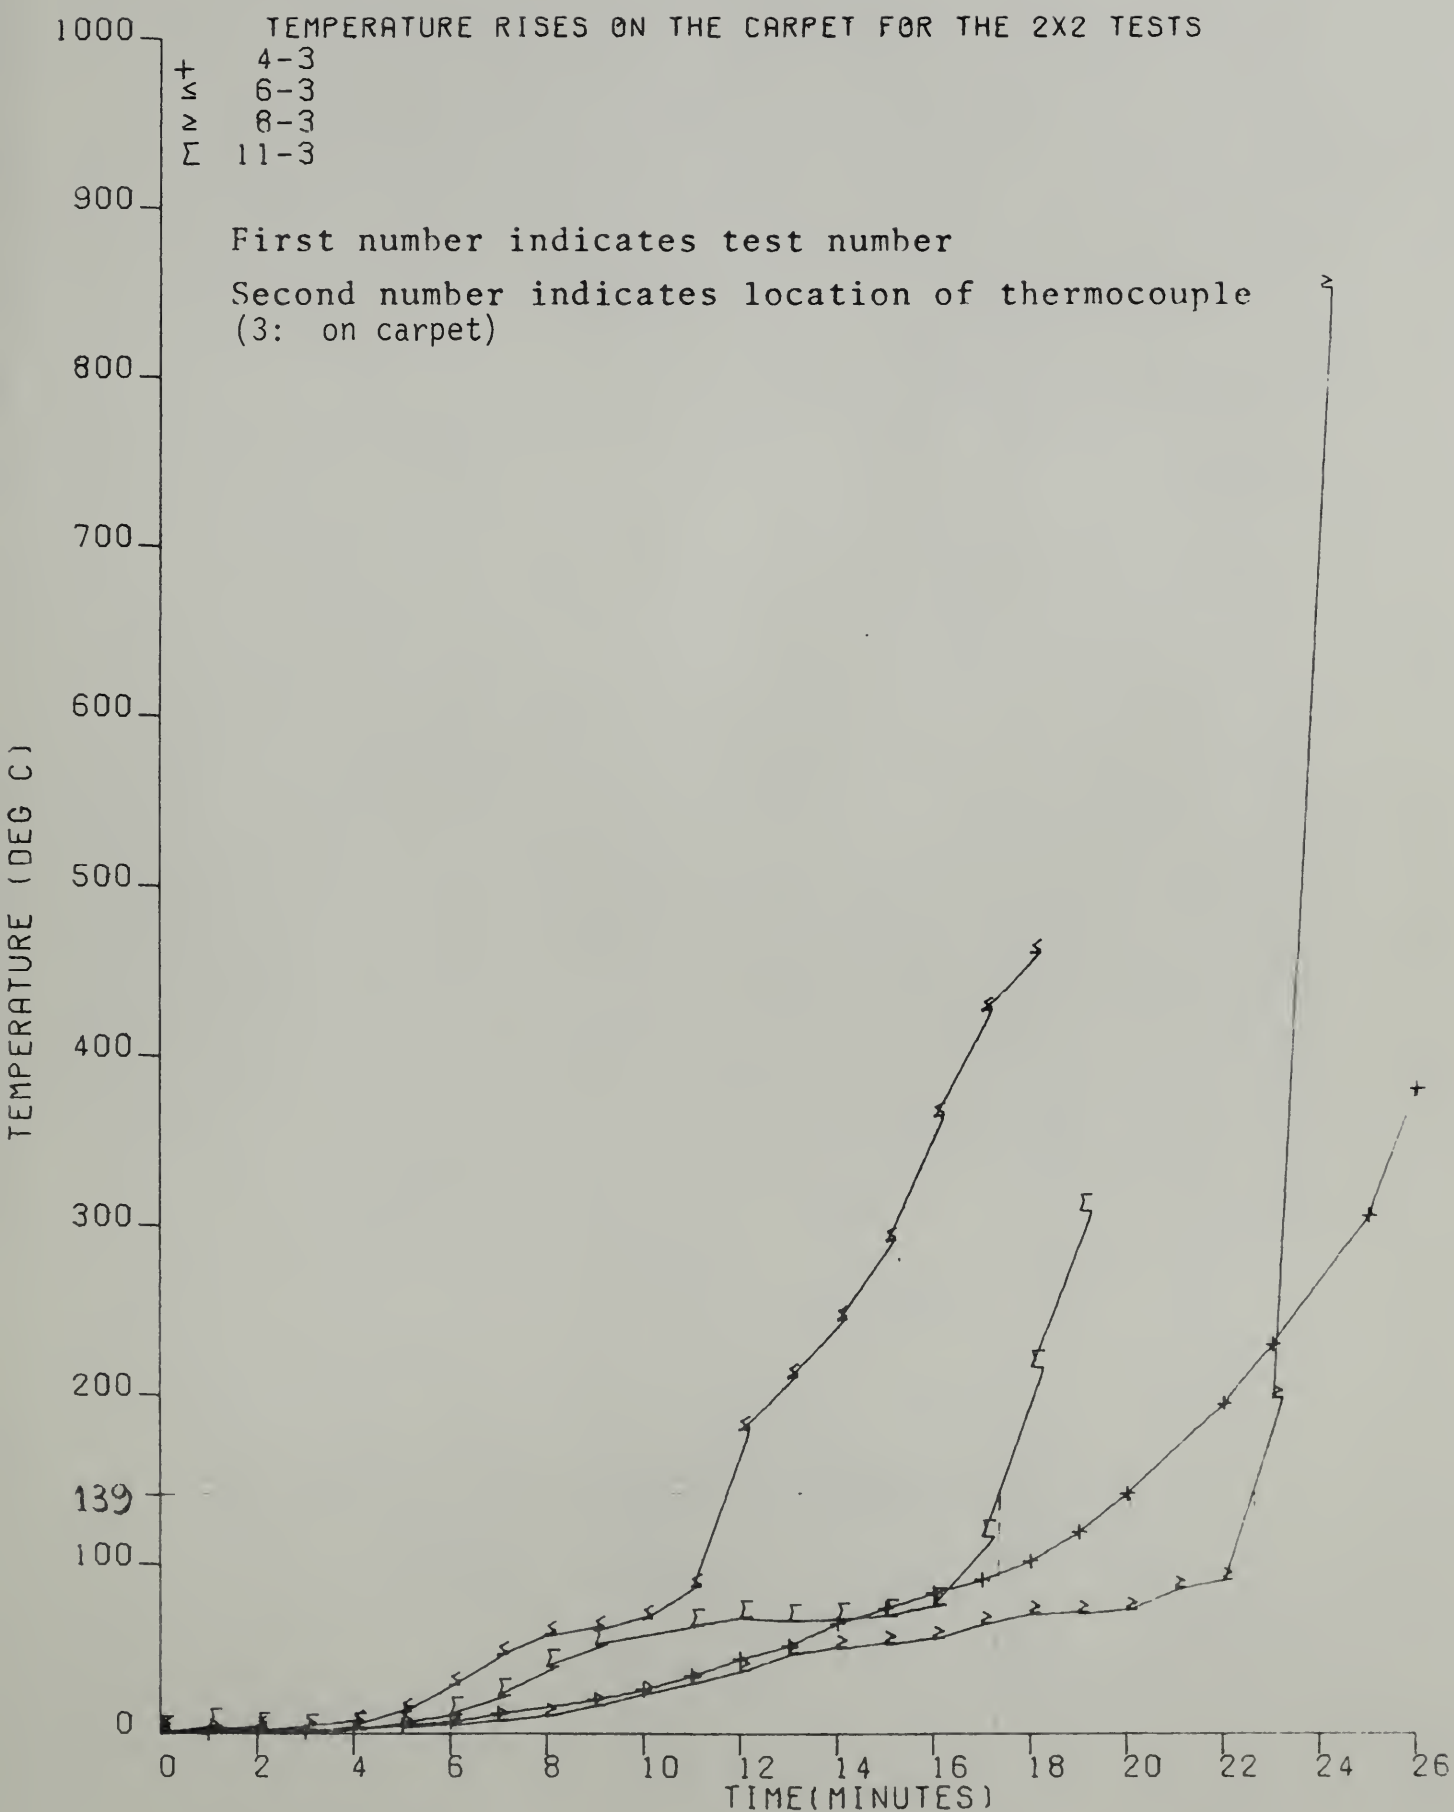
The temperature changes on the bare floor and on the carpet surface are shown in Figures 25, 26, and 27.

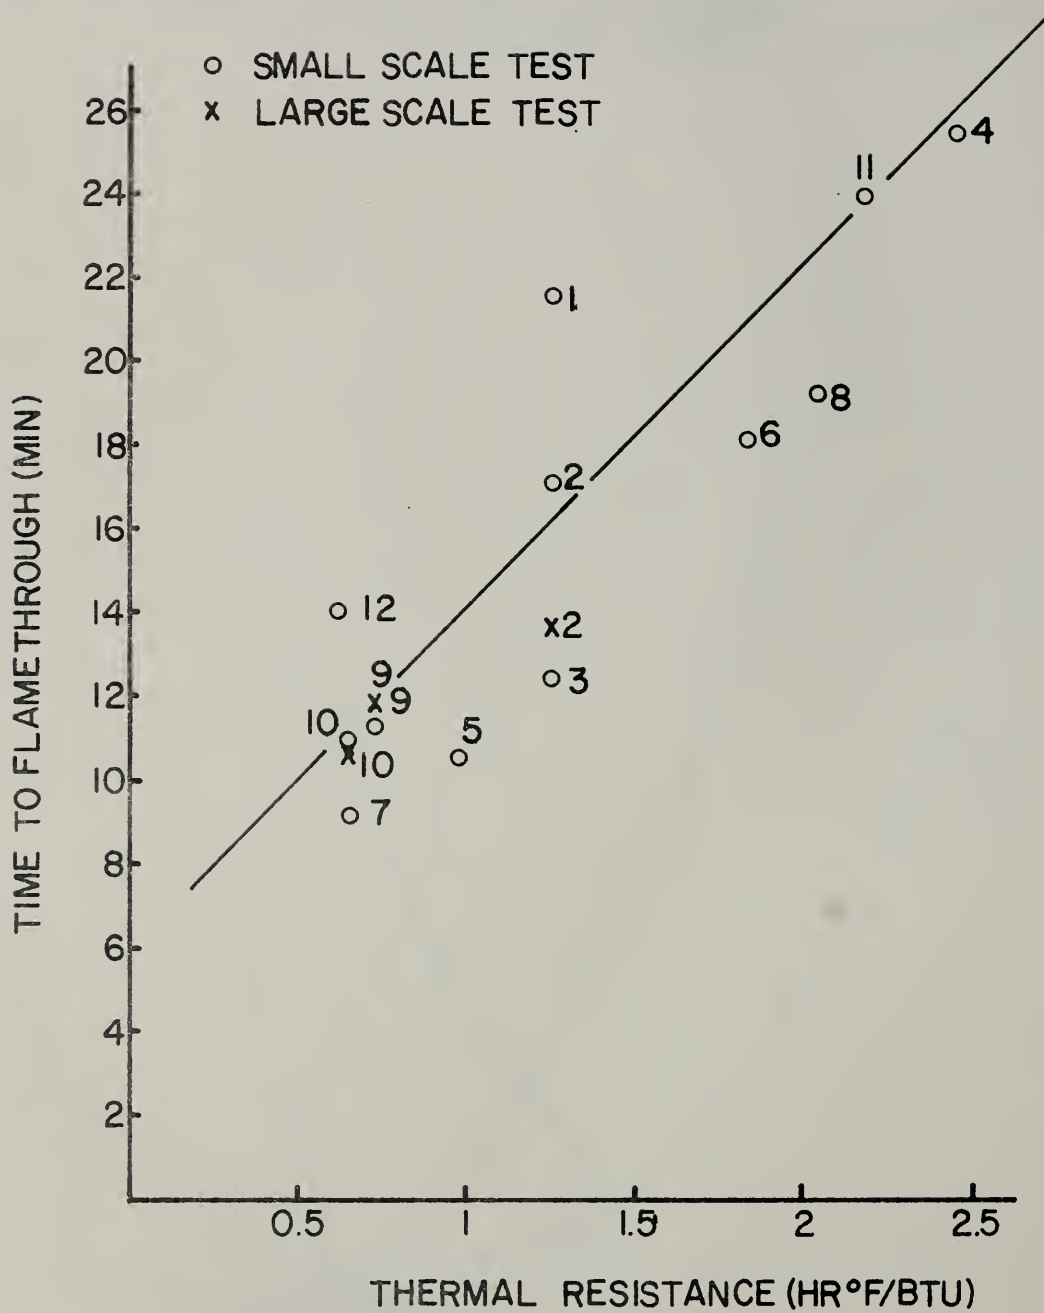
Figure 28 illustrates the influence of the thermal conductivity of various materials on the time of "flame through" under free convection conditions and at room temperature. It is apparent that construction #4 (1/2" + 1/2" + 1/8" gap + carpet) has the largest value of thermal resistance and requires the longest time for the flame to penetrate through the floor. It can be seen in figure 28, that empirically there is a linear relation between the thermal resistance and the "flame through" time. The slope is  $K = 0.133 \text{ (BTU/}^\circ\text{F)}$ .

Fig 28 Thermal RESISTANCE of Floor Construction Vs Flamethrough Time
