# AN INVESTIGATION ON THE FIRE SPREAD POTENTIAL OF PLASTIC PIPE INSTALLATIONS

September 18, 1970

. I. A. Benjamin and W. J. Parker

#### AN INVESTIGATION ON THE FIRE SPREAD POTENTIAL OF ABS PLASTIC DWV PIPE INSTALLATIONS

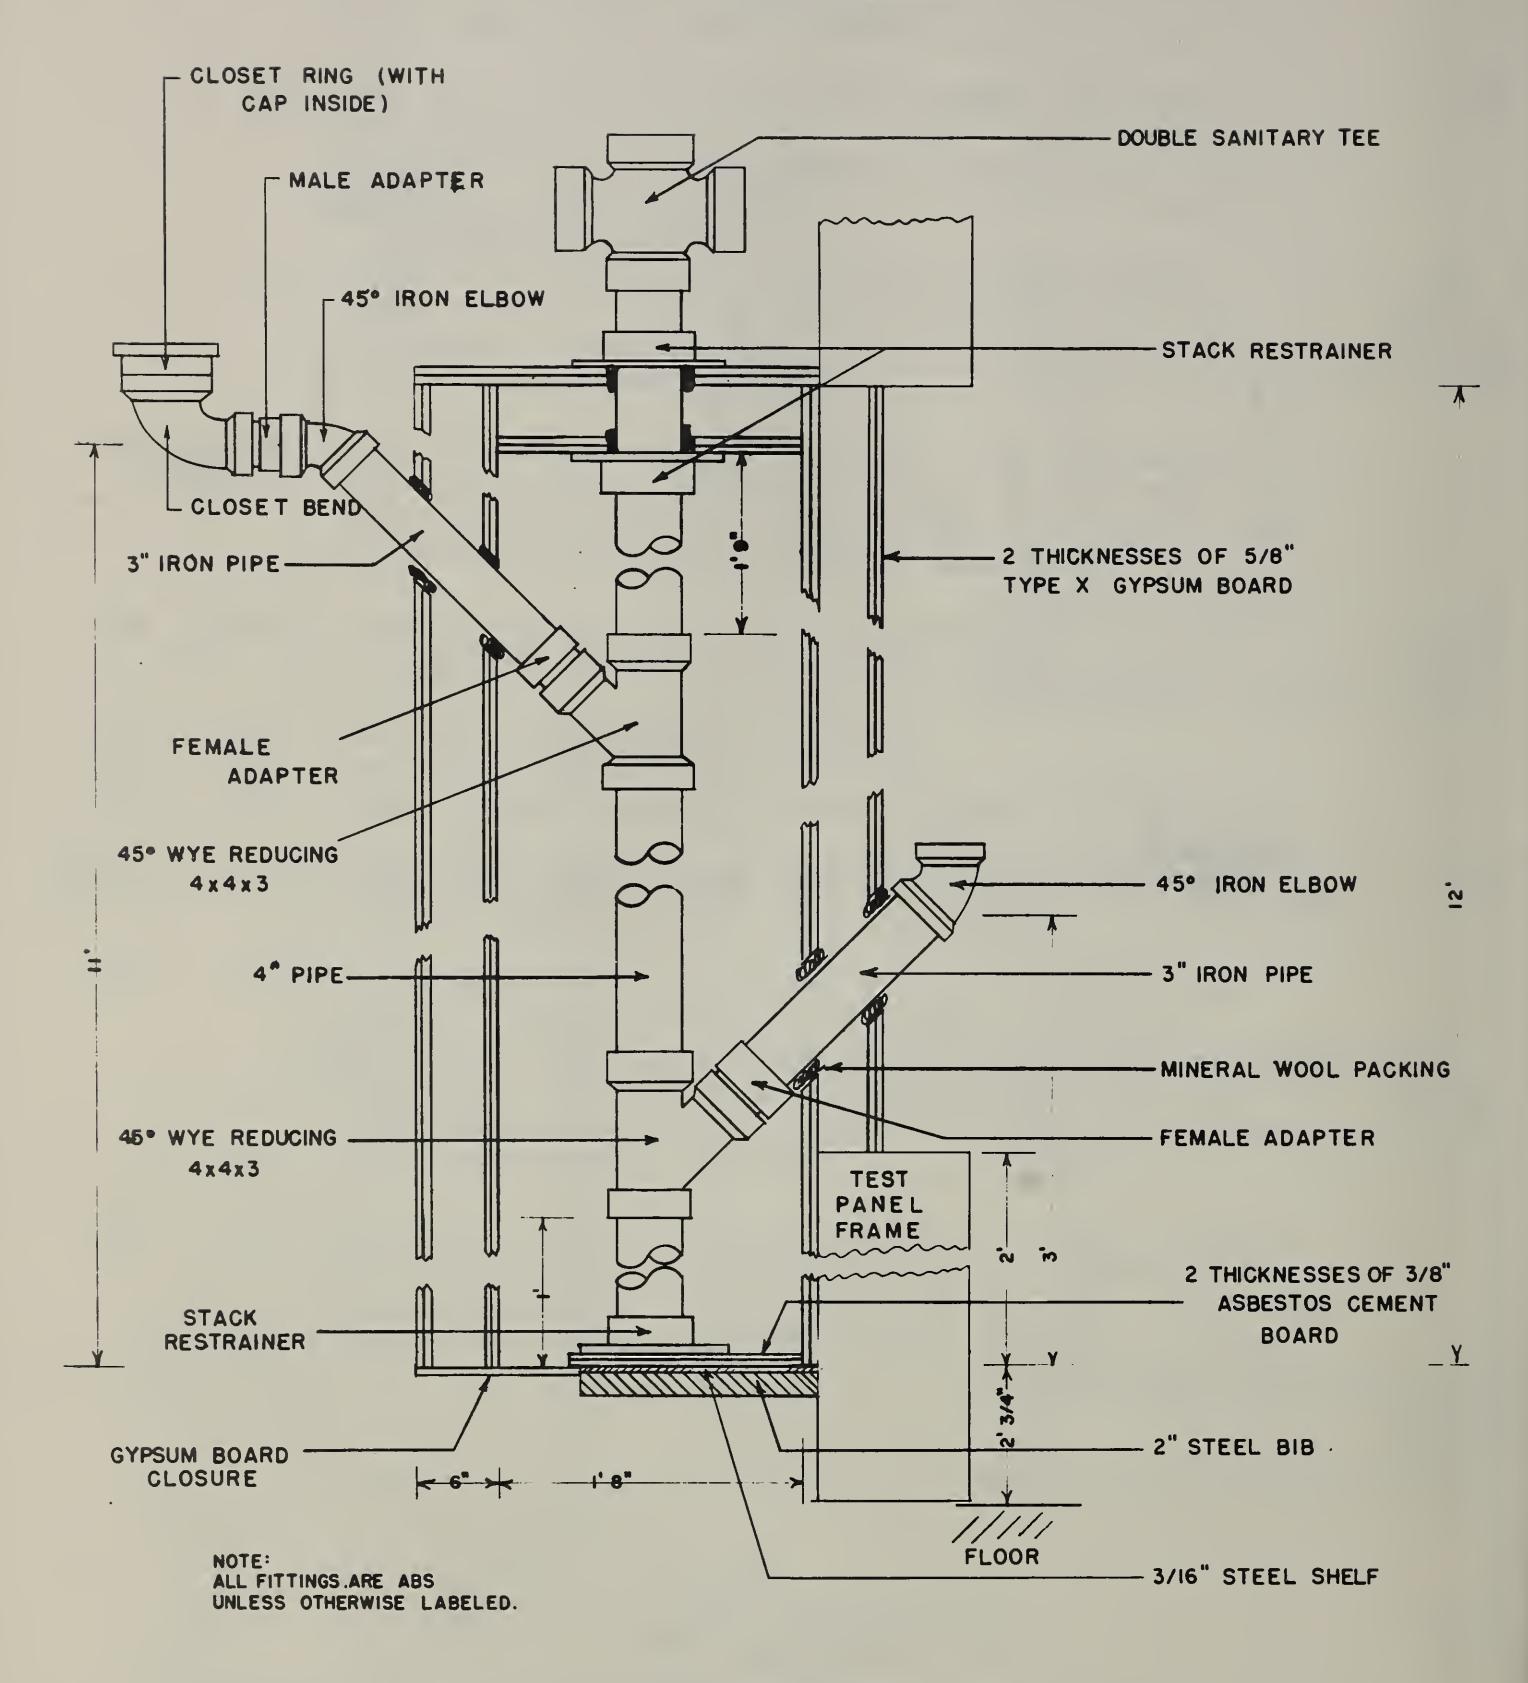
FIGURE 2A PIPING ARRANGEMENT IN CHASE 1

The pipe installation used in chase 1 is shown in figure 2A. The vertical pipe, four inches in diameter, was terminated at the top and bottom of the chase by ABS stack restrainers. The lower stack restrainer rested on two 3/8 inch thick sheets of asbestos cement board which sealed off the bottom of the pipe. For the first panel test the pipe opened into a double sanitary tee above the chase, which was used for smoke measurements. This tee was not used with the four chases on the second panel.

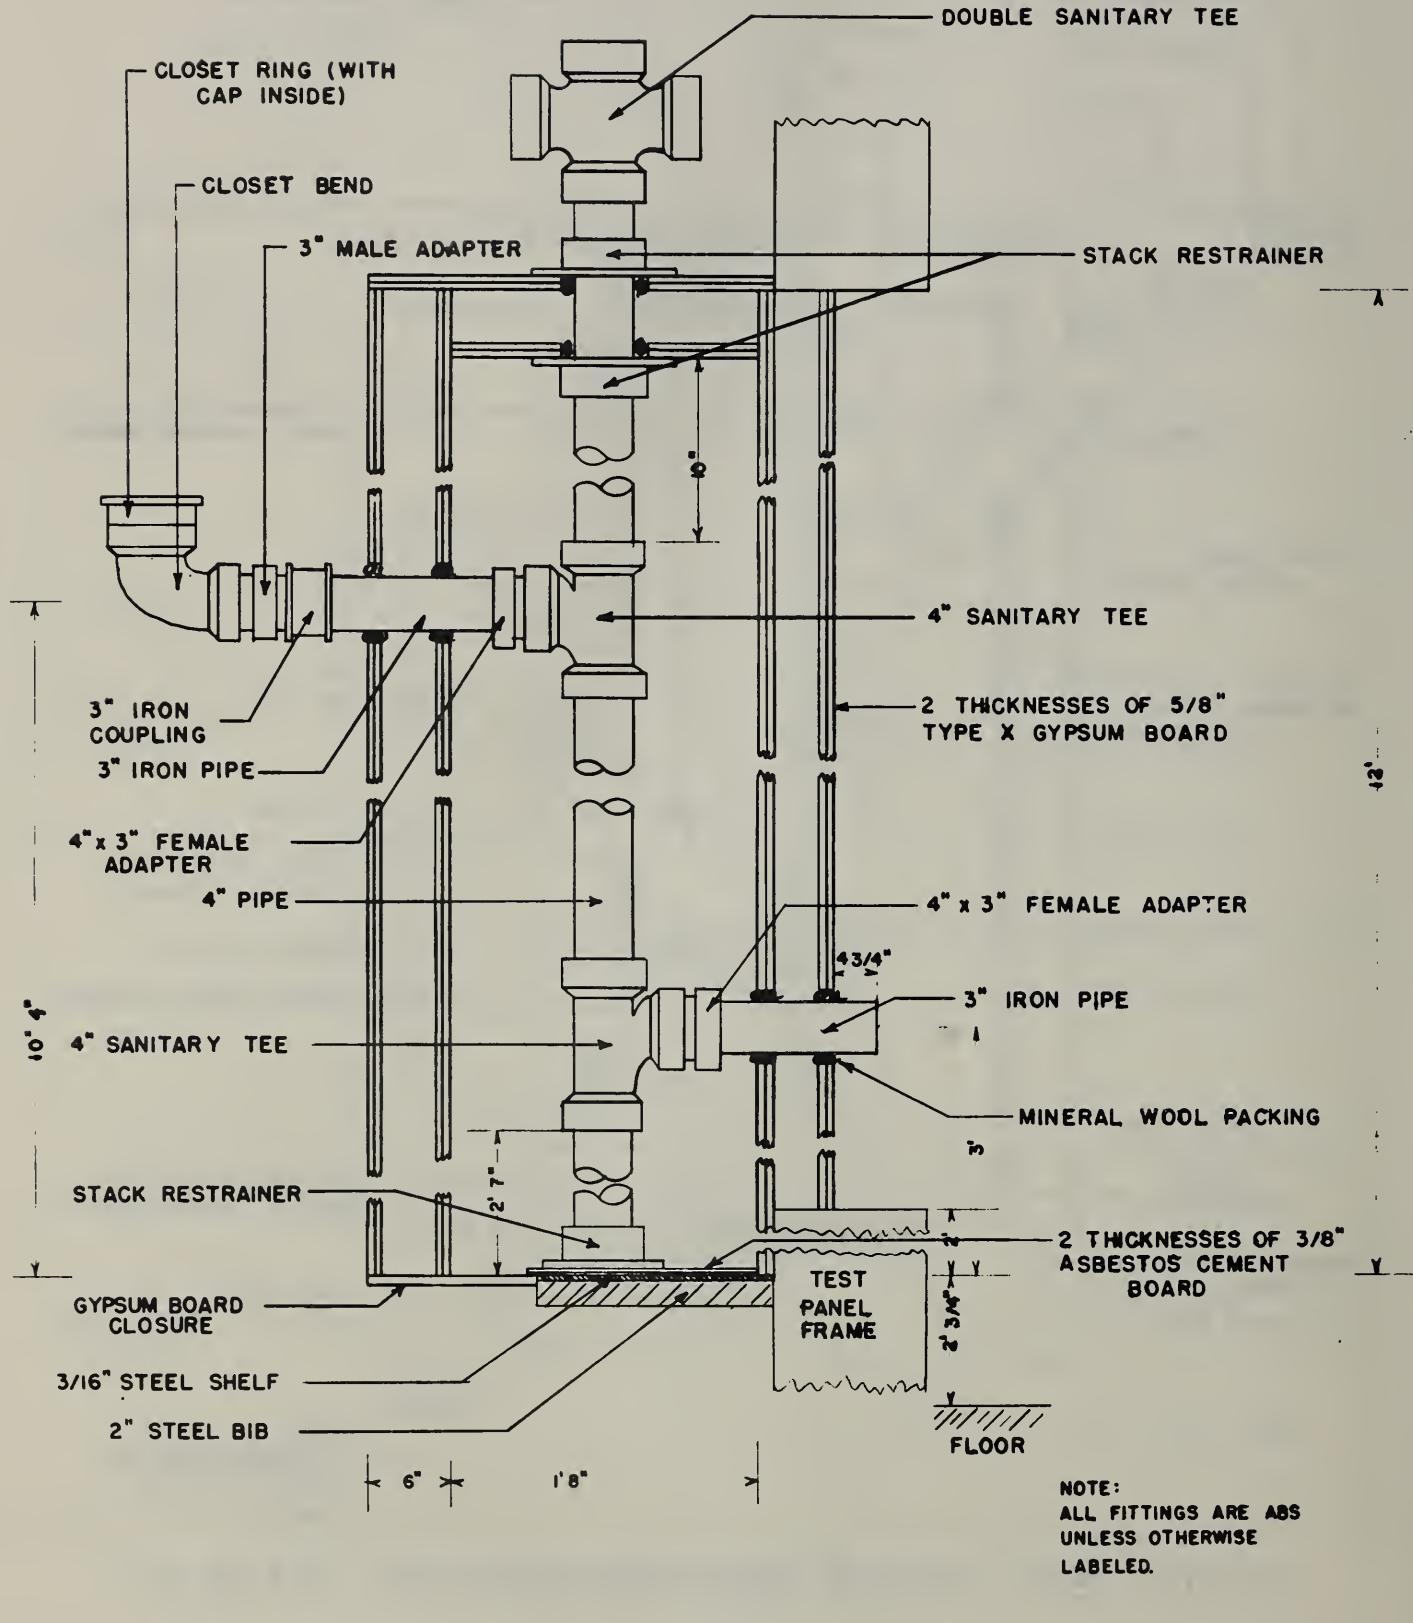
FIGURE 2C PIPING ARRANGEMENT IN CHASE 3
FURNACE SIDE

In Chase 3 single sanitary reducing tees replaced the 45° wyes and the 3 inch diameter galvanized iron pipes were connected to the tees by adapters. The iron pipes passed horizontally through the chase walls. This is shown in figure 2C. There was no fitting at the end of the pipe which projected into the furnace. The upper lateral iron pipe was terminated with an iron coupling connected to an identical set of fittings as that used in Chase 1.

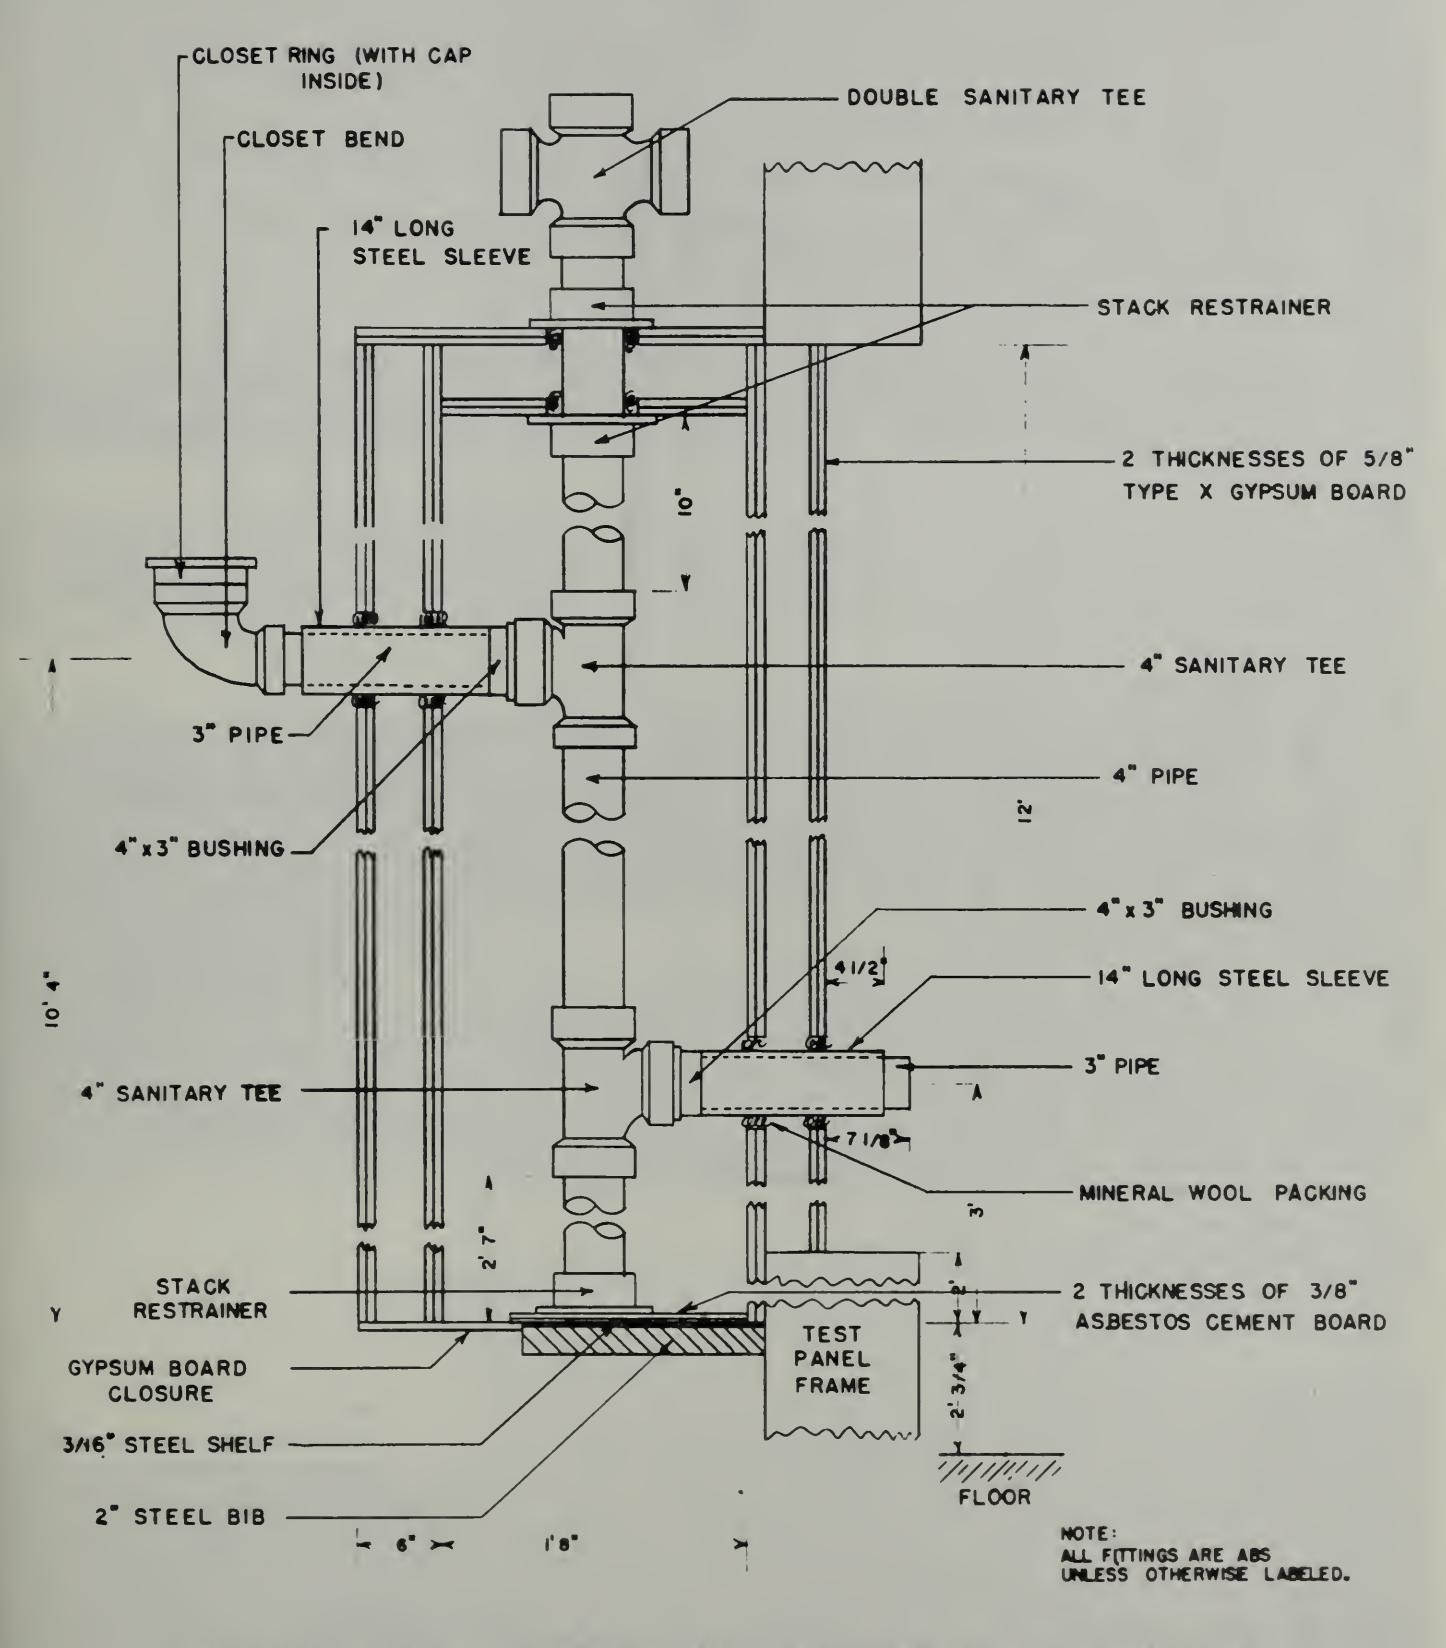
FIGURE 2D PIPING ARRANGEMENT IN CHASE 4

The installation in Chase 4 which is shown in figure 2D was the same as in Chase 3 except that ABS pipes with steel sleeves were used as in Chase 2. The adapters and the iron coupling were not needed.

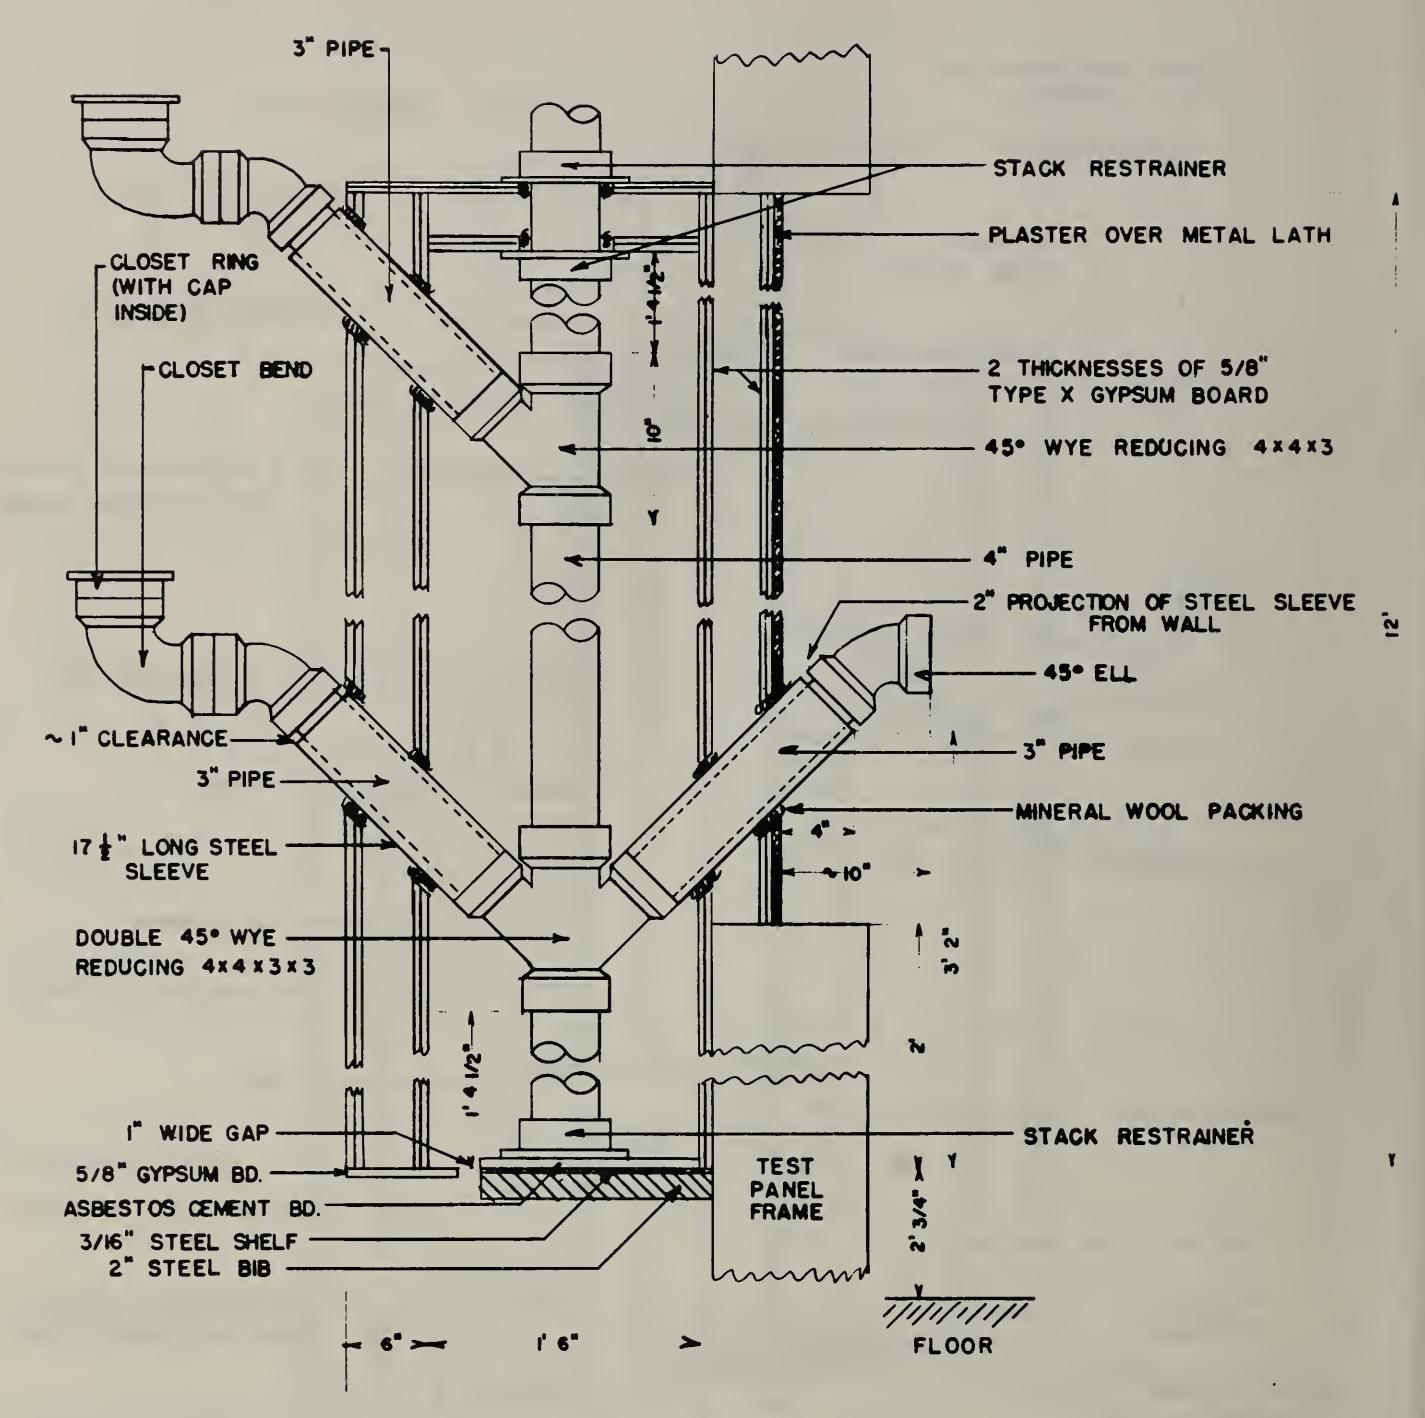
FIGURE 2E PIPING ARRANGEMENT FOR CHASE 8

The next four chases were built for the tests with the second panel. Chase 8 which includes the details of the other three chases is shown in figure 2E. A wye connection, a 3 inch lateral, a 45° ell which projects about 10 inches into the furnace at the lower level. And a combination of a 45° ell, a closet bend, a closet ring, and a cap at the upper level were common to all the chases tested with the second panel. The differences between the chases was in the number of lower laterals and the presence or absence of a steel sleeve.

Chase 5 had one lower lateral with a single 45° wye and a steel sleeve. Chase 6 had one lower lateral and no steel sleeve. Chase 7 had two lower laterals with a double 45° wye and no steel sleeves. Chase 8 had two lower laterals with a double 45° wye and steel sleeves. A photograph of the lower lateral of Chase 8 is shown in figure 3.
