FIRE ENDURANCE TESTS OF EXTERIOR WALL AND ROOF/CEILING CONSTRUCTIONS FOR SINGLE FAMILY HOUSE

January 28, 1972

Prepared for:
Department of Housing and Urban Development

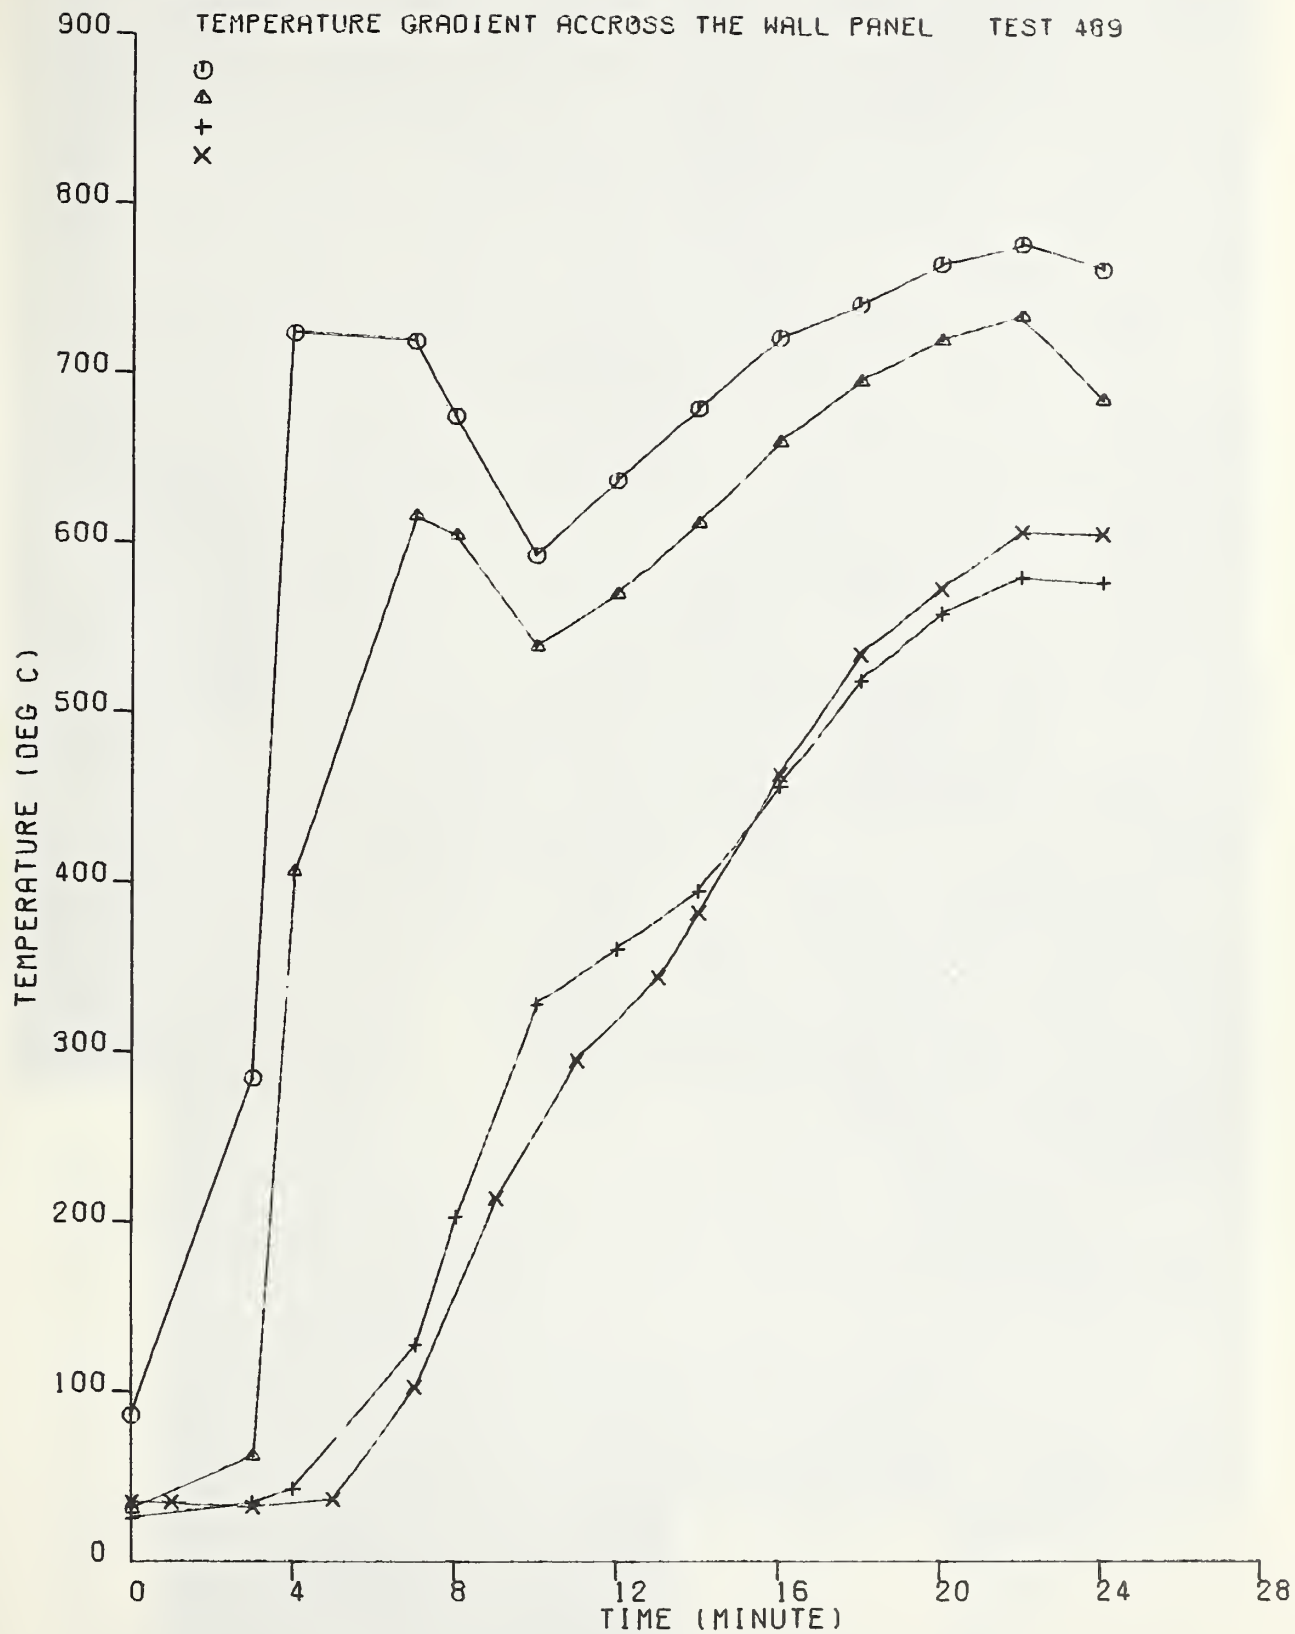
Figure 5

The average and maximum temperature rise of the unexposed surface and temperature gradient across the panel are shown in Figures 4 and 5, respectively. Figure 6 is a photograph showing the fire side of the panel after it was removed from the furnace just before extinguishment of the fire. Surfaces were buckled and the paint surfaces were blistered. Most of wood members, paper honeycomb and polyurethane foam were consumed during the 27 minutes of the test.

TEMPERATURE GRADIENT ACCROSS THE WALL PANEL TEST 489

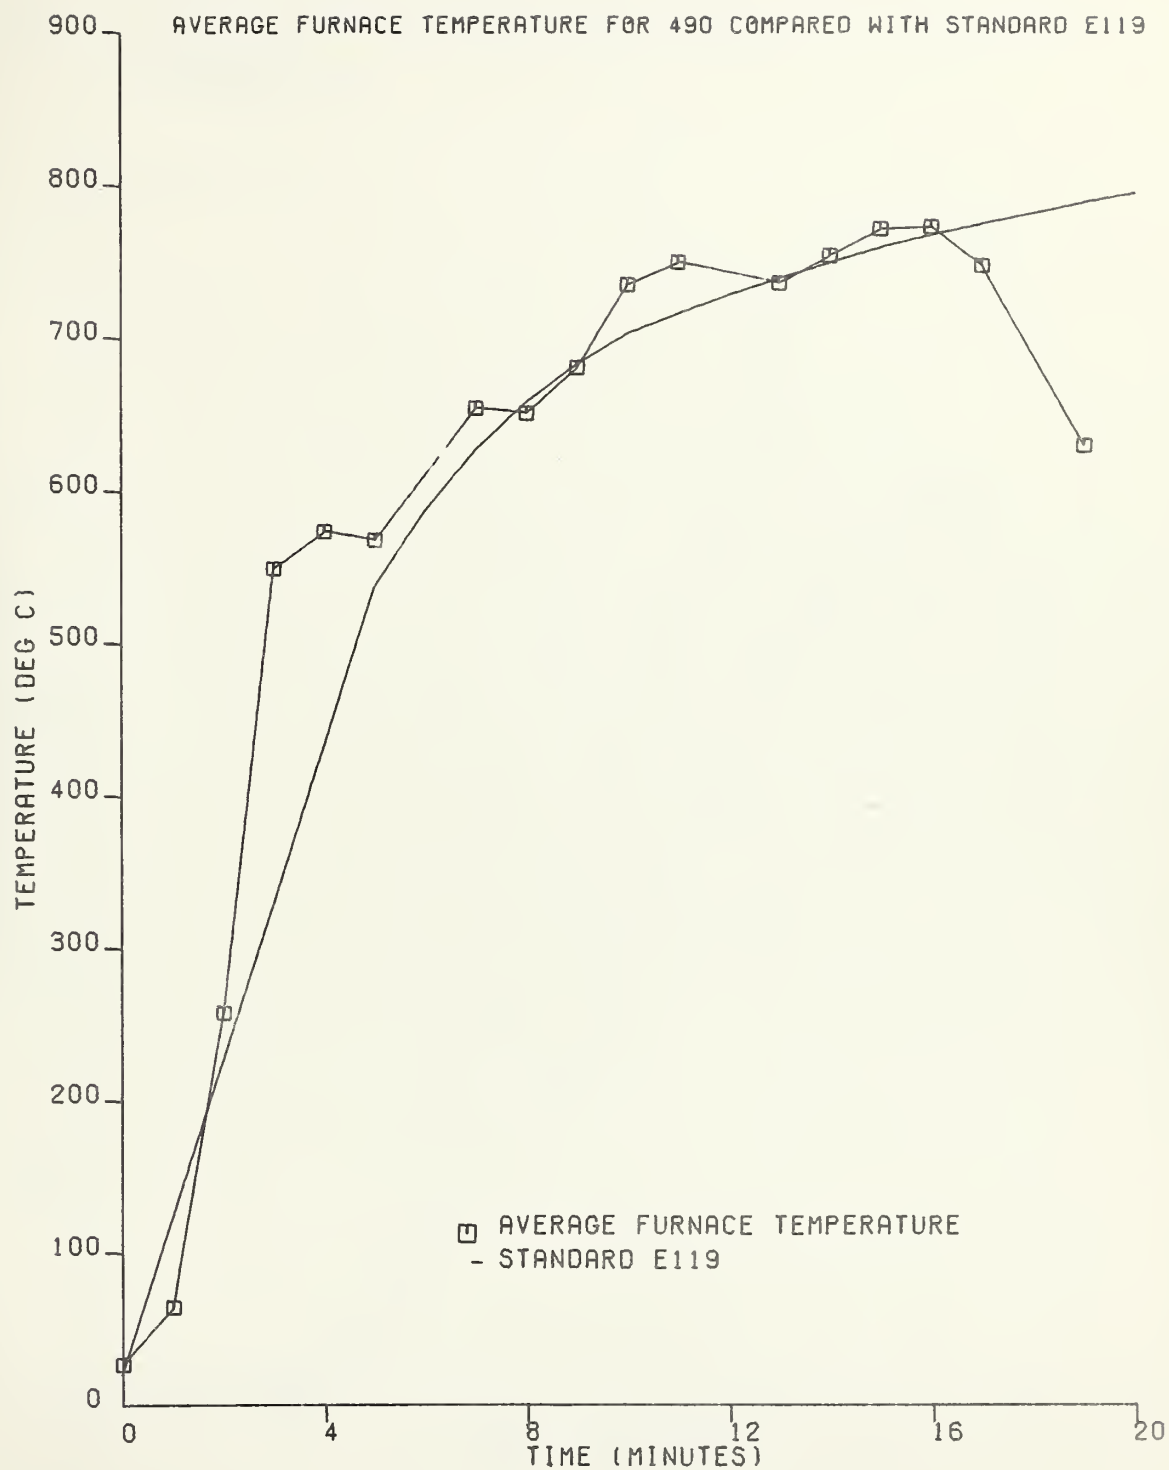
Figure 9

The temperatures inside the furnace were measured by twelve protected ASTM thermocouples. The temperatures were constrained to follow the standard ASTM E119-69 temperature time curve by automatic control of the gas flow to the burners. The furnace temperatures are shown in figure 9.

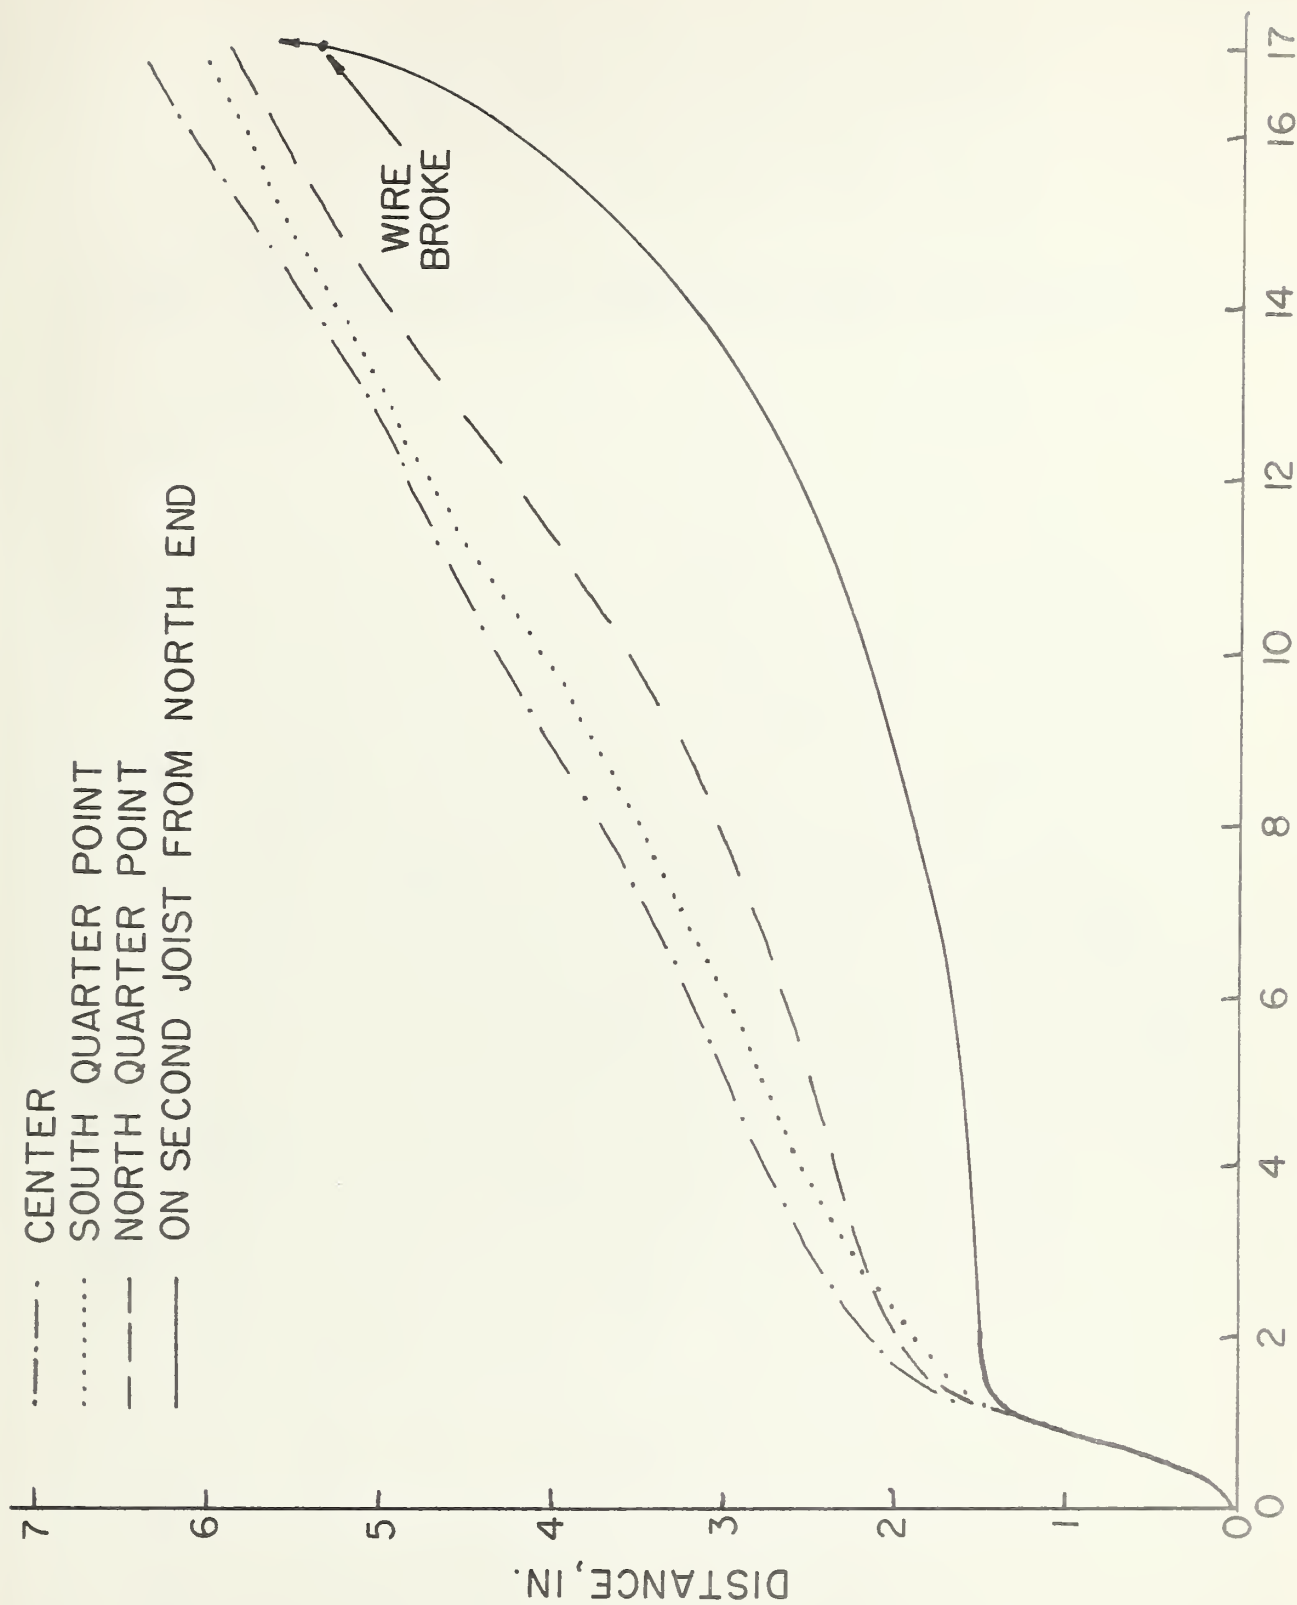
Figure 11 Deflections of the 4 points on the unexposed surface.

The deflections increased steadily as shown in figure 11. Load failure occurred suddenly at 17 minutes. The failure

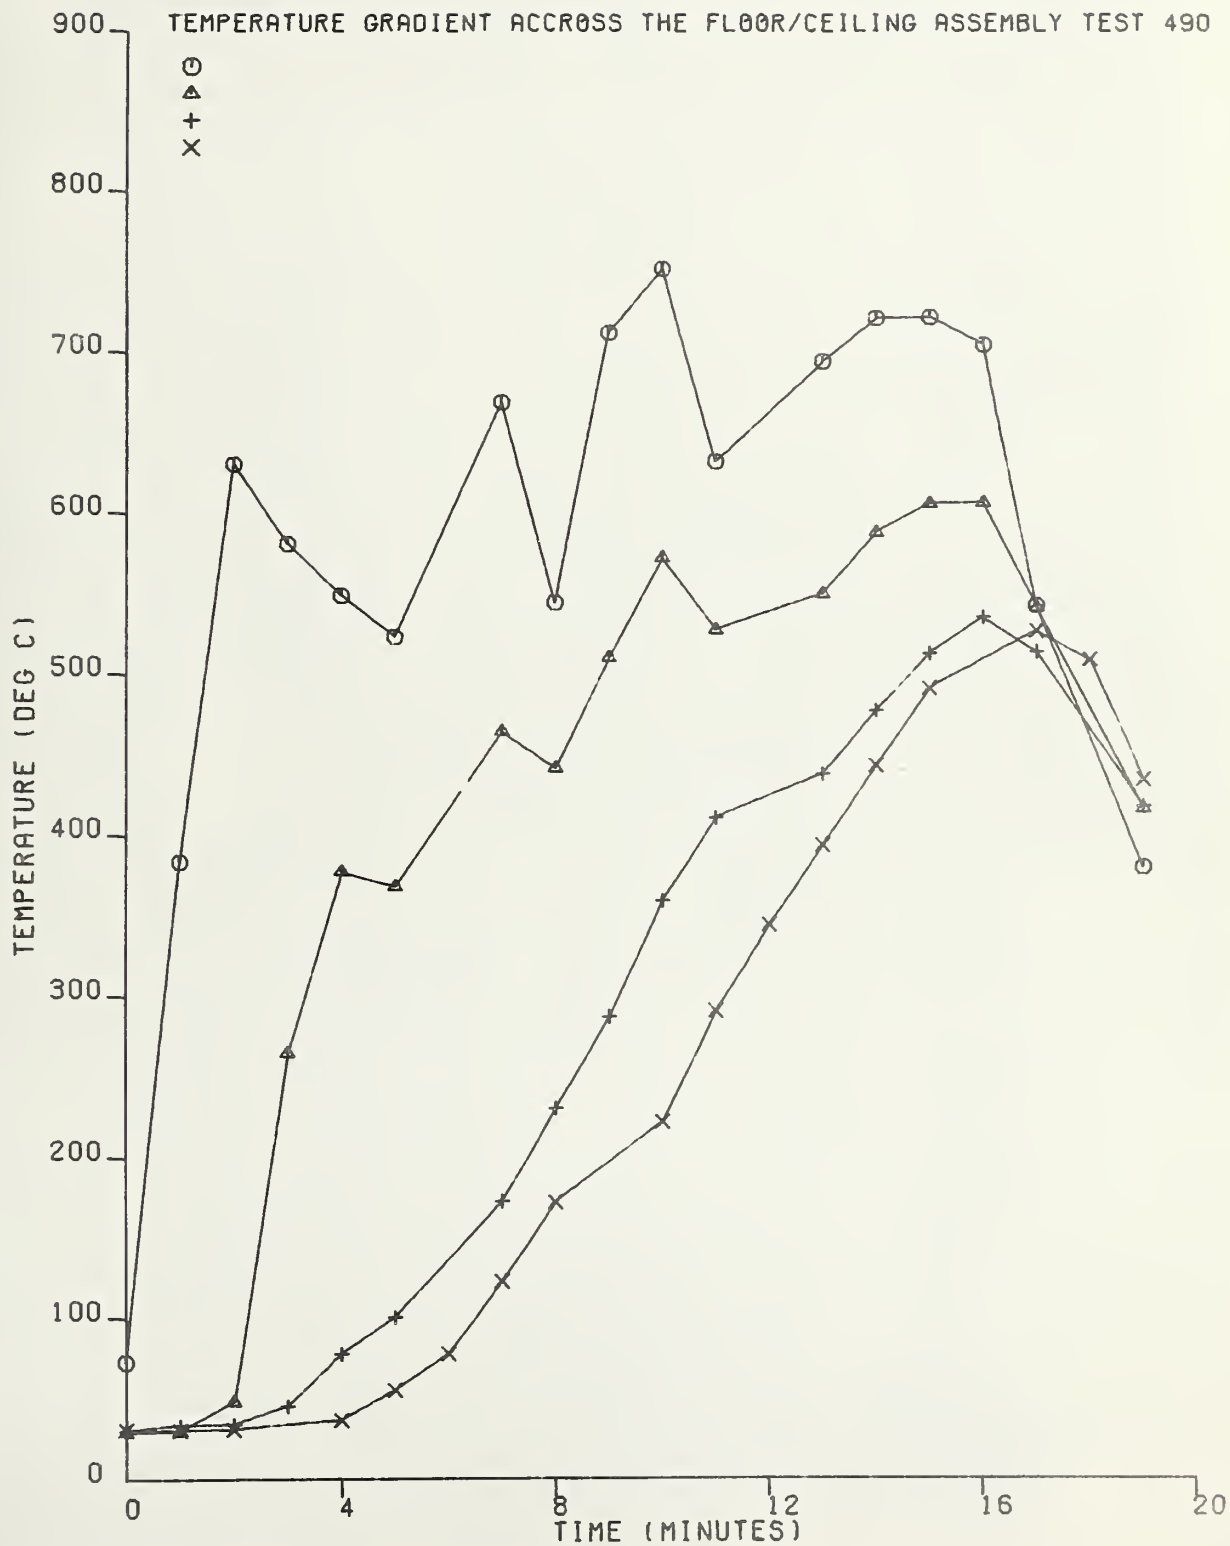
Figure 12

The average and maximum temperature rise of the unexposed surface and temperature gradient across the panel are shown in figures 10 and 12.
