NATIONAL BUREAU OF STANDARDS REPORT

10 677

FIRE ENDURANCE TEST OF AN INTERDWELLING WALL

The Gypsum Association

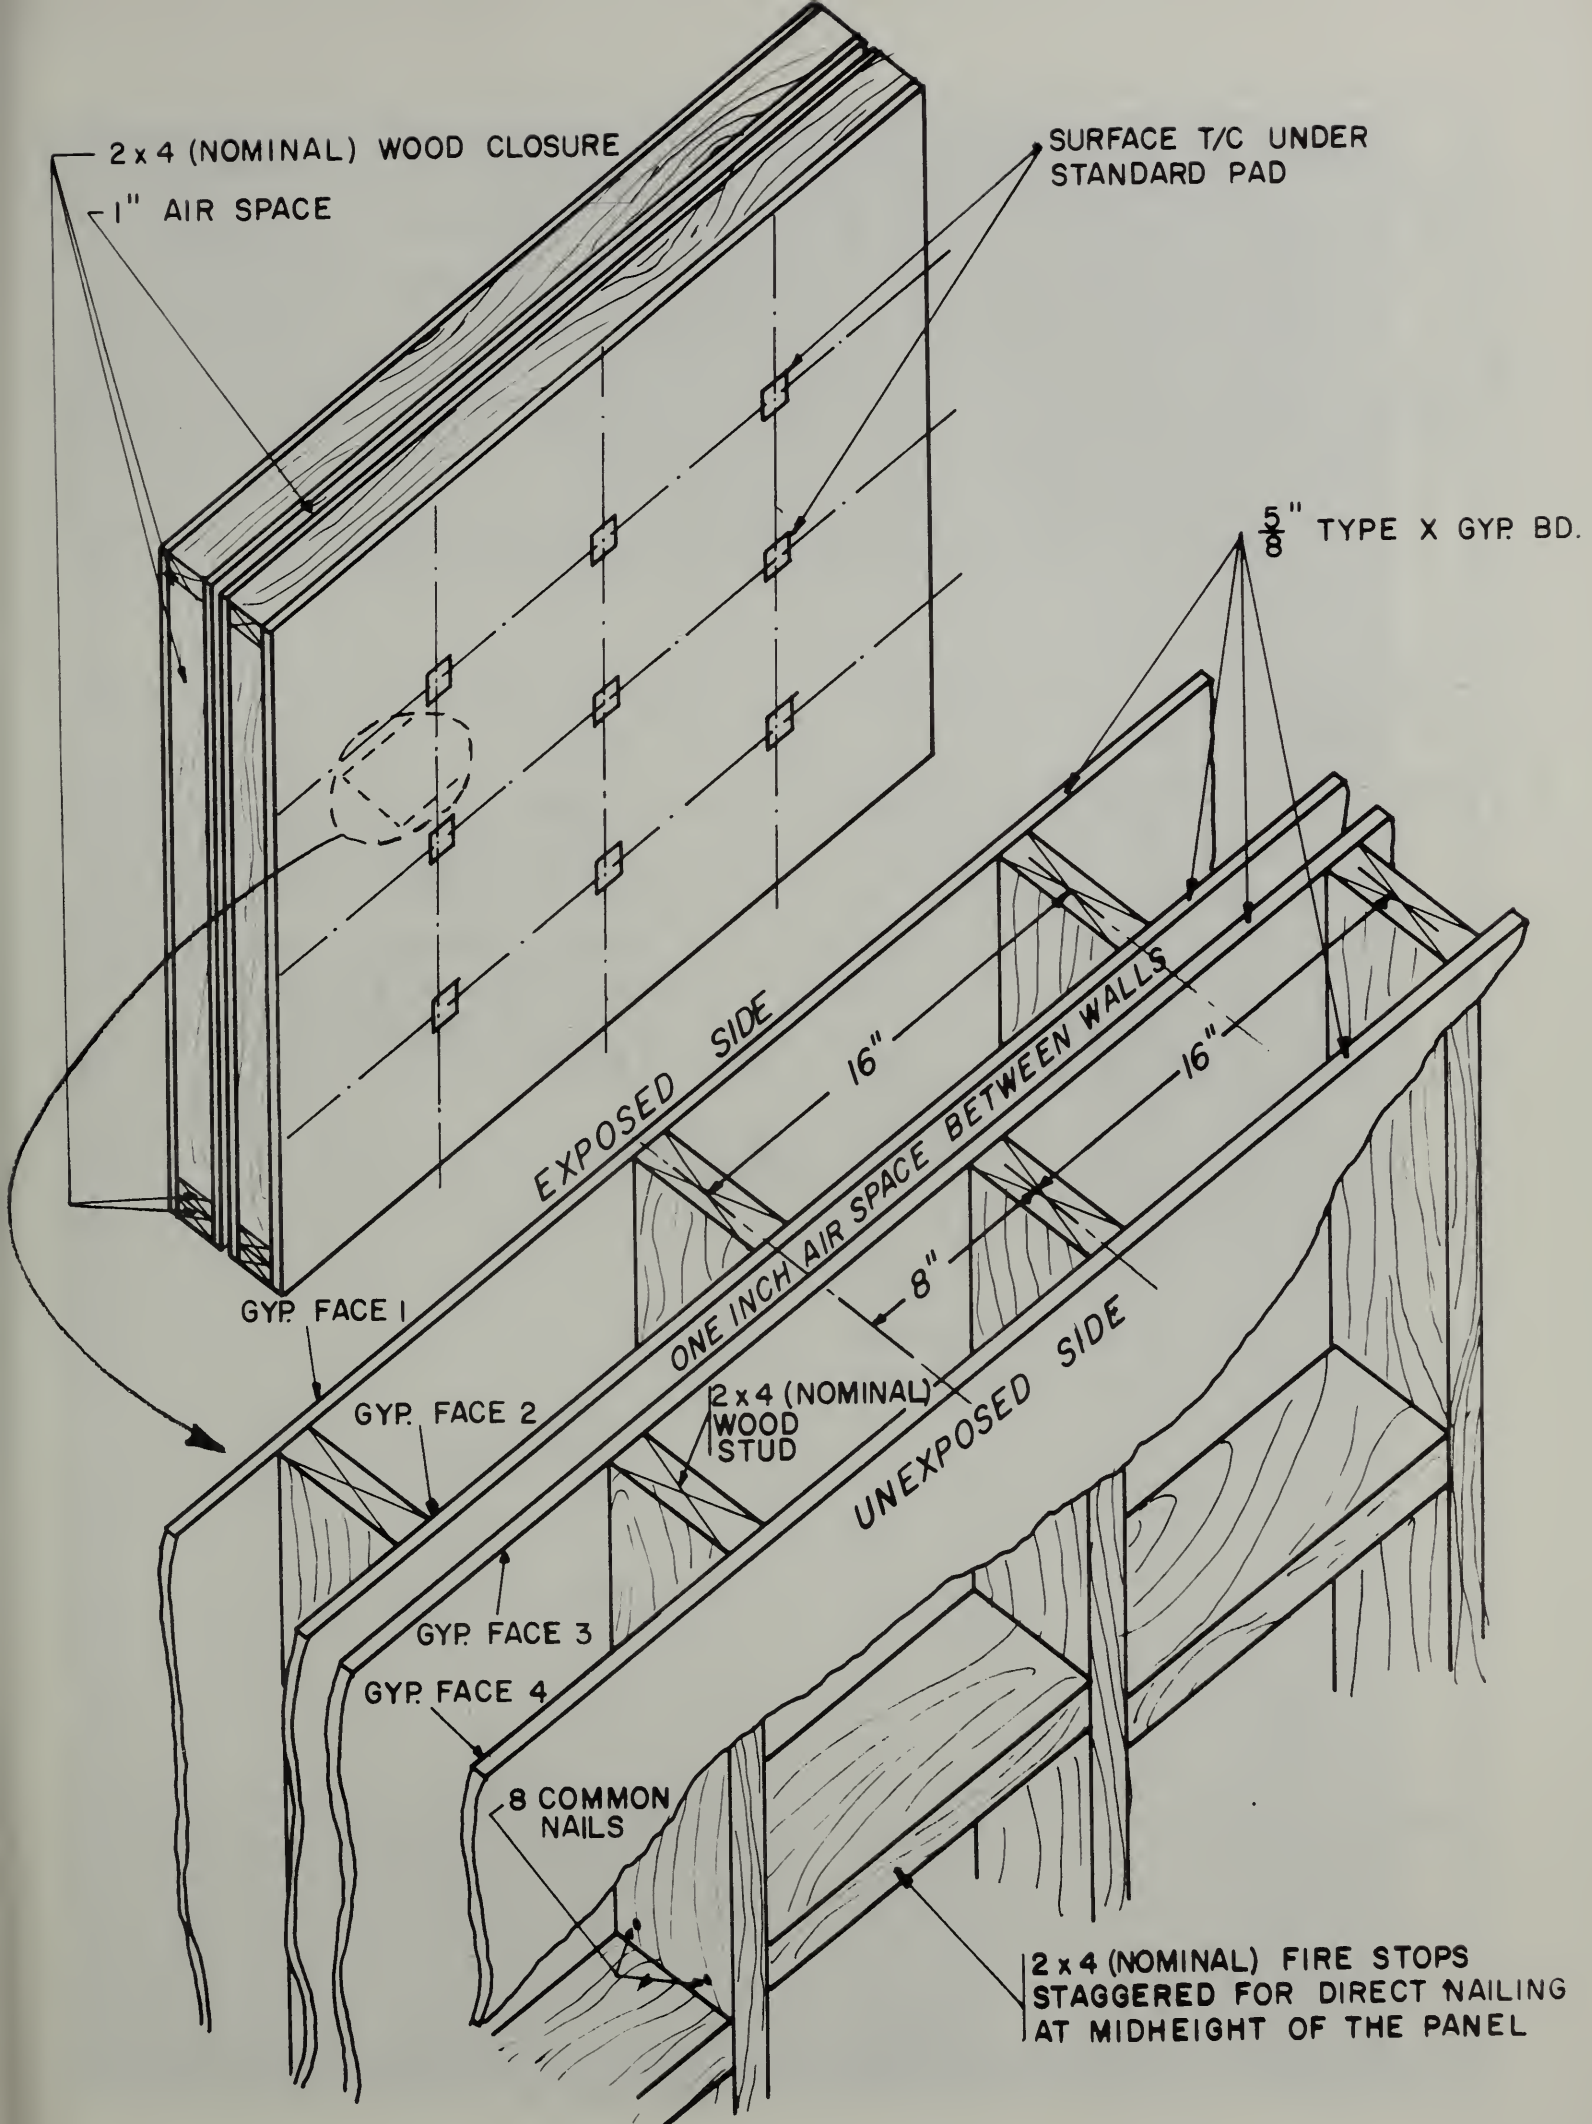
Figure 1. Construction Details

The construction of the specimen, as shown in Figures 1 and 2, was symmetrical except for the locations of the joints, so that if the opposite side would have been exposed to the fire it would have provided the same fire resistance.

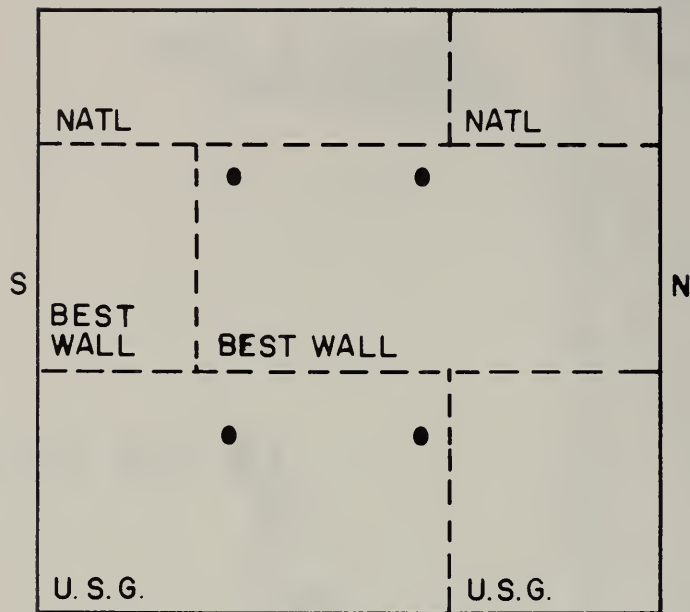
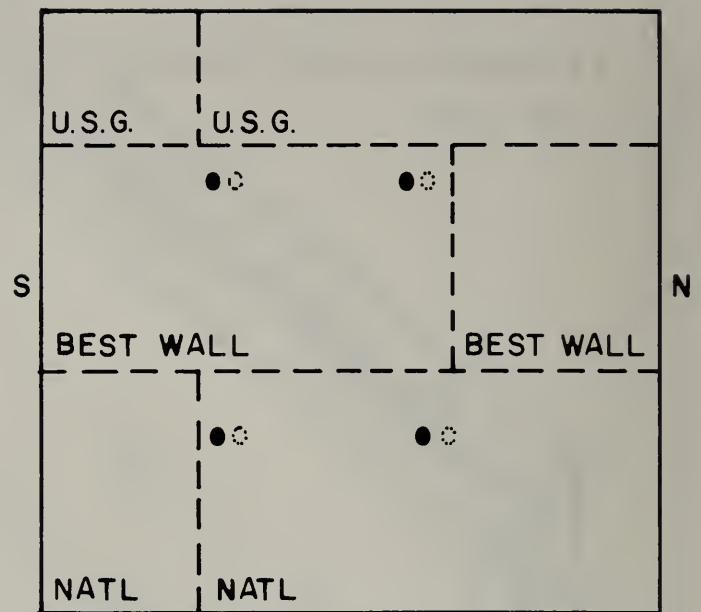
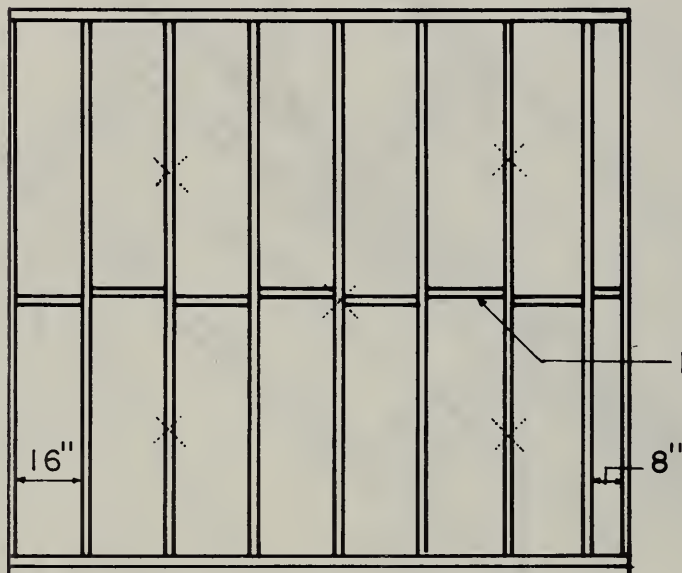
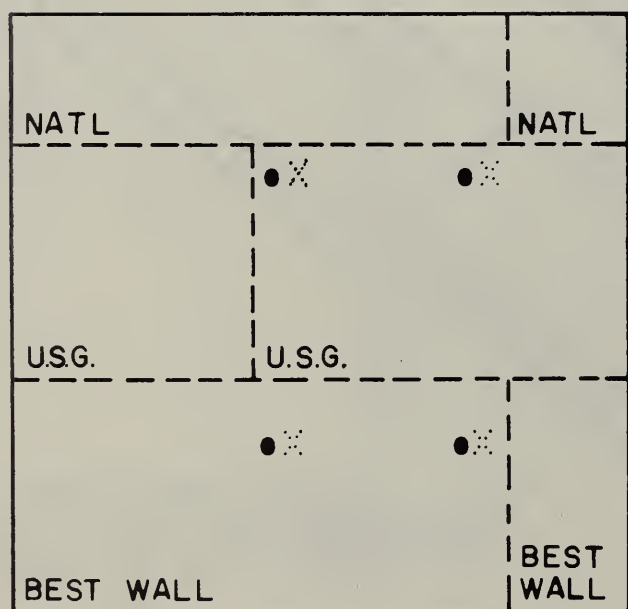
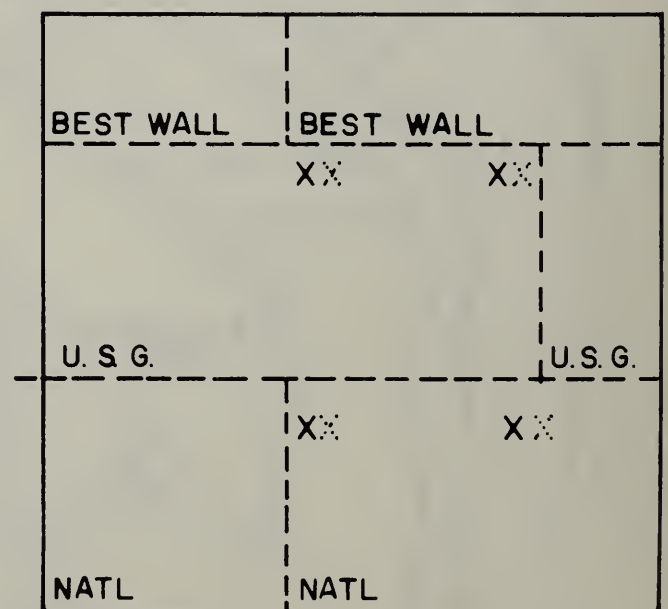
Figure 2. Locations of gypsum boards and thermocouples

Three different brands of 5/8 inch Type X gypsum boards were used to form the gypsum faces of the panels. The three brands were "Gold Bond" by National Gypsum Company, "Sheet Rock" by U.S. Gypsum Company, and "Best Wall" by Georgia Pacific Company. See Figure 2 for the locations of the different brands.

A total of 33 bare thermocouples, of which 16 were chromel-alumel and 17 were iron-constantan, were installed in the assembly. As is shown in Figure 2, four thermocouples were located on each of the four faces identified in Figure 1 and five between studs and the unexposed side of face 3.

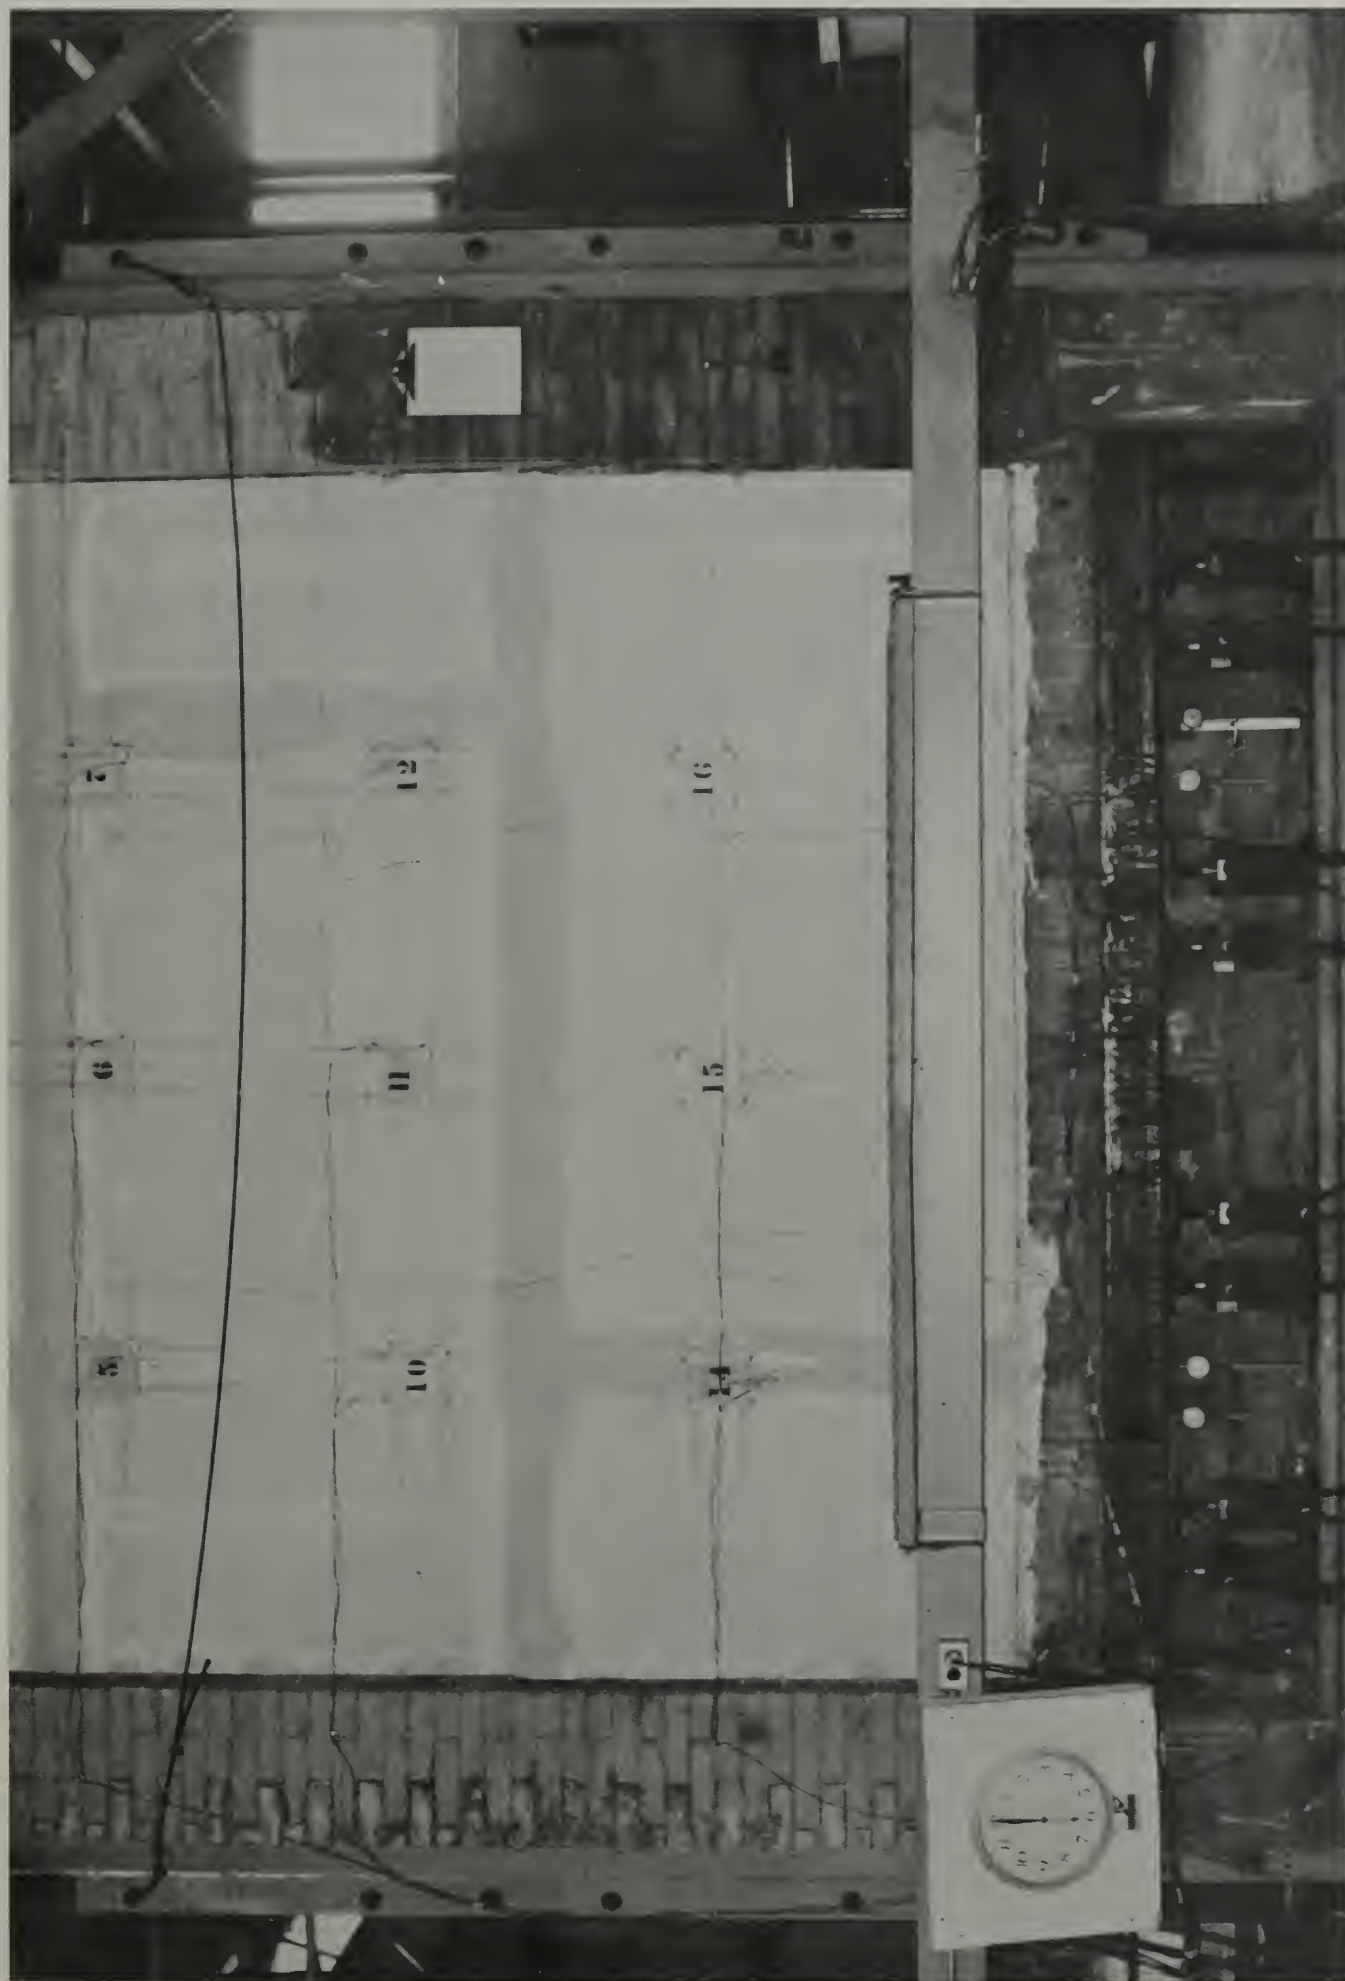
The vertical movements of each wall panel during the test were measured by four dial gages, which were located at the quarter points at the bottom of each loading frame, as shown in Figure 3.

Figure 3. The unexposed side of the assembly; the thermocouple connections, loading equipment, the lateral and the vertical deflection measuring device.

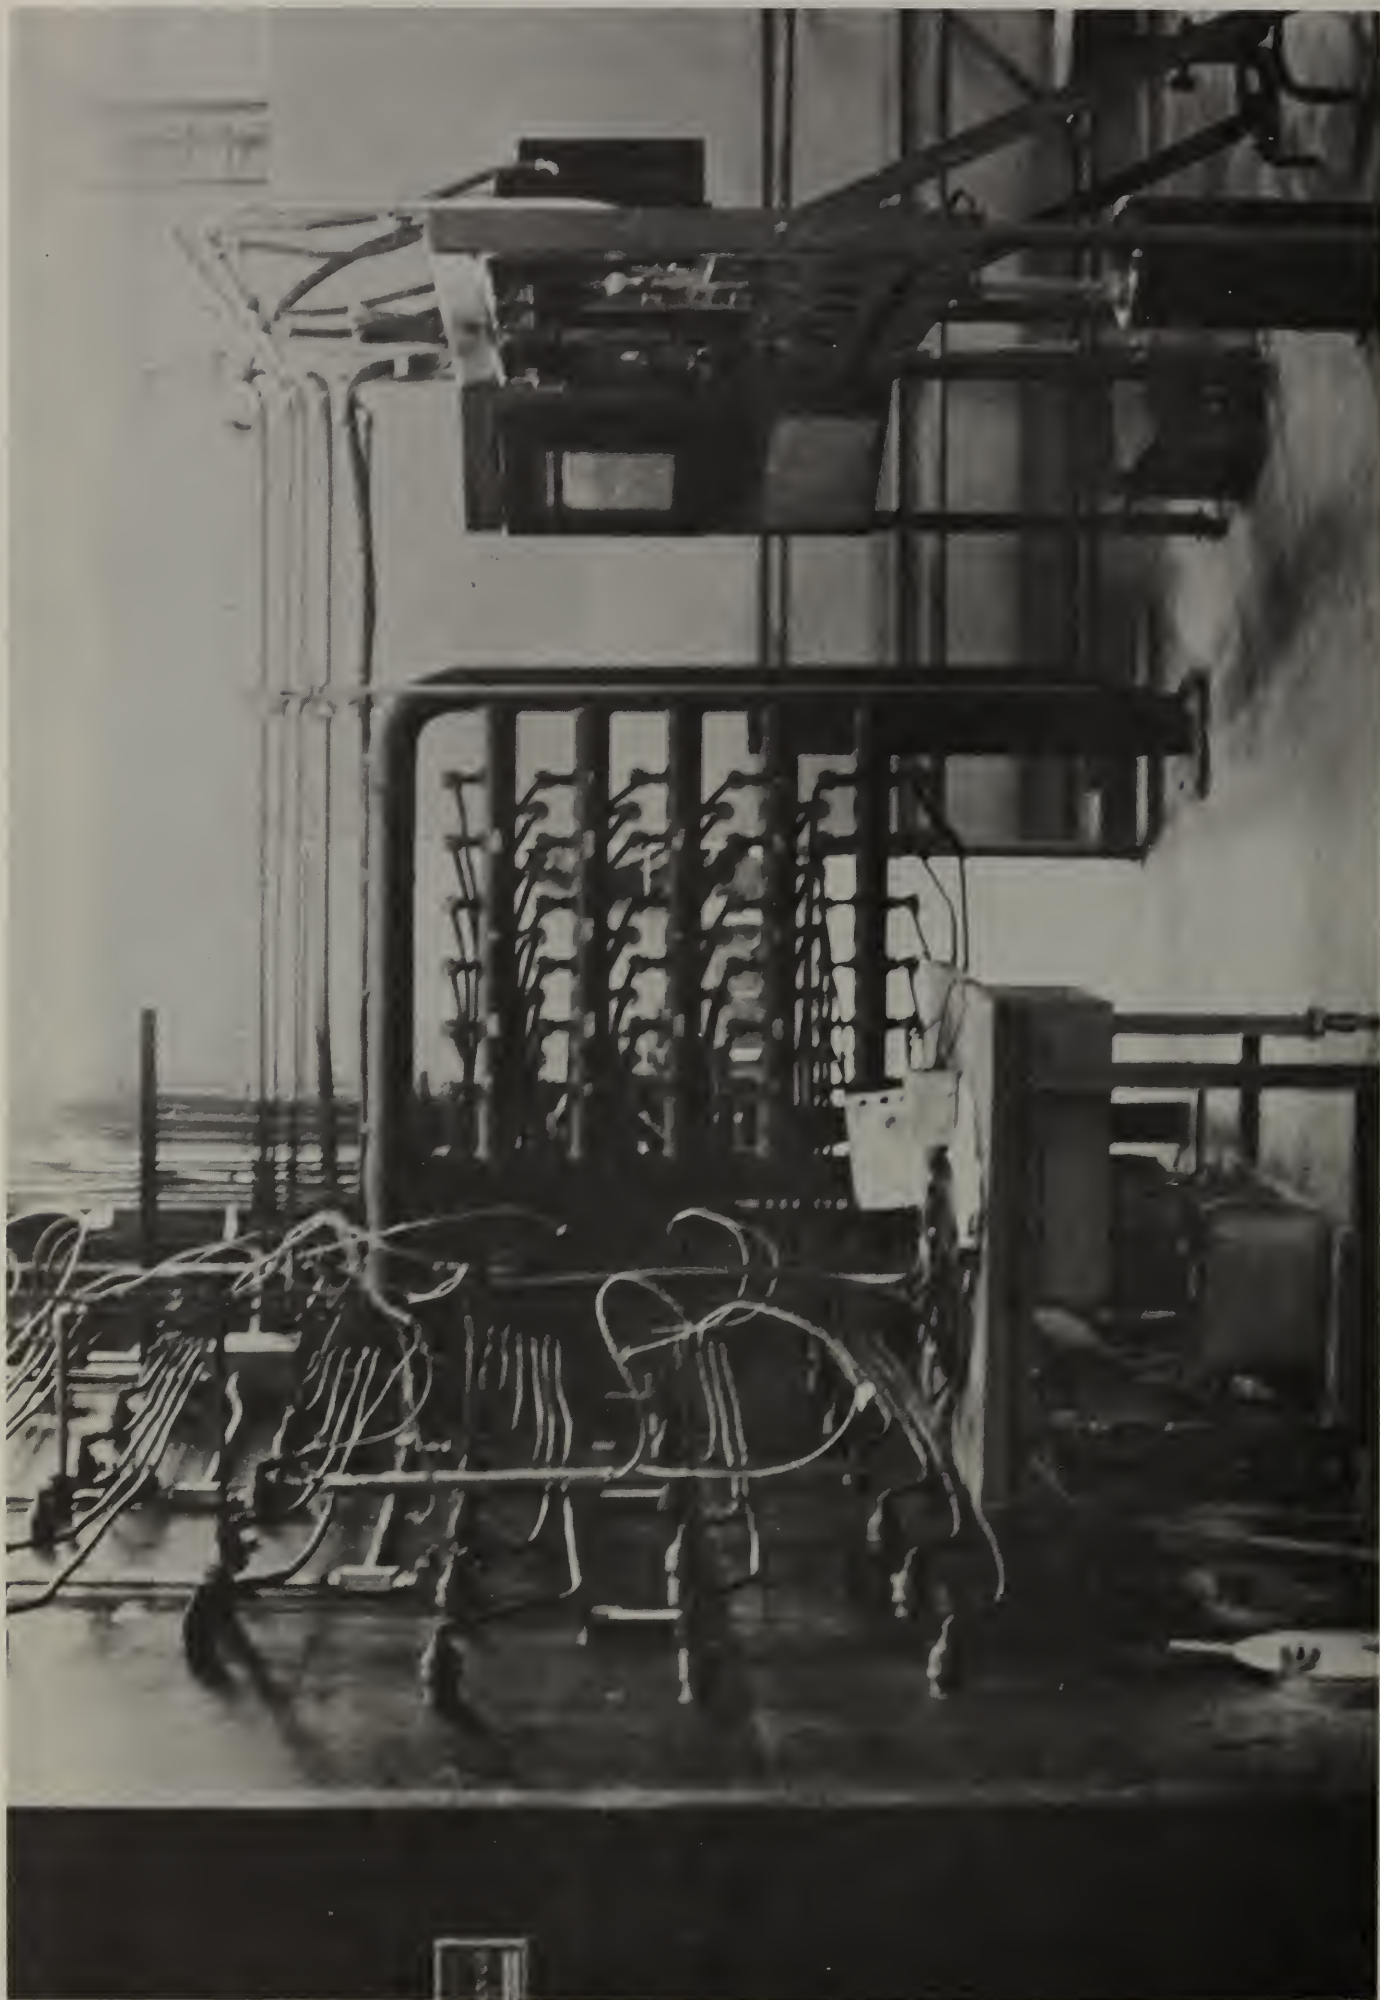
Figure 4. The back side of the furnace;
gas lines and recorders.

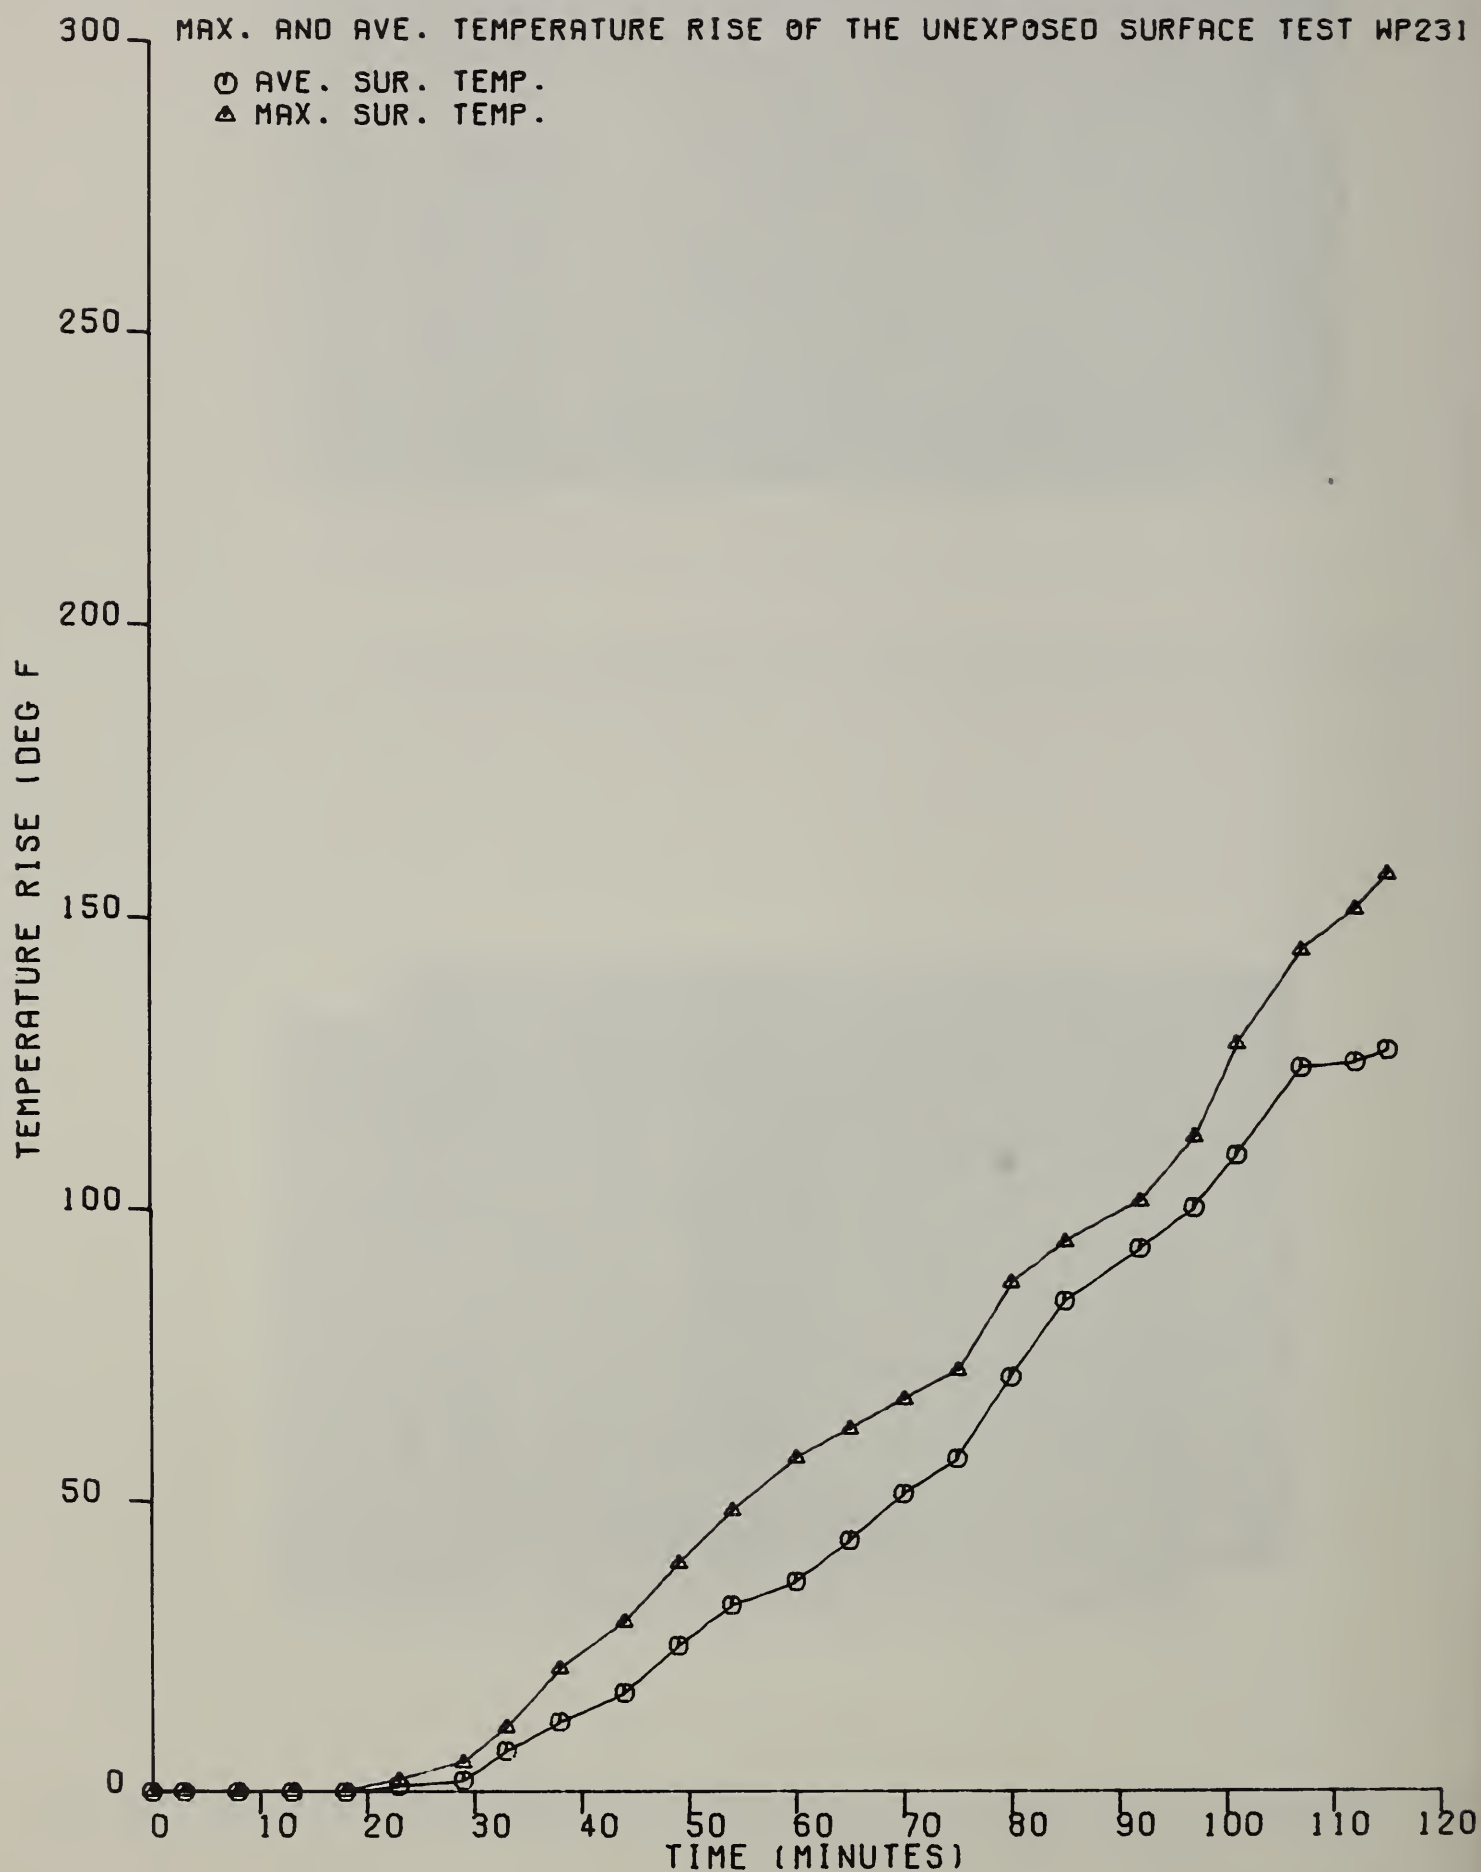
The average temperature rise of the unexposed surface and the maximum temperature rise during the test are shown in Figure 14. The average temperature gradients across the double wall assembly, the north half of the assembly and the south half of the assembly are shown in Figures 15, 16, and 17.
