# NATIONAL BUREAU OF STANDARDS REPORT

10 813

## FIRE ENDURANCE TESTS OF ALUMINUM BULKHEAD AND DECK ASSEMBLIES

SOCIETY OF NAVAL ARCHITECTS AND MARINE ENGINEERS

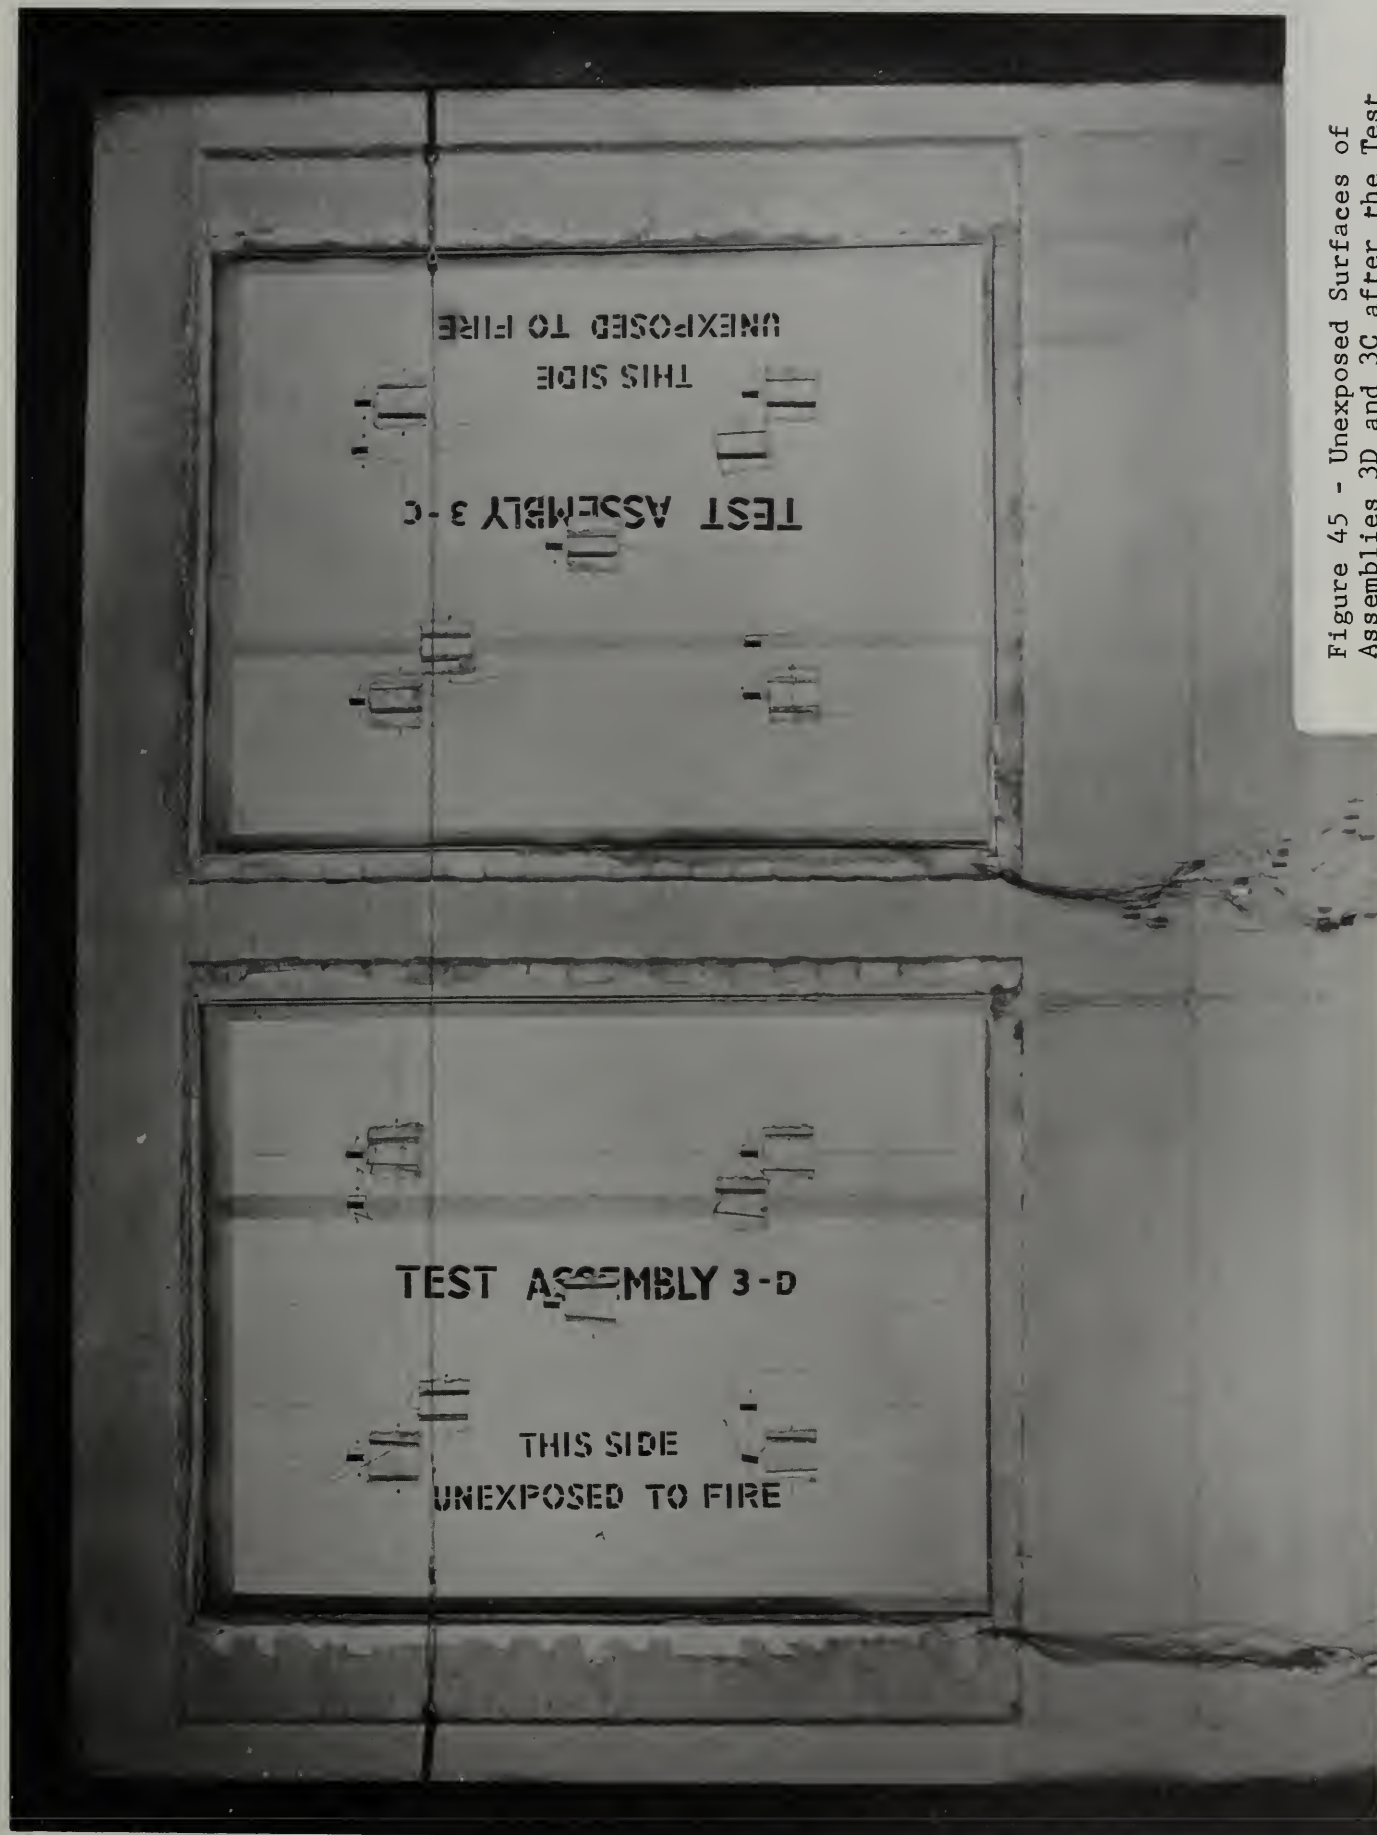
Figure 45 - Unexposed Surfaces of  
Assemblies 3D and 3C after the Test

35 minutes	Bowing of aluminum frame from raceway at lower left corner of unexposed side of 3C. Panel 3D exposed side deformed. Light grey smoke escaping at the top of panel 3C.
38 minutes	Dull noise. Slight flaming at left hand edge of 3D.
42 1/2 minutes	Louder noise on 3C.
44 1/2 minutes	Louder noise from panel 3D.
50 minutes	Horizontal crack on Marinite on fire side of panel 3C approximately 1/3 height. Slight bowing at lower left of unexposed corner of 3D are similar to 3C at 35 minutes.
53 minutes	Aluminum retainer buckled out approximately 1/2 inch over a 4 inch length at upper left corner of 3C.
55 minutes	Slight bowing at lower right unexposed corner of 3C.
58 minutes	No ignition of cotton pads at upper left corner of 3C and 3D.
