FIELD MEASUREMENT OF HCl CONCENTRATION
FROM
PVC ELECTRICAL CONDUIT INVOLVED IN FIRE

SINGLE STORY HOUSE

6 June 1972

February 4, 1972

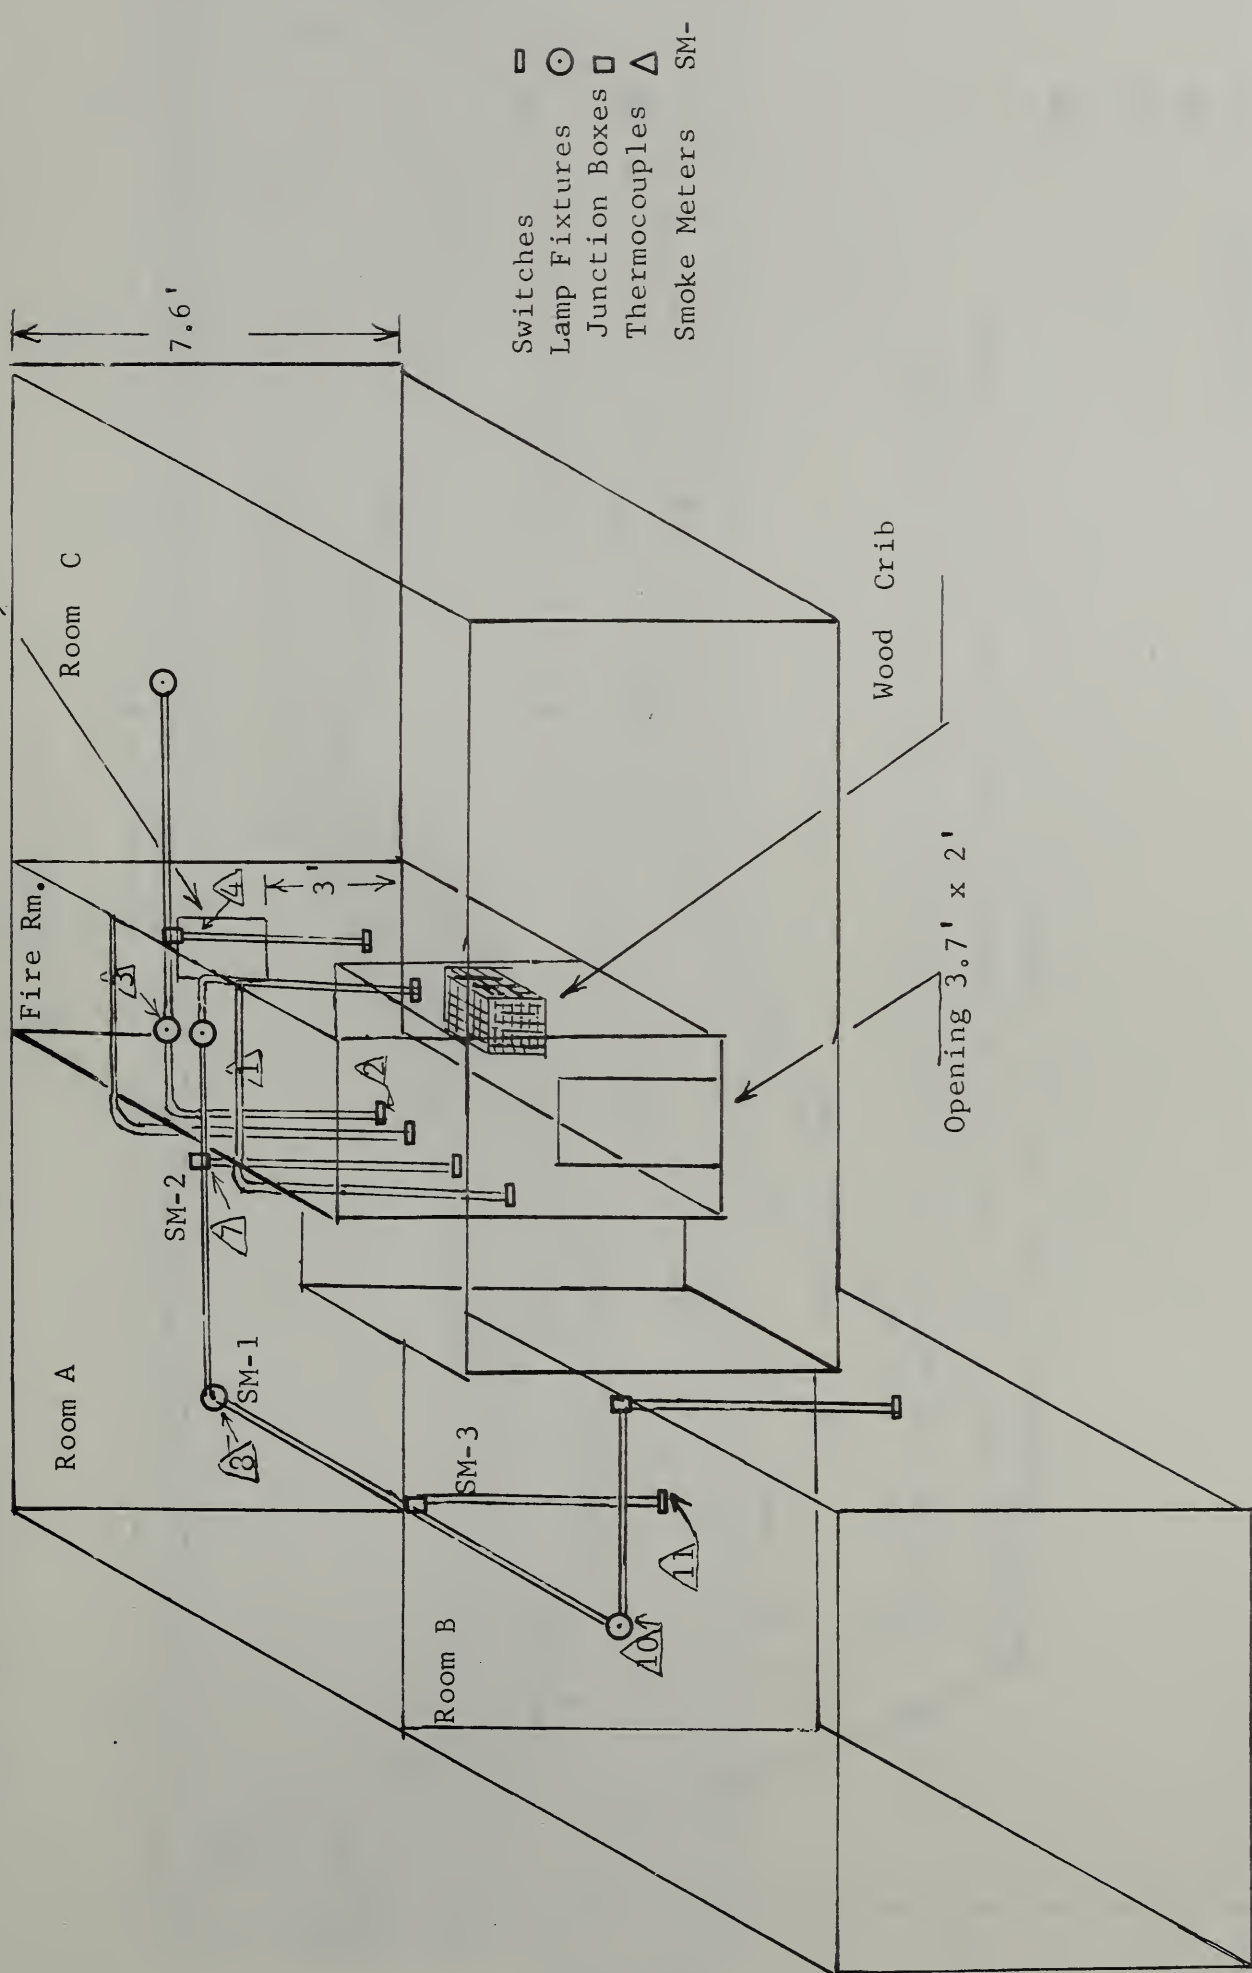
Fig. 3 Conduit Layout in Test House

The location of junction boxes, switches and light fixtures is shown in Fig. 3. The junction and outlet boxes for light switches were of the common residential type, 4" x 2 1/8" x 1 7/8", galvanized steel construction. Switches and light fixtures were also the type used in common residential houses. All boxes, switches and light fixtures were connected with 2 wires and had covers simulating normal installation. The other 4 of the 6 wires terminated in the box or fixture without connection. The two lamp fixtures in the fire room included 8 inch diameter glass covers, but without light bulbs.

Twelve thermocouples located within the fire and other rooms were used to monitor continuously the temperature profile of the fire. Figure 3 and 4 shows some thermocouple locations and selected time temperature profiles developed during the test, respectively.

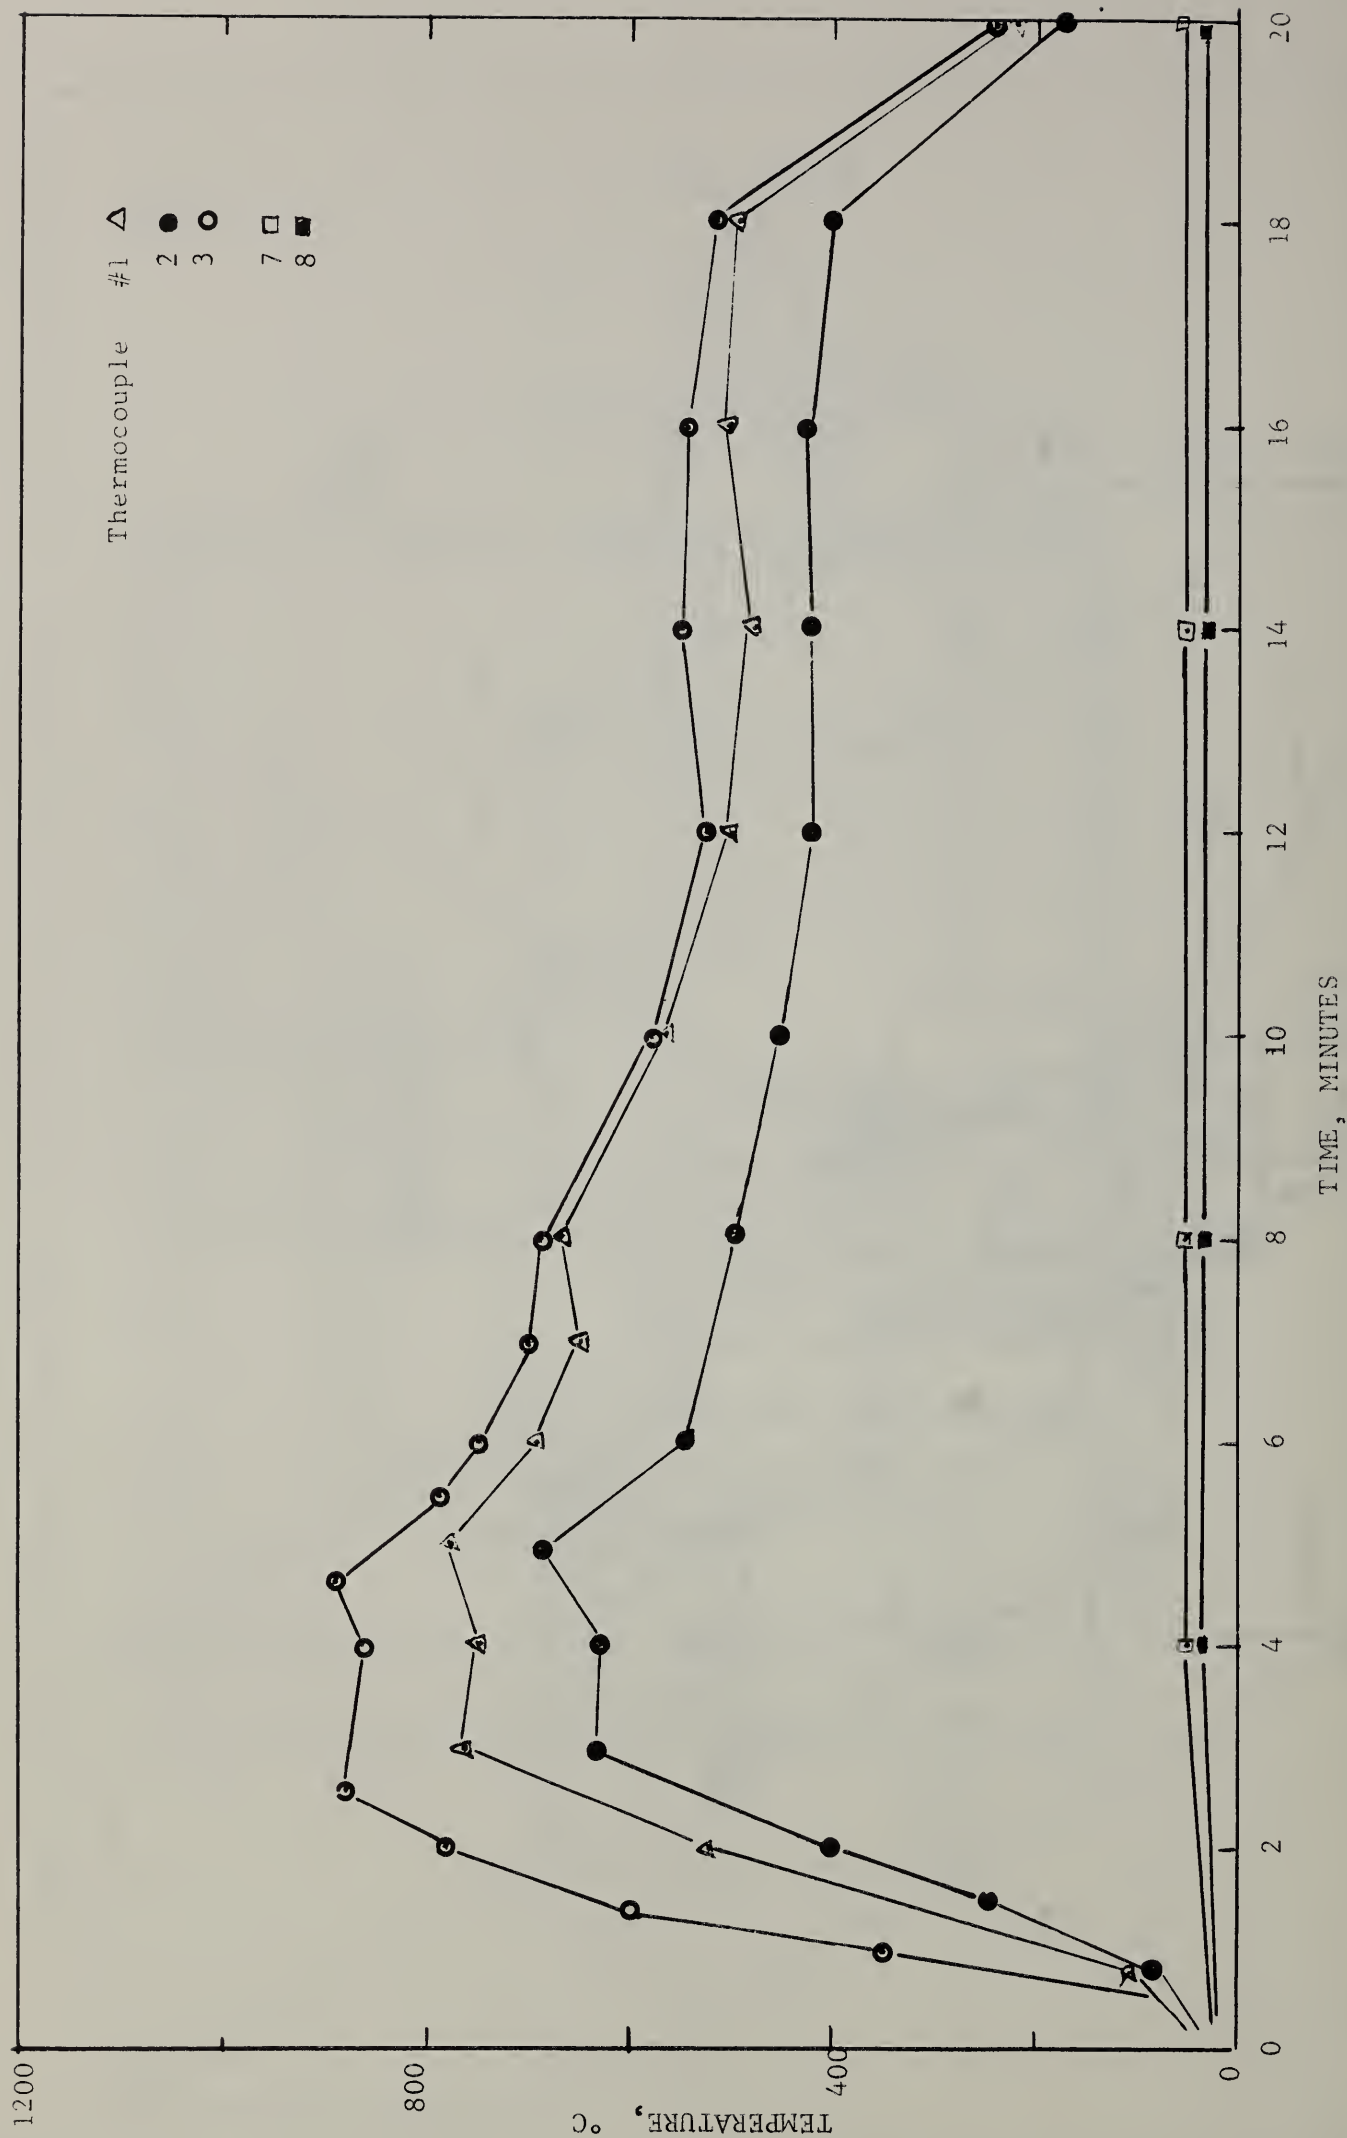
Fig. 4 Time-Temperature Profile of Fire and Other Rooms

At about 4 minutes, there was insufficient air flow into the fireroom as evidenced by the smoke exhaust and drop in fire room temperature. To remedy this, the board across the window at the exterior of the fire room was removed, doubling the original opening. The door in Room D to the outside porch was also opened. The fire resumed active burning as indicated by momentary temperature rise shown in Figure 4.

Because of the intensity of the fire in the fire room, practically all PVC conduit and wire insulation was decomposed leaving only a small amount of charred residue and bare copper wire. The maximum temperature reached was 850°C. The copper wire (melting point about 1100°C) did not melt. Where the conduit pierced a wall into another room, the charred residue from the thermoplastic conduit and internal wiring effectively blocked most of the smoke and gas movement through the conduit. The conduit in the adjoining rooms was almost unaffected with no signs of softening or charring. The detail of this is shown in Figure 5.

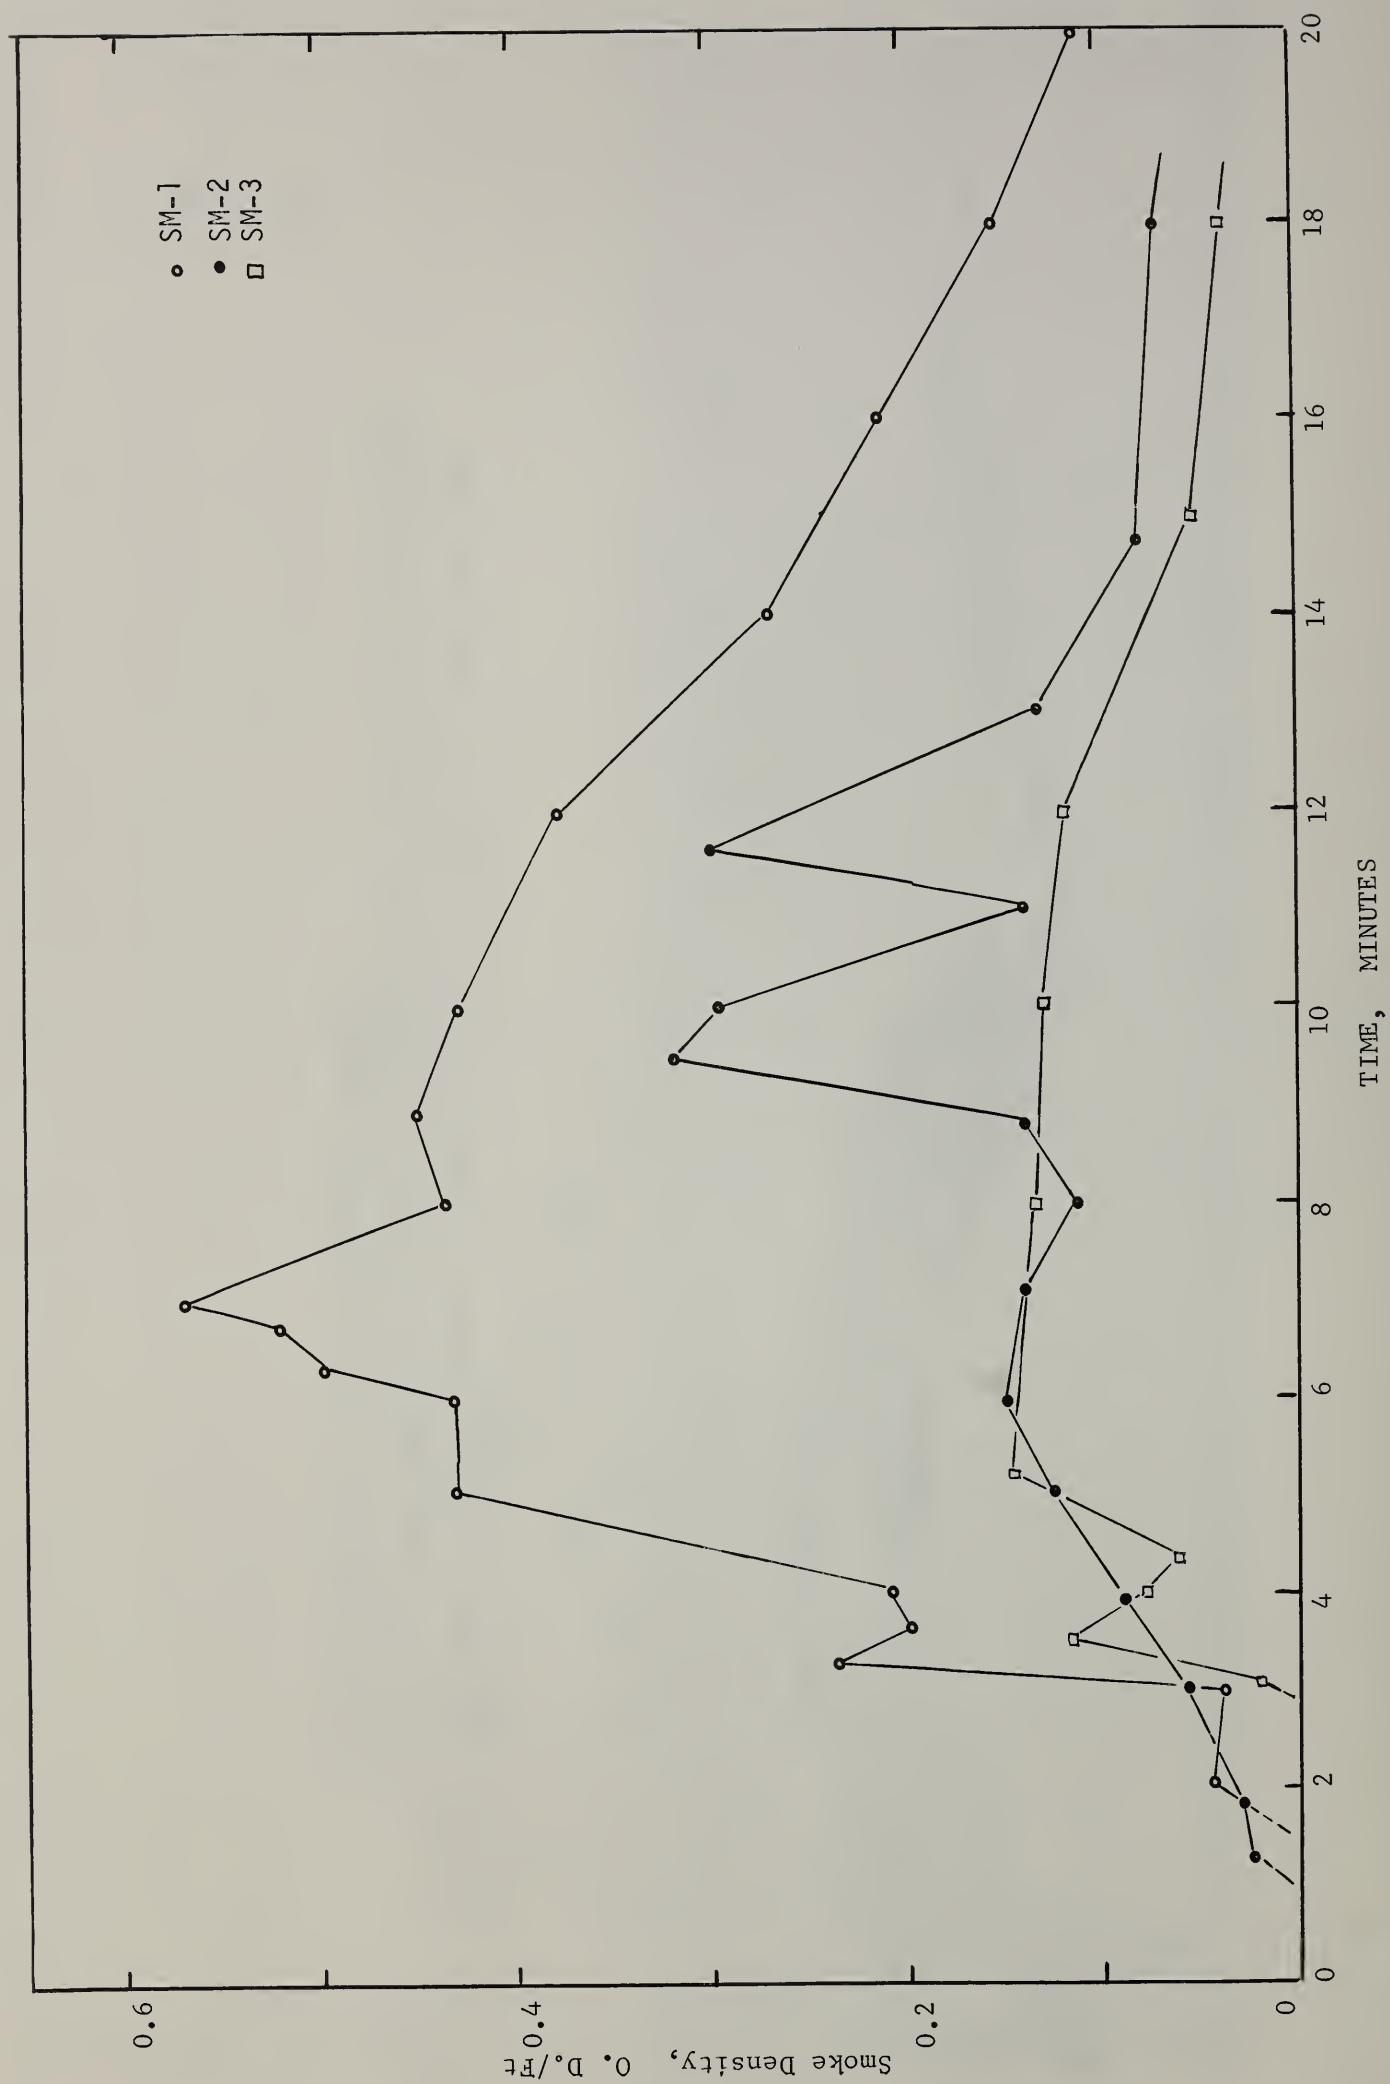
Fig. 6 Smoke Developed in Room A and B

Smoke was observed emanating from the junction and switch boxes in Room A in about 1.2 minutes. Figure 6 shows the smoke build-up as recorded by the smoke meters located in Rooms A and B. The smoke reached a maximum plateau of about 0.6 OD/ft* in the center of the room at about 7 minutes. The peaking time also matched the one based on HCl concentration measurement.

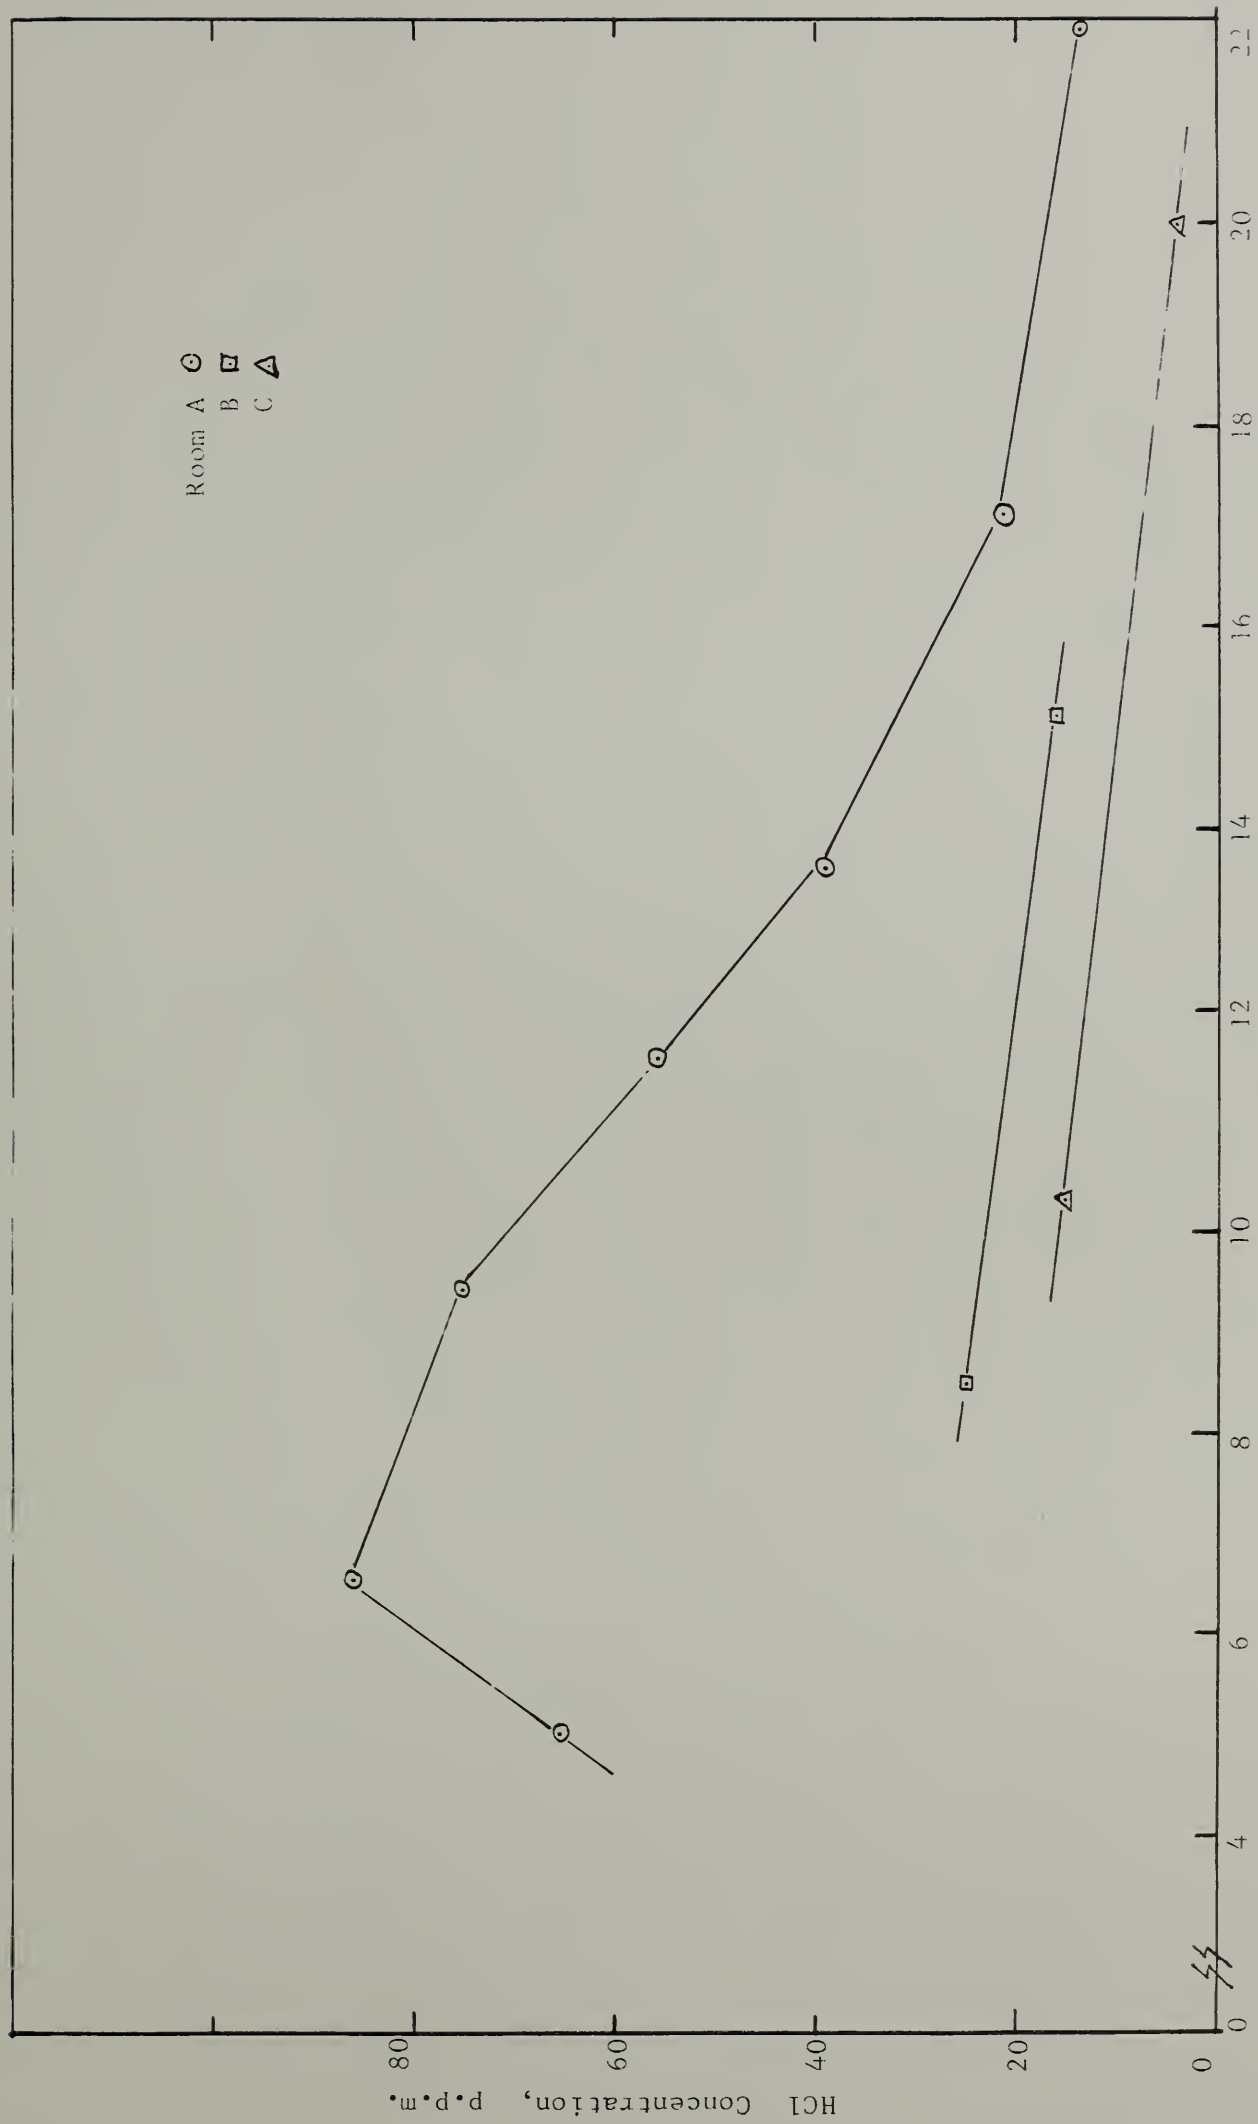
Fig. 7 Concentration of HCl in 3 Rooms

HCl concentration measurements were recorded periodically from the center of each room. Figure 7 shows measured HCl concentration at each room during the test. The maximum level was 85 ppm in Room A; 25 and 15 in Rooms B and C respectively.

In assessing HCl and smoke movement, it should be pointed out that HCl decays rather rapidly by absorption on solid surfaces. Undoubtedly much HCl is lost passing through the conduit where surface area including the insulated wire was $60 \text{ in}^2/\text{ft}$. A simple laboratory study could determine the losses per unit length. The decay portion of the curve in Figure 7 shows the relative ease with which HCl vapor in the room is lost, after 8 minutes, when HCl is no longer available from the fire room. Since the rooms were unusually cold (60°F), the loss rate was probably higher than might be expected at higher ambient temperature.
