NATIONAL BUREAU OF STANDARDS REPORT

3353

TEST OF PRECAST PANEL FRAME NO. 1

Report to
Bureau of Yards and Docks
Department of the Navy

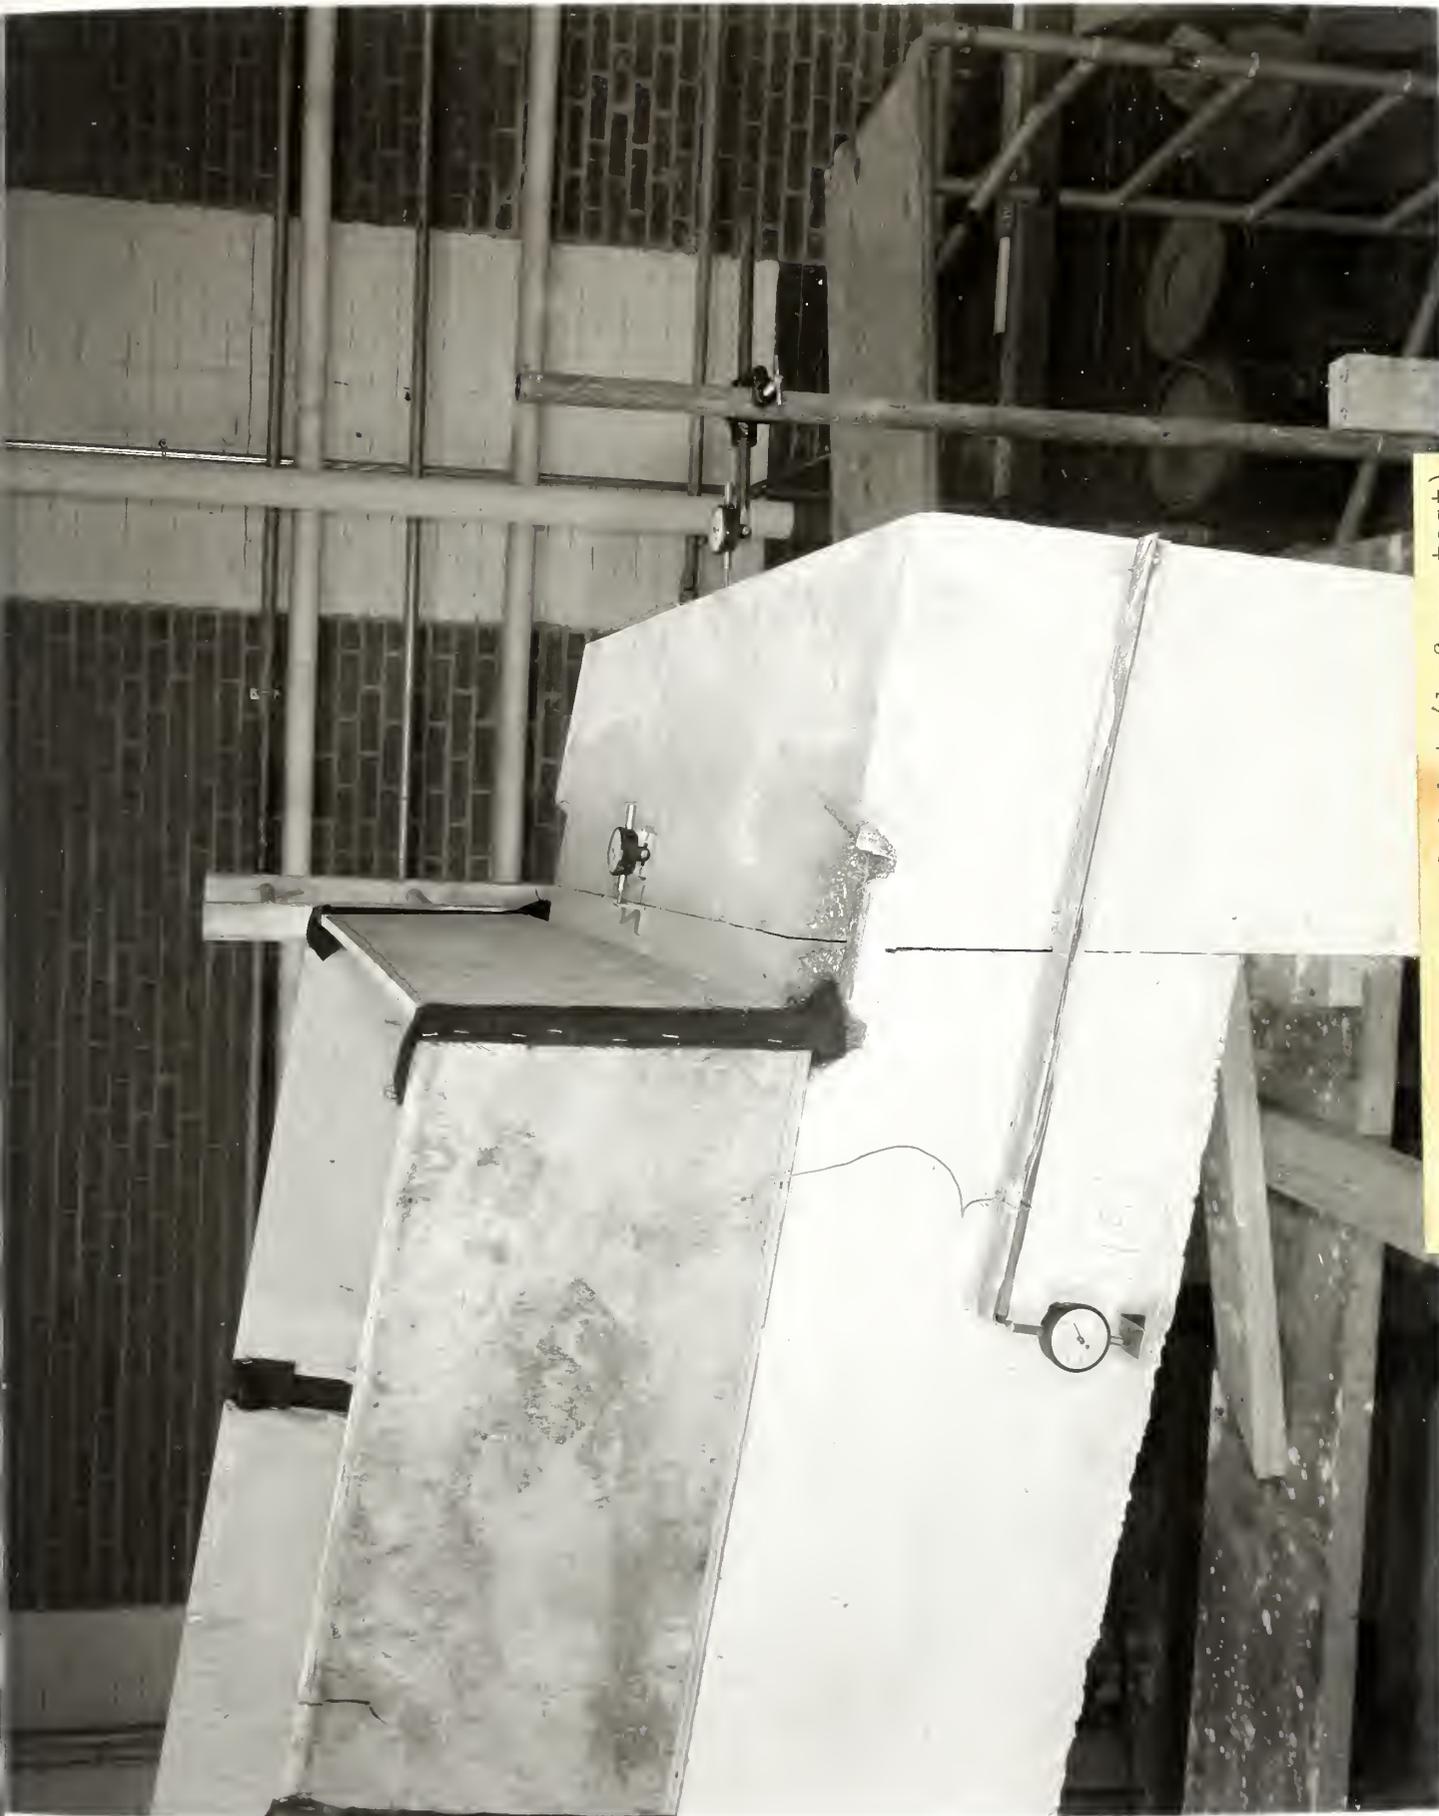
Fig. 3 - South end joint (before test)

Measurements were made of rotation at the end joints, center joint and also of the side walls with respect to the footings. Figures 3 and 4 show the instrumentation used for the measurement of the rotation at the end joints and center joint, respectively. Figures 8 and 9 give the results of these measurements plotting rotation in radians against time. Rotation at the center and end joints reached a maximum four days after the application on the 80 psf increment of load.

Changes in the width of crack between the wall and roof sections and also at the crown were measured with 1/1000 in. dial gages as seen in figures 3 and 4. The gages were placed in such a way as to measure the maximum opening. Figure 11 is a graphic picture of the results of these measurements. The maximum crack opening at the crown occurred at the maximum load of 80 psf and was .25 in. just prior to removal of load. The maximum crack opening between the wall and roof panels was .075 in. Recovery was observed for six days after the removal of the live load and amounted to .098 in. for the crack at the crown and .030 in. for the cracks between the wall and roof panels.

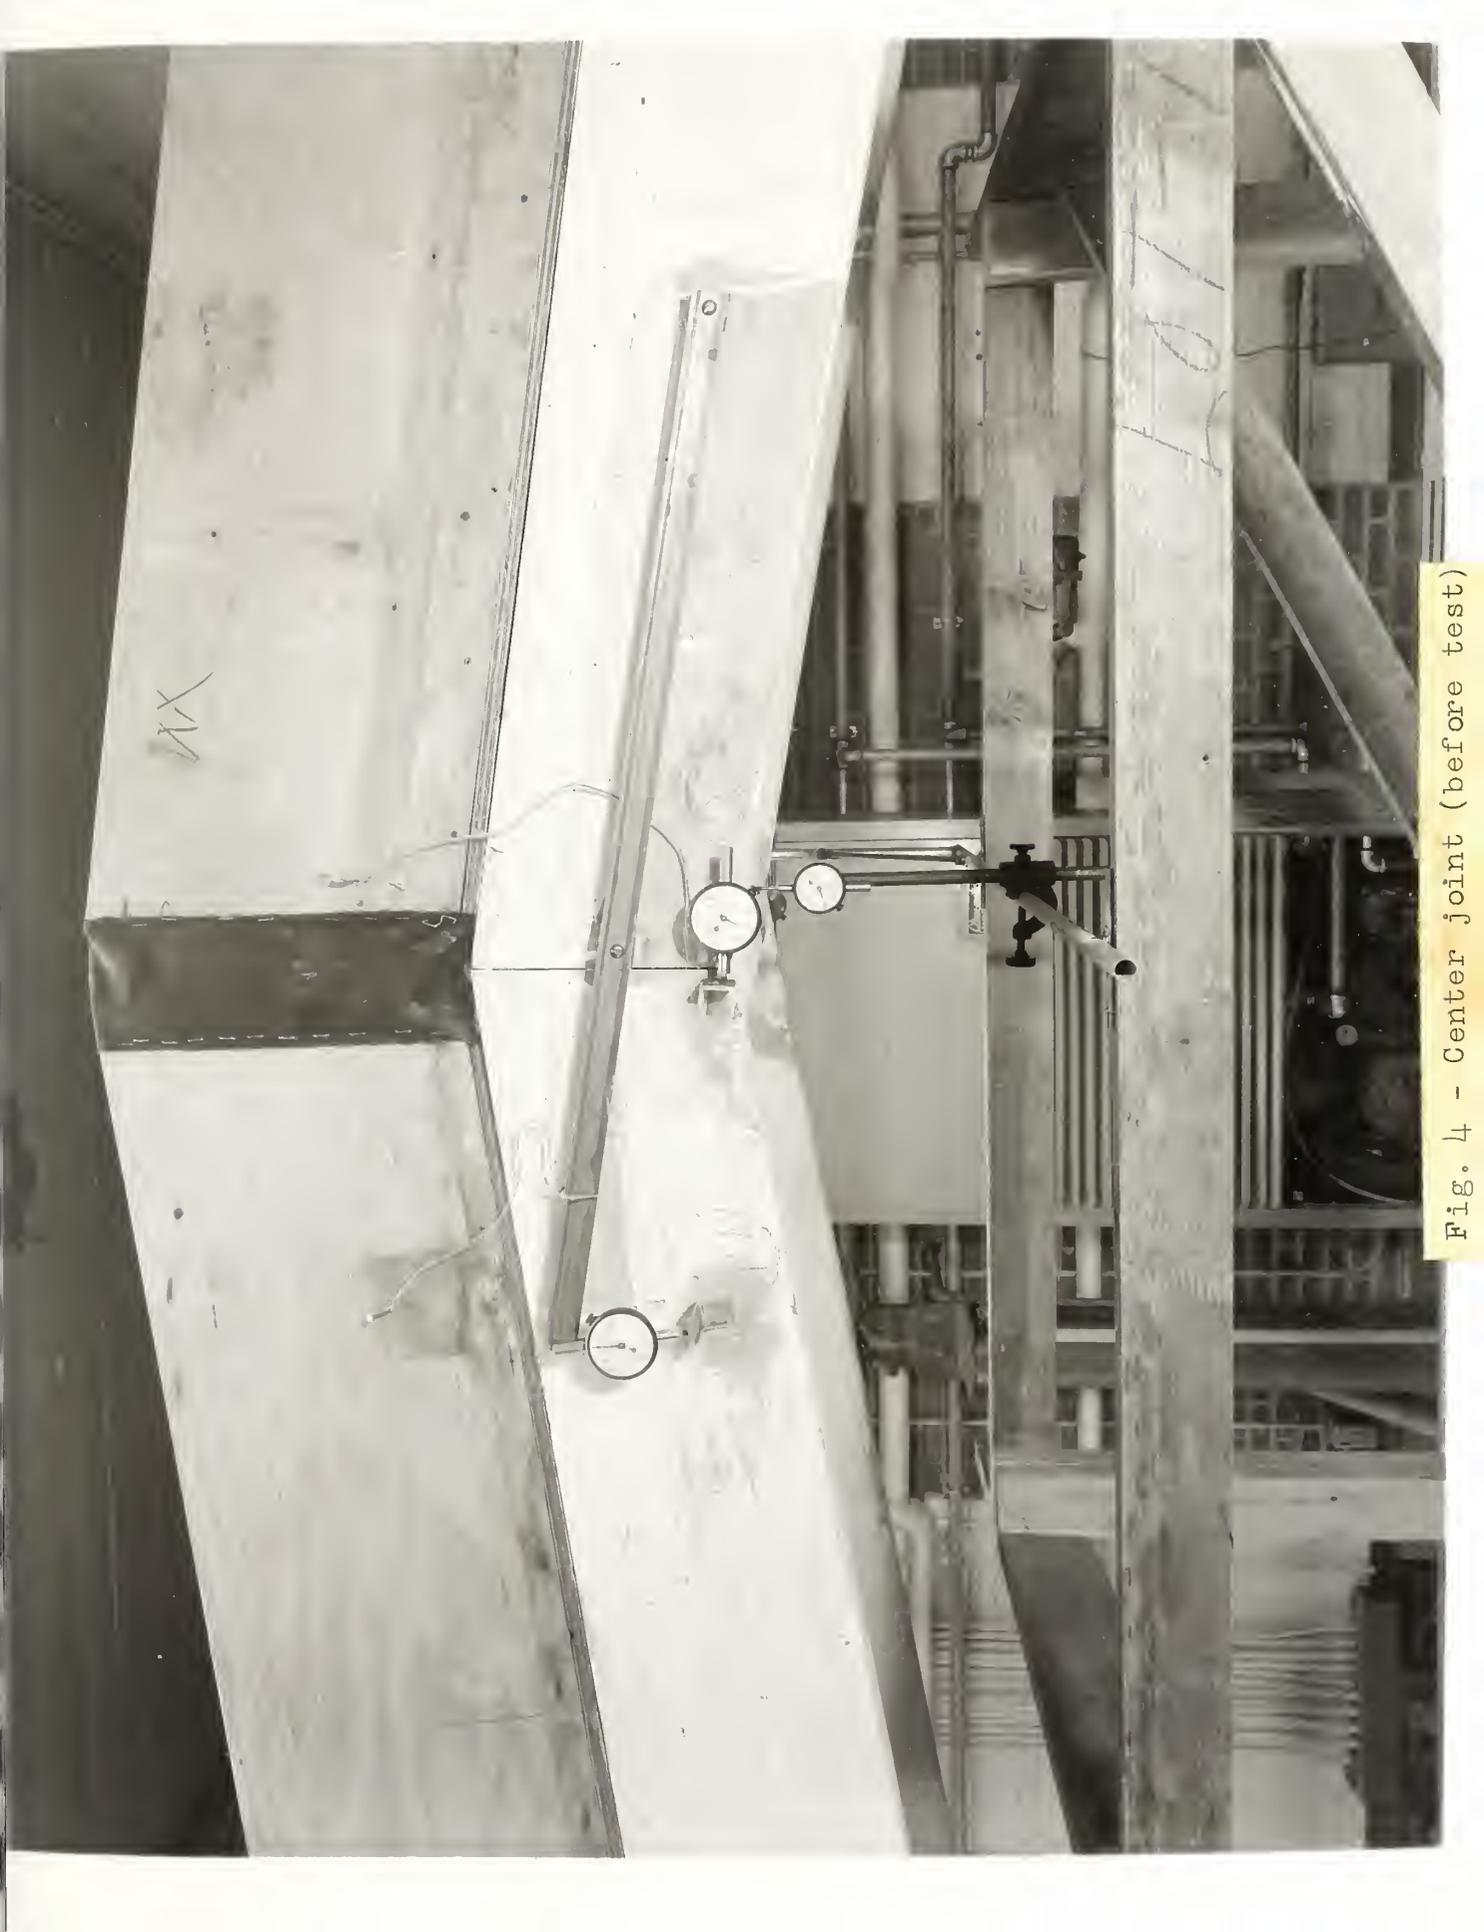
Fig. 4 - Center joint (before test)

The greatest movement was observed, at the crown. A single 1/1000 in. dial gage was placed at the center of the specimen at the crown as seen in figure 4. The maximum deflection occurred just prior to the removal of the total load of 80 psf and amounted to 2.88 inches. Upon removal of load the observed recovery was 1.15 inches.

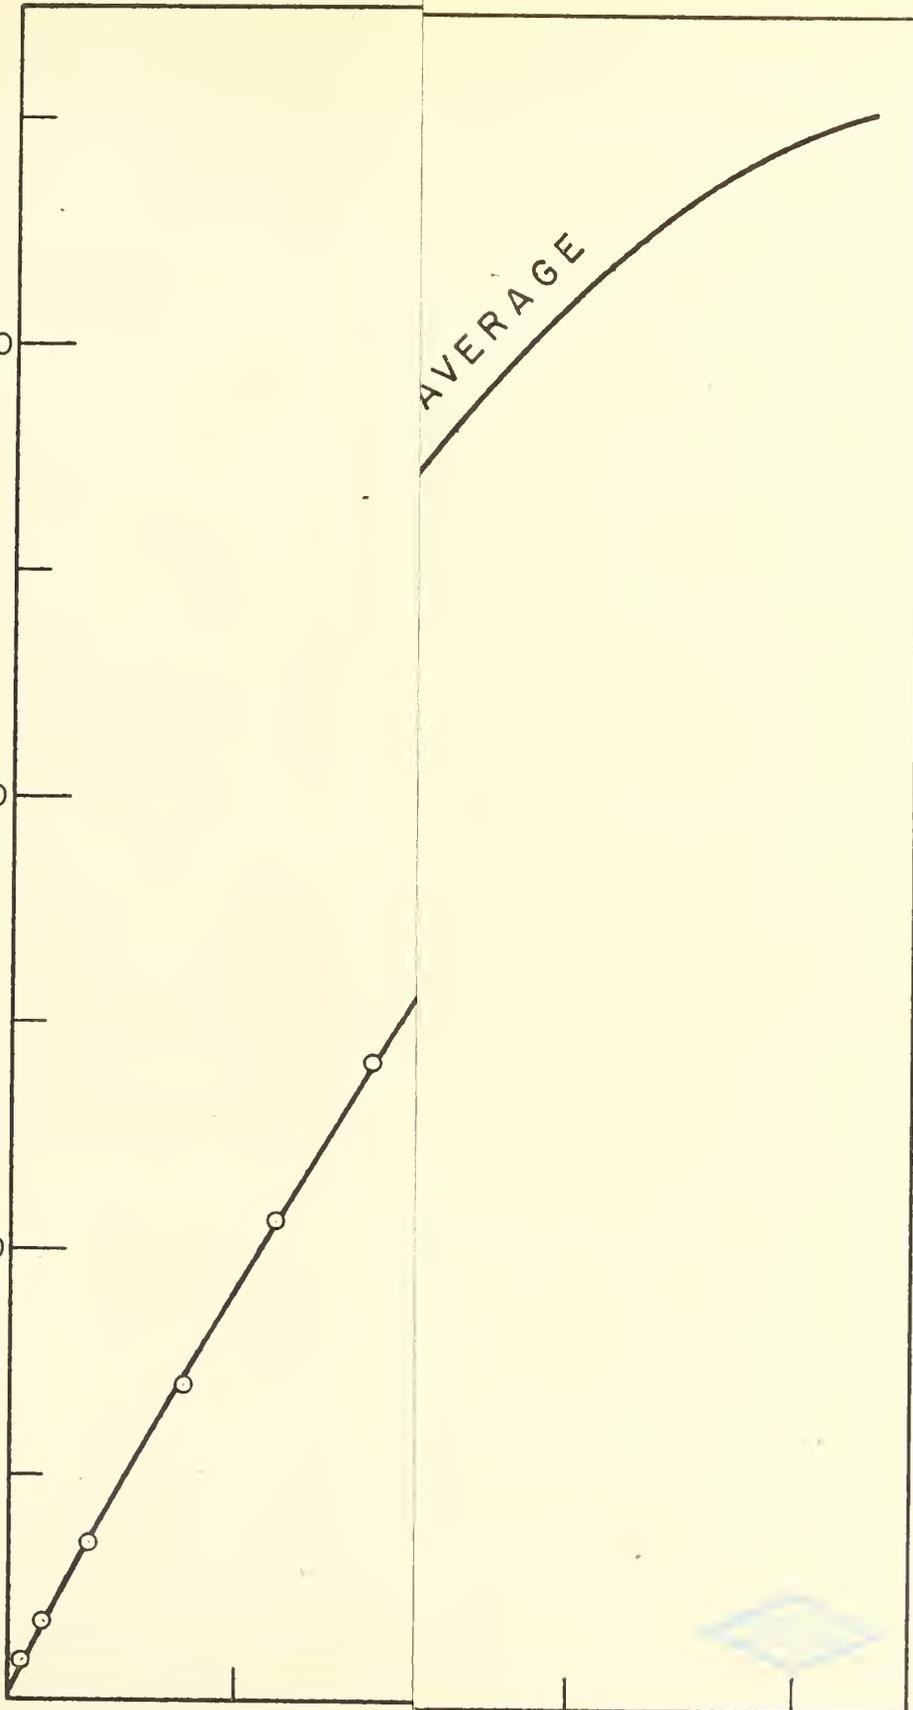
FIG. 5
STRESS-STRAIN CURVES OF PRECAST PANEL FRAME NO. 1
COMPRESSIVE TESTS OF 6" x 12" CONCRETE CONTROL CYLINDERS

The stress-strain curves obtained for the concrete used in Precast Panel Frame No. 1 are shown in figure 5. The original casting schedule was such as to produce a wall panel and roof panel for each of two castings; however, the roof panel of the second pour was damaged during removal from the form and necessitated casting on additional roof panel. The concrete in the first wall and roof section was 62 days old at the beginning of the test and a compressive strength of 7210 psi was realized from the 6- by 12-in. control cylinders. Wall panel No. 2 was 48 days old and roof panel No. 3 was 31 days old at the beginning of the test and produced compressive strengths of 6530 psi and 6870, respectively. The tangent modulus of the average of all sections was 4,650,000 psi.

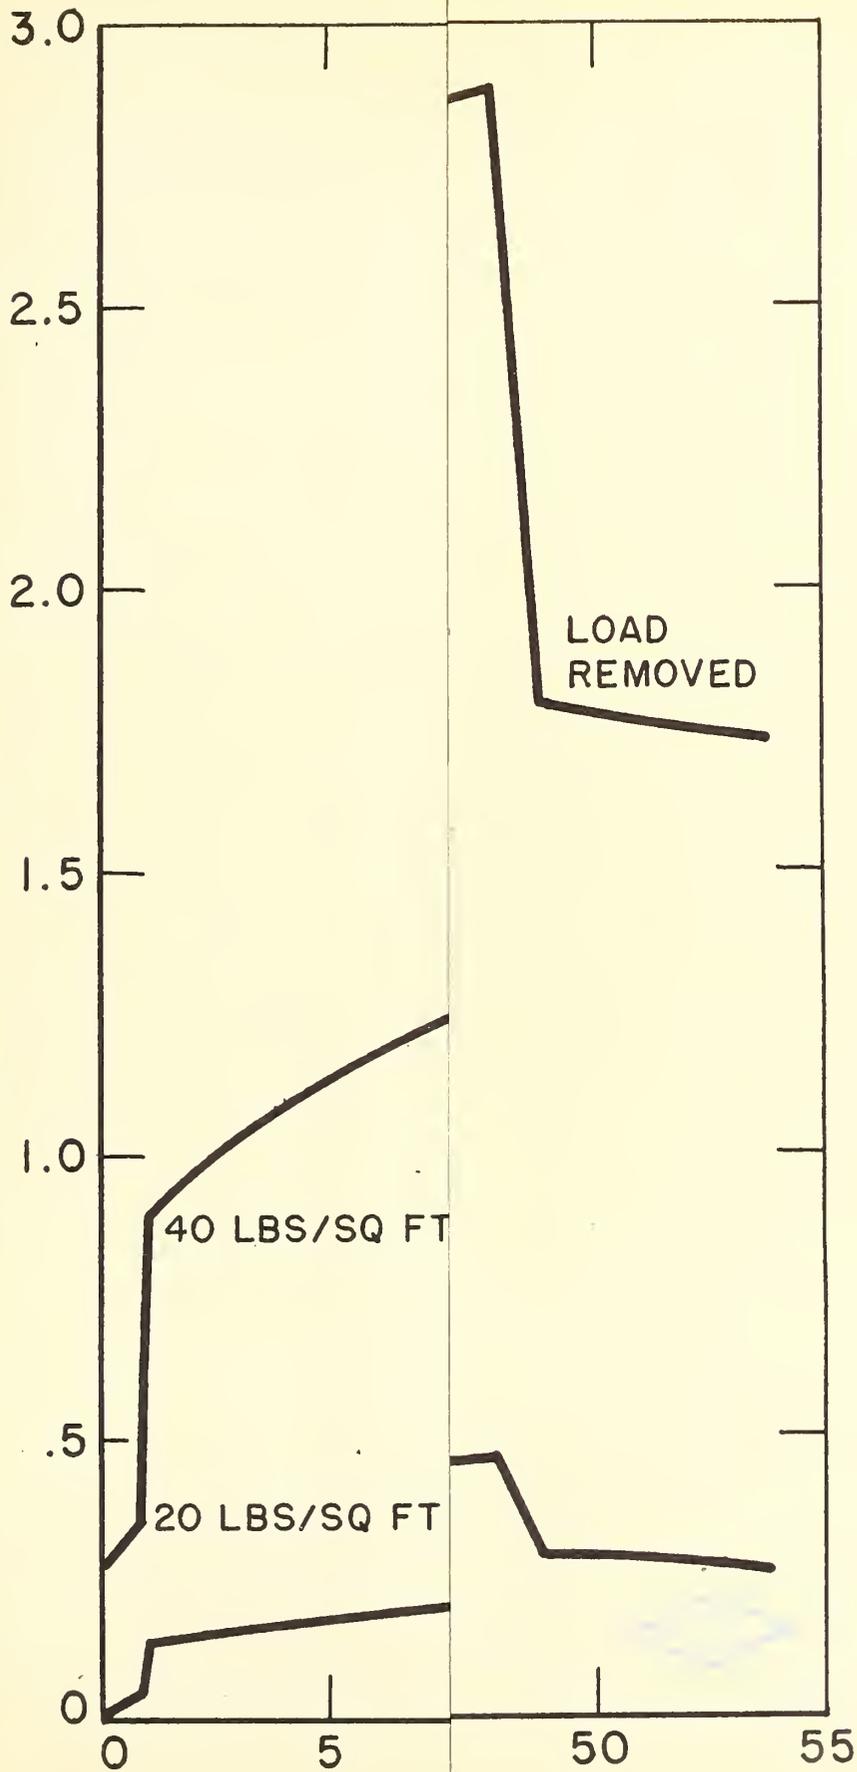
FIG. 6
DISPLACEMENTS VS. TIME

As can be seen in figures 6, 8, 9, and 11, the displacements and rotations observed in the structure were affected markedly by the duration of the test as well as by the magnitude of the applied load. A time increment of 41 days elapsed

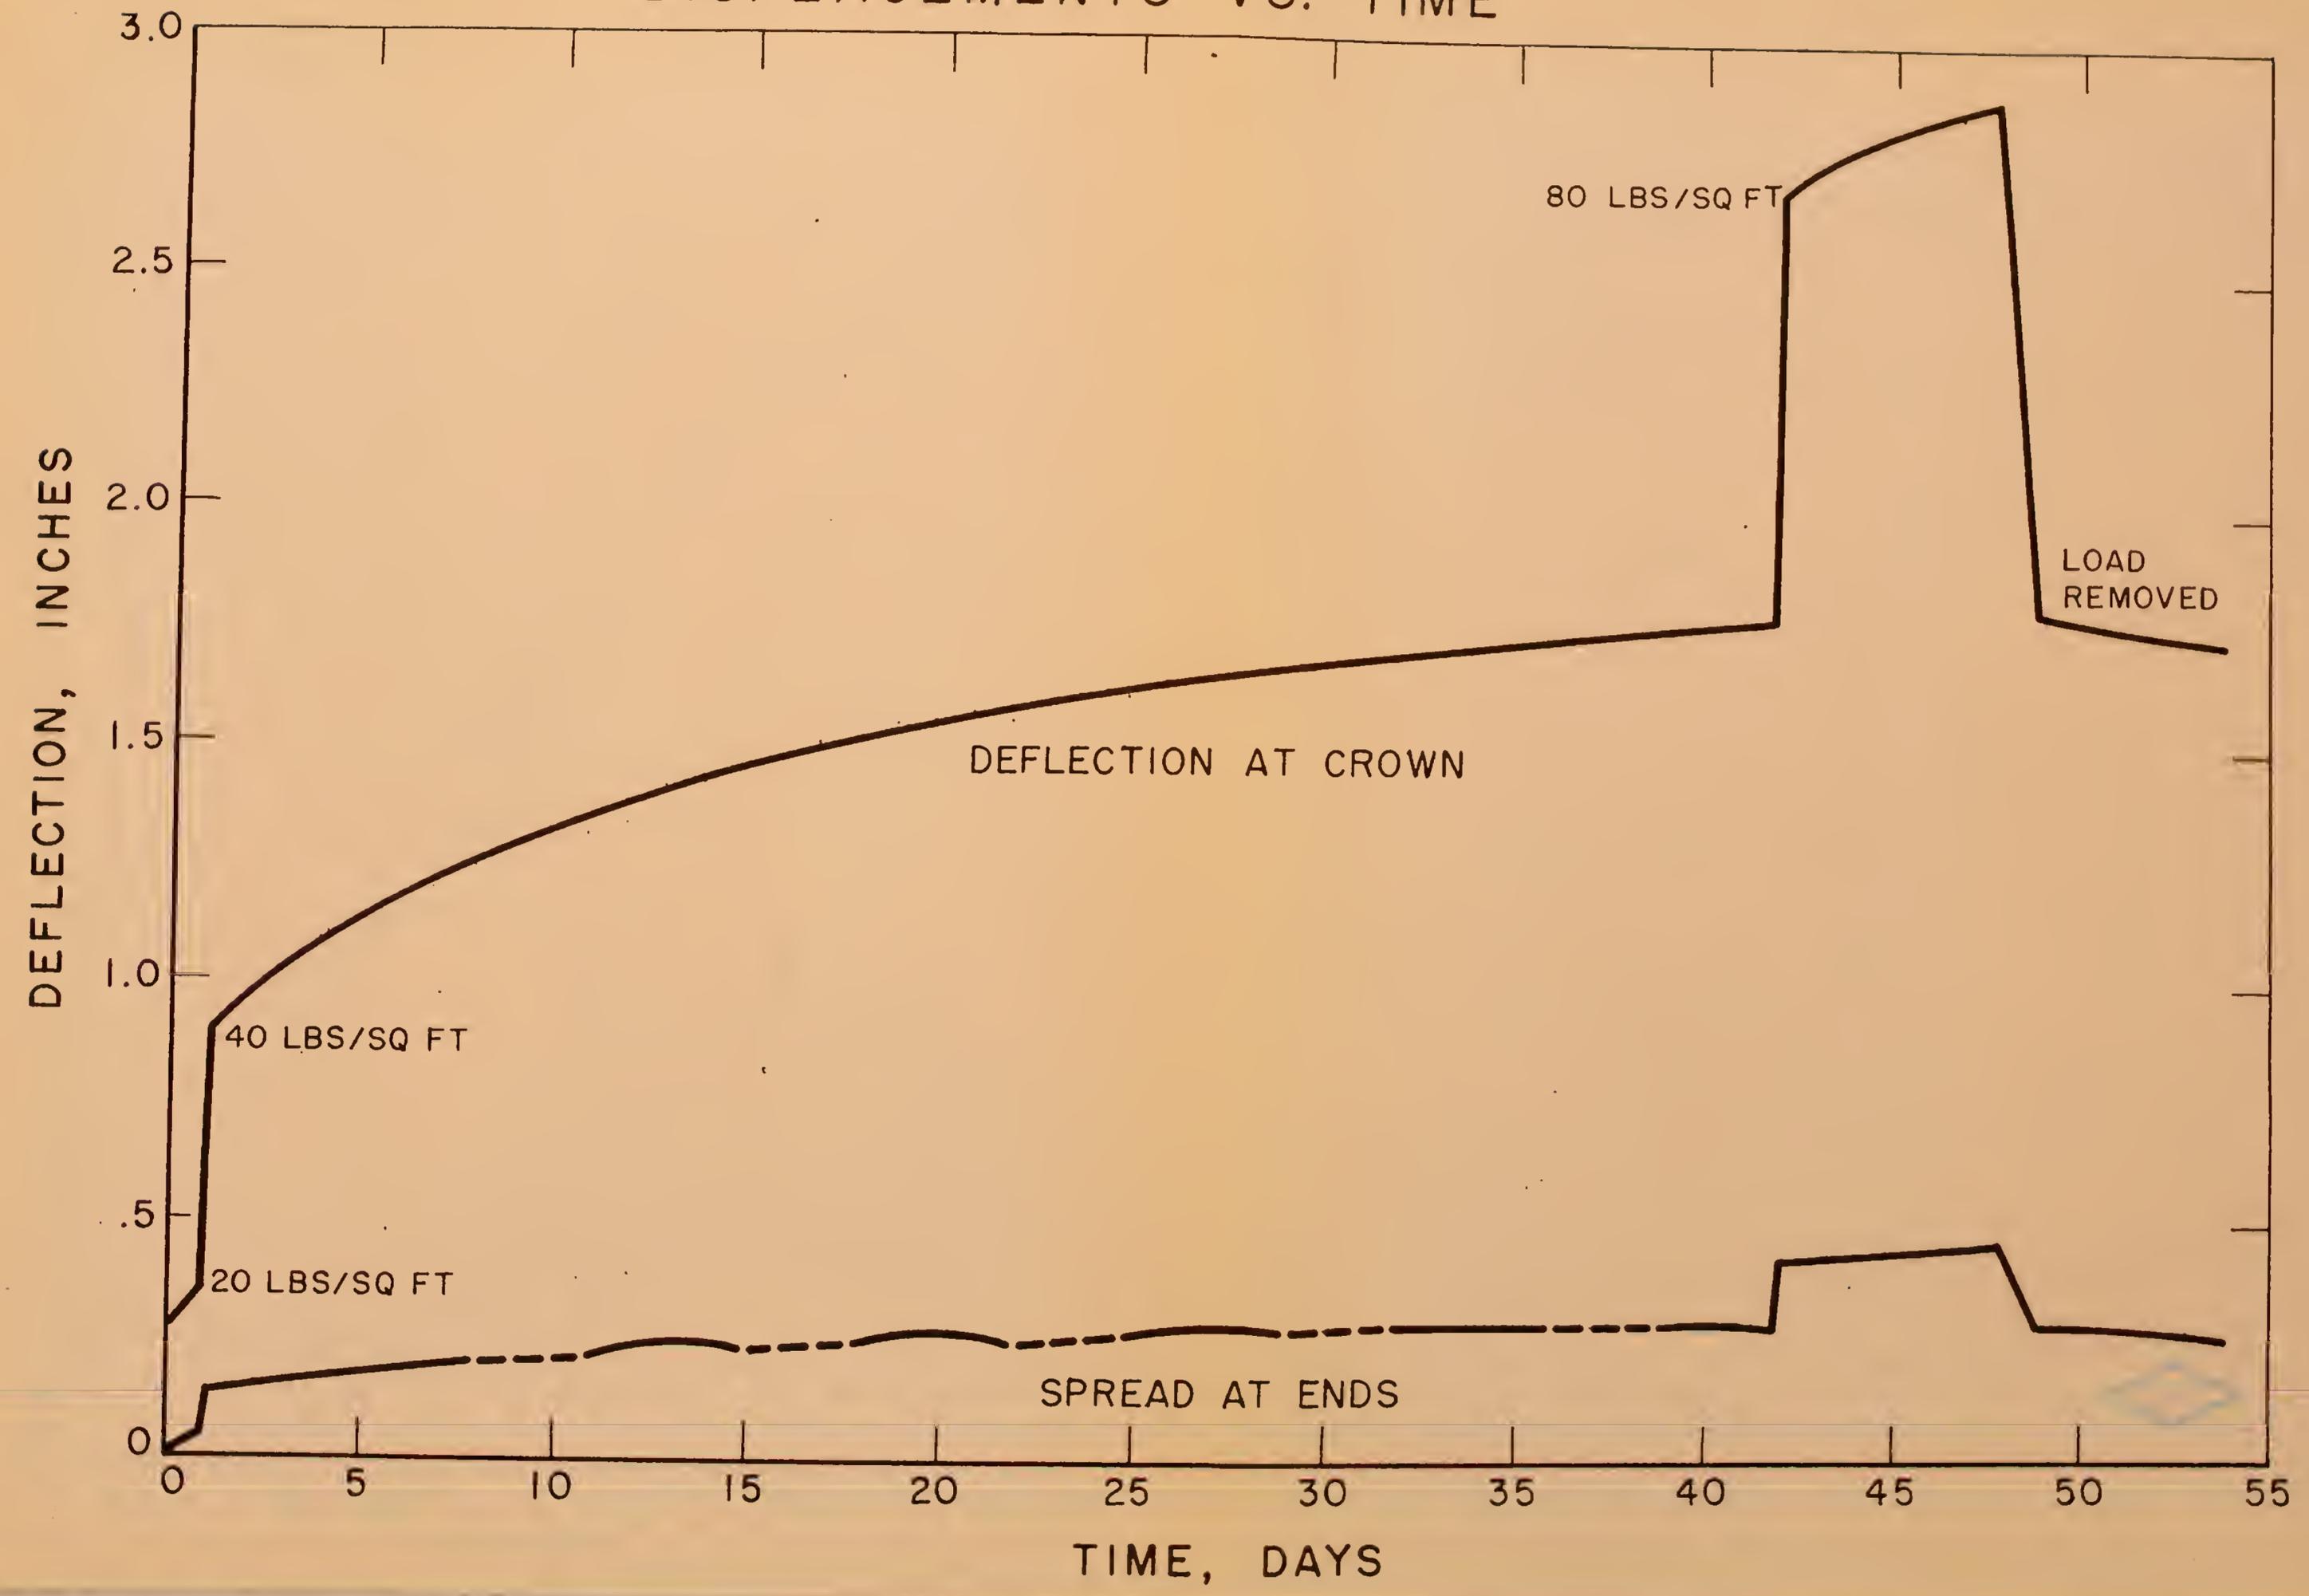
FIG. 7

Figure 7 shows the deflection of the center joint and the spread at ends plotted against the applied load. The displacements plotted are the values observed immediately after application of each load increment and do not include the increases resulting from the loads being sustained over long periods of time. It is noted that the structure was subjected to a load of 40 psf for a period of 41 days, after which the load was increased to 80 psf. Figure 7 shows that the structure was apparently stiffened by the sustained load test, as can be seen from the steeper slope of the load-deflection curve for the increments of load added subsequent to the sustained load test.

The calculated instantaneous rotations as shown in figure 10 verify the conclusions stated with regard to the instantaneous deflections shown in figure 7.
