NATIONAL BUREAU OF STANDARDS REPORT

6205

AN INTERIM REPORT ON BOILING TESTS OF INSULATION FOR UNDERGROUND HEAT DISTRIBUTION SYSTEMS

Selden D. Cole and Paul R. Achenbach
Air Conditioning, Heating, and Refrigeration Section
Building Technology Division

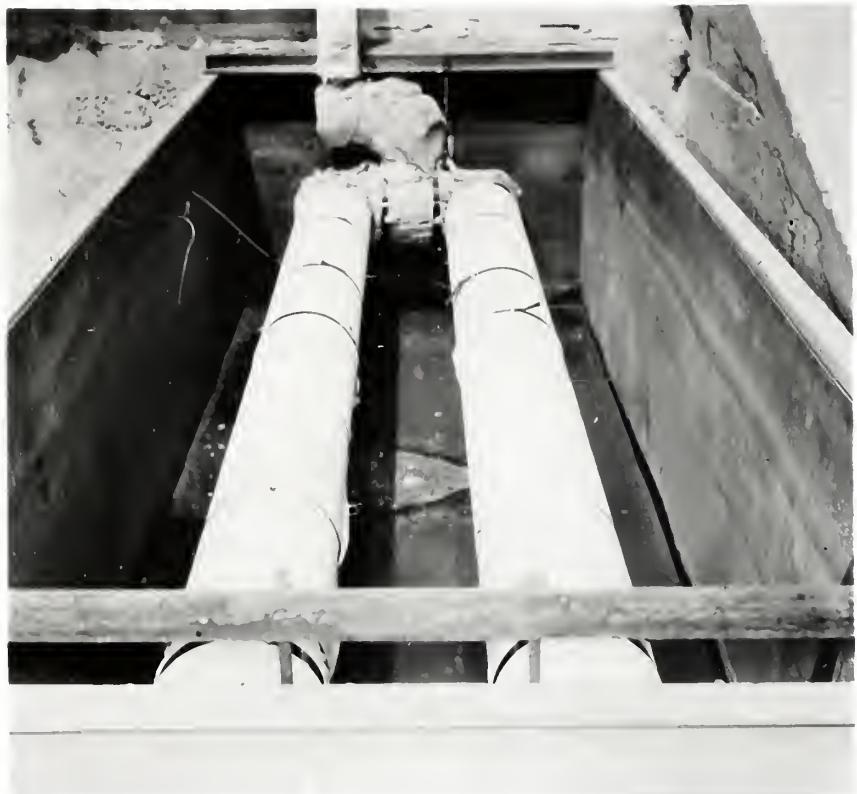
Figure 1

Reference to photographs: Fig 1 shows initial appearance; right specimen.

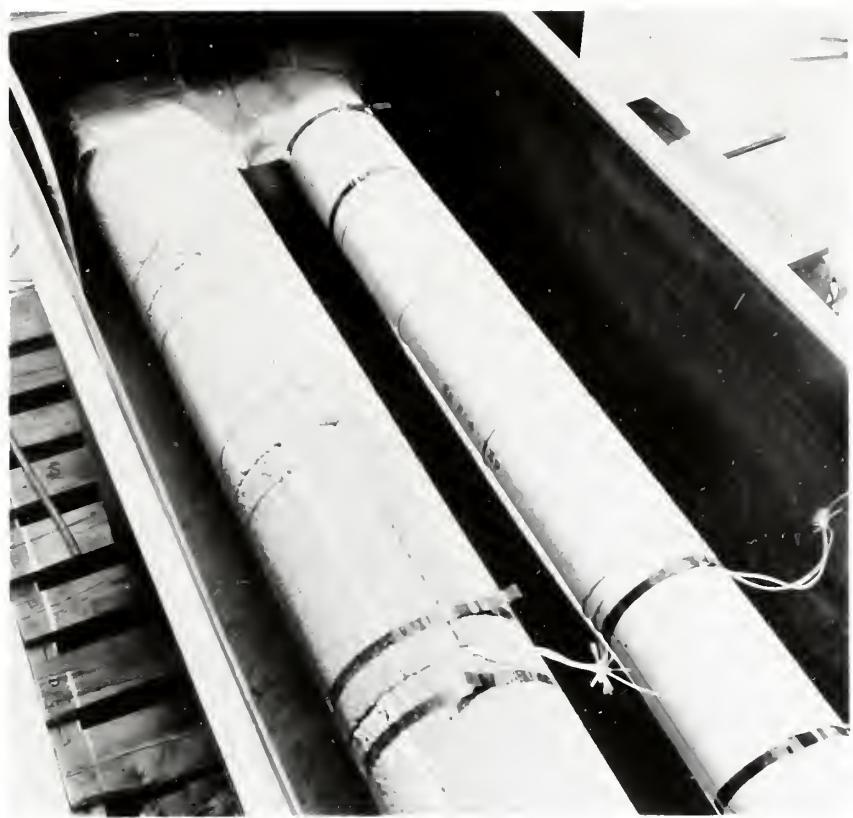
Figure 2

Reference to photographs: Fig 2 shows initial appearance; left specimen.

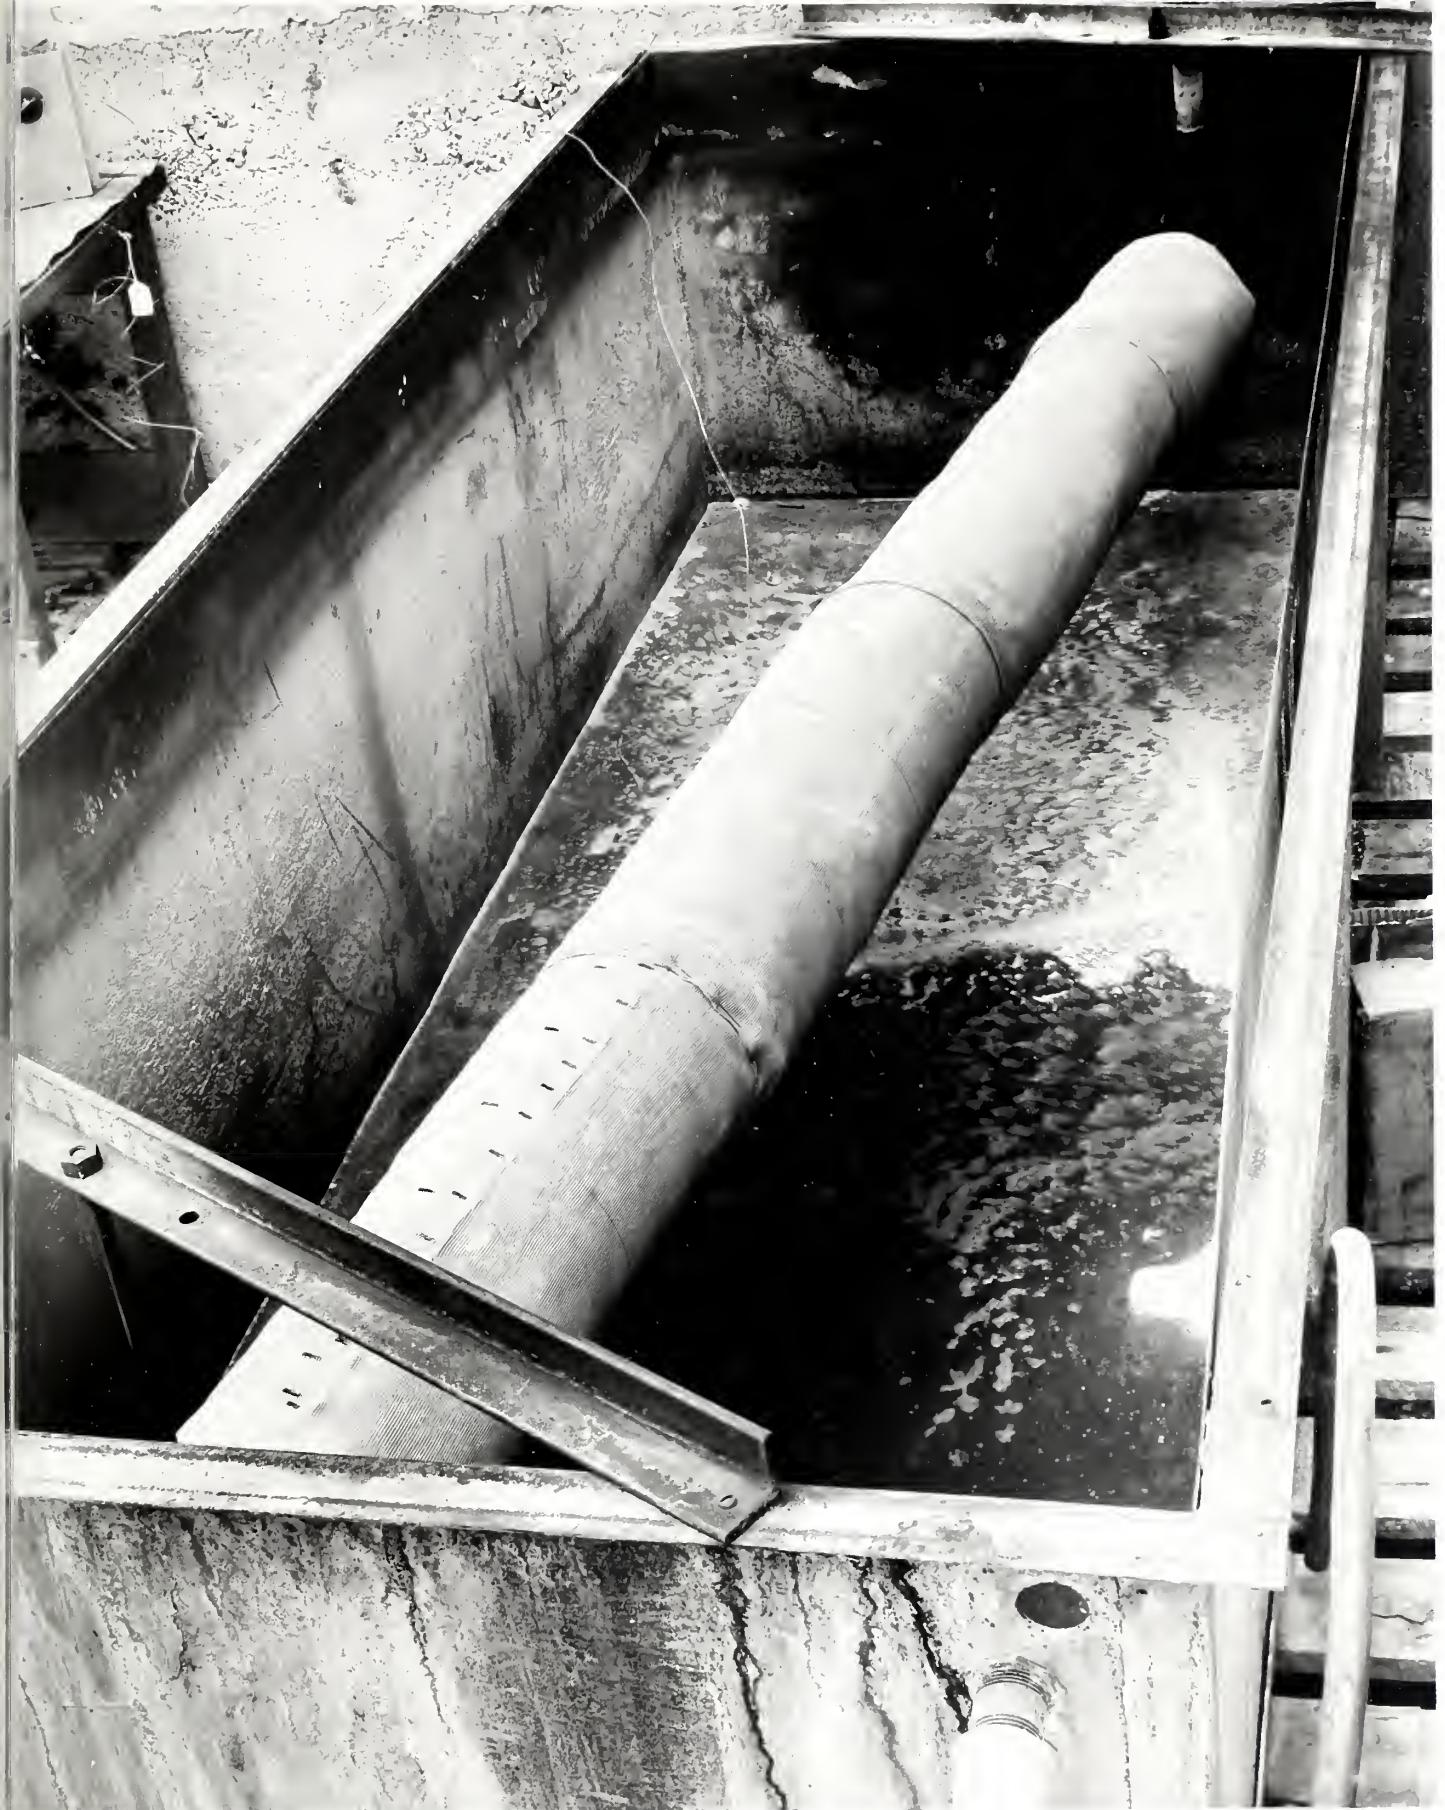
Figure 5

Reference to photographs: Fig 5 - after 72 hrs boiling

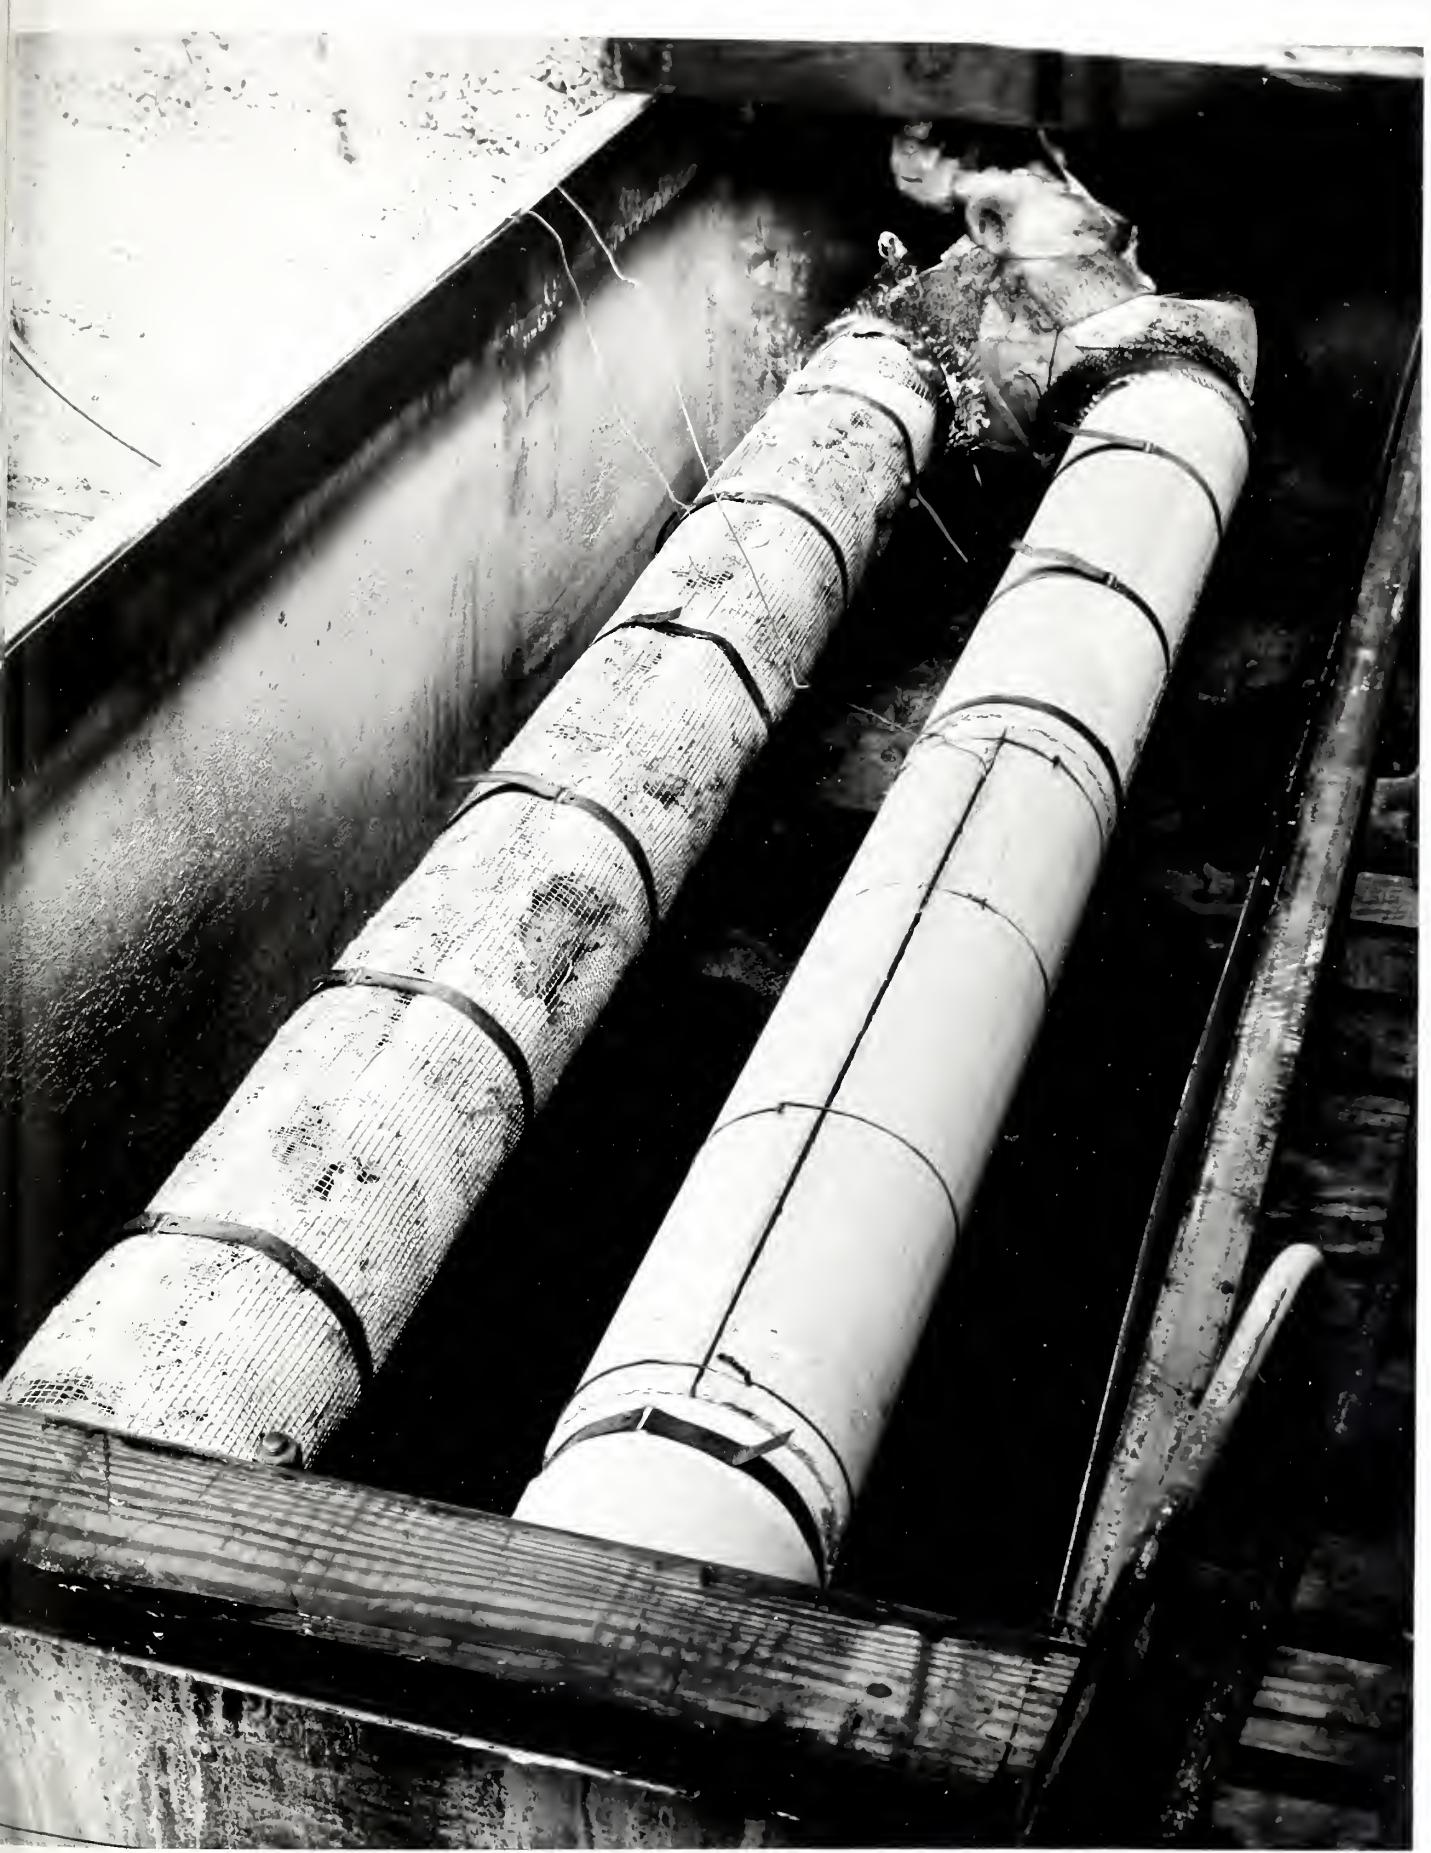
Figure 8

Reference to photographs: Fig 8, left specimen, shows appearance
after 72 hrs boiling
Fig 9 shows close-up view of voids in the
insulation

Reference to photographs: Fig 8, right specimen, shows appearance after 72 hrs boiling. Note slight separation of longitudinal joint and slight embedment of wire at farther end of the middle section

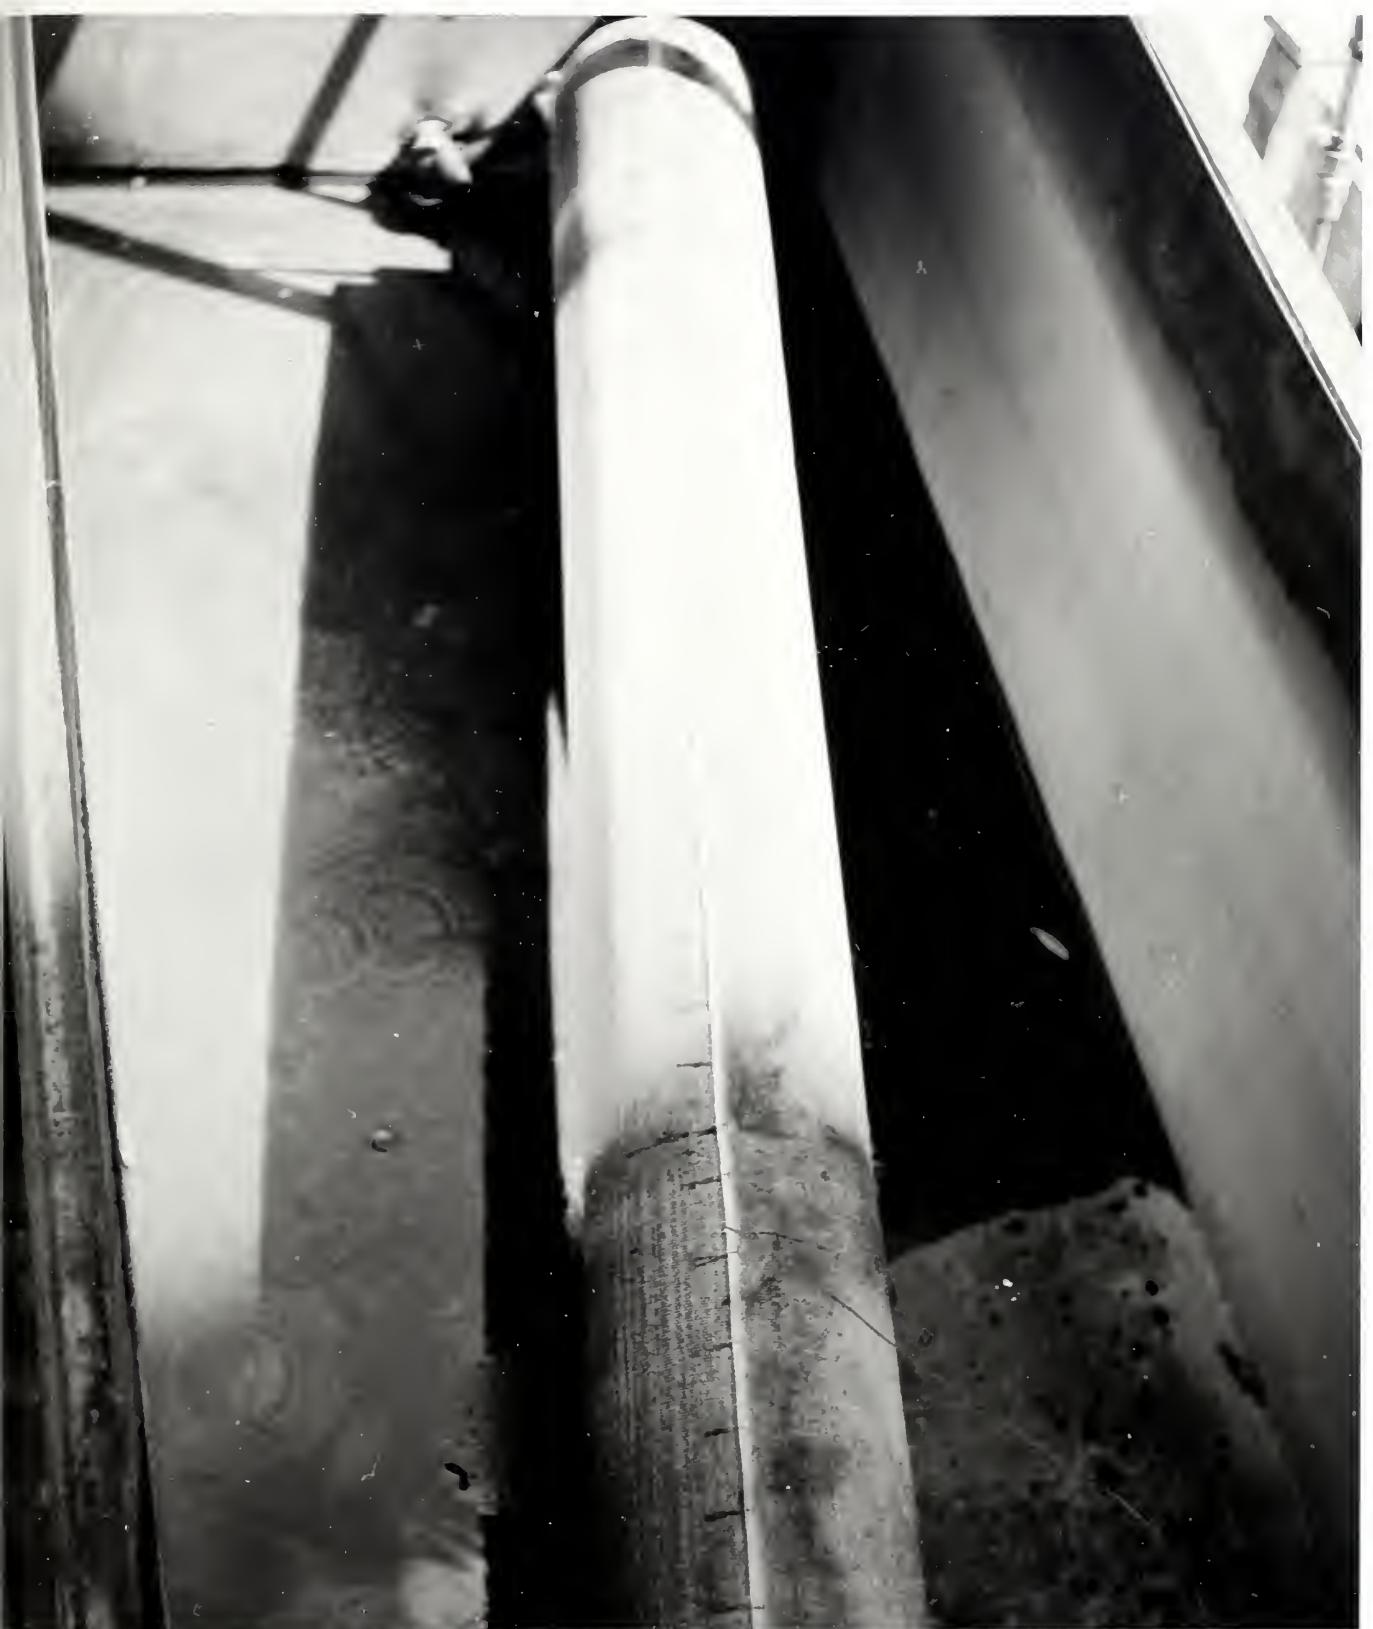
Figure 10

Reference to photographs: Fig 10 is a view of the specimen after 120 hrs of boiling.

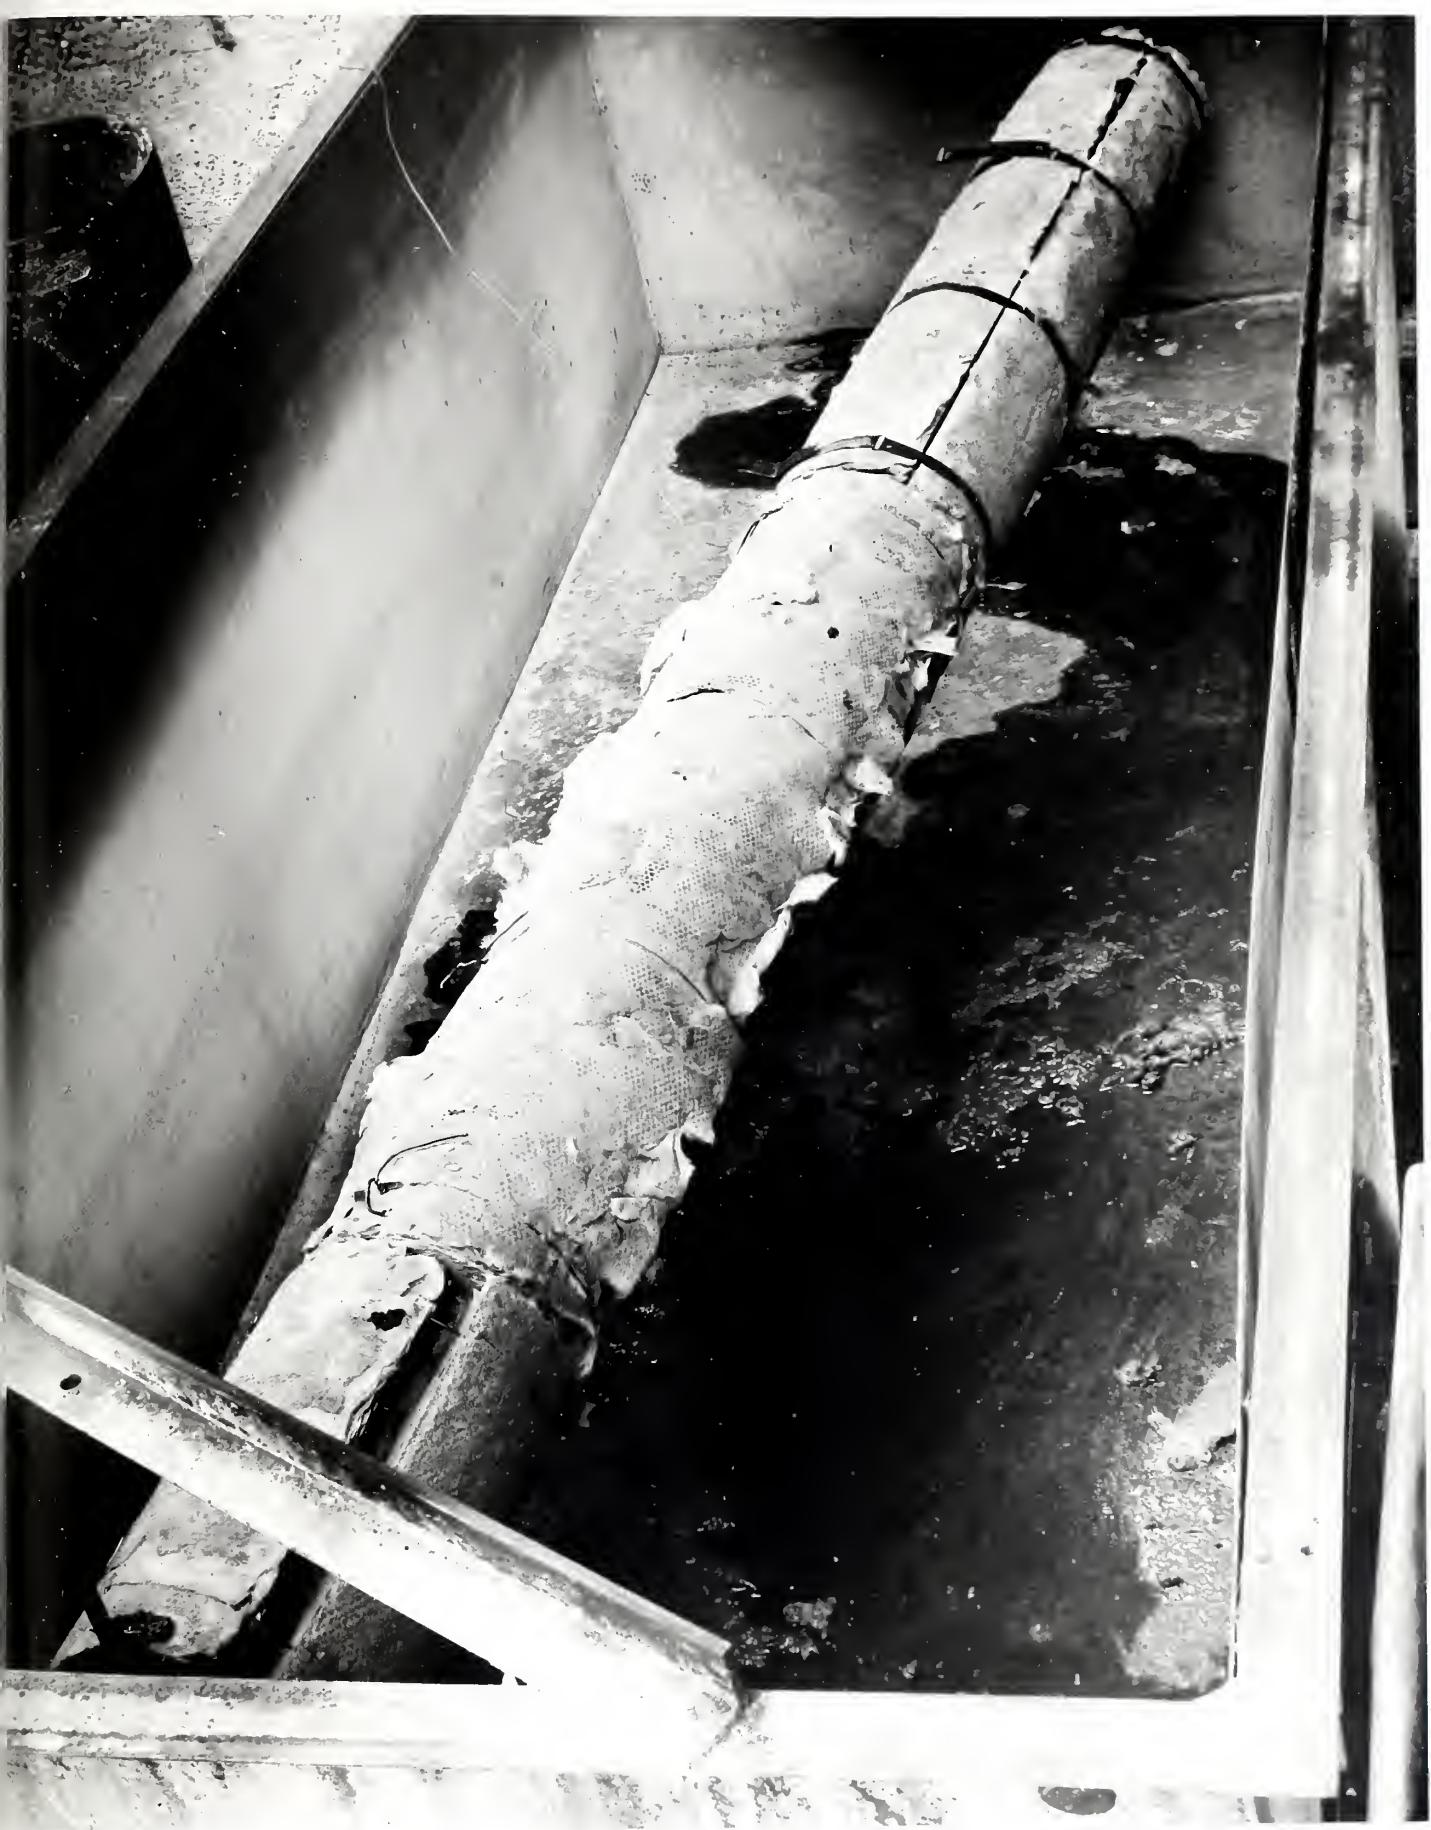
Figure 11

Fraying: All joints showed fraying. Fraying more extensive on second section with joints located horizontally. See Fig 11

Reference to photographs: Fig 11 shows appearance after 72 hrs boiling

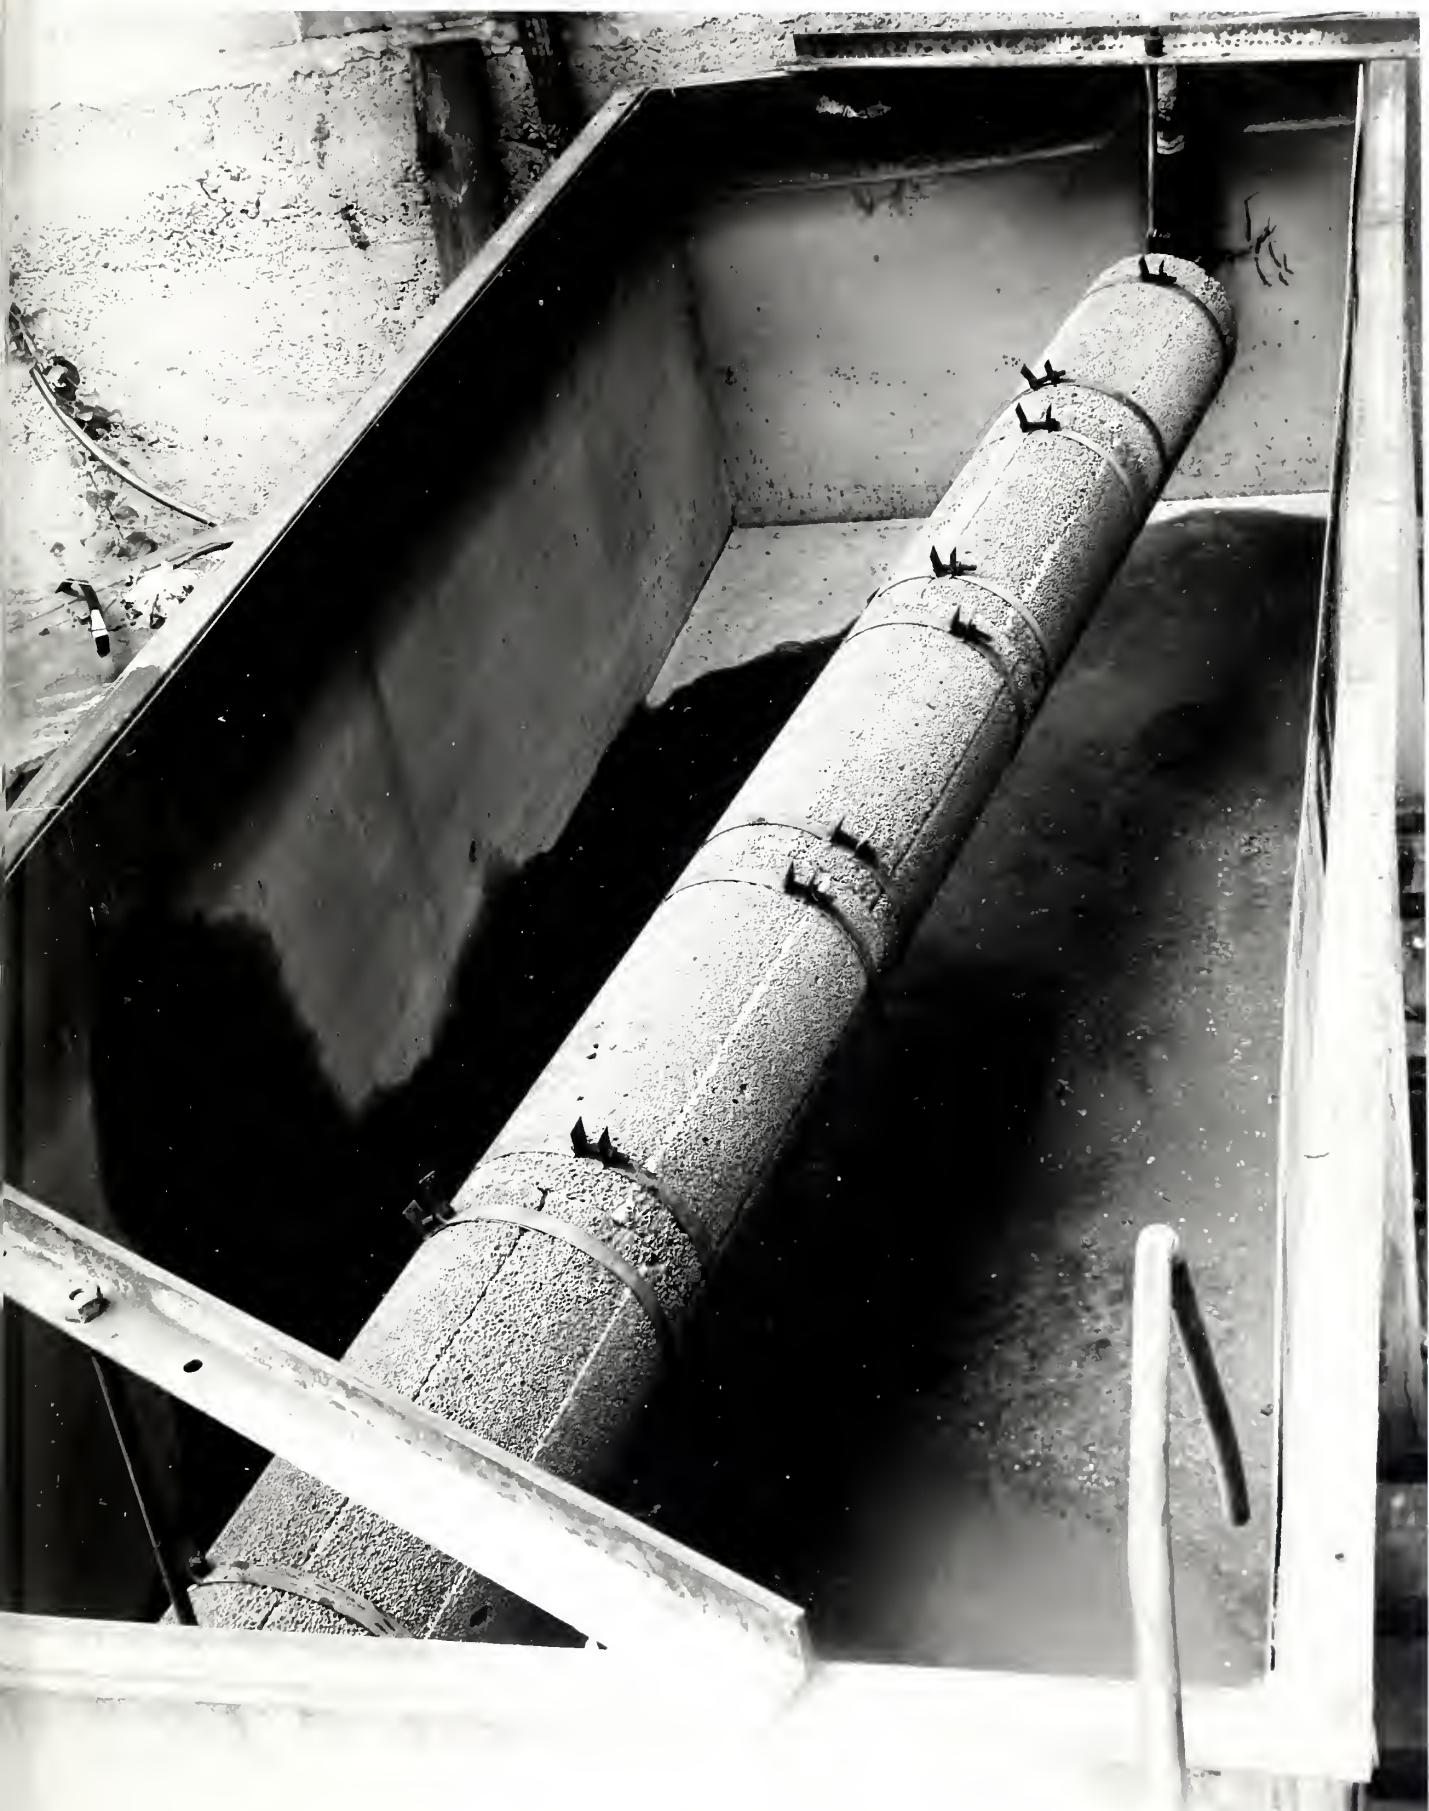
Figure 13

Reference to photographs: Fig 13 shows appearance of Foam-Sil after 72 hrs boiling

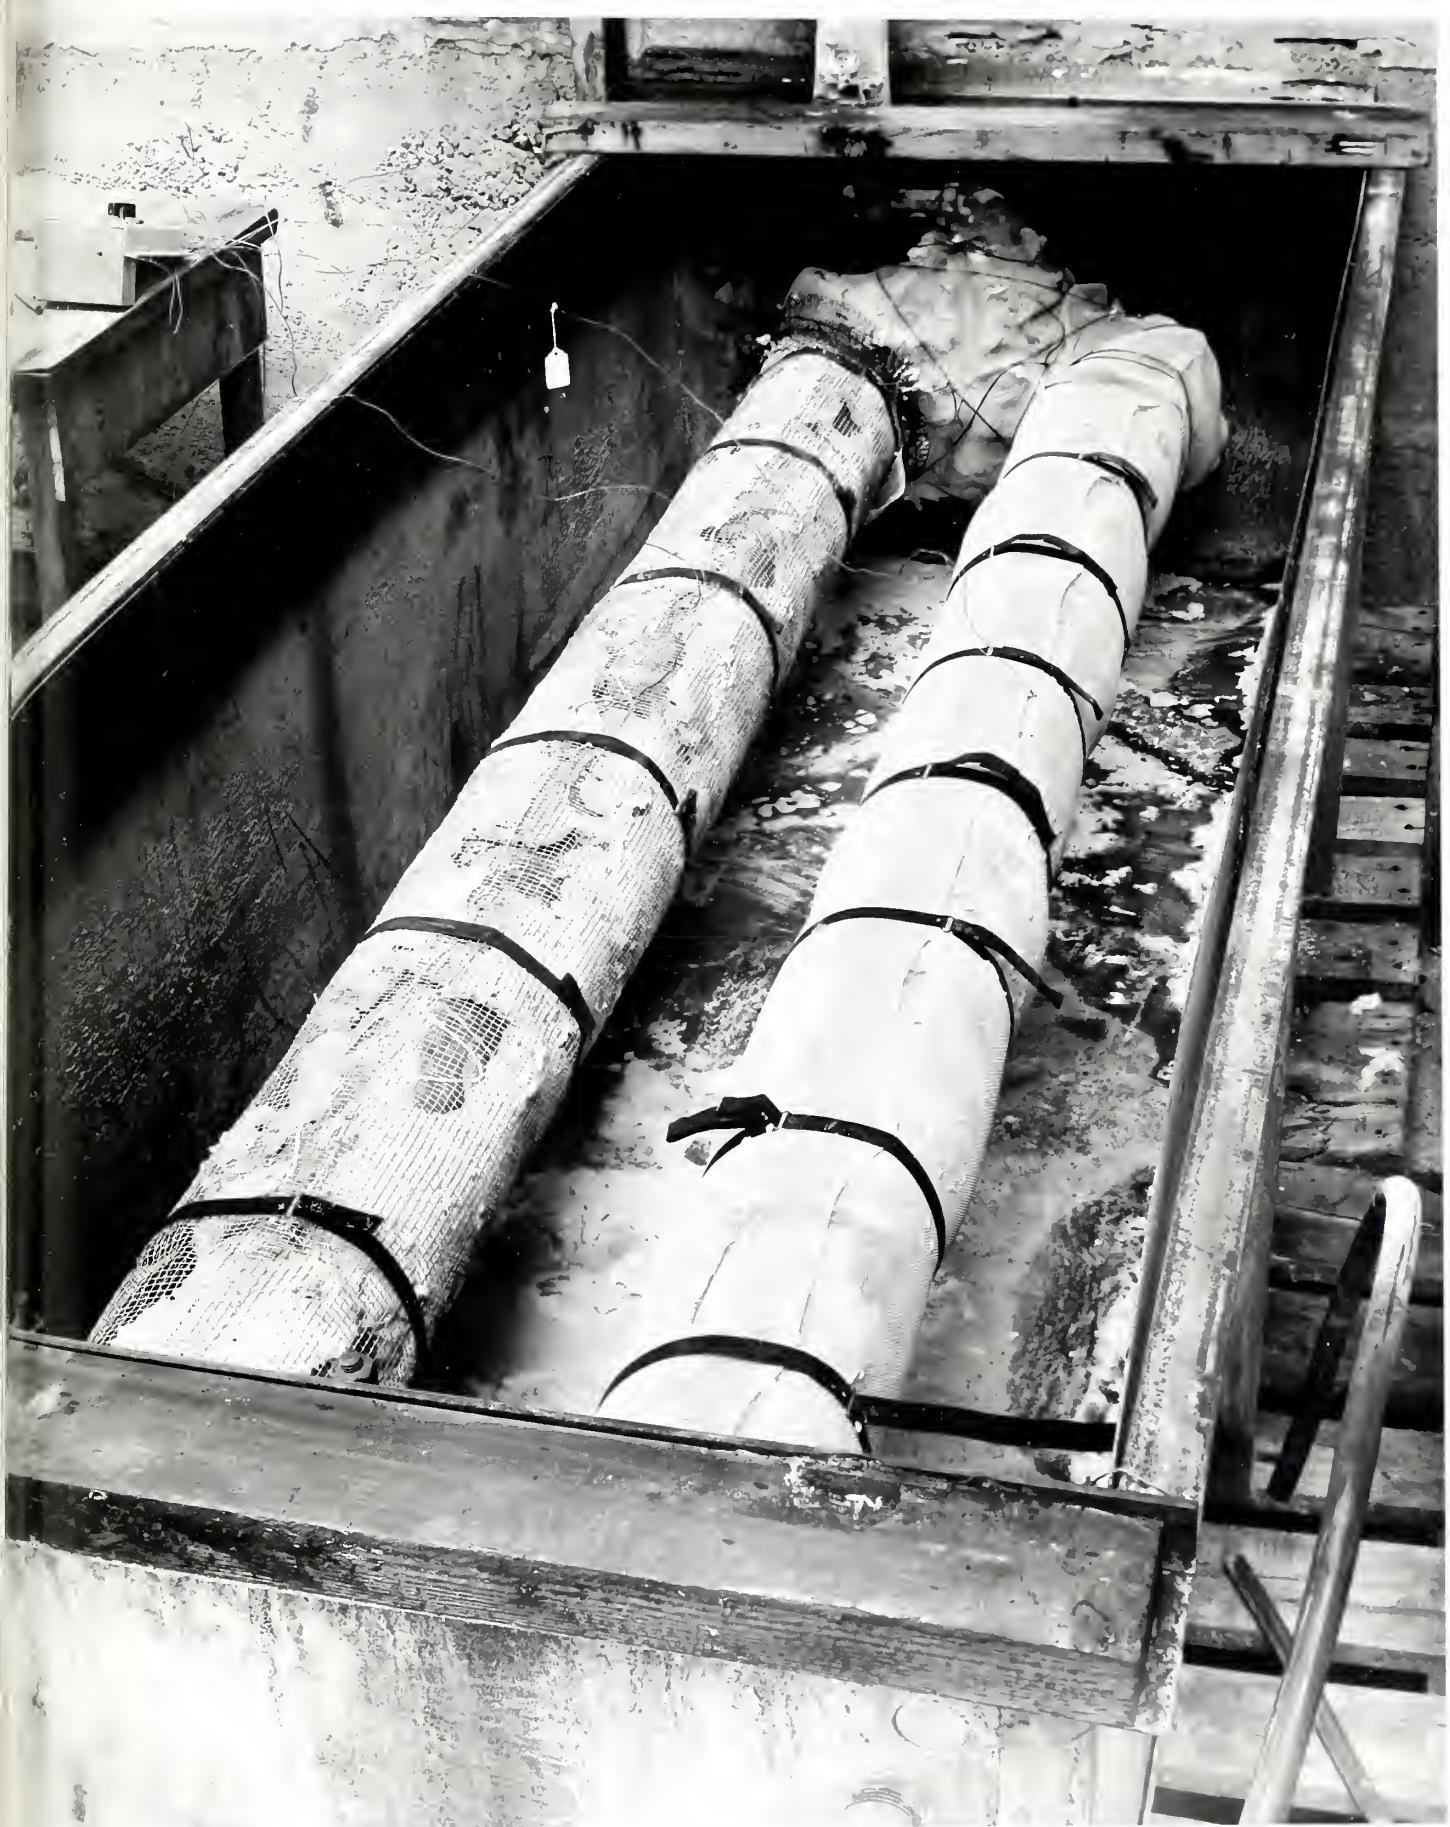
Figure 15

Reference to photographs: Fig 15, left specimen, shows appearance after 72 hours boiling

Reference to photographs: Fig 15, right specimen, shows appearance after 72 hours boiling

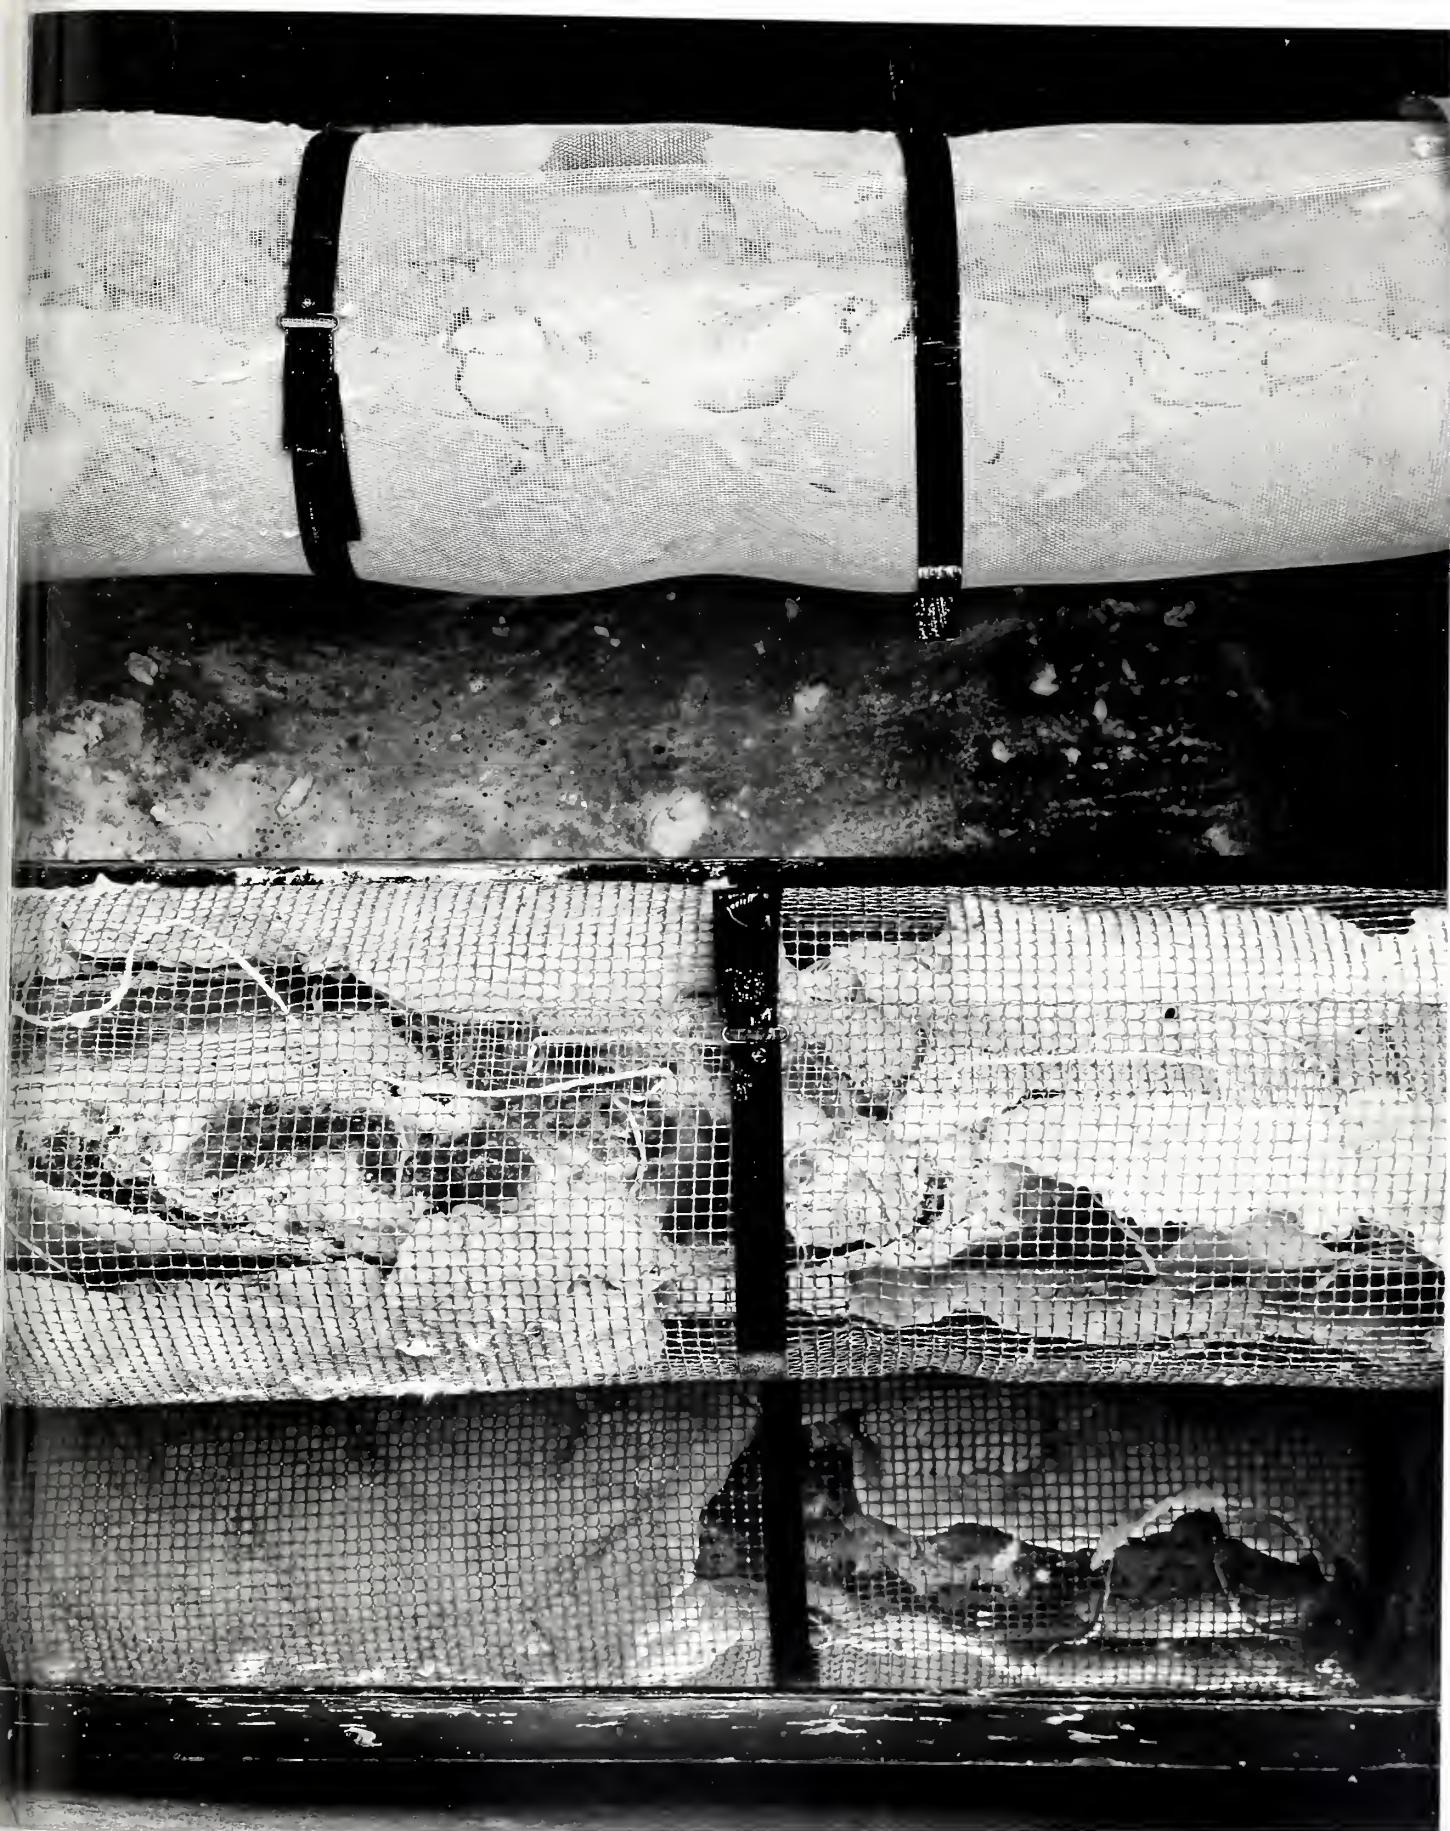
Figure 16

Fig 16, bottom specimen, shows closeup of voids with a mirror image of the underneath portion.

Fig 16, top specimen, shows one spot where pipe exposed. 16-mesh screen wire provided a sort of flexible wrapping that tended to bulge slightly between straps

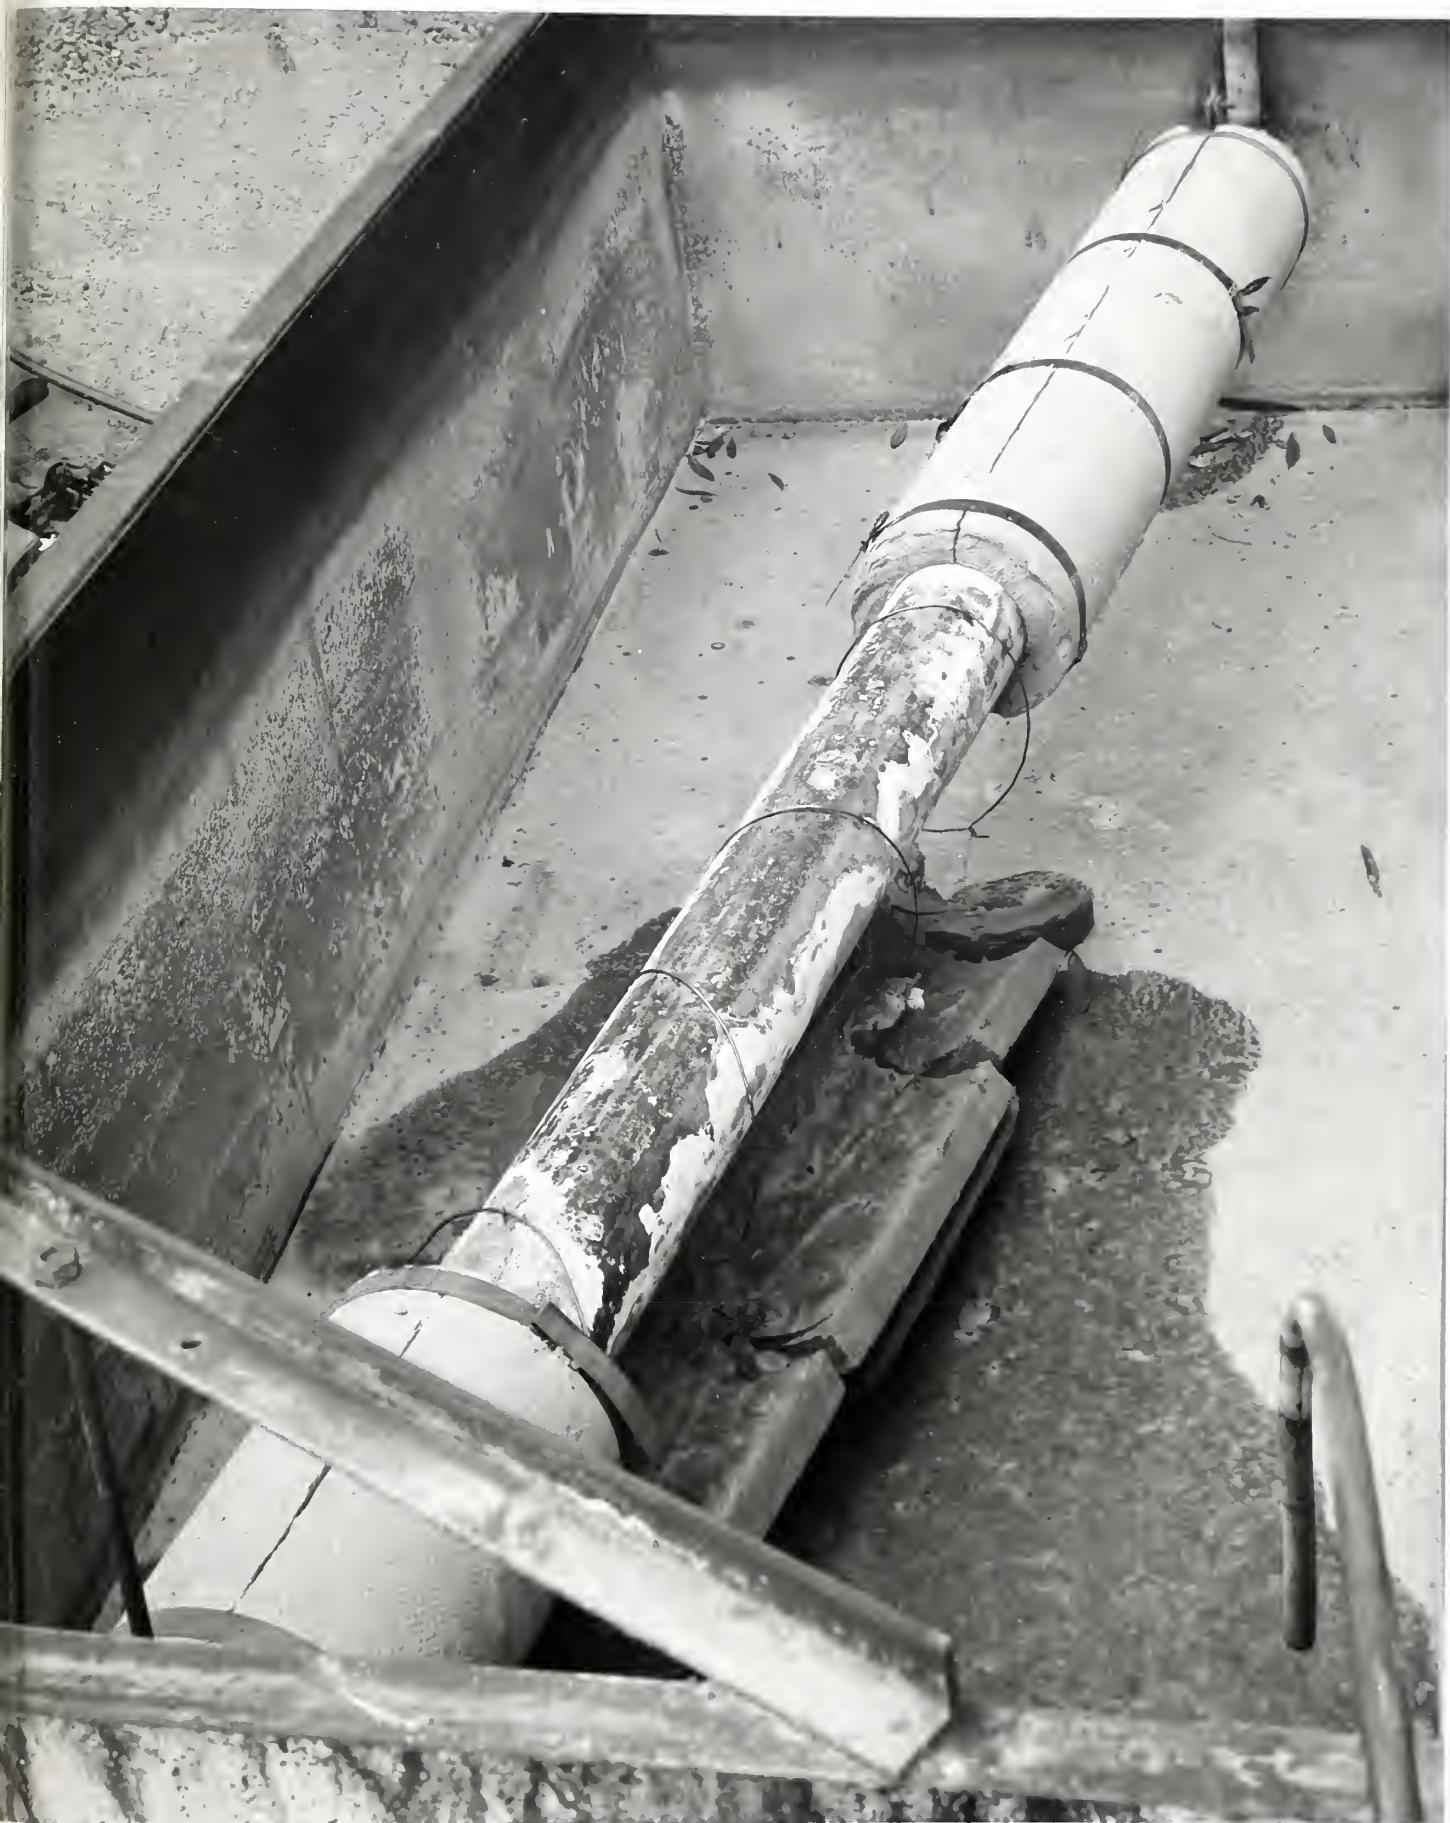
Figure 18

Reference to photographs: Fig 18 shows the appearance of the ins-
ulation after 72 hours boiling. The
first section, secured with straps, shows
slight erosion and fraying. The second
section, secured with wires, had separated
from the pipe and a part had fallen into
the bottom of the tank.
