NATIONAL BUREAU OF STANDARDS REPORT

6205

AN INTERIM REPORT ON BOILING TESTS OF INSULATION FOR UNDERGROUND HEAT DISTRIBUTION SYSTEMS

Selden D. Cole and Paul R. Achenbach
Air Conditioning, Heating, and Refrigeration Section
Building Technology Division

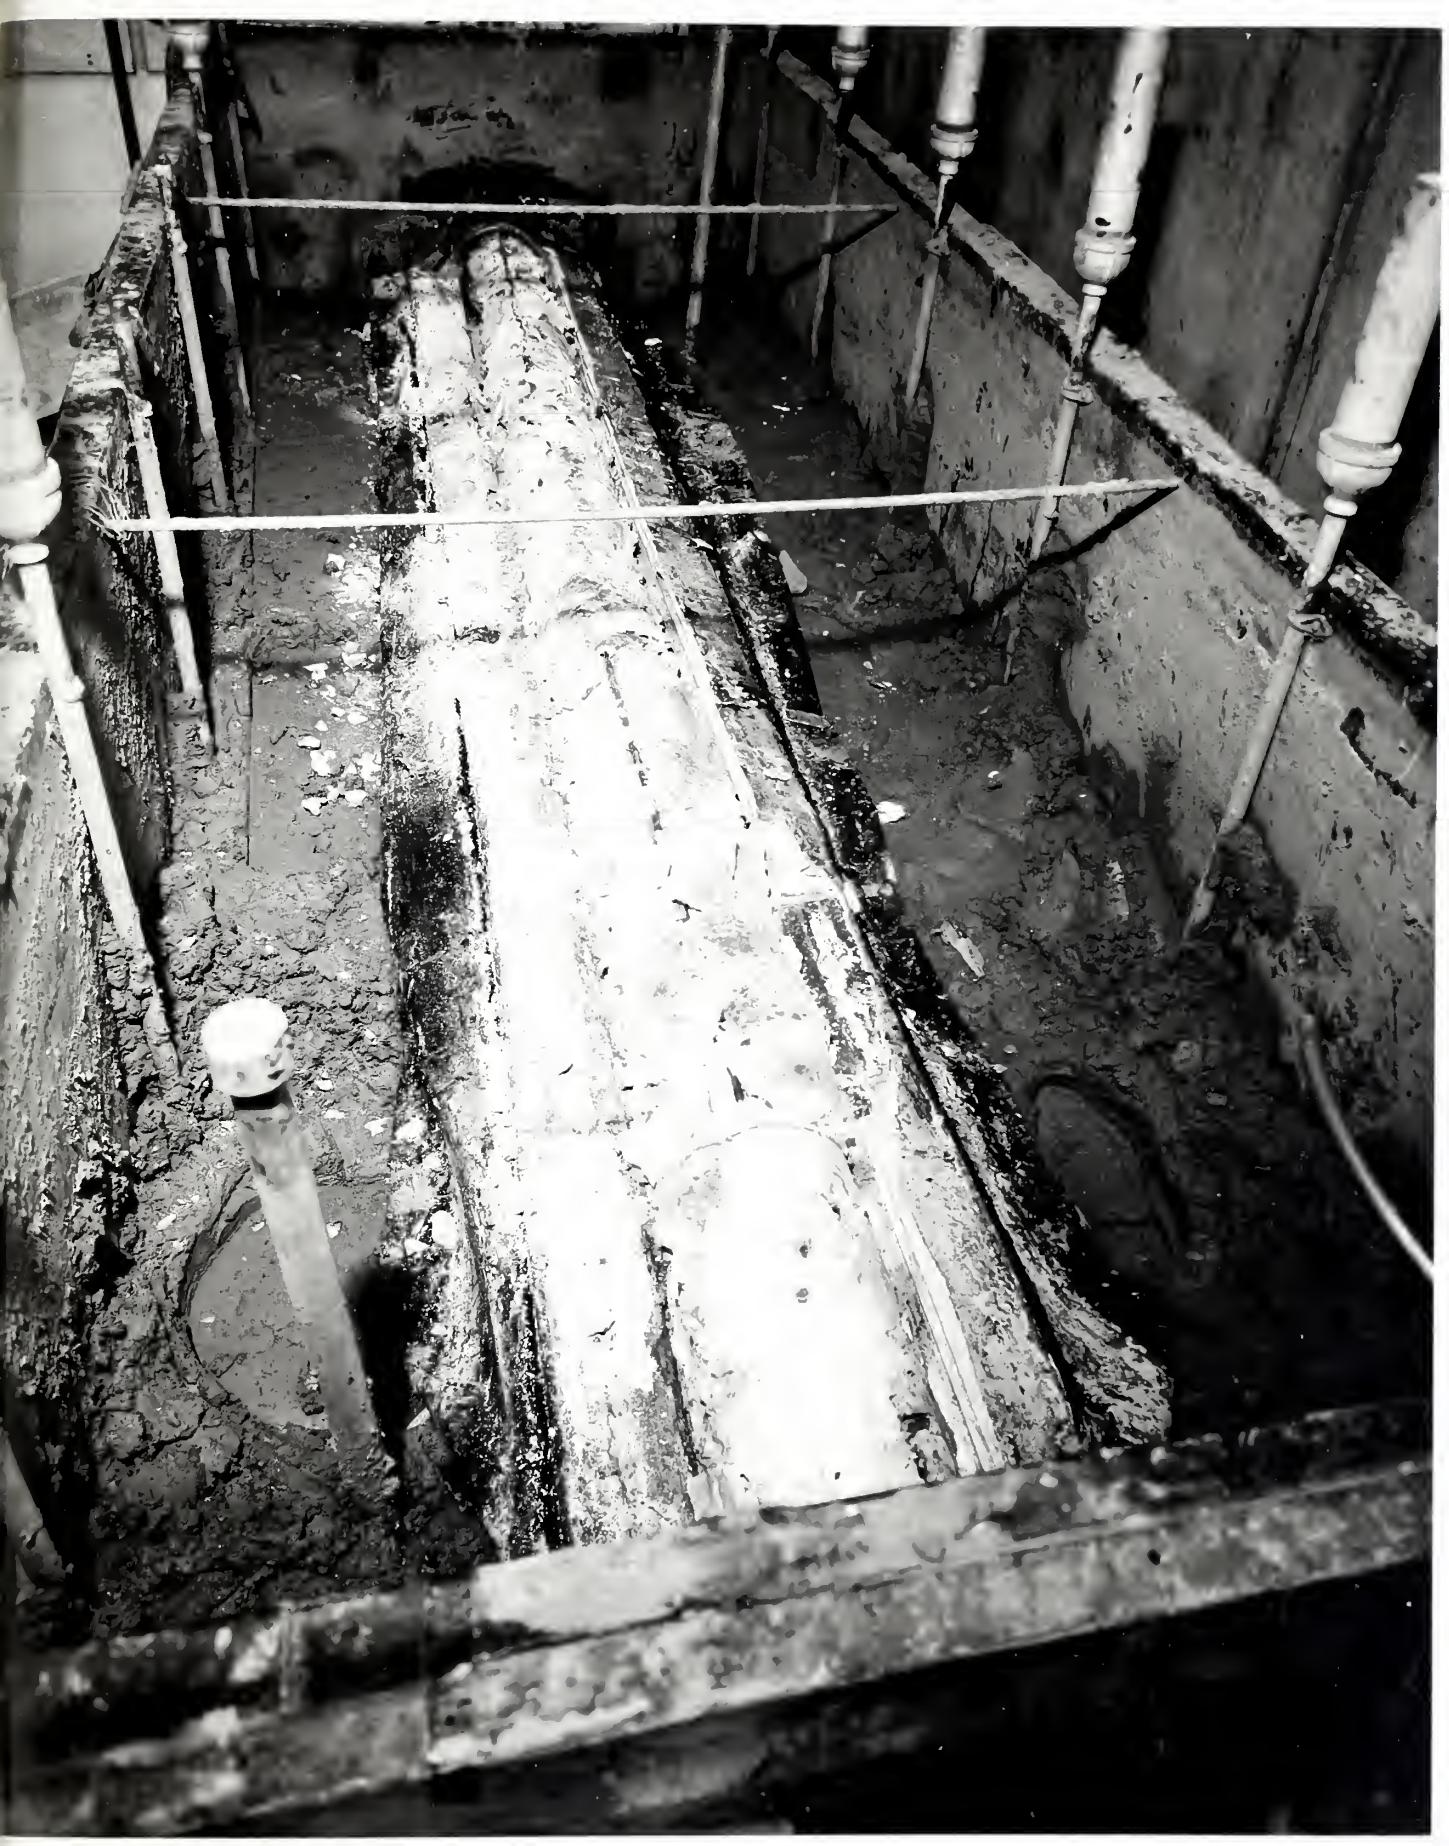
Figure 19

Fig 19 shows the appearance of the insulation in the conduit after boiling 72 hours. The dark streak at top center is a copper tube used at one time to introduce water to the insulation.
