NATIONAL BUREAU OF STANDARDS REPORT

6837

FIRE ENDURANCE AND HEAT TRANSFER
TESTS OF PREFABRICATED PANELS

FIRE ENDURANCE AND HEAT TRANSFER TESTS OF PREFABRICATED PANELS

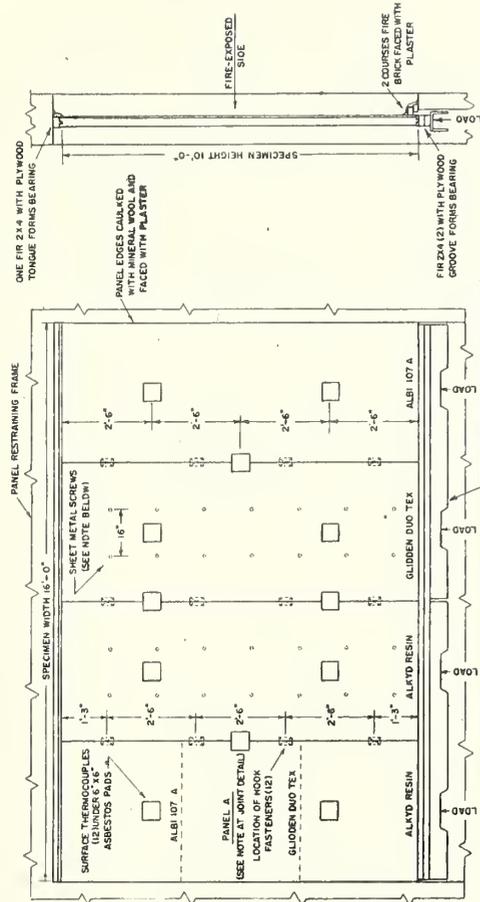
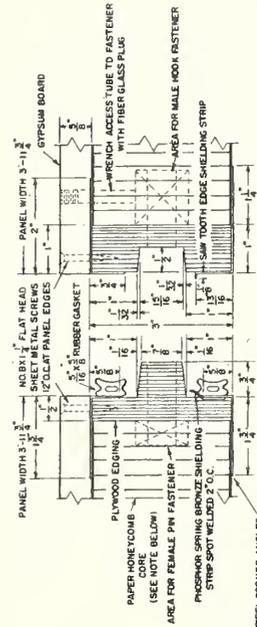
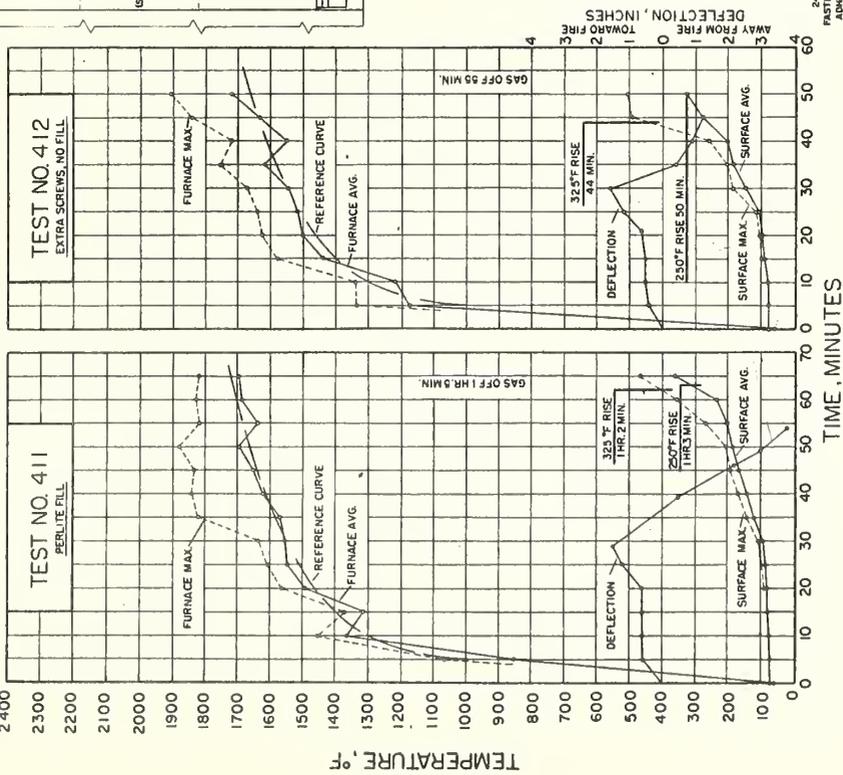
Figure 1. Construction details and data summary for wall tests.

The two wall specimens were identical in all but two features. In the first wall tested, the honeycomb had been filled with a perlite insulation; in the second, the honeycomb was empty. As a result of the behavior observed in the first test, it was decided to provide additional support for the gypsum board on the second specimen. This was done by means of 1-in. long No. 12, 13/32 in. cap head self-tapping sheet metal screws, with 3/4 in. OD washers, driven into holes drilled (No. 28 drill) through the gypsum board and metal skin. The locations of the holes are shown in Figure 1, at the end of this report. These screws were put into only the two center panels of the specimen.

The interior of the specimen continued to burn. The frame and specimen were removed from the furnace and the flames extinguished. Temperature and deflection data are summarized in Figure 1.

Flames penetrated joints in all the tests, but not until after limiting temperature rise on panels in both wall tests. Flame penetration occurred in the roof test before any significant temperature rise on the unexposed surfaces of the panels. However, except at the joint through which the flames penetrated, no significant temperature rise was observed over the joints either.

The wall, with perlite fill or without, provided appreciably longer fire endurance than the roof. In the case of a single-story building assembled from similar prefabricated elements, failure of the roof would amount to failure of the building so far as its contents were concerned. The longer fire endurance of the walls would be of value if they separated adjoining buildings or spaces in the same building. The results observed for the walls tested should not necessarily be expected to hold for walls having doors or windows.

The vertical joints between wall panels appeared to be more resistant than the panels to transient heat flow under the rapidly increasing "hot-side" temperatures of the fire tests. This fact is probably due to the thermal capacity of the comparatively high-density materials concentrated along the joints. However, under the steady-state conditions of the heat transfer tests, the joints leaked heat more rapidly than did equal areas of the panels.

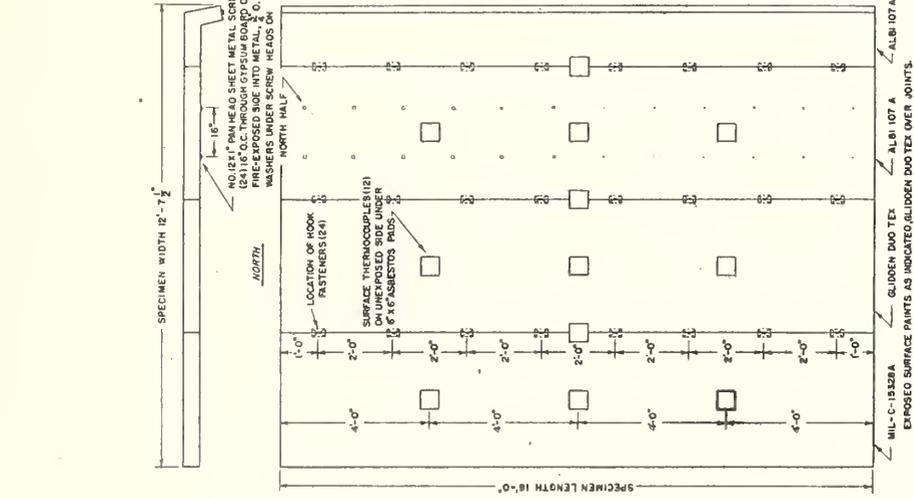
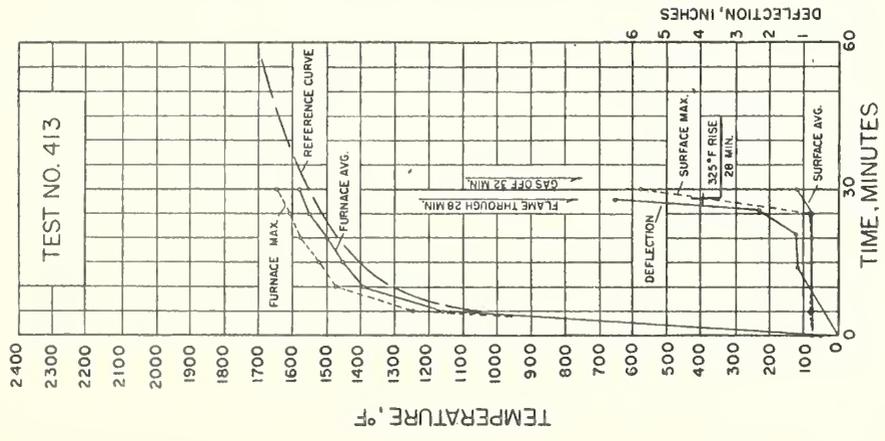
Figure 2. Construction details and data summary for roof test.

During the test, the specimen was subjected to an applied load of 50 lb per sq ft of roof area. Vertical deflections were measured at the center of the specimen. Temperatures were measured on the unexposed surface, by thermocouples under felted asbestos pads distributed as shown in Figure 2; and in the furnace chamber, by thermocouples encased in porcelain insulators and iron pipes. The furnace fires were regulated according to the same time-temperature curve as described for the wall tests.

heavy flames from its interior issued into the furnace chamber. The test was stopped at 32 min. The specimen continued to burn and a stream of water was used to extinguish the flames. Temperature and deflection data are summarized in Figure 2.
