7489

PERFORMANCE OF ROOFING IN PUERTO RICO

20 April 1962

The survey of roofing was conducted on March 20 through March 24, 1962, primarily in the vicinity of the cities of San Juan and Ponce, Puerto Rico. The following Military Installations were included in the survey:

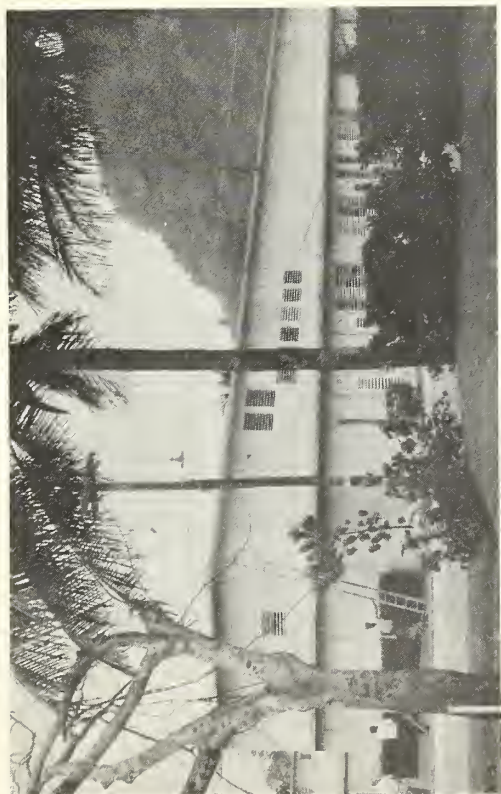
The performance of an elastomeric type of coating identified as "Hypalon" (a chlorosulfonated polyethylene roofing solution) was observed on the parabolic roof of the Santa Maria Reina Cathedral in Ponce, P.R., shown in Figure 6. The roof consisted of a 3-inch reinforced concrete shell supported by a series of 54-foot span catenary arches and had an area of about 240 squares. It was reported that two coats of "Hypalon" were applied by conventional pressure pot-spray equipment in January 1957. Our observations indicated the material had weathered quite well and no obvious defects were observed after 5 years exposure. A general view showed a somewhat mottled appearance indicating either unequal coverage or unequal weathering. It was felt that an additional application of the material should be applied in the near future.

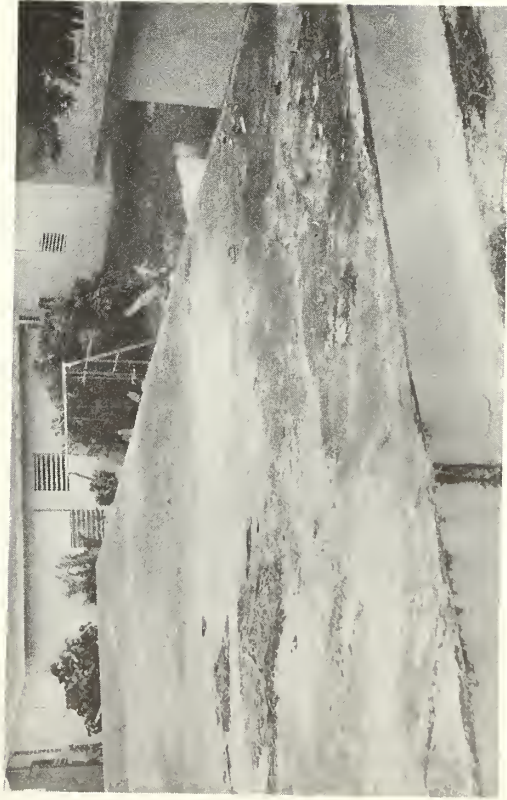
In cases where multiple roof levels were employed, some trouble was encountered at the junction of the deck with the vertical surface. A grout coating of concrete was unsuccessfully employed to remedy this condition. Cracking, as illustrated in Figures 11 and 12, soon developed and, in addition, the adhesion between the grout and the dense concrete was poor and water was invariably found in that area. Interior examinations generally revealed leakage in these areas.

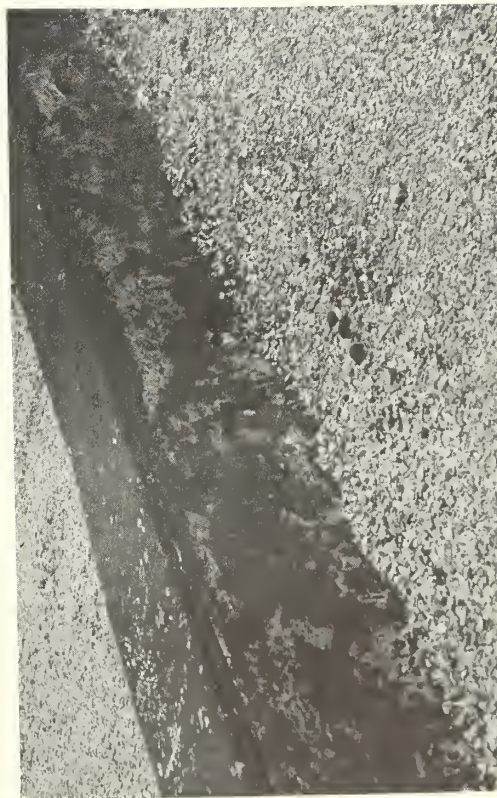
19

The appearance of this roof was good after about 20 years exposure, as shown in Figure 18. An examination of the asphalt showed it to be very hard and brittle even at the high temperature of the roof. However, there were no other signs of deterioration and it was apparently performing its basic function. The only defects observed were a number of bare areas where the felts were exposed. Some 41 leaks were reported in this roof. However, our observations indicated that most, if not all, of the leaks resulted from defective flashings, as shown in Figure 19. Obviously such deficiencies could be prevented by adequate and timely maintenance.
