# NATIONAL BUREAU OF STANDARDS REPORT

8339

## PERFORMANCE OF FLOORING MATERIALS IN MILITARY KITCHENS

30 April 1964

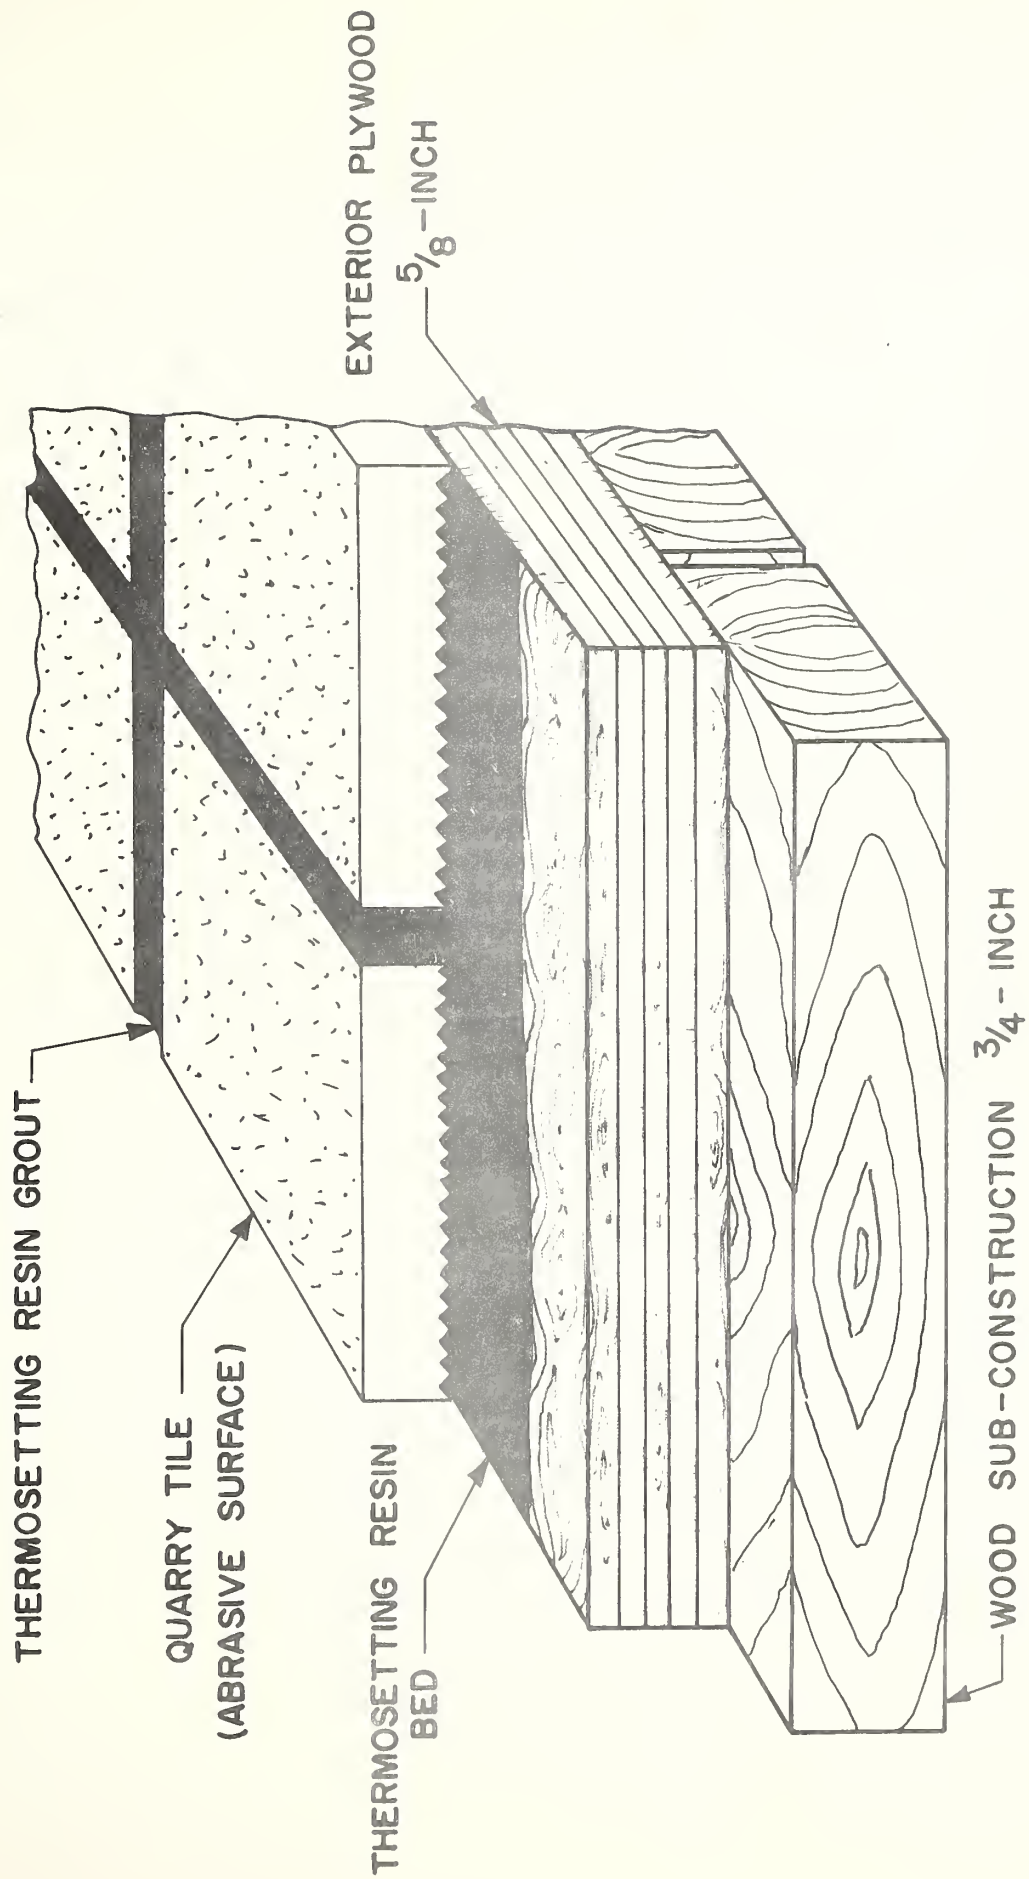
FIGURE 3. QUARRY TILE FLOOR CONSTRUCTION OVER WOOD SUBFLOORING.

Non-slip conditions were obtained by using tile with aluminum oxide particles embedded in the surface. Two thermosetting resins, epoxy and furan, were investigated for better joints and bed mortars. A floor design was used on floors numbers 9 and 10 that would permit the installation of quarry tile over wood (see Figure 3).

This kitchen has been occupied only 50% of the three years since its installation. Softening of the epoxy joints near the heated ranges has been noted.

Test floor number 10 was installed over plywood similar to floor number 9 and illustrated in Figure 3, except that furan resin was used as the bed and joint and the top surfaces of the tiles were waxed.
