NATIONAL BUREAU OF STANDARDS REPORT

8352

PERFORMANCE OF ROOFINGS ON GUAM, M.I. AND OKINAWA, R.I.

20 May 1964

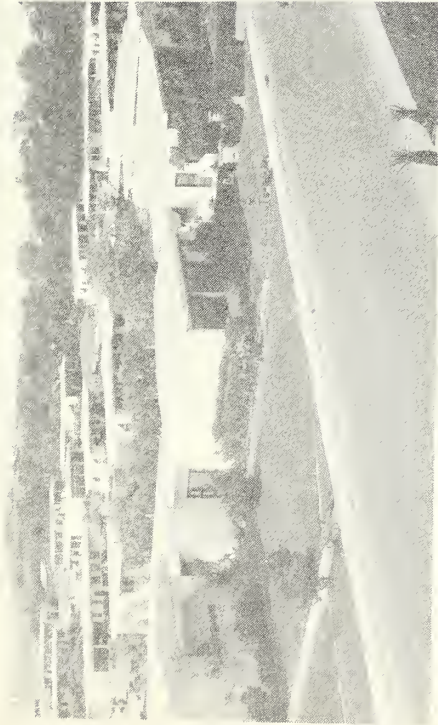
Smooth-surfaced, asphalt built-up roofs have been used to some extent on Okinawa to protect both pre-cast and poured-in-place concrete roof decks. The roof areas covered with such systems varied from 12 squares for a single family dwelling to over 2000 squares for large warehouses (as illustrated in Figures 13 & 14) and had roof slopes from flat to one inch per foot. Coal-tar-pitch has not been used to any extent for roofing on Okinawa.

FIGURE 14. ENGINEERING WAREHOUSES,
MACHINATO SERVICE AREA, OKINAWA.

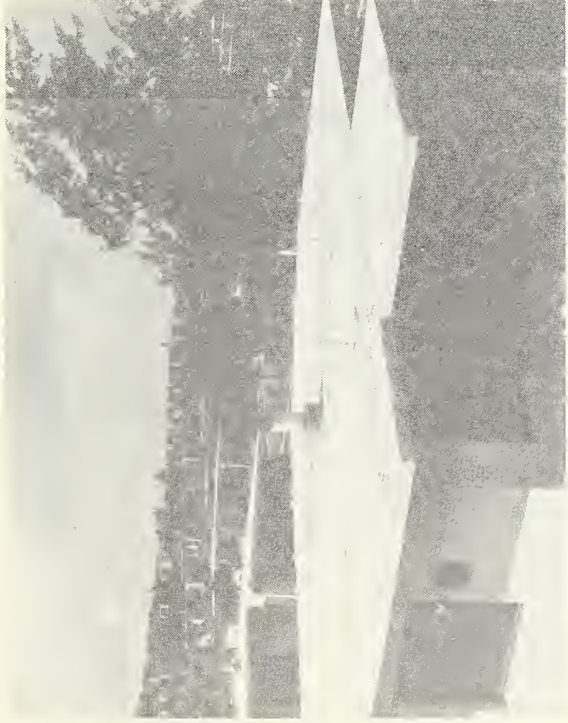
FIGURE 17. BUILT-UP ROOFING ON TYPE C HOUSING, SUKIRAN AREA.

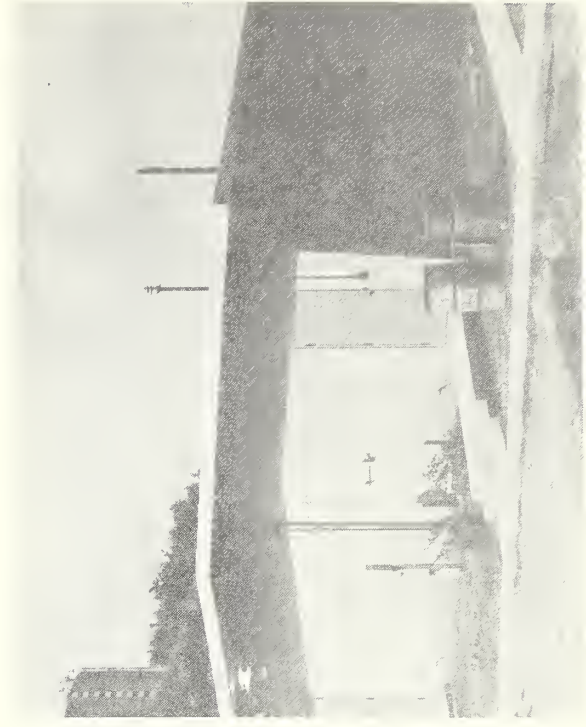
believe that it did not substantially contribute to premature failures. Examples of this defect were observed at Fort Buckner as illustrated in Figure 19 after 9 years exposure and on the built-up roof of the prototype barracks building (Figure 20) located at Camp Butler as evidenced by the numerous repaired areas shown in Figure 21.

FIGURE 20. PROTOTYPE BARRACKS BUILDING, CAMP BUTLER.

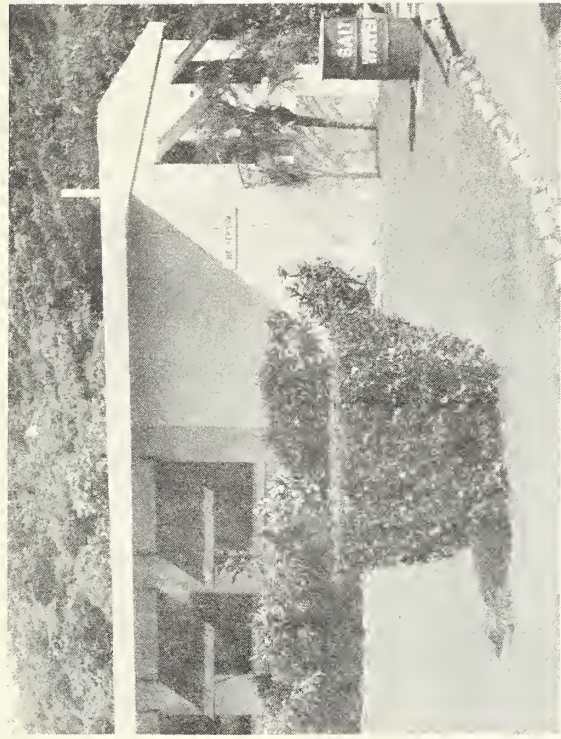
The performance of the glass mat - asphalt emulsion, etc., roofing system appeared to be quite satisfactory on both sloping and flat roofs. Figure 22 illustrates a typical home protected with such a roof and Figure 23 shows the roofing after about 11 years exposure. This system required periodic recoatings with the aluminum compound.

FIGURE 22. TYPICAL HOUSE, SUKIRAN AREA.

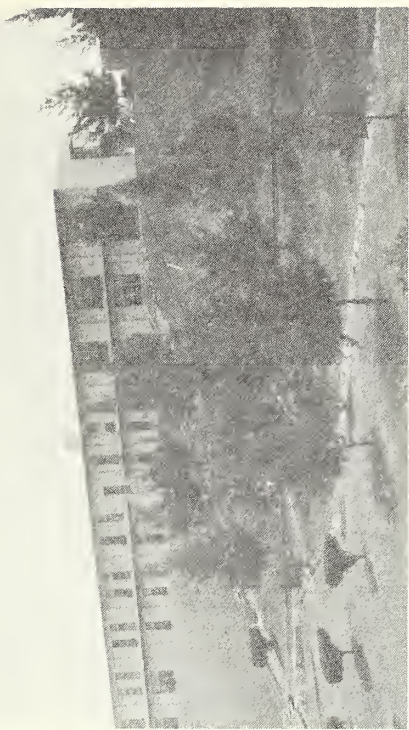
FIGURE 26. 165-MAN BARRACKS BUILDING.

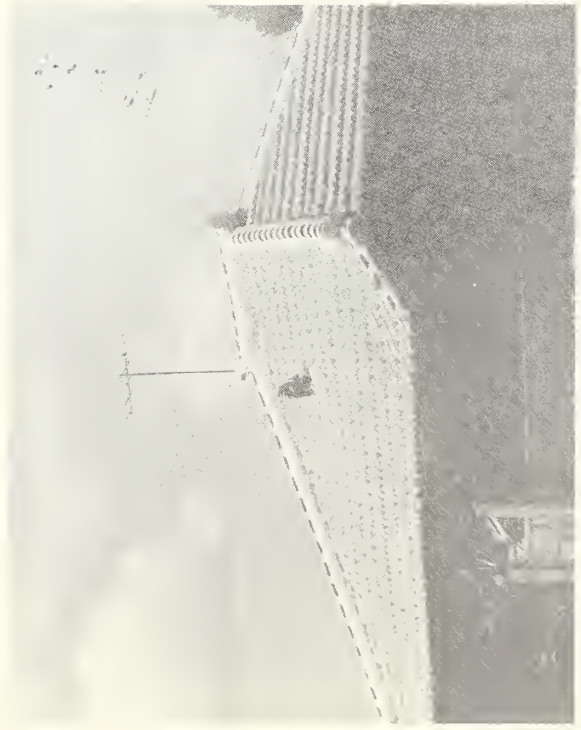
It was of interest to the author to observe the roofings used on the typical Ryukyuan homes. For the most part clay or concrete tile roofs complete with their "Kara Shishi", or Chinese Guardian Dogs, are traditional as shown in Figure 31. However, a number of thatched roofs were often seen in the rural areas as illustrated in Figure 32. These roofings have proven to be quite durable against the Okinawa weather. However, if it is of any comfort to the military engineer, these roofs also leak, are also vulnerable to damage during high winds and also require periodic maintenance.

FIGURE 31. CONCRETE TILE ROOFING COM-
PLETE WITH "KARA SHISHI" OR CHINESE
GUARDIAN DOG.

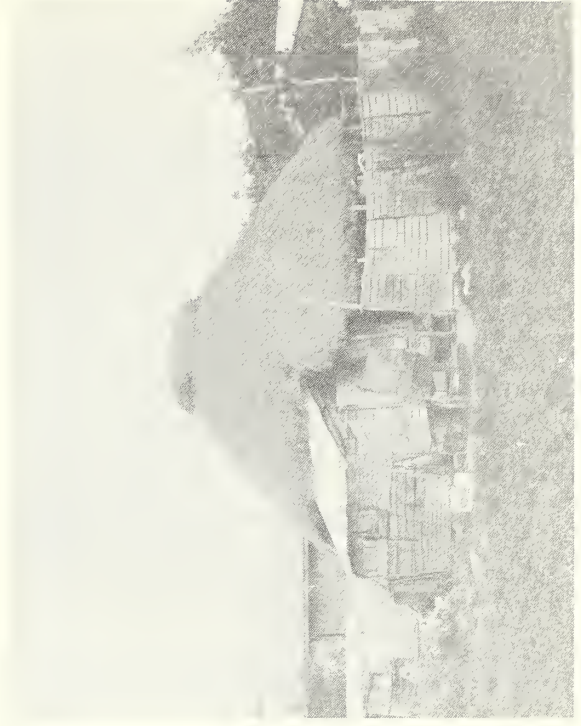
FIGURE 32. THATCHED ROOFS OBSERVED
IN RURAL AREAS.
