EVALUATION OF NEW ROOFING SYSTEMS ON GUAM, M.I.

30 June 1964

William C. Cullen
Organic Building Materials Section
Building Research Division

Office of the Chief of Engineers
Department of the Air Force
Bureau of Yards and Docks

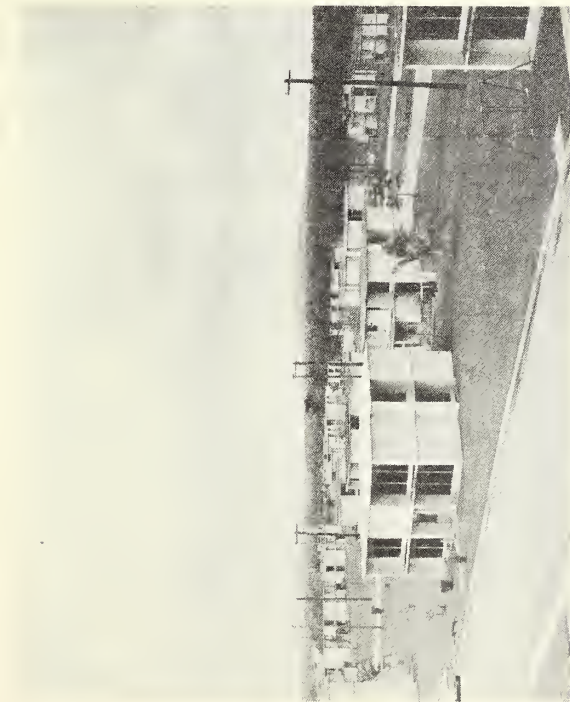
In some cases the materials included in this class initially failed to waterproof the concrete slab due to poor coverage at the high spreading rates recommended for these materials. The remaining materials failed to perform due to peeling, blistering, flaking, and in their ability to bridge even small structural or shrinkage cracks which developed in the concrete deck. Typical examples of failures which were common to coatings of this class are shown in Figures 4 and 5.

FIGURE 4. EROSION OF A PAINT TYPE
COATING. AGE 45 MONTHS.

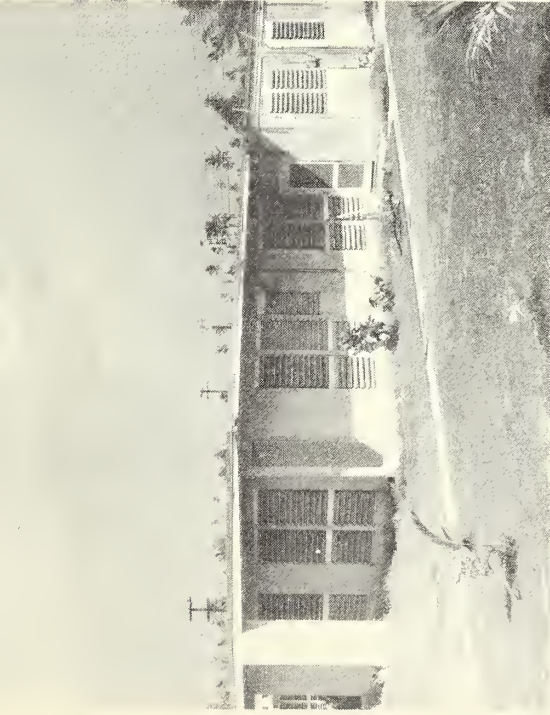
The buildings selected for the roofing tests were permanent quarters in the Tipalao Housing Area located on the Orote Peninsula, Guam. Figure 9 shows a typical house. The semi-detached, single-storey residences were scheduled for reroofing in 1964 and, therefore, were selected to receive the new roof systems.

FIGURE 9. TYPICAL HOUSE USED IN 1964
ROOF EVALUATION PROGRAM, TIFALAO
HOUSING AREA, GUAM

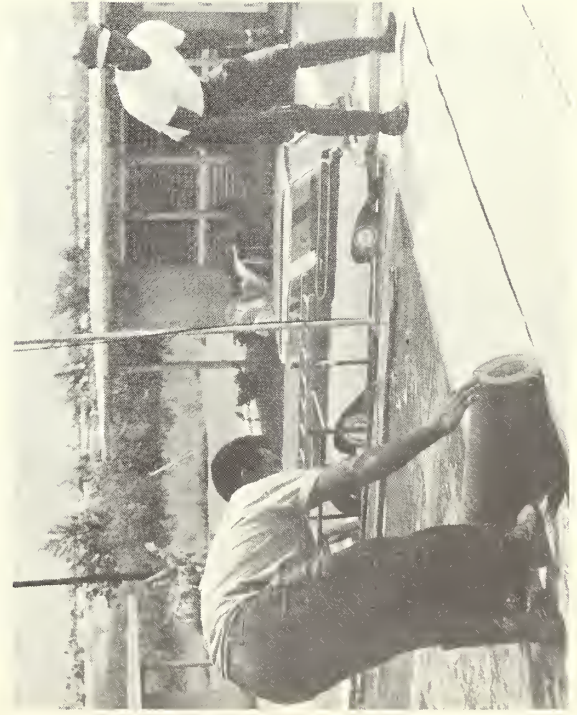
The roof system consisted of a 15 lb. base sheet mopped to the deck with hot asphalt, a 1-inch thickness of Fiberglas roof insulation, and two plies of 11 lb. asphalt-impregnated glass felt cemented to the insulation and to each other with hot asphalt. A granule-surfaced glass base cap sheet was applied as the weather surface as shown in Figure 11. Prior to the application of the built-up membrane, the joints between units of insulation were taped with a 6-inch wide roof tape.

FIGURE 11. APPLICATION OF MINERAL
SURFACED CAP SHEET.

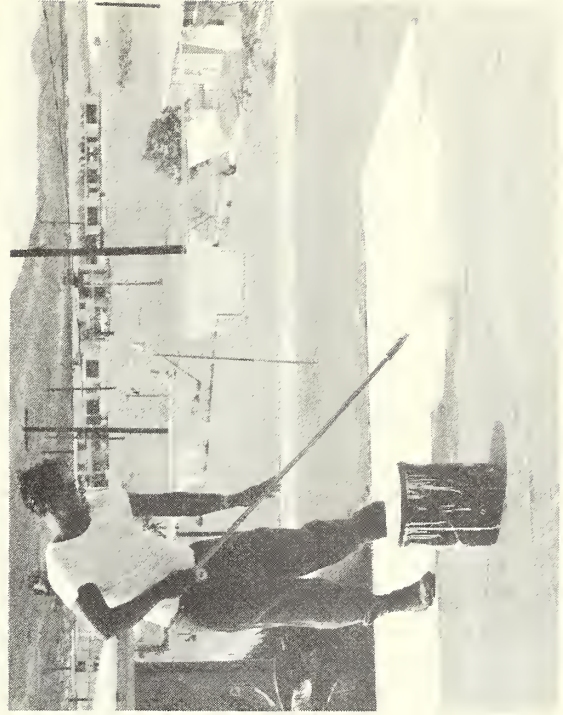
The roof system consisted of a sheet of "ventsulation" felt, spot mopped to the concrete deck with hot asphalt to which was mopped a one-inch thick perlite type insulation board. The one-ply membrane described above was cemented to the insulation using a ribbon pouring of a solvent-type polyisobutylene adhesive. The surface was roller coated with an elastomer-base white coating as shown in Figure 12.

FIGURE 12. APPLICATION OF WHITE
SURFACE COATING TO POLYISOBUTYLENE-
ASBESTOS FELT SYSTEM.

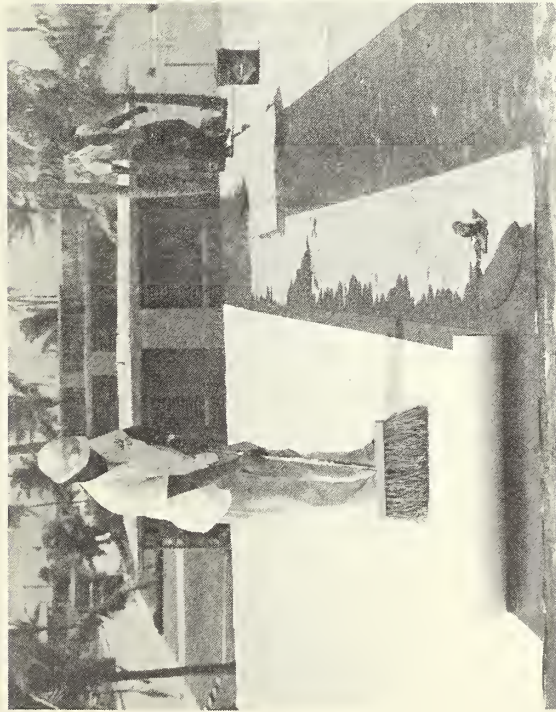
The roof system consisted of one ply of "vensulation" felt, spot mopped to the concrete deck with hot asphalt to which a one-inch thick perlite insulation board was mopped. A 43 lb., asphalt-saturated and coated base sheet was cemented to the insulation with a solvent-type, asphalt adhesive. The base sheet was surfaced with the one-ply polyvinyl fluoride-asbestos felt laminate which was also cemented with the cold asphalt adhesive as shown in Figure 13. No surface coating was applied to this system.

FIGURE 13. APPLICATION OF POLYVINYL FLUORIDE - ASBESTOS FELT SYSTEM.

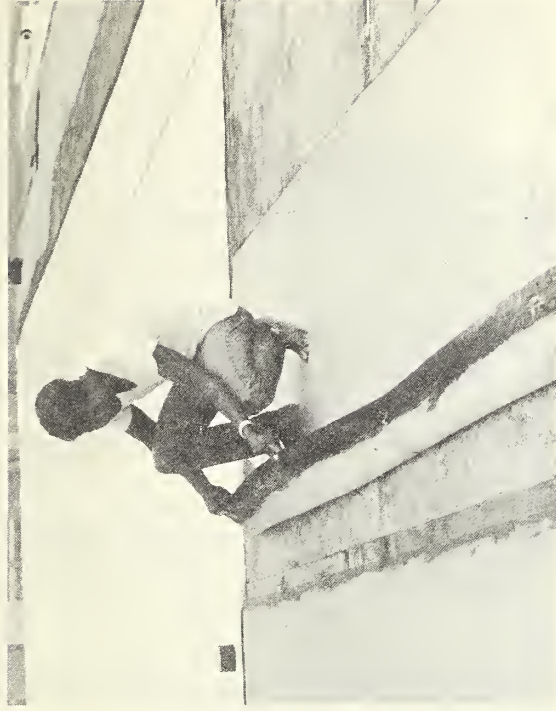
The roofing system consisted of one ply of "vensulation" felt, mopped to the deck with hot asphalt and a one-inch thickness of a perlite insulation board to which a 0.0625 (1/16 in.) thick sheet of butyl rubber roofing was applied using a solvent-type rubber base adhesive. An unvulcanized butyl rubber tape was used in conjunction with a butyl rubber adhesive to secure tight laps, as shown in Figure 14. The black butyl roofing was surfaced with a white chlorosulfonated polyethylene roofing solution applied by roller.

FIGURE 14. MAKING A LAP DURING INSTALLATION OF BUTYL SHEET RUBBER ROOFING.
