PROGRESS REPORT ON EXPOSURE OF NEW ROOFING SYSTEMS

Thomas H. Boone and William C. Cullen

31 July 1966

9381

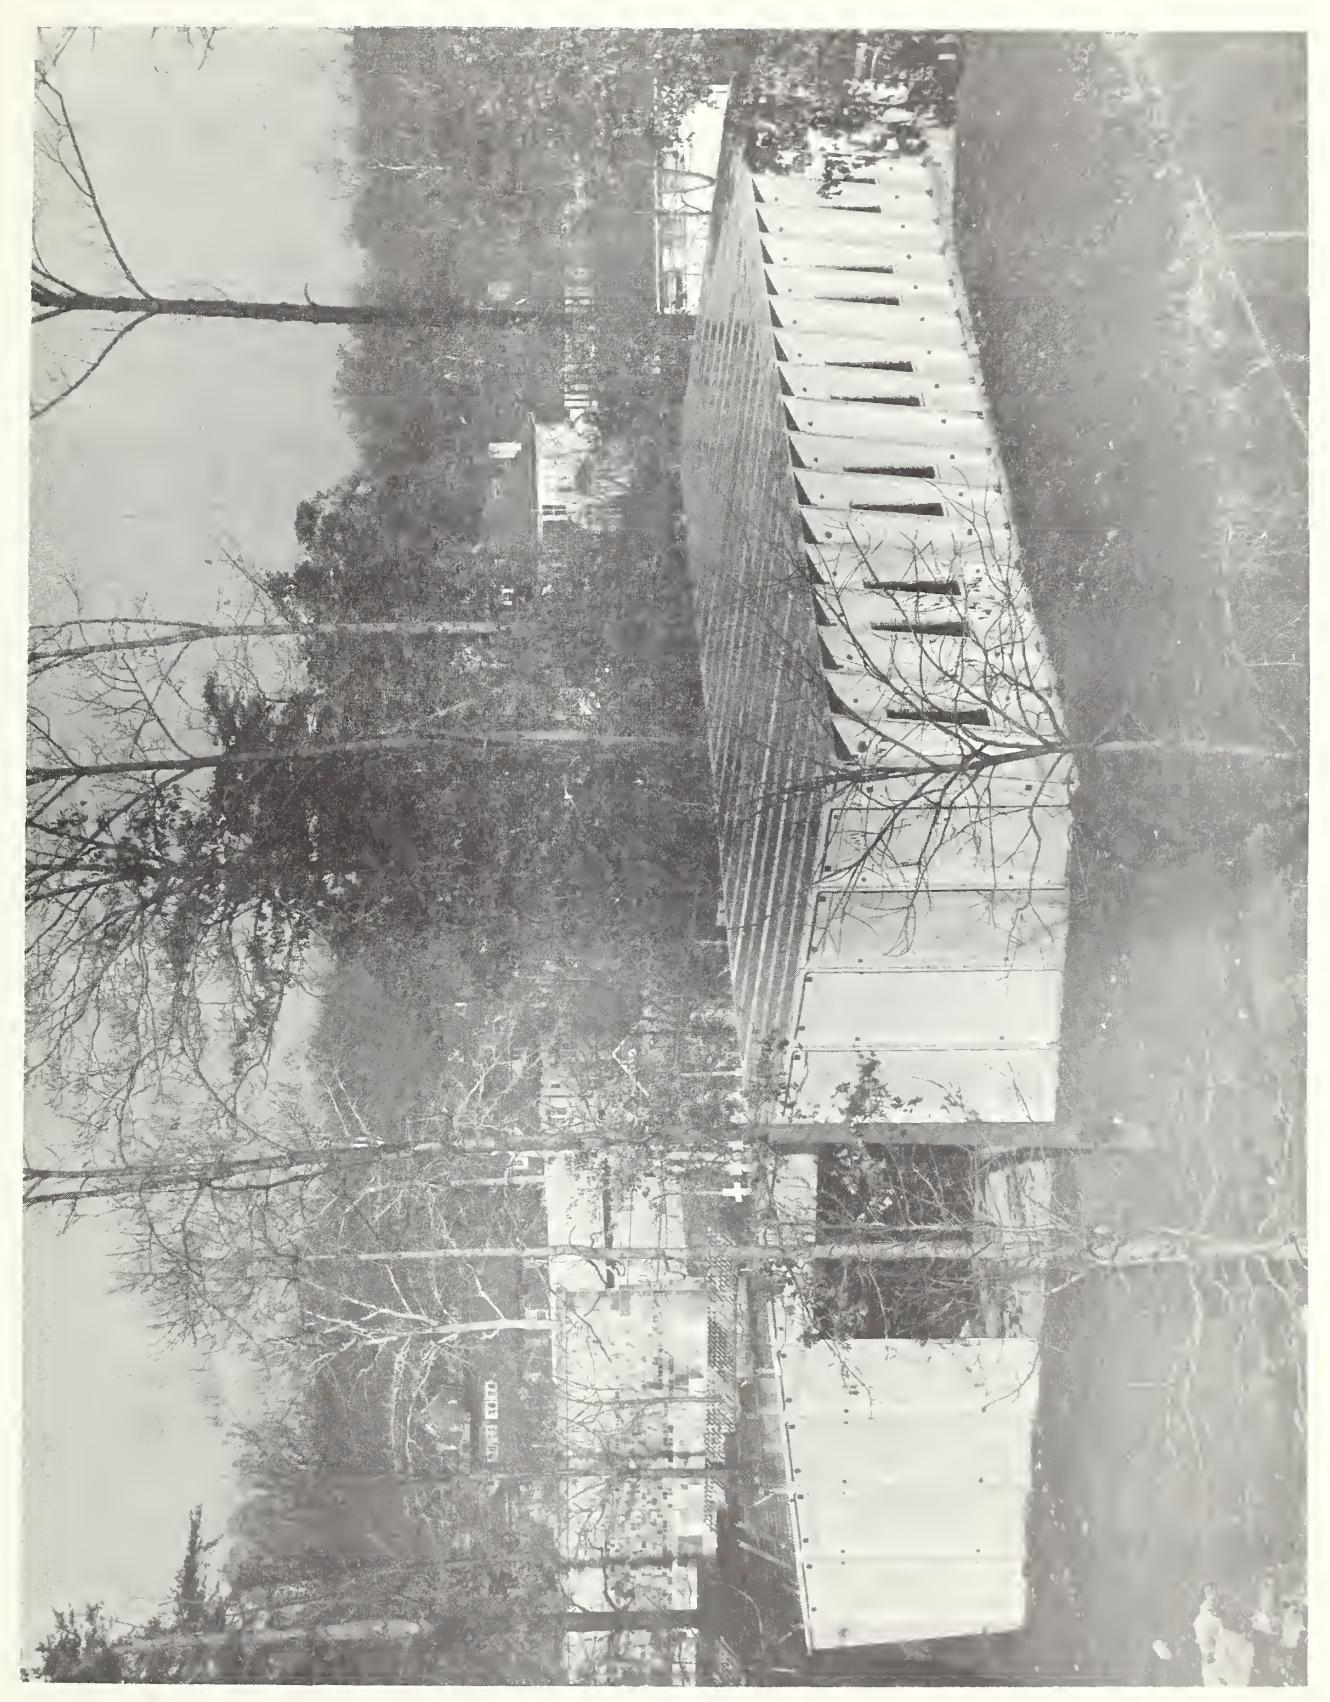
FIGURE 1. BUILDING OF PRECAST THIN SHELL PANELS USED FOR TEST ROOFS.

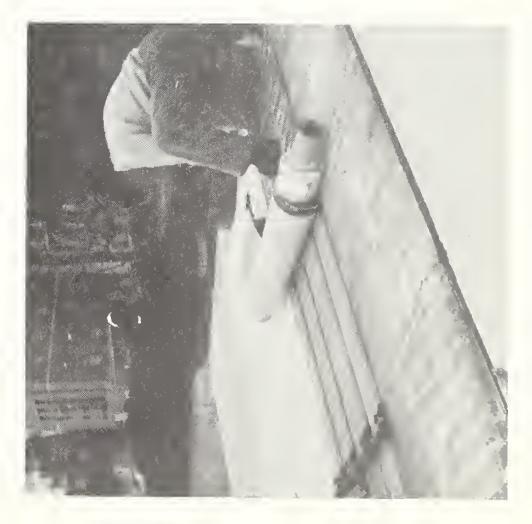
This sheet has an 80 mil-thick black rubberized-asphalt top surface which was laminated in the factory to a 20 mil asbestos backing felt. The sheet was applied directly to the concrete with an organic solvent-based adhesive spread in ribbons. See figure 15. The laps were sealed with the same adhesive.

FIGURE 15. APPLICATION OF RUBBERIZED ASPHALT SHEET WITH ADHESIVE APPLIED IN RIBBONS.
