NATIONAL BUREAU OF STANDARDS REPORT

9513

The Stress Corrosion and Galvanic Behavior of
17-4 PH Fasteners in Marine Environments

Materials Division
Air Systems Command
Department of the Navy

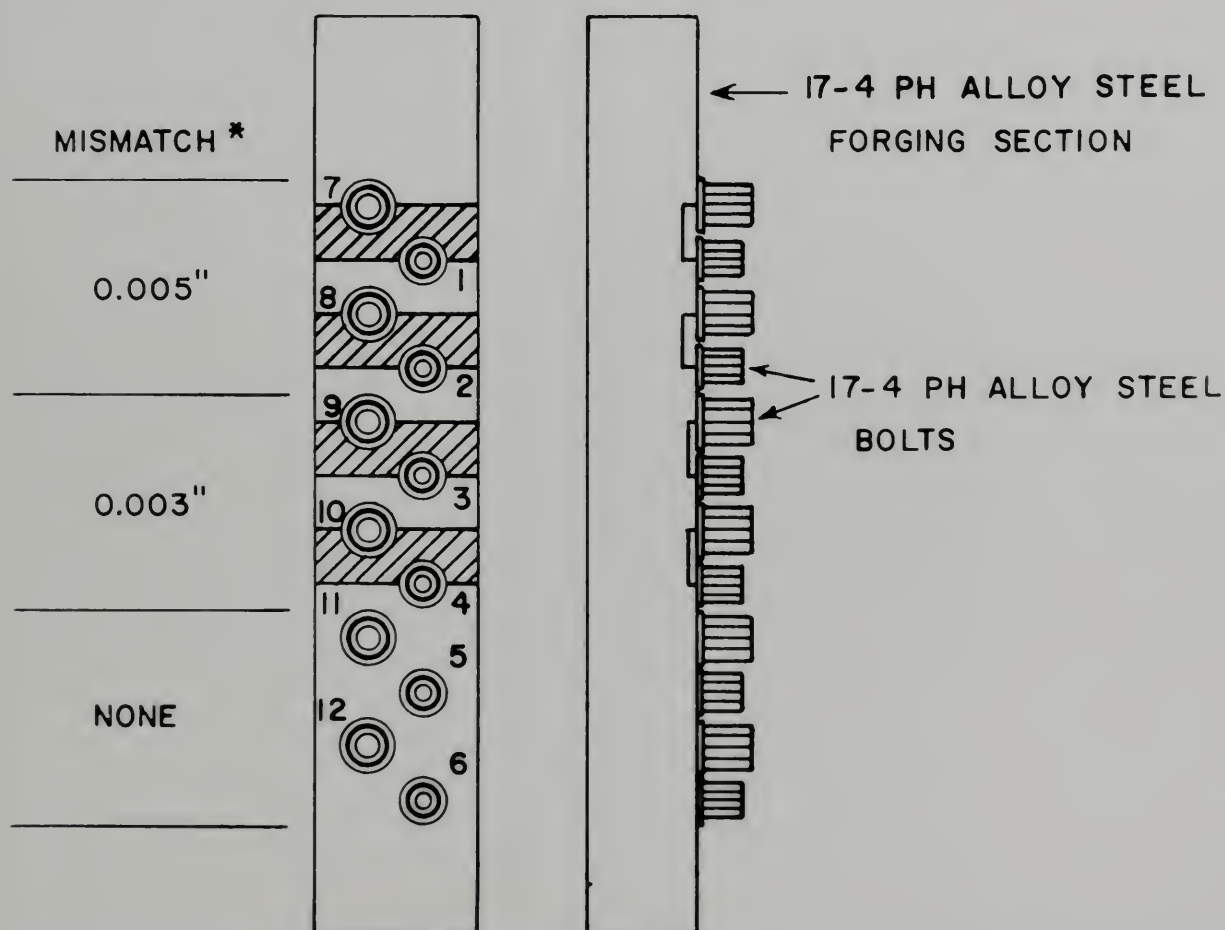
Figure 1. Typical Stress Corrosion Assembly.

MACHINED AREAS FOR MISMATCH SURFACES.

*Parallelism between spot face surface of bolt head and mating surface of part may deviate up to 0.003 inches. This is governed by squareness of head surface to shank and is a function of tooling operations, according to D. F. Wright, General Motors, Allison Div. communication dated Feb. 2, 1962.

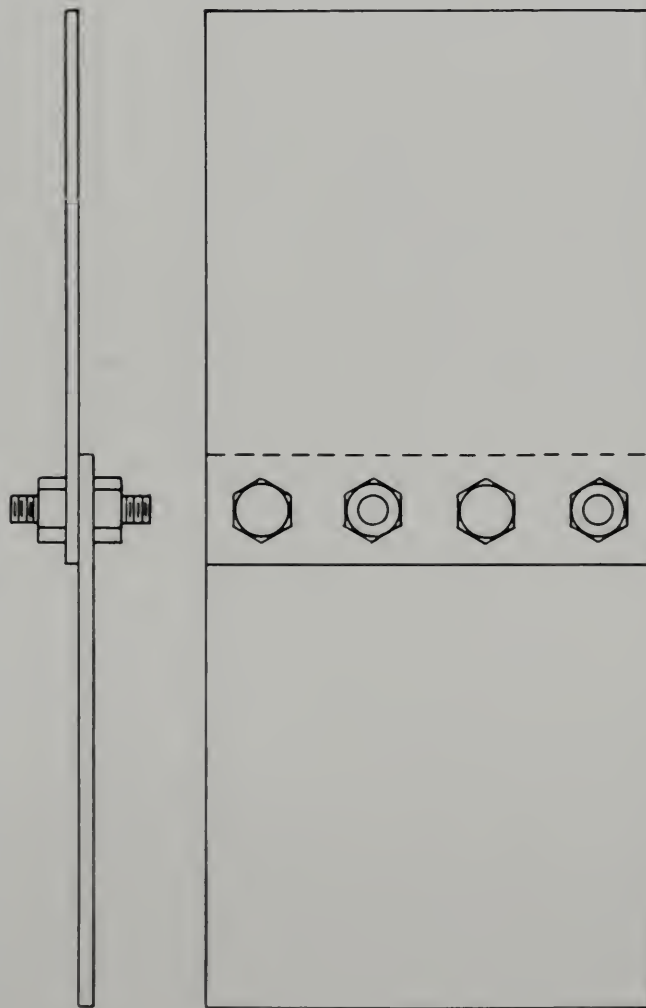
BOLTS - 17-4 PH ALLOY STEEL
1/4" - 28 X 15/32"

NUTS - 18-8 STAINLESS STEEL
ALLOY.

Figure 5. Typical dissimilar metal corrosion test assembly. 1/4" -28 bolts were positioned 1/2 inch from the edges and 1 inch apart. Applied torque to bolts was 85 lb-in. Sheet metal used is noted in Table 1.
