NATIONAL BUREAU OF STANDARDS REPORT

REPORT ON THE PERFORMANCE OF
ASBESTOS FIBER-BASE BUILT-UP ROOFS

7 February 1969

Thomas H. Boone and Leopold F. Skoda

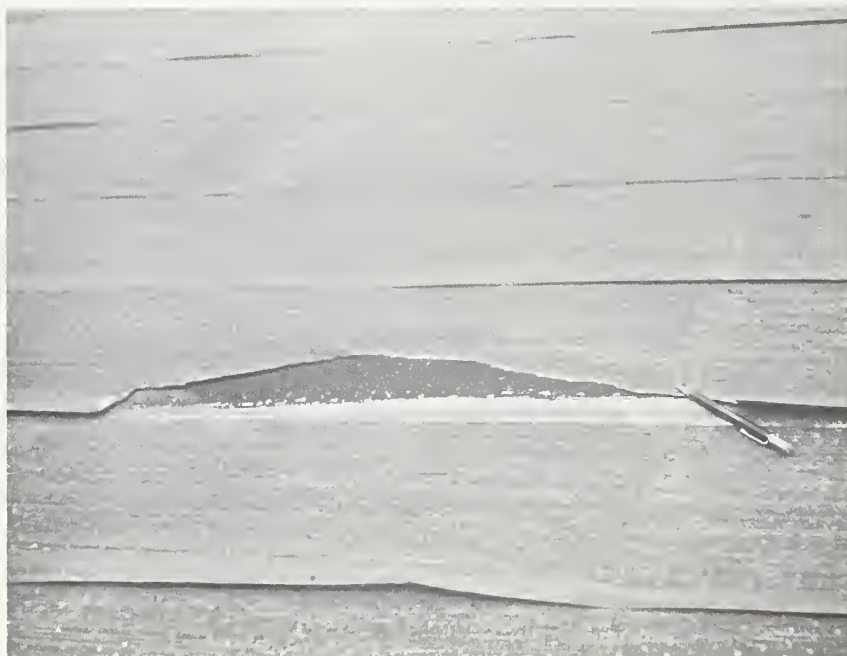
21	18	No leaks	Numerous blisters	Excellent bond between plies
22	13	No leaks	Extensive blisters	Excellent bond between plies
23	10	Subjected to several hurricanes, No leaks	Coating on south exposure worn off, Some felt torn	Excellent bond between plies
24	15	History of leaks	Roof covered with mineral cap sheet, Few large splits	Splits through complete membrane
25	15	Subjected to several hurricanes, No leaks	Coating worn off, Felts at laps delaminated & torn (see Fig. 8)	Excellent bond between plies

Figure 8. Asbestos felts delaminated and torn. This roof was subjected to several hurricanes.

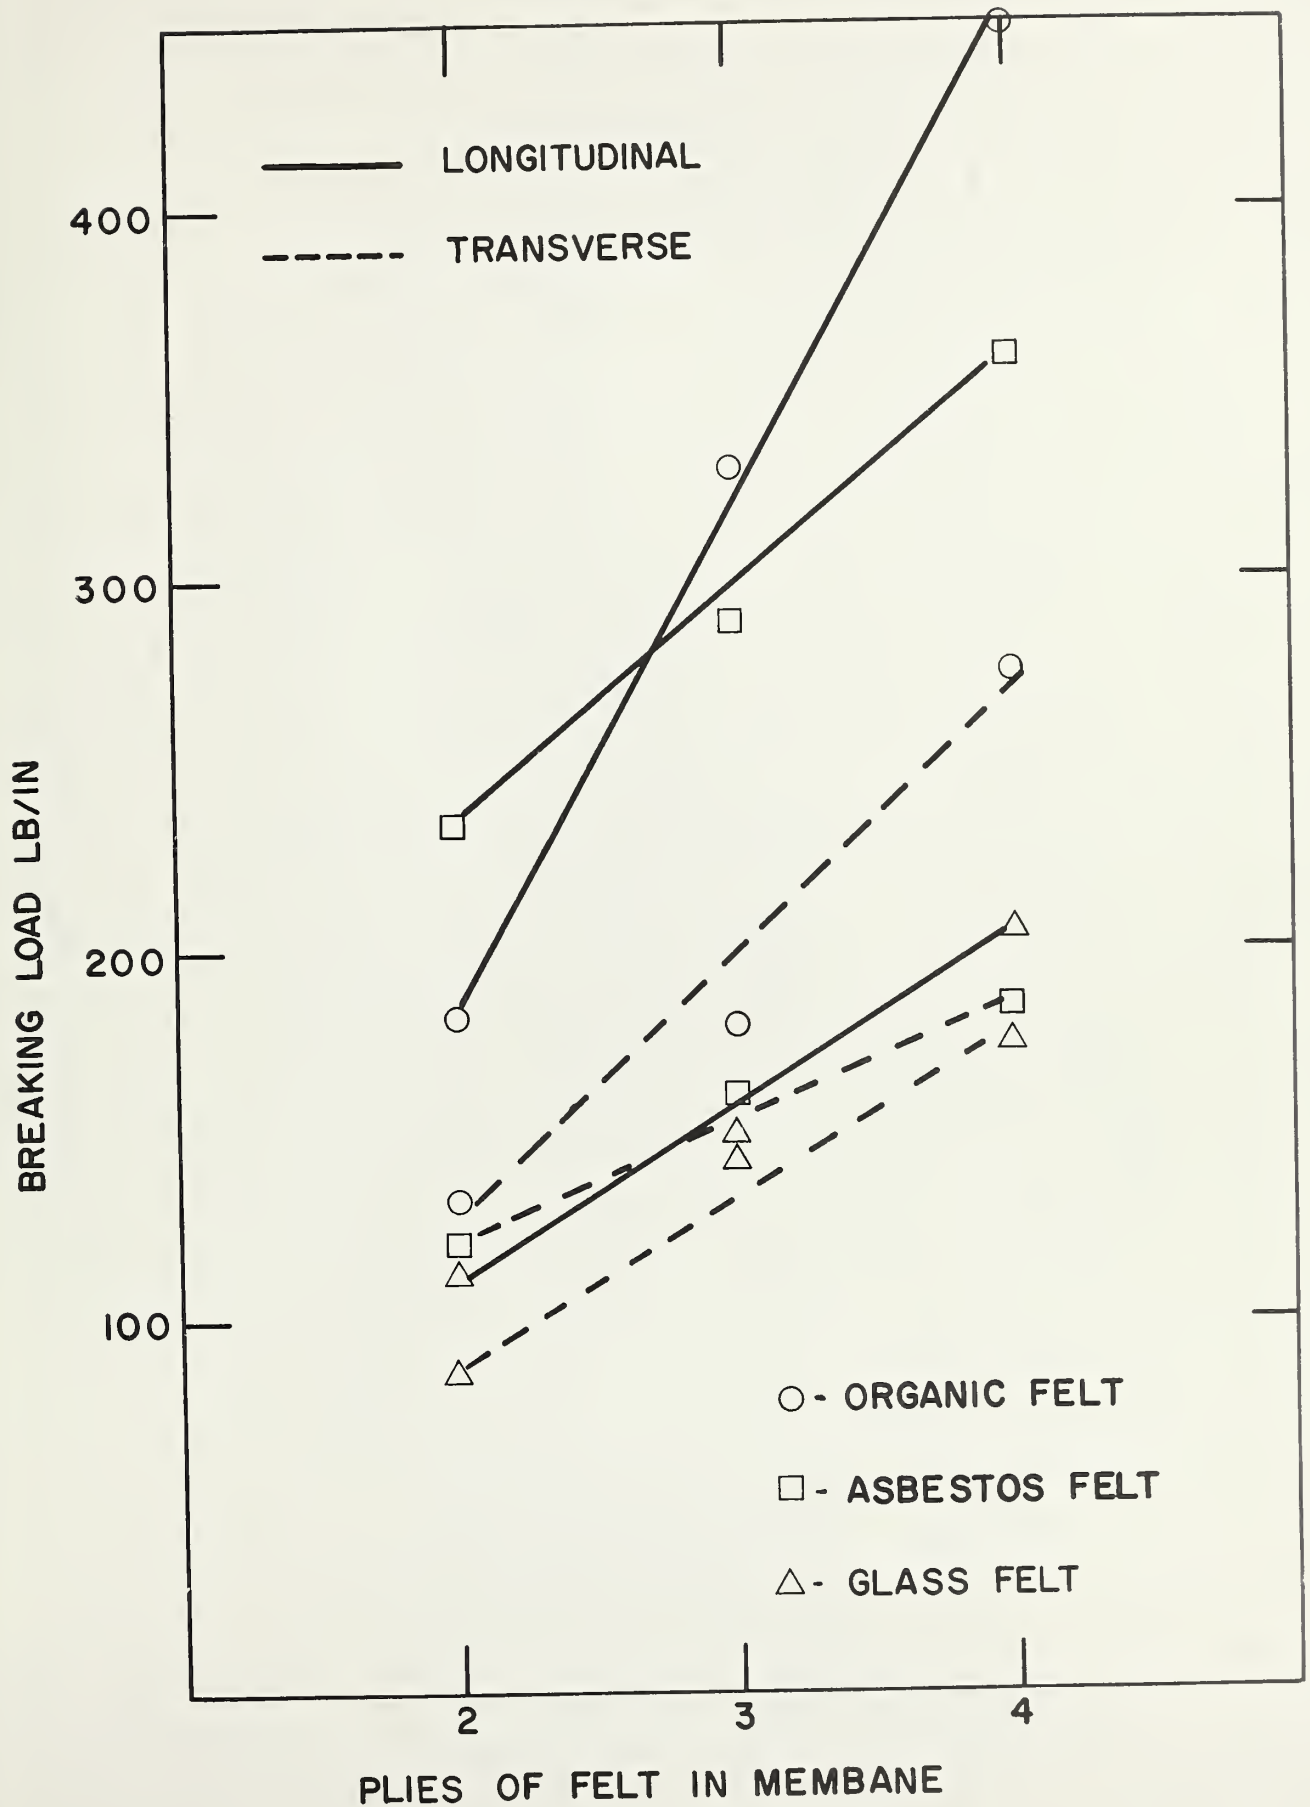
Figure a contains comparative tensile test data of roofing membranes constructed of various plies and various kinds of felts. The asbestos felts data was obtained from this series of tests. The organic felt and glass felt data were obtained on other investigations [3] [4]. All data included in Figure a were obtained from field prepared membranes or from existing roofs. Age of membranes was not considered. Figure a shows that the asbestos felt membranes are stronger than glass felt membranes but not as strong as organic felt membranes in every case.

FIGURE a. Breaking load of built-up roofing membranes at 0°F.
