NBS SPECIAL PUBLICATION 592

An Investigation of the Miyagi-ken-oki, Japan, Earthquake of June 12, 1978

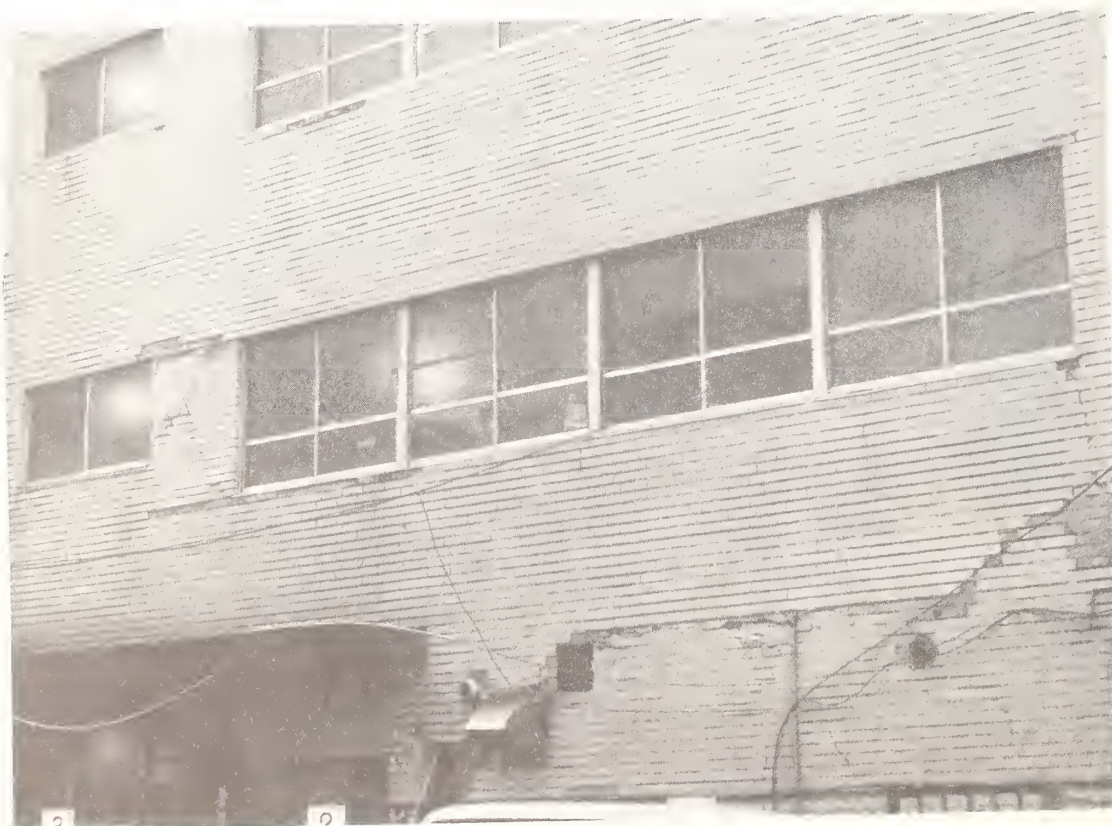
Figure 5.6 Second Eastern Building Company Building, Sendai. A typical modern building in Sendai; the only apparant damage to the glazed tile veneer on the exterior was cracking on spandrels and shear walls.

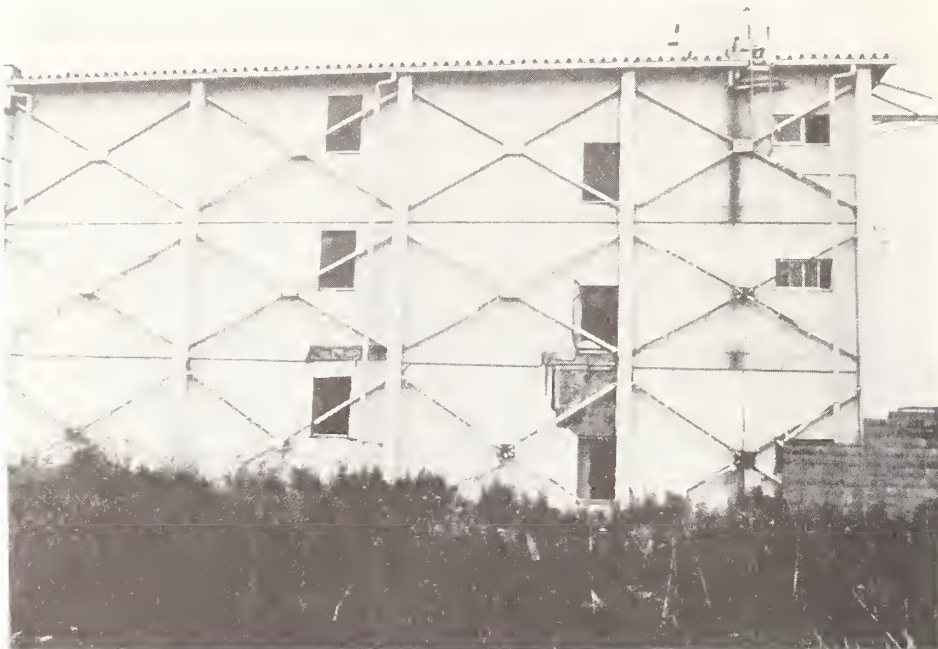
Earthquake resistance in steel buildings is provided either through the use of moment-resisting frames or through diagonal bracing. When braces are used as earthquake resisting elements, it is normal practice to design them so as to carry all of the horizontal force. An example of such a structure is a steel framed furniture warehouse on the outskirts of Sendai shown in Figure 5.11. There were many examples where the bracing members buckled under stress reversal or the connections failed. A number of the transverse diagonal braces used in this warehouse sheared at their bolted cross connections (Figure 5.12).

Figure 5.11 A damaged steel-framed furniture warehouse on the outskirts of Sendai.

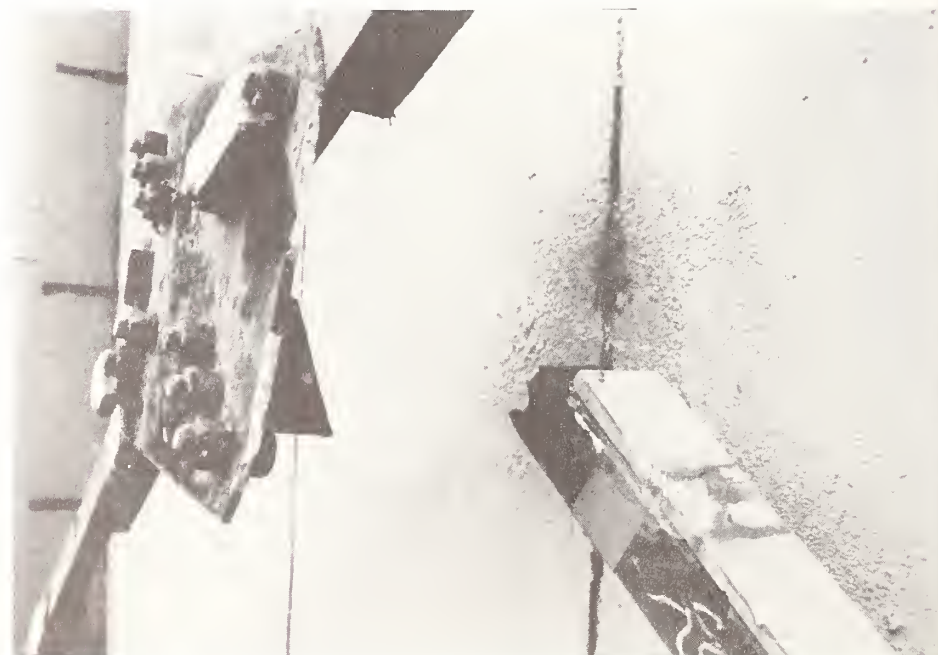
Figure 5.12 Detail of failure in transverse diagonal braces.

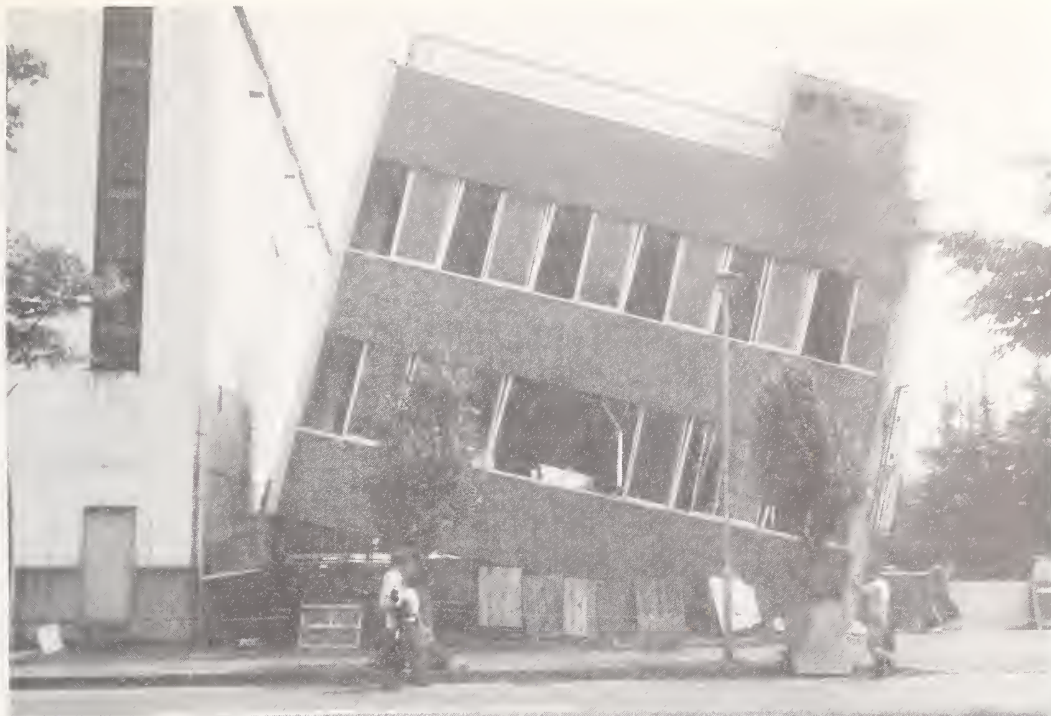
Figure 5.27 Obisan Building, viewed from the North. This three story reinforced concrete frame building had a heavy eccentric stairwell cantilevered over the column line at the right end of the building.

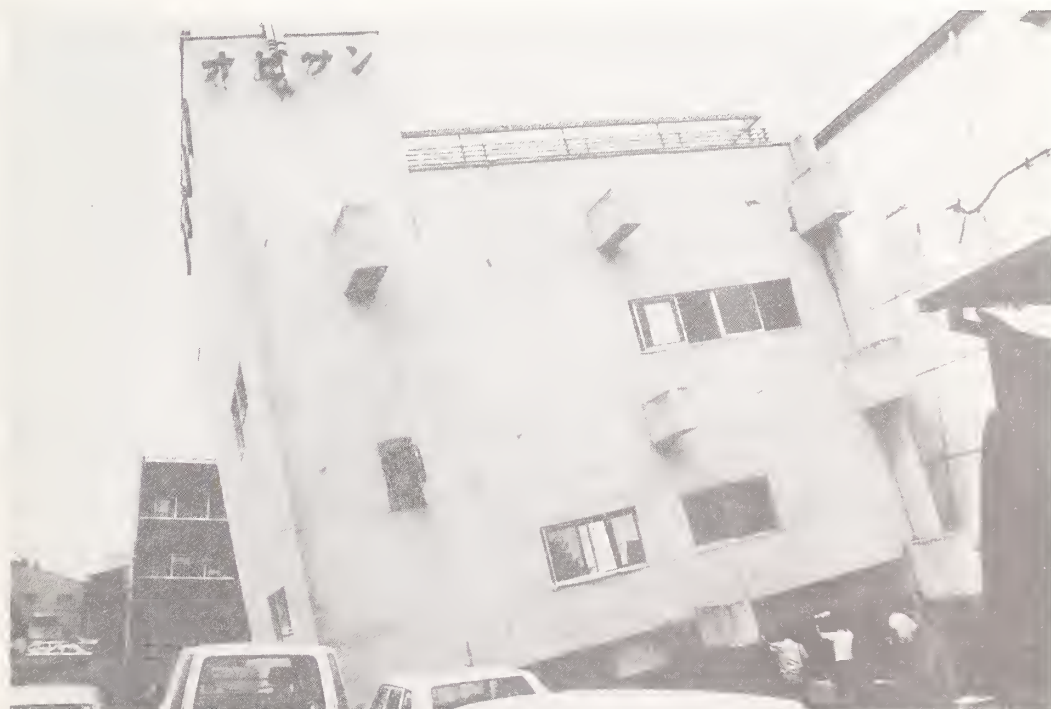
Figure 5.28 Obisan Building, viewed from the south. The upper stories rotated as a rigid body when the first floor column support was lost.

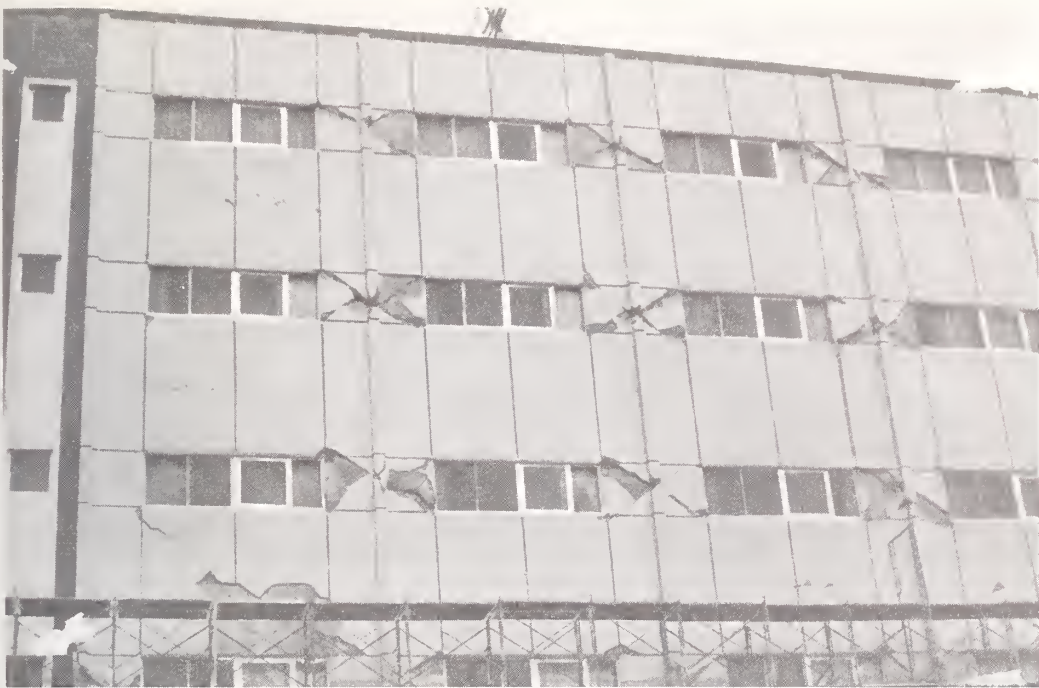
extensive diagonal cracking in the panels between window openings on both east (Figure 5.34) and west faces (Figure 5.35); this damage is especially severe on the west face, as shown in the detail in Figure 5.36. The decorative ceramic brick facing on the north side of the building did not appear to be damaged.

Figure 5.36 Maruhon Building, west face. Detail of the damage to panels between windows.

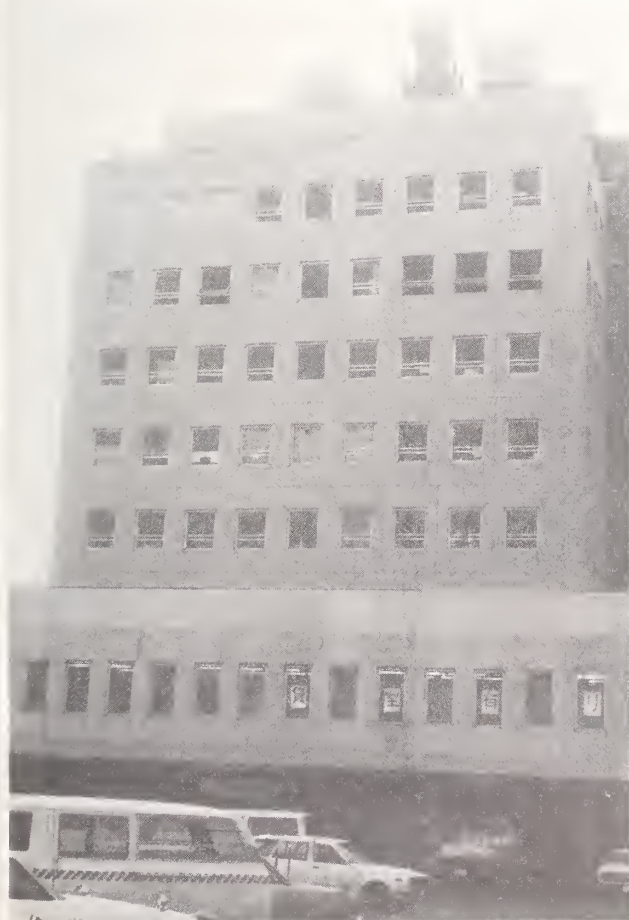
Figure 5.37 A slightly damaged 9 story building in the Oroshicho area of Sendai.

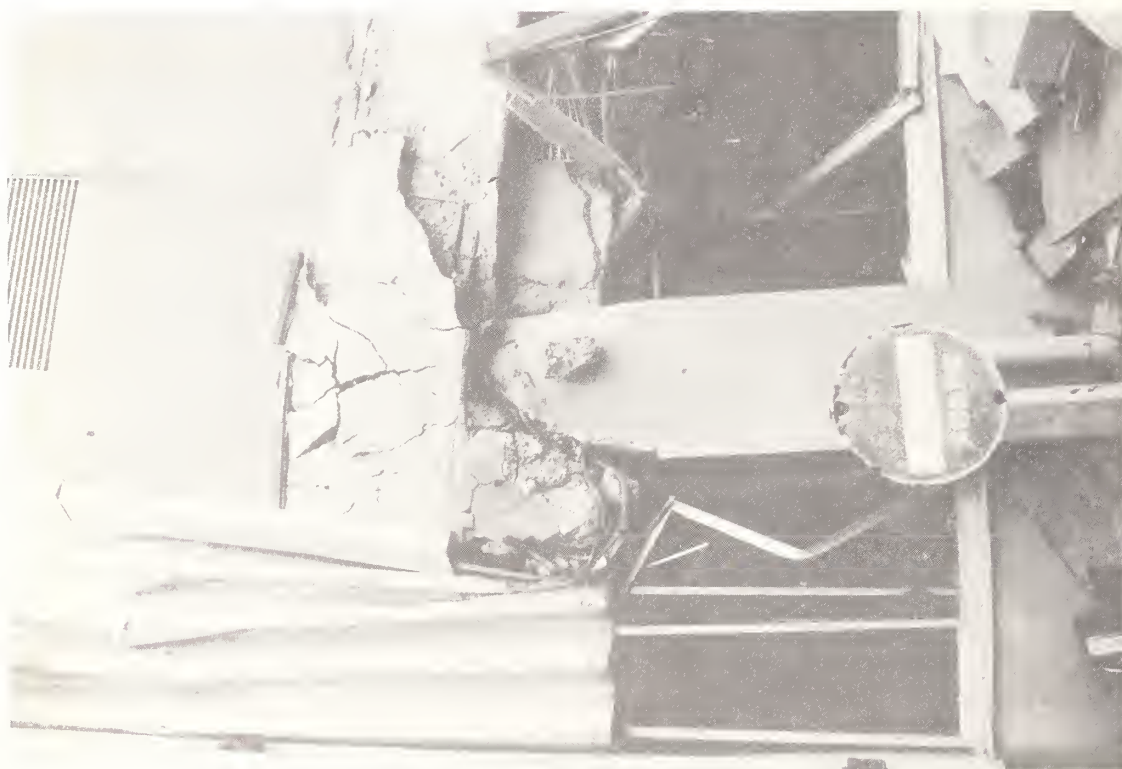
Figure 5.42 Yazaki Industries Building, showing beam-column joint at top of first

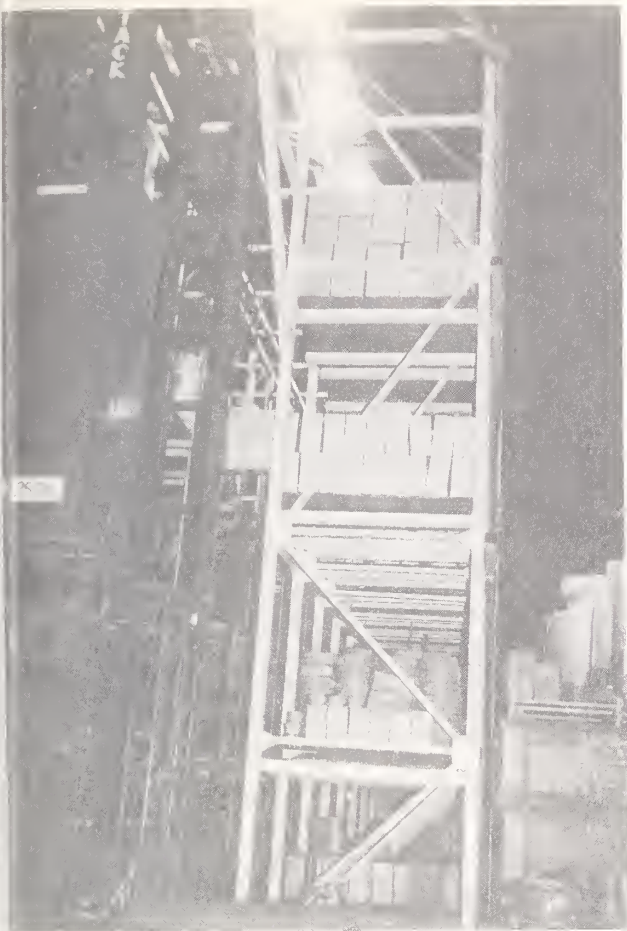
Figure 5.44 Yazaki Industries warehouse building. A number of multi-level tubular steel storage racks had damaged transverse braces at ground level.

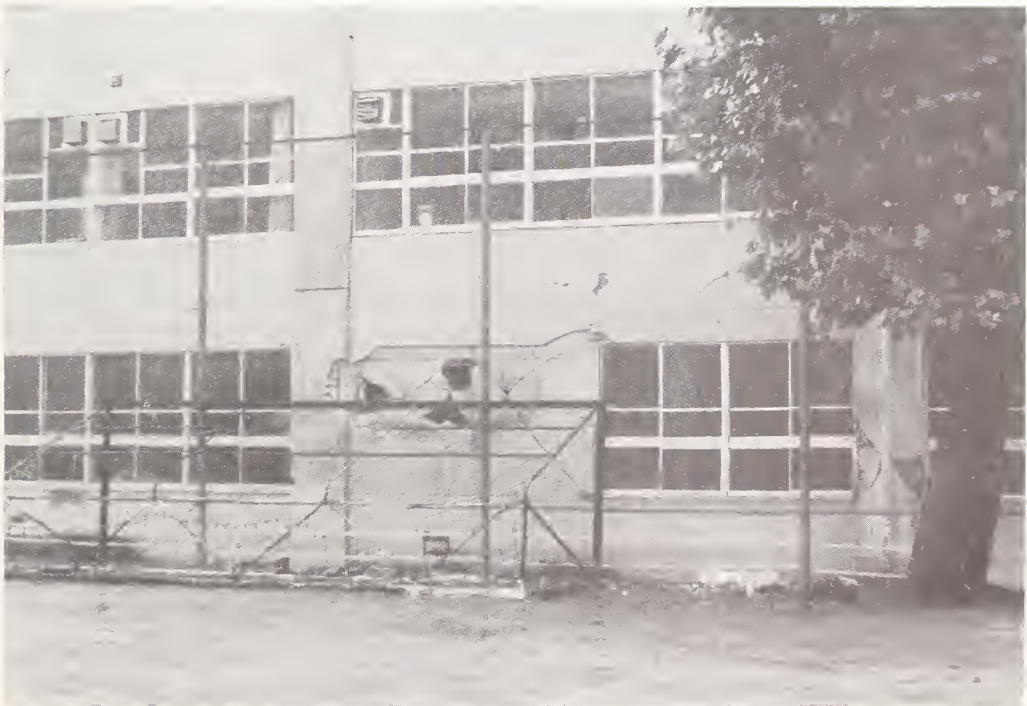
Figure 5.54 Tonan High School - Detail of damage to west face.

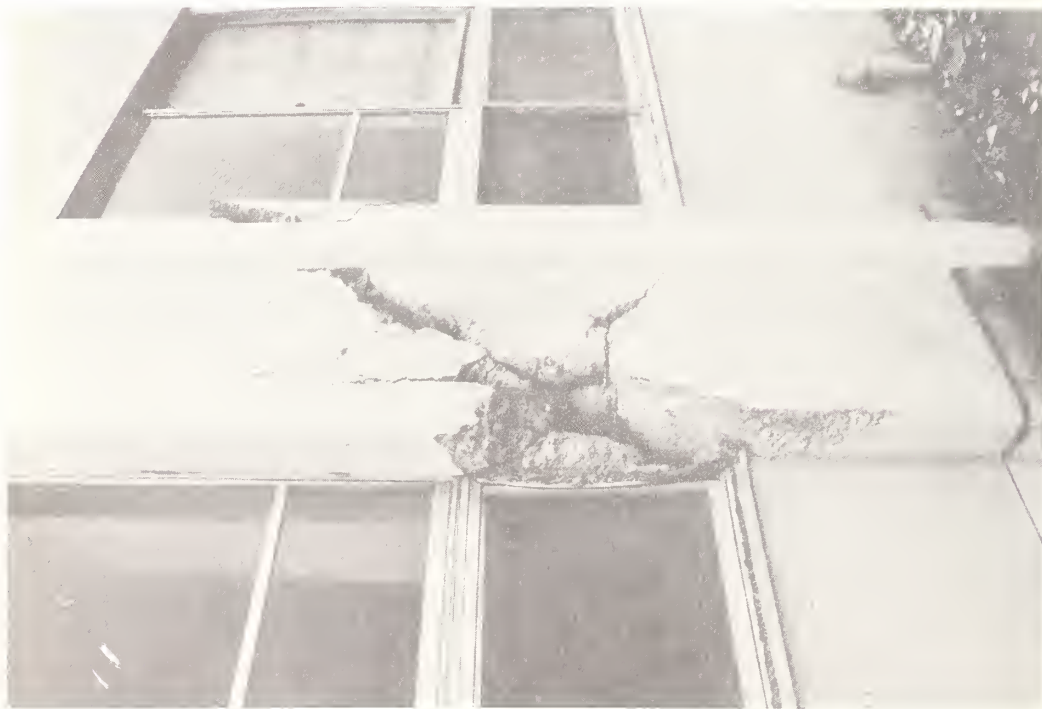
The west face elevation and the school yard are shown in Figures 5.53 and 5.54. The exterior first-story columns were all severely damaged, the shear cracks occurring just above the infill panels, (Figures 5.55 and 5.56). In many cases the width of the cracks was over 20 mm. The upper story columns showed less shear cracking. The interior columns did not appear to be damaged. They lacked the stiffening provided by the infill panels. A corridor ran along the length of the building in the middle, and the shear walls were not continuous across the width of the building. Undeformed reinforcing bars were used in the columns. The ties in the exterior columns were spaced at roughly one-half the maximum dimension of the column.

Figure 5.55 Tonan High School. Detail of shear cracking in exterior column above partial infill panels on east face

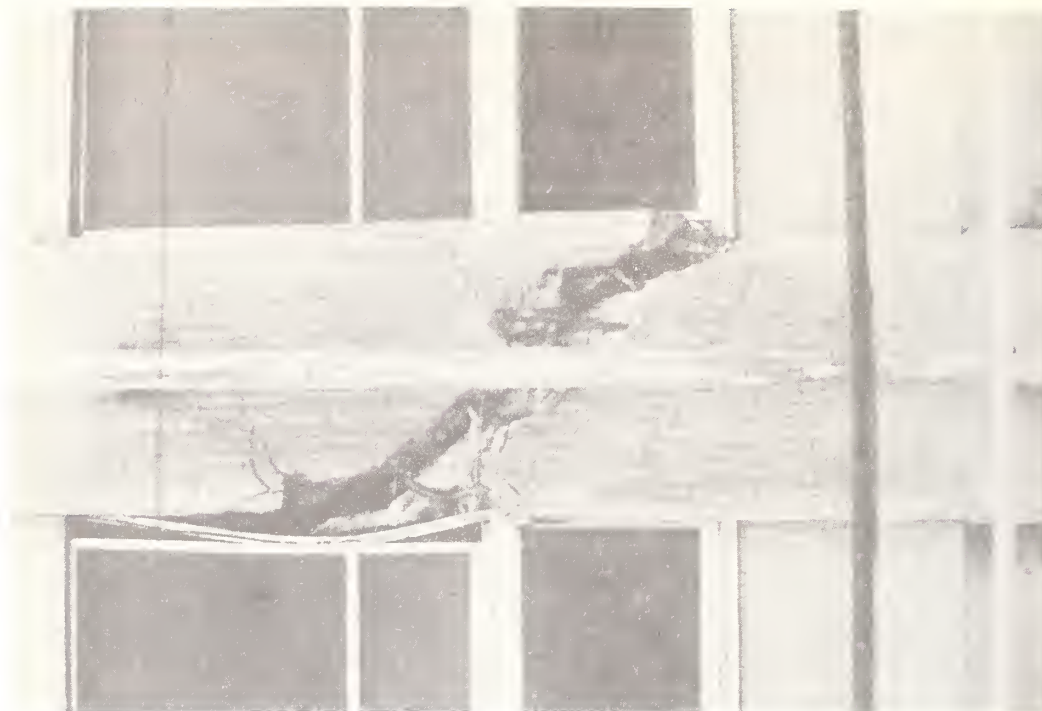
Figure 5.56 Tonan High School. Detail of column damage, exposing reinforcement.

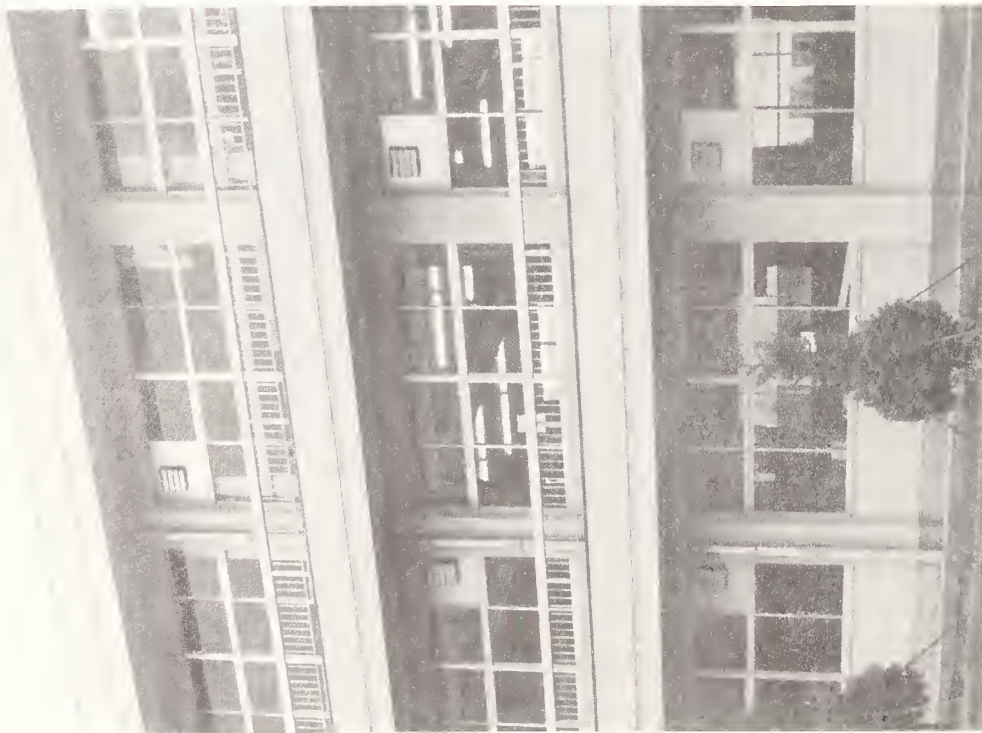
Note from Figure 5.57 that the interior shear walls do not run the width of the building, as they are interrupted by the corridor on the north side of the building. The cracking was less severe on the open side of the building, where the shear walls connect to the columns.

Figure 5.62 Izumi High School, typical classroom building, south face. This side of the building, which is relatively open, suffered little damage.

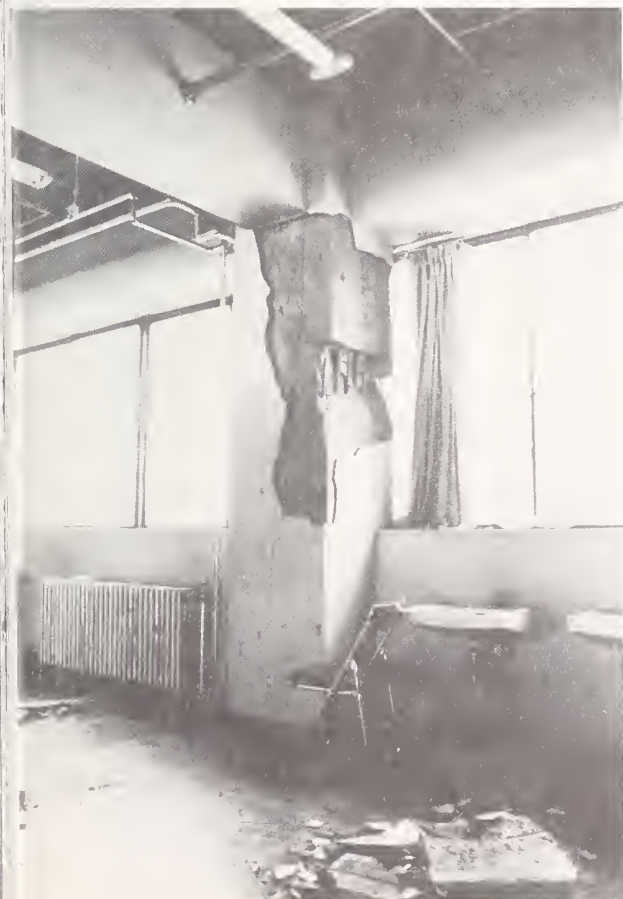
Figure 5.70 Tohoku Institute of Technology, Building 5. Damage to column on north side of third story. The tie spacing is 25 cm.

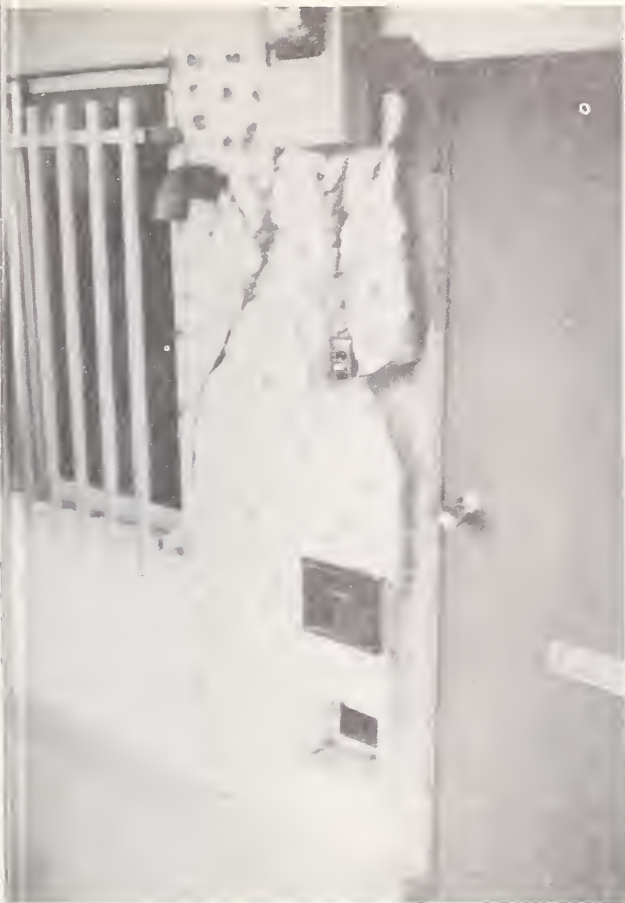
Figure 5.82 Sunny Heights Apartment Building. Detail of cracking of panels adjacent to doorways. Such cracking was typical at all levels on the east facade of the structure.

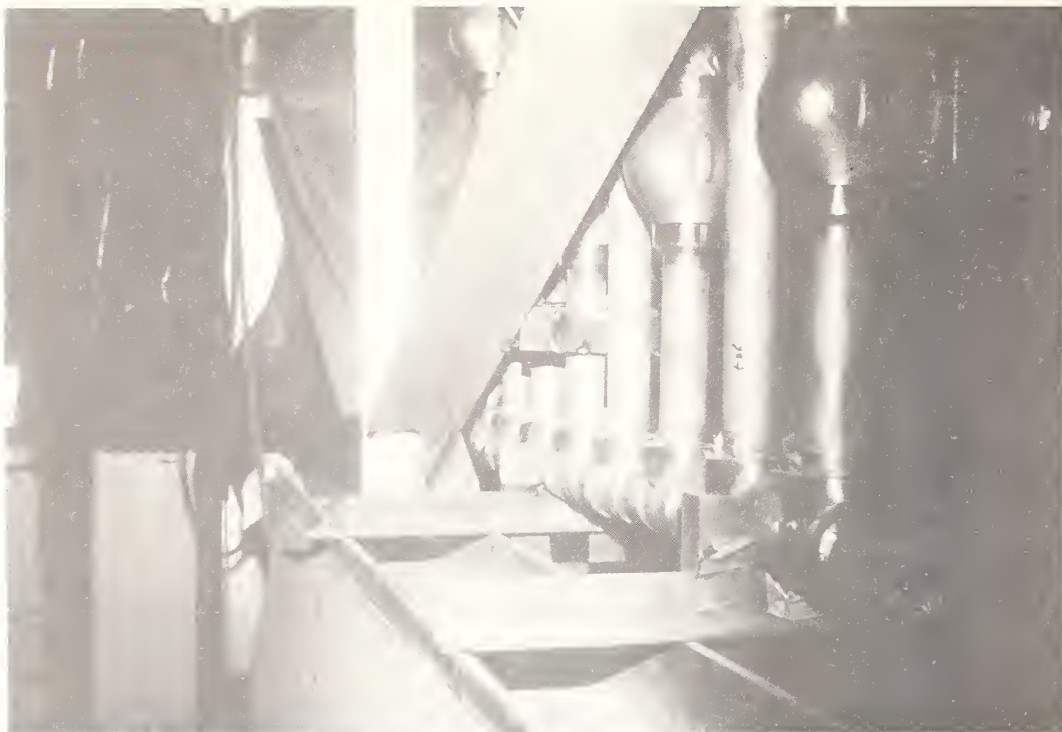
Figure 6.7 Fukushima Nuclear Power Plant: a partial view of the Unit 6 control rod drive and its supports. The unit is still under construction and was more than 95% completed at the time of the reconnaissance. There was no apparent damage or any evidence of working connections at this system or at the other systems of Unit 6 that were examined.

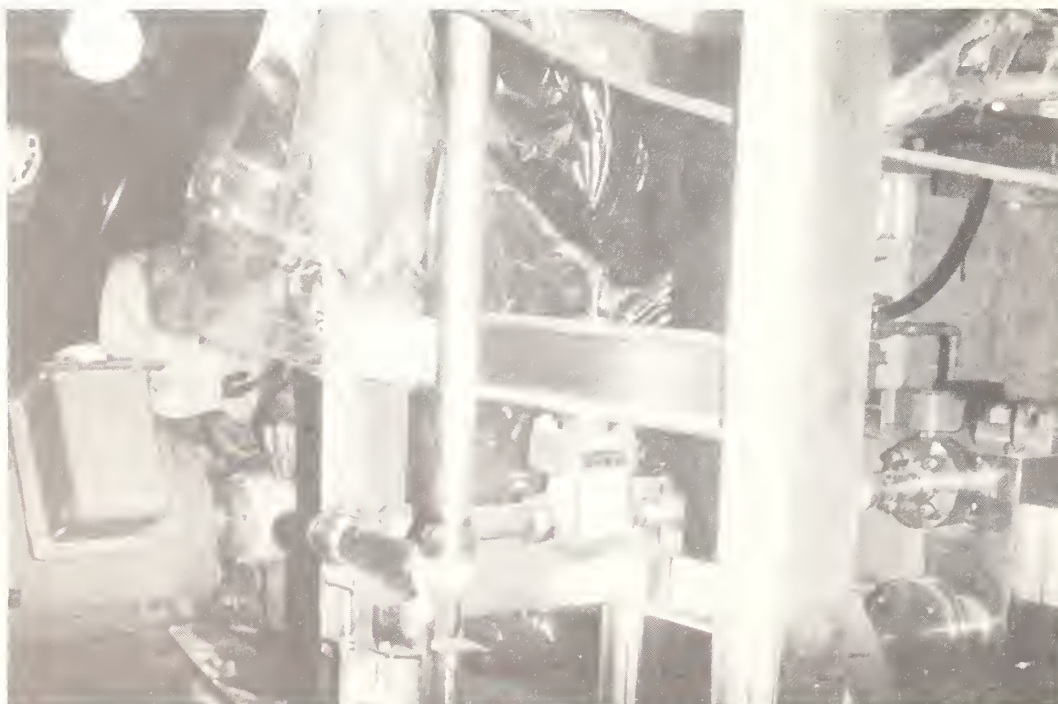
Figure 6.8 Fukushima Nuclear Power Plant: a typical view of massive seismic and/or pipe whip bracing of critical piping inside the reactor building of Unit 6. The equipment showed no evidence of damage. This unit is still under construction.

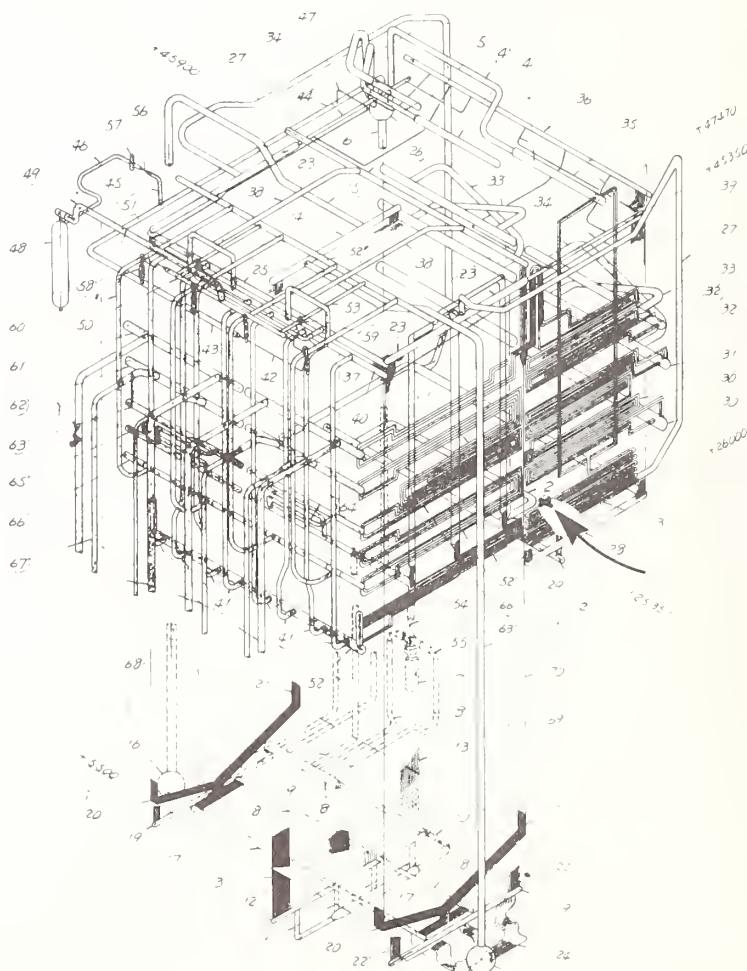
Both Unit 1 and Unit 2 suffered damage to tubing inside the boilers (Figure 6.17). A small furnace platen cooler tube inside the slag screen was sheared in the Unit 1 boiler (Figure 6.18). A similar failure occurred in the boiler of Unit 2 to one of the reheater spacer tubes. The suspended boilers and their structural supports also pounded against one another and also sustained some damage (Figure 6.19).

Figure 6.17 New Sendai Power Plant, Tohoku Electric Power Company. The arrow points to the location of the damaged horizontal spacer tubes in the 600-MW boiler of Unit No. 2. (See Figure 6.18).

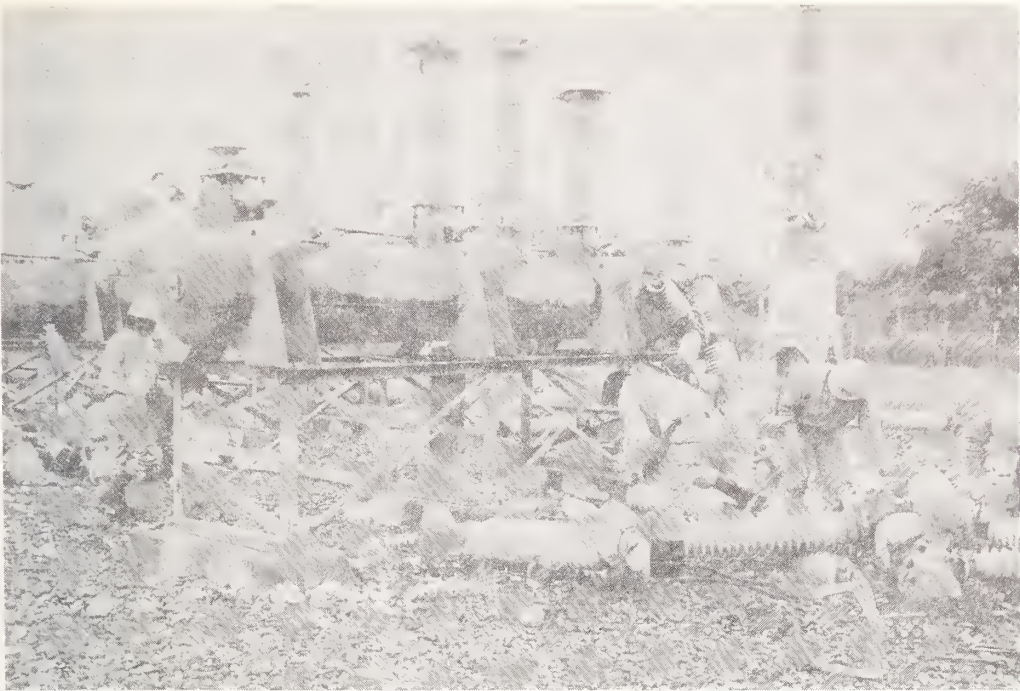
Figure 6.28 Sendai Substation, Izumi; one of several piles of broken equipment, including several line traps or reactors in the back (note the damaged base of the left stem) and the horizontal tanks of several circuit breakers of the live tank type (in the foreground are the failed columns of the circuit breakers and of other equipment).

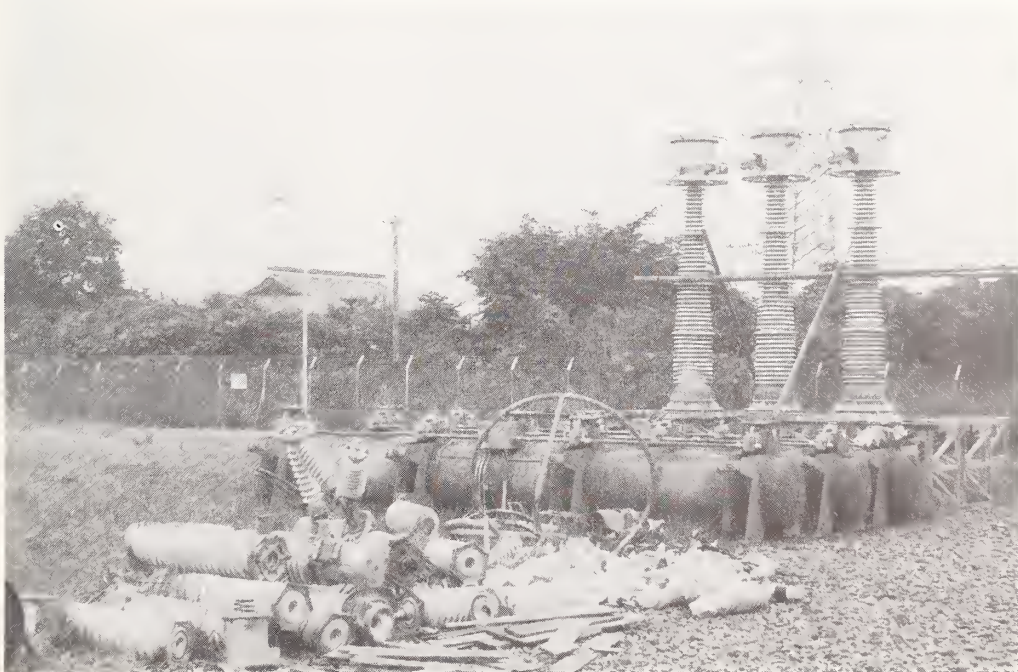
Figure 6.29 Sendai Substation, Izumi; a repaired but still disconnected transformer. All of the transformers at the substation lost some bushings or lightning arrestors. Some damaged parts were being replaced at the time of the investigation.

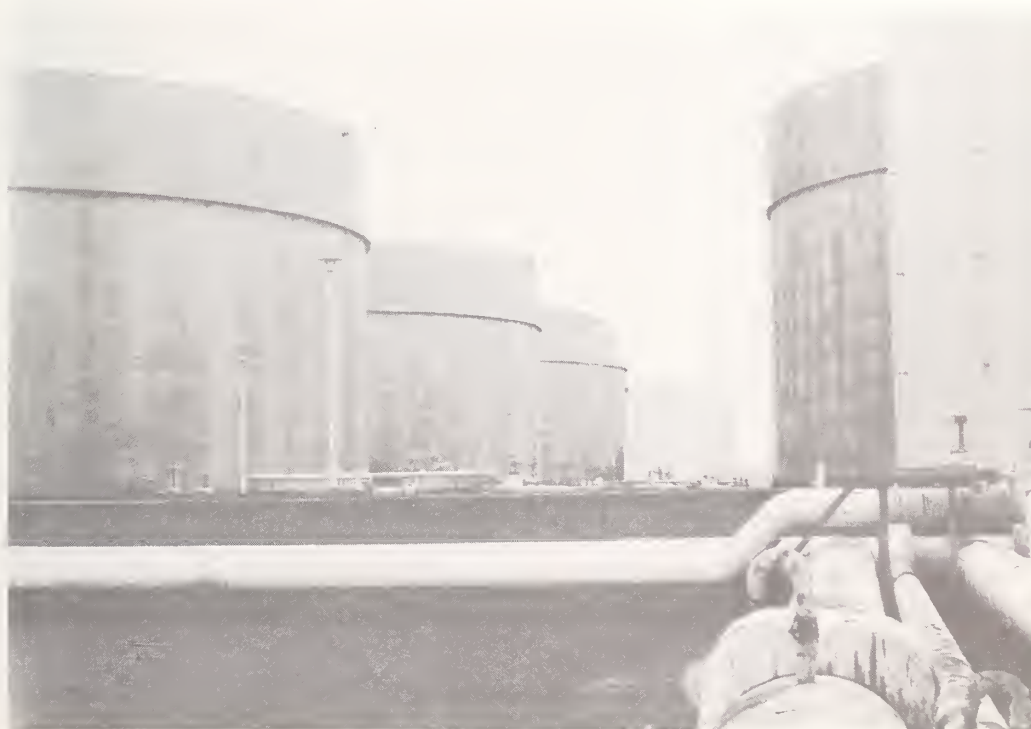
Sendai Refinery, Tohoku Oil Company, Ltd. A large water storage tank (left) near the main refinery complex appeared to have experienced significant rocking. Detail (right) of one of the pulled-out, or stretched, anchor bolts of the water storage tanks shown at left.

Another large water storage tank experienced interesting damage (Figure 6.45). The welded steel plate tank was anchored with bolts, spaced at approximately 6 ft (2 m), and embedded in a continuous concrete pad. The bolts around the entire circumference were stretched, or more likely, pulled out from their embedment from 1 to 6 in (2.5 to 15 cm). However, there was no apparent buckling or other damage to the steel base of the tank.

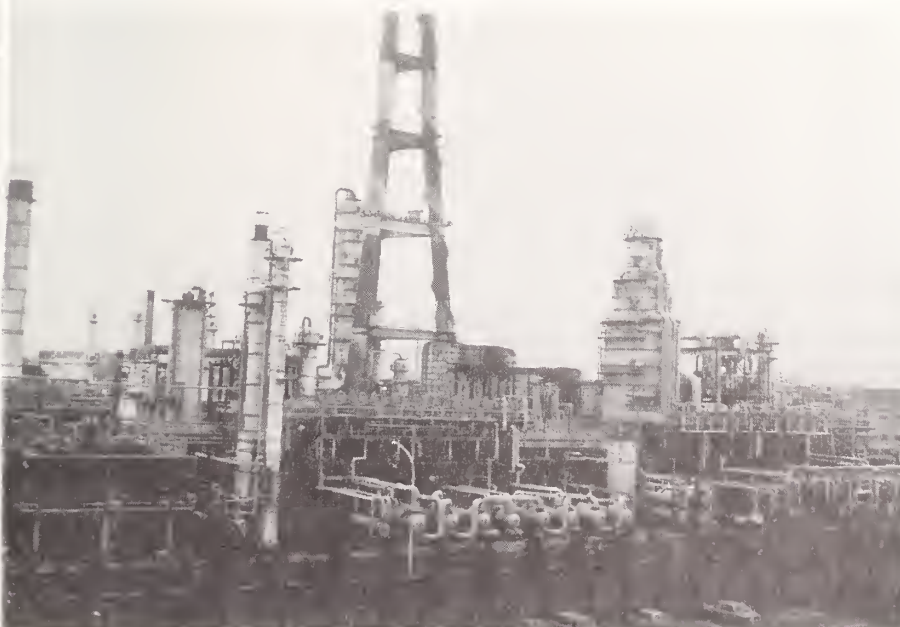
Figure 6.48 Sendai Refinery, Tohoku Oil Company, Ltd.: ground settlement at the refinery.

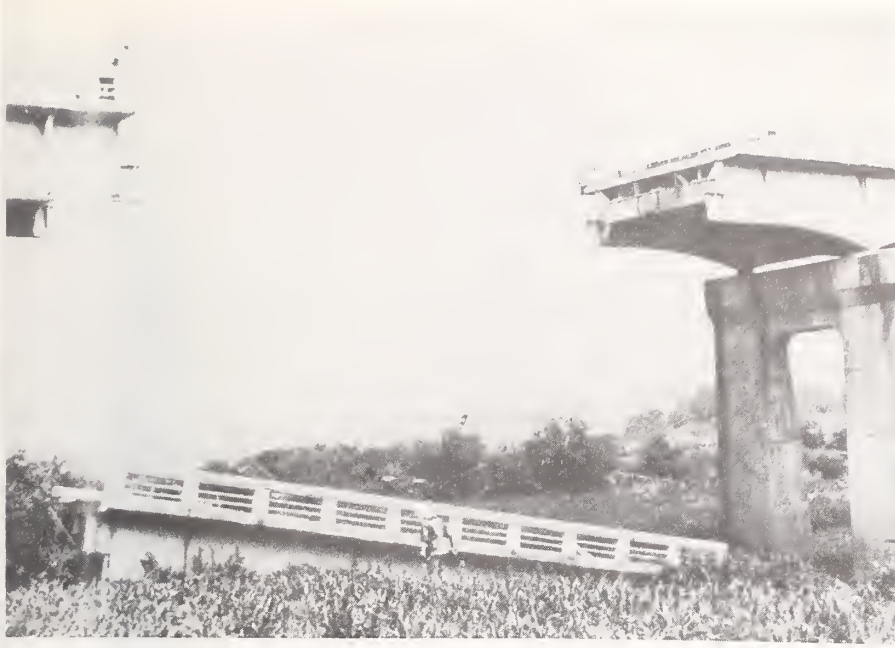
Figure 7.3 Kin-noh Bridge. View of the collapsed suspended plate girder span. Similar damage occurred to bridges in the 1971 San Fernando and 1976 Guatemala earthquakes because of lack of superstructure restraint and small bearing seats. Suspended spans are no longer used in seismically active areas. (Courtesy J.M.O.C.)

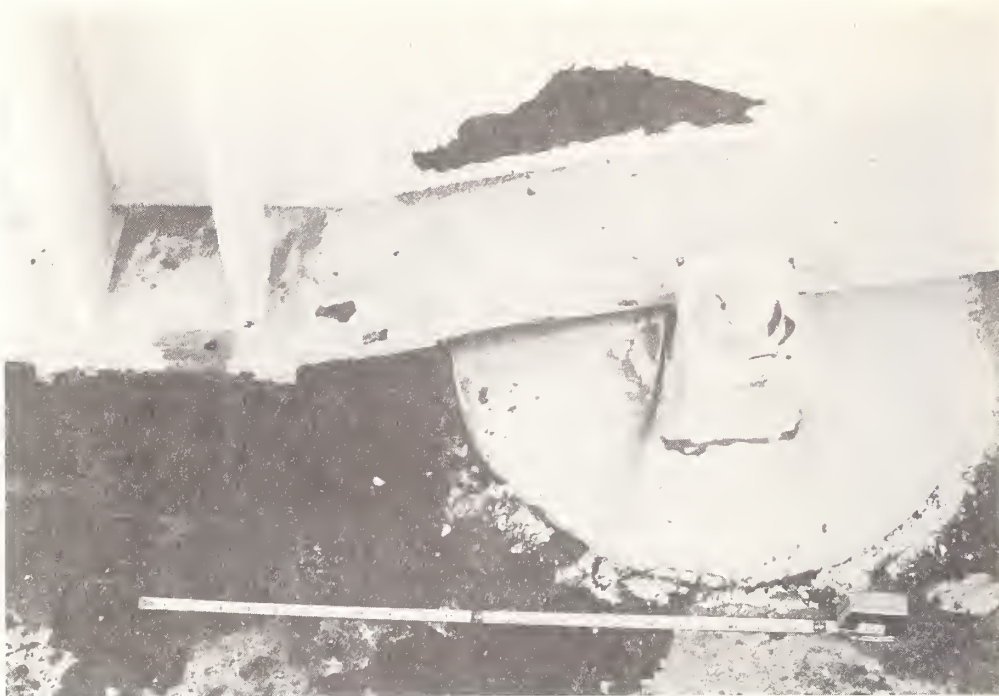
Figure 7.5 Kin-noh Bridge. The girders at Pier 8 displaced longitudinally toward the abutment 55 cm allowing the unrestrained suspended span to drop off the 45 cm hinge seat. The movable girder bearing plate came to rest at the edge of the pier cap. The fixed bearing on Pier 7, the opposite side of the suspended span, displaced longitudinally 0.5 cm.

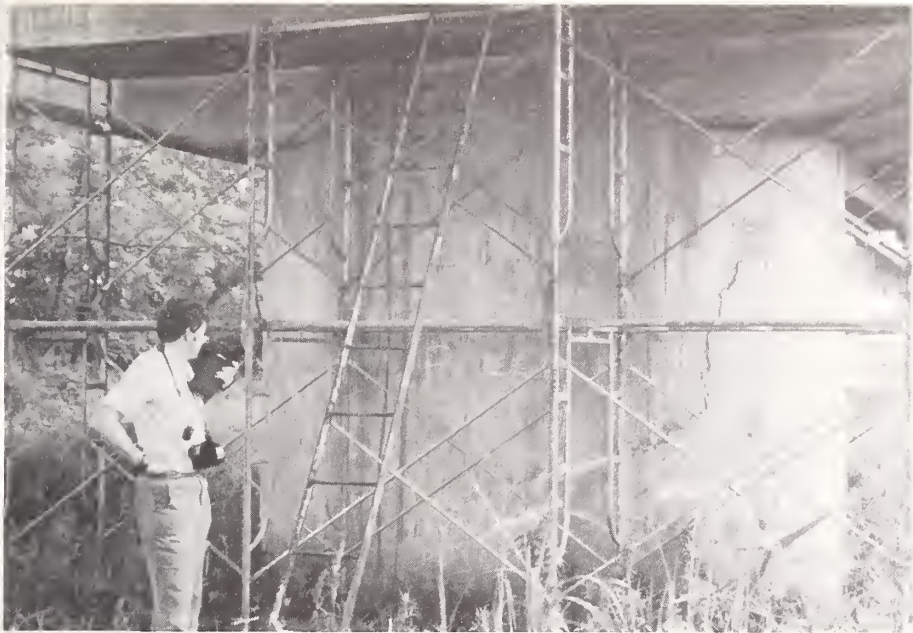
Figure 7.15 Yuriage Bridge. The face of Pier 1 showing severe distress. The plaster of paris patchwork is used to determine if additional pier cracking has occurred.

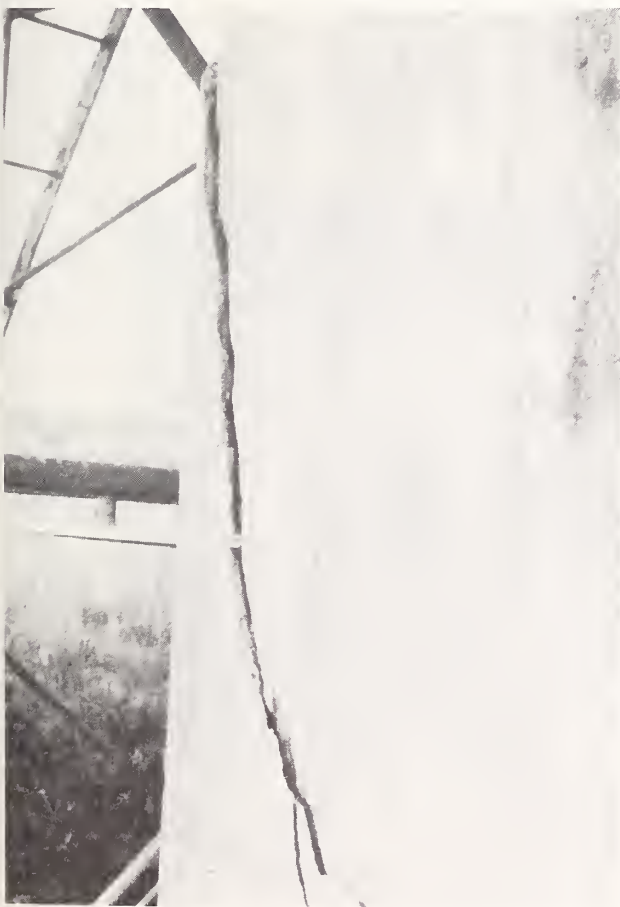
Figure 7.16 Yuriage Bridge. Detail showing 1 cm offset of cracking, indicating torsion in pier.

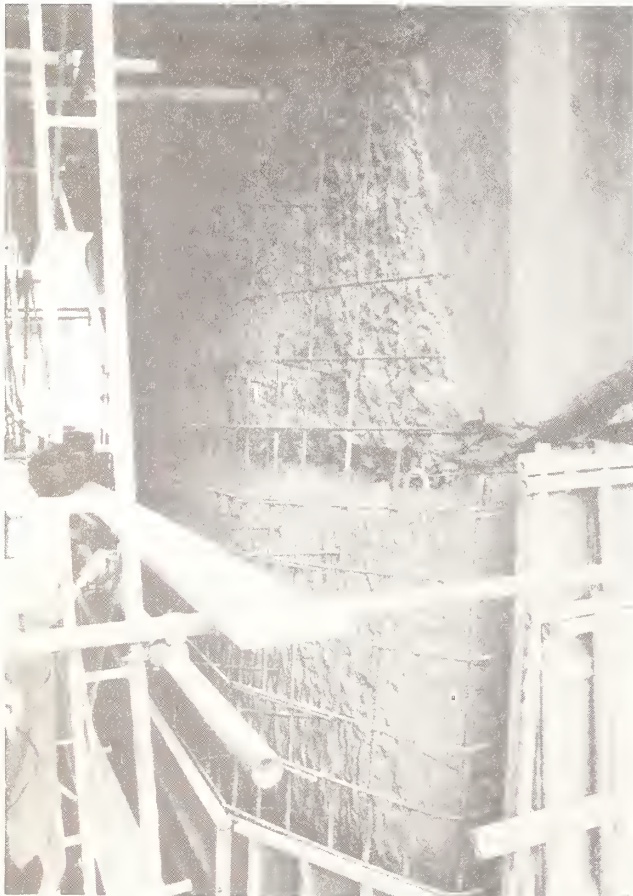
Figure 7.26 Sendai Ohashi Bridge. Details showing the added reinforcing concrete form work. The pier thickness will be increased on each side by 50 cm at the top, tapering to 70 cm at the base.

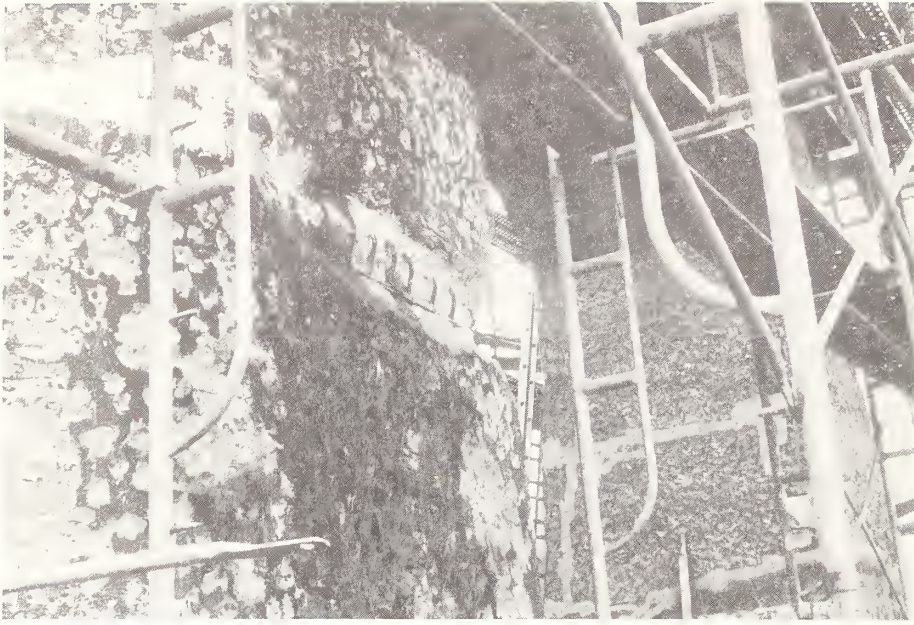
Figure 7.29 Abukuma Bridge. Outward buckling of vertical rebar at one of the damaged piers.

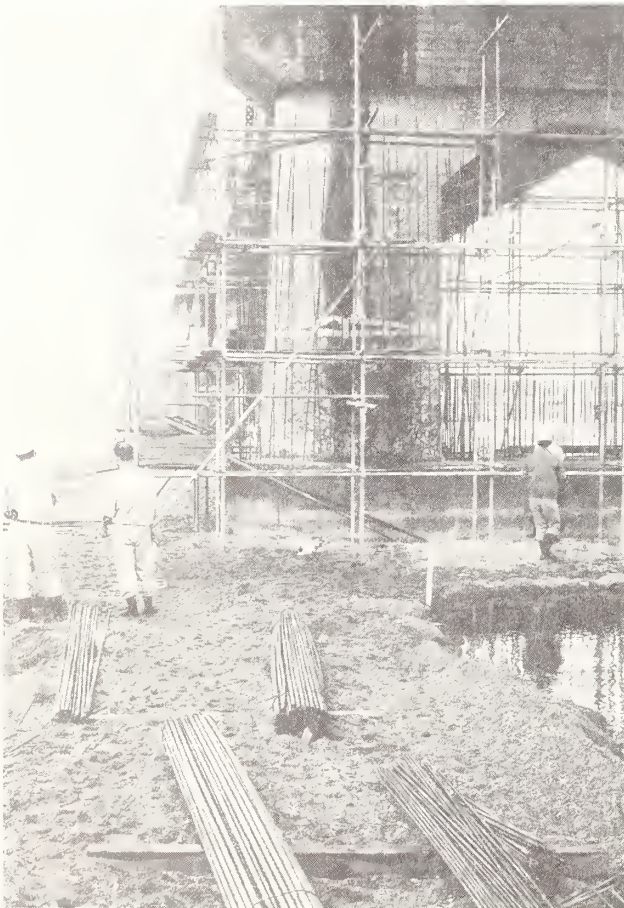
Figure 7.30 Abukuma Bridge. Typical repair of a damaged pier includes epoxy injection of cracks, epoxy covering of buckled rebar, preparation of existing concrete surface to accept fresh concrete, emplacement of vertical rebar into the footing and horizontal rebar into the pier, and an increase of the gross cross sectional area of the pier with new concrete. The technique is similar to that used on the Yuriage and Sendai Ohashi bridges.

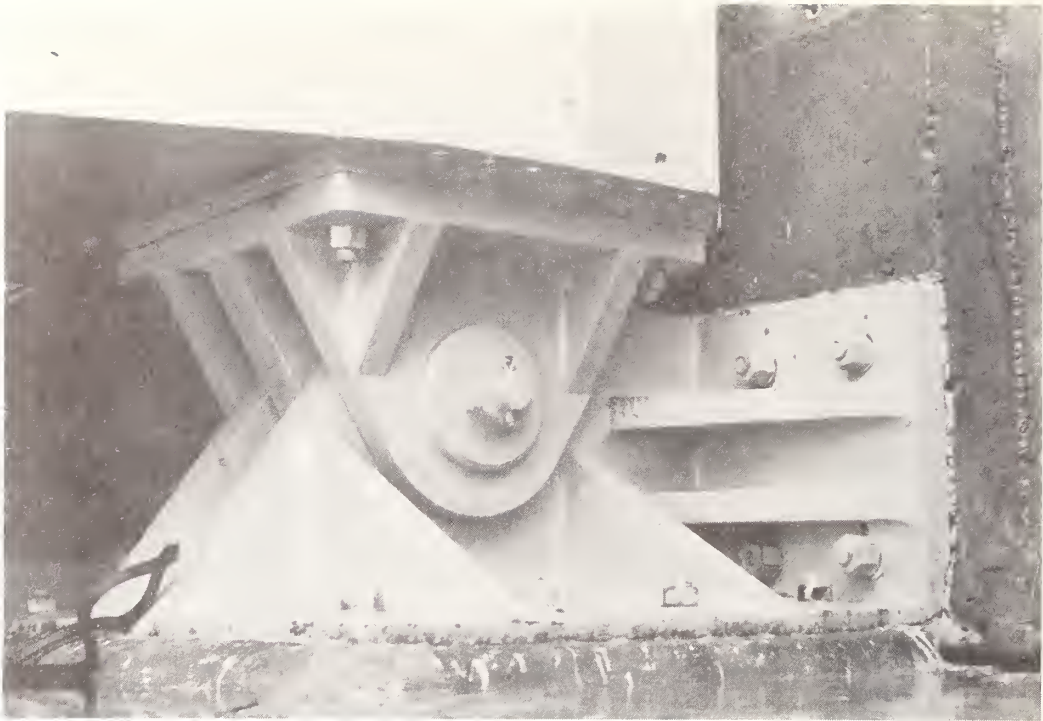
Figure 7.35 Kitakami Ohashi Bridge. Detail of a seismic bearing device at the abutment.
