NBS SPECIAL PUBLICATION 592

An Investigation of the Miyagi-ken-oki, Japan, Earthquake of June 12, 1978

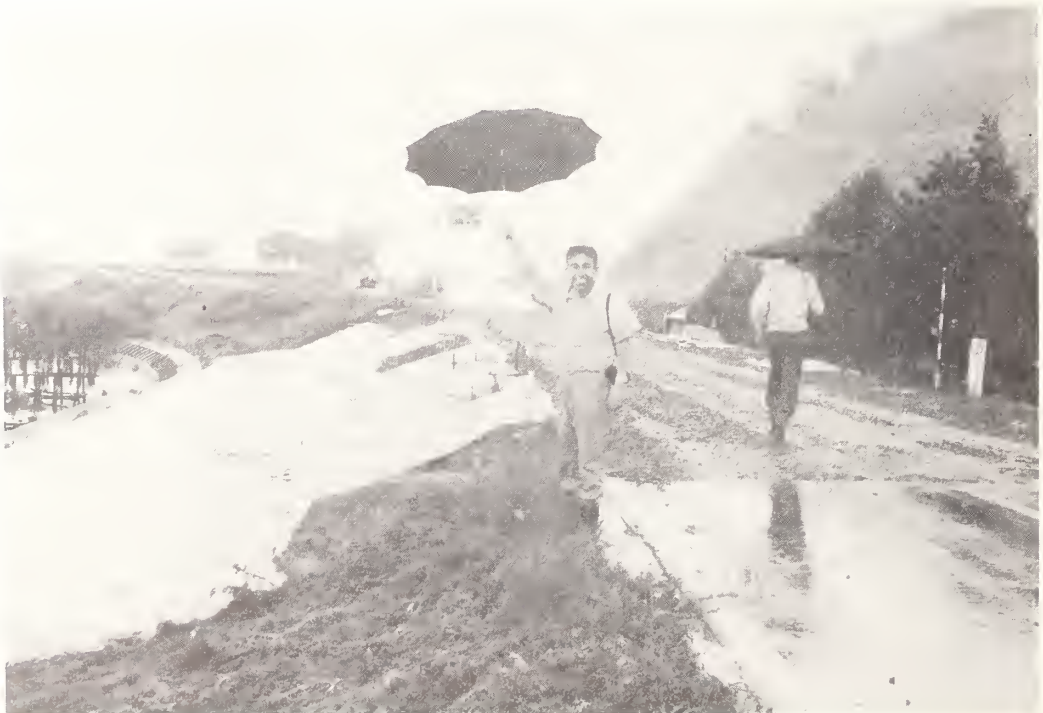
Figure 7.36 Road damage and temporary stabilization of the Kitakami Dike near the bridge site.

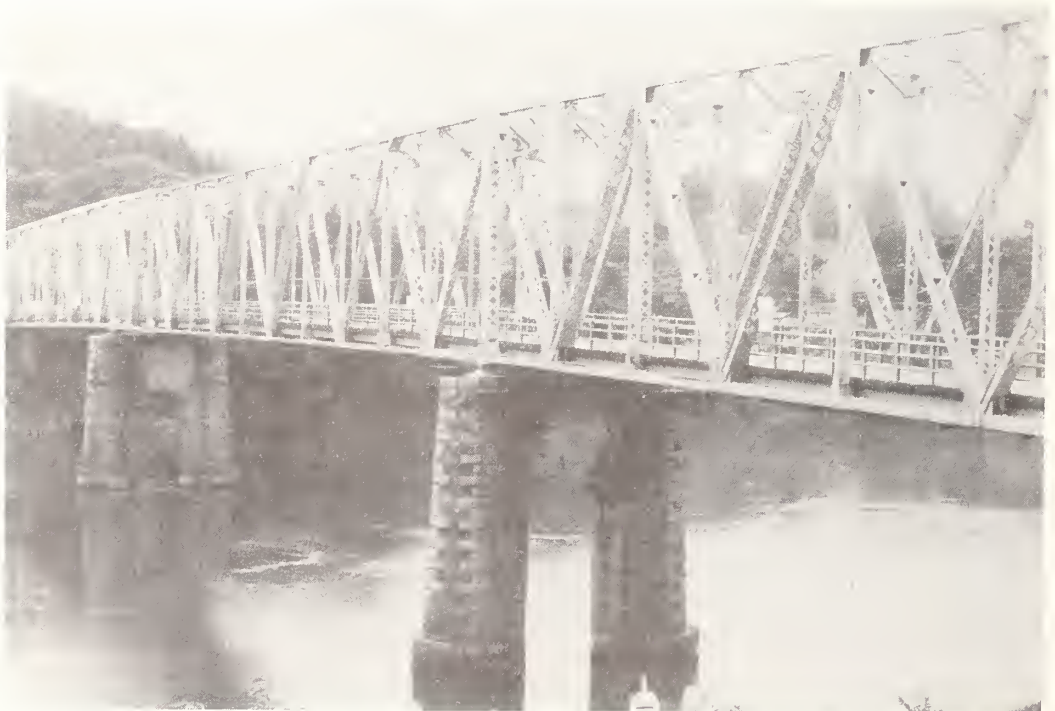
Figure 7.41 Maiya Ohashi Bridge. Steel plates welded to the top chord channel members. Note the clean fracture at a line passing through the centerline of the rivet holes of the lattice bracing and the permanent 2.5 cm separation.

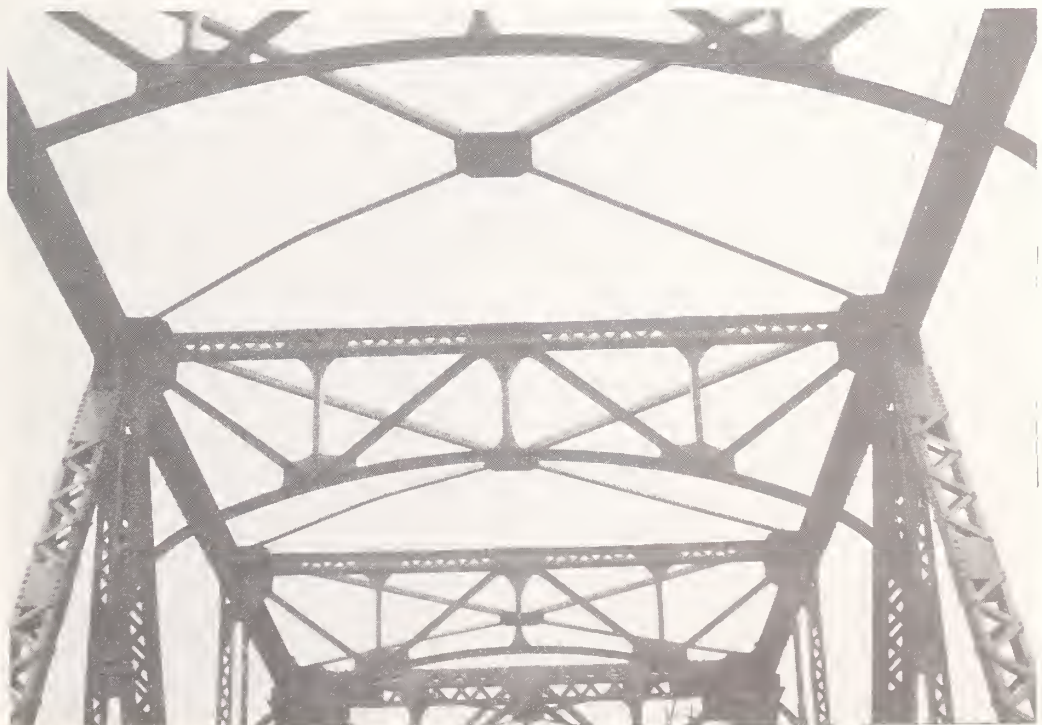
Figure 7.42 Maiya Ohashi Bridge. Buckled lateral bracing of the overhead truss.

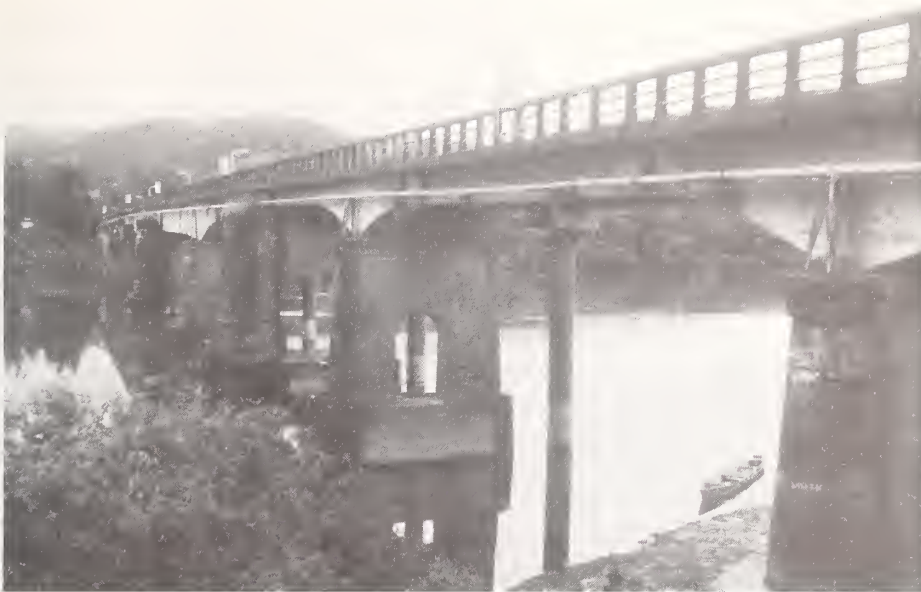
The Toyoma Bridge is a 13-span concrete T-beam bridge constructed in 1945, (Figure 7.43). Prior to the earthquake, the bridge, located about 60 km northeast of Sendai, was restricted to automobile traffic because of damage suffered during the February 20, 1978, earthquake. The bridge was closed following the June earthquake. Flexural induced cracking of the girders occurred at the center of the spans and at the haunched ends over the piers. Shear cracking was also noted at the corners of the concrete hinge seats of several suspended spans. The ground motion, between 0.1 and 0.2g, was sufficient enough to induce pavement cracking of the roadway.

Figure 7.43 General view of the Toyoma Bridge which was closed to traffic. The columns in the background support an independent steel box girder pedestrian structure which was undamaged.

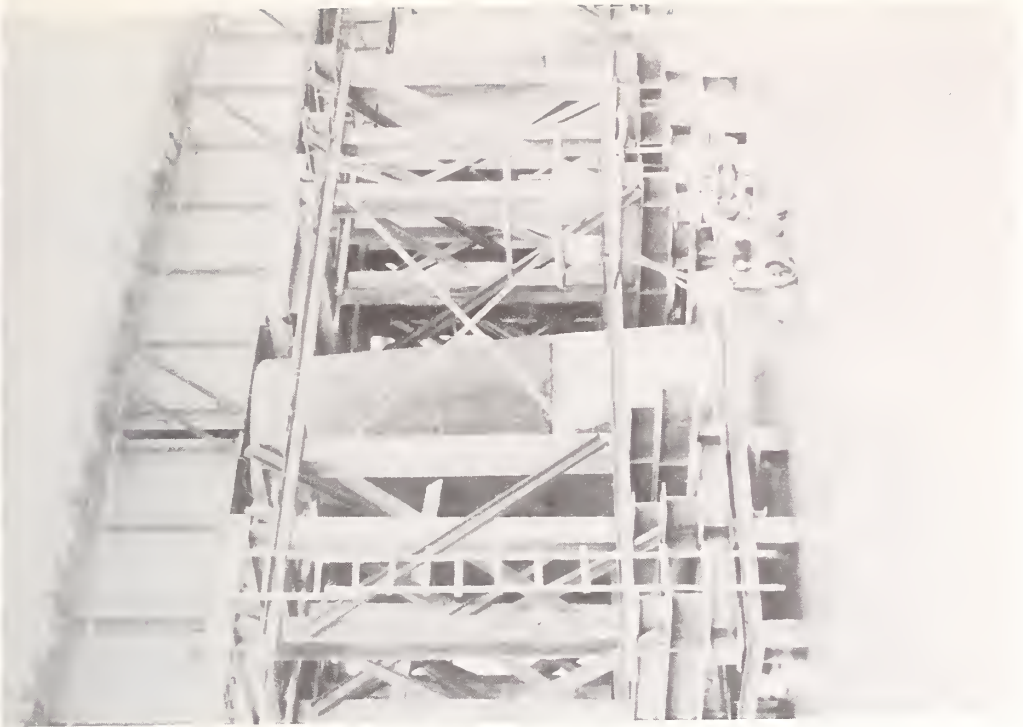
Figure 7.48

The Eai River Bridge (Figure 7.48), owned by the Japanese National Railways (JNR), is a dual eight-span steel plate girder structure 160 m in length, which is located 40 km northeast of Sendai. The superstructure is supported by massive unreinforced concrete gravity piers on caisson foundations. Ground acceleration in the area was estimated by the Ministry of Construction to be 200-250 gal. Two piers were severely damaged when large wedged shaped sections of concrete dropped out below a construction joint.

Eai River Bridge. Damaged pier of Eai River Rail Bridge. Temporary pier supports were constructed following the earthquake. Full train service was established approximately 10 days after the earthquake.

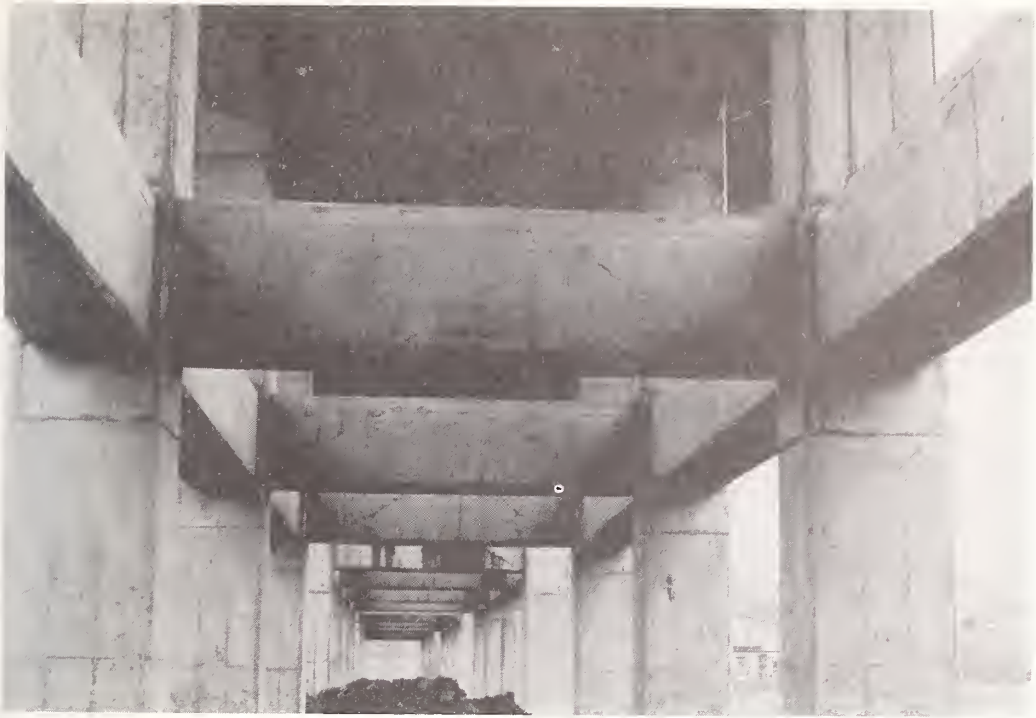
Figure 7.53 Tensile cracking of space frame tie beams near the Rifu Construction Office.

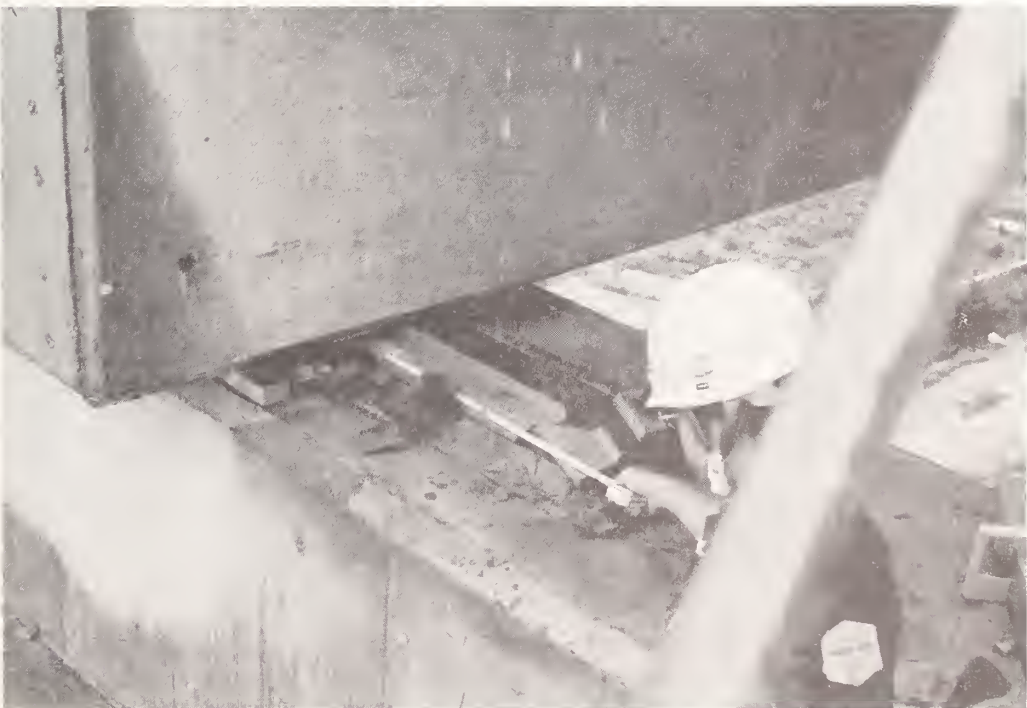
Figure 7.54 Failure of a bearing plate supporting a single cell box girder near the Higashi Sendai Construction Office. Girder displaced laterally 50 cm.

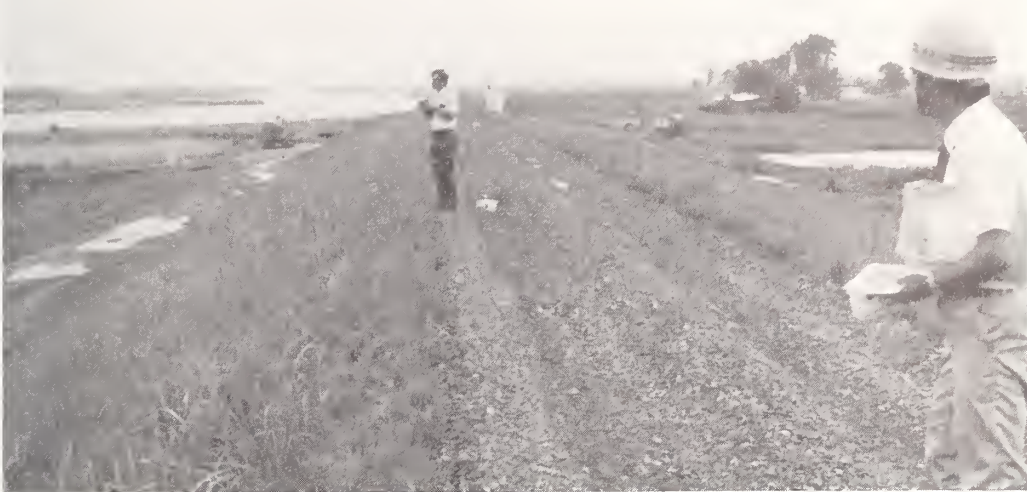
At Site 1, liquefaction caused slumping, lateral spreading, and settlement of up to 1.5 m along a 160-m-long section of the dike (Figures 8.2, 8.3, and 8.4). Longitudinal cracks several tens of meters long opened in the dike crest. Between the dike and the river, fissures striking obliquely to the dike formed, and sand was ejected from them (Figure 8.5). Other fissures trending parallel to the dike and the river formed near the river bank, more than 100 m from the base of the dike. The occurrence of fissures and sand boils in ground away from the dike indicates that liquefaction took place primarily in material beneath the dike and not in the dike material itself.

Figure 8.3 Site 1, Natori River. Slumping of dike on flank away from river. View north. (Photo courtesy Tohoku Regional Construction Bureau)

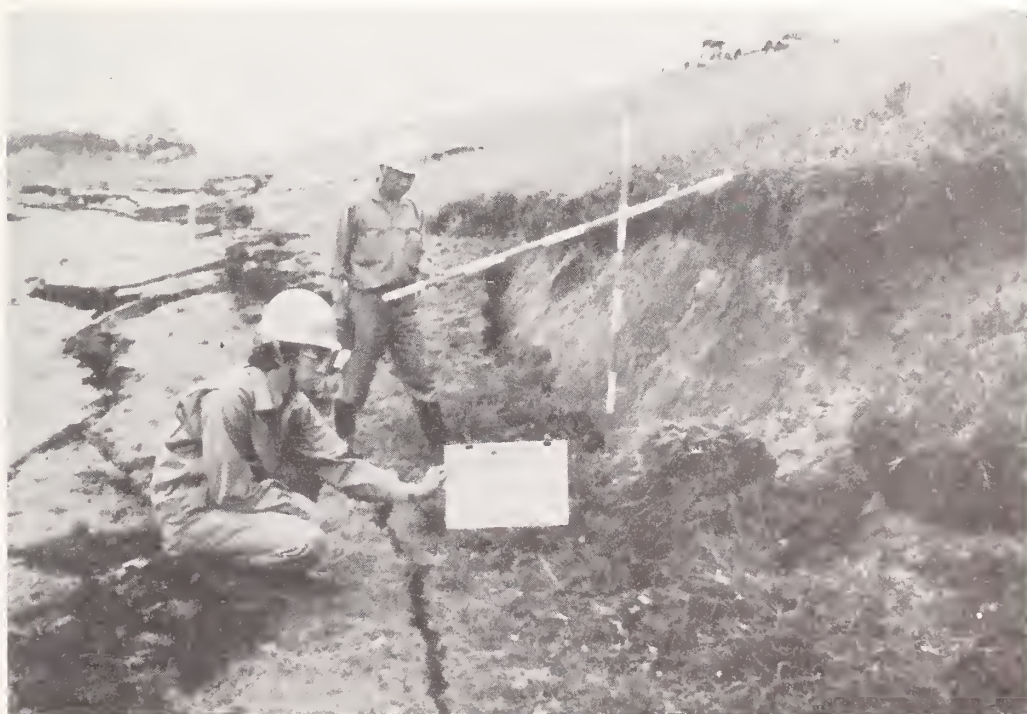
The configuration (Figure 8.4) and composition of this dike are typical of those seen throughout Miyagi Prefecture. The dike is composed primarily of compacted, fine to medium sand. It rises 2 m above the high water level of the river and is 4 m wide at its crest. Its riverward flank has a slope of 2H: 1V. The opposite flank descends as a series of slopes (2H: 1V) and benches to the agriculture land beyond.

Figure 8.4 Site 1, Natori River--cracking, settlement, slumping, and lateral spreading induced by liquefaction. (From Tohoku Regional Construction Bureau, MOC, unpublished data)

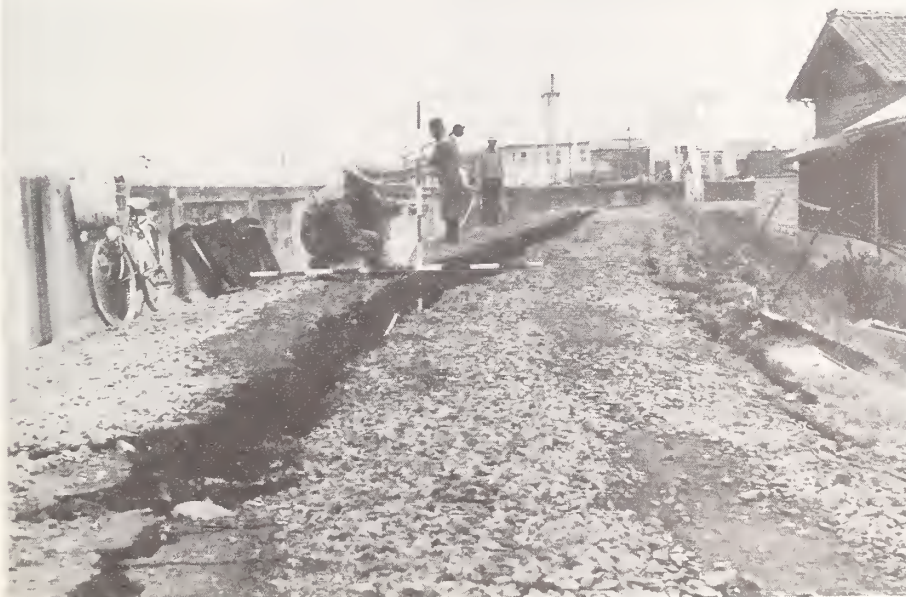
Figure 8.8 Site 2, Natori River. View is west across tributary of Natori River. Dike section shown in Figs. 8.6 and 8.7 is to right of houses in background of this figure. Note crack in concrete pavement in foreground is aligned with crack in retaining wall in background.

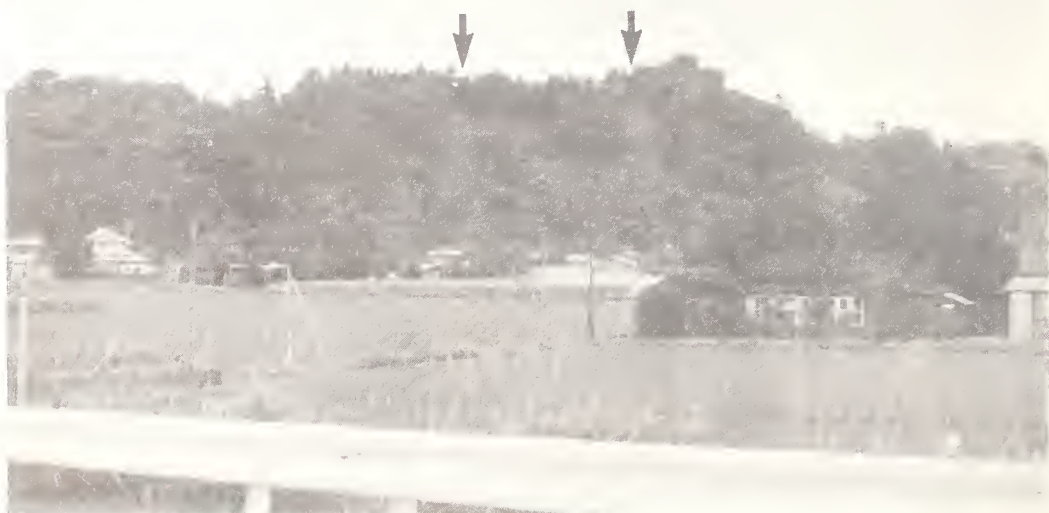
Three rock falls occurred on steep east-facing bluffs flanking a broad flood plain near the mouth of the Naruse River. All three were narrow failures, about 15 m wide, that occurred in dark brown volcanic rock similar to the smaller rock fall at Site No. 1. The slides extended from near the crest of the bluffs to the base, a height of approximately 30 m. Two of the slides are shown in Figure 9.5.

Figure 9.5 Rock falls (arrows) in steep bluffs bordering flood plain near mouth of Naruse River.

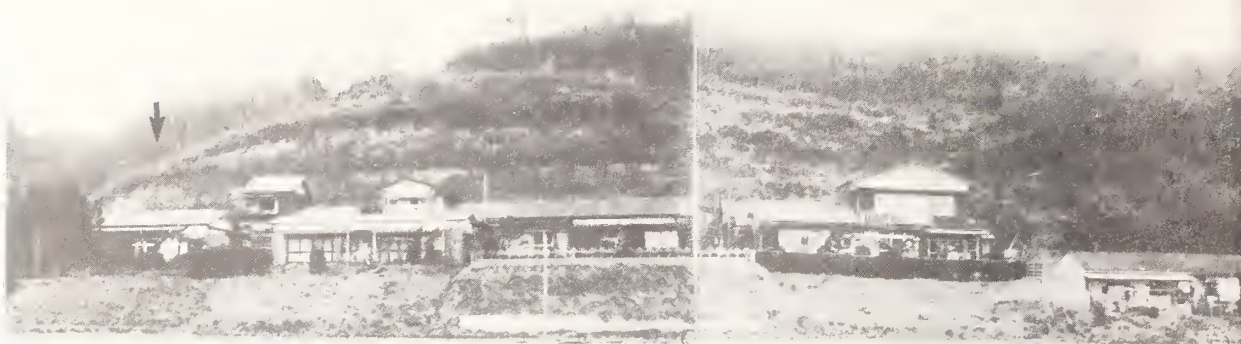
At Kitashionai, Murata, 25 km southwest of Sendai, another steep slope in tuff failed, generating a small rock fall damaging one house. Figure 9.10 shows several houses near the nearly vertical cut slope about 15 m high. One of these houses suffered damage to a retaining fence and part of the roof. A closeup of the rock fall and roof damage is shown in Figure 9.11.

Figure 9.10 Panorama of cut slope near Kitashiona in Miocene tuff which produced rock falls during earthquake damaging nearby houses. Arrow points to damaged house shown in closer view in figure 9.11. (Photograph courtesy of Y. Tsuruya)

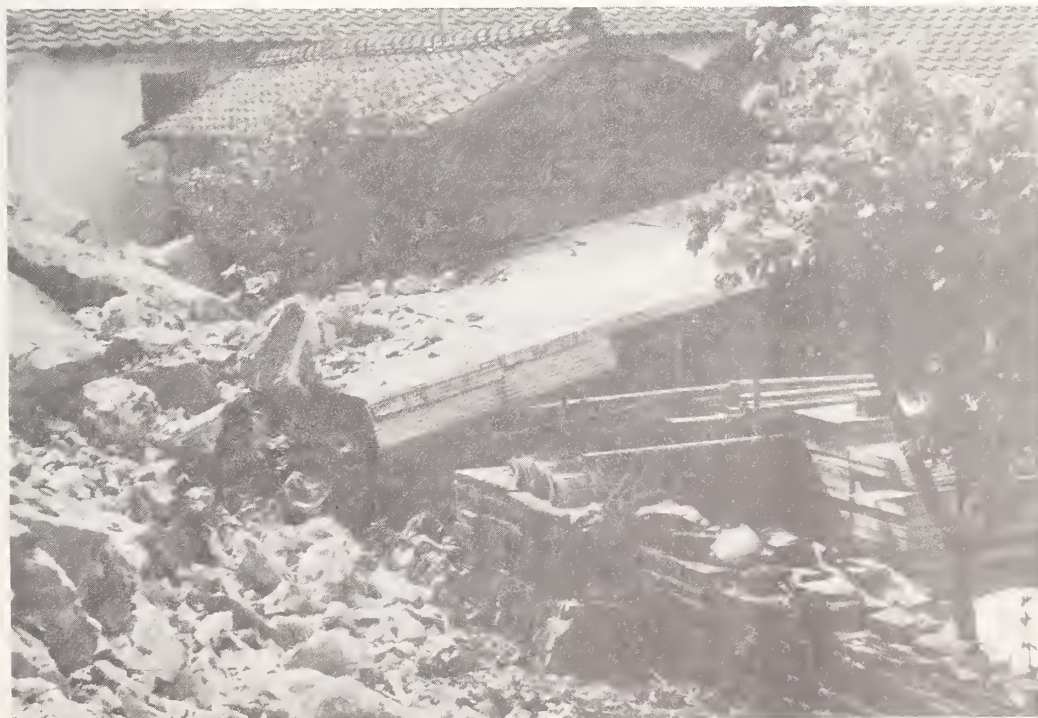
Figure 9.13 Rock fall from slope shown in figure 9.12 impinging on storage shed next to slope.

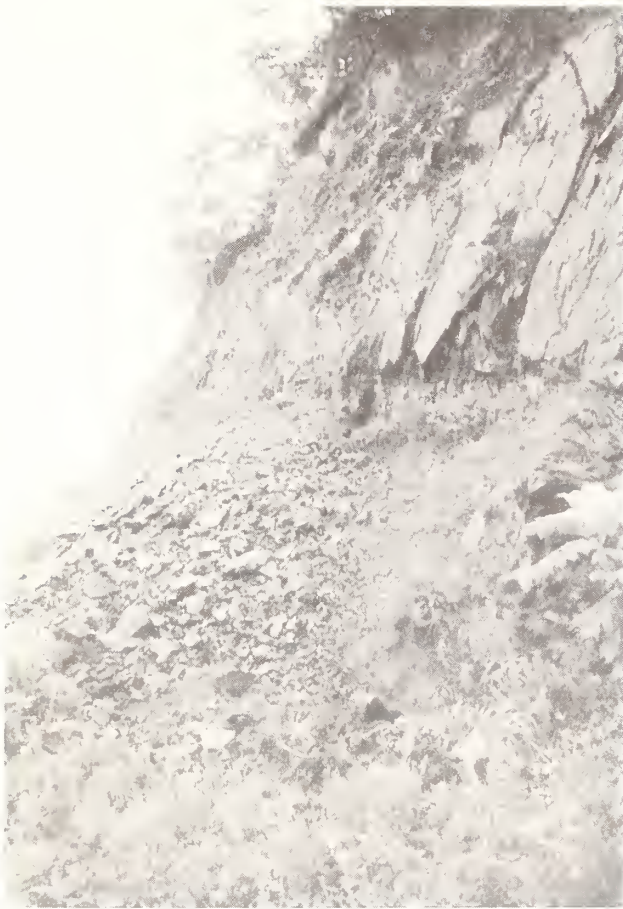
A rock fall in Triassic slate and fine-grained quartzite occurred on a steep roadcut slope on the north side of the New Kitakami River. The scarp of the rock fall is inclined at about 60° and is formed by prominent slaty cleavage planes (Figure 9.15). The blocky debris broke into pieces of up to 30 cm in longest dimension. Almost all of the debris consisted of blocks that had separated along pre-existing fractures.

Figure 9.15 Rock fall in roadcut. Note slaty cleavage planes that form the rock fall scarp.

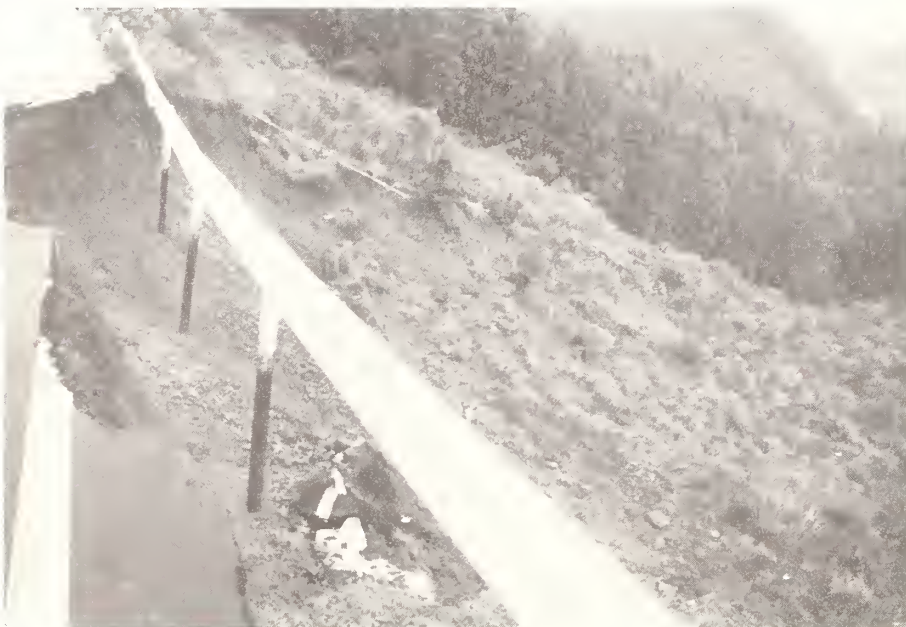
Several artificial fill failures occurred on roads on the Ojika Peninsula; one such failure is shown in Figure 9.16. The fill material slumped away from beneath the road surface and formed a scarp cutting about 2 m into the highway. The fill appeared to be either uncompacted or poorly compacted sandy clay derived from adjacent bedrock and soil. This failure occurred at a site where rainfall-induced slumping had occurred repeatedly before the earthquake (T. Tazaki, 1978, oral communication). At the time of the visit, plastic sheets had been spread over the extensively cracked pavement to prevent or minimize rainfall infiltration into the scarp area. During observation, heavy rainfall was mobilizing the debris into small mudflows.

Figure 9.16 Slump in artificial fill along a highway on the Ajika Peninsula.
