NIST Special Publication 1000-5

June 2004
Progress Report on the
Federal Building and Fire Safety
Investigation of the
World Trade Center Disaster

Volume 4
Contains Appendices G, H, and I

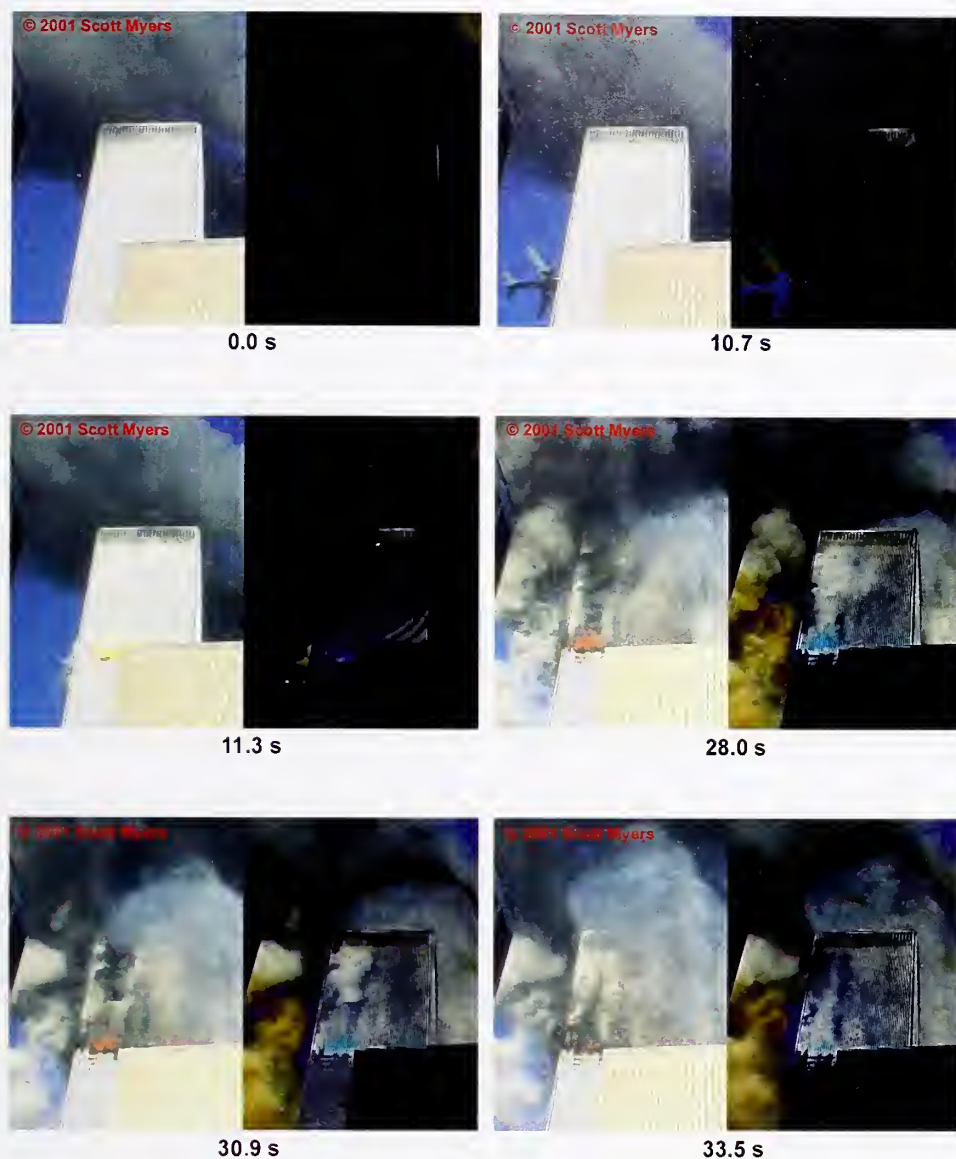
Figure H-17. Frames from a composite video are shown. The half frames on the left are taken from a video showing the plane strike on WTC 2, while the half frames on the right are generated by subtracting a frame recorded prior to the plane strike from all subsequent frames in the original video. Times refer to the period since the start of the difference video.

Following the plane strike, areas of the tower face above the strike floors become hidden by smoke, and it is difficult to see the moiré patterns in the difference frames. However, the area of the tower below the strike floors to the left of the building in the foreground continues to show a distinct difference pattern because it is not obscured by smoke. This pattern is apparent in the fifth frame (time = 30.9 seconds). On the other hand, frames 4 and 6 (times = 28.0 seconds and 33.5 seconds, respectively) have been chosen because they are near null points, and the area appears dark in the difference frame because the location of the building is essentially unchanged from its position before the plane struck. When the video is

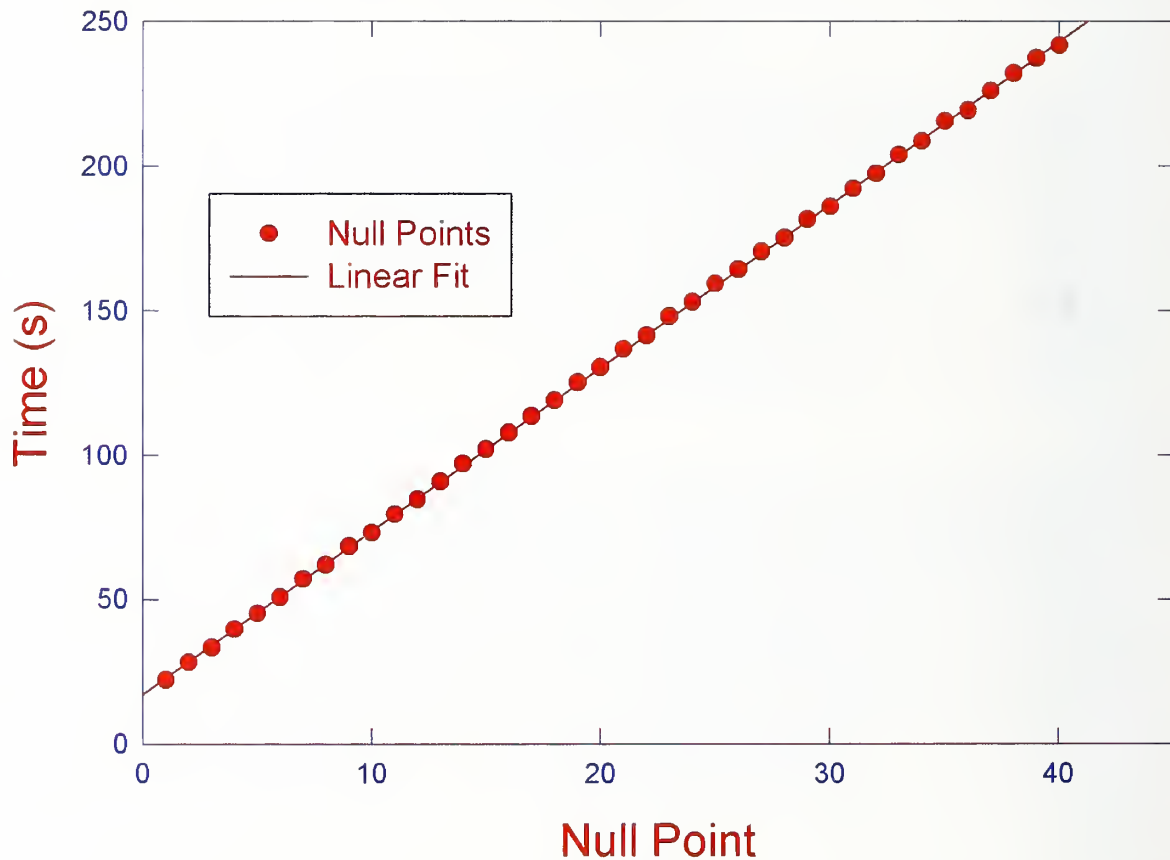
Because the absence of color is easiest to identify, it is straightforward to determine times when the null points occur in the difference image. Figure H-18 shows a plot of time versus null point number obtained from the difference video. The points fall on a straight line having a slope of 5.647 seconds \pm 0.008 seconds (95 percent confidence interval). Because the building passes through a null point twice during a single full oscillation, the period required for a single oscillation is 11.3 seconds.

Figure H-18. The time when null points are observed in the difference video following the plane strike on WTC 2 are plotted versus the null point number. The points fall on a very good straight line having a slope of 5.647 seconds \pm 0.008 seconds.

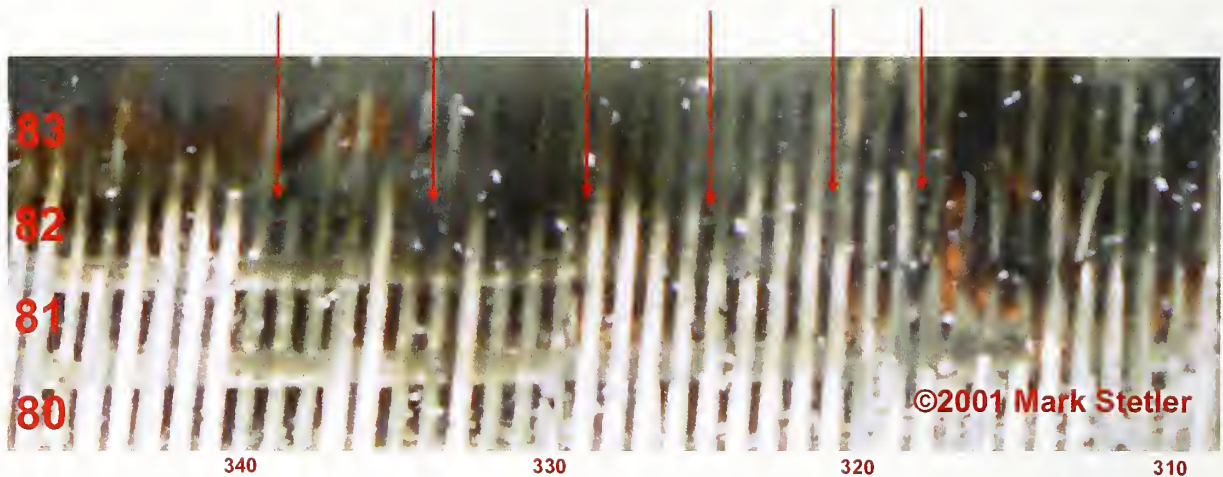
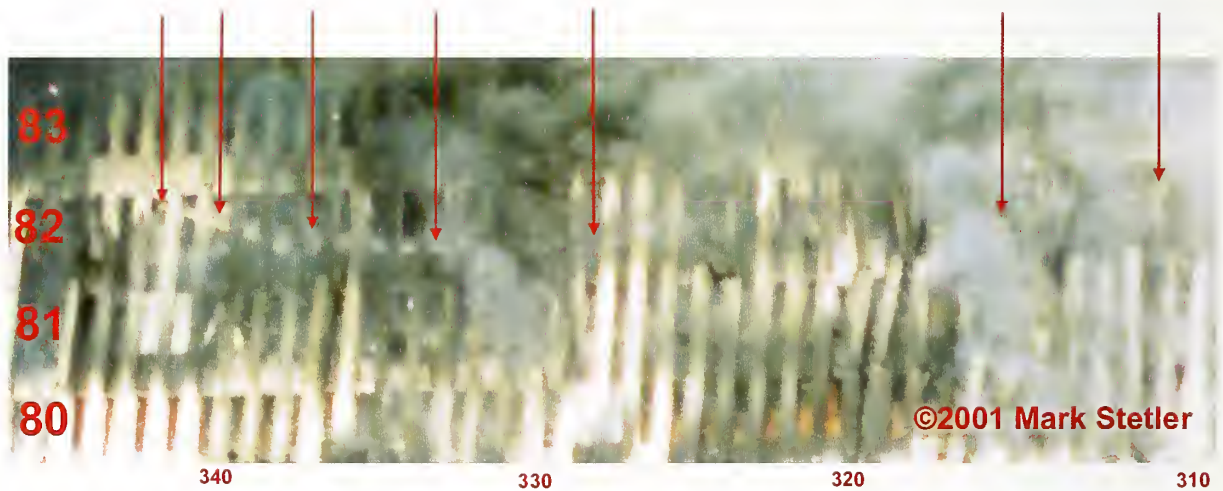
In the *May 2003 Investigation Progress Report* (NIST 2003), a photograph was shown in which there appeared to be a floor draped across a number of windows extending roughly from 310 to 342 across the east face of floor 82 of WTC 2. Figure H-22 compares an image taken shortly after the plane strike at 9:03 a.m. and one taken at 9:55 a.m. shortly before the tower collapsed. At the earlier time, the hanging object is already present, but is seen through the windows draped much higher on the floor 82. An interpretation consistent with these observations is that floor 83 along the east side of WTC 2 was partially collapsed over a significant fraction of its length by the passage of the plane through the building. At the later time the floor has sagged further. By reviewing a number of photographs and videos, it has been determined that the change in floor position occurred between 9:34 a.m. and 9:38 a.m.

Figure H-22. Images of the east face of WTC 2 taken shortly after the plane struck and shortly before the tower collapse are shown. An object that is most likely a floor can be seen through windows on floor 82 as indicated by the arrows. The object has dropped lower between the times the two photographs were taken.

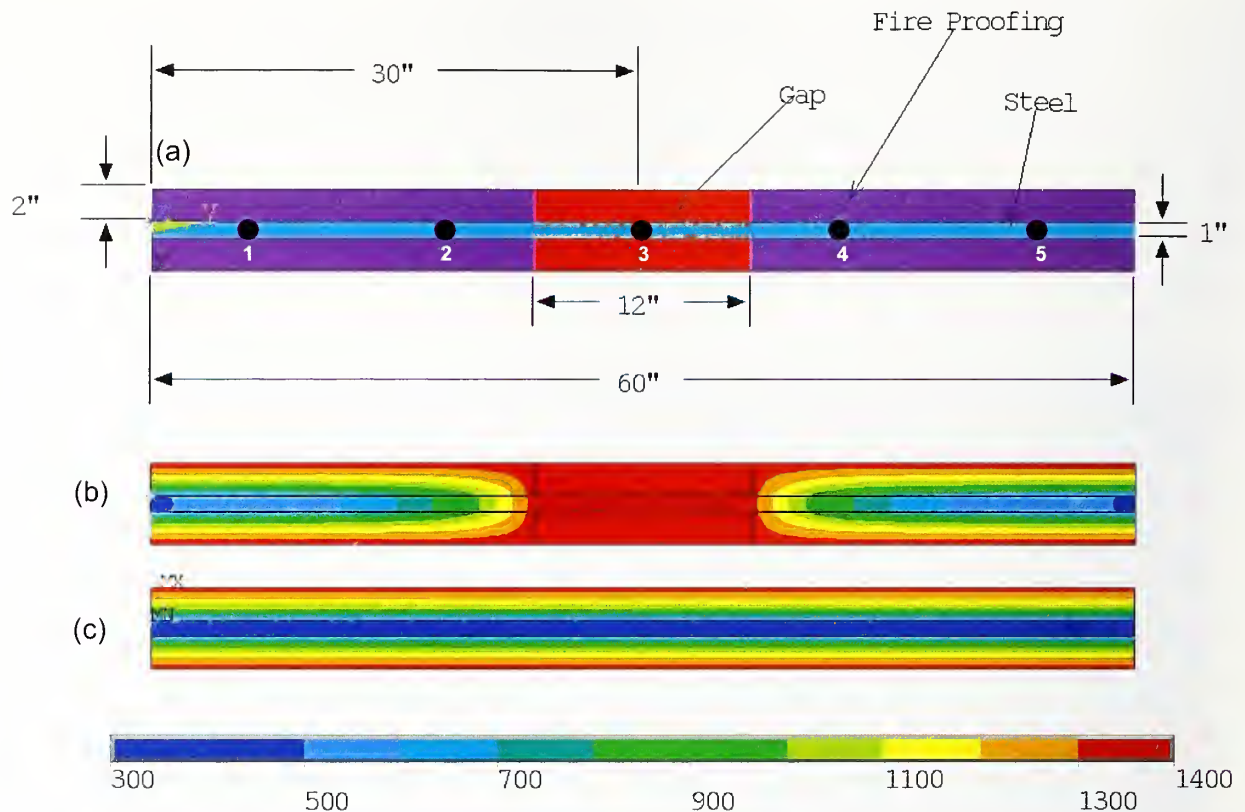
In addition to the effect of variation in thickness, it is important to understand the effect of missing fireproofing over a portion of a member. As an example, Fig. I-4 shows missing fireproofing from a diagonal of a bridging truss of the WTC towers floor system. Figure I-5 (a) shows an example of a numerical model with missing fireproofing. In this case, there is 12 in. of missing fireproofing on the steel plate, which is otherwise protected by 2 in. of uniform thickness fireproofing. Figure I-5 (b) shows the temperature contours (isotherms) at time 50 min. For comparison, Fig. I-5 (c) shows isotherms at the same time in a plate with no gap in the fireproofing. As expected, the bare steel at the missing fireproofing is at the gas temperature, but more importantly the “gap” in fireproofing leads to a “leakage” of heat into the interior steel.

Figure I-5. Effects of gap in fireproofing: (a) model of plate with fireproofing having 2 in. uniform thickness and 12 in. gap, (b) isotherms (K) at time = 50 min with 12 in. gap, and (c) isotherms without gap.

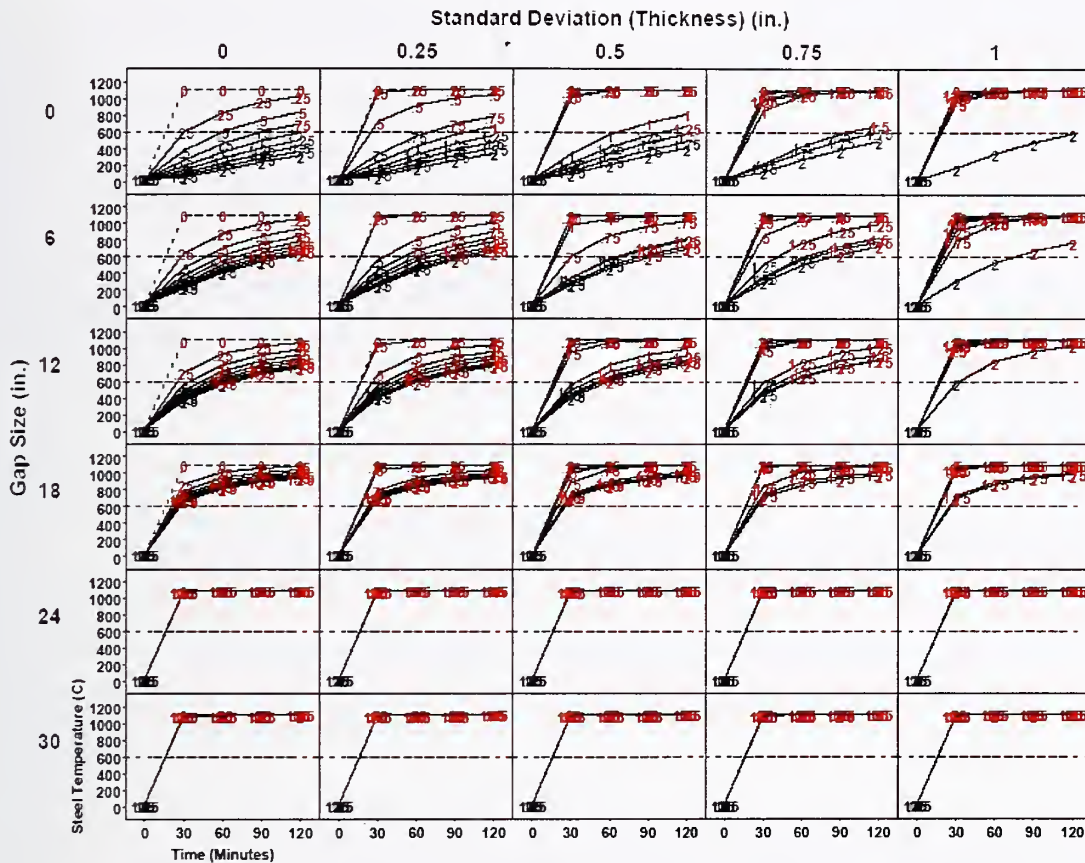
The results of the sensitivity study can be summarized in a series of plot matrices, which show the time histories of the steel temperature for different combinations of gap length and variability in fireproofing thickness. For example, Fig. I-6 shows the plot matrix for the temperature history at point #2 (18 in. from the end of the plate). Each plot contains a series of curves representing different average thickness of fireproofing, as in Fig. I-3. Each column of plots represents a constant value of thickness variability (standard deviation), and each row represents a constant gap length. The plot in the upper left corner represents the case of uniform thickness of fireproofing and no gap, which is the same plot as in Fig. I-3(a). (Note that for the case of uniform thickness and no gap, the steel temperature at any point in a cross section is the same along the length of the plate, as shown in Fig. I-5(c).) For gaps of 24 in. and 30 in., the temperature at point #2 rises rapidly because there is no fireproofing on the plate at that location. This explains the shapes of the curves in the two lower rows. In going from left to right in one of the top four rows it is seen that as variability of thickness increases, the time histories shift upward, thereby reducing the time to reach 600°C. This is the same observation as shown in Fig. I-3. Moving from the top to the bottom in any column shows the effects of increasing gap length. The effect of gap length depends, of course, on where the steel temperature is measured. At a point within the portion of steel that is bare, the temperature rises quickly. At points within the steel that are surrounded with fireproofing, the gap provides a path for heat flow, as shown in Fig. I-5 (b). As a result, points in the steel within the vicinity of the missing fireproofing will experience higher temperatures, as indicated by the rising trend of the curves in going downward from the top of a column in Fig. I-6. The National

Institute of Standards and Technology (NIST) does not have sufficient information to determine the frequency of occurrence of these gaps or their typical locations. Therefore, gaps in fireproofing will not be considered in the thermal modeling.

Figure I-6. Example of plot matrix from sensitivity study of the effects of missing fireproofing and variability of fireproofing thickness on steel temperature. Each graph is a temperature history of the steel at point #2 (see Fig. I-5) for different thicknesses of fireproofing.

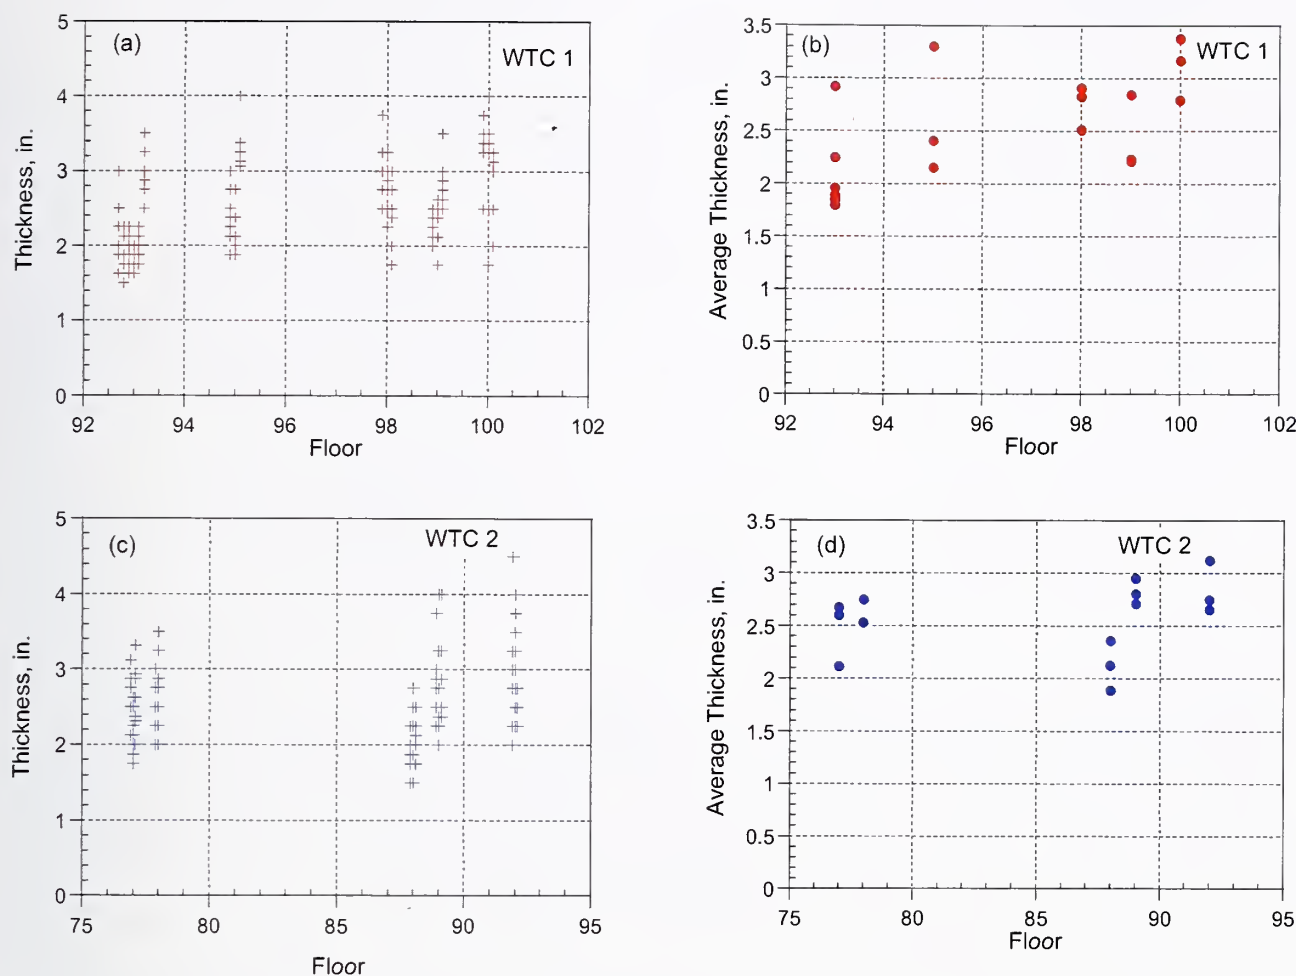
Figure I-11. Fireproofing thickness on floor trusses in upgraded portions of WTC towers: (a) individual measurements in WTC 1, (b) average thickness in WTC 1, (c) individual measurements in WTC 2, and (d) average thickness in WTC 2.

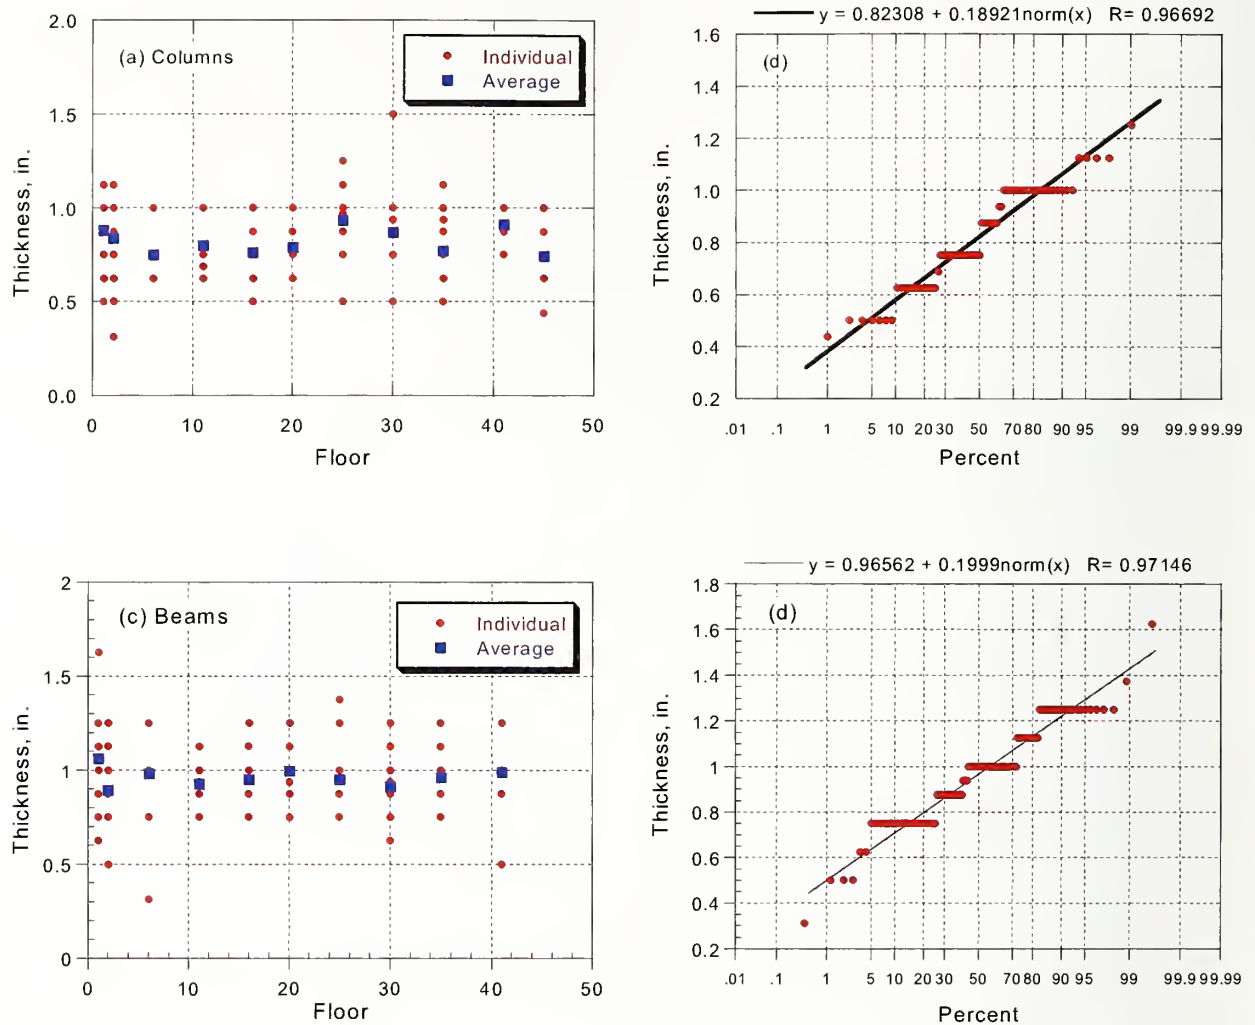
Figure I-12 (a) shows the individual and average fireproofing thickness on the core columns. Analysis of variance indicated no statistically significant differences among the average values and all data were pooled together. The average thickness for the columns is 0.82 in., the standard deviation is 0.20, and the coefficient of variation is 0.24. The information from the Port Authority indicated that the “minimum thickness required” for the columns was 0.5 in. Figure I-12 (b) is the normal probability plot of the individual thickness measurements. Because most of the thicknesses were reported to the nearest 1/8 in., the points are staggered instead of uniformly distributed. The plot, however, shows that the points follow a linear trend, and it appears that the thickness of the fireproofing on the core columns could be described by a normal distribution. Figures I-12 (c) and (d) shows the corresponding plots for the thickness of fireproofing on the beams. The average thickness for the beams is 0.97 in., the standard deviation is 0.21 in. and the coefficient of variation is 0.21. The information from the Port Authority indicated that the “minimum thickness required” for the beams was 0.75 in.

Figure I-12. (a) Individual and average thickness for core columns, (b) normal probability plot of individual measurements on columns, (c) individual and average thickness for core beams, and (d) normal probability plot of individual measurements on beams.

As might be expected, the variation in thickness of fireproofing for the beams and columns is lower than the variation observed in the floor trusses. The planar surfaces of the beams and columns result in more uniform application of the sprayed fireproofing than for the slender truss members. This results in reduced differences in the average thickness of fireproofing on different members and less variability within a member.
