NIST Special Publication 778

Performance of Structures During the Loma Prieta Earthquake of October 17, 1989

H. S. Lew, Editor

January 1990

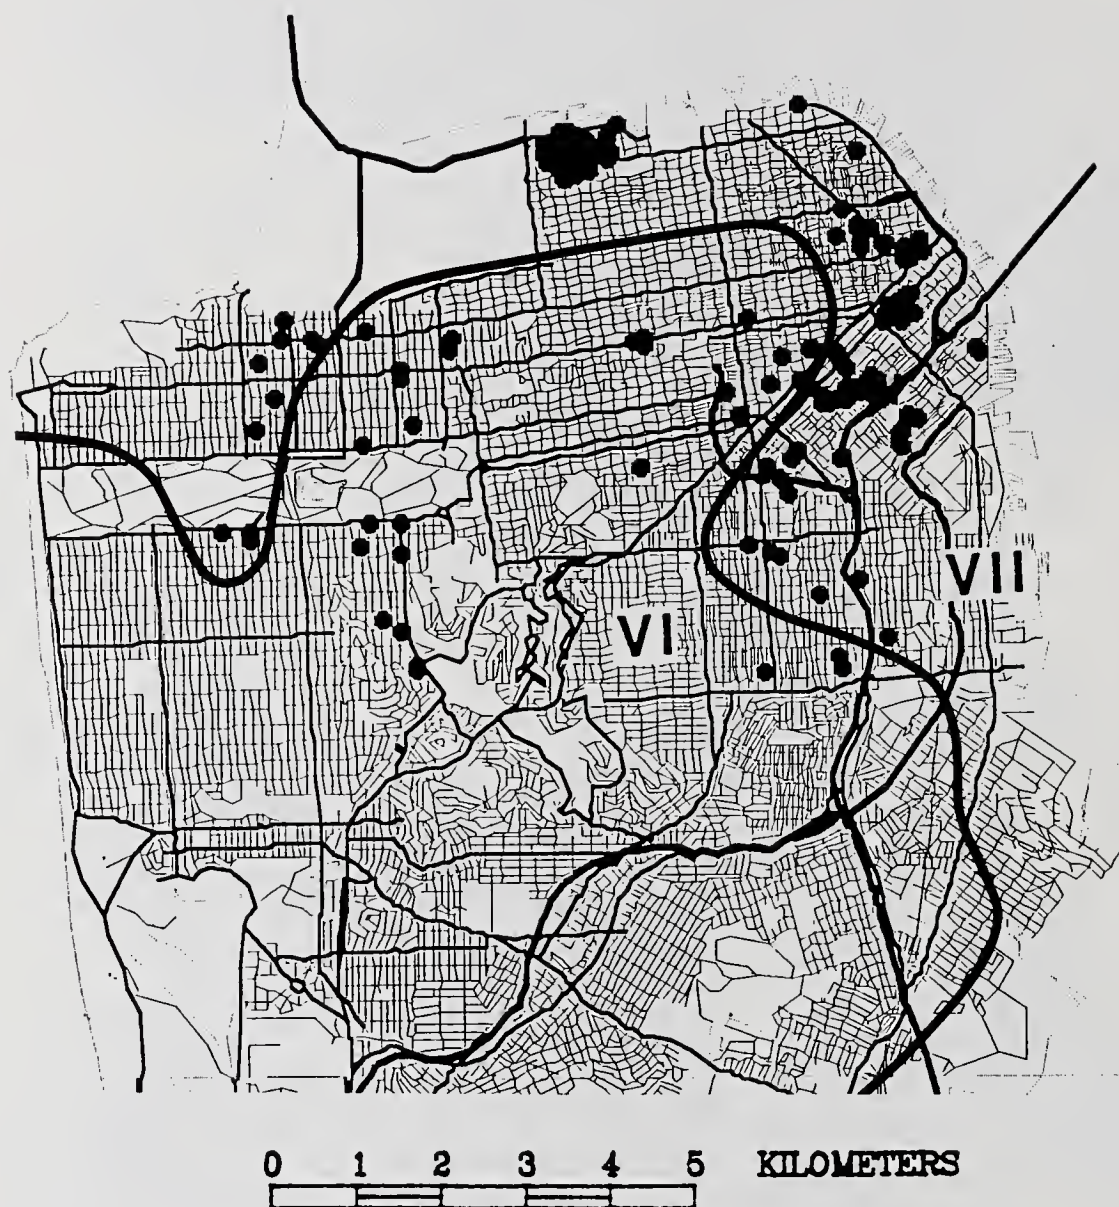
As an example of the wealth of data available, figure 2.4.2 shows some of the safety inspection results available for San Francisco (Lew, 1989). These represent 378 inspected buildings using post-earthquake safety evaluation procedures developed by the Applied Technology Council (ATC, 1989). These are only

Figure 2.4.2 Damage inspections for San Francisco. The figure shows 378 inspections judged as "red" using the ATC postearthquake safety evaluation procedures (ATC, 1989a,1989b). Damage judged sufficiently for a "Red" designation may be caused by either ground shaking, ground failure, or be in a dangerous area. The preliminary intensity contour based on ground shaking effects from figure 2.4.1 is shown for comparison.

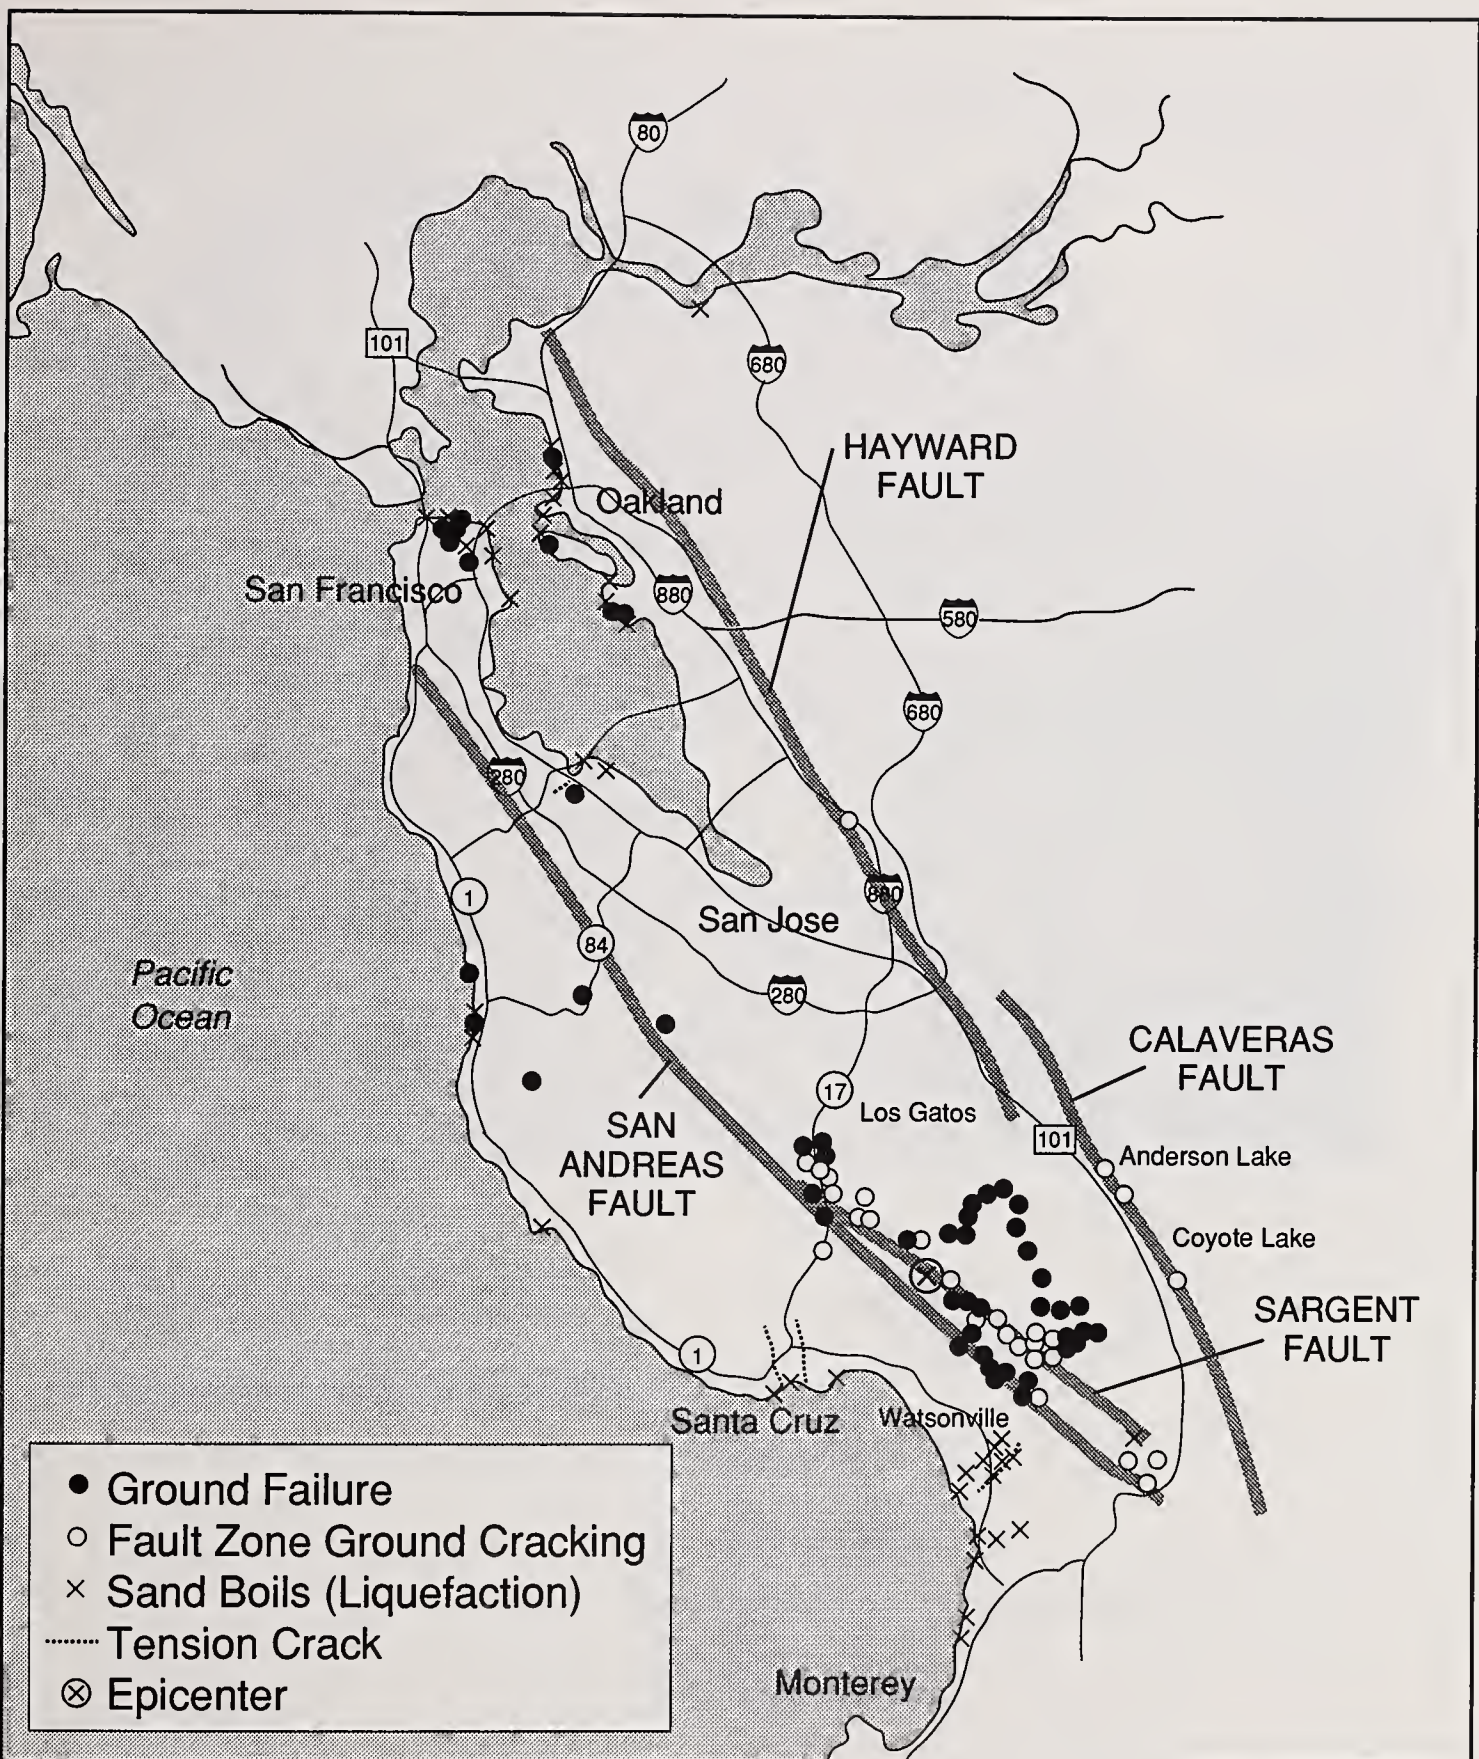
Figure 3.2.1 shows the approximate locations of observed ground failures. Four failure categories are identified: (1) fault zone ground cracking; (2) ground failures; (3) liquefaction; and (4) tension cracks. The observations compiled in the map were recorded by the U.S. Geological Survey in Menlo Park, CA, (prior to October 23, 1989), the University of California at Berkeley (Abolhassan et al., 1989), the U.S. Army Corps of Engineers, and the ICSSC team.

documented by the U.S. Corps of Engineers, and the ICSSC team. The failure categories identified in figure 3.2.1 are not mutually exclusive. For instance tension cracks in embankments may be attributable to a stability failure, in which case they would fall under "ground failures," or to liquefaction.

Figure 3.2.1 Ground failures caused by the Loma Prieta earthquake.

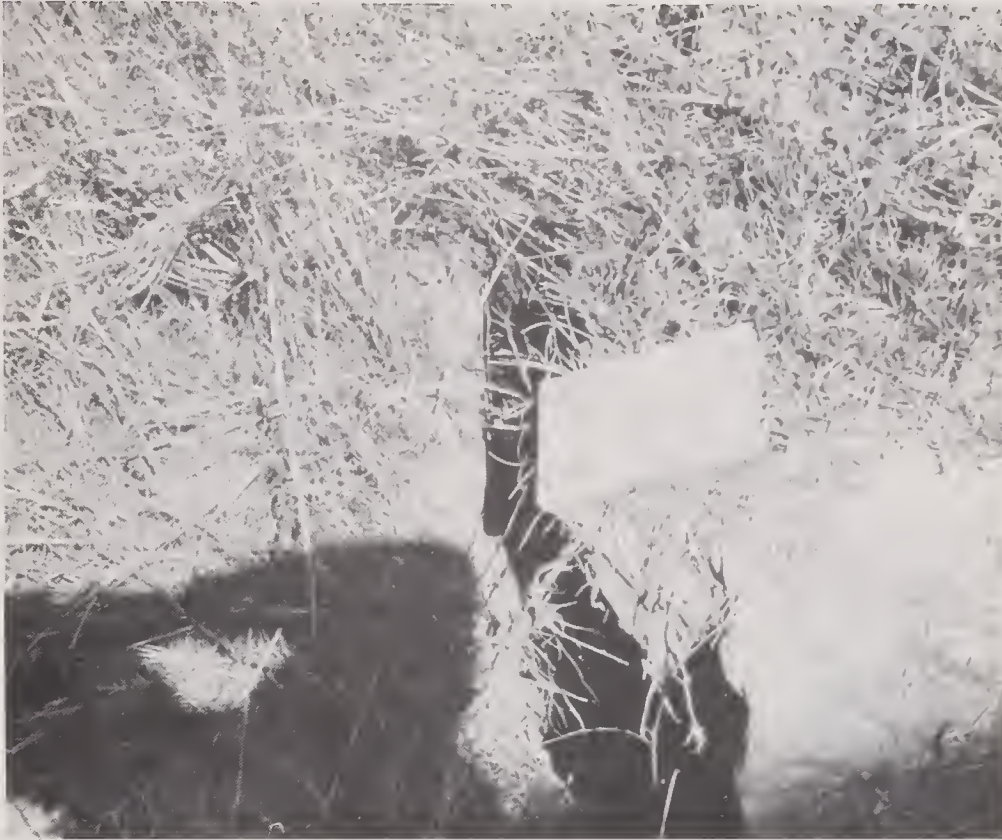
Extensive tension cracking was observed along the embankments of the Pajaro River (fig. 3.2.1). Figure 3.3.8 shows a 2 ft (600 mm) wide tension crack near the bridge of Main Street over the Pajaro River. The crack was parallel to the river between the dike and the river. There was a second parallel crack nearer the river which was approximately 6 in (150 mm) wide. There were also some tension cracks outside the embankment and parallel to it (fig. 3.3.9). The tension cracks in the soil parallel to the

Figure 3.3.8 Tension cracks on Pajaro River bank in Watsonville.

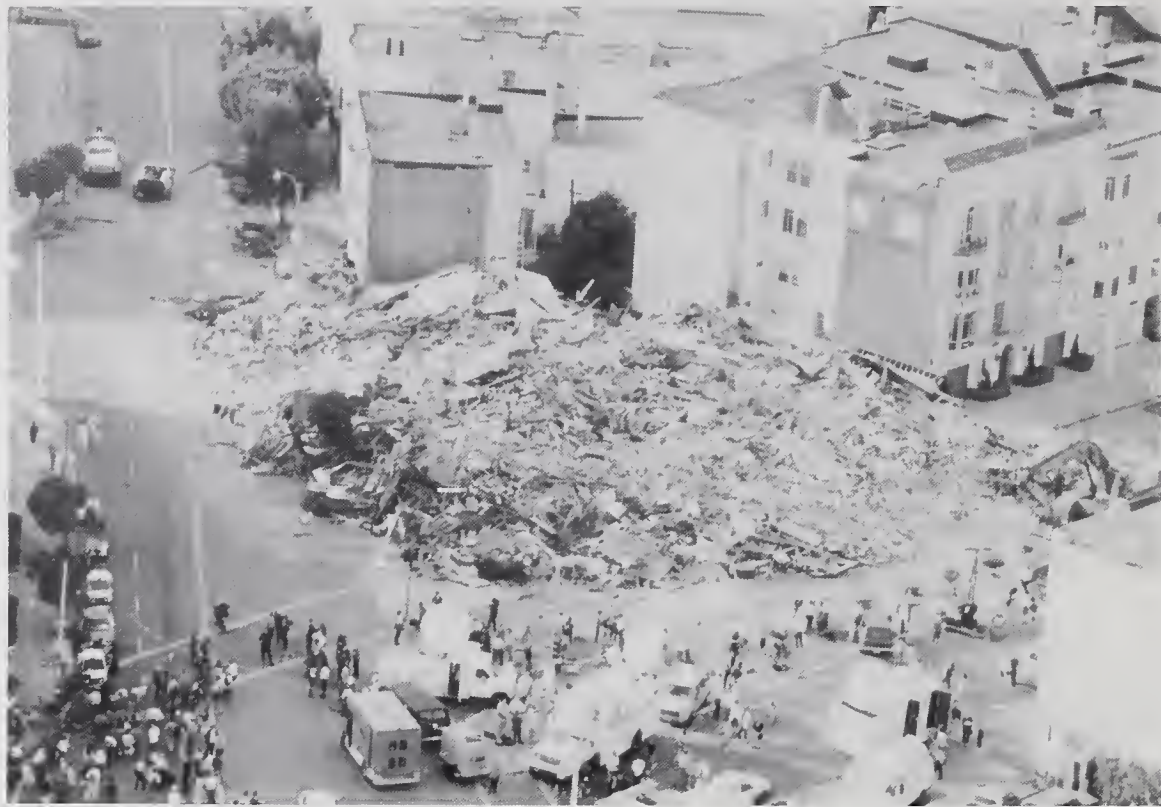
Figure 4.2.4 Aerial view (#2) of demolished building at the intersection of Fillmore St. and Cervantes Blvd.

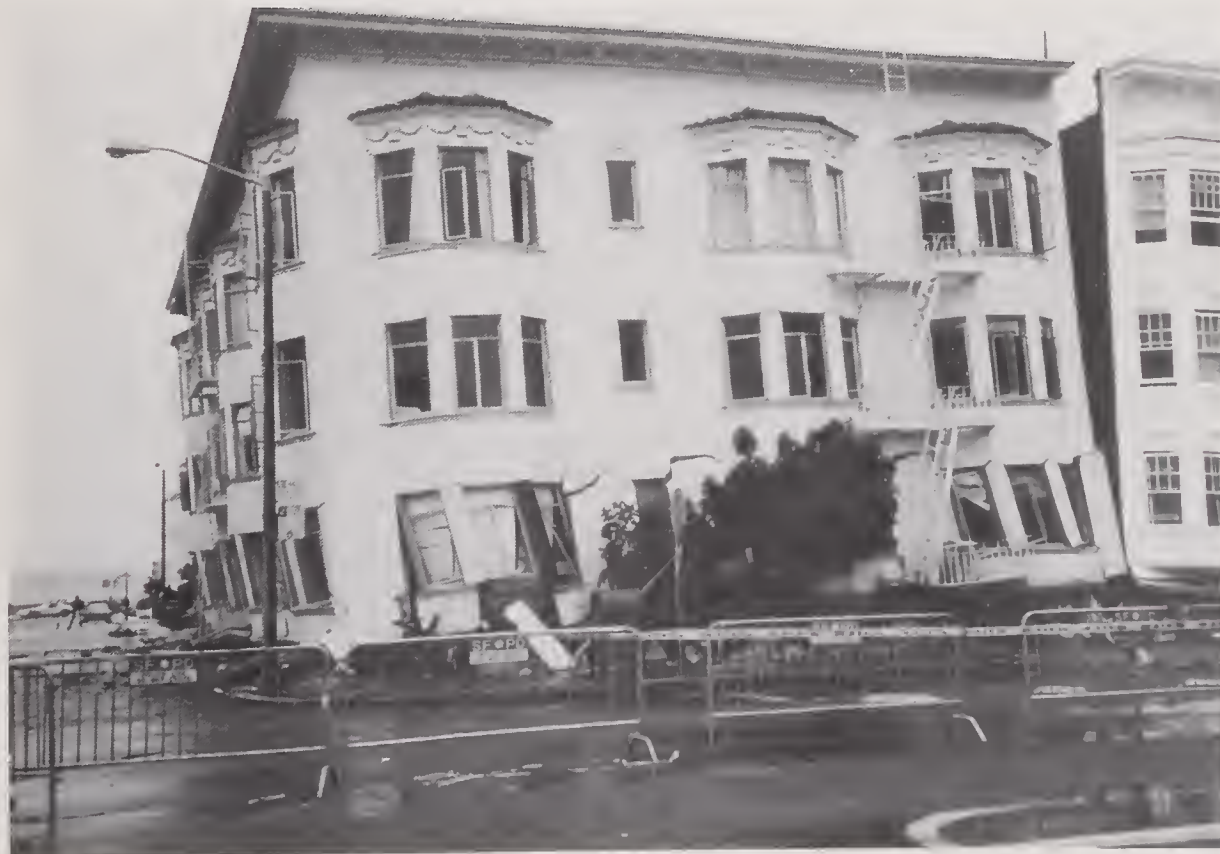
Figure 4.2.7 Two four-story buildings which suffered total collapse of their first stories (location #14).

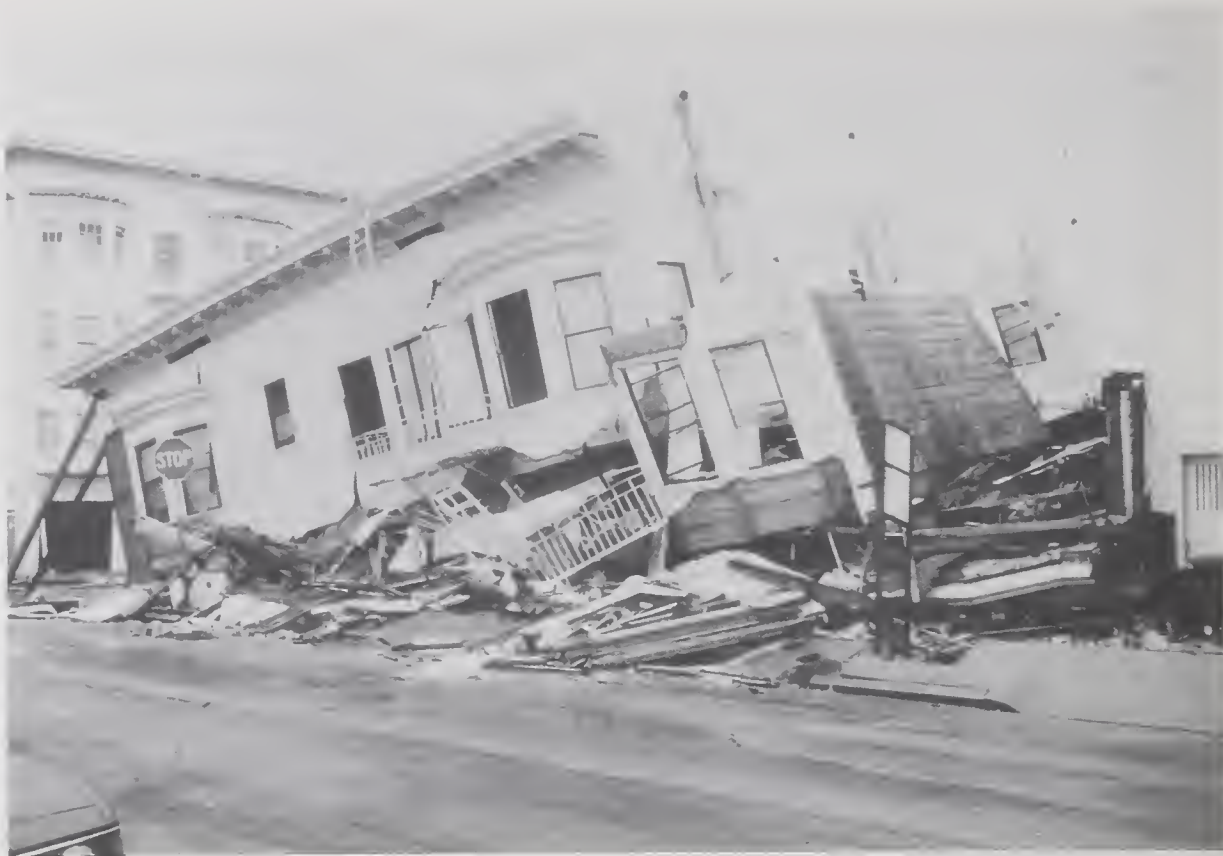
Figure 4.2.8 Four-story building which suffered total collapse of its lower stories (location #3).

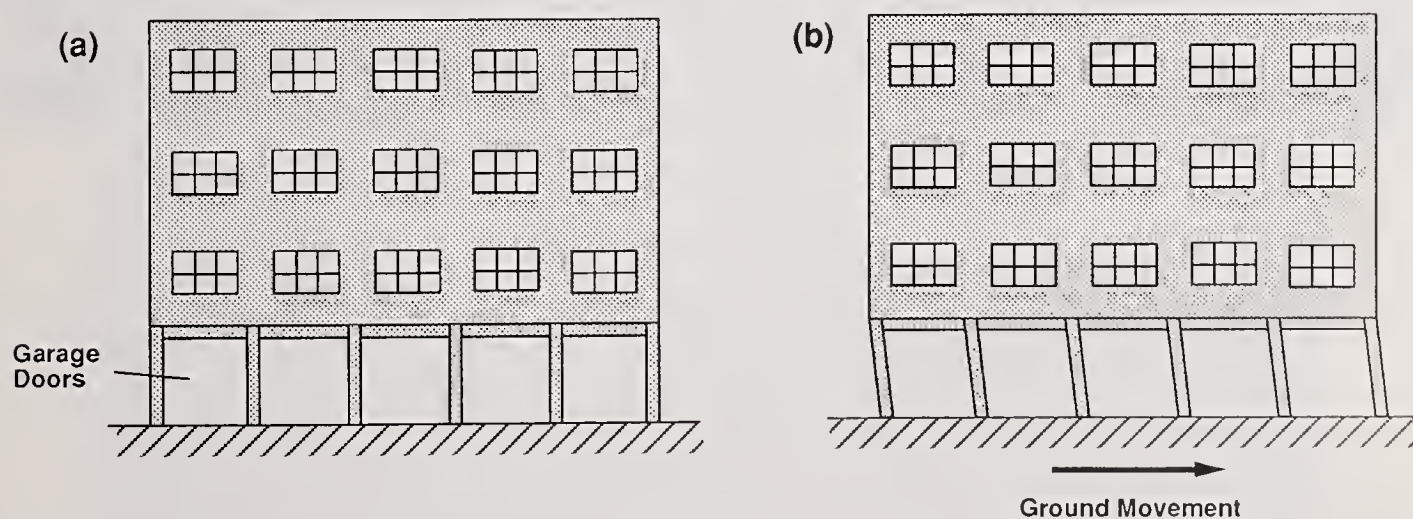
Figure 4.2.15 (a) Schematic elevation view of a four-story building with multiple garages and (b) expected building distortion due to ground motion.

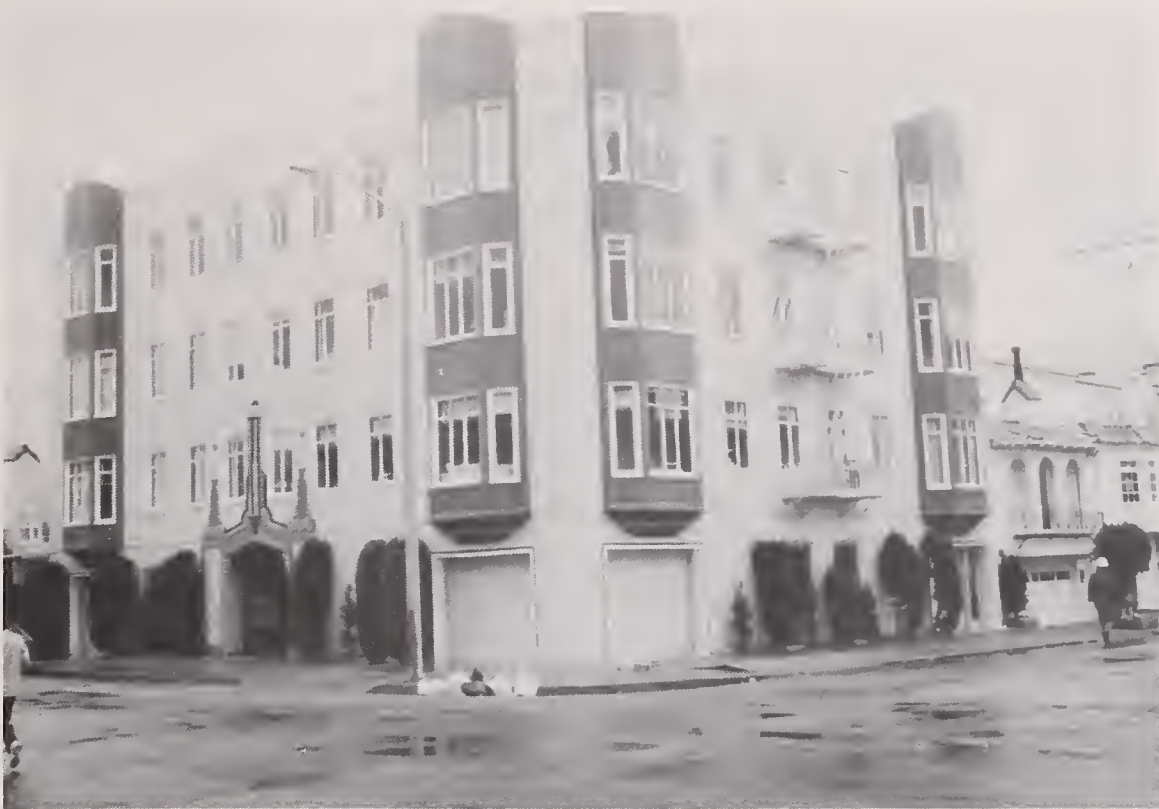
Figure 4.2.20 An undamaged four-story building on the corner of Broderick and Beach Streets (location #7).

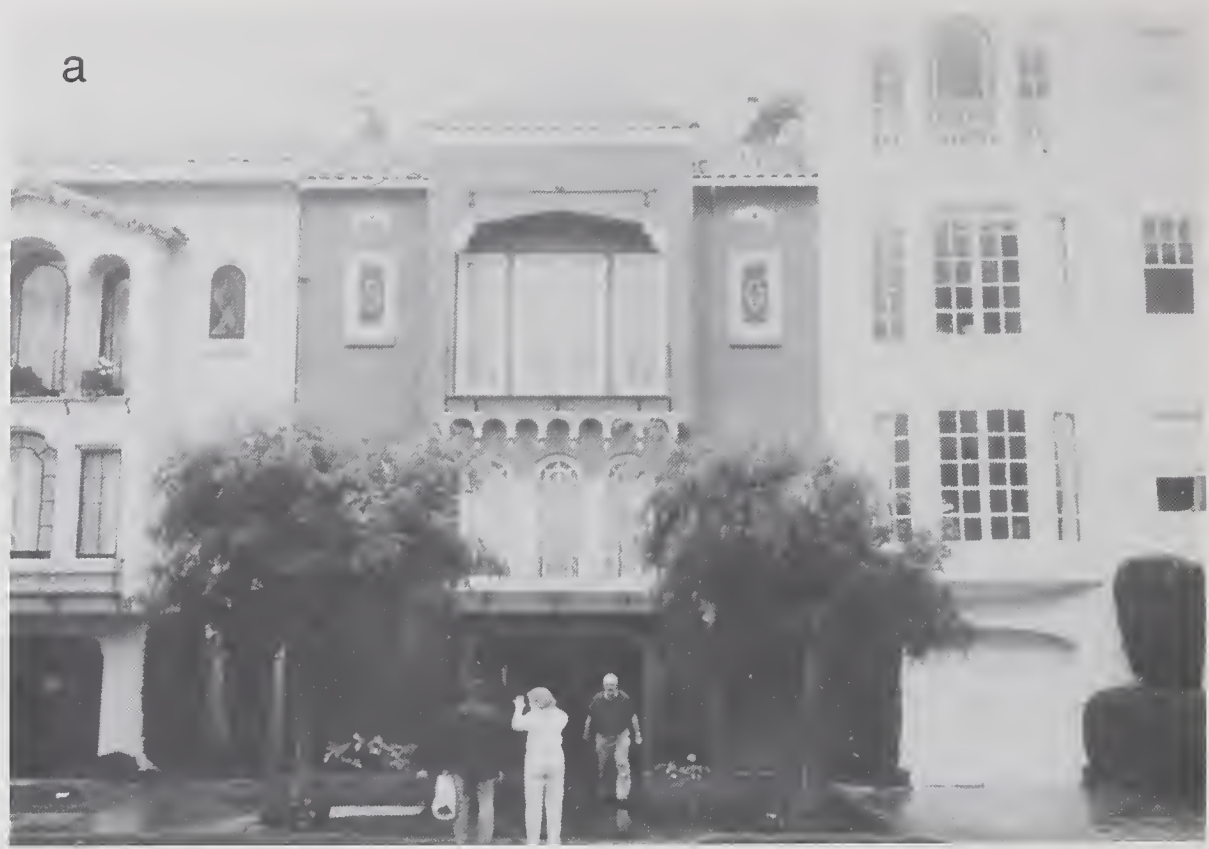
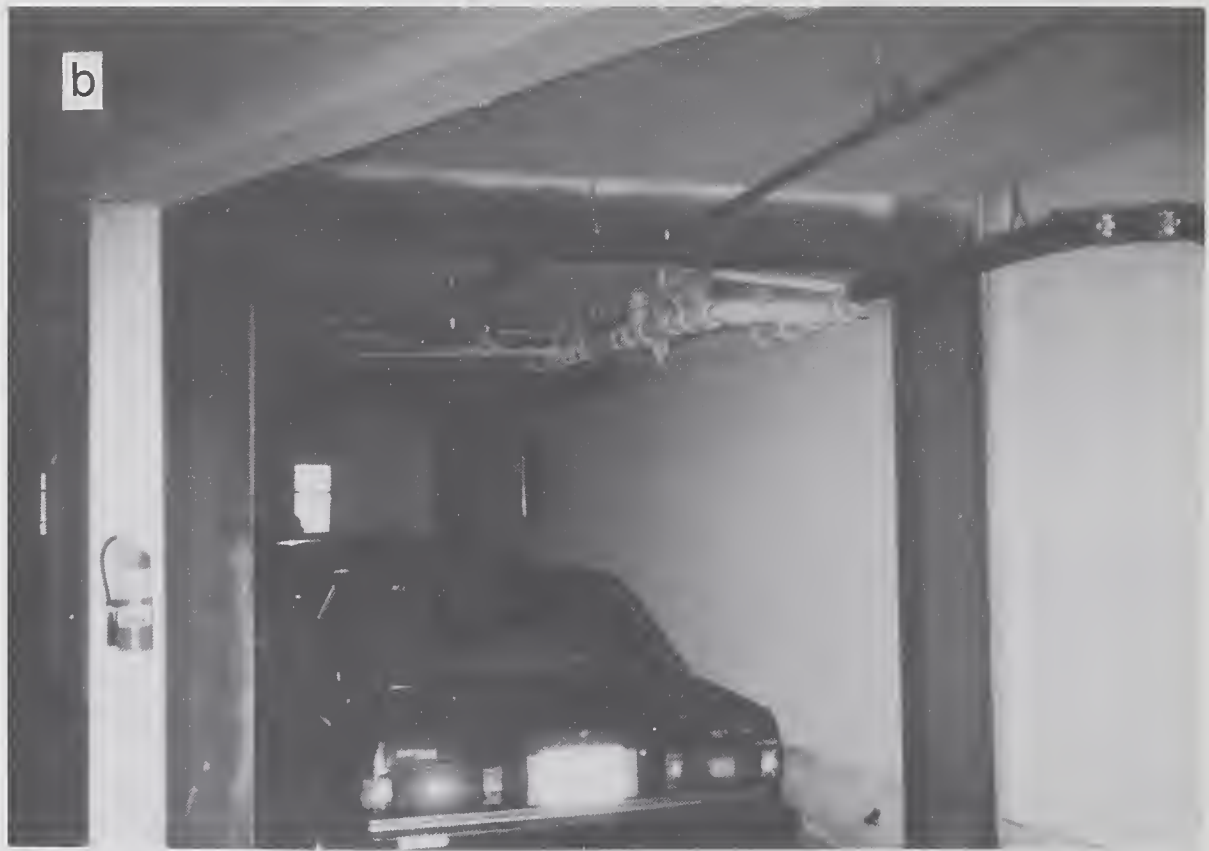
Figure 4.2.22 (a) An undamaged, three-story building (location #8) and (b) view of the moment-resting frame used for retrofitting.

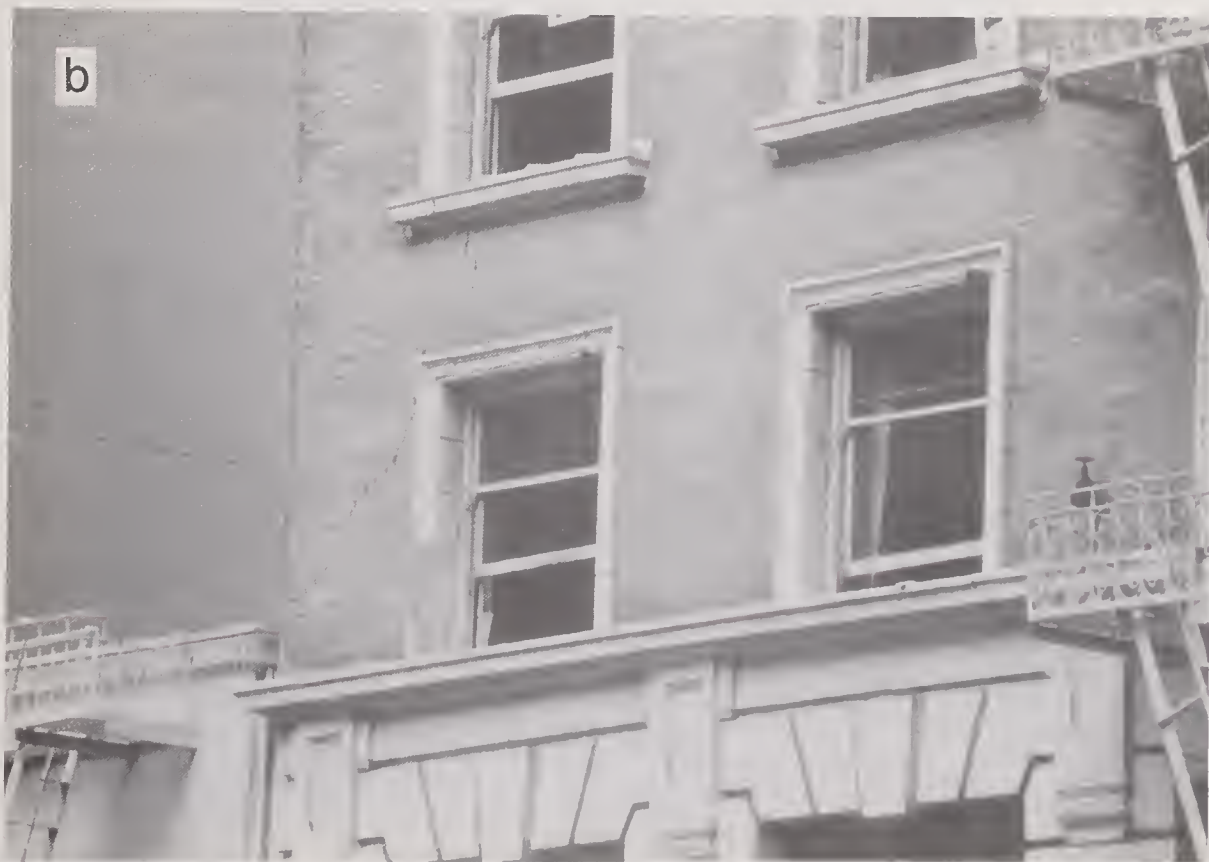
Figure 4.2.27 (a) Severely damaged Marine Building at corner of Front St. and California St.; (b) Close-up view of the northwest corner showing severity of cracking.

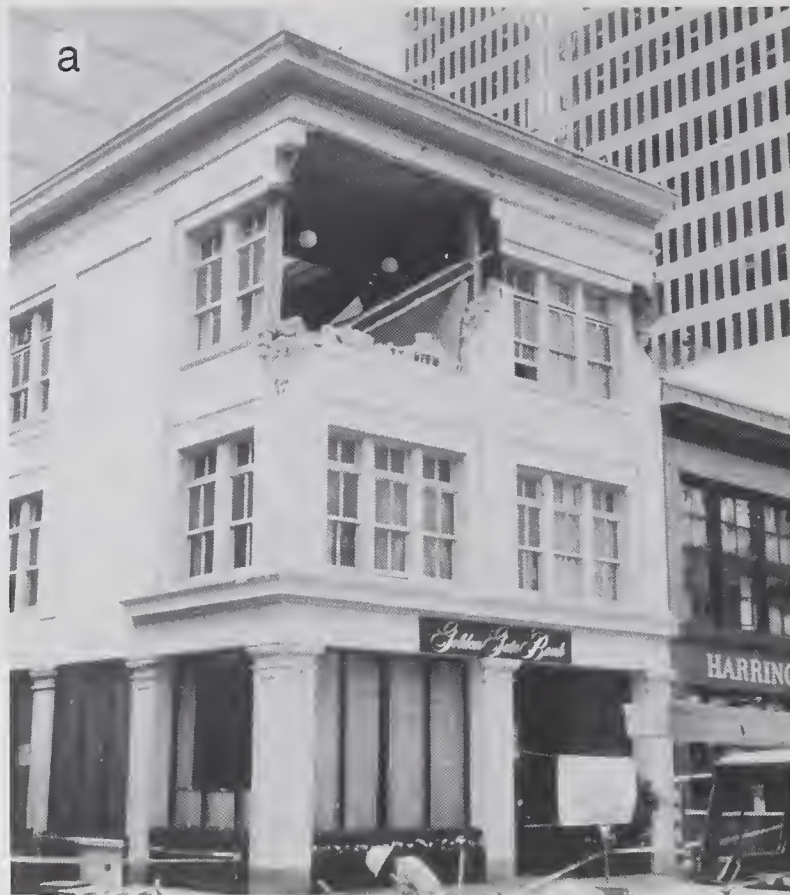
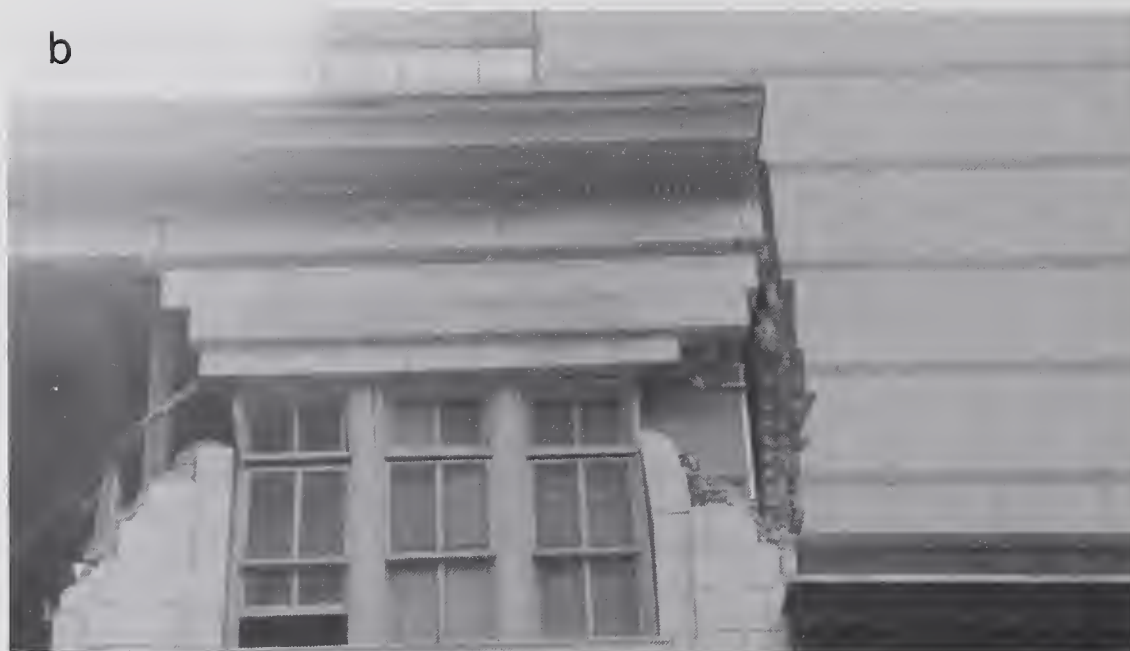
Figure 4.2.28 (a) Damage to the southeastern corner of the Golden State Bank Building; (b) Close-up view of the northeastern corner; damage was likely caused by pounding against the adjacent building.

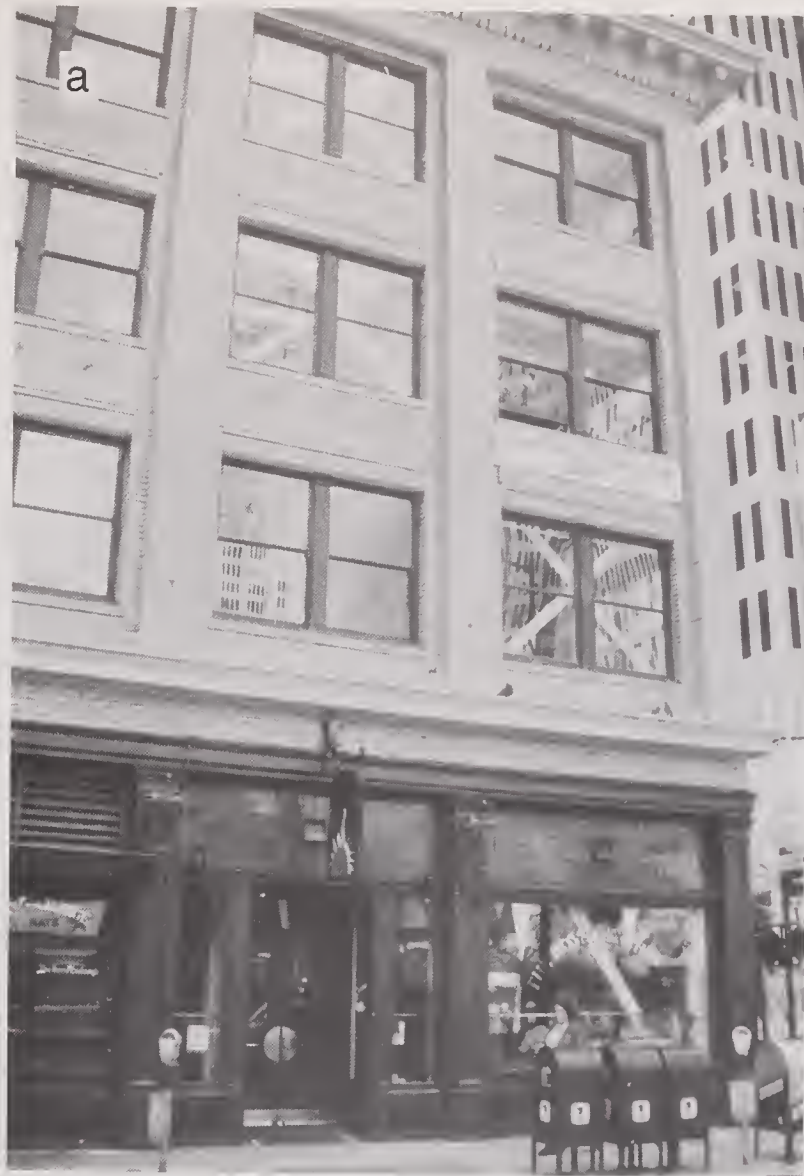
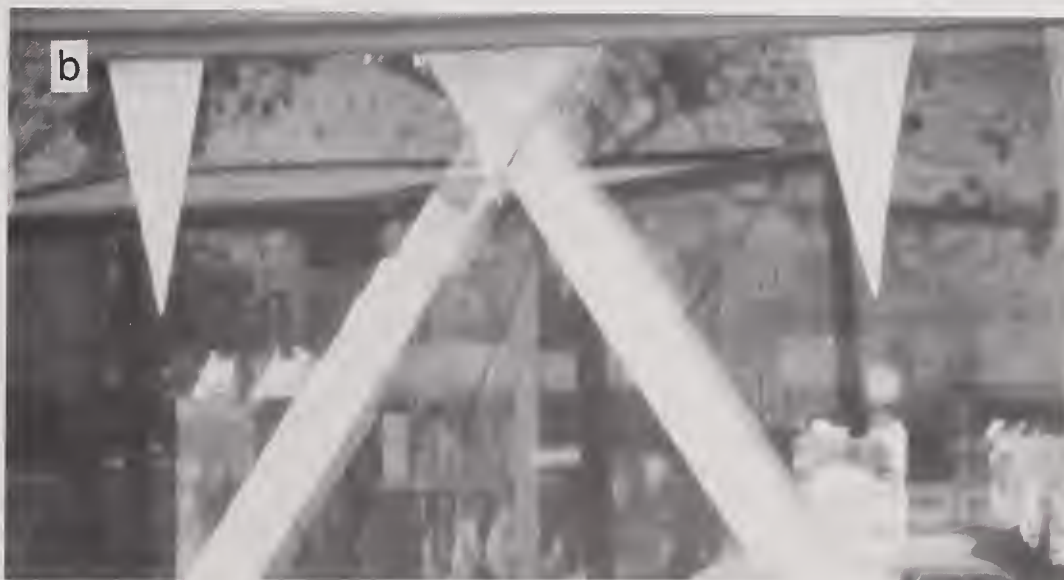
Figure 4.2.29 (a) The historic DeBernardi warehouse building showing the bracing added during seismic retrofitting; (b) close-up view of the bracing showing damage caused by earthquake.

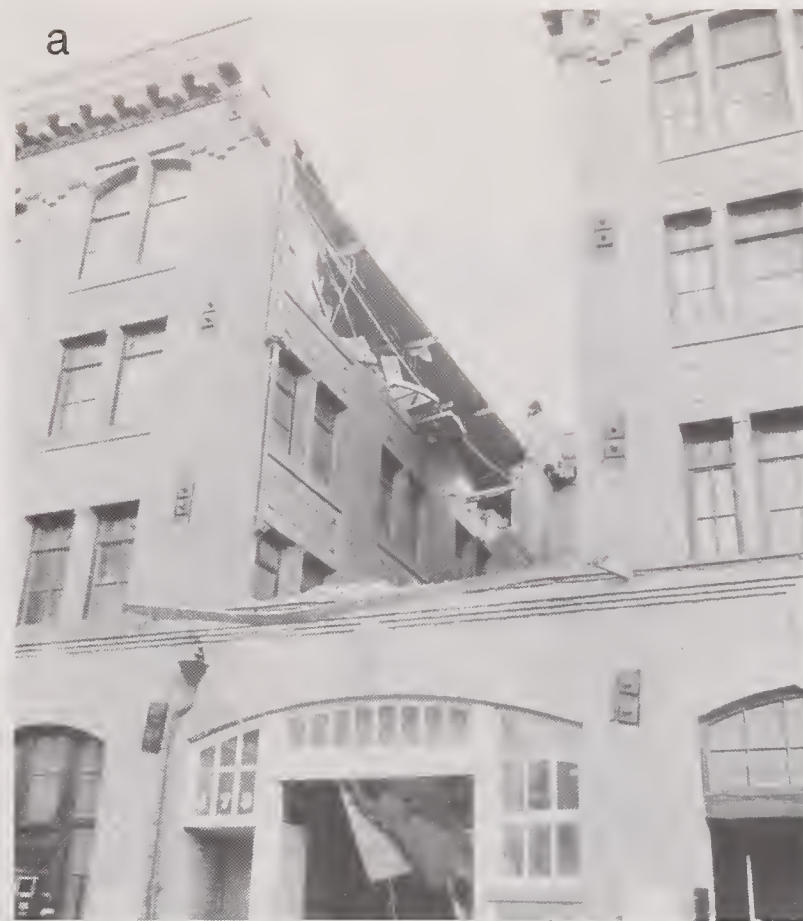
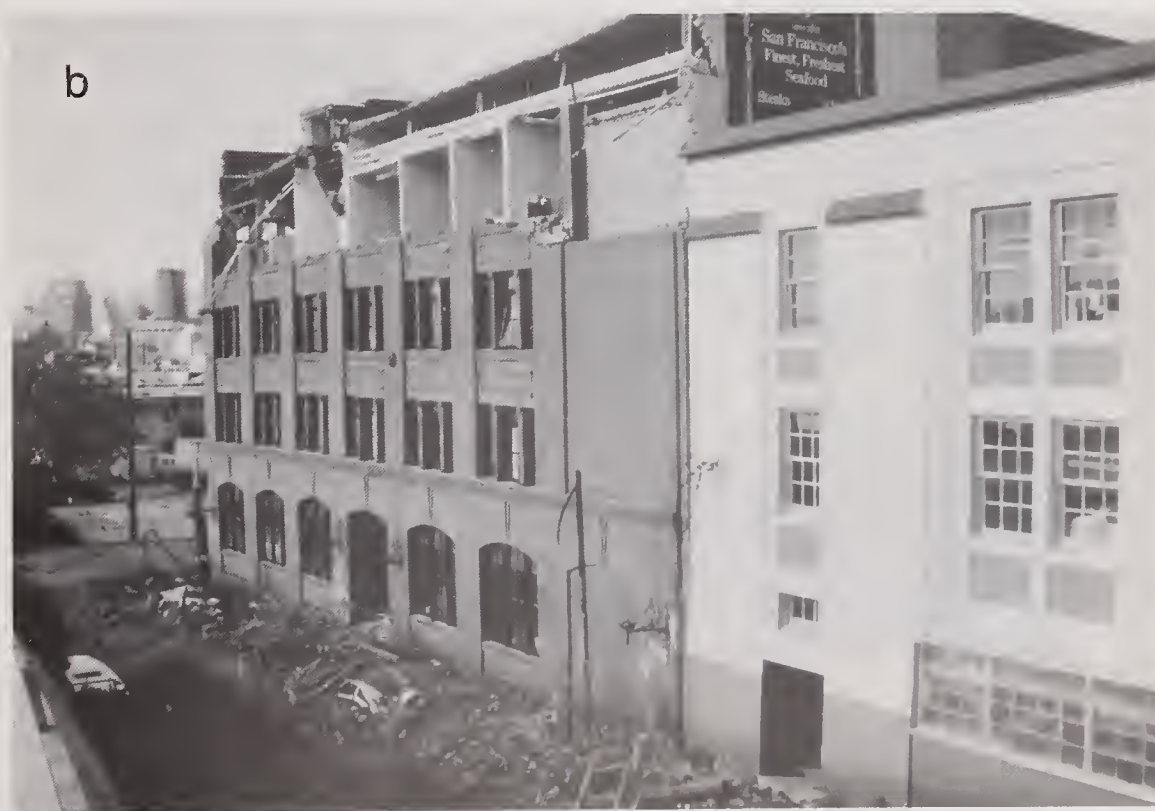
Figure 4.2.34 (a) Damage to upper story of unreinforced masonry building on Bluxome St. (location #8);
 (b) damage to the southwestern wall which resulted in the death of six persons.

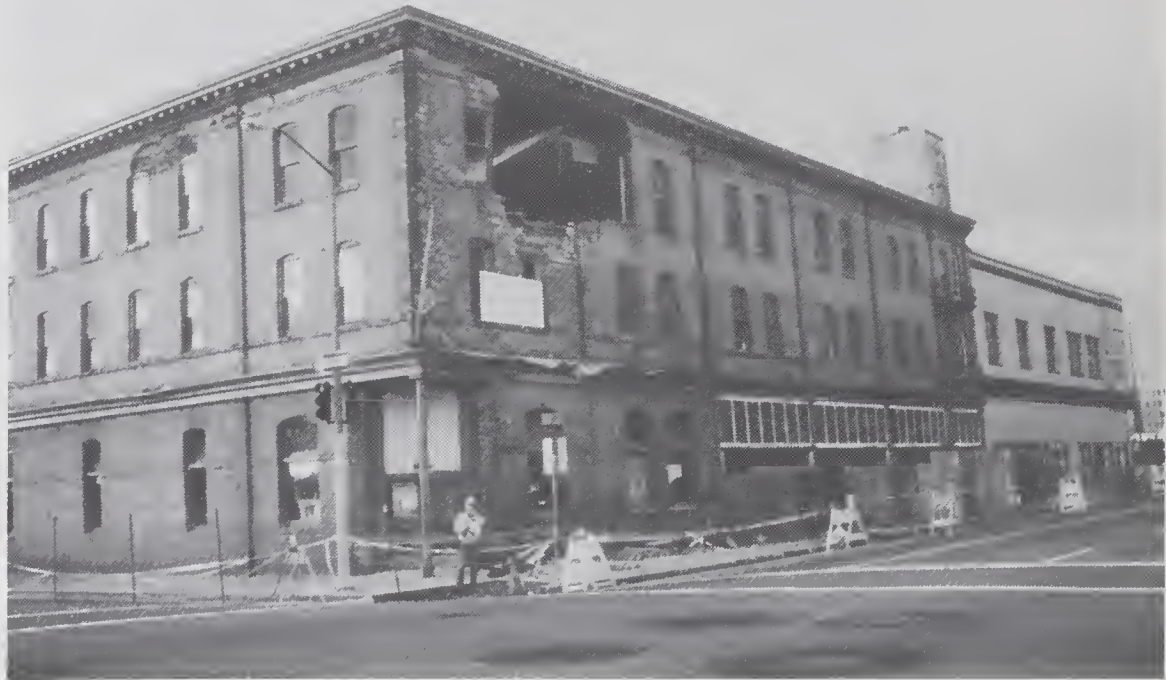
Figure 4.3.4 shows the three-story Clay Building (location #2) which had a serious failure of its unreinforced masonry walls. On the corner opposite to the Clay Building there was a two-story URM

Figure 4.3.4 Damage to the Clay Building, an unreinforced masonry structure (location #2).

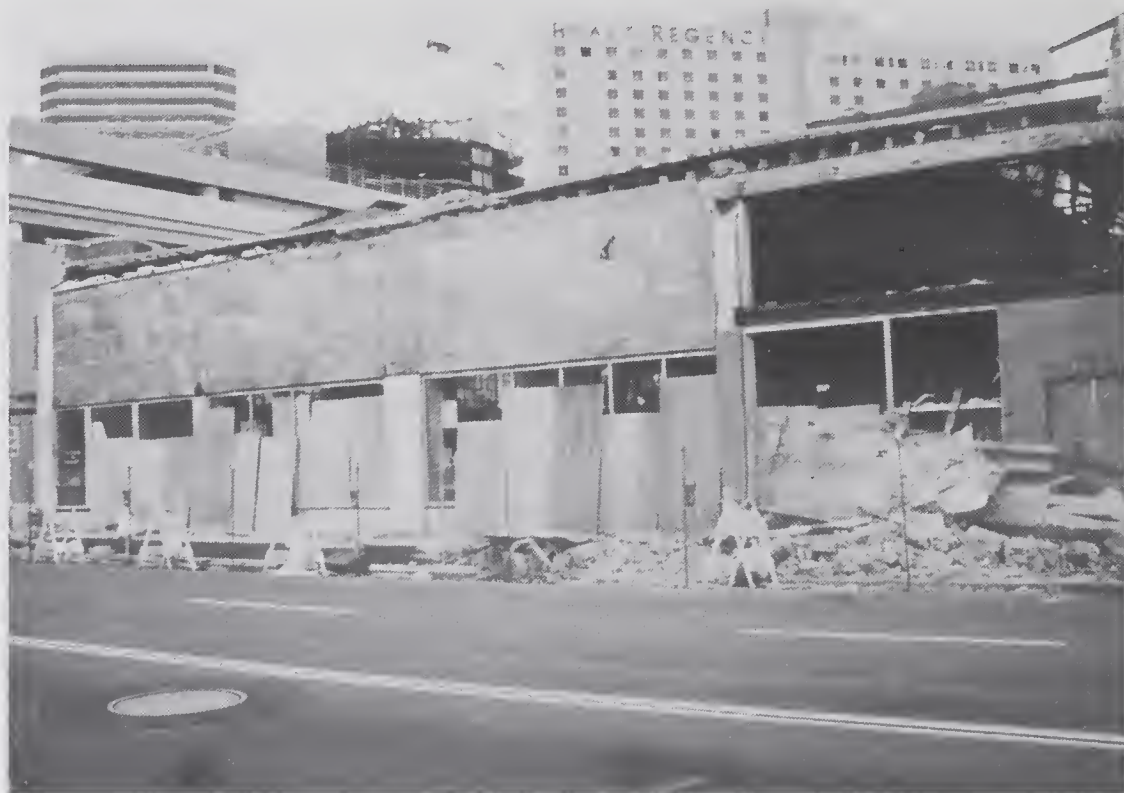
building (location #3) which was apparently built as a produce market in 1917. As is shown in figure 4.3.5, there was failure of the parapet as well as a portion of the infilled wall. The building occupied the entire block, and the eastern portion, which was being renovated, did not appear to have been damaged. Another example of a URM-building failure (location #5) is shown in figure 4.3.6. The collapse of the outer wall crushed three vehicles parked in the adjacent lot. The high-rise steel frame structure, seen in the background of figure 4.3.6, being constructed at 12th Street and Broadway, suffered damage at the top. It was reported⁶ that some steel members and the construction elevator fell to the ground. Fortunately there were only some minor injuries from what could have been a serious accident.

Figure 4.3.5 Extensive damage occurred to a two-story unreinforced masonry building built in 1917 (location #3).

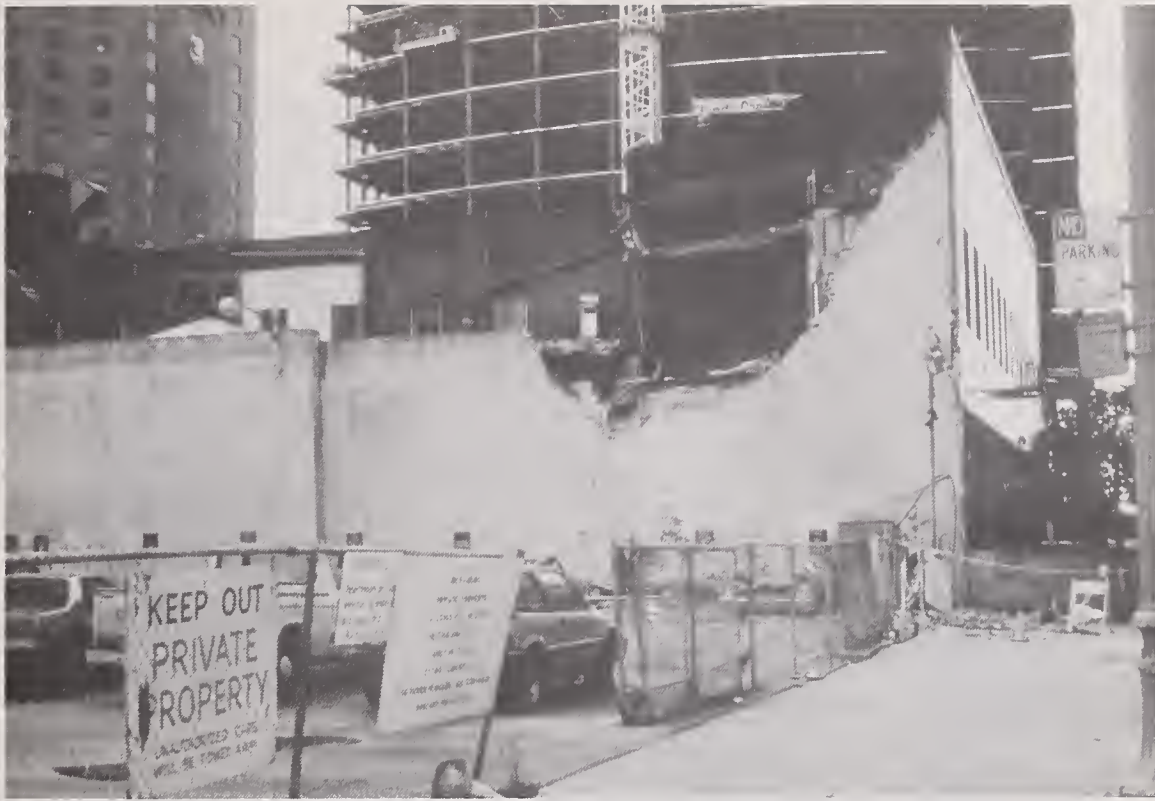
Figure 4.3.6 Collapse of unreinforced masonry wall crushed vehicles in adjacent parking lot (location #5). In background is a steel-framed building under construction which sustained damage.

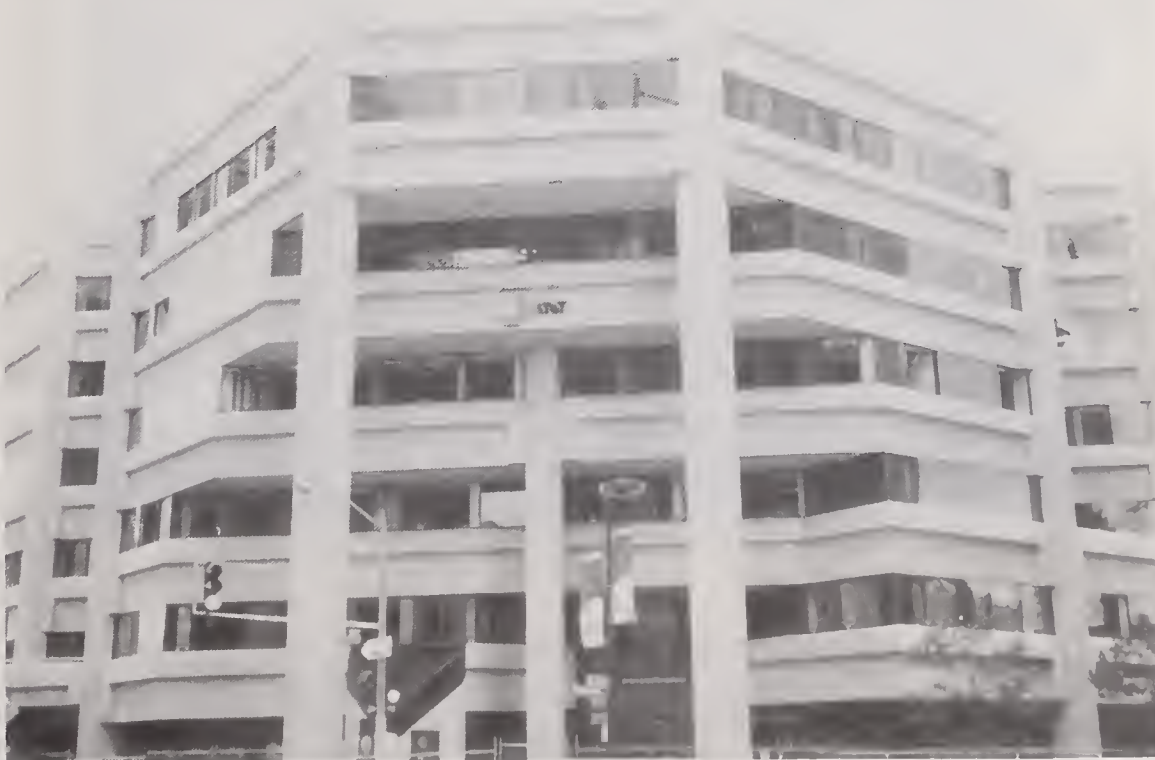
Damage also occurred to some modern buildings. Figure 4.3.7 shows the Trans Pacific Centre at 11th Street and Broadway (location #4). The building had to be evacuated not because of structural damage, but because of ruptured sprinkler lines, broken windows, and fallen ceiling tiles. The 16-story telecommunications building at 20th and Franklin Streets (location #7) suffered damage. The structural system consists of a steel frame with reinforced concrete shear walls. As is shown in figure 4.3.8, extensive damage occurred to the shear walls as well as other concrete structural members.

Figure 4.3.7 Trans Pacific Centre Building which suffered extensive damage due to ruptured water pipes, broken windows, and fallen ceiling tile (location #4).
