NIST Special Publication 778

Performance of Structures During the Loma Prieta Earthquake of October 17, 1989

H. S. Lew, Editor

January 1990

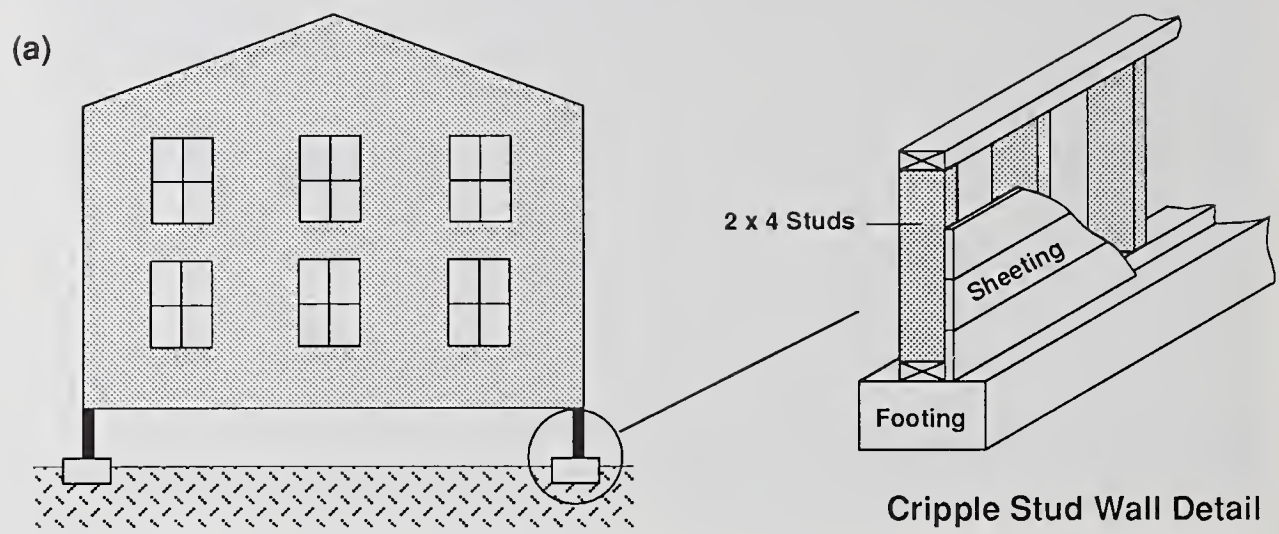
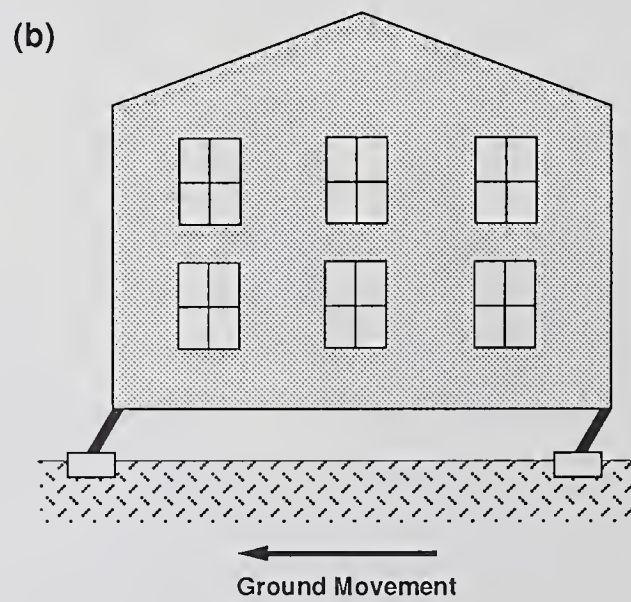
Figure 4.4.3 Schematic of failure caused by inadequately braced cripple stud walls: (a) construction of cripple stud wall and (b) failure mechanism.

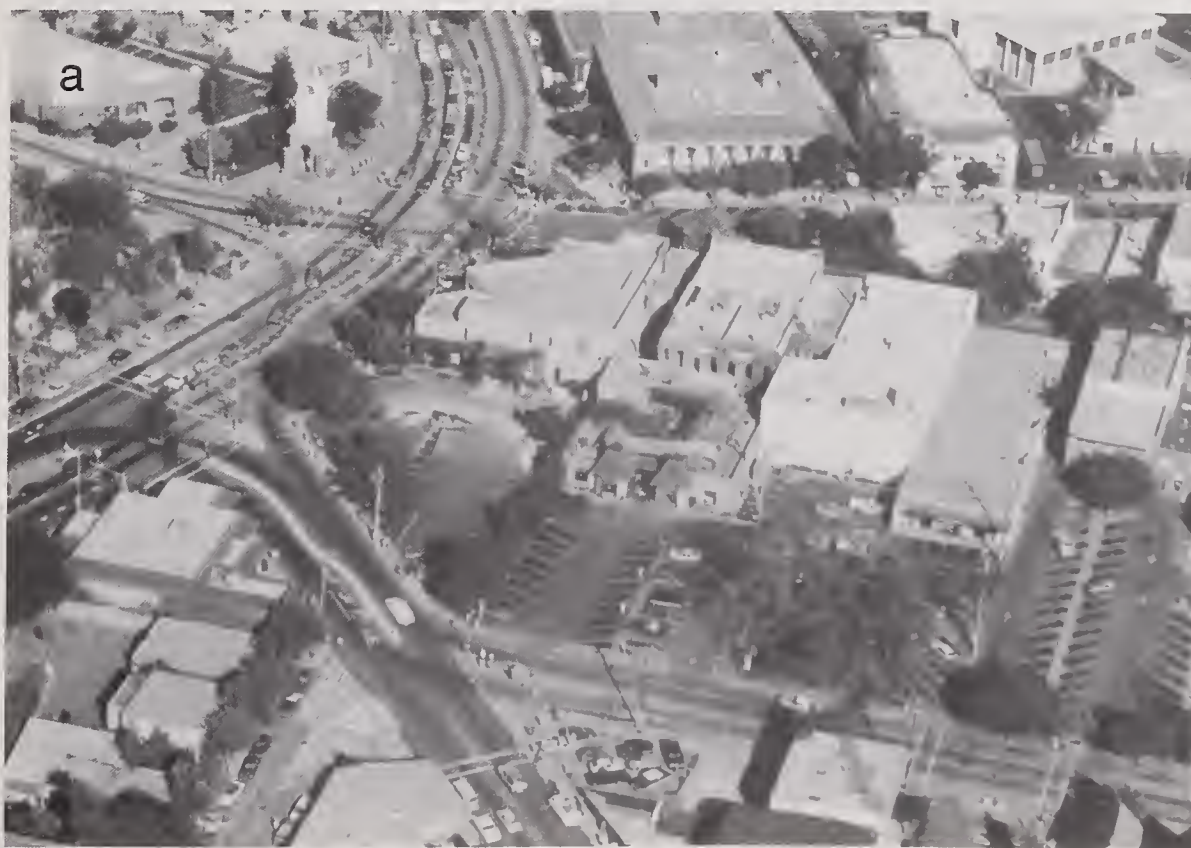
At the center of figure 4.4.8(a) there is a two-story masonry structure at the corner of Pacific Avenue and Water Street (location #1). Figure 4.4.9 shows the appearance of the structure at street level. It was designed about 15 years ago according to the 1973 Uniform Building Code, and it survived without any sign of structural damage. Adjacent to this modern building is an older unreinforced masonry building, which is seen on the left side of figure 4.4.9. Although the facade shows a small amount of damage, the roof of the building collapsed and killed two persons.

Figure 4.4.8 Aerial views of the Pacific Garden Mall: (a) northern portion.

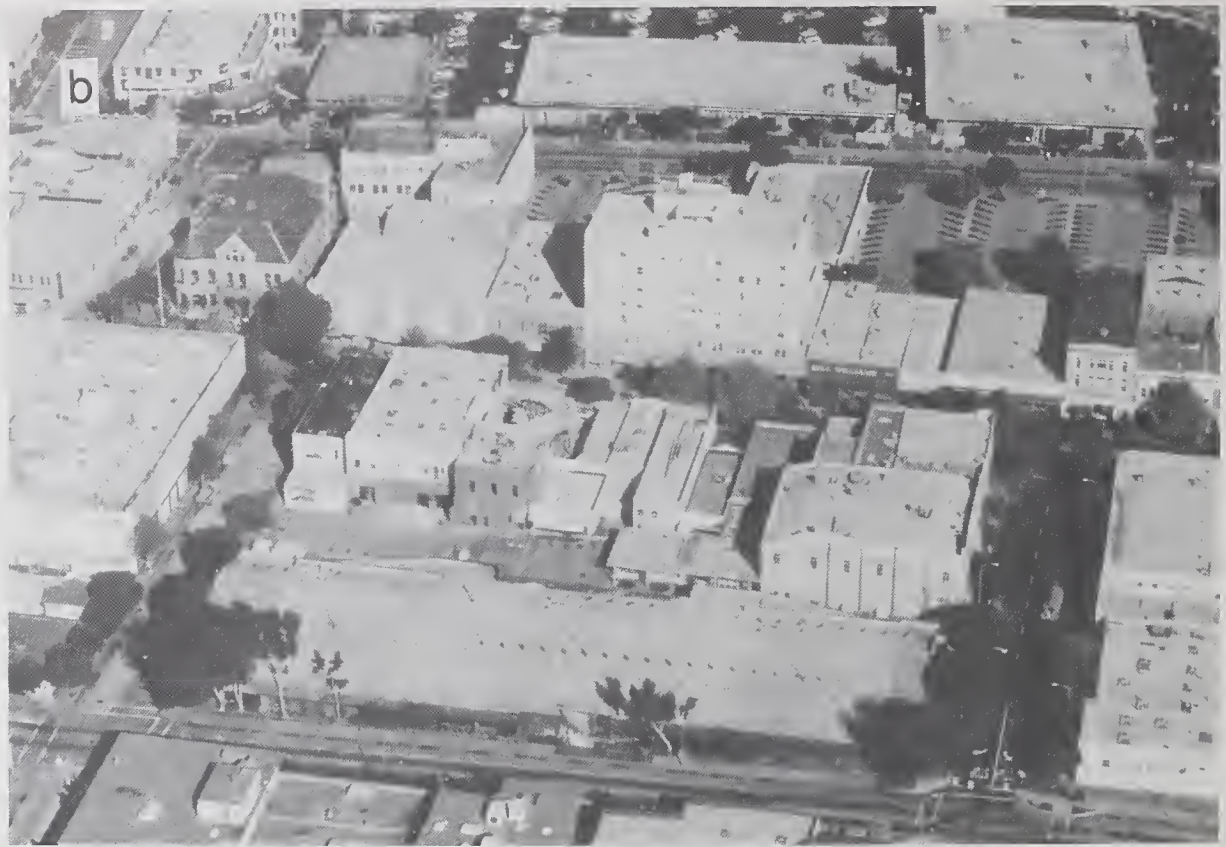
Another roof collapse in the mall caused the death of one person. This failure occurred to the department store on the corner of Pacific Avenue and Cathcart Street, and can be seen in figure 4.4.8(c). The roof failure was caused by the collapse of the top story masonry wall of the adjacent building. This type of damage was observed at several other stores within the mall.

A seven-story building is seen near the center of figure 4.4.8(b) (location #3). This reinforced concrete building, which was reported to have built in the 1920's, was severely damaged. The street level view in

Figure 4.4.8 (Cont'd) Aerial views of the Pacific Garden Mall: (b) central portion, and (c) southern portion.

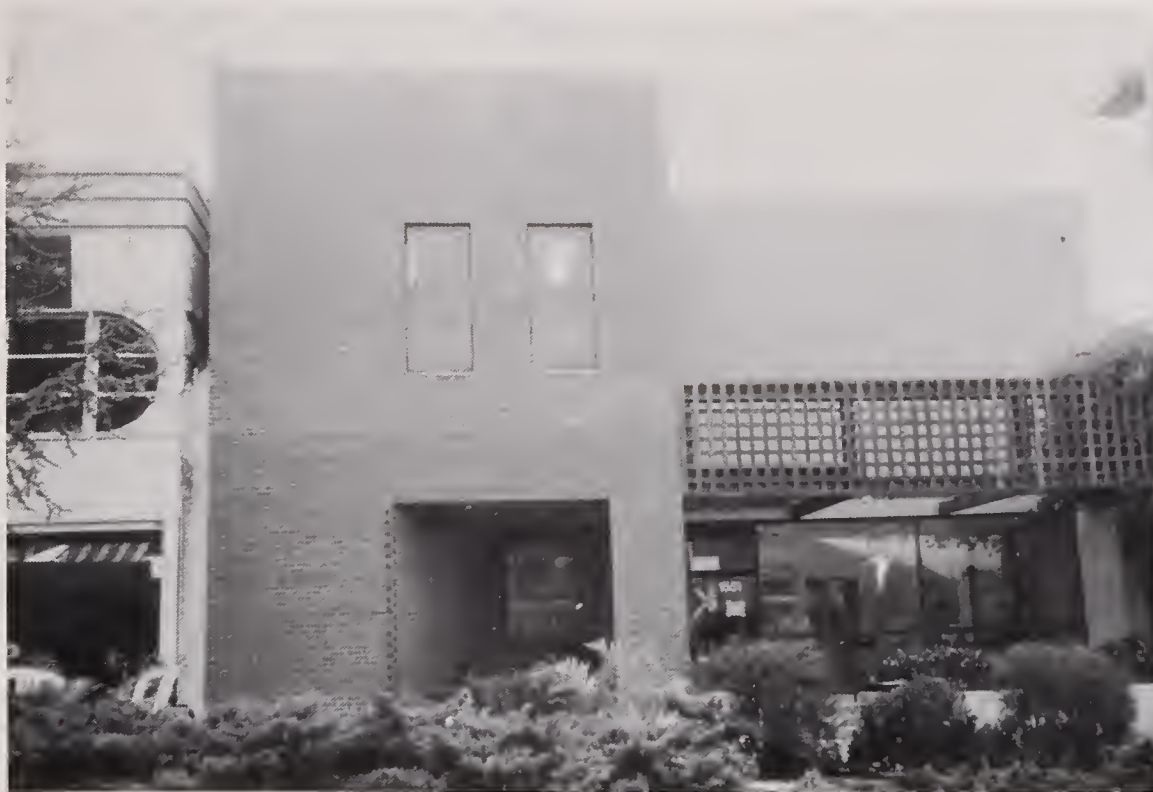
Figure 4.4.9 Modern reinforced masonry structure which was undamaged; building on the left suffered roof failure causing two deaths (location #1).

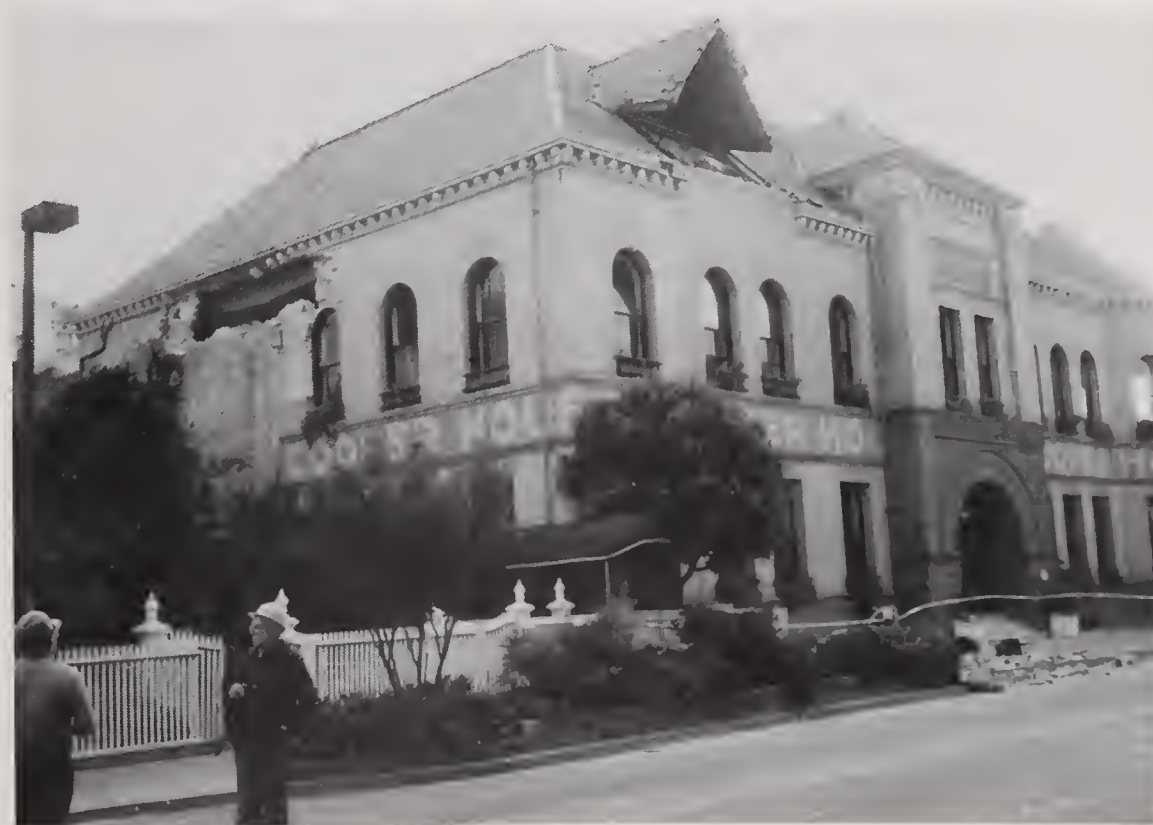
One of the historic structures severely damaged is the Cooper House located on the corner of Pacific Avenue and Cooper Streets (location #2). The unreinforced masonry building was built in the 1880's as the county courthouse. The building was reported to have survived the 1906 San Francisco earthquake⁷, but it was extensively damaged during the Loma Prieta earthquake. As shown in figure 4.4.10, portions of exterior walls collapsed and there were extensive diagonal cracks throughout the exterior walls. The damage was so severe that the building subsequently was demolished.

Figure 4.4.10 Historic Cooper House in Santa Cruz was severely damaged and had to be demolished (location #2).

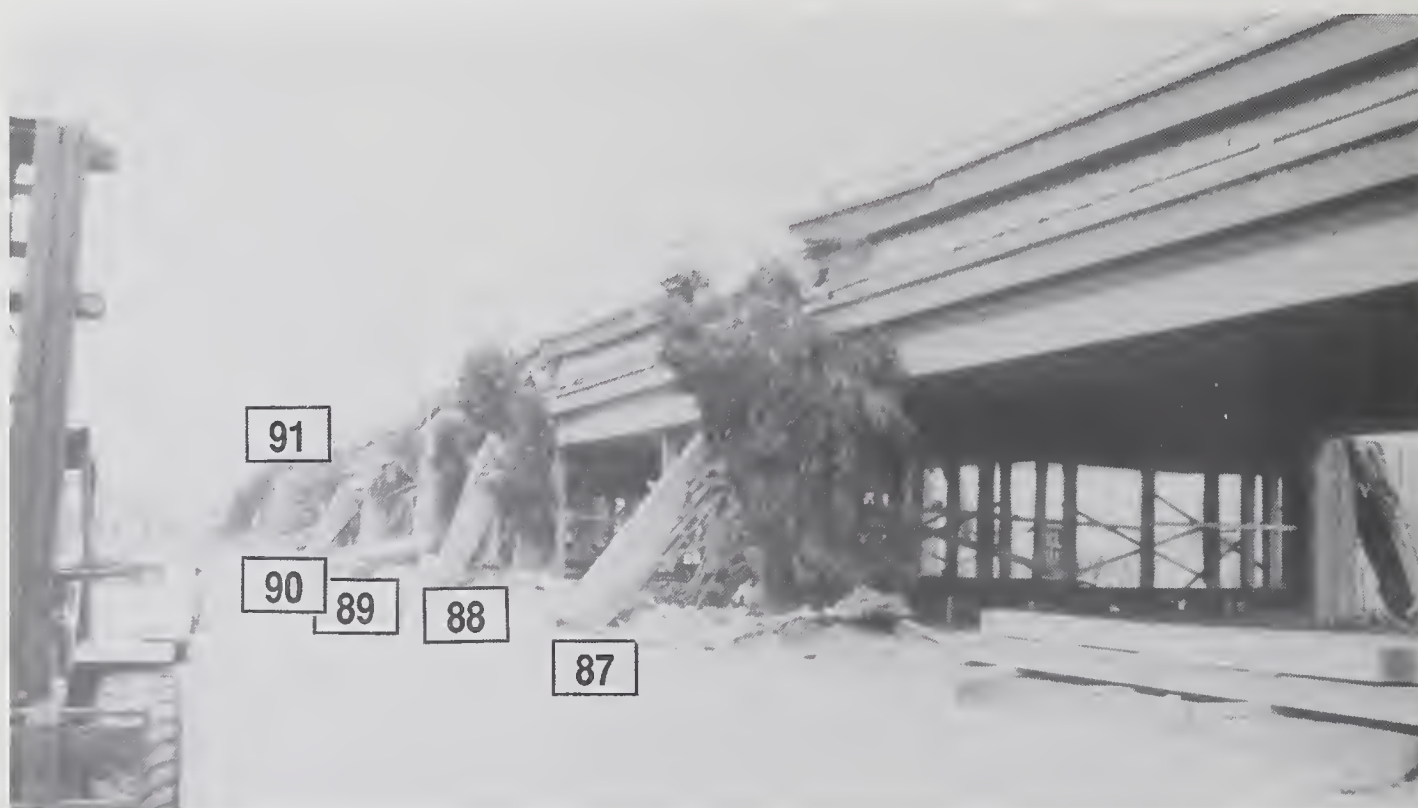
Figure 5.6.23 shows a ground-level view looking northward from Bent 86 on the west side of the expressway. All of the bents visible in this photo were Type 1 which invariably exhibited a symmetrical failure with both upper columns shearing free at their base and being splayed outward as the upper deck fell. The timber posts visible beneath the lower deck were installed by Caltrans under each bent to insure that there was no subsequent settling of the structure during rescue operations. Further evidence that the upper deck fell nearly squarely on the lower deck with no significant sidesway is shown in figure 5.6.24 which is looking northward from atop Bent 80.

Figure 5.6.23 View of the west side of Cypress Structure looking north between Bents 86-92. These were all Type 1 bents which demonstrate the uniformity of the collapse mechanism.

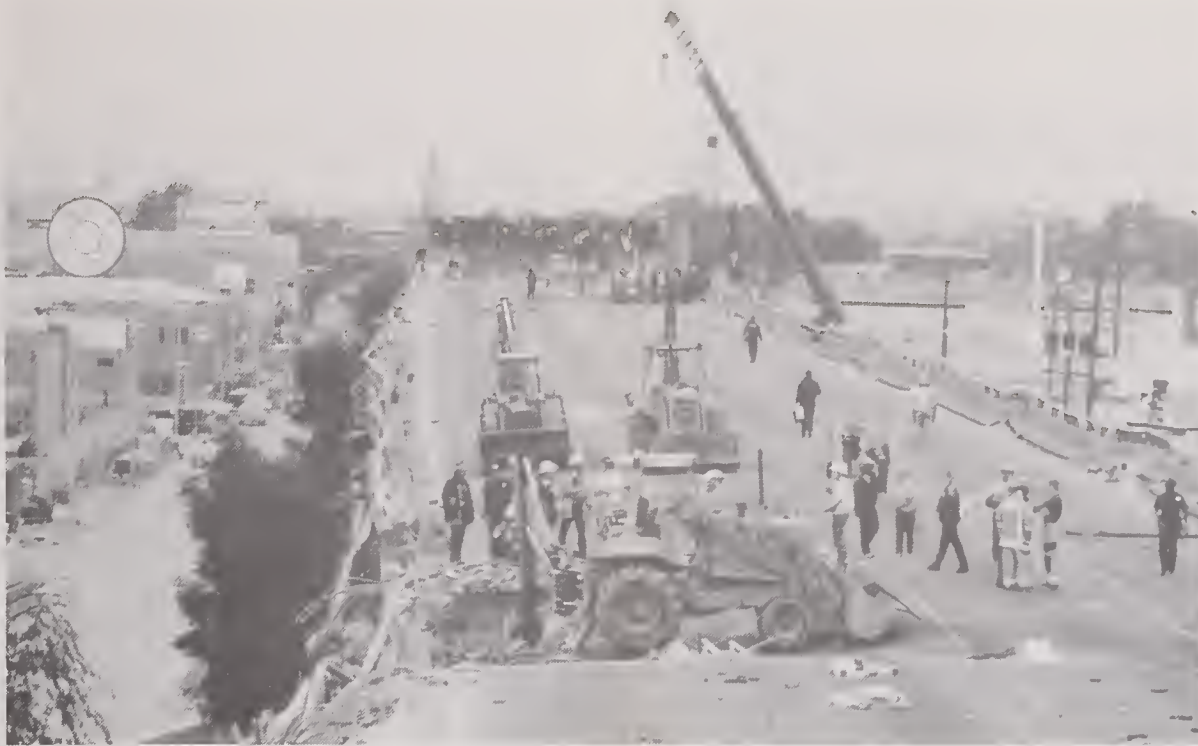
Figure 5.6.24 View of the upper deck of Cypress Structure looking north of Bent 80. This photo illustrates the negligible lateral displacement of the upper deck relative to the lower deck during the collapse.

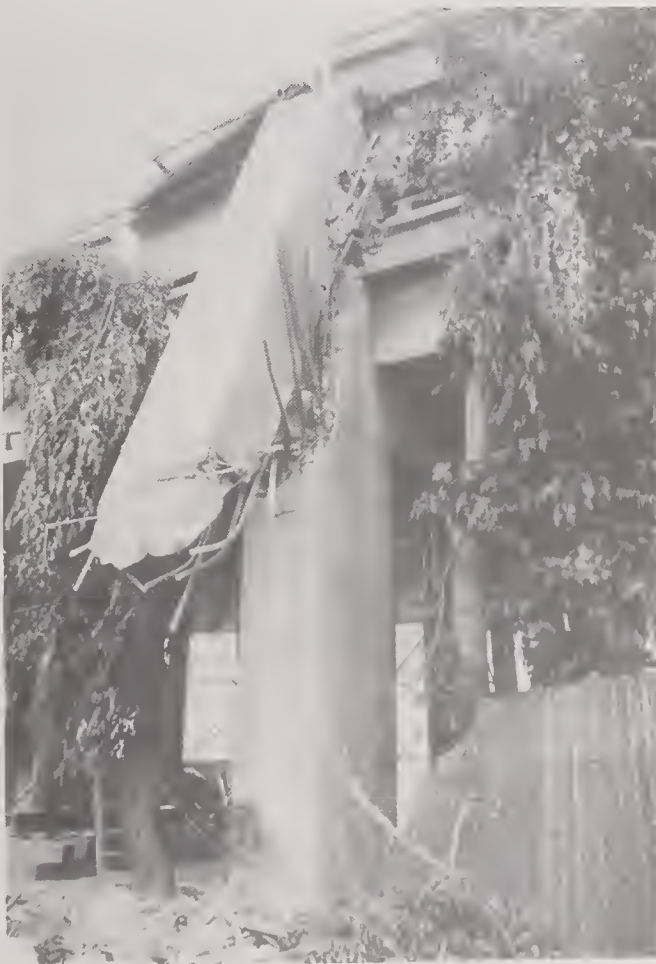
Figure 5.6.25

Figures 5.6.25 through 5.6.28 show four minor variations of Type 1 bent failure. All views are from the west side of the respective bents. At Bent 65 (fig. 5.6.25), it can be seen that the upper column support pedestal is still attached to the base of the column and that an inclined failure plane exists through the failed pedestal. Note that confining reinforcement in the vicinity of the lower girder/column joint is non-existent. As for most Type 1 bent failures, the upper columns remained tenuously attached to the upper bent girder. Bent 85 (fig. 5.6.26) shows a similar situation regarding the upper column support pedestal (beneath the numbers "85" in the figure). Here it is evident that the failure plane for the pedestal ran flush with the curved face formed by the lower bent girder negative moment steel. It is also evident that the seismic loads, in combination with a lack of confining steel in the upper beam/column joint, were sufficient to induce an explosive rupture of concrete at the top of the column, breaking it free from the upper girder steel seen at the top center of the photo. It should be emphasized, and it will become clear in subsequent discussion, that such compressive failures did not initiate the collapse of the bent, despite the lack of lateral confining steel in the upper girder/column joint. At Bent 90, the upper column apparently sheared through the 4-#10 dowel bars at the center of the shear key and was propelled outward

A view of the west side of Bent 65 of Cypress Structure illustrating the predominant failure mode for a Type 1 bent. The upper frame columns sheared through the support pedestal which connected them to the lower frame. In most cases the upper columns remained connected to the upper deck as shown.

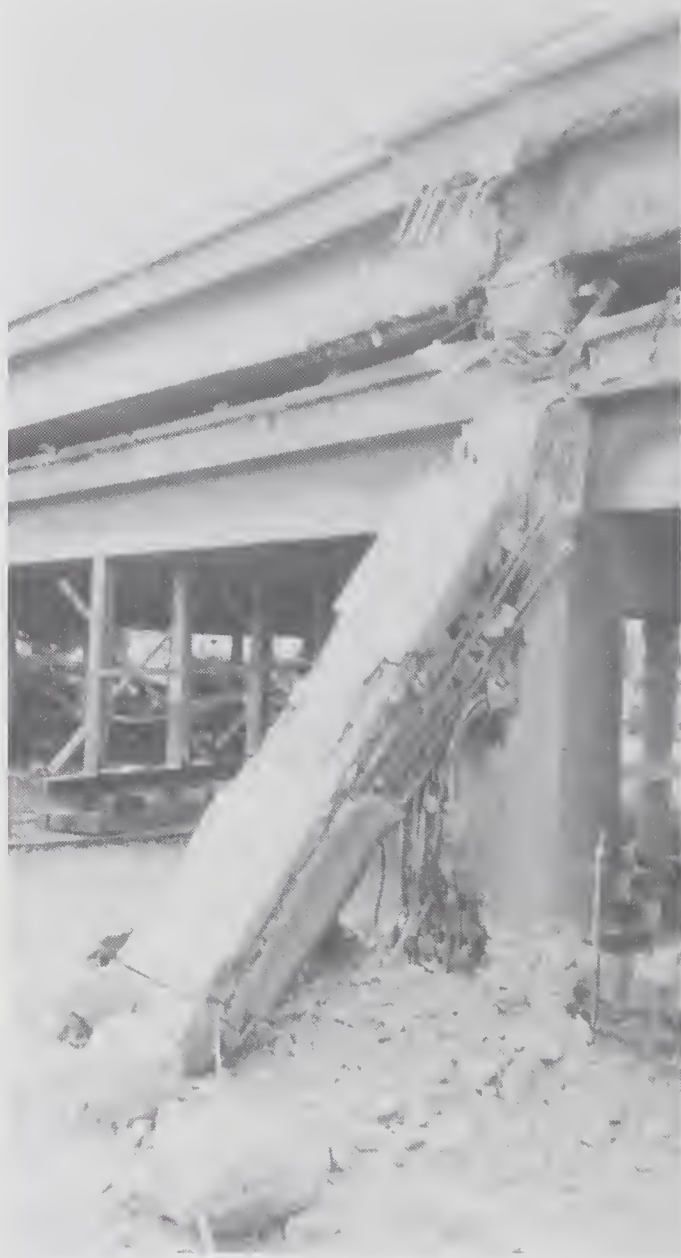
Figure 5.6.26

Failure of the west side of Bent 85. In this particular case a portion of the sheared support pedestal is still attached to the base of the upper column. The top of the column failed explosively and separated from the upper frame girder.

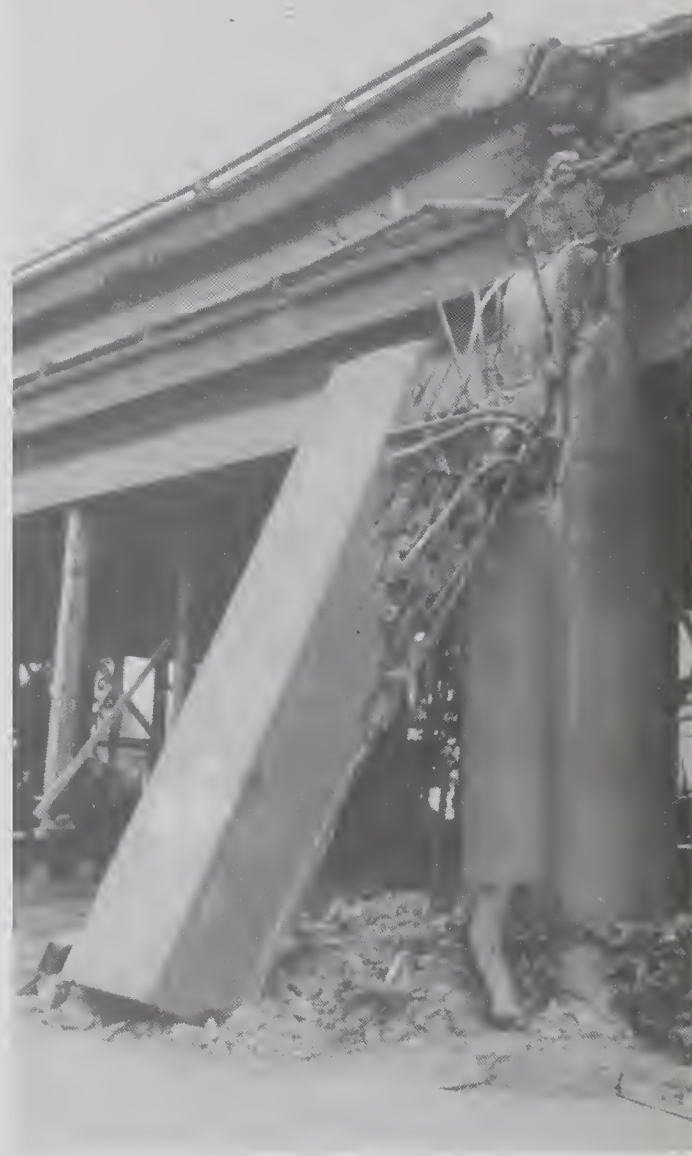
Figure 5.6.27

Failure of the west side of Bent 90. In this case the supporting pedestal for the upper columns was completely disintegrated; only the interior face of axial reinforcement that was present in the pedestal remains imbedded in the lower column. It can be seen that the failure plane followed the face of the curved negative moment steel from the lower frame girder.

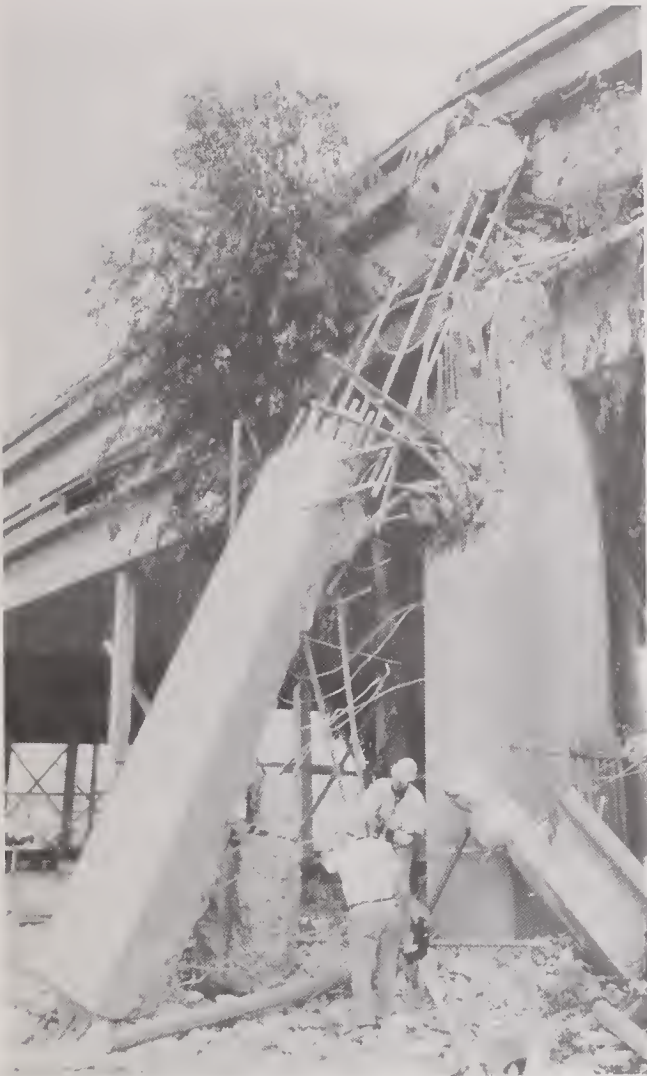
Figure 5.6.28 shows a final variation of a Type 1 bent failure. This particular column, at Bent 94, carried a pipe through its center which drained the upper deck. Given a lack of significant confining reinforcement (note the thin #4 ties which appear as wires compared with the massive #18 axial reinforcement), the presence of this pipe likely served to create the fracture path which split the column.

Failure of the west side of Bent 94. The presence of a central pipe, used to drain the upper deck, permitted a fracture plane to develop through the center of the column. The eastern half of the column disintegrated under compressive load while the western half spalled off.

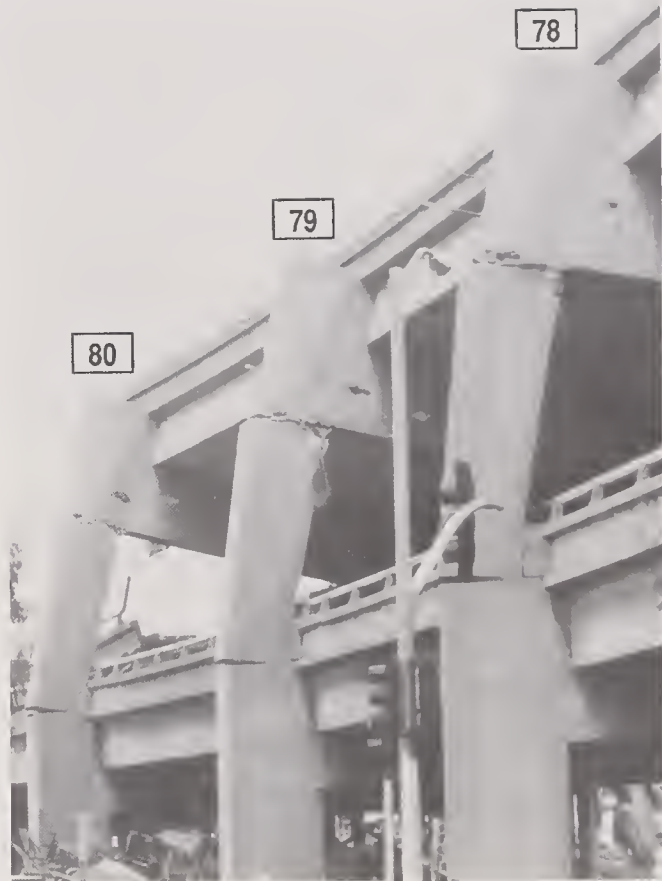
Figure 5.6.29 shows a closeup of a Type 2 bent failure in which the eastern half of a series of three-hinged prestressed bents collapsed, due to shearing failure at the base of the east column, leading to a rigid body rotation of the upper deck about the western, two-hinged columns. As can be seen, the western column shear keys did perform as hinges even under rotations sufficient to cause compressive spalling on the interior face of the columns (fig. 5.6.30). Most of the upper bent girders fractured due to impact-induced bending stresses. This in turn yielded, and subsequently fractured most of the post-tensioning bars which, because they were unbonded, were partially expelled from the girder due to rebound from the release of stored elastic energy, as shown in figure 5.6.31. It is of some significance that Bent 78, the innermost frame in figure 5.6.32, was skewed at an angle of 16 degrees. This difference, although subtle, may be part of the explanation for why this particular section did not fail completely. This performance is to be directly contrasted with Bent 72 (see figs. 5.6.33 and 5.6.34) in which the western two-hinged columns were ejected from the structure. Of particular note in figure 5.6.33 are the bent #10 bars projecting both from the top of the lower bent column as well as the bottom face of the upper bent girder. These represented the only continuous reinforcement through the upper and lower shear keys. Figure 5.6.35 leaves no doubt that lateral confining steel was insufficient to prevent localized fracture of the concrete and the subsequent pullout of these dowels. A closeup of the top of the Bent 71 upper two-hinge column in figure 5.6.35 shows a detail of the still intact shear key, 4-#10 dowel bars, and, in this particular instance, a central drainage pipe. In this case the dowel bars remained intact within the column and pulled out, instead, from the upper girder joint.

A view looking north at the west side of Bents 78-80. These were all Type 2 bents which included prestressing of the upper girders. This particular mode of failure, in which only the east columns of the upper frames failed, is noted as a Type A Failure in subsequent discussions. Type A Failures occurred in Bents 74 through 80 (see figs. 5.6.18 and 5.6.19).

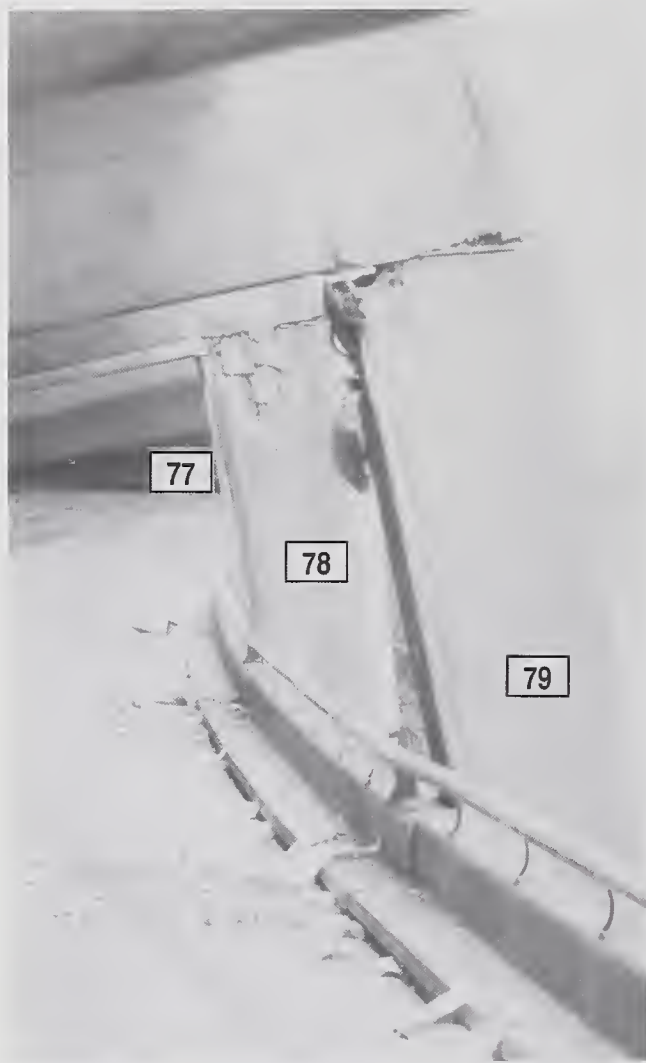
Figure 5.6.30

A close-up view looking south from Bent 80 at the west side of the upper portion of Cypress Structure. Note compression spalling along the interior face of the tops of the columns.

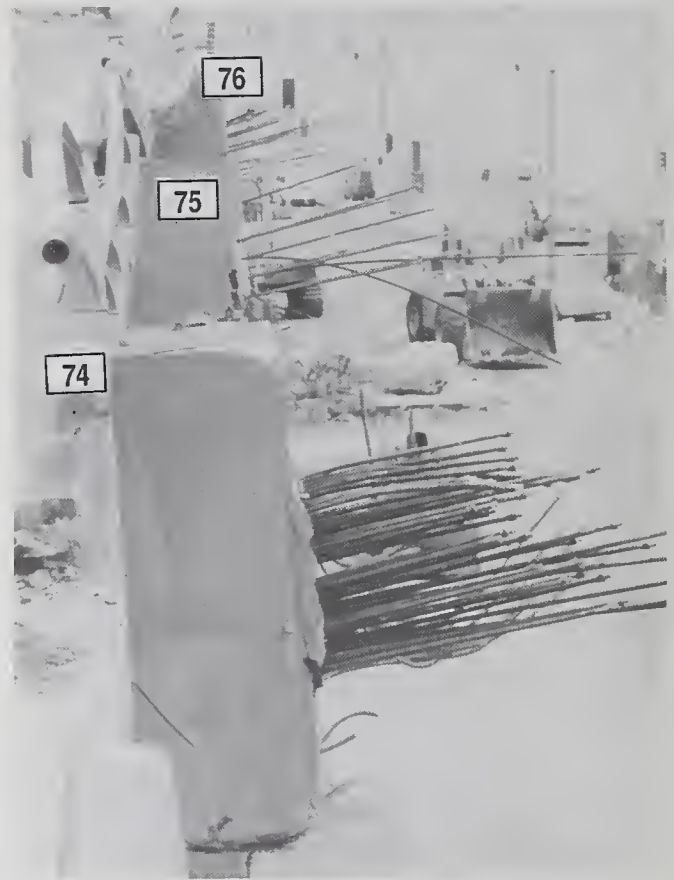
Figure 5.6.31

Due to excessive flexural displacements in the upper frame girder, most of the post-tensioning tendons yielded and then fractured. The tendons were unbonded, to permit extension of the top girder at a later date as part of a planned access ramp. The stored elastic energy drove the tendons from their ducts, as shown here at Bents 74, 75, and 76 on the east side of Cypress Structure.

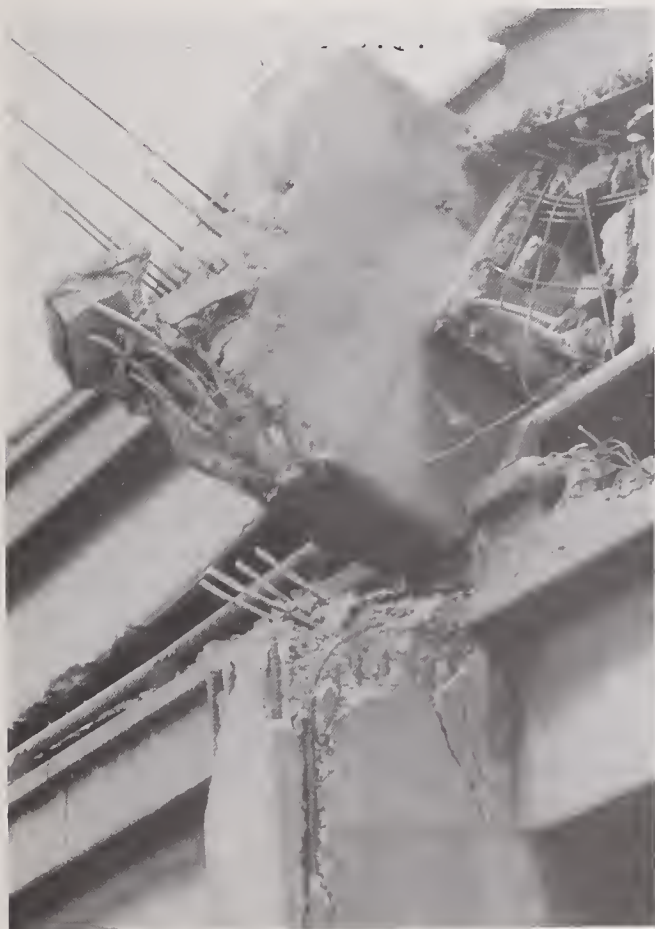
Figure 5.6.33

A close-up of the west side of Bent 72 shows the second, or Type B, variation of failure observed for Type 2 bents. In this case the entire double-hinged upper frame column segment has been ejected from the structure. The 4-#10 bars which passed through the upper and lower shear keys may be seen projecting from the base of the upper girder and the top of the lower column.

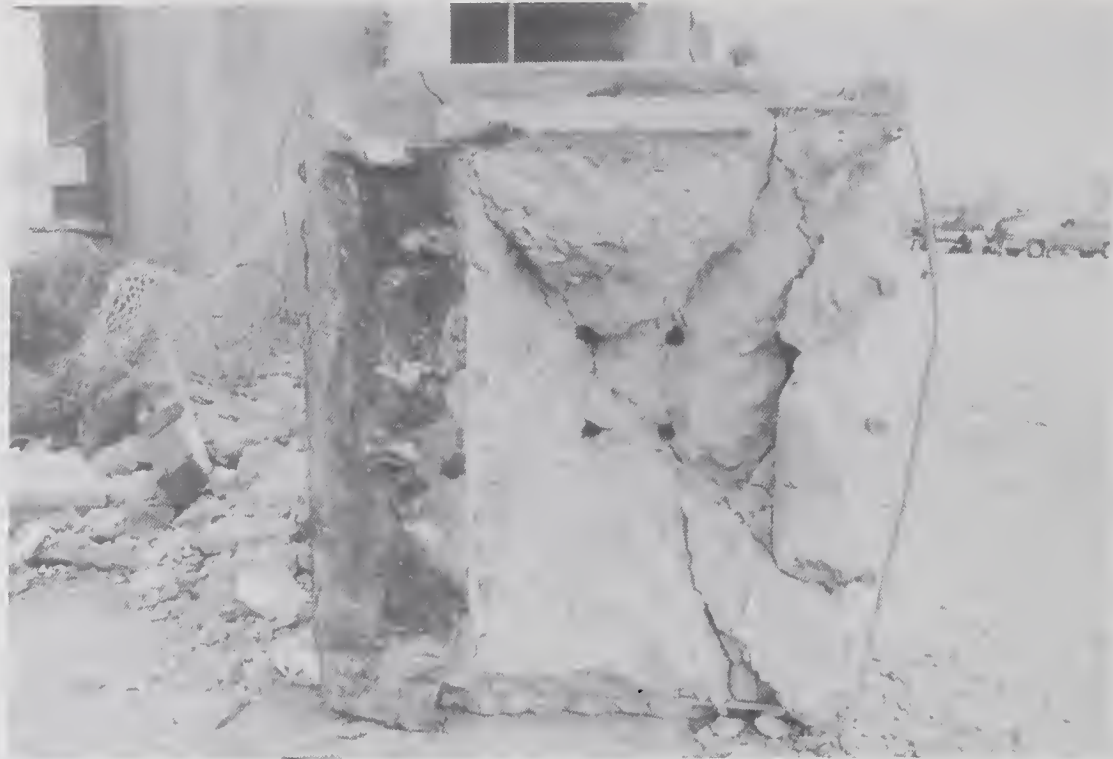
Figure 5.6.34 Detail of the base of the two-hinged column that was ejected from the west side of Bent 72. The 4-#10 dowel bars which passed through the center of the shear key have been pulled free.

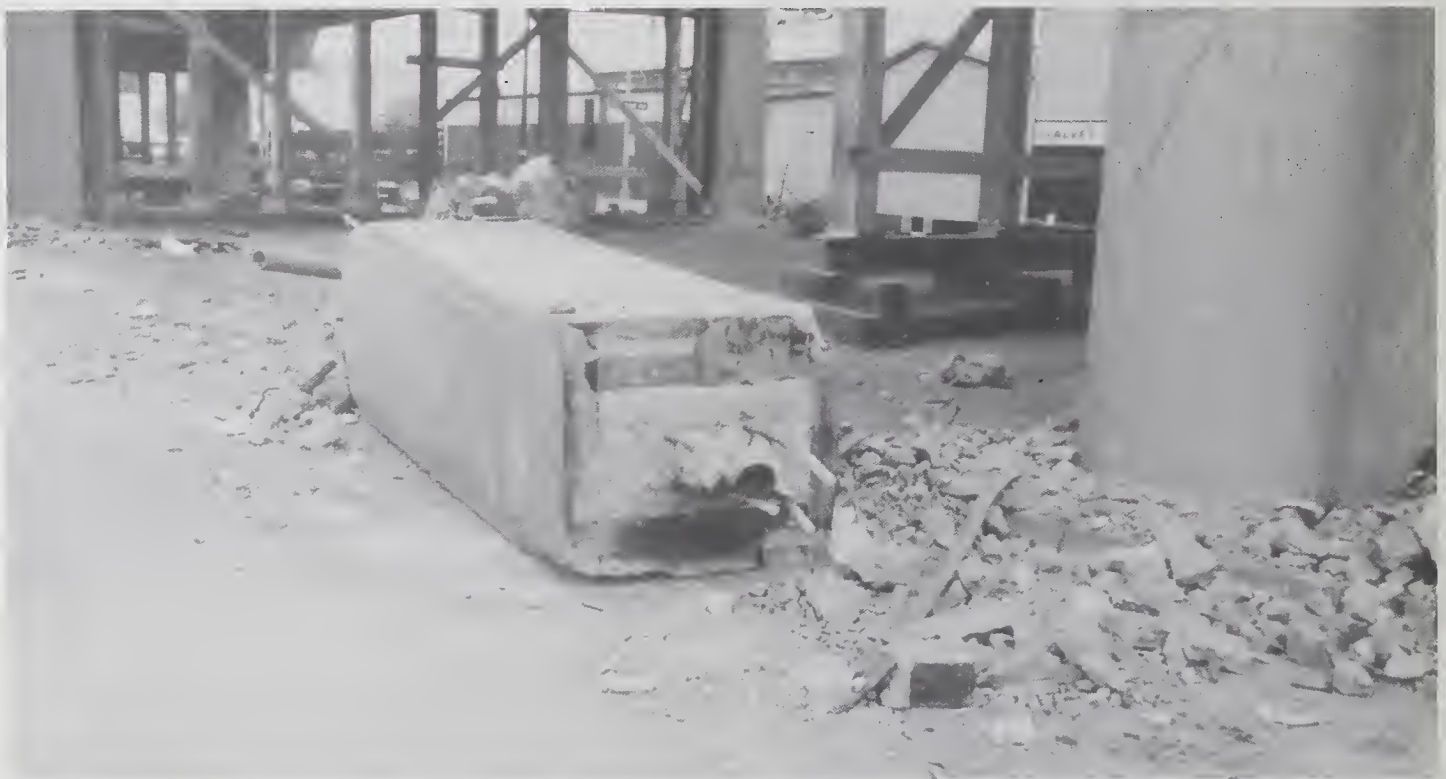
Figure 5.6.35 Detail of the bottom of the two-hinged column that was ejected from the west side of Bent 71 showing central pipe used to drain the upper road deck and the 4-#10 dowel bars used to transfer shear across the hinge.

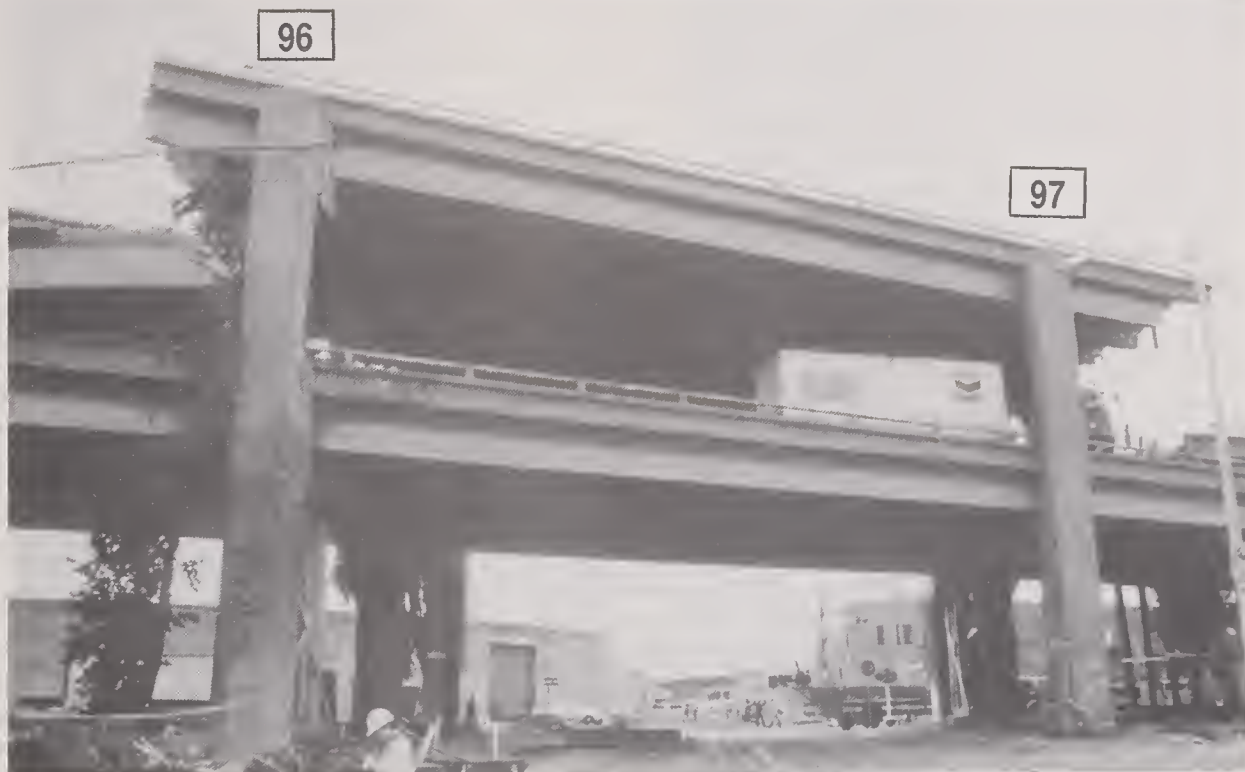
Figures 5.6.36 and 5.6.37 show details of the span between Bents 96 and 97, the only one to remain completely intact between Bents 62 and 113. There are several obvious differences which could account for this. The Type 4 bent, which includes Bents 95-98, contains an additional central column in the lower bent which would serve to limit lateral sway at the first deck level. More importantly, the reinforcing steel at the base of the upper bent columns is continuous with the lower columns, eliminating the pedestal/hinge detail that appears to have contributed to widespread failure in Type 1 bents. Figure 5.6.37 indicates that, despite severe flexurally induced cracking at the lower column/girder joint, the upper and lower

Figure 5.6.36 View looking west towards Bents 96 and 97 which supported the only segment of the upper deck to remain standing between Bents 62 and 113.

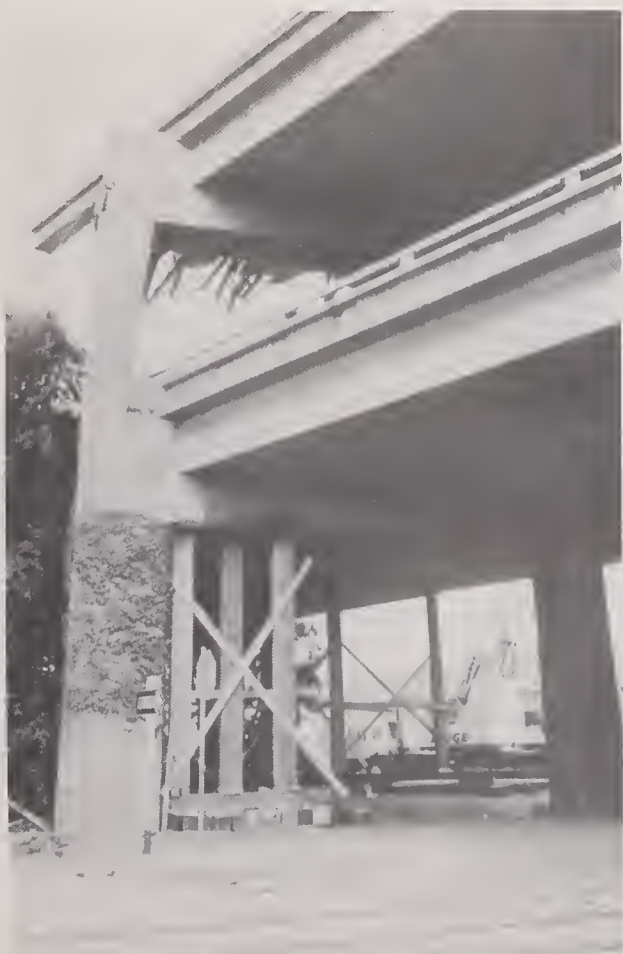
Figure 5.6.37

It is interesting to note that the calculated column shear resistance reported by Priestley et al. (Priestley, 1989) for Type 4 bents (see fig. 5.6.5), when modified to account for the measured compressive strength of the concrete, comes to 398 kips (1770 kN). Accounting for portal frame reaction shear at the column bases for the upper bent, the lateral base acceleration required to achieve failure is 0.38g, i.e., greater than the expected acceleration from the response spectra reported by CDMG (CDMG, 1989b). These frames, as can be seen in figure 5.6.37, suffered significant damage, but remained standing.

Detail of the west side of Bent 97 showing extensive shear cracking at the interior beam/column joint for the lower frame and compression spalling at the upper beam/column joint. Axial reinforcement for the upper frame columns was continuous with the lower frame columns on both east and west sides. This, and the larger cross section, helps to explain why these Type 4 bents did not collapse.

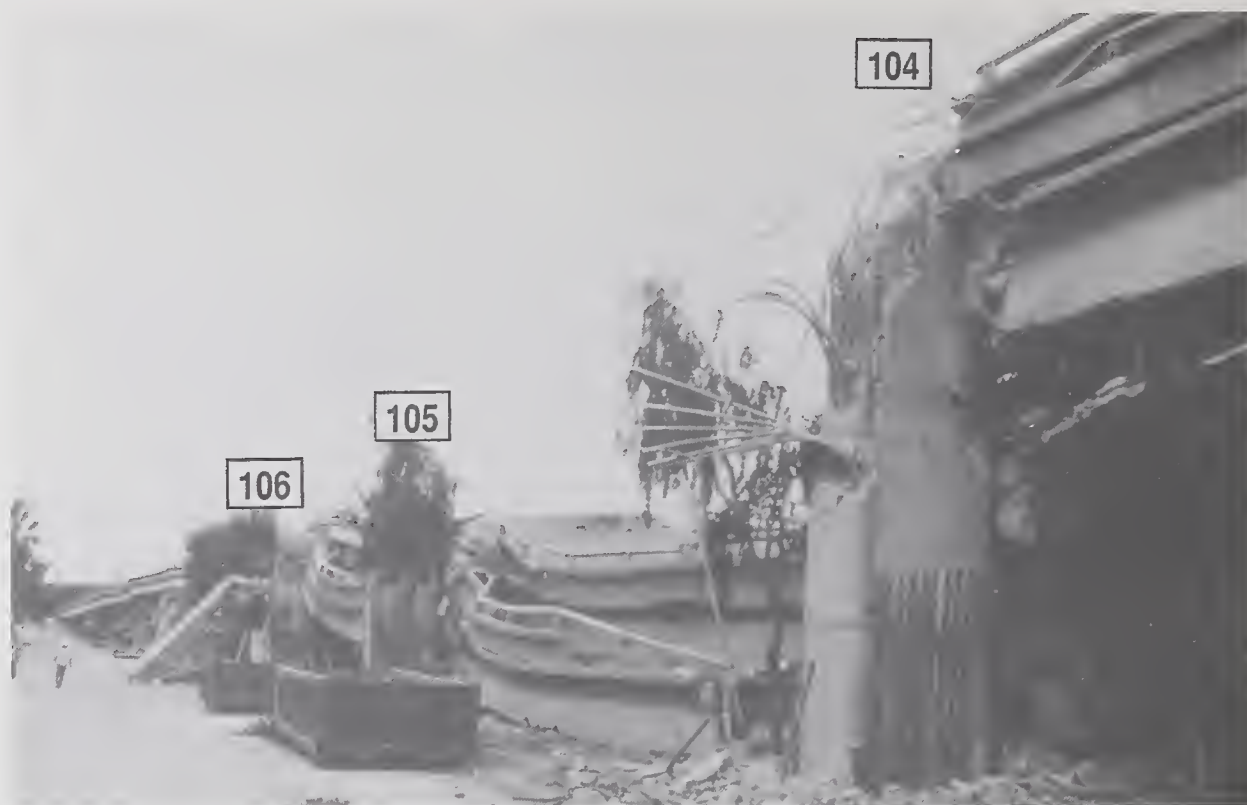
The section of expressway between Bents 104 and 106 (fig. 5.6.38) contains the only portion of the Cypress Structure to have exhibited complete failure in both upper and lower decks. These were Type 1 bents in an area where the lower road deck was beginning its descent to the northern distribution structure. Beyond Bent 106 both upper and lower decks were superelevated on the east side. Other than these minor differences, there were no particularly distinguishing characteristics which would have made these bents more susceptible to failure. It has been suggested (EERI, 1989) that greater accelerations may have been experienced towards the northern end of the structure due to the presence of Bay Mud deposits, which are deepest towards the northern end of the collapsed section and would have led to soil amplification. This argument is unconvincing in light of geotechnical data subsequently made available (CDMG, 1989b). The remaining possibilities include construction defects and/or resonance of the entire Cypress Structure which could have led to higher forces in this particular area, as a result of random coincidence of modes, than would be expected using the simple Newtonian lateral force approach discussed below. In any event, there was vastly different performance of the lower bent columns to the north of Bent 104, as exhibited, for example, at Bents 105 and 108 shown in figures 5.6.39 and 5.6.40. Bent 108, in particular, exhibited the only gross shear failure of a lower column seen in the entire Cypress Structure.

Figure 5.6.38 The section of Cypress Structure between Bents 104 and 106 was the only location in which both upper and lower bent frames failed.

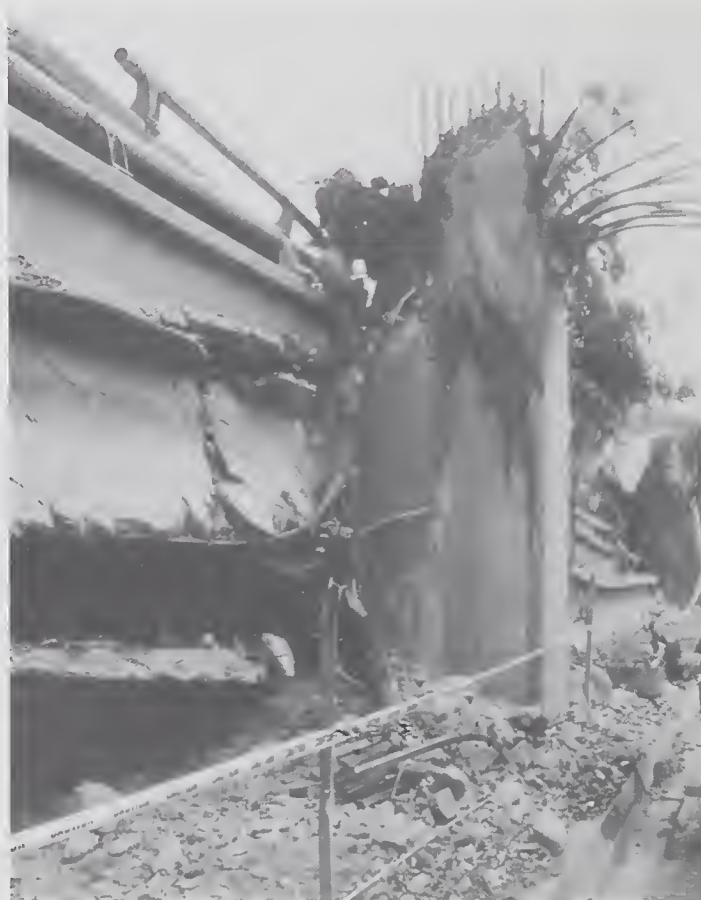
Figure 5.6.39

Close-up of the west side of Bent 105 looking south, illustrating complete shear failure of the lower bent beam/column connection.

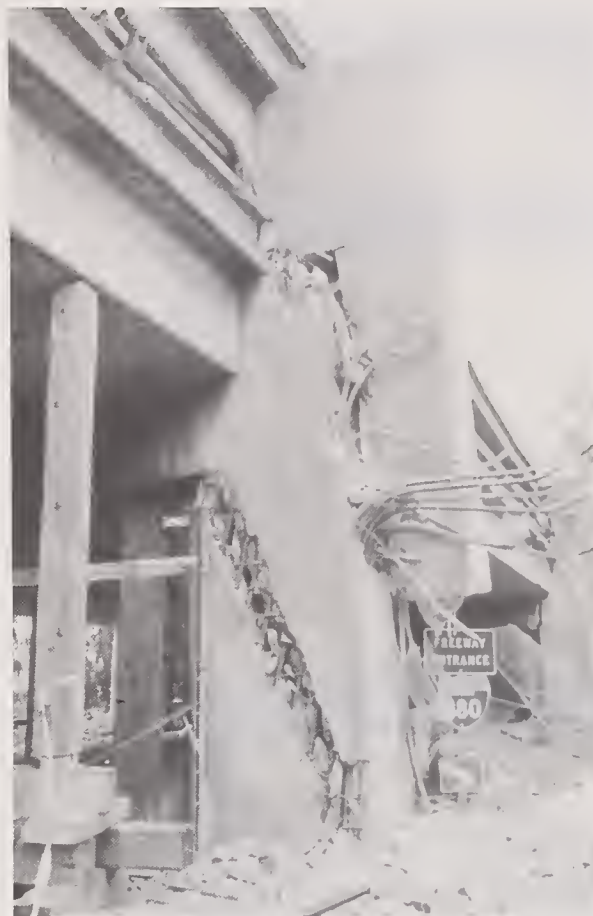
Figure 5.6.40

Close-up view of the east side of Bent 108 looking north. This was the last Type 1 bent prior to the northern limit of the collapse at Bent 113. In addition to the common failure of the pedestal supporting the upper frame column, the column of the lower frame sustained a total shear failure.

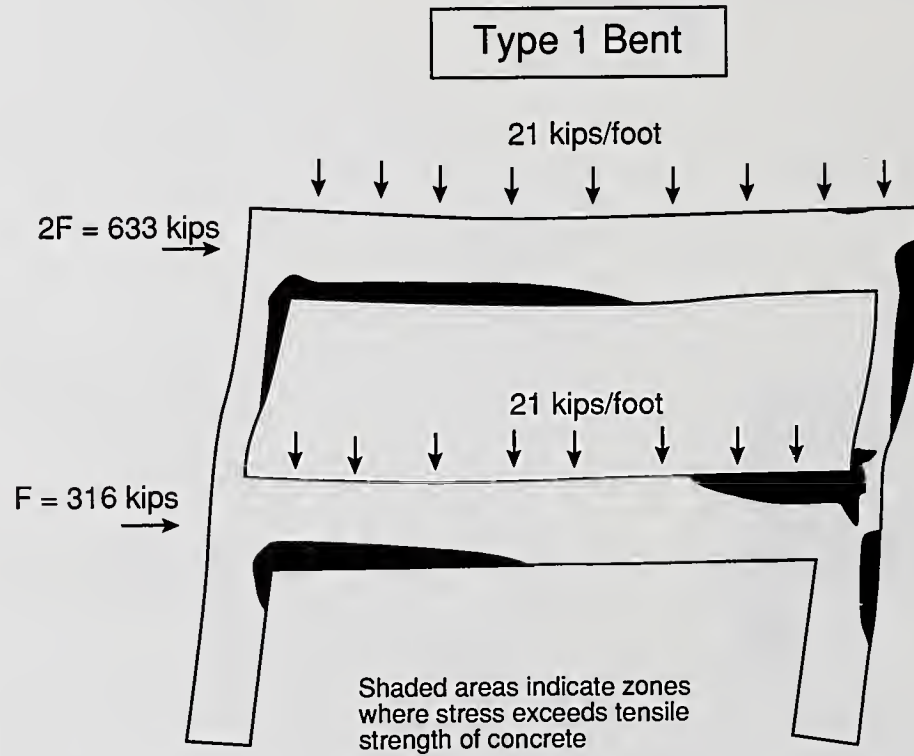
Figure 5.6.44(b) Displaced shape of Type 1 bent under applied loads showing zones of principal tensile stress sufficient to induce cracking.
