NIST Special Publication 778

Performance of Structures During the Loma Prieta Earthquake of October 17, 1989

H. S. Lew, Editor

January 1990

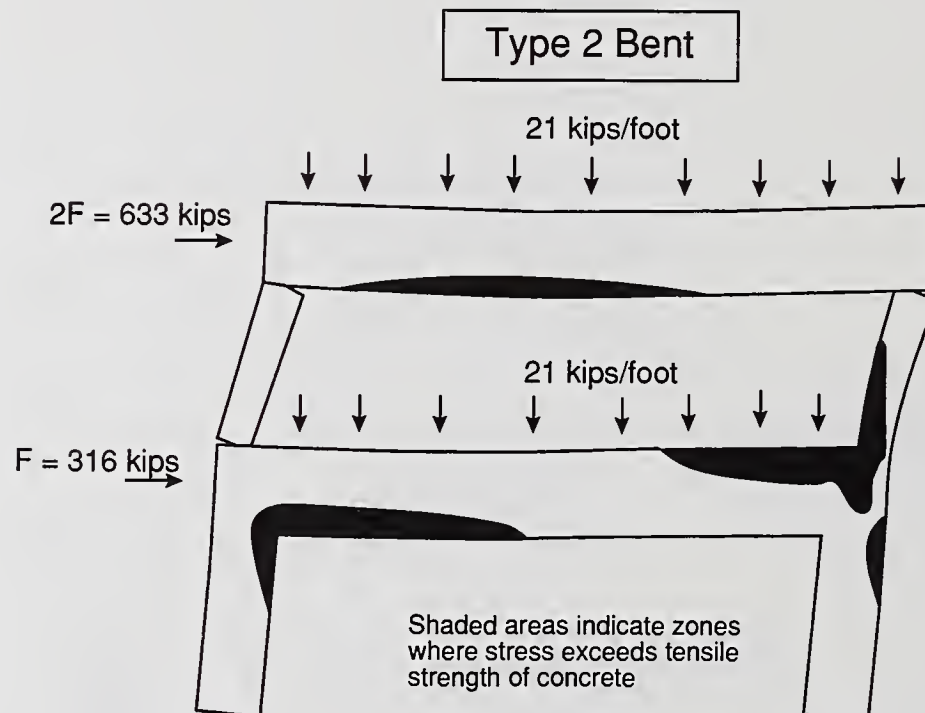
Figure 5.6.45(b) Displaced shape of Type 2 bent under applied loads showing zones of principal tensile stress sufficient to induce cracking.

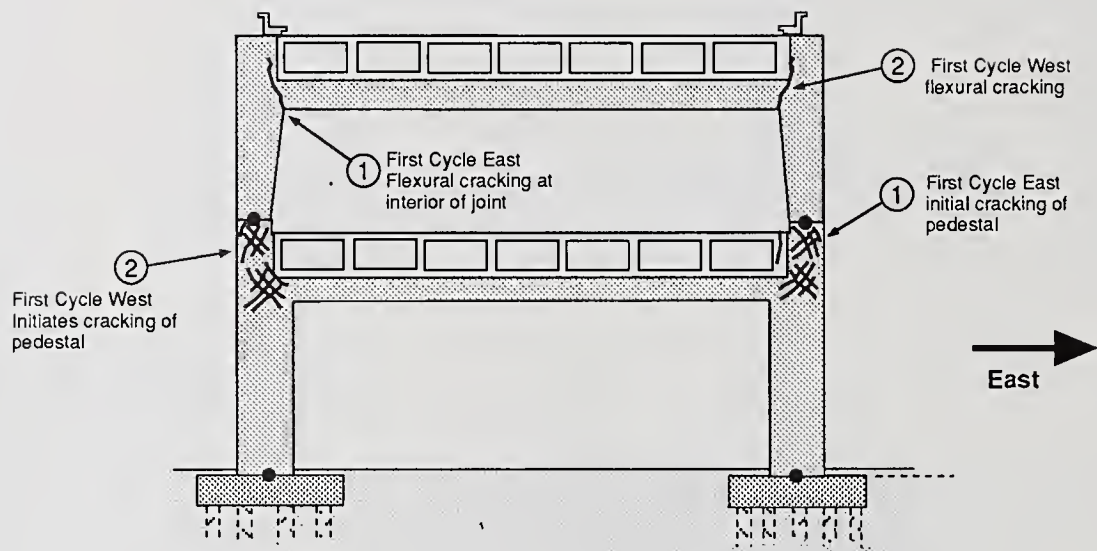
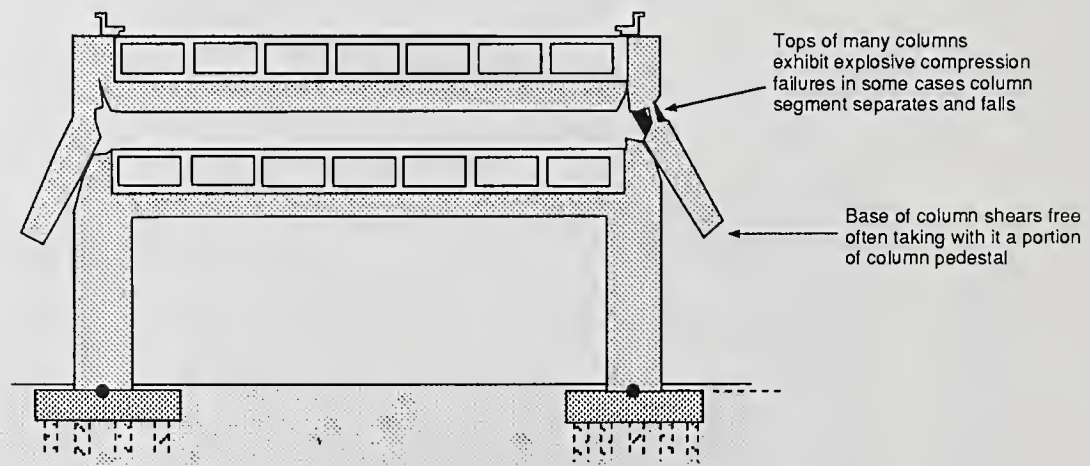
Figure 5.6.47 Top: Anticipated crack initiation sequence for Type 1 bents under lateral loading. Bottom: Observed failure mode for Type 1 bents at Cypress Structure.

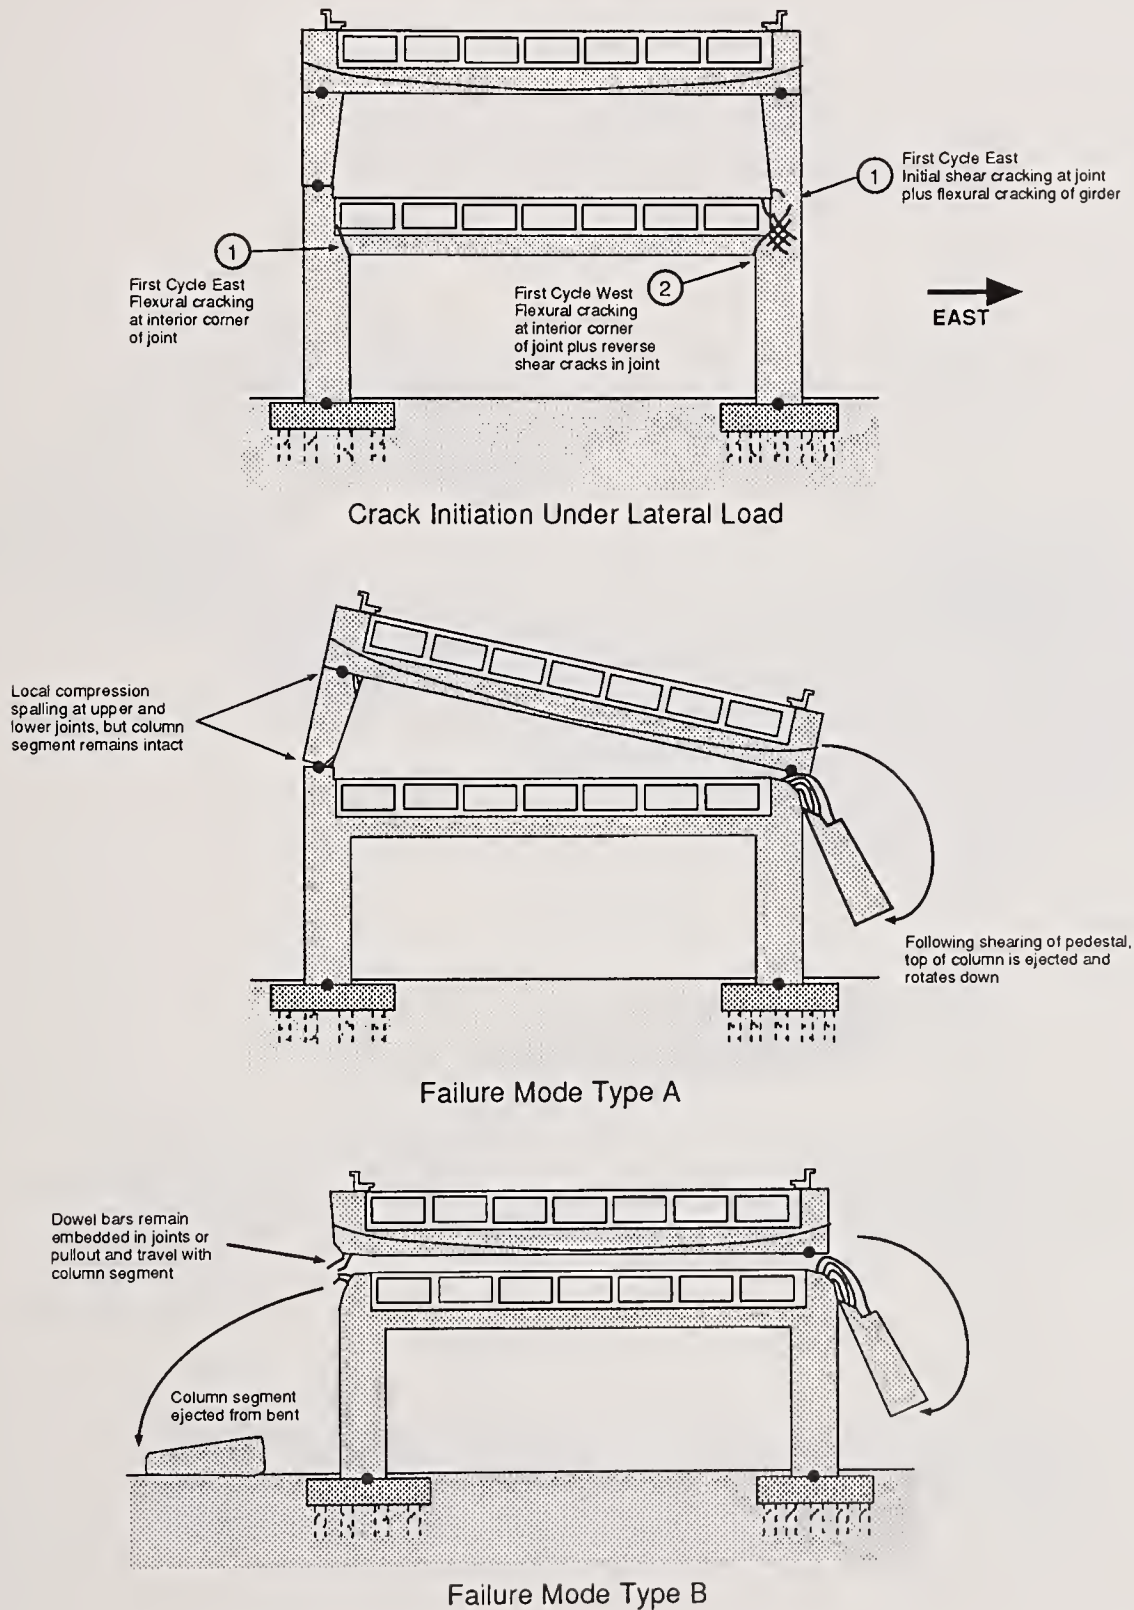
Figure 5.6.48 Top: Anticipated crack initiation sequence for Type 2 bents under lateral loading.
 Middle: Observed failure mode "A" for Type 2 bents at Cypress Structure.
 Bottom: Observed failure mode "B" for Type 2 bents at Cypress Structure.

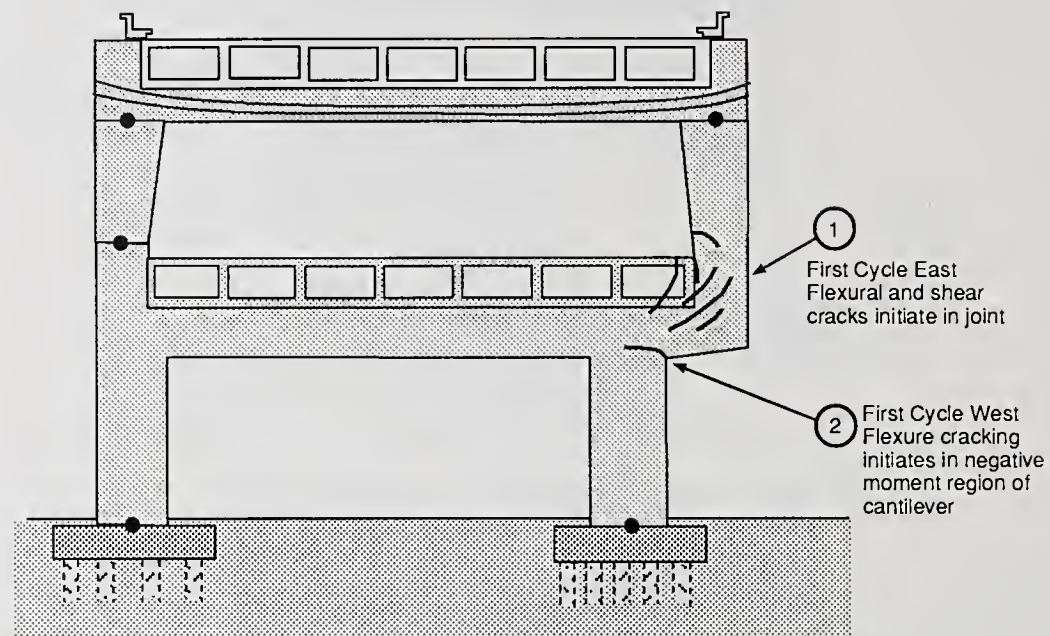
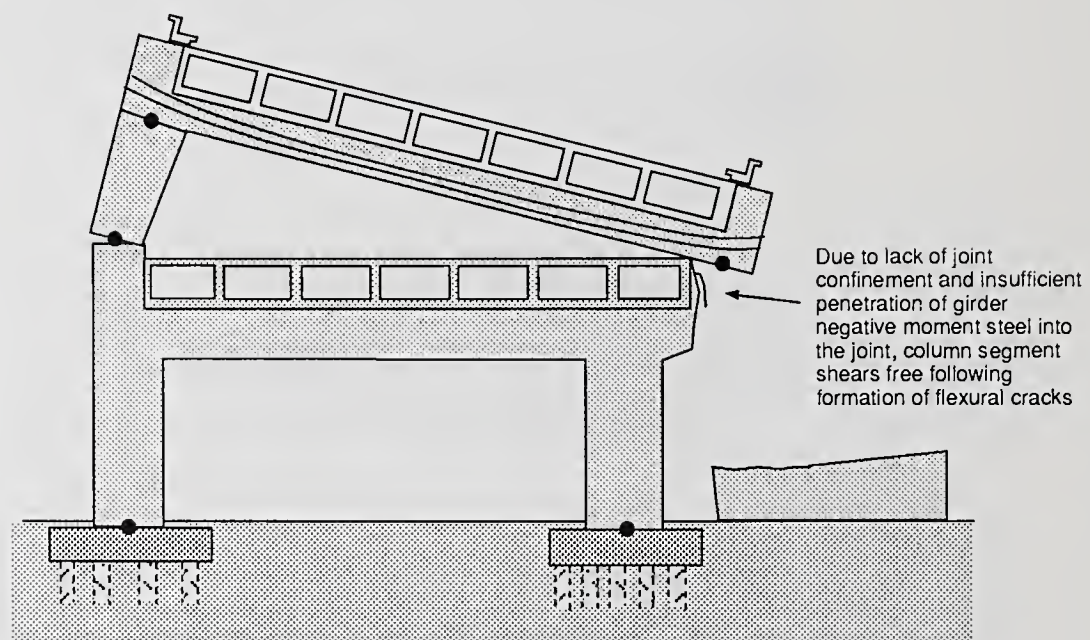
Figure 5.6.49 Top: Anticipated crack initiation sequence for Type 5 bents under lateral loading. Bottom: Observed failure mode for Type 5 bents at Cypress Structure.

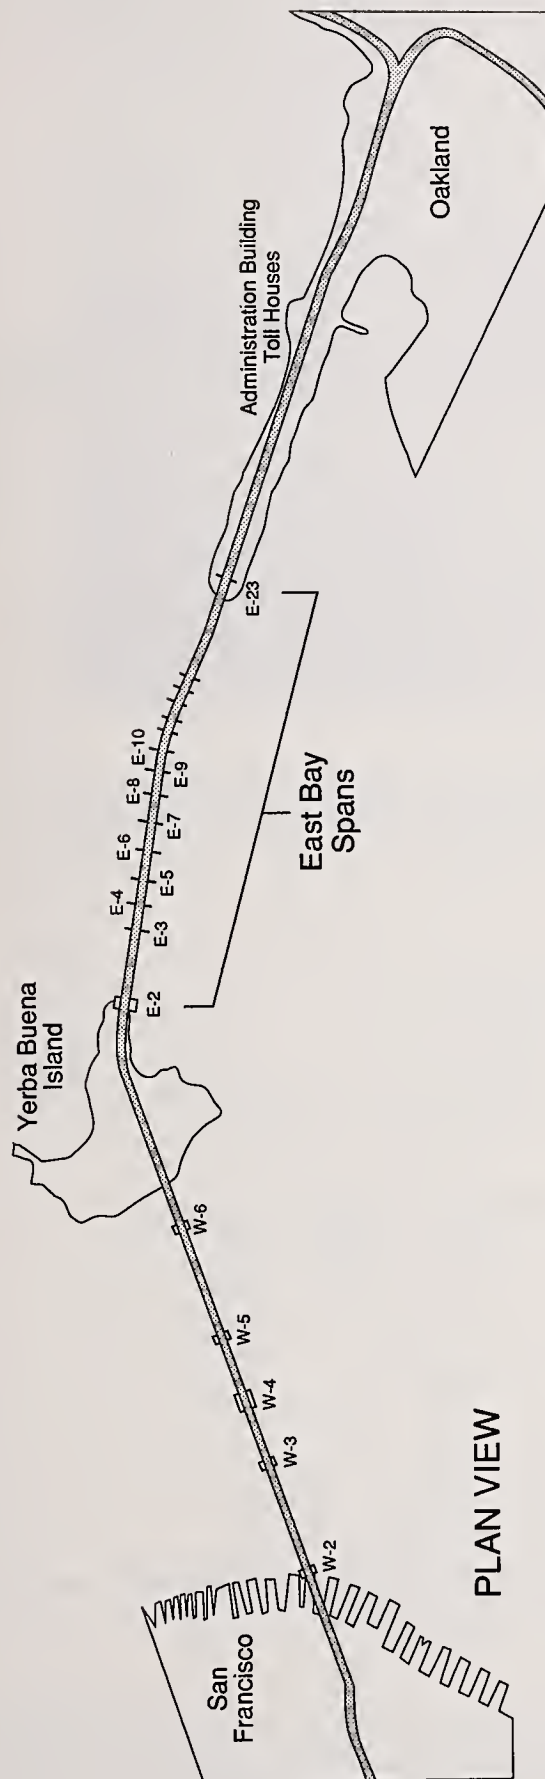
Figure 5.7.2 Plan and profile views of the San Francisco-Oakland Bay Bridge. Damage, as well as significant residual displacement of structural elements, was confined to the section between Piers E-9 and E-23 in the east bay spans.

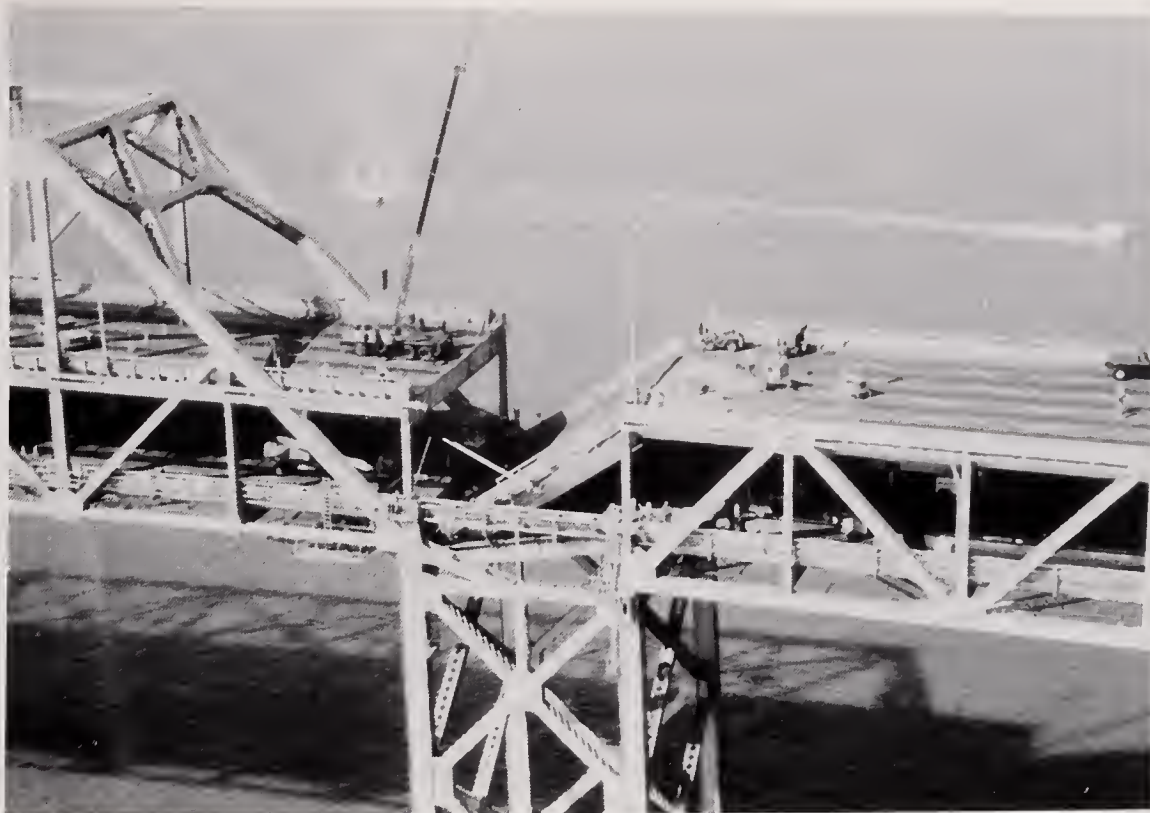
There was no apparent damage as a result of the earthquake to the west bay suspension bridges. First reports of the earthquake via the media, however, showed the dramatic collapse of the 50 foot (15 m) link spans at pier E-9 (see fig. 5.6.4), approximately halfway between Yerba Buena Island and the Oakland landing. Inspection revealed that both the upper and lower decks had simultaneously been pulled off their bearing seats as the truss east of pier E-9 moved, by Caltrans measurements, as much as 10 inches (250 mm) east during the first excursion of motion before returning 5 inches (130 mm) to the west, leaving a residual 5 inch (130 mm) eastward displacement. The western girder seats for the upper and lower bridge decks (see fig. 5.6.6) were simply supported configurations in which the bottom flange of the deck girders sat on a riveted angle bracket while two vertical angle brackets constrained movement of the girder web. The bearing seat was only 6 inches (150 mm) wide, so that when truss E9-E10 moved eastward both top and bottom decks slipped off their respective angle brackets and pivoted downward, landing as shown in figures 5.6.4 and 5.6.5. This mechanism is evident when viewing figures 5.6.7 and 5.6.8 which show closeup photos of the western bearing seats for the lower deck girders and the eastern hinge seat for the upper deck girders, respectively. There is practically no damage visible in figure 5.6.7 to the bearing seats, indicating that the girder flanges had cleared the edge quickly and fell away without any further impacting before the lower deck girders landed on a transformer station mounted on the utility deck on the north side of the bridge. The eastern deck girder supports for the link spans, which were in contrast bolted to the girder, were severely distorted (fig. 5.6.8) and in some cases torn loose. It has been suggested that were it not for the presence of the transformer station both spans would likely have torn

free from the girder restraining bolts and fallen into pier E-9, causing far greater damage⁶. During the fall the upper deck cut through several power and communication lines and additionally severed a water main on the south side, but otherwise the damage was confined to the decks themselves.

Figure 5.7.4 Aerial photo looking north at Pier E-9 on October 19, 1989 showing the collapsed upper and lower 50 foot deck spans.

and that there was some elastic rebound from pier E-10⁷. Within 4 weeks of the quake, Caltrans had replaced the deck girders for the pier E-9 link spans, placed precast concrete panels between them, cast the composite deck, and reopened the bridge for traffic. The 40 1 inch (25 mm) bolts connecting the E-9/E-10 truss shoes to the eastern column tops of pier E-9 were replaced with high strength bolts. Whether this is to the advantage of the bridge during future earthquakes is subject to review. Opinions have been expressed by some⁸ that the shearing of these bolts served as a fuse, isolating pier E-9 from otherwise large lateral loads which could have led to disastrous column buckling.

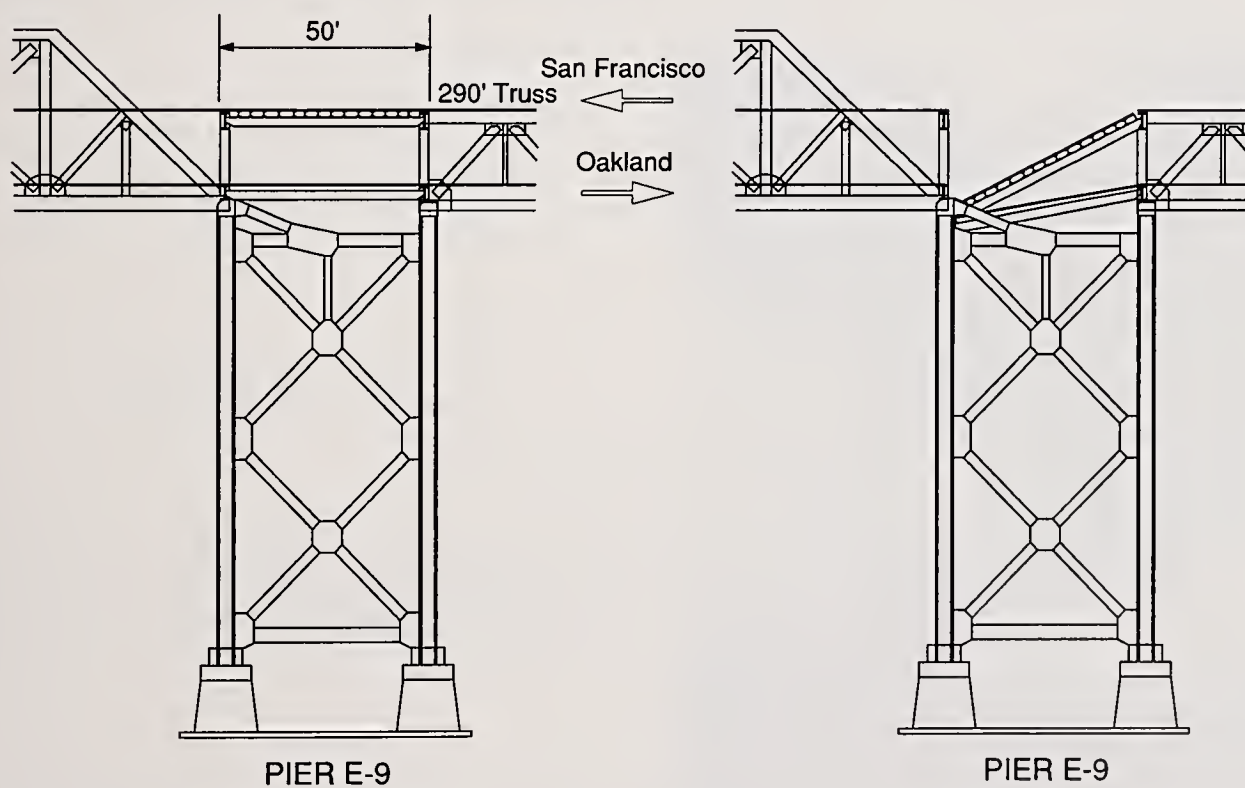
Figure 5.7.5 Schematic detail of Pier E-9 looking north. Evidence indicates that the 290 foot truss segment on the east side of the pier moved eastward, simultaneously unseating both Upper and lower deck segments.

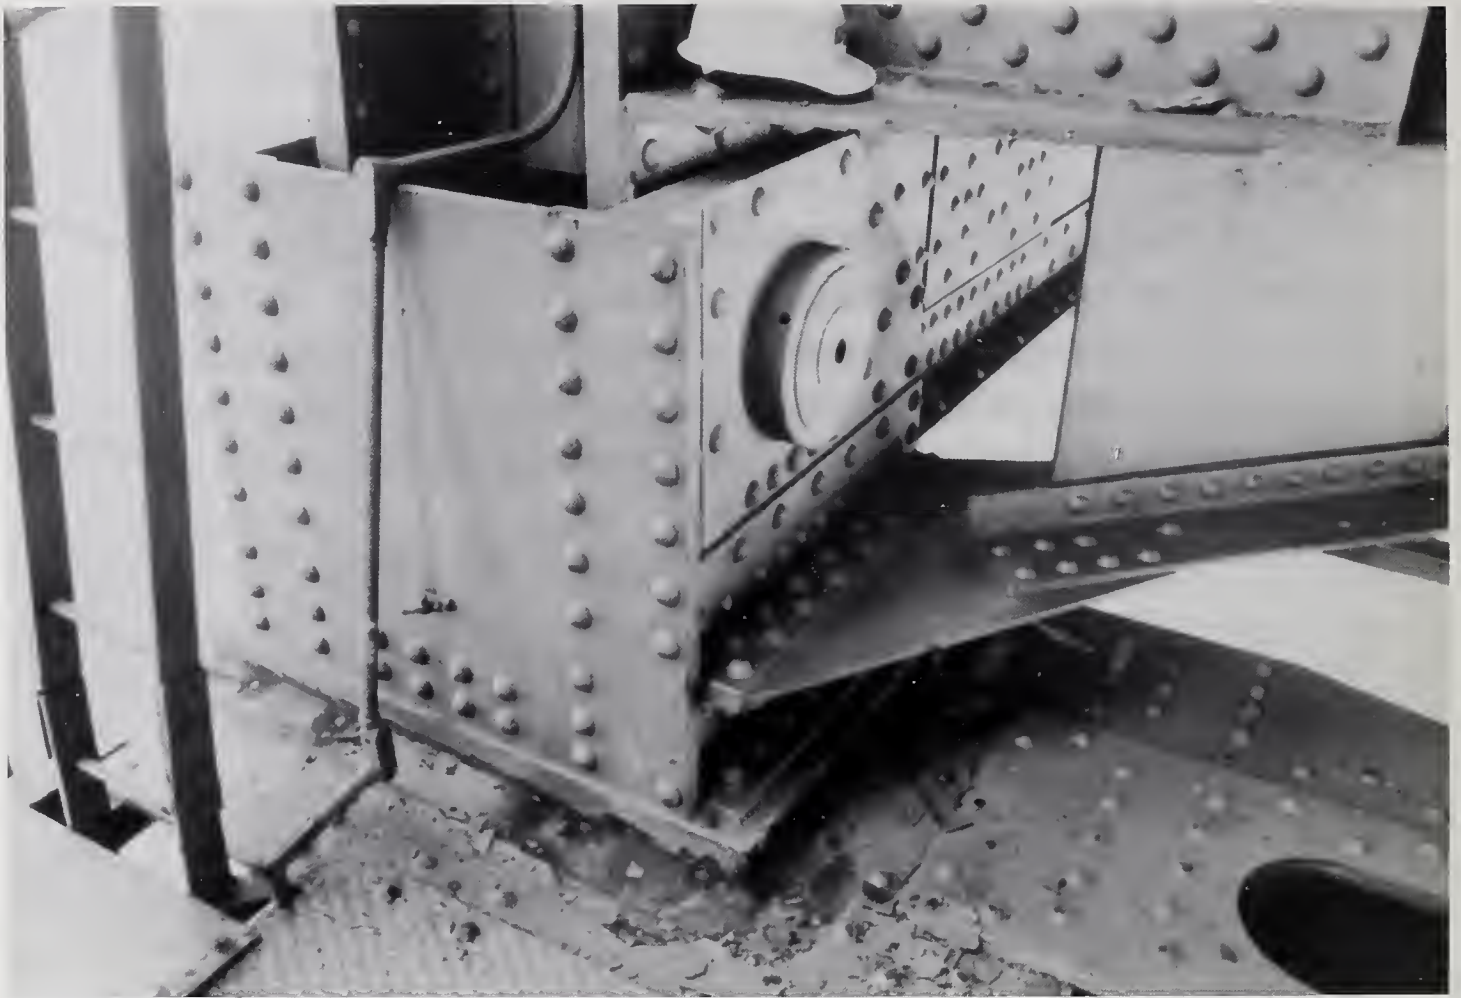
Figure 5.7.9 Close-up of the northeast shoe for the 290 foot truss between Pier E-9 and E-10. During the earthquake this truss moved eastward as much as 10 inches before returning to leave a 5.5-inch residual displacement to the east and 5/8-inch to the north.

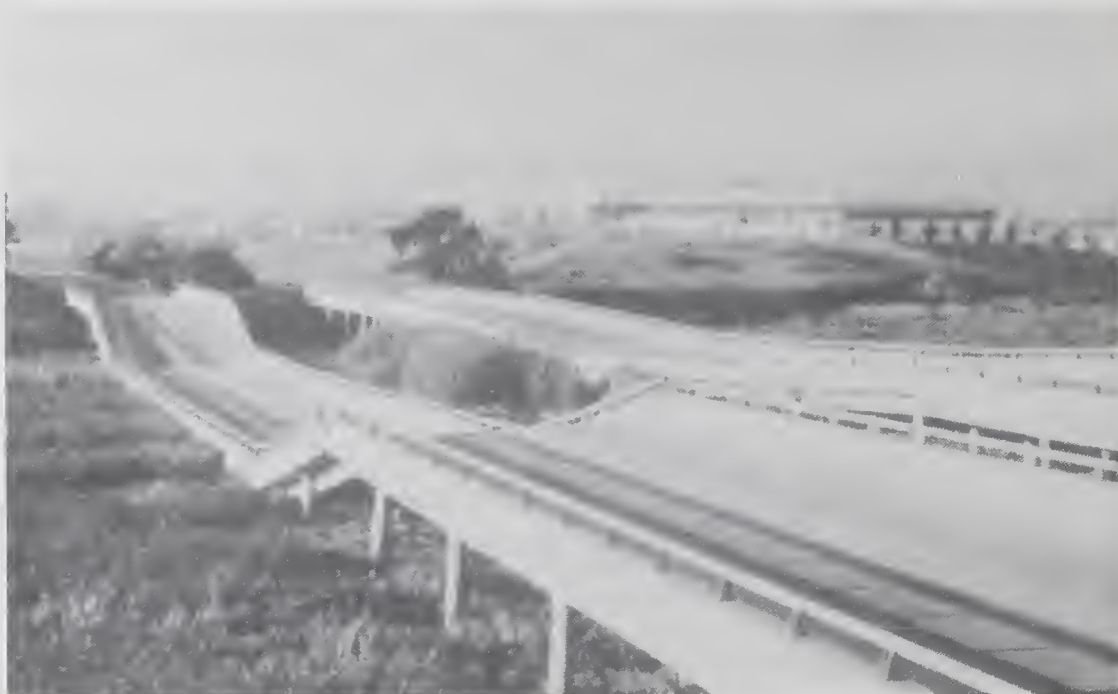
"The hinge restrainers performed well and held the structure together in spite of the large downward movement. Some evidence existed at the site that auto traffic had crossed the bridge during or immediately after the event. The pile extensions under the structure were lightly confined with #3 wire at about 12 inch (305 mm) pitch and failed primarily at the top. Some piles apparently also failed some distance below the ground surface. The soil displacement at the base of several of the piles was in several directions up to a maximum of 18 inches (460 mm). The eastern structure dropped about 5 feet (1.52 m) onto damaged pile extensions. The western structure dropped to the ground surface about 8 to 10 feet below (2.44 to 3.05 m). A few of the piles on the western bridge separated from the bent, displaced, and punched through the deck slab as the superstructure fell to the ground (see fig. 5.8.1)."

Figure 5.8.1 View looking north of State Highway 1 crossing Struve Slough, approximately 1 mile south of Watsonville. Piles on the left bridge separated from the bent, displaced, and punched through the deck slab as the superstructure fell to the ground (photo courtesy EQE Engineering).

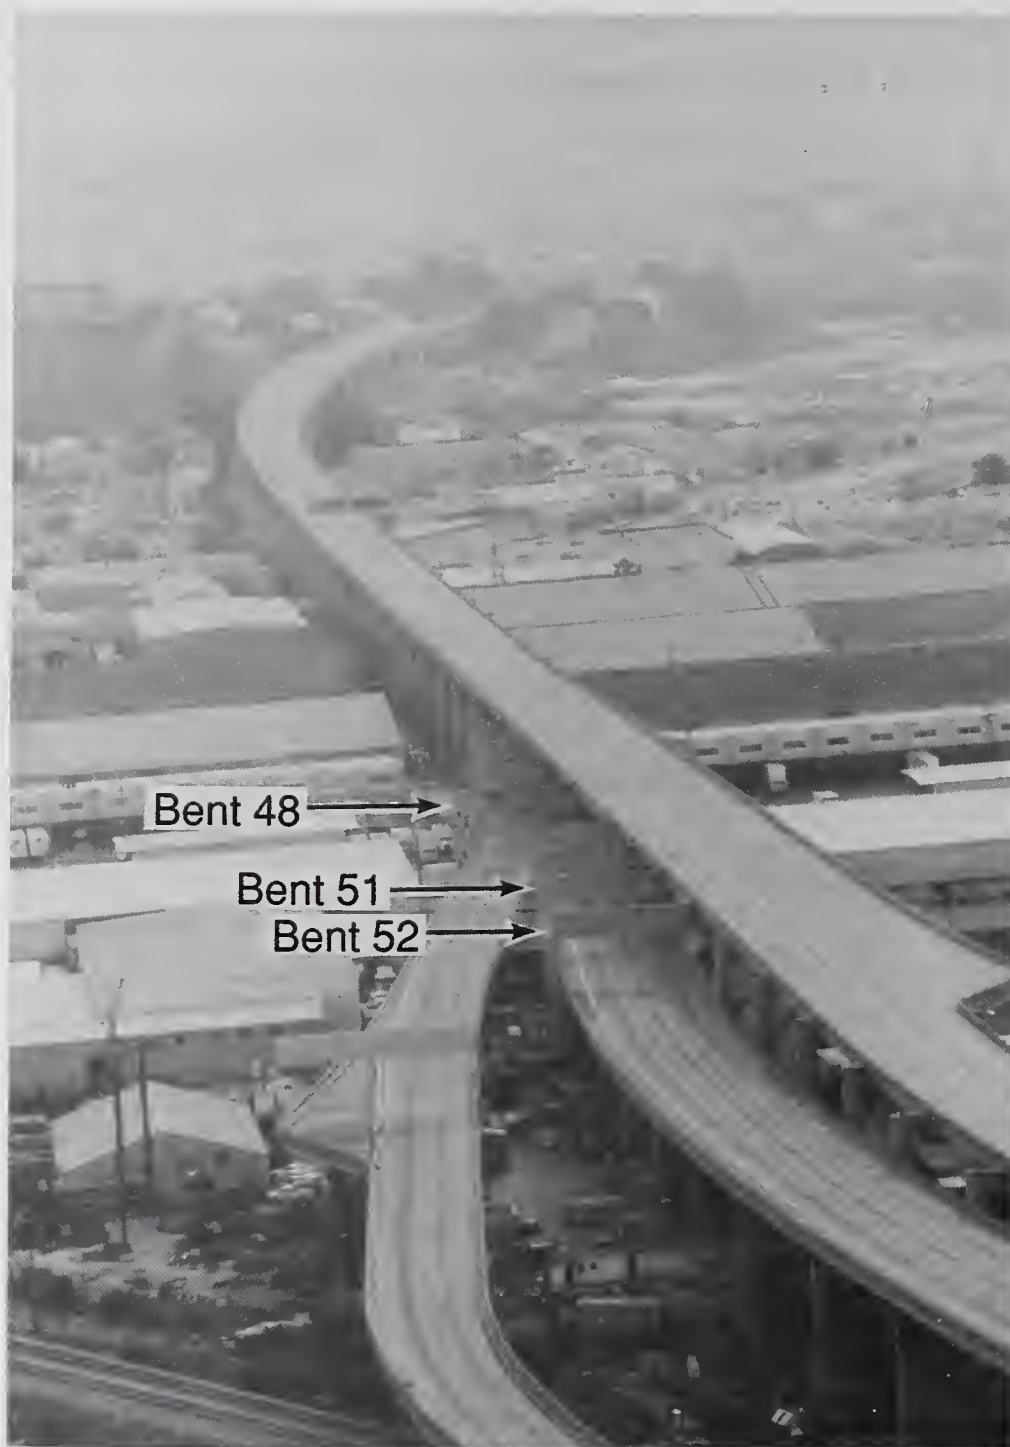
Figure 5.9.2 is an aerial view, looking south, of I-280 south of Army Street. At this location a two-level elevated highway (to the south) transforms into to a single level divided highway (to the north). In addition, there is an exit ramp for the lower level northbound section. Damage was observed at Bent numbers 48, 51, and 52.

Figure 5.9.2 Aerial view of I-280 south of Army St., note the transition from a two-level elevated structure to a single-level, divided structure (view is looking south).

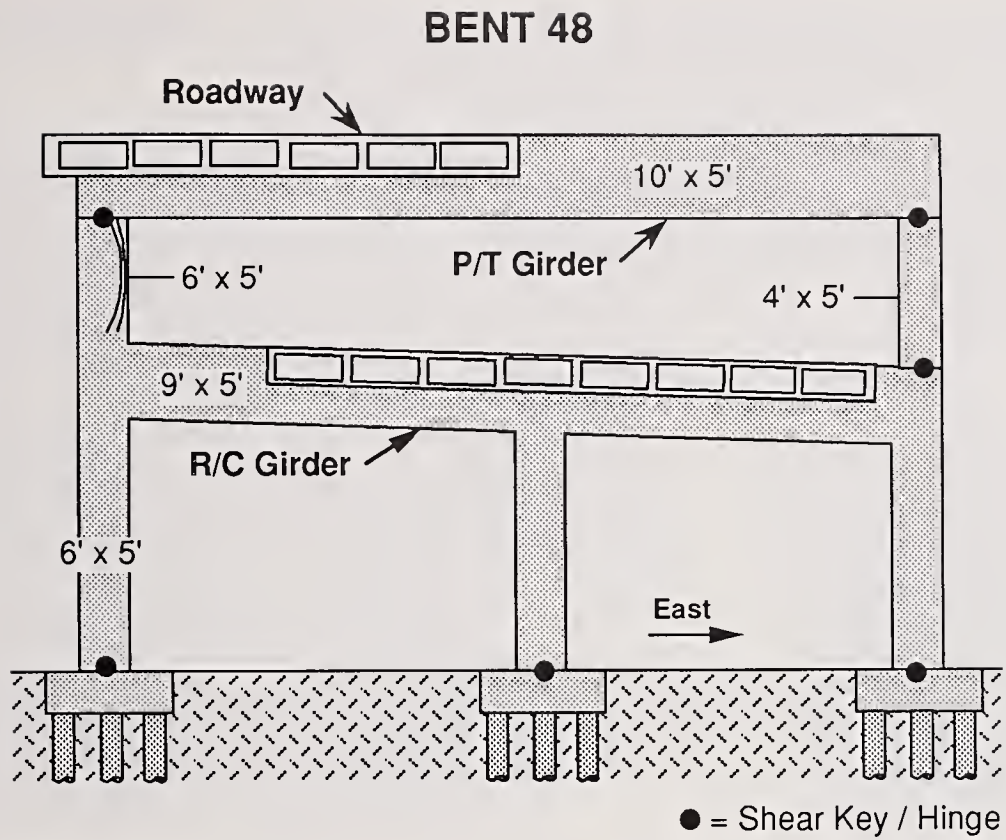
Figure 5.9.3 is a schematic elevation view (looking north) of Bent 48. The top girder is post-tensioned and supports at the columns are designed as pinned connections, with details similar to those used on I-880. The column reinforcement includes #18 longitudinal bars and #4 ties at 12 in. (0.30 m) spacing. The damage occurred at the top of the west-side column. Figure 5.9.4 shows the nature of the damage, which appears to be a combination of diagonal tension failure and splitting parallel to the longitudinal column steel. Note that the girder is permanently displaced toward the east.

Figure 5.9.3 Schematic elevation view of Bent 48 of I-280 (looking north).

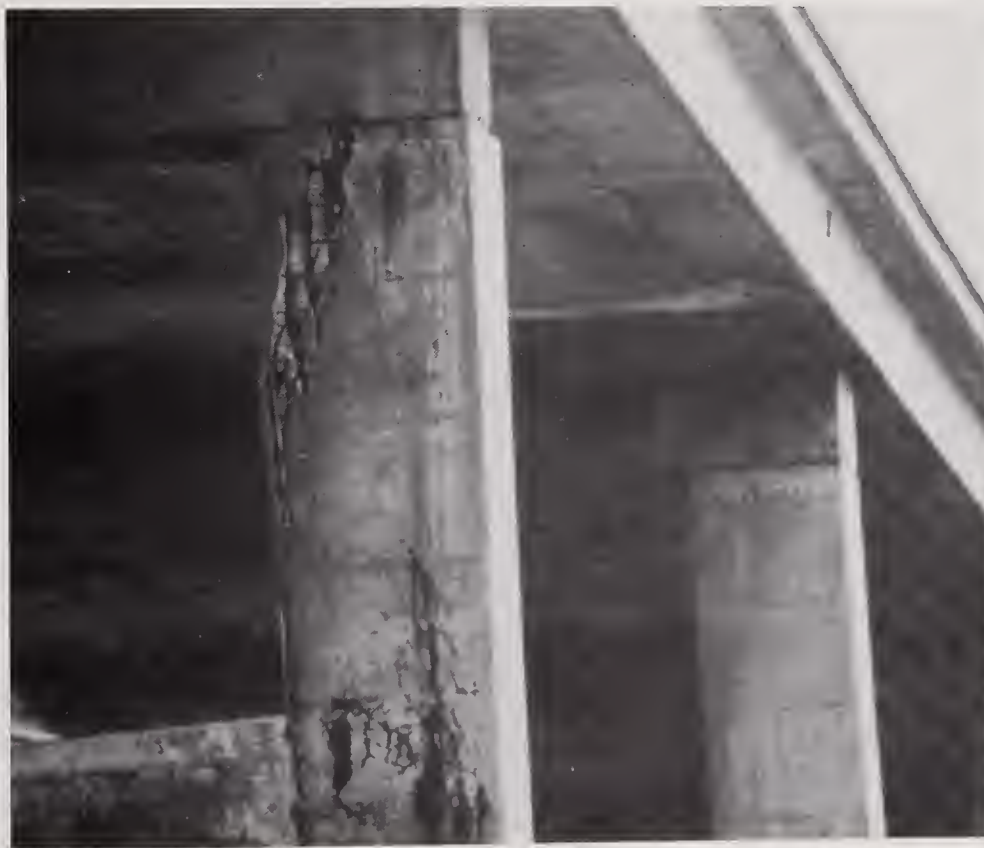
Figure 5.9.4 Damage to west-side column of Bent 48 (looking toward south).

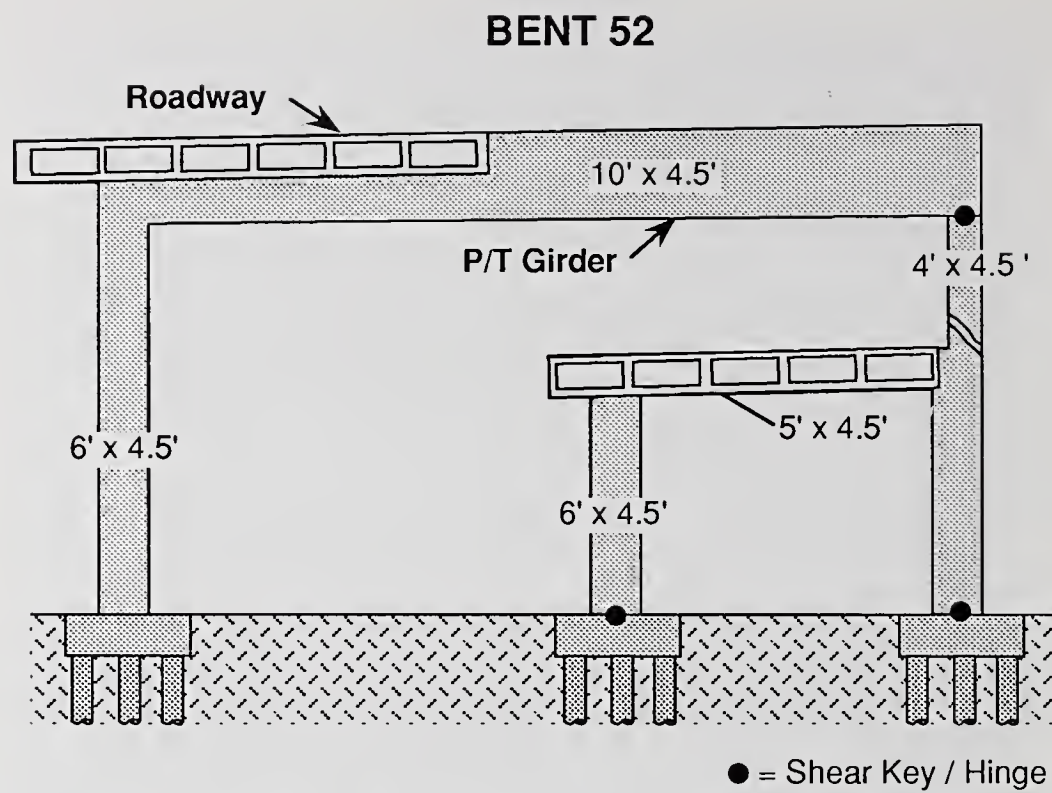
Figure 5.9.5 is a schematic elevation view of Bent 52. The configuration of Bent 51 is similar. The upper, post-tensioned girder is monolithic with the column on the west side and is supported as a pinned connection on the east side. Figure 5.9.6 is view (looking south) as seen from the lower northbound lanes; the upper girder of Bent 52 is in clear view. Damage occurred to the east-side columns of Bents 51 and 52 at approximately the elevation of the roadway. Figure 5.9.7 shows the damage in Bent 52 as it appeared on the northern column face. The damage in Bent 51 was similar as can be seen in figure 5.9.8, which shows that southern column face. Figure 5.9.9 is a close-up view of the damage zone in Bent 51. It is seen that the concrete is extensively fractured and the #4 ties lost their effectiveness because of the inadequate anchorage provided by the 90-degree hooks. The corner #18 bar also appears to have buckled.

Figure 5.9.5 Schematic elevation view of Bent 52 of I-280 (looking north).

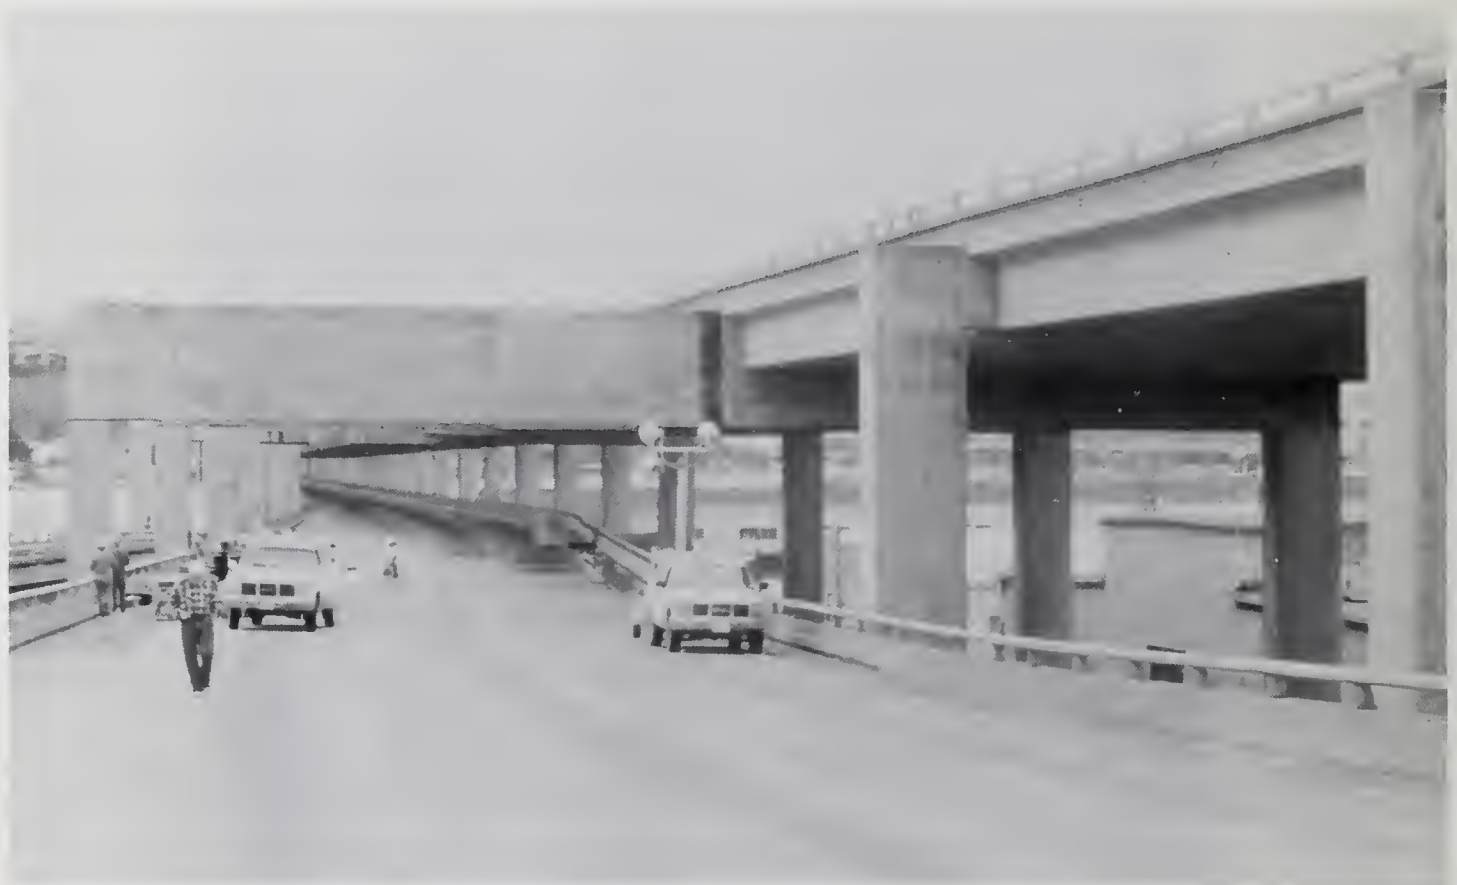
Figure 5.9.6 View looking south on I-280 showing the upper girder of Bent 52.

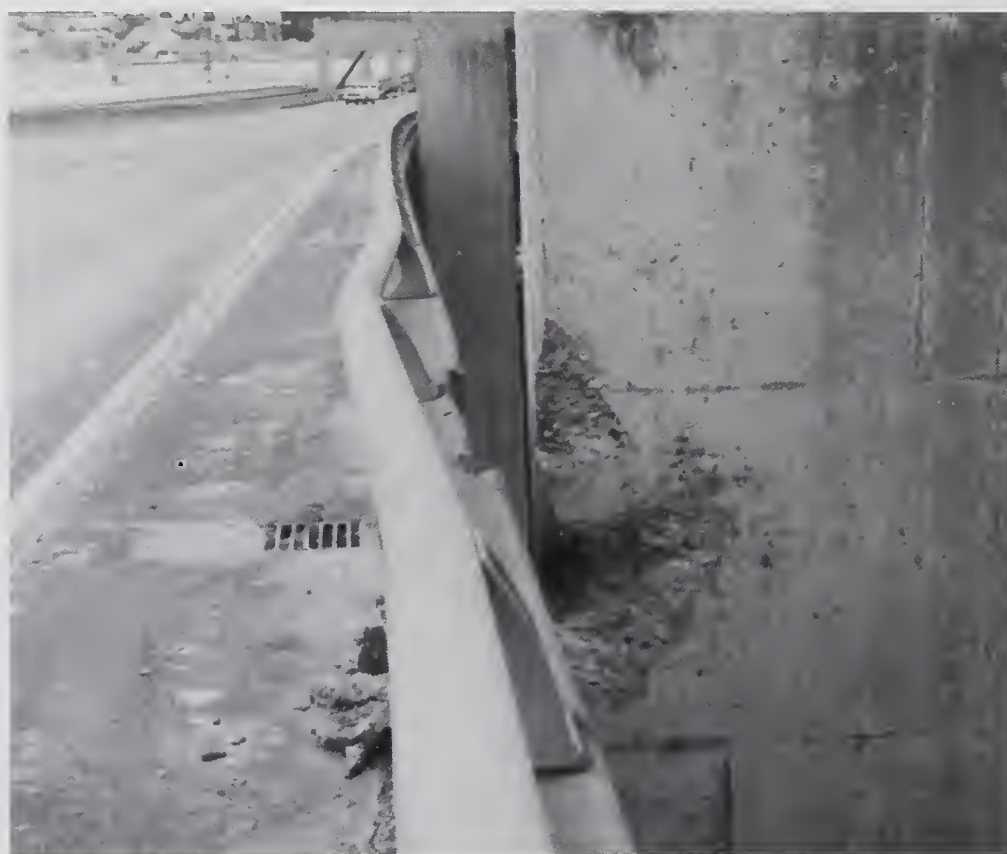
Figure 5.9.10 Pounding damage at I-280 south of Army Street.

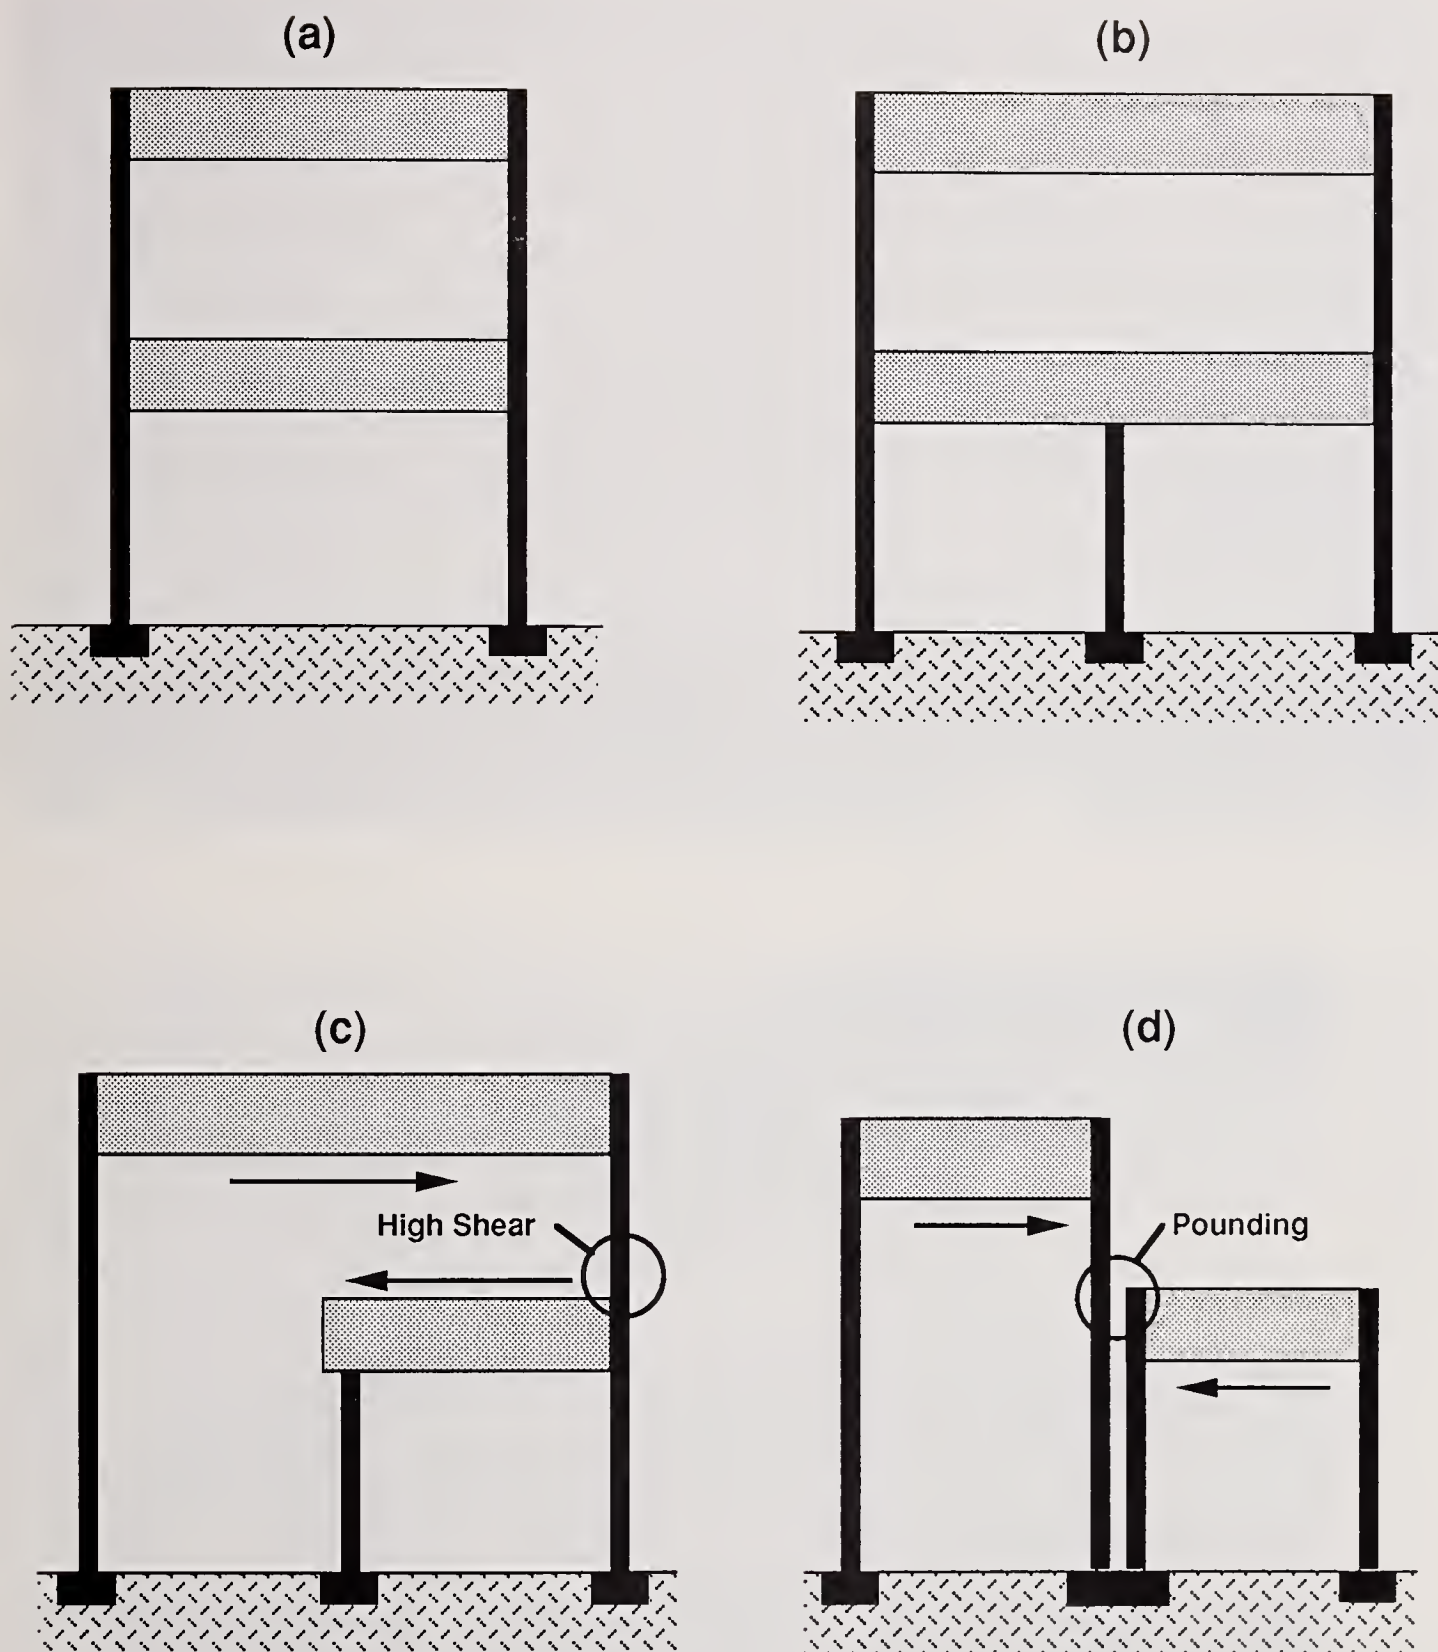
Figure 5.9.11 Schematic illustration of the various structural configurations as I-280 undergoes transition from a two-level to a single-level elevated highway.

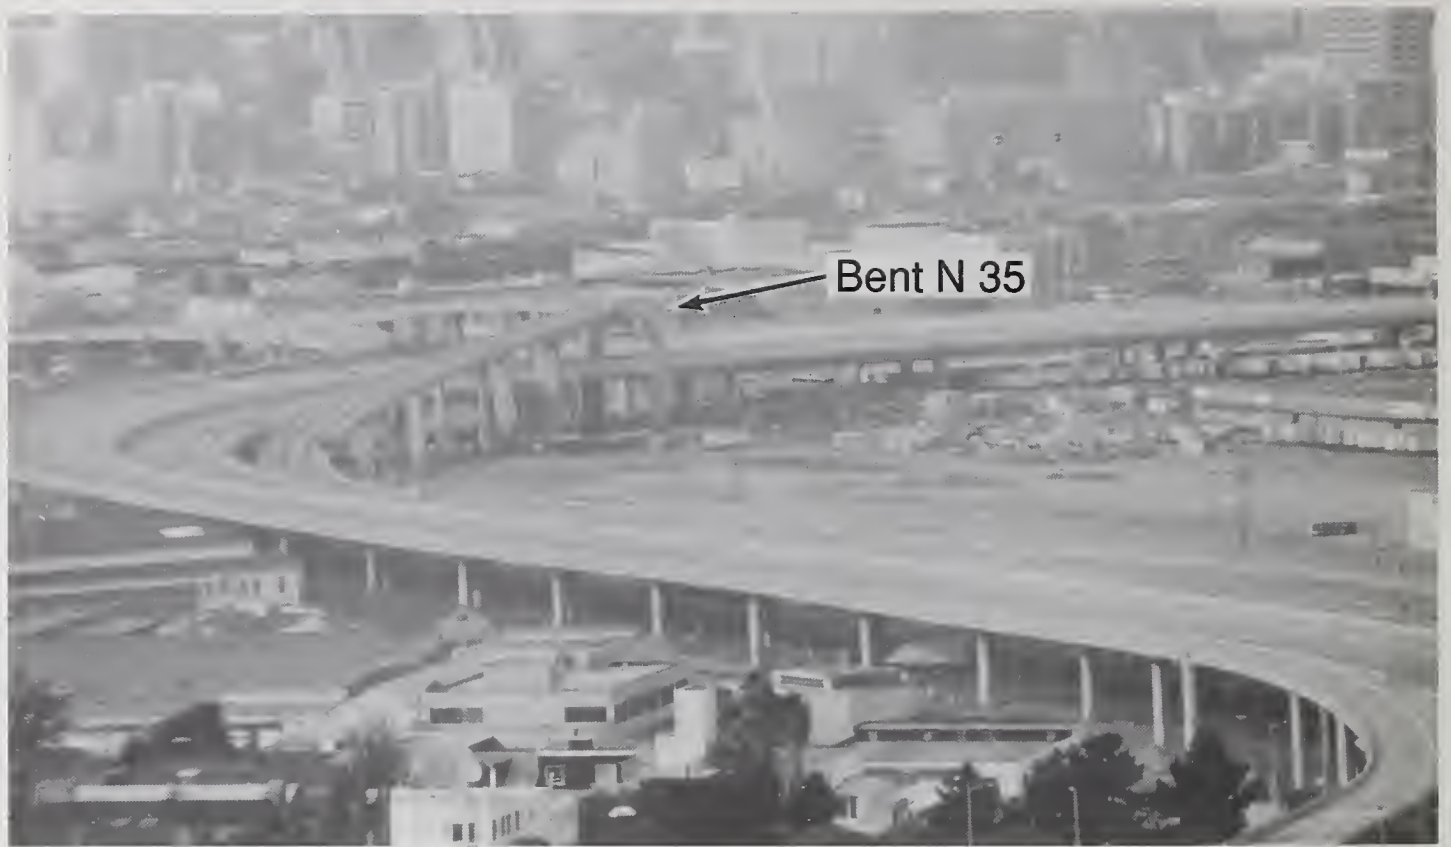
Figure 5.9.12 Aerial view of the Sixth St. exit of I-280.
