NIST Special Publication 778

Performance of Structures During the Loma Prieta Earthquake of October 17, 1989

H. S. Lew, Editor

January 1990

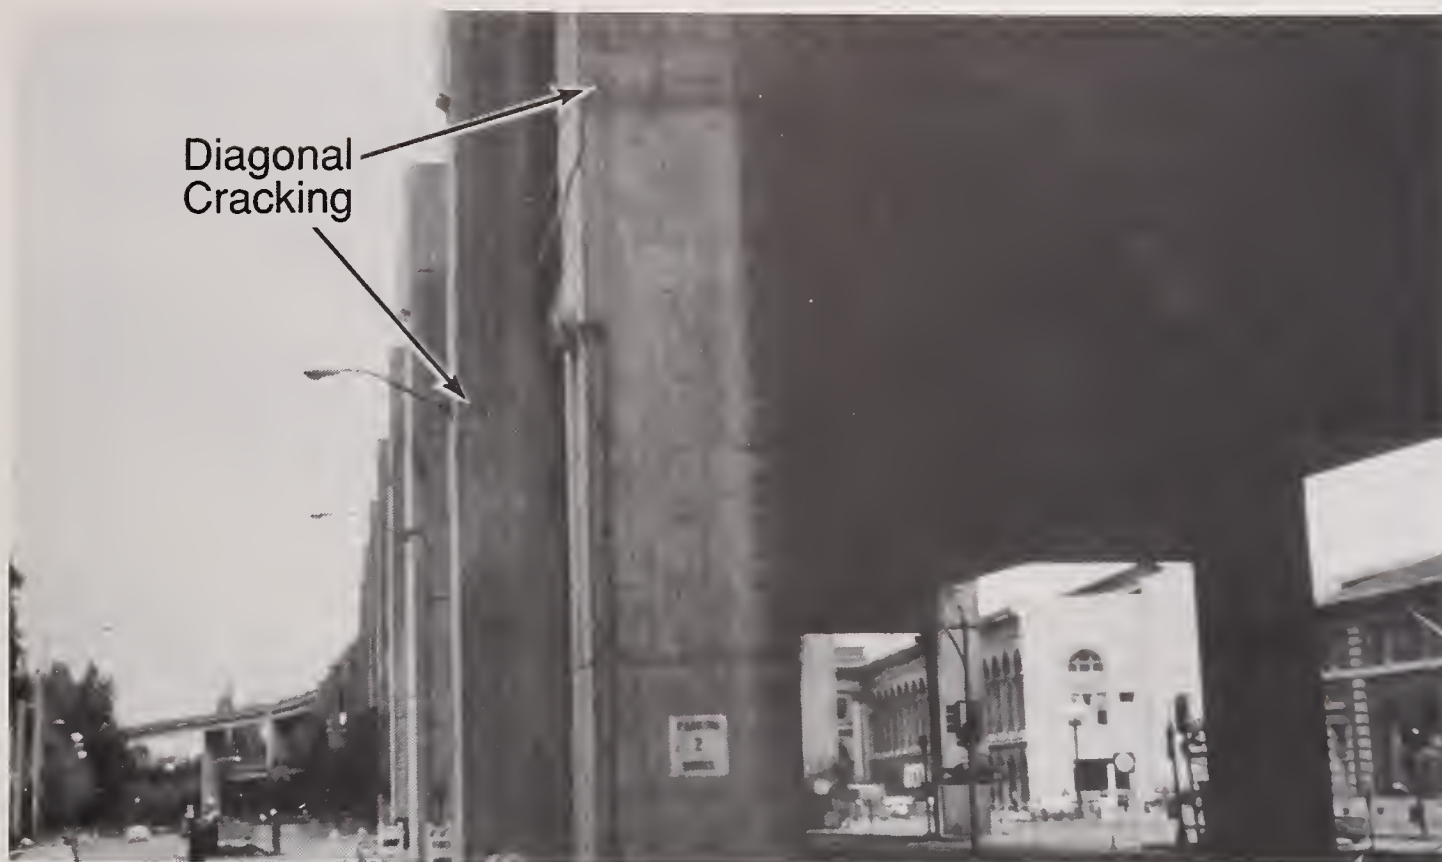
Figure 5.10.2 is a ground-level view looking north along the west side of the freeway; Bent 76 is in the foreground. The vertical metal covers which can be seen at the top girder-column joints protect restraining tendons which were added during the earthquake upgrading in 1972. Figure 5.10.3 is a ground-level view from the east side looking north; Bent 78 is in the foreground. Mission Street is located between Bents 78 and 79 (numbers increase toward the north). The observed damage occurred at the lower girder-column joints in bents located north and south of Mission Street.

Figure 5.10.2 West side of Embarcadero Freeway south of Mission St., Bent 76 is in foreground.

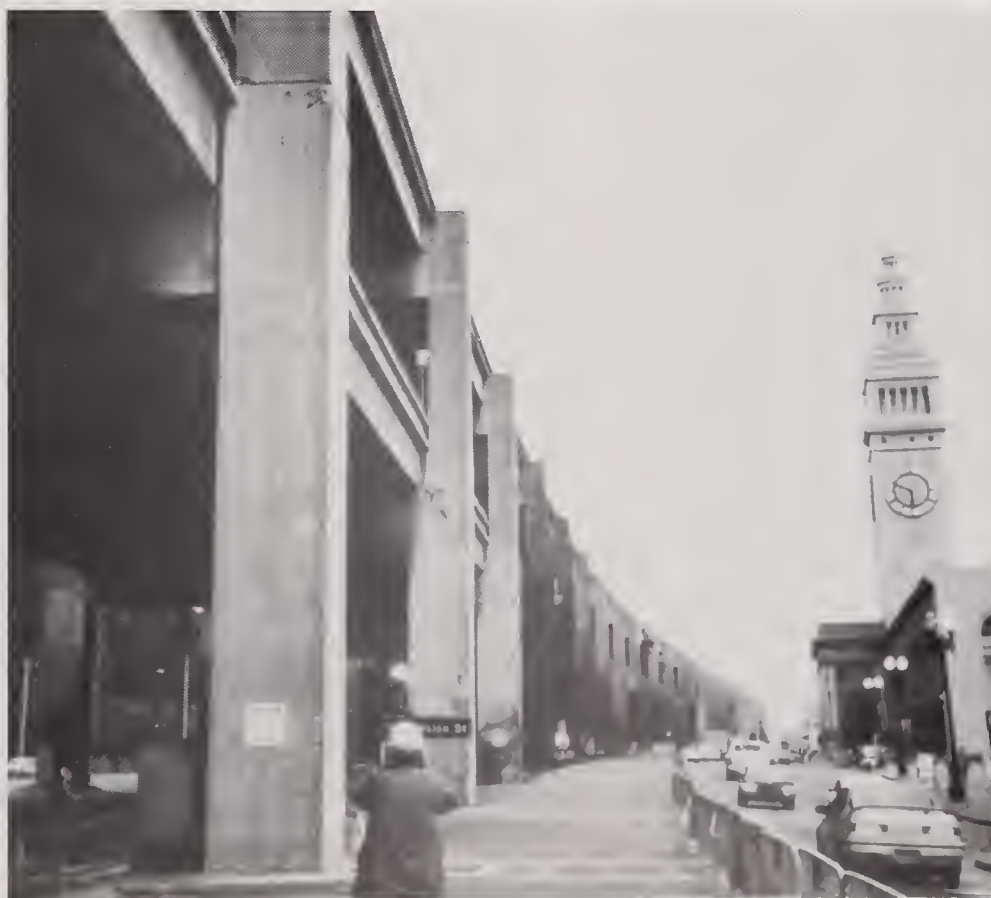
Figure 5.10.3 East side of Embarcadero Freeway at Mission St., Bent 78 is in foreground.

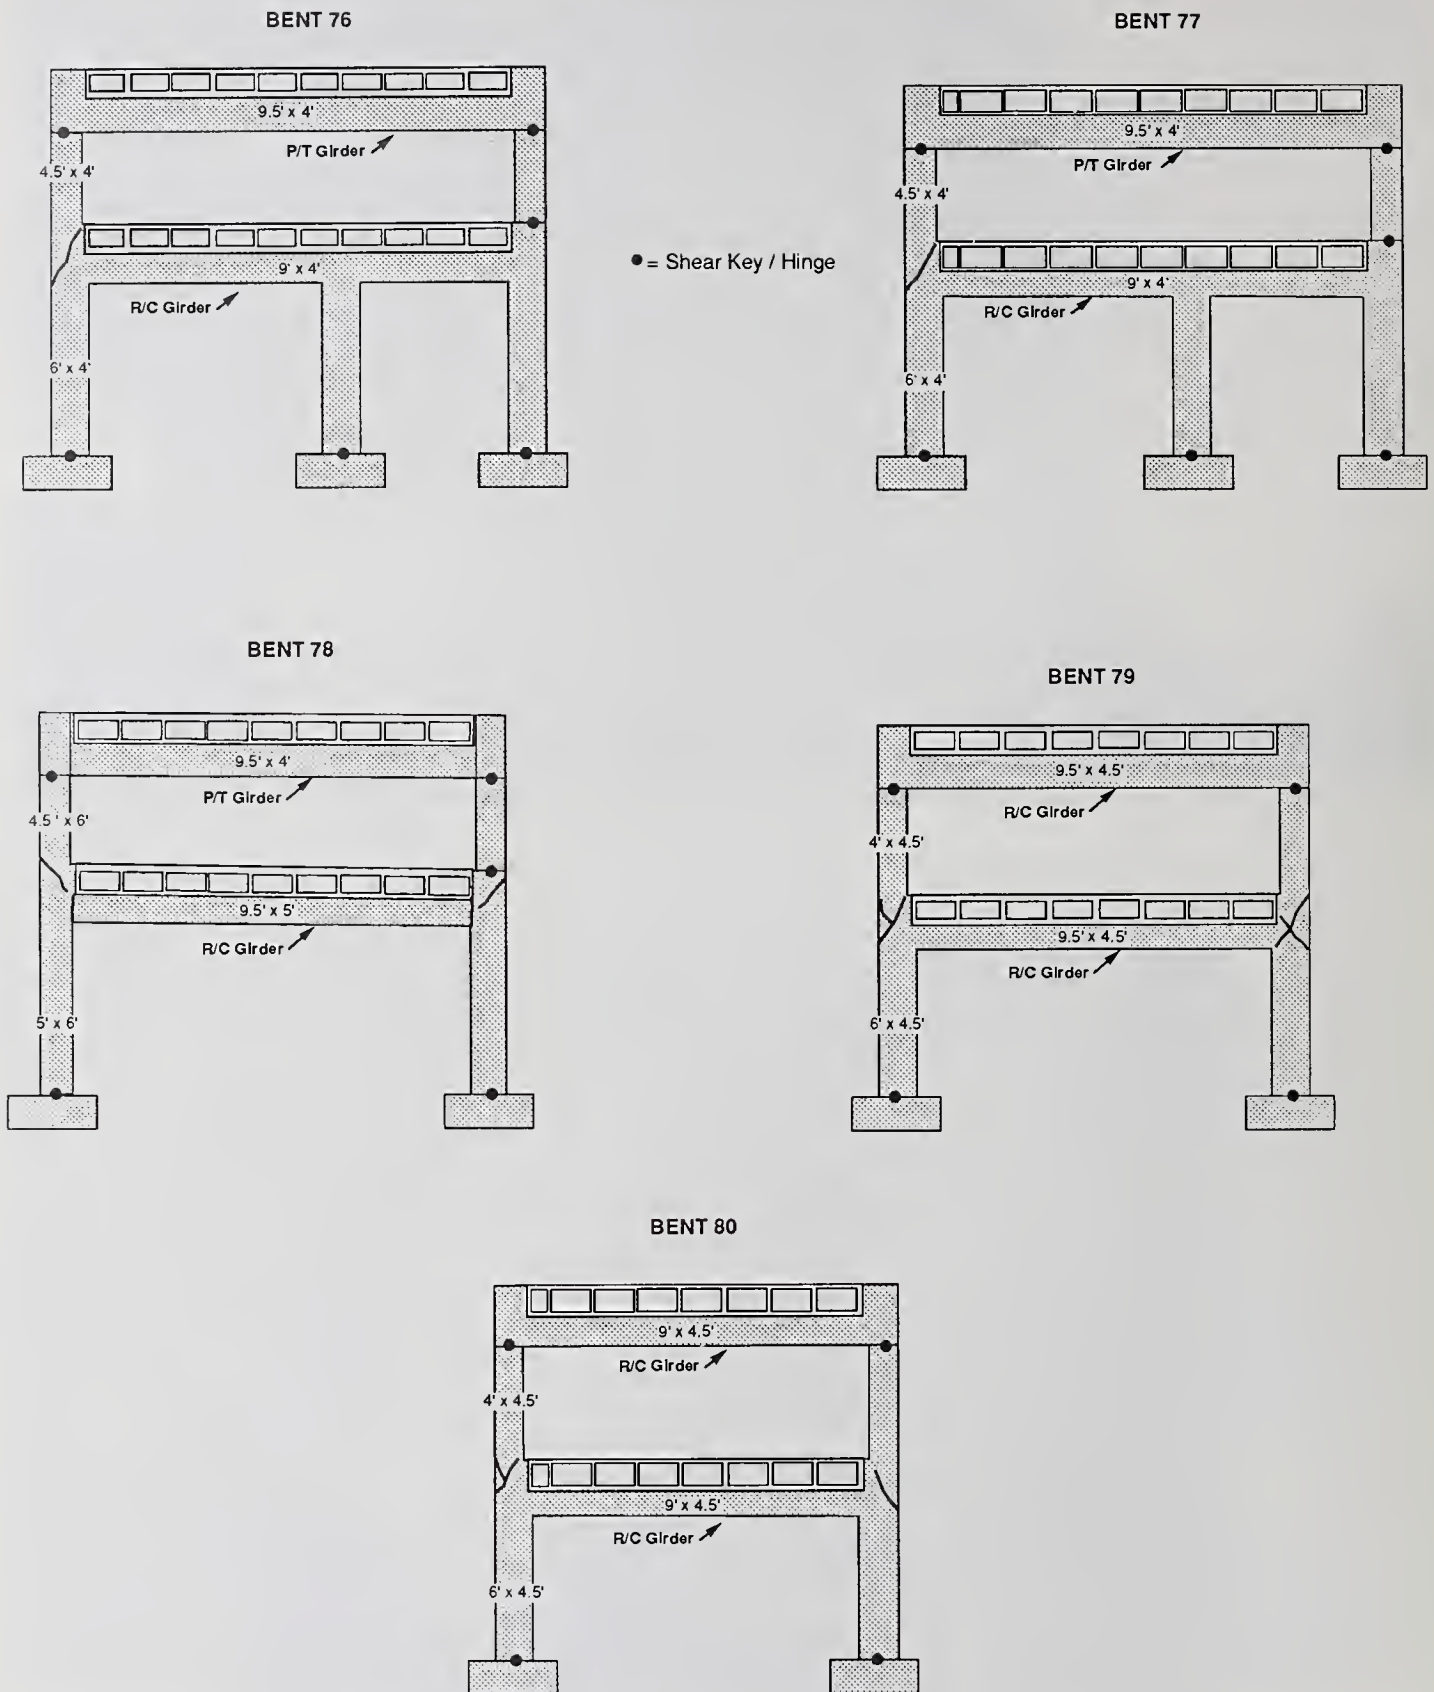
Figure 5.10.4 shows the configurations of the bents to the north and south of Mission Street. As can be seen at the bottom of the aerial photograph in figure 5.10.1, the Embarcadero Freeway undergoes a transition in width south of Mission Street, and this is the reason for the different bent configurations. For the wide portion of the freeway, the upper girder is post-tensioned and supported on pinned joints. A detail similar to that used in the design of I-880 was used for the pinned joints. Likewise, for bents with post-tensioned girders, column segments were pinned at both ends on one of side of the bent. The predominant damage was in the form diagonal cracking within the lower girder-column joint, as indicated by the heavy lines in figure 5.10.4. This indicates that the weakness of the Embarcadero Freeway is similar to that of the collapsed portion of I-880. In no cases were the cracks as severe as those observed in the columns of I-280.

Figure 5.10.4 Schematic of bent configurations and damage at lower girder-column joints.

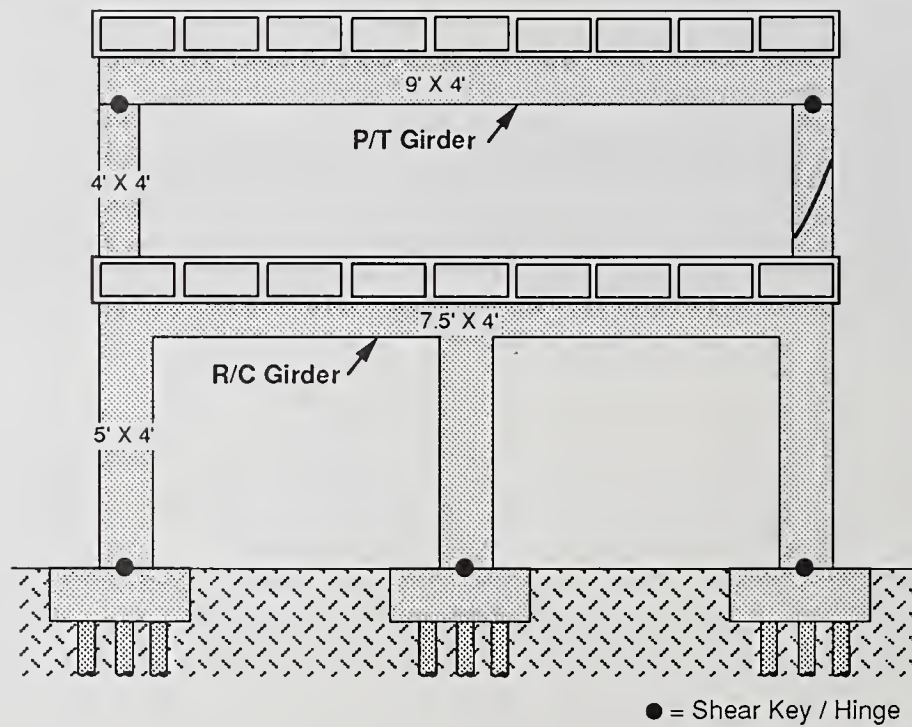
BENT 43

Figure 5.11.3(a) is close-up view of the east-side column of Bent 42. A series of diagonal cracks occurred at the middle of the column, and finer cracks developed at the top of the column inclined in the opposite direction. The more serious damage was observed at Bent 43. As shown in figure 5.11.3(b), extensive diagonal cracking developed just above the roadway.

Figure 5.11.2 Schematic of Bent 43, which had the more severe damage.
