NIST Special Publication 862

1994 Northridge Earthquake

Performance of Structures, Lifelines, and Fire Protection Systems

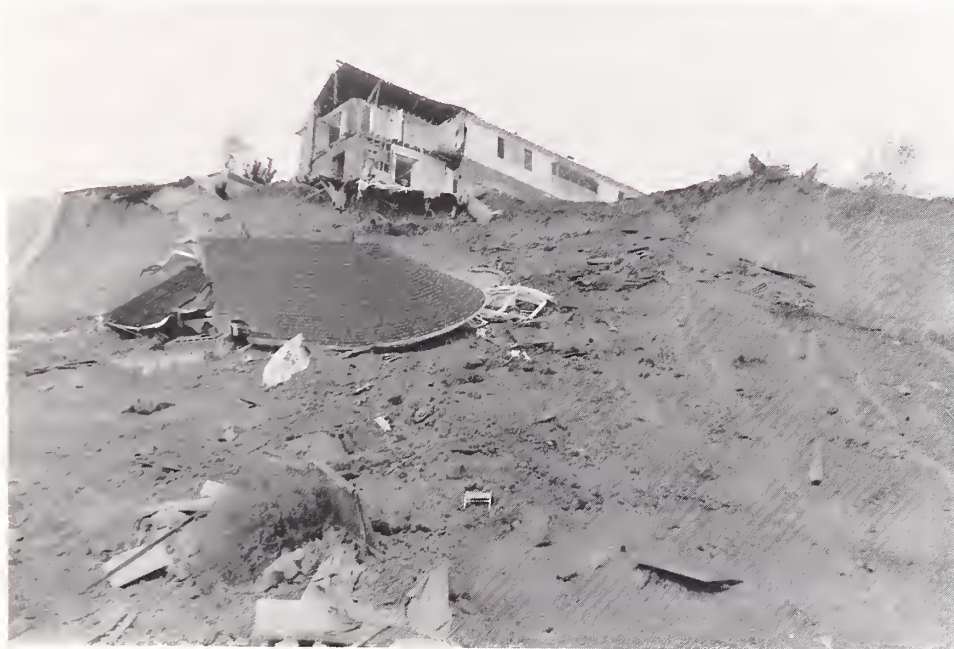
Landslides, rock slides and slope failures were the most visible geotechnical effect caused by the earthquake. Landslides along the Pacific coast in Santa Monica and Malibu damaged several buildings (fig. 2.8). Rockfalls in the Santa Monica, Santa Susana, and San Gabriel Mountains closed roads. Mulholland Drive in Sherman Oaks was temporarily closed because of the threat of slope failure.

Figure 2.8. A landslide along the Pacific Coast Highway north of Santa Monica undermined the foundation of a house at the crest of the slope, bringing a portion of the house down.

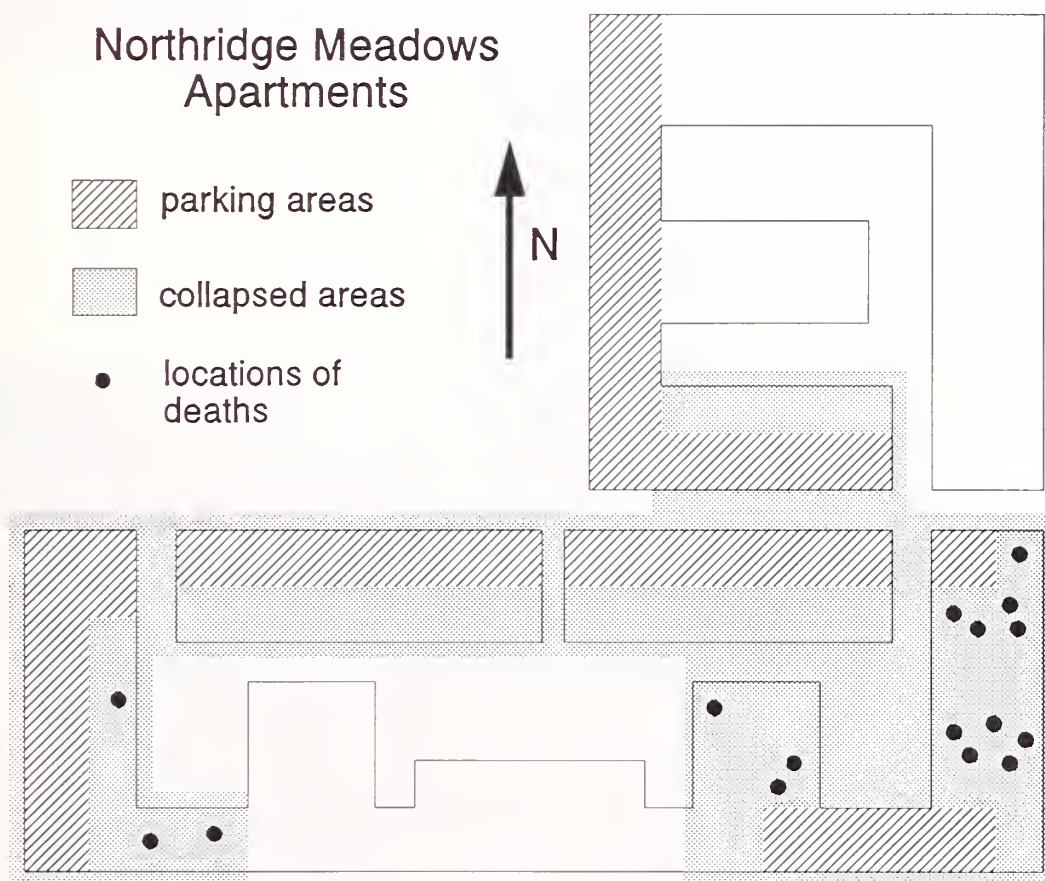
Collapses in a single apartment complex caused sixteen of the twenty-two deaths related to building failures [12]. The Northridge Meadows complex, constructed in 1972 (Los Angeles Times, January 19, 1994), consisted of several three-story wood-frame buildings, arrayed around courtyards on two sides of a mid-block alley. About half of the units had open spaces for parking on the street level. Typically these were around the perimeter of the complex. Most of the interior courtyard-facing units had living space at the ground level rather than parking. About half of the buildings in the complex collapsed. In all of the collapses, the first story gave way while the second and third stories remained largely intact. The 16 people killed were in first story apartments. All the buildings in the complex suffered some damage (figs. 3.3 and 3.4).

Figure 3.3. This plan of the Northridge Meadows apartment complex shows the distribution of parking and living spaces at the first level, and locations of deaths (source: Los Angeles Times, January 24, 1994). The shaded areas indicate the portions of the complex which collapsed.

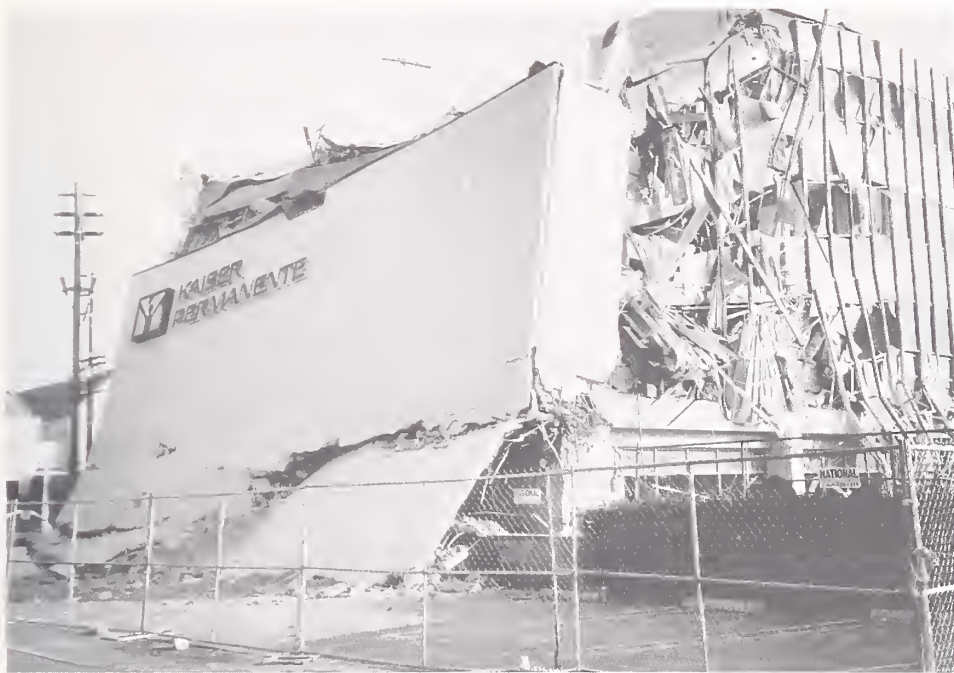
Figure 3.43.
Damage at the
north end of the
building was similar
to damage at the
south.

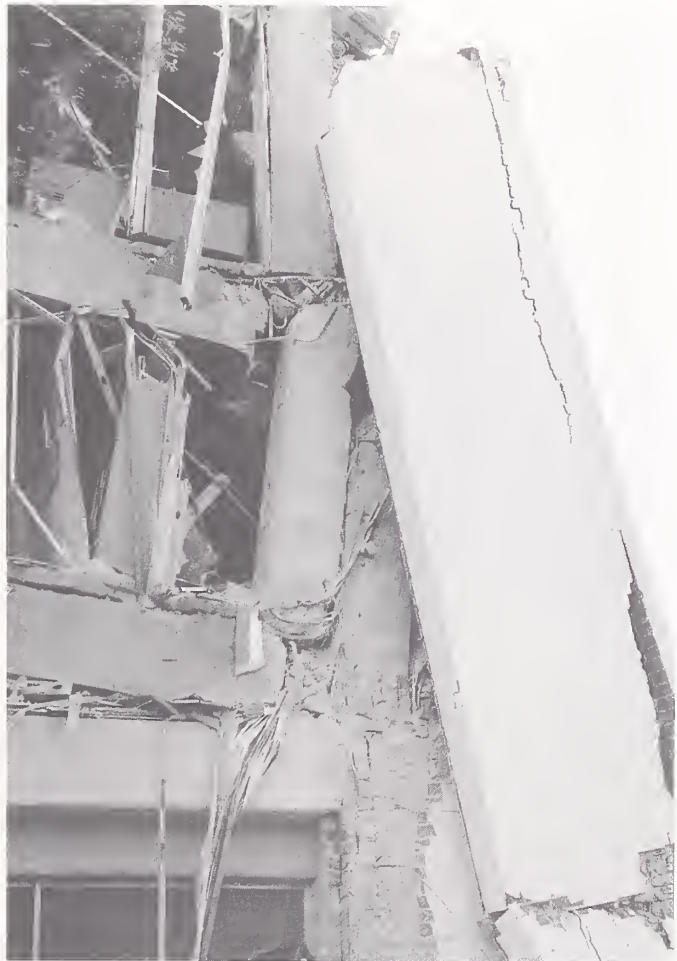
The bare frame exposed by the damage suggests that the buildings had a strong-beam/weak-column configuration (fig. 3.44). The damage appears to have initiated at the joints. At the damaged ends, the beams and columns remained essentially intact, but the joints disintegrated.

Figure 3.44. The exposed concrete
frame of the Kaiser Permanente
building, revealing deep beams,
suggests that the building had a strong-
beam, weak-column configuration.
Except for the second story columns,
the columns and beams remained intact
while the joints disintegrated.

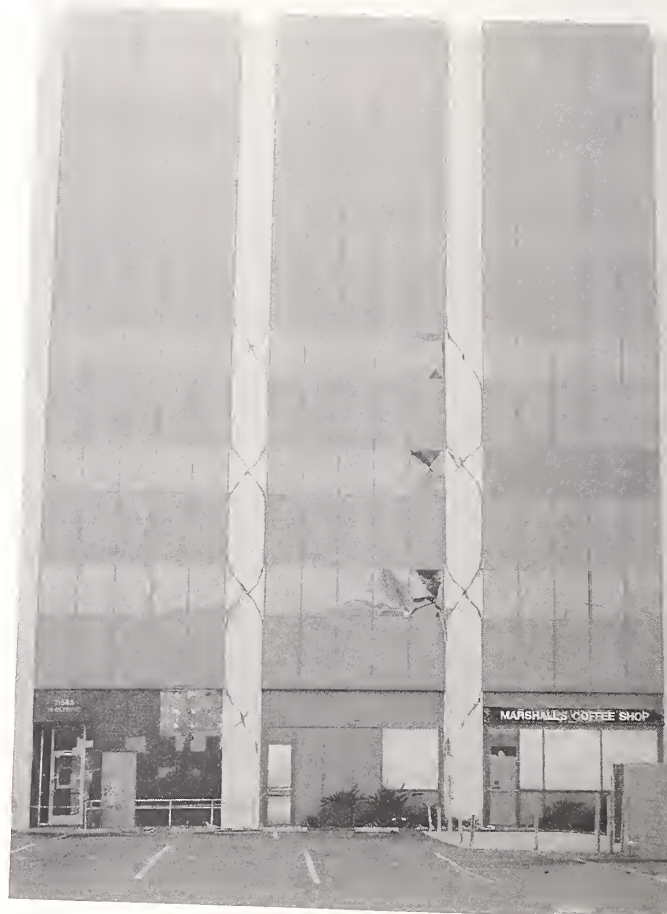
The L-shaped concrete frame Barrington Building in West Los Angeles also had damage concentrated in the second story columns (fig. 3.45). In this building, the horizontal architectural panels stiffened the lower half of the columns at each story, creating a short-column effect. The effectively shortened columns failed in shear between the windows, creating a pattern of X-cracking in the columns that diminished in severity towards the top (fig. 3.46). At the second story, the cracking was severe enough to cause a loss of vertical-load-carrying capacity; the bulging window frames indicate about a 50 to 100 mm reduction in height (fig. 3.47). The building was demolished within a few days of the quake.

Figure 3.46. The stiff infill panels of the Barrington Building effectively shortened the concrete columns, forcing all the displacement into the column sections bounded by windows. Diagonal X-cracking decreased in severity towards the top of the building.

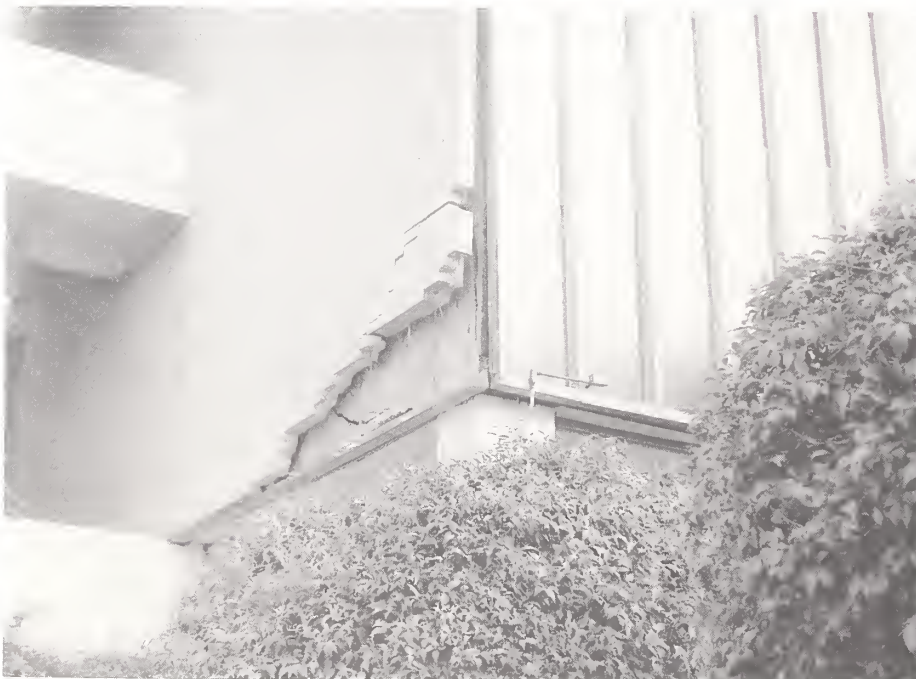
Figure 3.50. The similar west wall of was damaged, but did not peel away from the structure. This close up of the interface between the first and second stories shows that the masonry facade is supported on a steel angle. At the west end of the building, the facade was crushed at the toe where it is supported by the angle.

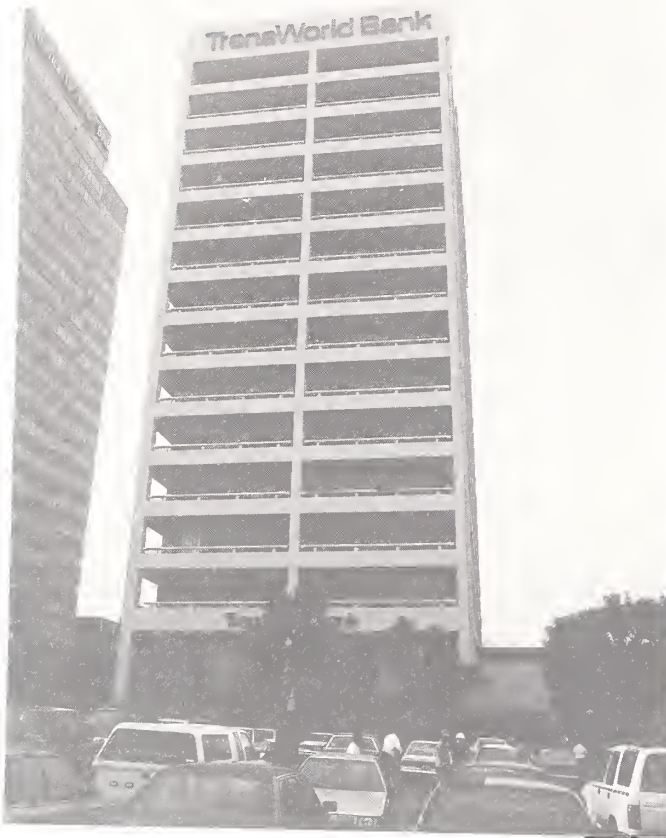
The business district along Ventura Boulevard in Sherman Oaks was another area with significant numbers of badly damaged buildings. The 13-story Trans World Bank Building is located at 15233 Ventura Boulevard (fig. 3.53). There is a two-level underground garage below the building and a mechanical penthouse on the roof. This reinforced concrete frame building was designed under the 1964 Los Angeles City code. Structural damage was in the first-story columns, primarily at the second-floor beam-column joints. Identical failures occurred during the 1971 San Fernando earthquake. The damaged joints were repaired with epoxy shortly after the 1994 earthquake (fig. 3.54).

Figure 3.53. The Trans World Bank building, in Sherman Oaks, was damaged in both the 1971 San Fernando and 1994 Northridge earthquakes.

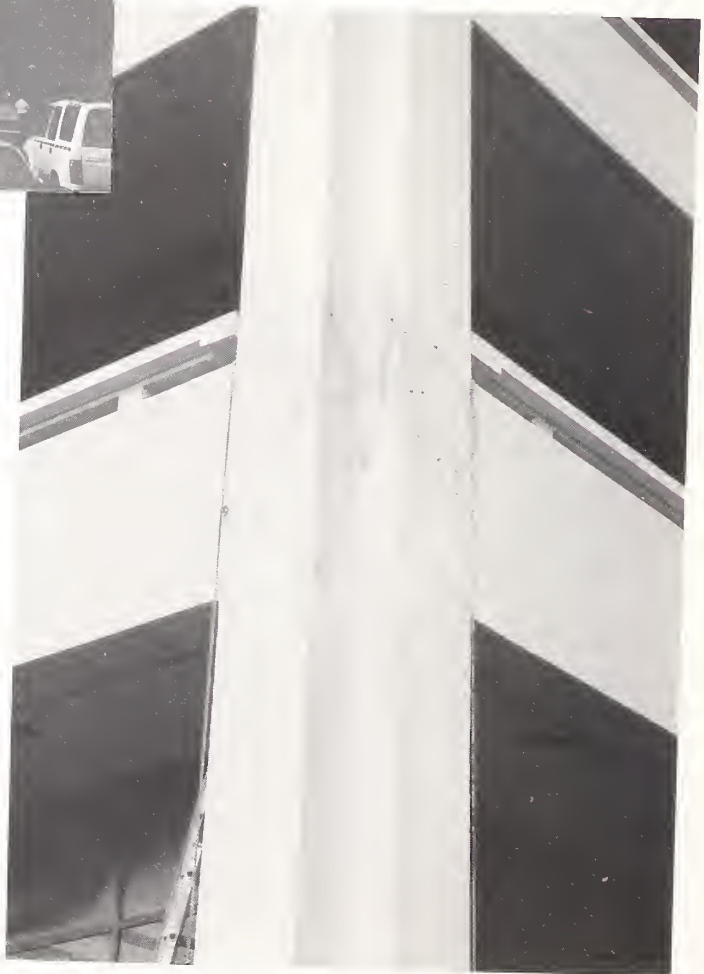
Figure 3.54. The cracked beam-column joints between the first and second stories of the Trans World Bank building were repaired using epoxy injection.

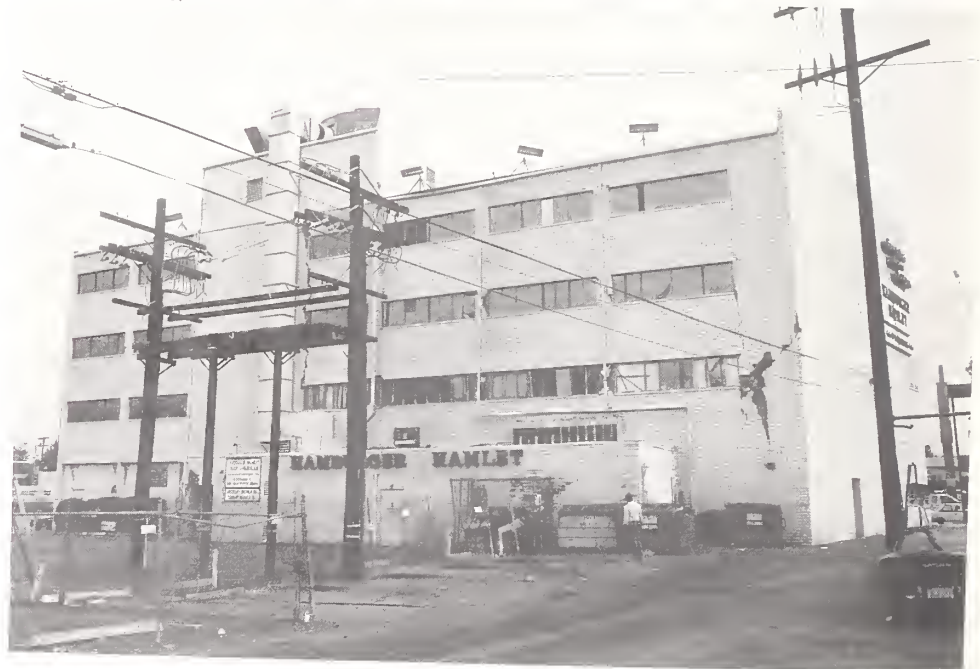
A four-story steel frame structure located at the intersection of Moorpark Street and Cedros Avenue in Sherman Oaks was shaken seriously during the earthquake (fig. 3.58). The exterior reinforced masonry wall was cracked in many places, particularly at the second floor level (fig. 3.59). The evidence of large ground shaking in the Sherman Oaks area was also seen by serious lateral displacements of single family houses and three-story apartment buildings from their foundation. In fact, a strong-motion instrument station in Tarzana located only a few kilometers away from this general area recorded the largest acceleration in this earthquake (1.82g horizontal, 1.18g vertical).

Figure 3.59. A close-up view of the damage shows the pattern of reinforcing used in the masonry facade.

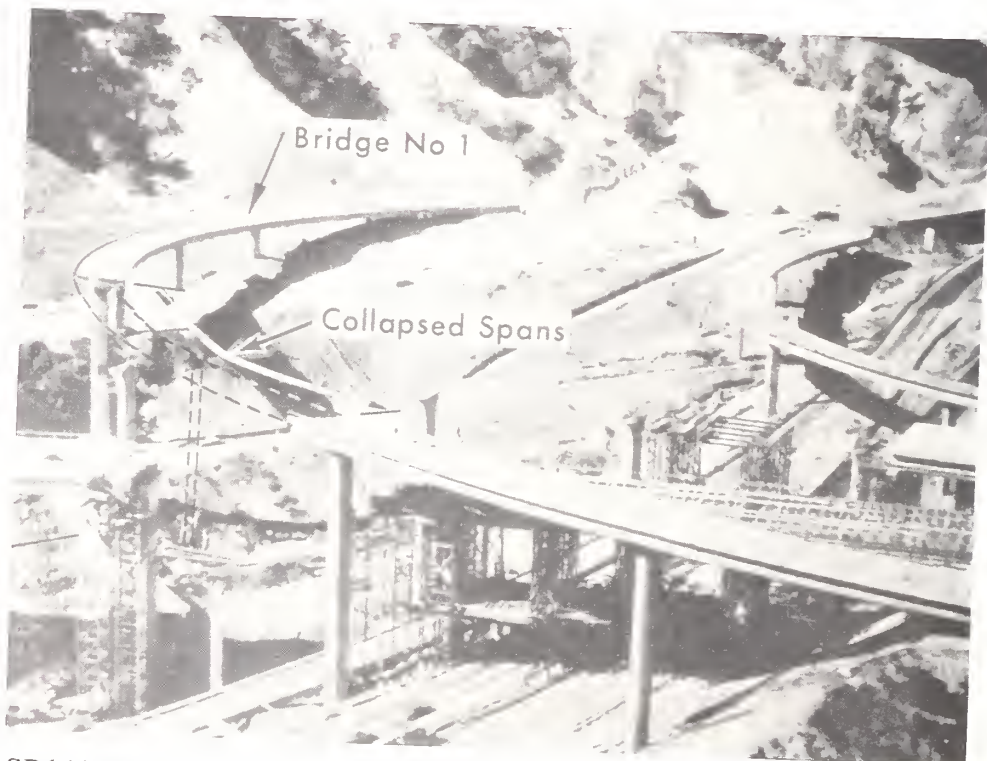
This interchange was designed in 1968 and was under construction in 1971 when portions were damaged by the San Fernando earthquake. At that time, one of the completed ramps in the interchange collapsed, and two ramps which were under construction were damaged. The portion which collapsed in 1971 was the South Connector Overcrossing, connecting southbound I5 with eastbound SR14. A photograph of the collapsed ramp, taken in 1971, is shown in figure 4.8. This ramp was later rebuilt, with improved pier reinforcement, and it suffered no significant damage in the Northridge earthquake. The damaged portions of the other two ramps under construction in 1971 were repaired in place, but not strengthened; the portions not yet constructed were completed with limited seismic upgrading. Both of the ramps which partially collapsed in the Northridge earthquake were under construction at the time of the 1971 earthquake.

Figure 4.8. SR14/I5 interchange after the 1971 San Fernando earthquake. View looking to the west, showing collapsed South Connector Overcrossing.

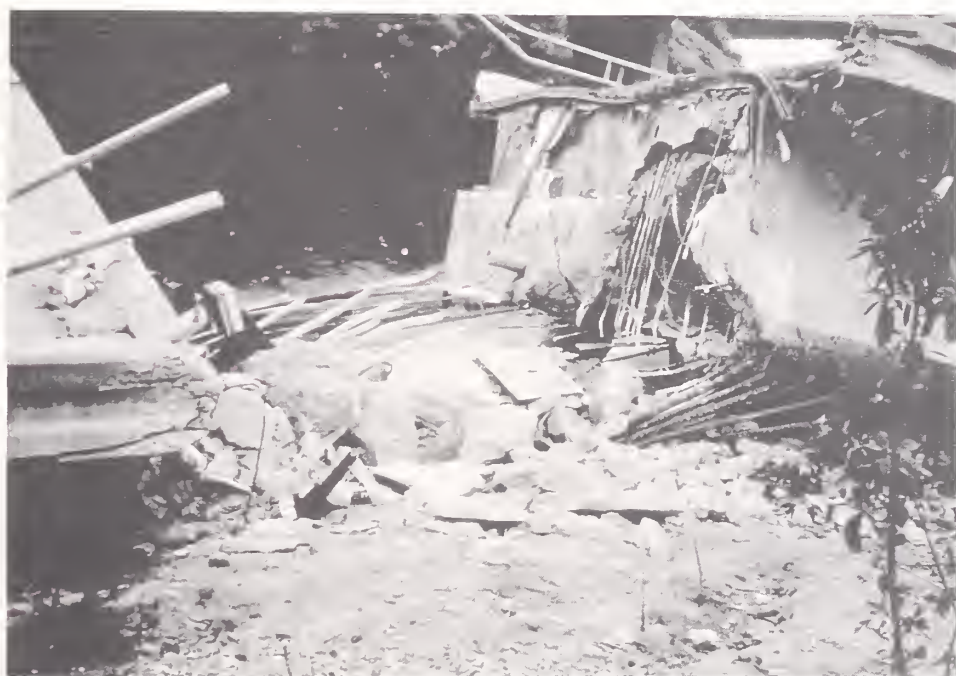
Figure 4.16. View of crushed Pier 2 and the hinge near Pier 2 (Photo courtesy EERC).

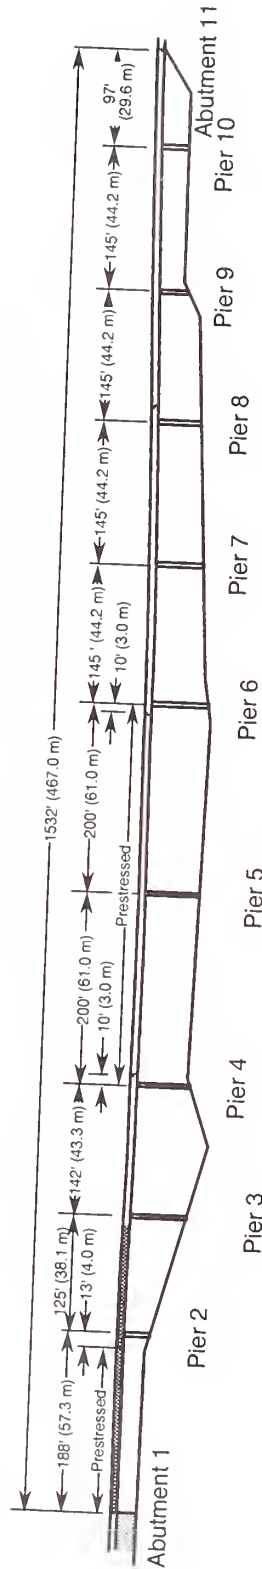
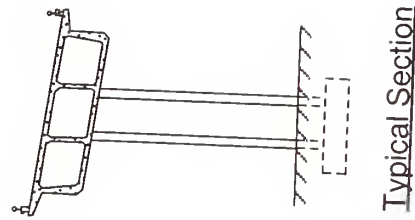
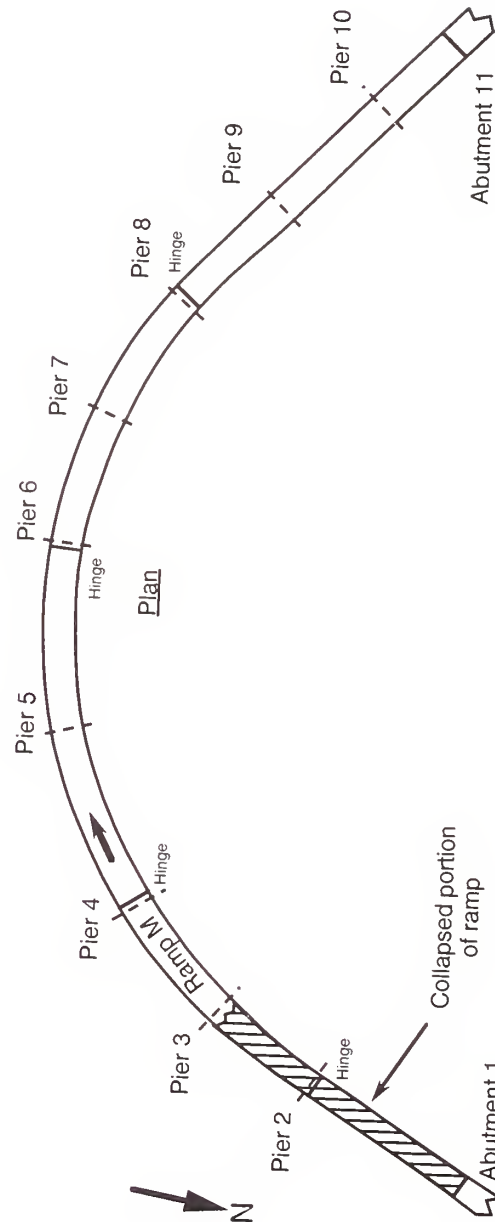
Figure 4.17. Plan and elevation view of the SR14/15 North Connector Overcrossing.

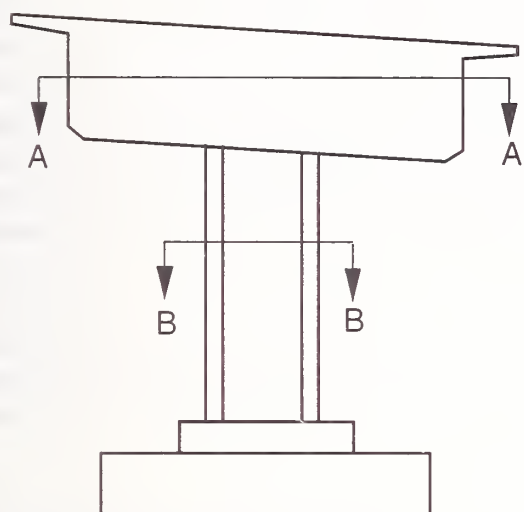
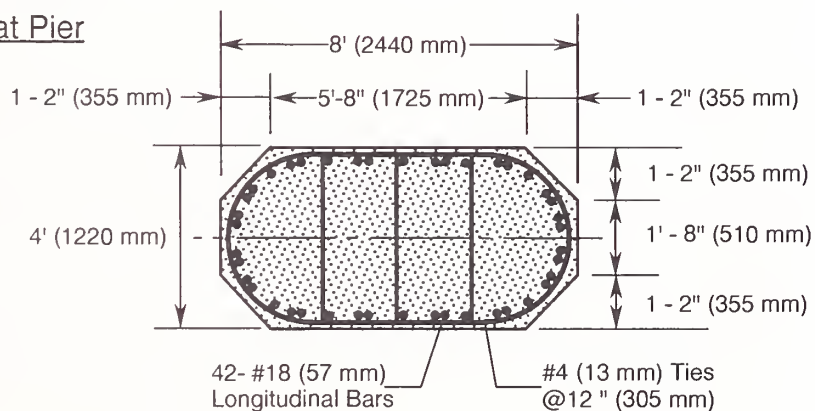
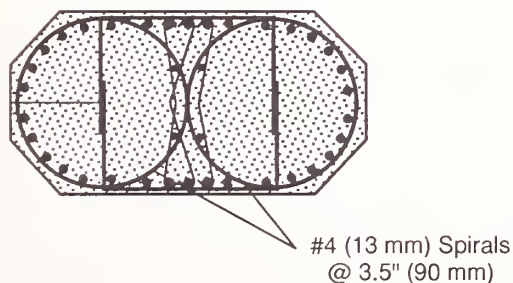
Figure 4.18. Reinforcement details for Pier 2 of the SR14/I5 North Connector Overcrossing, Ramp M.

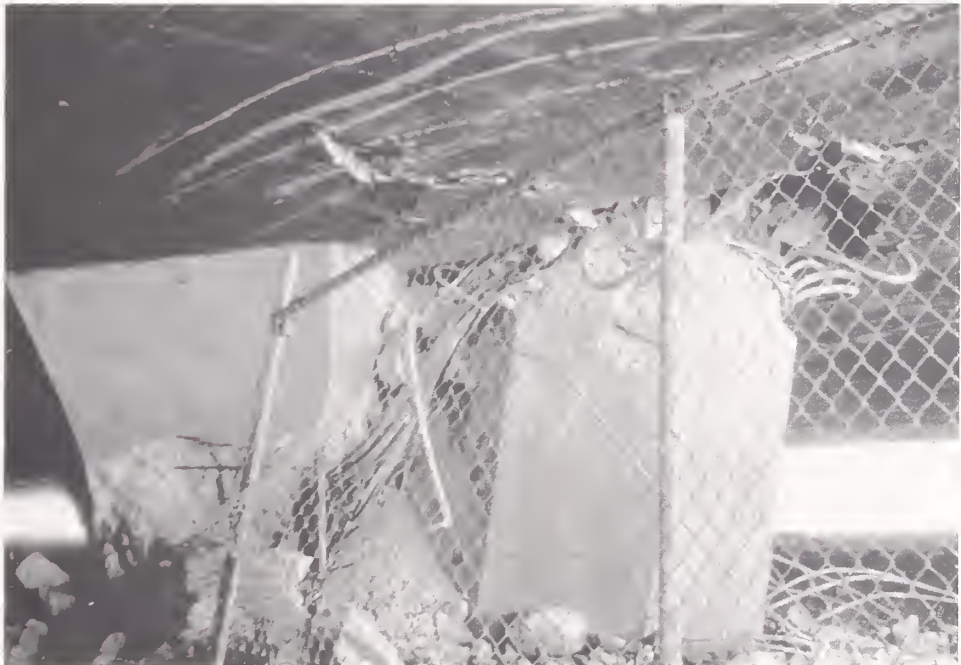
The likely failure mode of the bridge was that the piers initially suffered severe shear damage, followed by crushing of a number of piers in compression. The structure may also have shifted to the southwest, as constrained by the geometry of the abutments. Although unseating at Abutment 5 did occur, this was probably a secondary effect, as the seat lengths were generous by current standards. Rather, failure was probably initiated by damage to the piers. In this case the failure of piers has important theoretical implications, as the piers of this bridge contained quantities of lateral reinforcement similar to those required by current seismic design standards. Therefore, further research will be required to determine why the pier reinforcement was inadequate in this case.

Figure 4.22. Damage to a pier of the SR118 Mission-gothic Undercrossing, looking to the west at Bent 4 of the eastbound bridge, which collapsed (Photo courtesy of EERC).

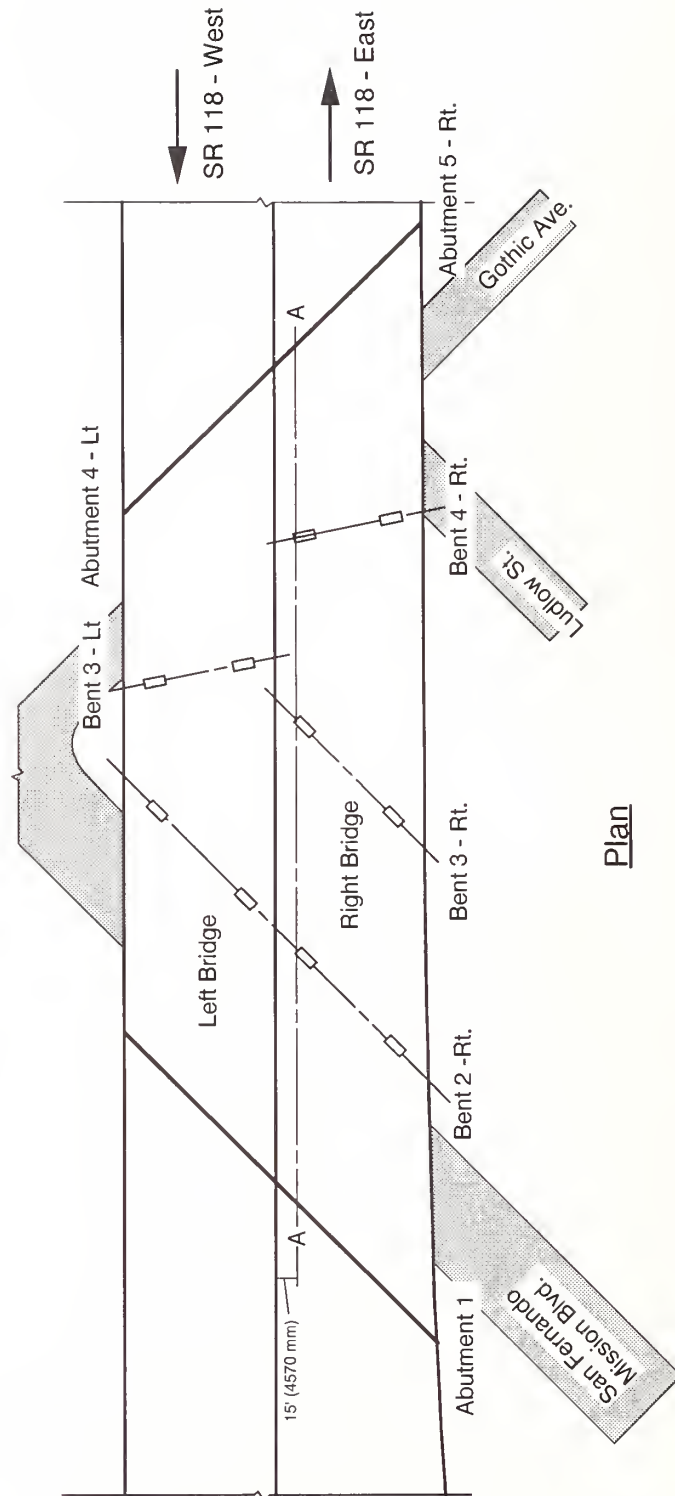
The first important feature of the bridge is its irregular geometry. Figure 4.23 shows that the plan shape of the bridge is a trapezoid. Thus, because of the orientations of the abutments, the structure was constrained to move in only one lateral direction during the earthquake, roughly to the southwest. Indeed, figures 4.21 and 4.22 show that the superstructure moved in this direction, creating a diagonal shear failures in many of the piers. There is also a highly irregular placement of piers, dictated in part by the trapezoidal plan shape of the bridge, and in part by right-of-way restrictions. The irregular plan shape and placement of piers created asymmetric stiffness and mass distributions, which undoubtedly lead to some piers being more heavily loaded than others during the earthquake. Detailed analyses will be required to determine how lateral earthquake loads were distributed among the piers.

Figure 4.23. Plan and elevation views of the SR118 Mission-Gothic Undercrossing.

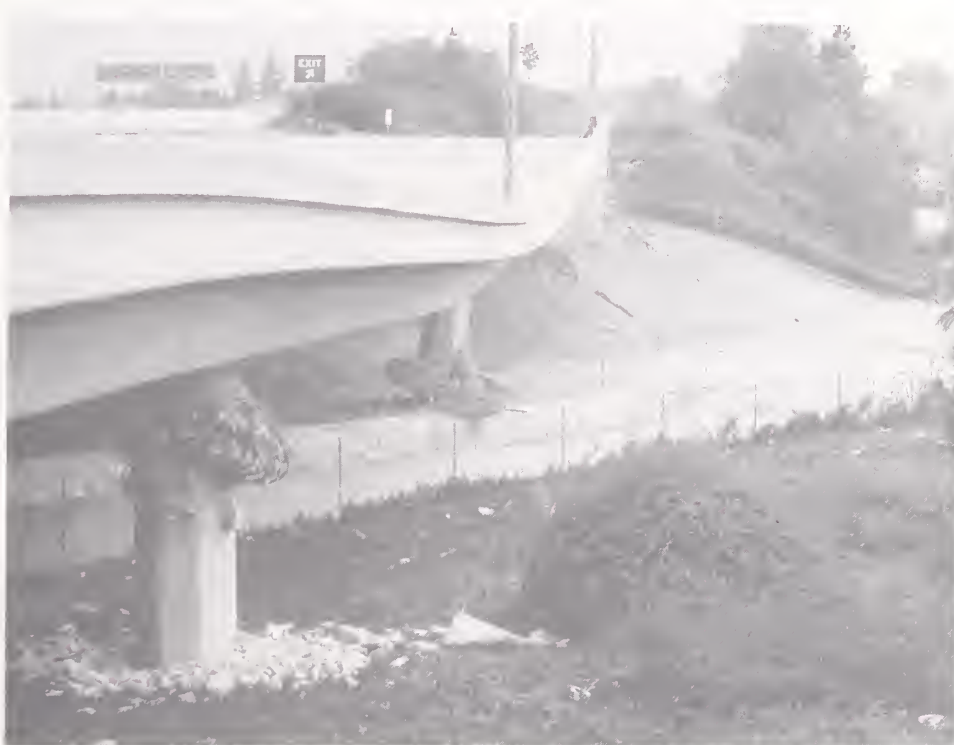
All ten of the piers in Bent 3 failed in combined shear and compression near their bases, as shown by figures 4.27 and 4.28. In Bent 2, Piers on the south side of the span failed near their top end, as shown in the left foreground of figure 4.26, and the damage became progressively less for piers to the north in Bent 2. The farthest north piers in Bent 2 showed relatively little damage - only diagonal shear cracks near the base, with no spalled concrete. This uneven distribution of damage to piers was probably caused by the asymmetric plan geometry of the bridge, as shown in figure 4.29.

Figure 4.26. Ground-level view of State Route 118 at Bull Creek Canyon Channel, looking along the south edge, towards the east.

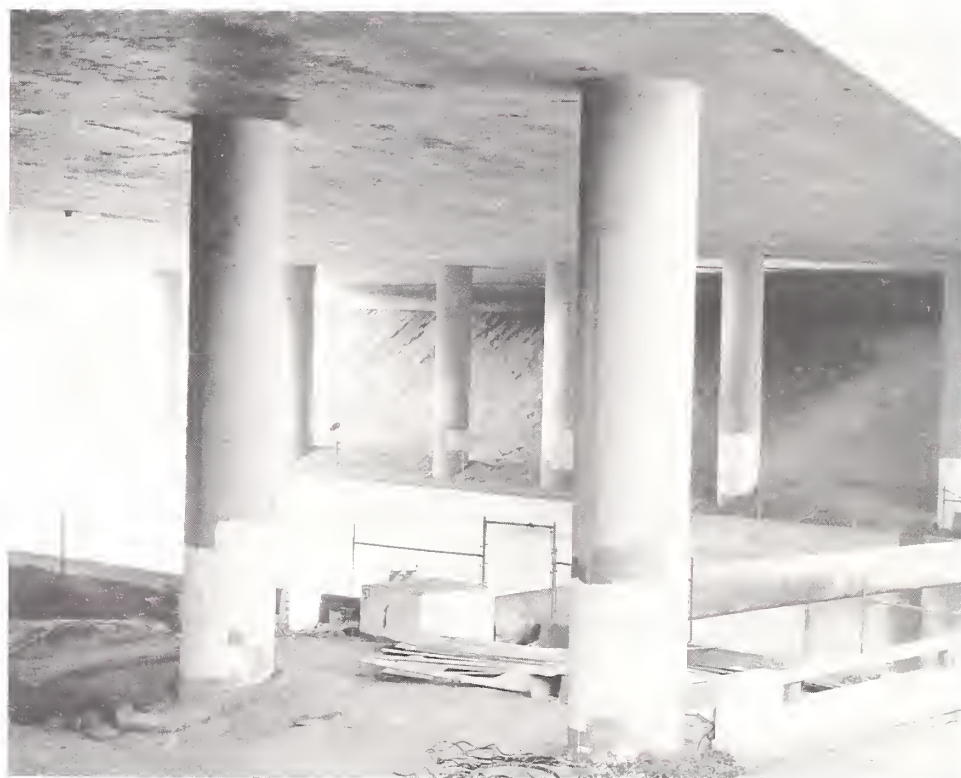
Between the two bridges which collapsed, I10 passes over Ballona Creek. Figure 4.33 is a view looking toward the southwest of the spans over the creek. There was essentially no damage to the supporting piers. Adjacent to the bridge over Ballona Creek, there is a westbound ramp which exits from I10 to Cadillac Ave. A portion of this ramp is supported by single piers which have been retrofitted with steel jackets, as shown in figure 4.34. No damage was noted to these retrofitted piers. The Cadillac Ave. ramp represents the only case known to the authors where undamaged retrofitted piers were located close to major collapse sites. However, because the retrofitted Cadillac Ave. ramp piers were immediately adjacent to an older, non-retrofitted multispan bridge which was undamaged (the Ballona Creek overpass), it is not known whether the Cadillac Ave. ramp piers were subjected to the same levels of lateral forces as piers at the two collapse sites at La Cienega-Venice and Fairfax-Washington.

Figure 4.33. I10 Bridge over Ballona Creek, looking to the southwest.

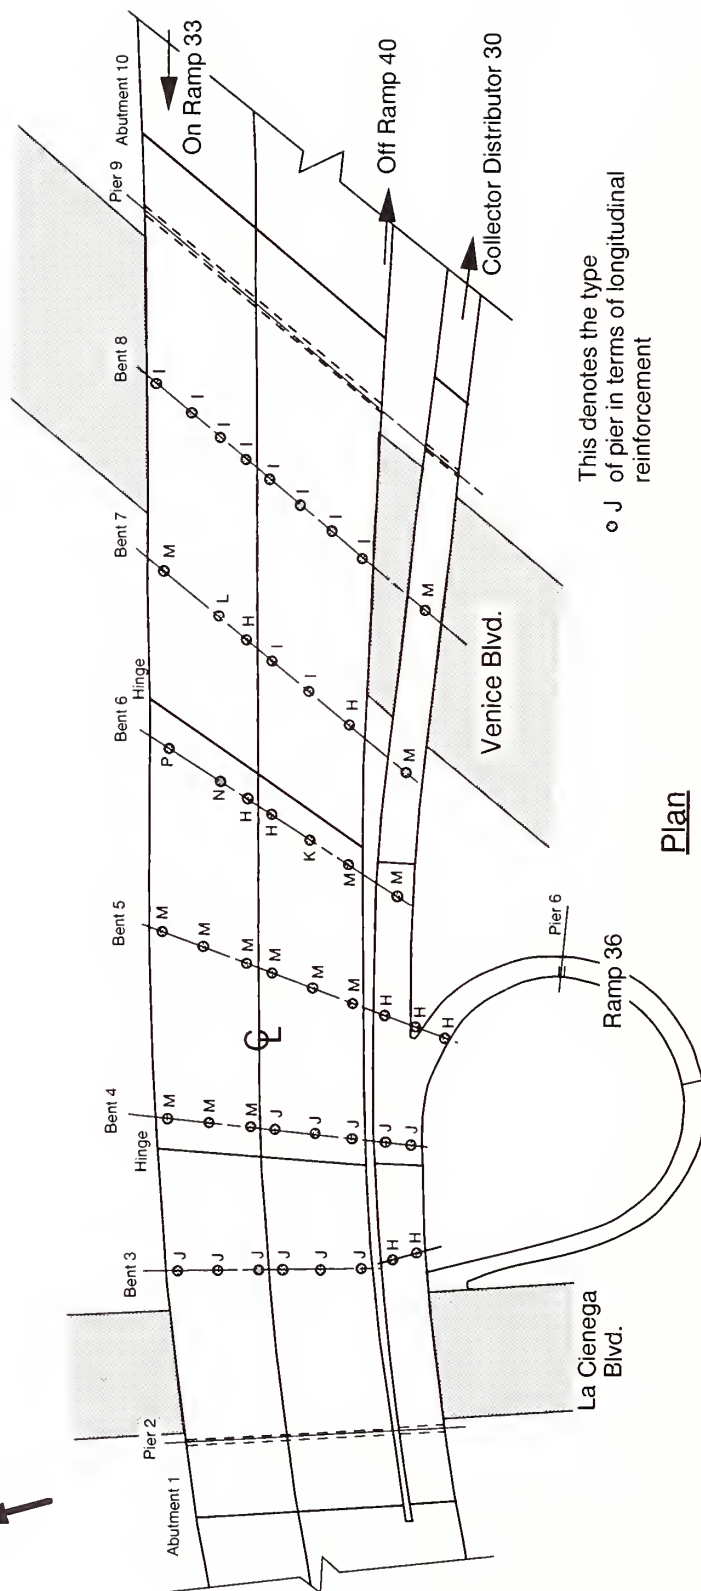
Figure 4.36. Elevation and plan of I10 Separation at La Cienega Blvd. and Venice Blvd.

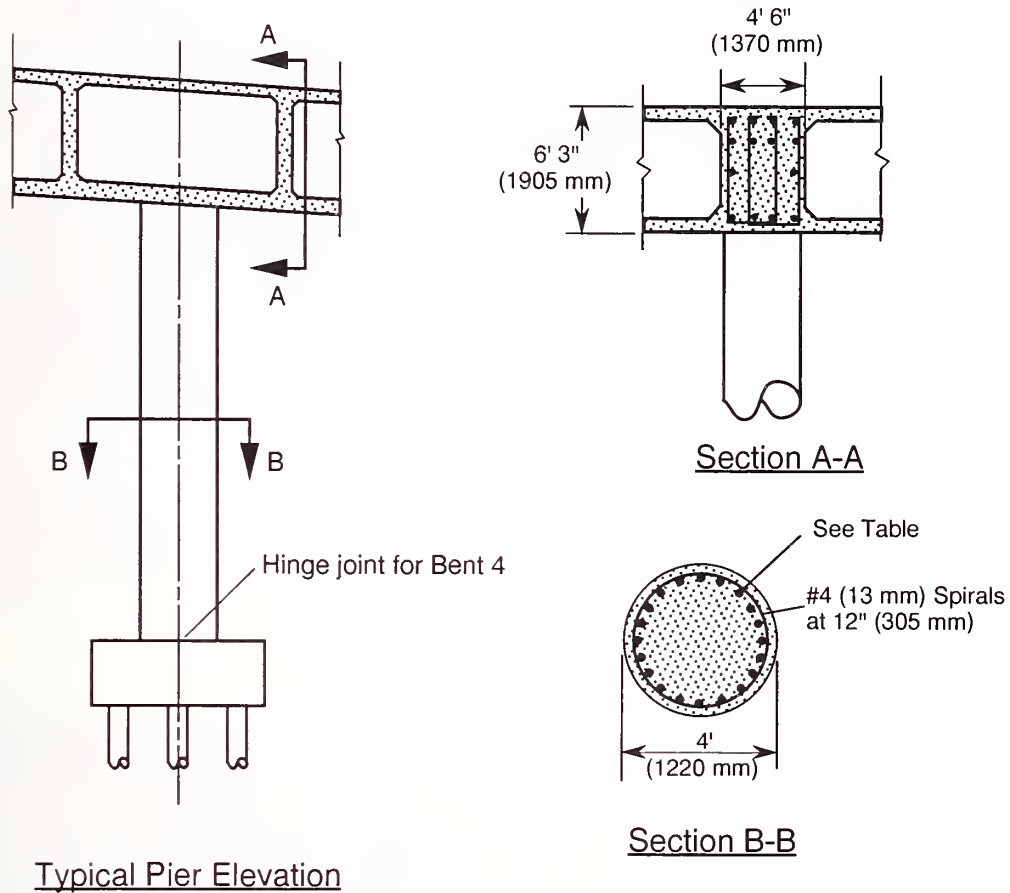
Figure 4.37. Pier details for I10 Separation at La Cienega Blvd. and Venice Blvd.

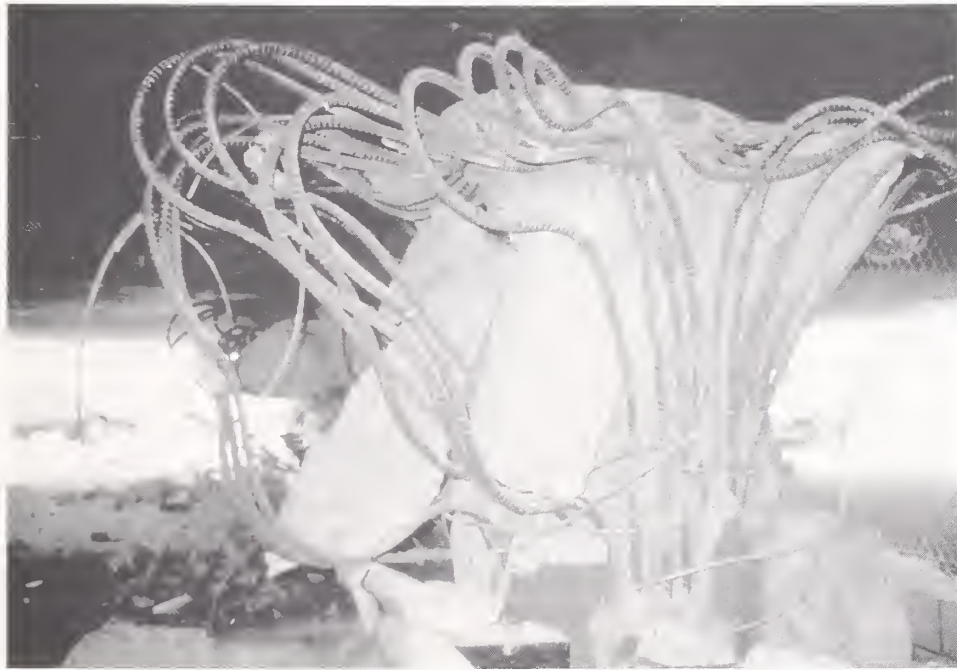
Figure 4.45. Failed column in Bent 3 of I10 at Fairfax Ave. (Photo courtesy of EERC).

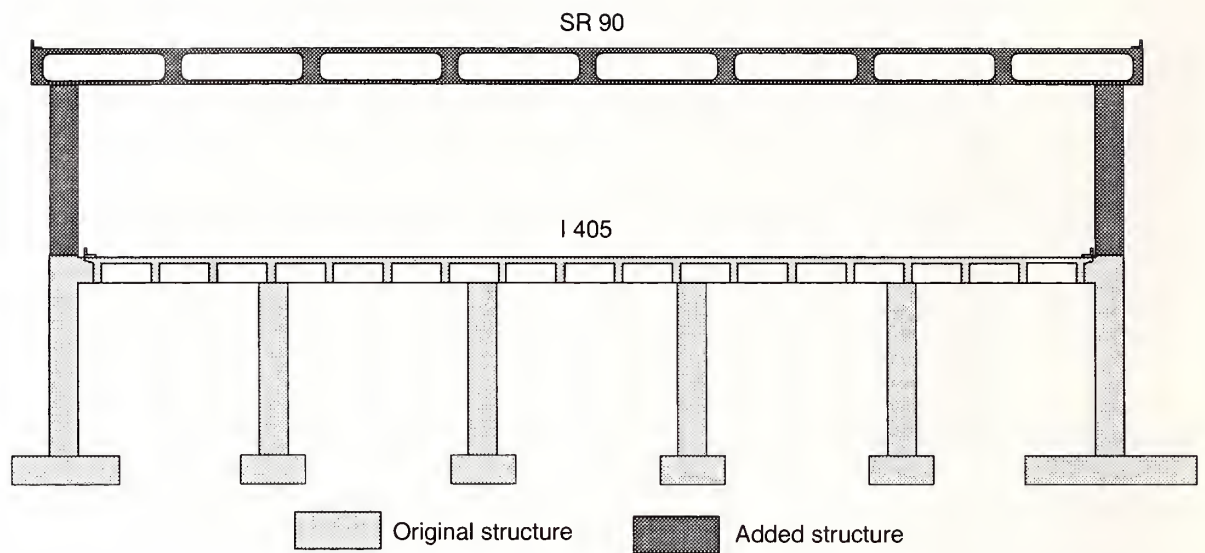
This bridge was constructed in about 1961, so generally speaking it does not meet current seismic design standards. The bridge is somewhat unusual because in the original design allowances were made for future construction of the ramps of the SR90/I405 interchange passing overhead: the outermost piers of the bridge were more heavily reinforced to allow for later extensions of the height of those piers. The reinforcement in the exterior piers consisted of 22 #18 bars (57 mm) longitudinally, and #5 bar (16 mm) spiral hoops spaced at 114 mm (4.5 in); the inner piers were reinforced with 14 #9 bars (29 mm) longitudinally, and #4 (13 mm) spirals spaced at 305 mm (12 in). The exterior piers were later extended in height, as can be seen in figure 4.53. It is not clear how structural continuity was achieved between the original exterior piers and the pier extensions, since no explicit provisions were made in the original design for extending the longitudinal reinforcement.

Figure 4.55. Schematic cross section, showing columns shared by SR90 and the Jefferson Boulevard Undercrossing.

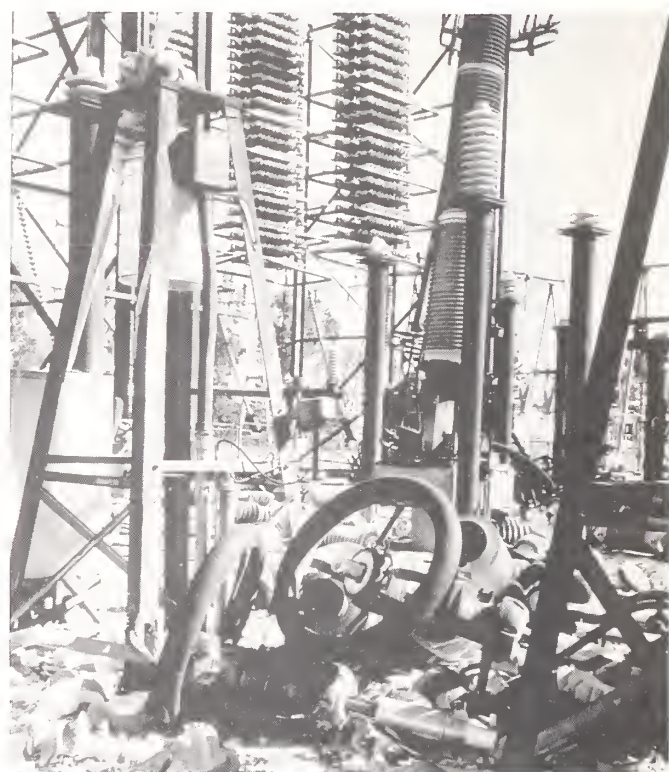
Figure 5.16. Porcelain is an integral part of high voltage electrical equipment due to insulation requirements and is also the most vulnerable to damage during strong earthquake shaking. (Photo courtesy of Edward Matsuda, Pacific Gas and Electric Company.)

- Improved methods for avoiding damage to high voltage substations should be developed. New materials are needed to replace the brittle porcelain insulators. Better switch systems should be developed and installed to prevent blackouts. Failures of foundations for transmission towers should be thoroughly investigated.

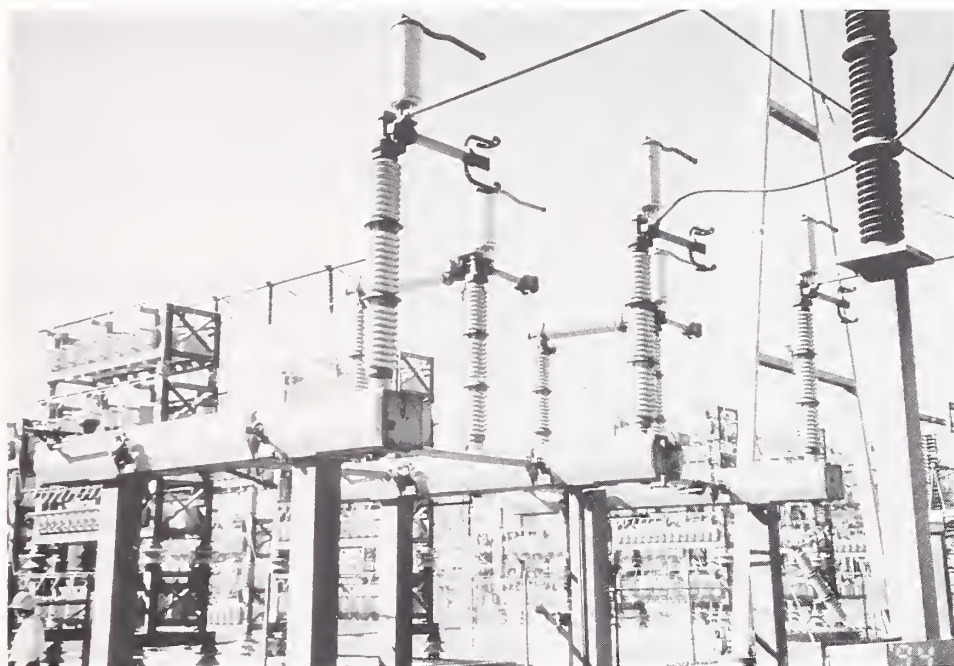
Figure 5.17. Most of the 230-kV circuit switchers (in the forefront) at the Sylmar substation were damaged. Most of the capacitor banks (in the background) performed well in this earthquake, whereas most collapsed during the 1971 quake. (Photo courtesy of Edward Matsuda of Pacific Gas and Electric Company.)
