Performance of Physical Structures in  
Hurricane Katrina and Hurricane Rita:  
A Reconnaissance Report

# NIST Technical Note 1476

*National Institute of Standards and Technology  
Gaithersburg, MD 20899*

June 2006

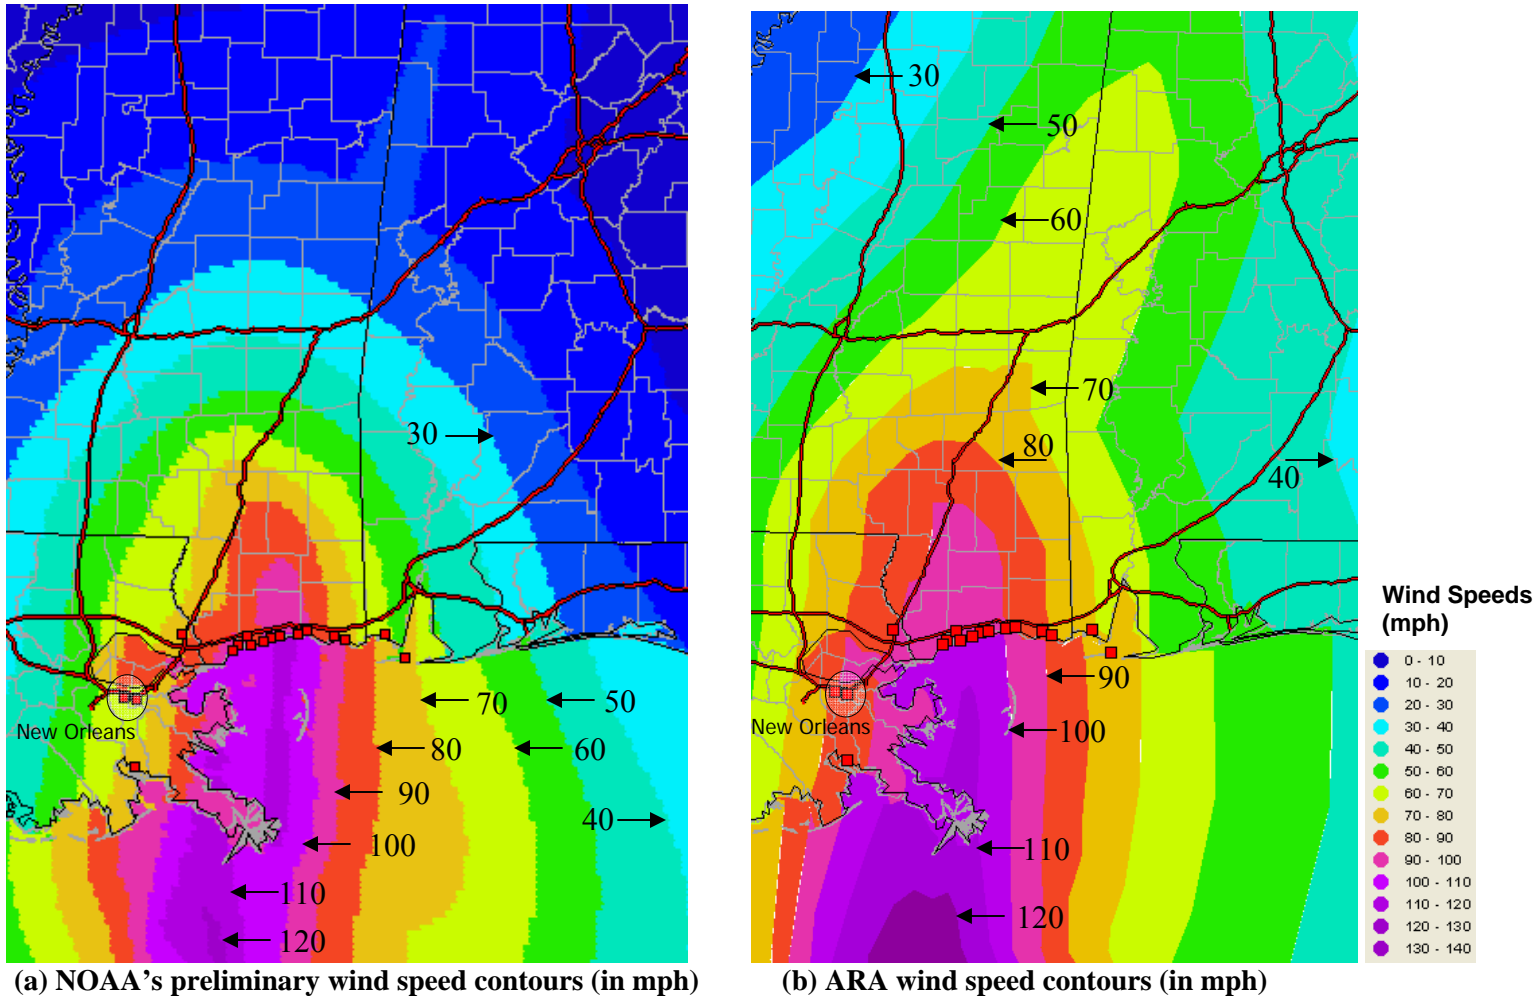
Figure 2-4 shows the estimated maximum sustained wind speeds from Hurricane Katrina for coastal Louisiana and Mississippi, including experimental (preliminary) data from NOAA HRD<sup>11</sup> [7] and final data from ARA [13]. Sustained wind speeds are averaged over a period of 1 minute and are reported at a height of 10 m above the surface. The NOAA’s preliminary maximum sustained wind contours for Hurricane Katrina, as shown in Figure 2-4a, are based on the August 29, 2005 1132 UTC (Universal Time Coordinated, same as Greenwich Mean Time) landfall analysis [14]. Figure 2-4b shows the final ARA estimated (modeled) maximum sustained wind speeds for Hurricane Katrina. The analysis of maximum sustained wind speeds is based on the ARA hurricane wind field model [12] and key hurricane parameters obtained by ARA from the National Hurricane Center.

Both Figs. 2-4a and 2-4b indicate that the maximum open-country equivalent sustained wind speed at landfall for Hurricane Katrina was between 110 mph and 120 mph. The ARA map, however, shows open-country equivalent sustained high winds (e.g., 80 mph or greater) extending over larger areas than in the NOAA's preliminary wind map. While the NOAA preliminary contour map shows only three counties affected by wind speeds higher than 90 mph at landfall, the ARA map shows at least six counties affected by winds of 90 mph or greater. In New Orleans, the ARA maps suggest that open-country equivalent sustained wind speeds reached as high as 90 mph, while NOAA's preliminary maps indicate that the sustained winds were 80 mph or less. One possible reason for differences in the NOAA and ARA maps is the use of different inland wind-speed decay models [26]. Other reasons may include differences in the formulation of the models. The NOAA H\* wind product is created by translating all upper level and surface data into functions to create an overall wind field model. The ARA model is based on an analytical formulation that uses key parameters such as central pressure, maximum wind translation speed, and radius to generate the wind field. The two models generally have predicted similar estimates of peak wind speeds (within a few mph) for all storms analyzed over the past two years, but typically produce different geographic distributions of the winds.

**Figure 2-4** Estimated maximum sustained wind speeds (mph) at 10 m above surface for Hurricane Katrina (using the August 29, 1132 UTC landfall analysis). NIST reconnaissance sites are shown as red squares (Source: (a) NOAA; (b) with permission from Peter Vickery, ARA. Enhanced by Ron T. Eguchi, ImageCat)

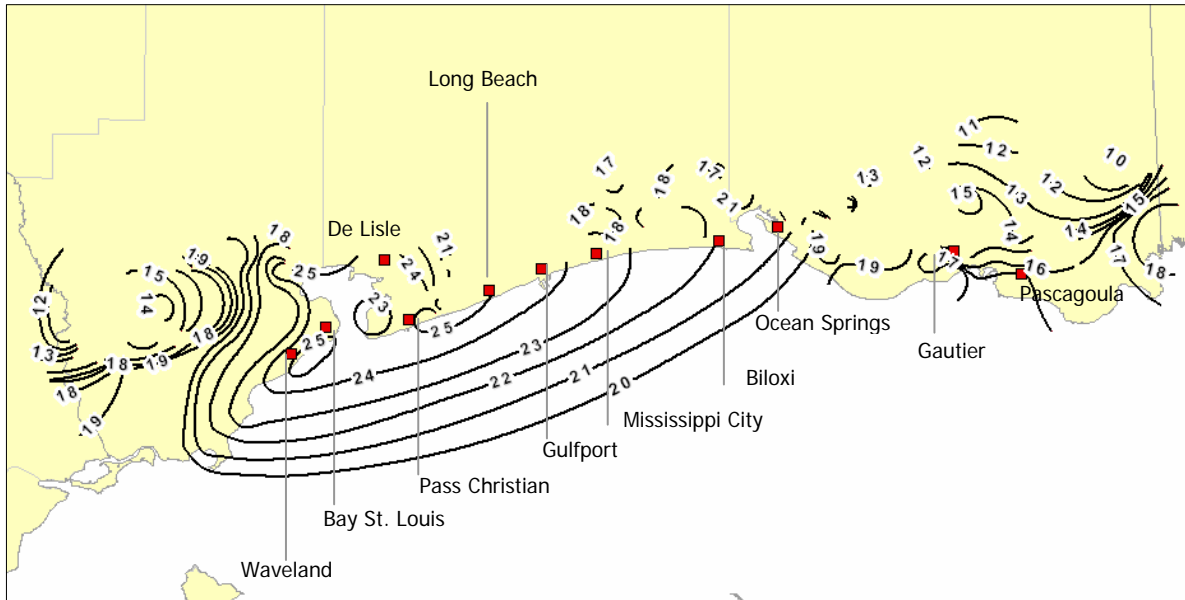
**Figure 2-10** Storm Surge contours for Mississippi, as mapped by FEMA (heights measured in feet). Note: red squares indicate sites inspected by NIST-led reconnaissance team (Source: FEMA, enhanced by Ron T. Eguchi, ImageCat)

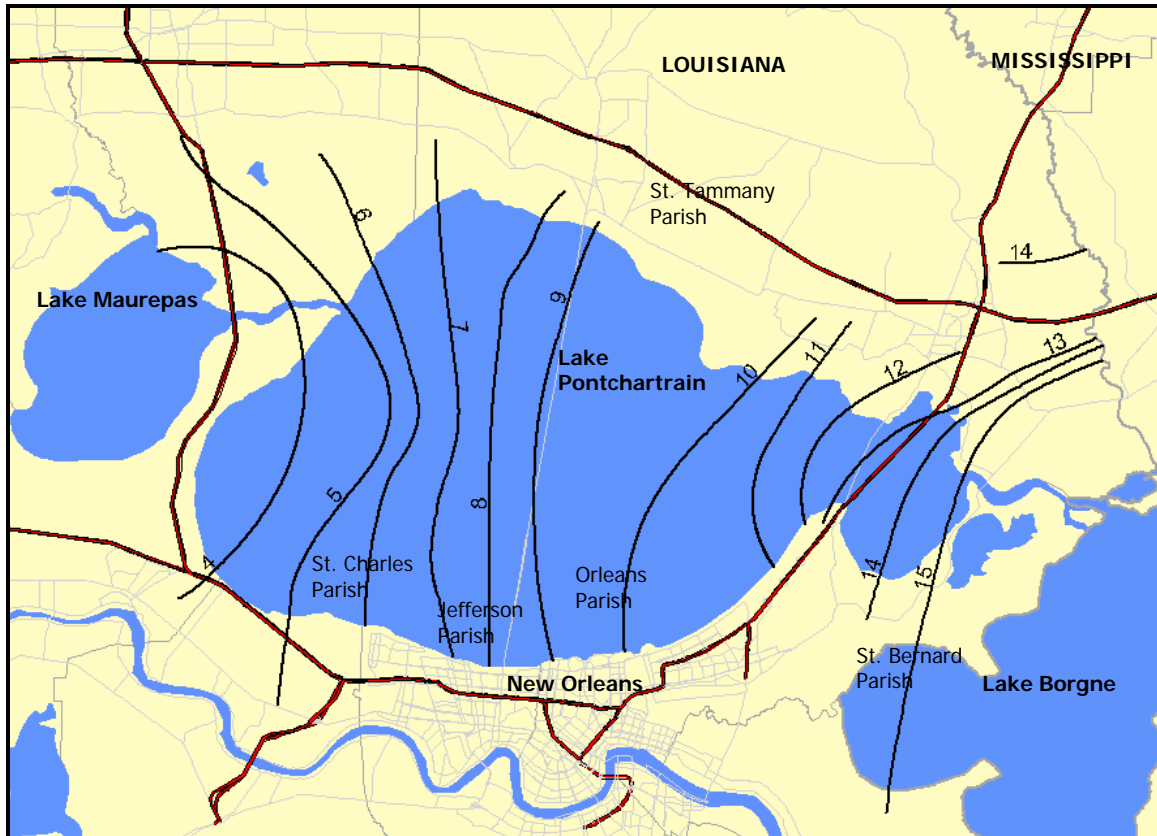
A storm surge contour map was also created for the New Orleans area of southeastern Louisiana. The spatial coverage of these contours included Tammany, Tangipahoa, St. John the Baptist, St. Charles, Jefferson, and Orleans Parishes. Figure 2-11 depicts surge elevation contours calculated from post-Katrina HWMs collected along the Gulf of Mexico, Lake Borgne, and Lake Pontchartrain coastlines of Louisiana.

**Figure 2-11** Storm surge contours (heights measured in feet) for the New Orleans area of southeastern Louisiana, as mapped by FEMA (Source: FEMA, enhanced by Ron T. Eguchi, ImageCat)

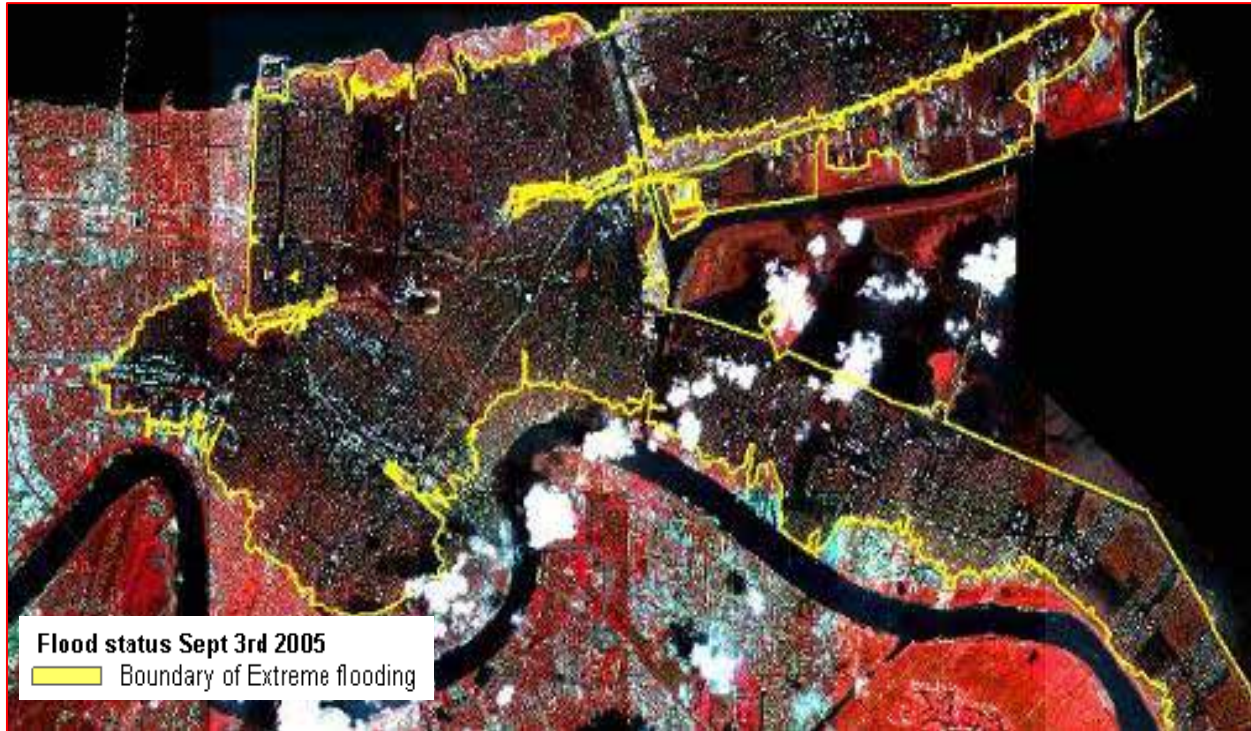
A determination of flood extent for a larger area of New Orleans, including sections of Jefferson and St. Bernard Parishes, was made by MCEER researchers using high-resolution QuickBird satellite imagery from DigitalGlobe [19]. The resulting flood extent boundary is shown in Figure 2-14.

The flood boundary in Figure 2-14 was visually compared with an automatically-generated spectral classification of the inundated area, obtained from moderate resolution (30m) Landsat 5 coverage. The Landsat coverage was captured on August 30, 2005 and posted by the USGS on September 3, 2005. From Figure 2-14, the Landsat image corresponds with QuickBird™ coverage for metropolitan New Orleans. Although a comparison is precluded in some areas due to cloud cover, the degree of correspondence between the QuickBird™ flood line and the classified flood extent is generally high.

**Figure 2-14** Expert interpretation of flood limit (yellow lines) overlaid onto DigitalGlobe QuickBird “false color” composite image of New Orleans (September 3, 2005). (Photo courtesy of DigitalGlobe, enhanced by Ron T. Eguchi, ImageCat)

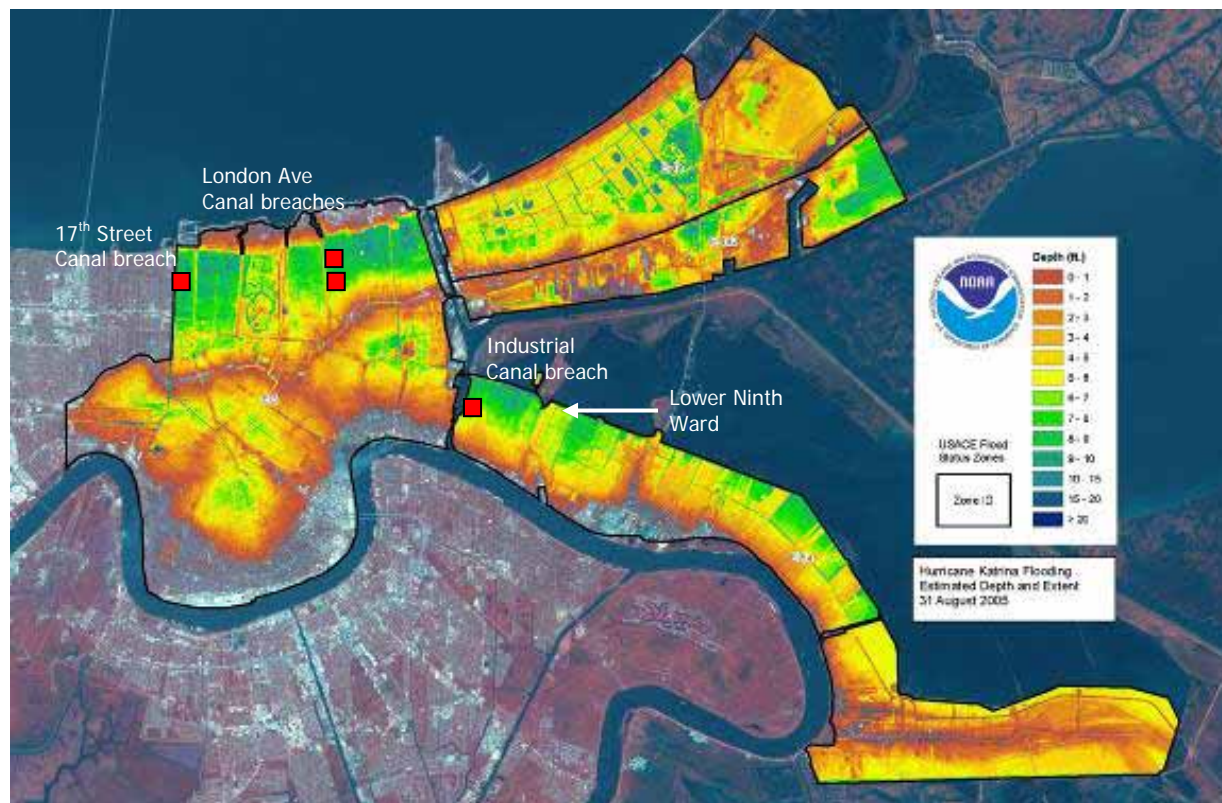
**(1) Flood depth maps produced by NOAA:** NOAA’s flood depth map for August 31, 2005 was developed using a combination of satellite imagery from the National Geospatial Intelligence Agency and LIDAR (Light Detection and Ranging) data from Louisiana State University and the State of Louisiana. This map (Figure 2-15) shows that many areas of New Orleans were covered by at least 7 feet to 9 feet of water, with some areas exceeding 20 feet. The extent of flooding (surface-wise) shown in Figure 2-15 corresponds well with the flood boundary delineations made in Figure 2-14. In both cases, independent data sources (i.e., high-resolution optical imagery and LIDAR) were used to determine the flood extent boundaries.

**Figure 2-15** Flood depth estimation for New Orleans by NOAA, 31 August 2005 (Source: NOAA [25], enhanced by Ron T. Eguchi, ImageCat).

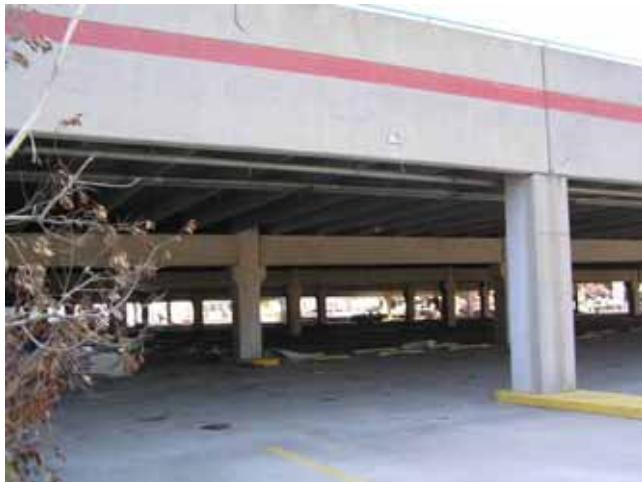
**Figure 3-2 Successful performance of a single-story parking structure in Biloxi, MS (Photo credit: NIST).**

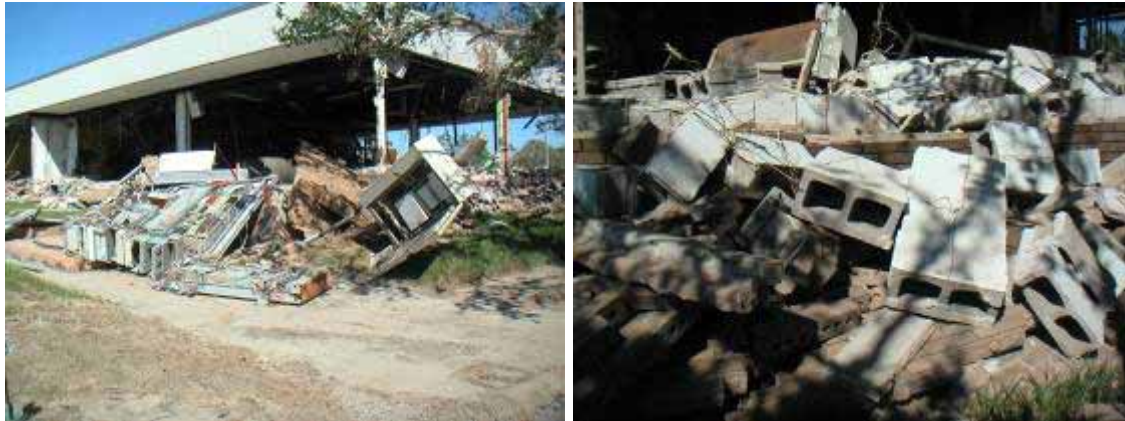
The Venetian Isles Fire Station in New Orleans is a single-story building with steel columns, concrete masonry infill walls, and brick veneer. Storm surge collapsed the ungrouted and unreinforced CMU walls of the building but left the columns and roof standing (Figure 3-4).

**Figure 3-4 Storm-surge-induced collapse of CMU walls at the Venetian Isles Fire Station in New Orleans (Photo credit: Keith Porter, Scawthorn Porter Associates).**

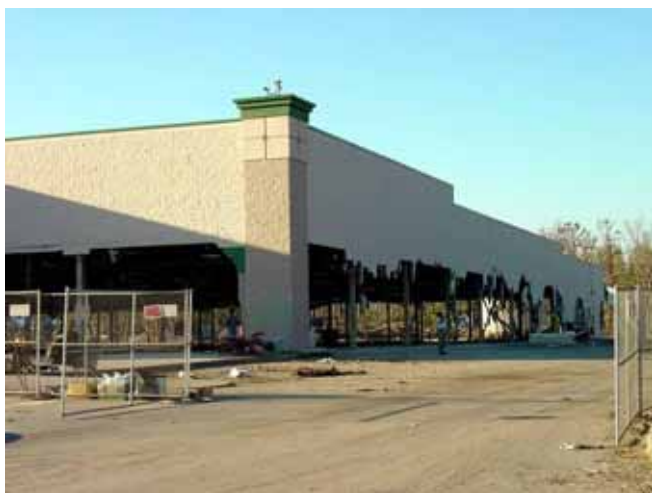
Figure 3-5 shows the effects of storm surge on a similarly constructed building, but with reinforced CMU walls. This retail store is located on US 90 west of Gulfport and fronts almost immediately on the Gulf. The storm surge here would have been approximately 30 ft above mean sea level. The lower portion of the walls around most of the entire building's perimeter was destroyed by the surge, but the upper portion stayed in place owing to the reinforcement in the CMU walls.

**Figure 3-5 Storm-surge-induced collapse of the lower portions to a reinforced CMU wall in Gulfport, MS (Photo credit: Habib Rahman, National Research Council of Canada).**

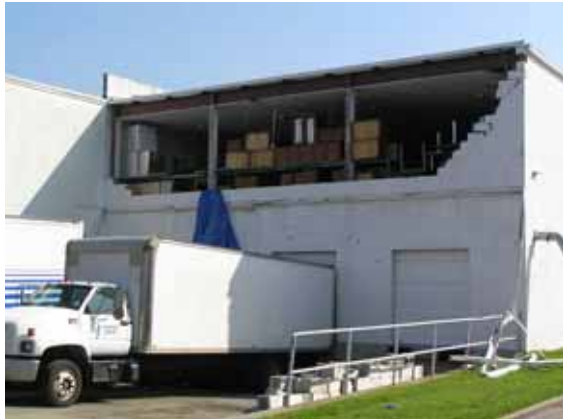
Strong winds in areas of the NIST-led reconnaissance not exposed to storm surge also induced damage to masonry walls. A two-story, steel framed warehouse in Beaumont, TX, with unreinforced and ungrouted masonry block wall infill failed due to wind loads acting on the roof parapet wall (Figure 3-9). The winds

apparently<sup>15</sup> blew the parapet wall over, causing failure of the entire masonry block wall on the second floor. Similar failures of masonry parking deck wind screens were observed in New Orleans: one of the three walls that failed showed evidence that adequate reinforcement and grouting of cells had not been followed, thus likely<sup>15</sup> contributing to the collapse. These types of failures of masonry block walls exemplify the need for adequate reinforcement and anchoring of the walls to the steel structure or roof diaphragm.

**Figure 3-9 Failure of a non-load bearing masonry wall in Beaumont, TX (Photo credit: NIST).**

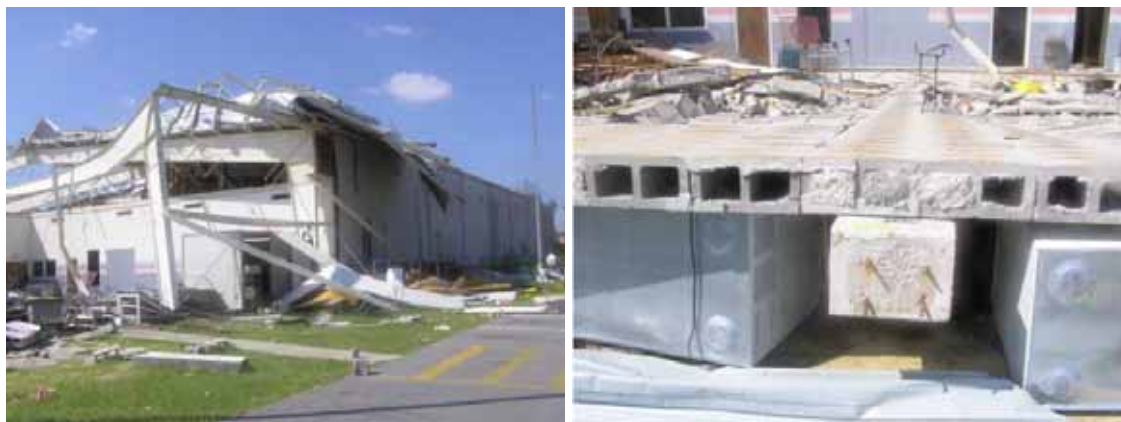
The Gaston Hewes Recreation Center in Gulfport, MS, stands about 0.6 miles from the coast (Figure 3-10). This 1974-built single-bay, single-story metal-framed building had CMU exterior walls backed by perimeter reinforced concrete columns anchored to a concrete slab foundation with four anchor bolts. The NIST-led reconnaissance team observed severe damage due solely to wind, with collapse of the windward masonry exterior wall, partial collapse of the leeward wall and the supporting reinforced concrete columns, and damage to the curtain wall frame near the entrance.

**Figure 3-10 Damage to Gaston Hewes Recreation Center in Gulfport, Mississippi (Photo credit: NIST).**

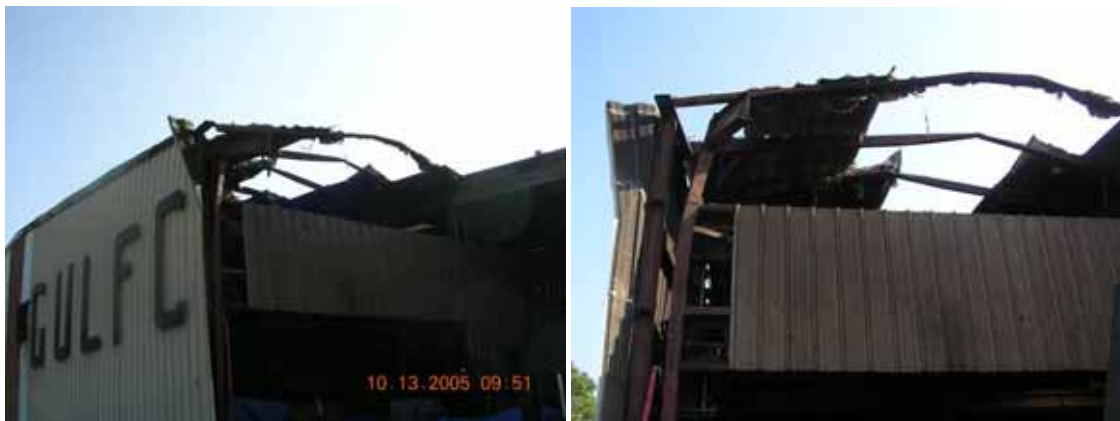
The second partial building collapse observed was at the Gulco Machine and Supply Co. in Beaumont, TX (Figure 3-16). The roof purlins had buckled upward, and the windward wall collapsed inward even though angle bracing was provided between the purlins and the bay frames for added vertical support. A 3 in. by 3 in. steel angle was still securely attached to the floor slab near the corner column's base connection. The failed portion of the building had been removed, so it was unclear if the column to slab connection detail contributed to the column failure. A larger moment resisting frame warehouse at the same facility but about two hundred yards to the east lost the metal roof on the windward bay and had no evidence of buckled purlins or end bay frame failure. Round metal bar cross braces (about 3/4 in diameter) were observed just under the purlins in the end bay, spanning between the frames.

**Figure 3-16** Buckled purlins and collapse of a portion of the end bay of a steel-frame warehouse from wind pressure in Beaumont, TX (Photo credit: NIST).

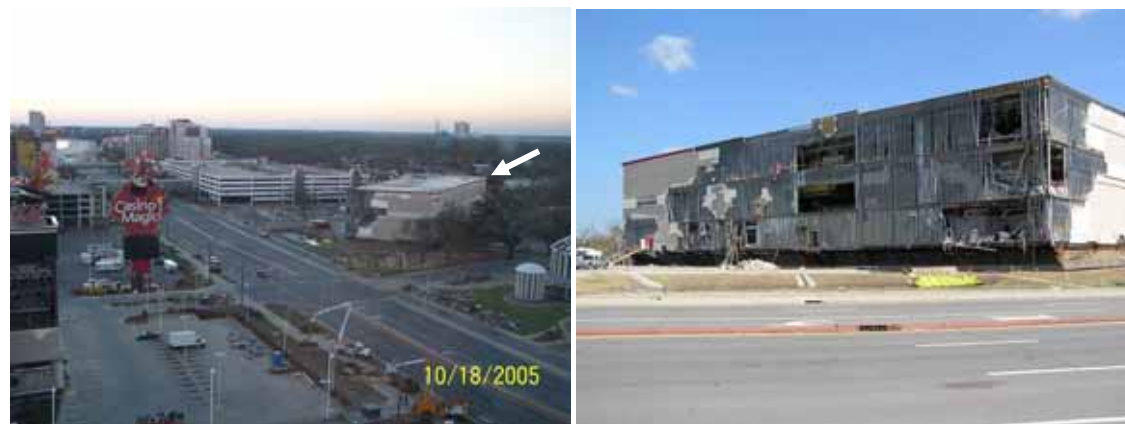
Barges that broke completely free of their moorings were lifted inland by storm surge and caused extensive damage. Figure 3-19 depicts the distances traveled by three of the barges. The barge at the right of Figure 3-19 (furthest east) floated about one-quarter mile inland before coming to rest in an open area next to a circular church structure (see also Figure 3-20). The two other casino barges in Figure 3-19 were moored parallel to one another on the southern side of a hotel. The hulls of both casino barges were filling with water while they were floating inland, as evidenced by large gashes observed alongside the hulls caused by the moorings and by testimony of local contractors hired to dismantle the barges for scrap metal. The longer barge destroyed a house before coming to rest, and the smaller barge to the west collided with a five-story building just north of coastal U.S. Route 90 (see also Figure 3-21a). The building experienced partial collapse of the southeast corner of the lower four stories. The top story at this corner did not collapse, likely<sup>15</sup> because of a redundant load path that transferred gravity loads to bays in both directions. Another, four-story hotel structure was impacted by a casino barge that floated more than half a mile from its original location (Figure 3-21b). Figure 3-22 shows a barge in Biloxi, MS, that did not break free from its moorings but rather sank in place.

**Figure 3-20** Casino barge (arrow) in Biloxi, MS, broke free of its mooring and floated about one-quarter mile inland (Photo credit: NIST).

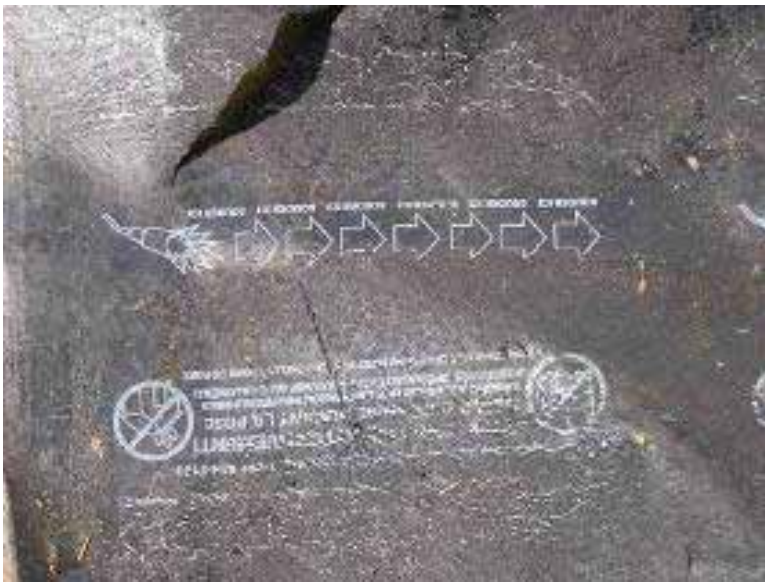
In this regard, where detailed observations of roofing damage on major buildings were made, the NIST reconnaissance team often observed that the installation was not consistent with currently accepted practice as given in manufacturers' literature and trade association guidelines. For example, in many cases, 20 percent to 40 percent of the expected total number of fasteners was omitted. A specific example is given in Figure 3-23 showing a lack of fasteners in the bottom ply of a mechanically attached bituminous membrane. In other cases, asphaltic materials were not sufficiently heated during installation as illustrated in Figure 3-24, which shows the bottom ply of a blown-off, heat-applied, polymer-modified bituminous membrane.

**Figure 3-24** Had this failed heat bonded polymer-modified bitumen membrane been heated in accordance with acceptable practice, the plastic film and white markings would not be present (Photo credit: Robb Smith, Amtech Roofing Consultants).

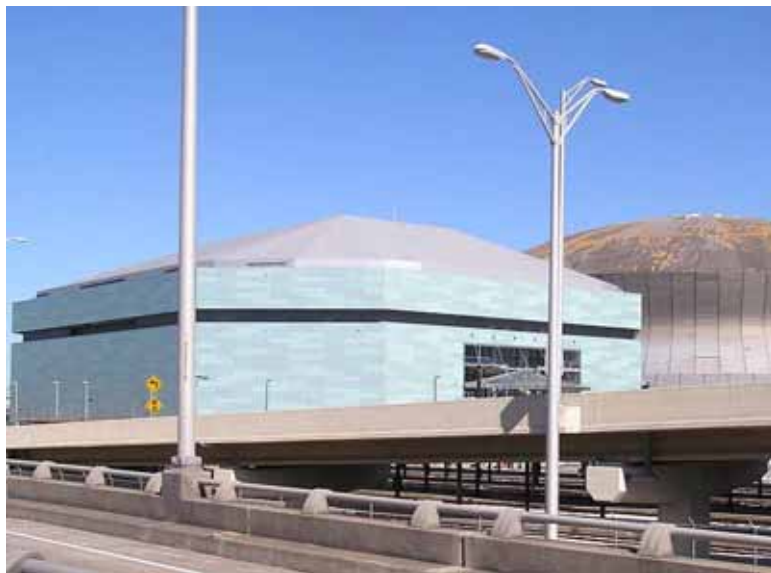
An example of a successfully performing roof was that on the New Orleans Arena (Figure 3-25). As observed from ground level, this SBS modified bitumen membrane system, which was about 6 years old,

was in good condition without evidence of wind induced damage. In contrast to this example, within the New Orleans area, a number of roofs on major buildings sustained considerable damage. For example, note in the right background of Figure 3-25 the New Orleans Superdome, which lost its flexible membrane during Hurricane Katrina (see below).

**Figure 3-25** The New Orleans Arena, which has an SBS modified bitumen membrane, withstood the Hurricane Katrina winds without damage. (Photo credit: Robb Smith, Amtech Roofing Consultants).

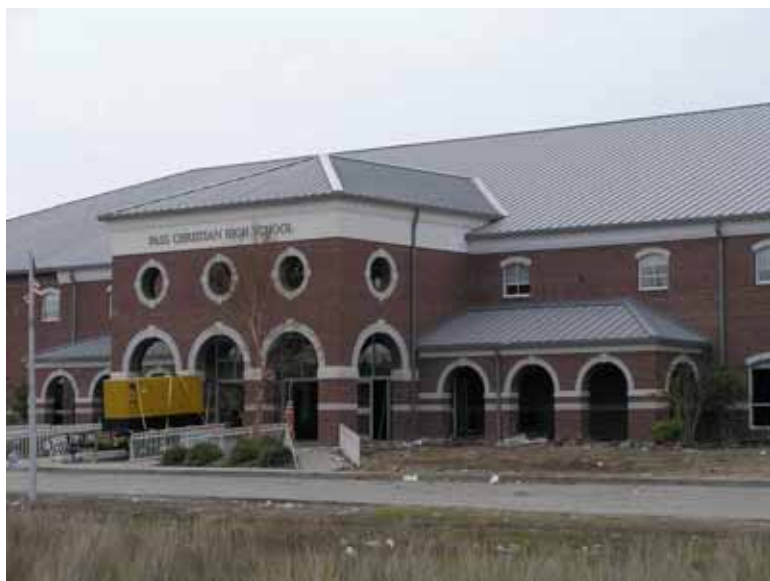
Many metal roofs throughout the Hurricanes Katrina and Rita damage zones performed well, particularly standing seam metal roofs installed on commercial and industrial buildings and schools. A clear example is the standing seam metal roof of the Pass Christian High School (Figure 3-33), which was located less than 1.5 km (1 mi) from the coast. Although this building was located near the coast east of Bay St. Louis where some of Hurricane Katrina's highest winds, yet still below design levels, may have been experienced (Table 2-2a), the roof sustained the winds without damage. In contrast, the first floor of the school sustained considerable damage due to storm surge and accompanying wave action and/or flooding.

**Figure 3-33** Standing seam metal roof in the coastal region of Pass Christian, MS, that sustained Hurricane Katrina without damage (Photo credit: NIST).

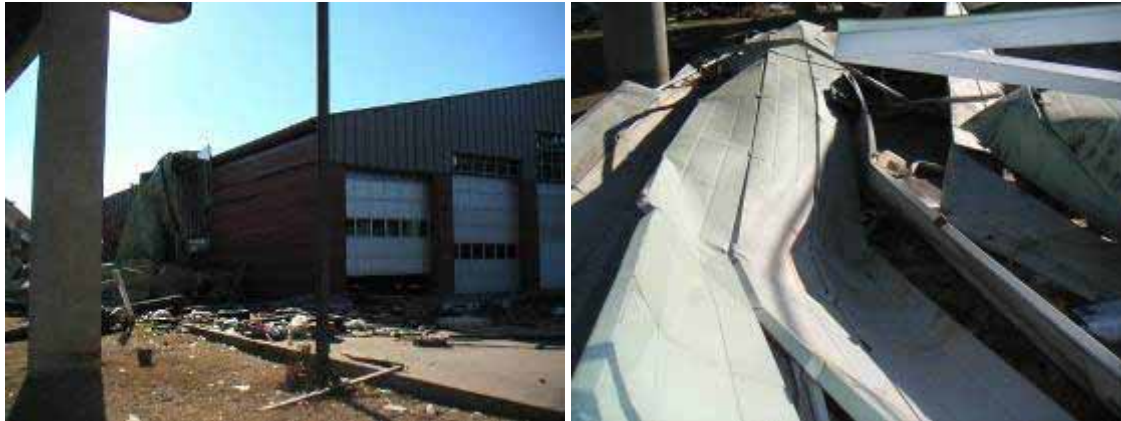
The Third District Fire Headquarters in New Orleans is a four bay building with a single story area for the living quarters. The building was constructed with steel columns and masonry infill walls with a brick façade. Steel box section trusses support the single slope roof over the apparatus bays. The steel roof deck was supported on I-beams attached to the trusses. Four-inch (4 in.) thick insulating panels were supported on the roof deck and a metal roof over top. The metal roof consisted of sections that attached via screws 48 in. on center to hat sections and the individual, 16 in. wide panels were connected together with tabs that were attached by screws 48 in. on center. The roof continued down the side of the building on the low side of the bays. Half of the roof panels over the fire equipment bays was peeled back by winds during Hurricane Katrina, beginning at the peak of the roof and continuing down over the side of the building

(Figure 3-38). Connection to the roof diaphragm appeared to have been inconsistent. Some segments had short screws at 48-inch centers that connected the panels to the diaphragm; in others, screws were not apparent for 20 feet. The foam insulation remained in most of the exposed areas, and the roof deck also remained in place. Water marks observed in the building interior indicated that flooding to a depth of approximately 8 in. occurred due to the hurricane; the building was not in operation at the time of the NIST reconnaissance due to the flood damage.

(a) (b)  
**Figure 3-38 New Orleans Third District Fire Headquarters. (a): roof damage. (b): apparent lack of fasteners (Photo credit: Keith Porter, Scawthorn Porter Associates).**

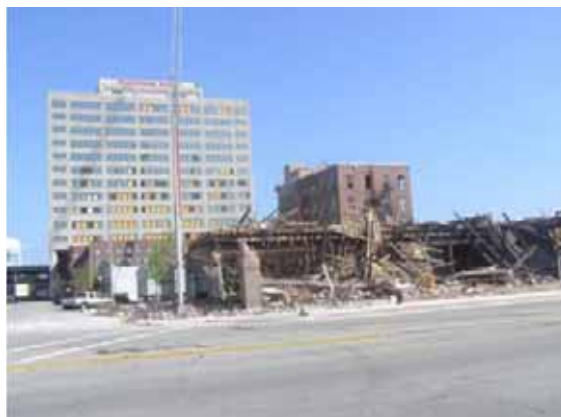
Wind-borne debris during Hurricane Katrina also caused damage to window systems in Gulfport, MS. Approximately 50 percent of the windows of the Memorial Hospital of Gulfport and the Hancock Bank building (Figure 3-46) were broken by roof aggregate and other types of wind-borne debris typical to hurricane level winds. For the Hancock Bank building, such debris may have originated from a severely damaged, unreinforced masonry building upwind.

**Figure 3-46 Hancock Bank building (background) in downtown Gulfport, Mississippi, downwind (north) of partially collapsed unreinforced masonry building (Photo credit: NIST).**

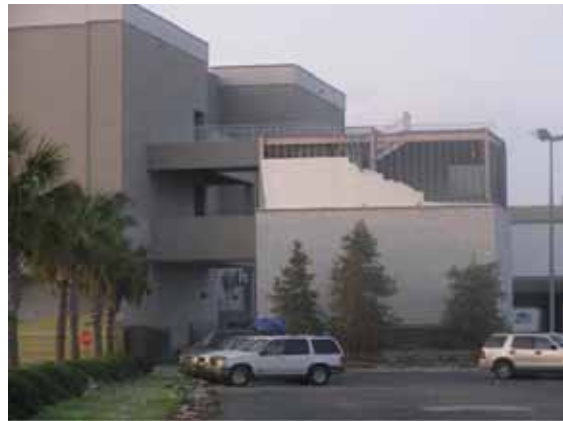
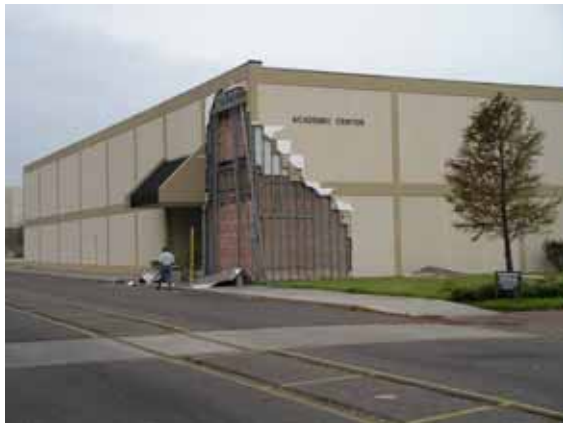
The EIFS was blown off the leeward sides of buildings in Biloxi, MS, New Orleans, LA, and Orange, TX. A few incidences of the damage were at an elevation subjected to storm surge, so water may have also contributed to the EIFS failure (Figure 3-48a). Commercial buildings in New Orleans also experienced damage to their EIFS, e.g., the AMC Palace Shopping Mall (Figure 3-48b). Similar damage to EIFS was observed at Lamar State University in Orange, TX. Many of these EIFS walls did not appear to be subject to substantial wind- or water-borne debris, suggesting that wind pressure alone caused the damage.

**Figure 3-48** EIFS damage to (a) a hotel in Biloxi, MS and (b) the AMC Palace Shopping Mall in New Orleans, LA, and (c) a building at Lamar State University, in Orange, TX (Photo credit:(a) NIST; (b) Robb Smith, Amtech Roofing Consultants; (c) Jon Heintz, Applied Technology Council).

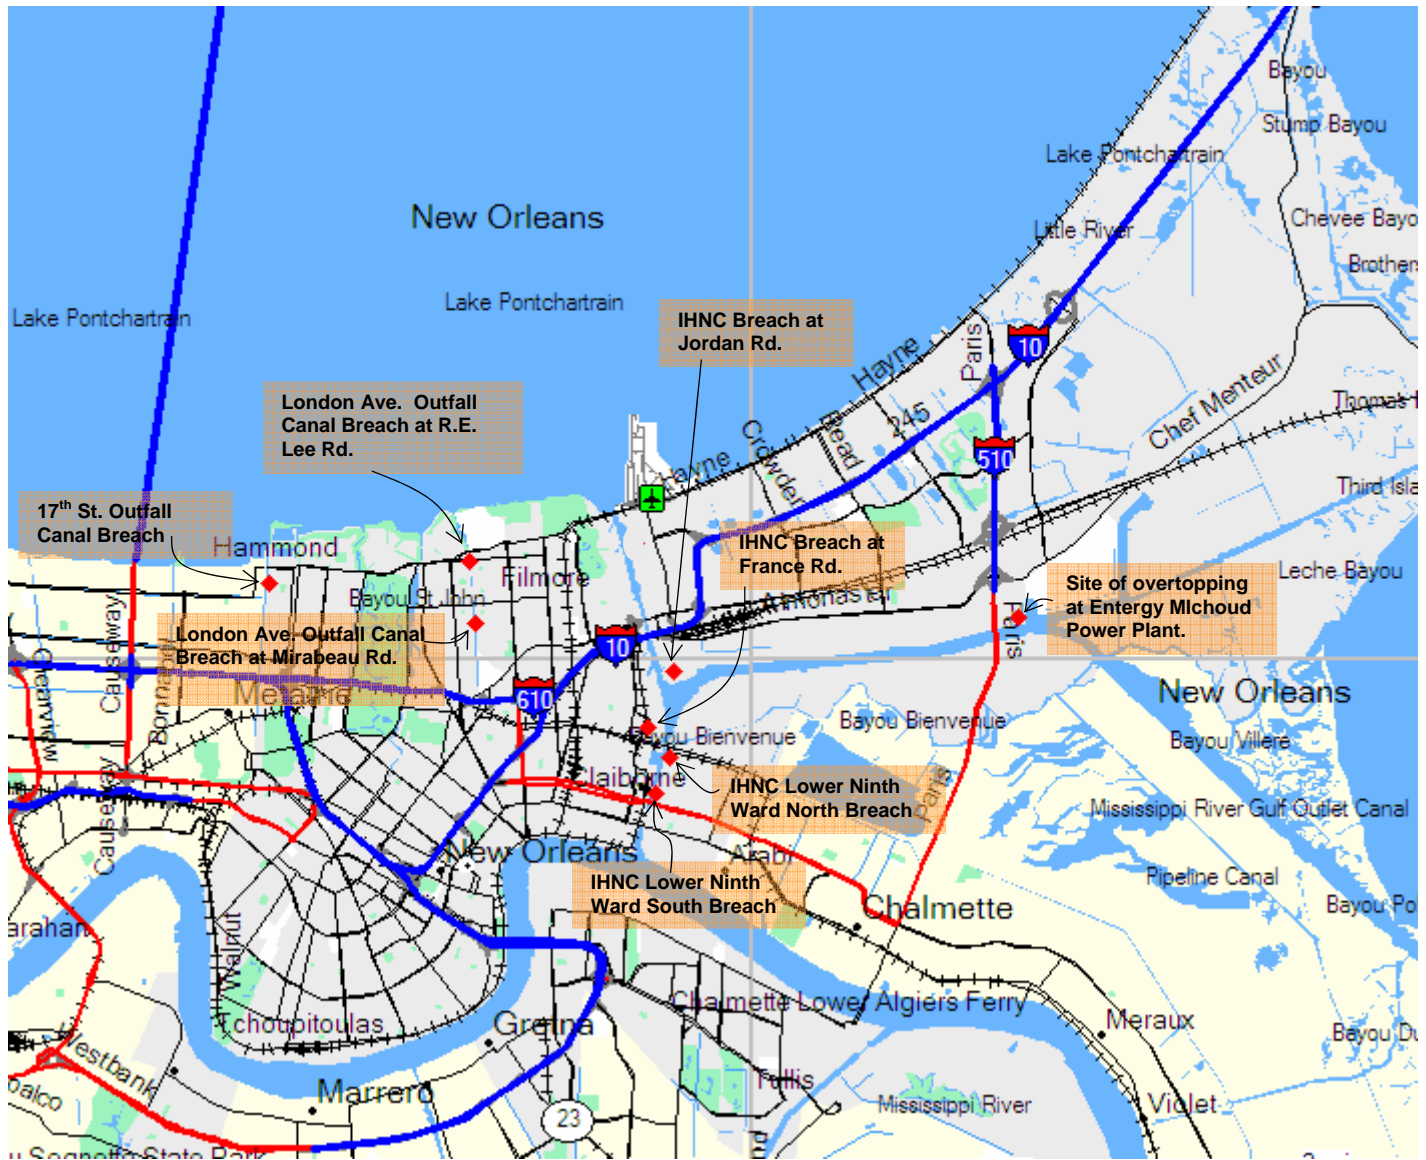
Orleans East Bank, New Orleans East, and St. Bernard Parish are separated by the IHNC in the north-south direction, and the Intracoastal Waterway (IWW) part of the Mississippi River Gulf Outlet (MRGO) in the east-west direction. Specifically, the Orleans East Bank protected area is bounded by Lake Pontchartrain to the north, the 17<sup>th</sup> Street Outfall Canal to the west, the Mississippi River to the south, and the Inner Harbor Navigation Canal (IHNC) to the east. The New Orleans East protected area is also bounded by Lake Pontchartrain to the north and east, the IHNC to the west, and MRGO/IWW to the south. The St. Bernard Parish area is bounded by MRGO/IWW to the north, IHNC and the Mississippi River to the west/southwest, and MRGO to the east. The approximate areas and boundaries of these three protected areas are shown in Figure 4-1 (shaded red, orange, and purple). It was breaches in the flood protection systems of these three areas that caused widespread flooding in and around New Orleans. The breaches include (1) the 17<sup>th</sup> Street Outfall Canal breach, (2) the London Avenue Outfall Canal breach at Robert E. Lee Road, (3) the London Avenue Outfall Canal breach at Mirabeau Road, (4) the IHNC breach at Jordan Road, (5) the IHNC breach at France Road, (6) the IHNC Lower Ninth Ward south breach, (7) the IHNC Lower Ninth Ward north breach, and (8) site of floodwall overtopping on the MRGO/IWW at the Entergy Michoud Power Plant. Figure 4-2 shows the locations of the major breaches that were inspected as part of this study.

Figure 4-2 Major breaches in the flood protection systems of the three protected areas (© Copyright 2006 Garmin Ltd. or its subsidiaries. All rights reserved. Map data © 2002 NAVTEQ. All rights reserved. Enhancement by NIST)

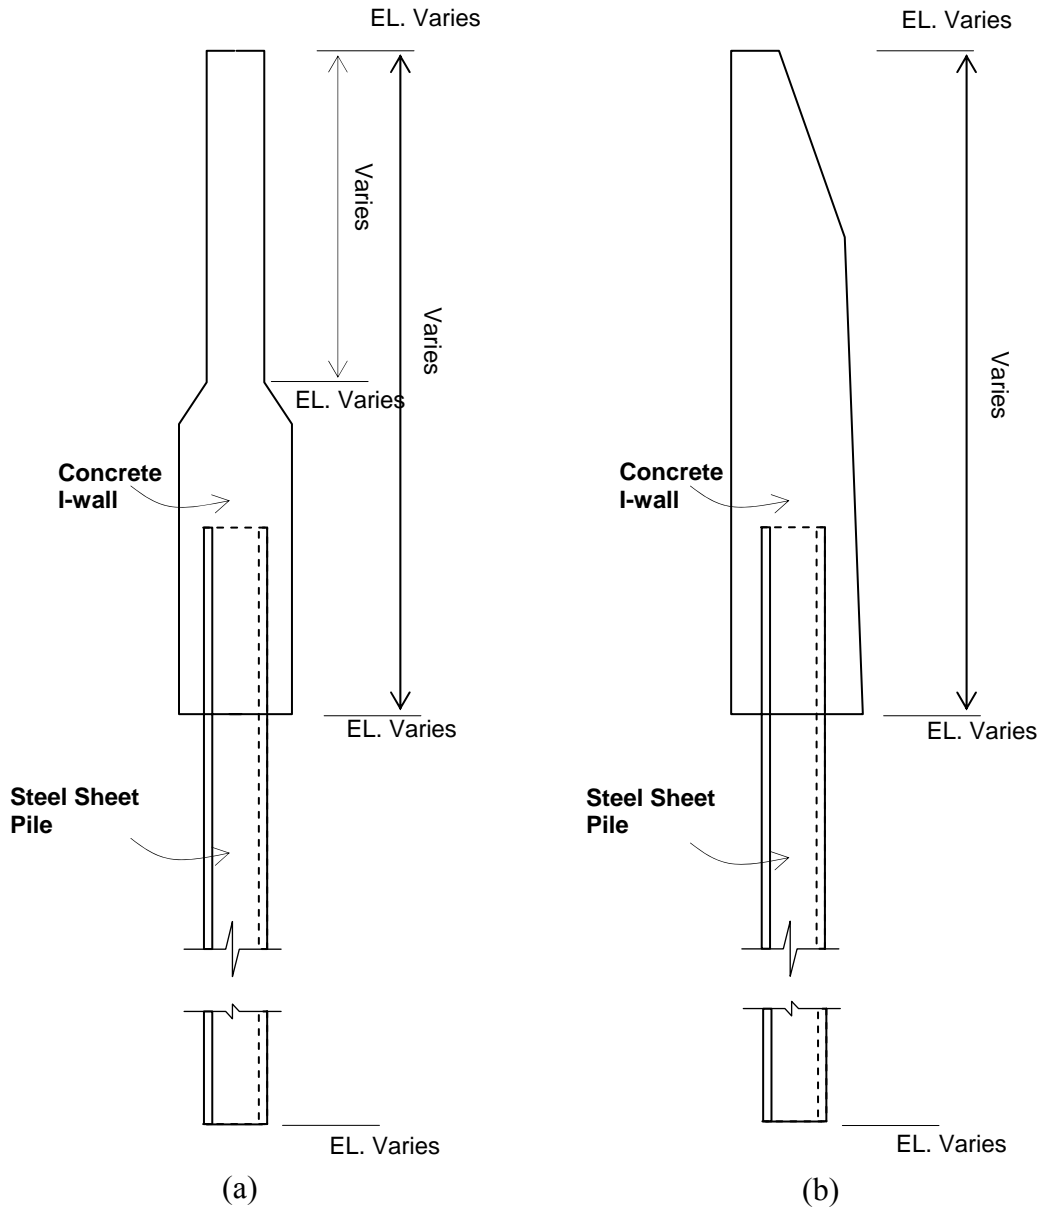
Most of the floodwalls that failed had the typical I-Wall cross section as shown in Figures 4-3 (a) and (b). These I-wall sections consist of I-shaped reinforced concrete cap walls cast on top of interlocking Z-shaped, ½-in. thick steel sheet piles (about 33 inches of the sheet piles are embedded in the concrete cap

Figure 4-3 Typical I-Wall cross-sections of the floodwalls along (a) the 17<sup>th</sup> Street and London Avenue Outfall Canals and (b) the IHNC (Source: NIST)

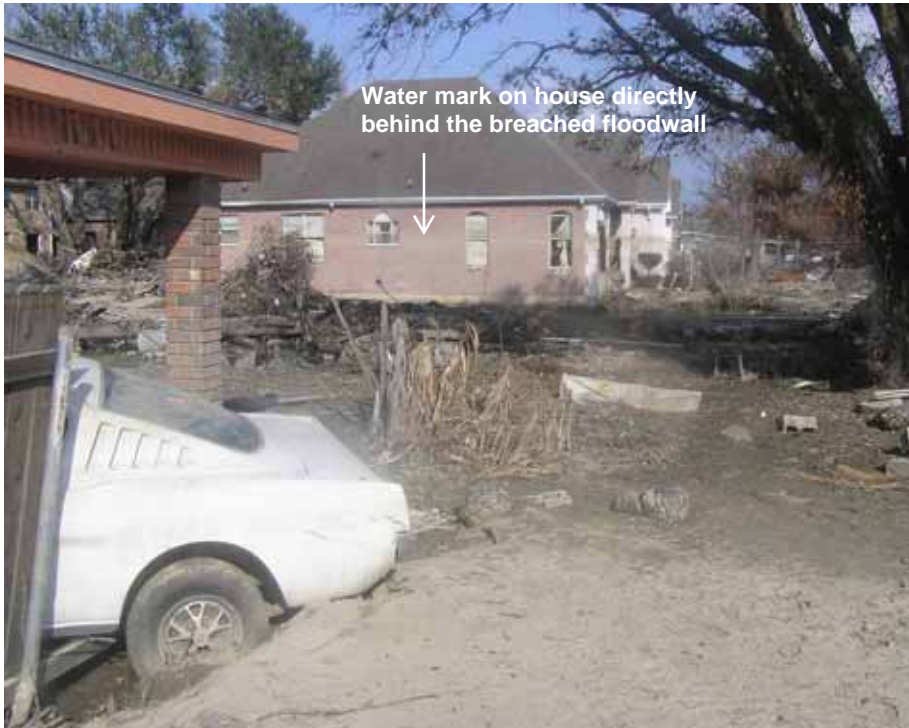
The failed I-walls have all been separated from their adjacent walls. Some of the failed I-walls were also found to have been disconnected from the sheet piles at the time of the NIST inspection (see Figure 4-6). However, the disconnection between the I-walls and the sheet piles was likely<sup>15</sup> the result of emergency repair work immediately after the hurricane, and not an indication of structural failure due to increased hydrostatic pressure. The final location and condition of the steel sheet piles that were part of the breached section are not known since they were covered by the emergency embankment at the time of the inspection. Figure 4-7 shows the water mark due to ponding on a house in the New Orleans Parish directly behind the breached section, indicating a flood depth of about 2/3 of the first story height.

**Figure 4-7** Water mark showing extent of flooding in area of New Orleans Parish directly behind the breached section of the floodwall (photo credit: NIST)

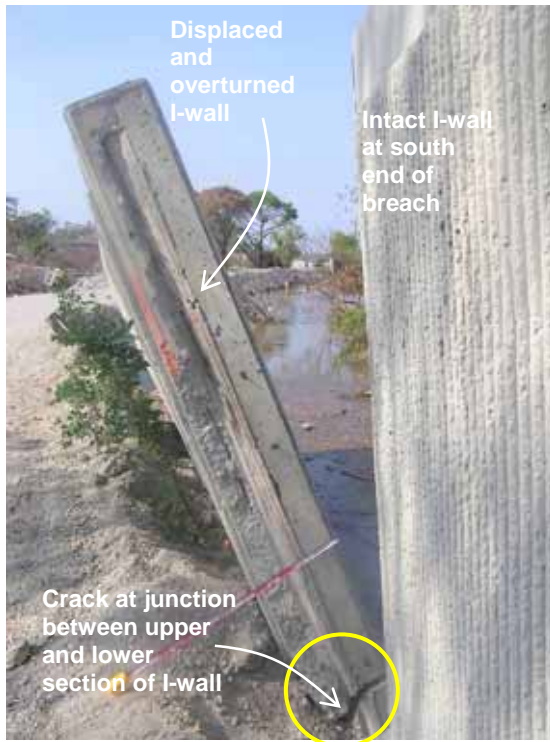
Figure 4-9 Cracked I-wall (photo credit: NIST)

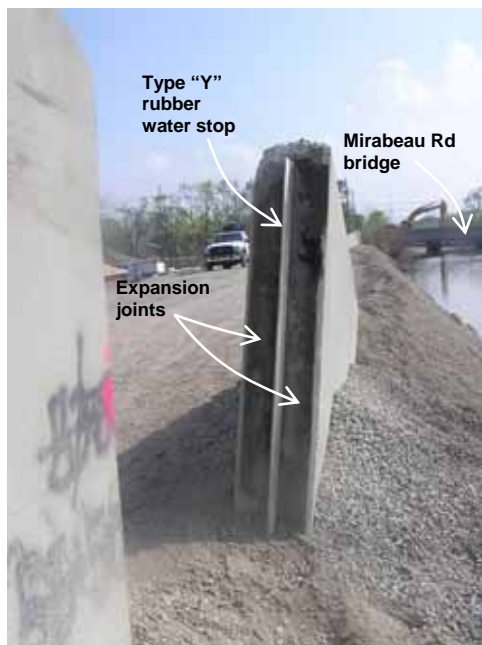
**Figure 4-13** I-walls of failed floodwall section separated along water stop joint (photo credit: NIST)

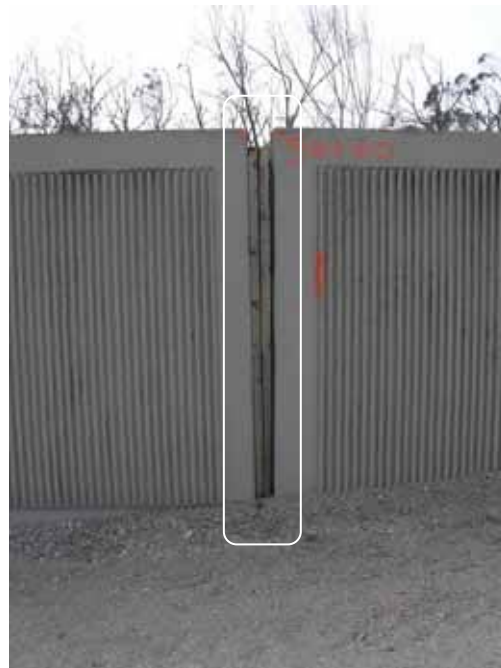
**Figure 4-14** Partial separation of adjacent I-walls along water stop joint (photo credit: NIST)

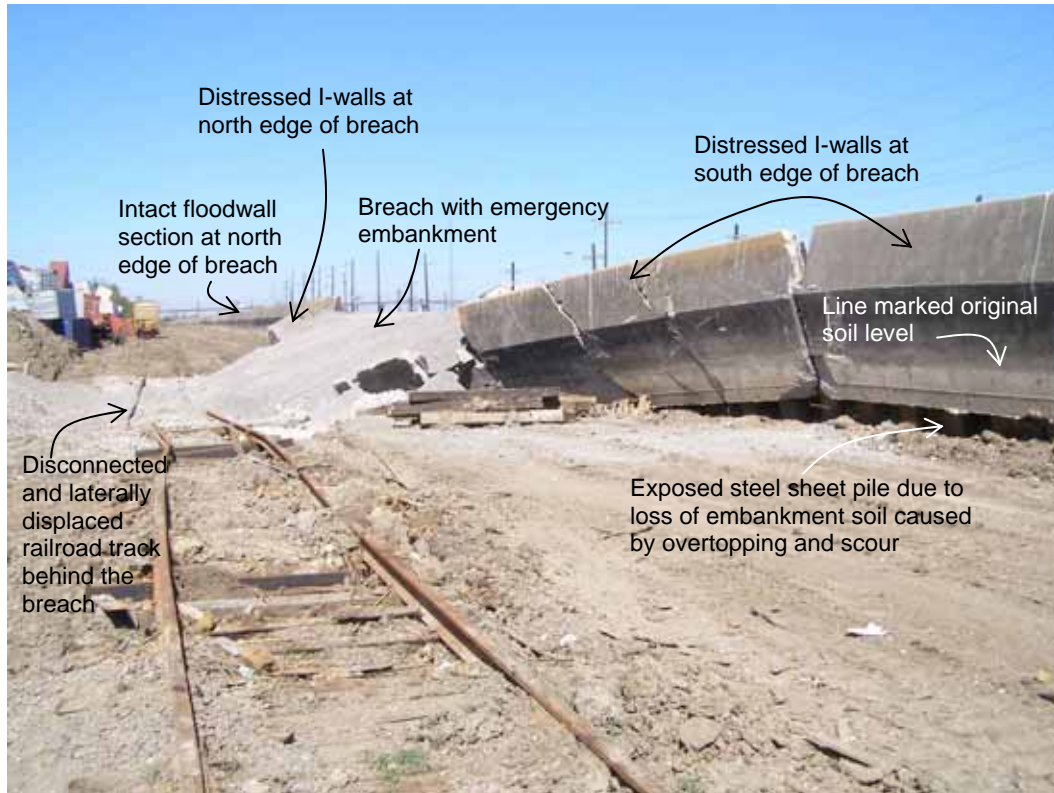
**Figure 4-16** View looking north at the breach on IHNC at France Rd from the protected side (photo credit: NIST)

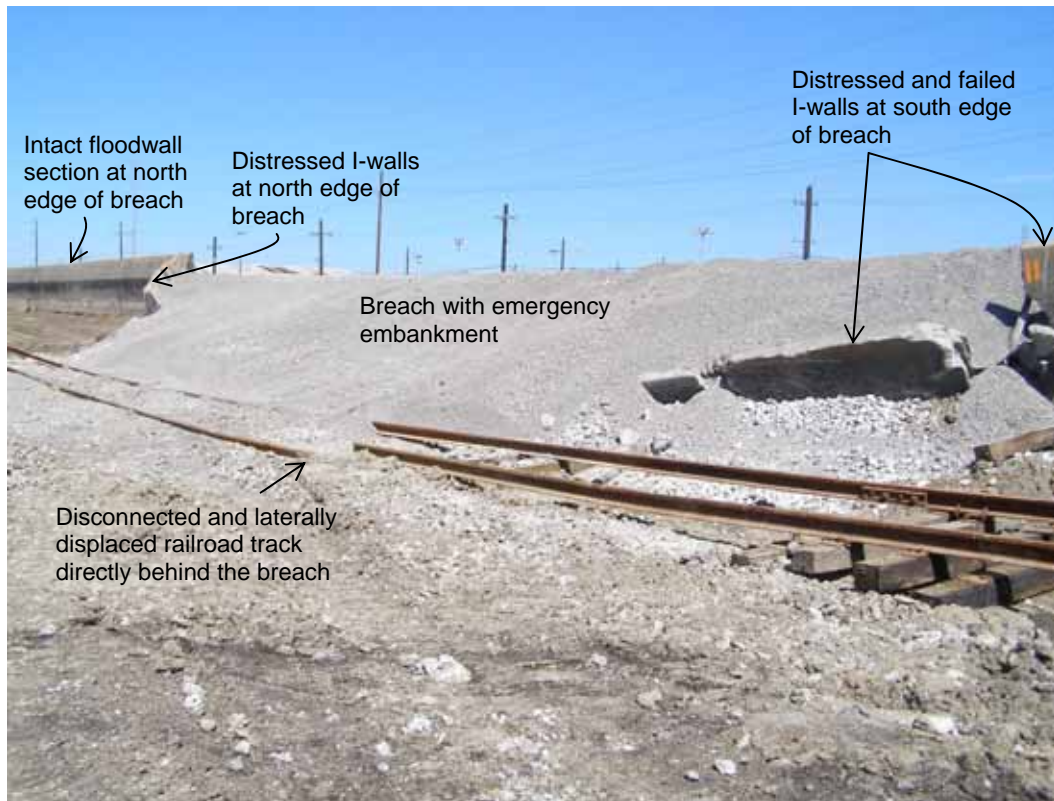
**Figure 4-17** A closer view of the breach on the IHNC at France Road (photo credit: NIST)
