Performance of Physical Structures in  
Hurricane Katrina and Hurricane Rita:  
A Reconnaissance Report

# NIST Technical Note 1476

*National Institute of Standards and Technology  
Gaithersburg, MD 20899*

June 2006

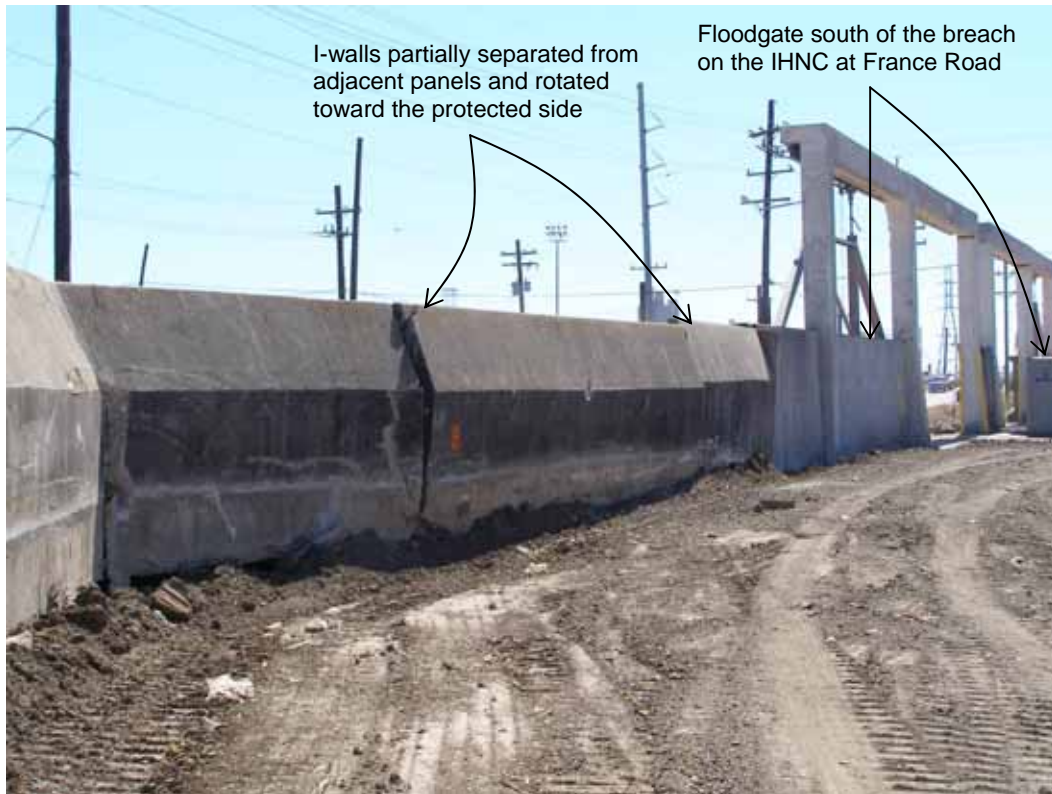
**Figure 4-18** View from the protected side looking south from the breach showing distressed I-walls adjacent to floodgate on IHNC at France Rd (photo credit: NIST)

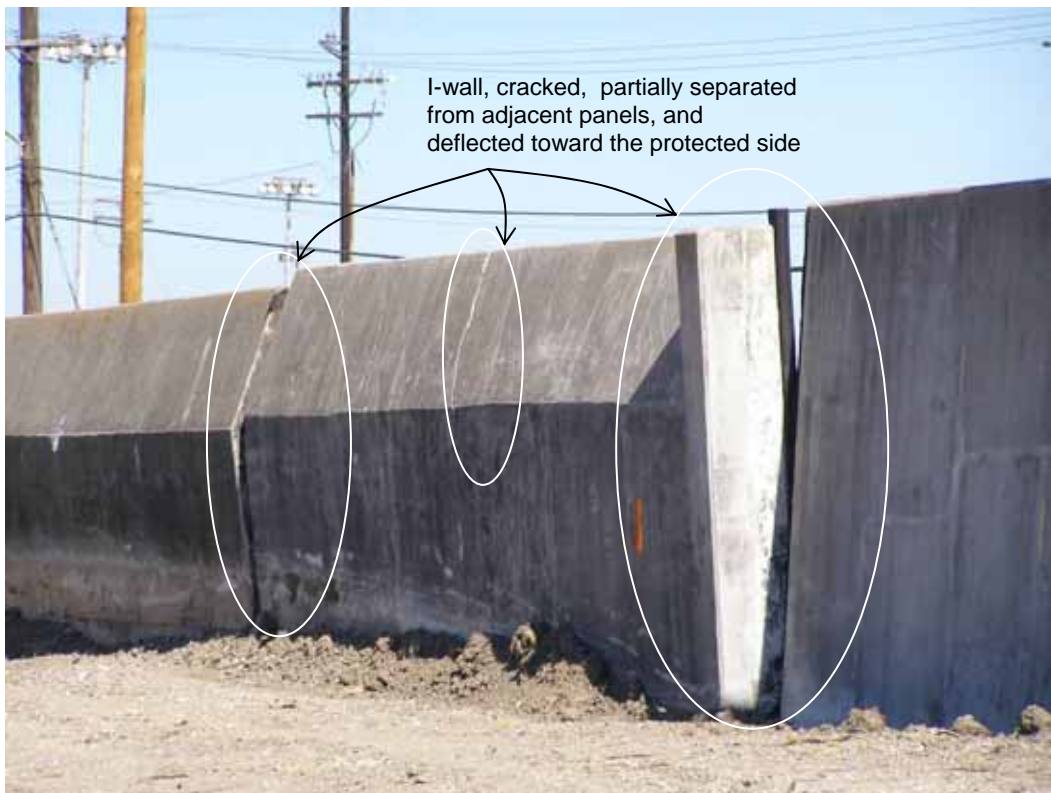
**Figure 4-19** View from the protected side south of the breach showing distressed I-walls near the floodgate on IHNC at France Rd. (photo credit: NIST)

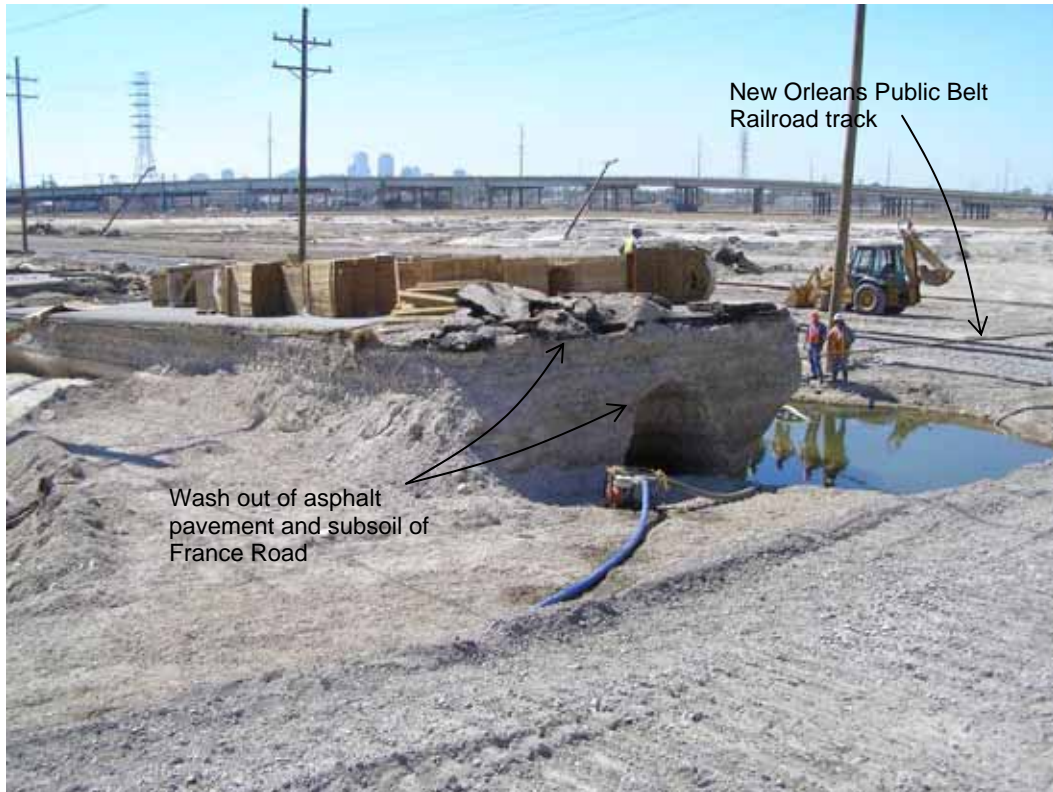
**Figure 4-20** Erosion due to scour at France Road at section south of the breach in the floodwall on the west bank of the IHNC (photo credit: NIST)

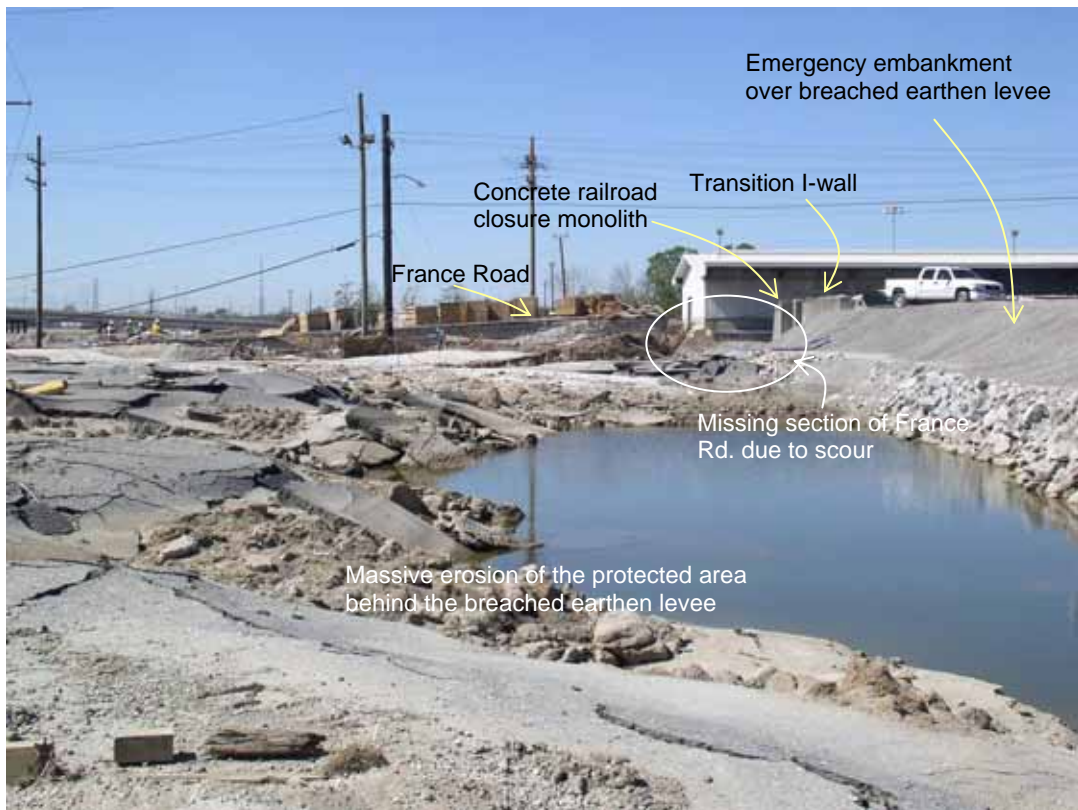
**Figure 4-21** Erosion behind breached earthen levee. The breach occurred at the transition between the earthen levee and the transition I-wall (photo credit: NIST)

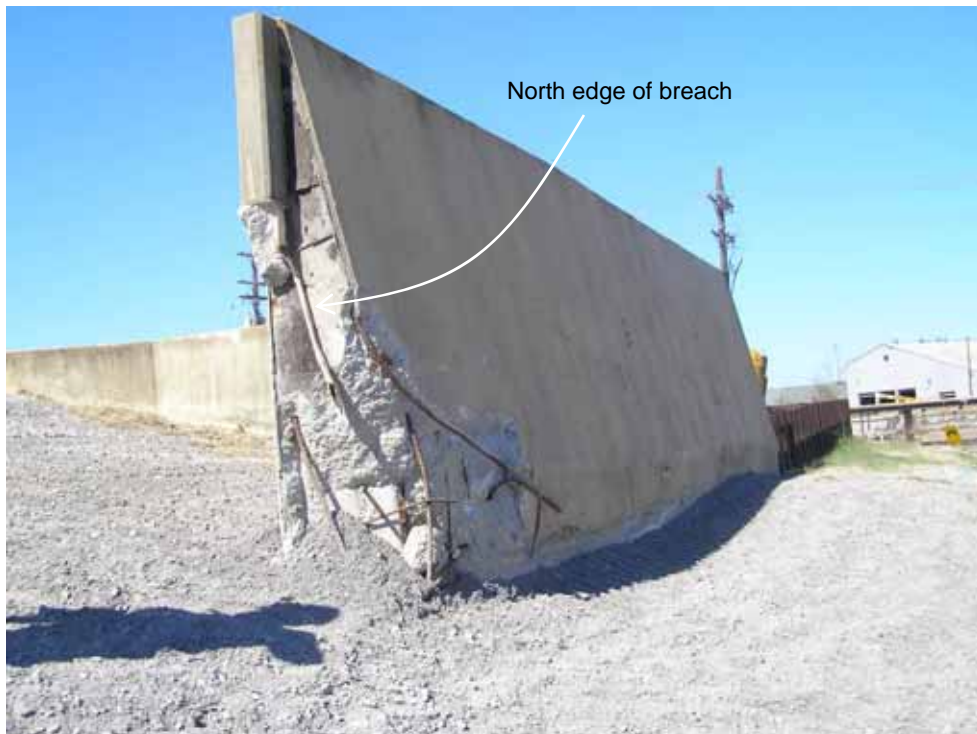
**Figure 4-23** View looking north at the north edge of the IHNC Lower Ninth Ward North breach (photo credit: NIST)

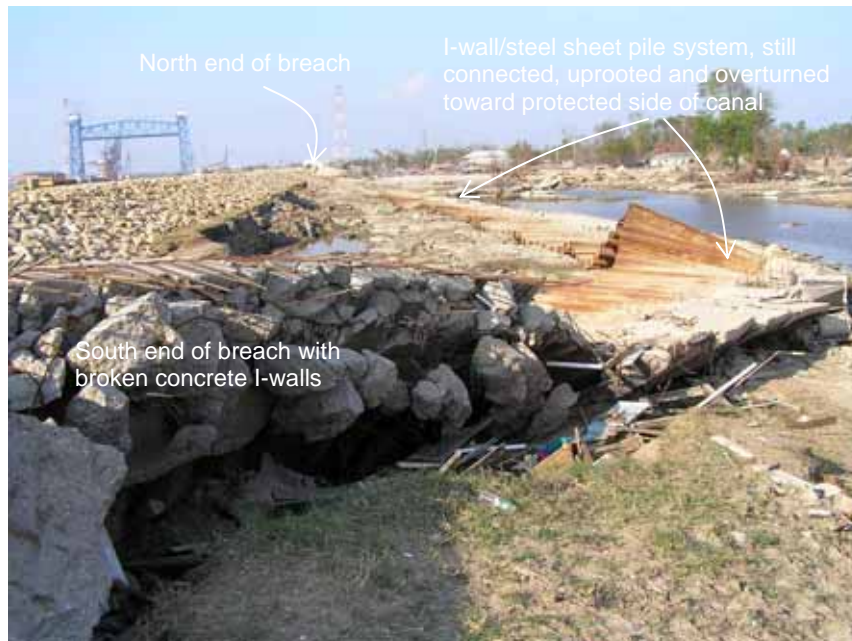
**Figure 4-26** Overturned and uprooted floodwall at the IHNC Lower Ninth Ward South breach, with the I-walls remained connected to the sheet piles (photo credit: NIST)

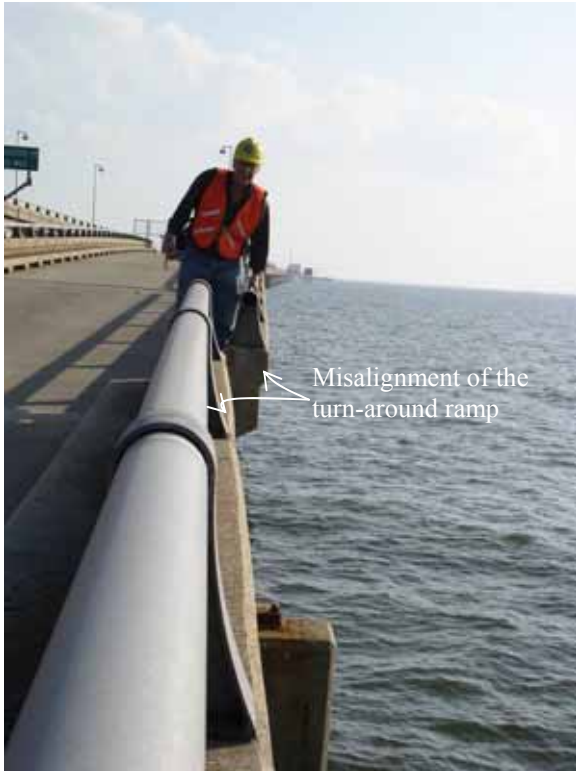
**Figure 4-35** Misaligned spans of the Toll Causeway's turn around ramp (photo credit: Ron T. Eguchi, ImageCat).

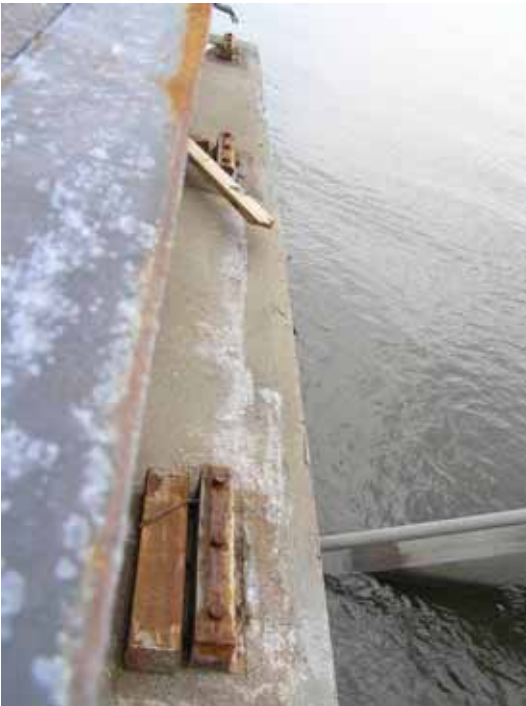
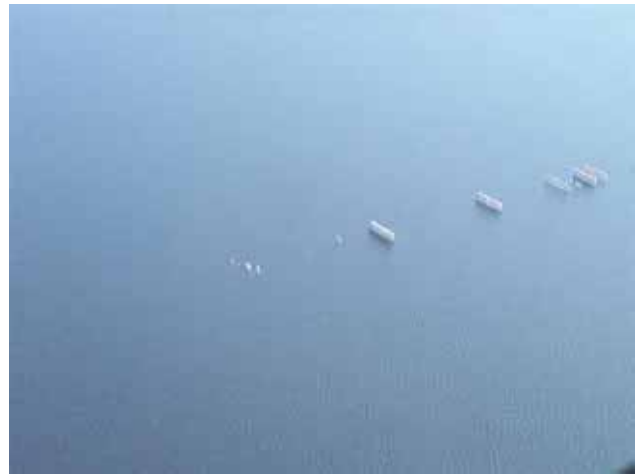
**US-90 bridge** The US-90 bridge is a 1.8 mile long, four-lane, low-water crossing concrete bridge with operating bascule (moveable) spans across the navigation channel of the Bay. It is located slightly north of the CSX railroad bridge over St. Louis Bay. Similar to the construction of the Toll Causeway and the US-11 bridges over Lake Pontchartrain, the US-90 bridge is also a simply supported, multi-span concrete bridge. Its superstructure consists of simply supported, prefabricated and monolithically cast spans, each comprised of an 8 in.-thick concrete bridge deck with fascia section and eight rectangular concrete girders (1ft-7 in. x 2 ft-11 in.) at 7 ft-11 in. spacing across the span. Each superstructure span is simply supported on concrete piers with steel bearing blocks. The connection between the superstructure span and the piers is mainly by gravity and provides little restraint against transverse lateral and uplift displacements. The cap beam of the pier does not have shear blocks and thus provides minimal restraint against lateral displacement of the superstructure spans. As was typically observed for this type of bridge construction subjected to storm surge and wave actions, most of the US-90 bridge's superstructure spans were displaced and dropped from the supporting piers. Figure 4-38 shows the US-90 bridge with the displaced and dropped superstructure spans. Figure 4-39 (left) shows the detailed connection (steel bearing blocks) between the superstructure span and the pier. Many of the US-90 bridge's piers were also lost, possibly due to tidal scour (i.e. undermining). Figure 4-39 (right) shows some remaining piers of the US-90 bridge over St. Louis Bay.

**Figure 4-39** Steel bearing blocks (left, photo credit: NIST) and few piers remain in this section of US-90 bridge over St. Louis Bay (many piers scoured out in the surge) (right, photo credit: J. O'Connor, MCEER).

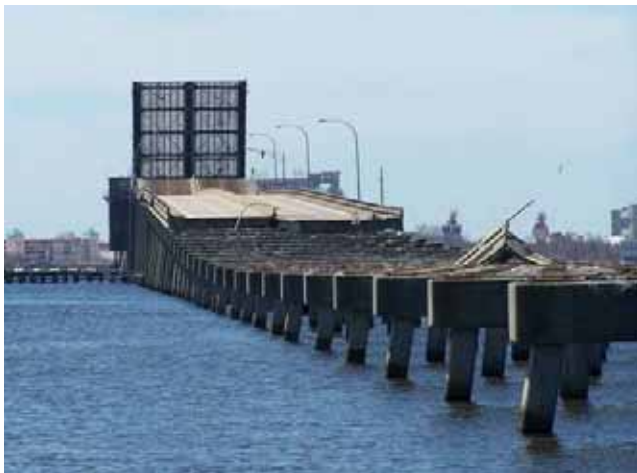
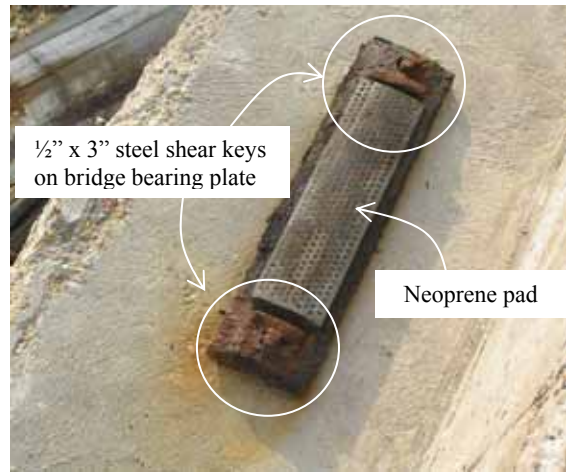
partially or completely dropped into the water (see Figure 4-42). The ½ inch low-rise steel shear keys on the bearing plates were clearly unable to provide restraint against the combined uplift and lateral wave forces. The superstructure spans that were constructed at a higher elevation near the navigation channel, i.e. spans above an elevation of approximately 22 feet, were apparently high enough to avoid direct surge and wave actions and survived intact (see Figure 4-43(a)).

**Figure 4-43** (a) Looking west toward Biloxi, spans above the surge line near the navigation channel survived, but the superstructure in the foreground was dropped off the piers (photo credit: J. O'Connor, MCEER), (b) A typical bearing plate from the US-90 bridge with ½ in. thick shear keys (photo credit: NIST).

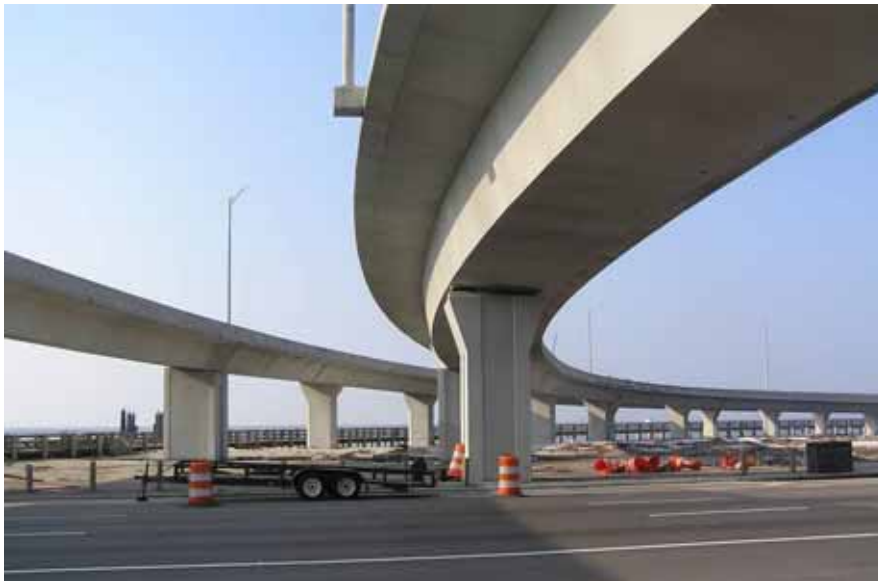
At the southernmost end of I-110, immediately adjacent to the beach and Gulf, are ramps connecting I-110 (which runs north-south) and US-90 (which runs east-west) (see Figure 4-41). The I-110 bridge ramps are cast-in-place, continuous concrete box girder bridges. The superstructure has gradually changing elevation and is positively connected to some of the supporting piers through cast-in-place connections. These bridge ramps are very close to the beach and aligned transversely along the shore line, making them fully exposed to direct effects of Hurricane Katrina's surge and wave actions. However, despite the full effects of the surge and wave forces, the I-110 bridge ramps survived intact. This can likely<sup>15</sup> be attributed to the continuity of the superstructure and the positive connection between the superstructure and the bridge piers. Figure 4-45 shows a view looking south (toward the Gulf) of the I-110 bridge ramps taken on September 29, 2005. Although the I-110 bridge ramps are not over the bays under discussion, they are in the area and because of their proximity to the Gulf were likely<sup>15</sup> subjected to similar surge and wave actions as the bridges over the bays. They are, therefore, included in this discussion for comparison purposes.

**Figure 4-45** I-110 bridge ramps with cast-in-place, continuous box girder superstructure positively connected to bridge piers (photo credit: NIST)

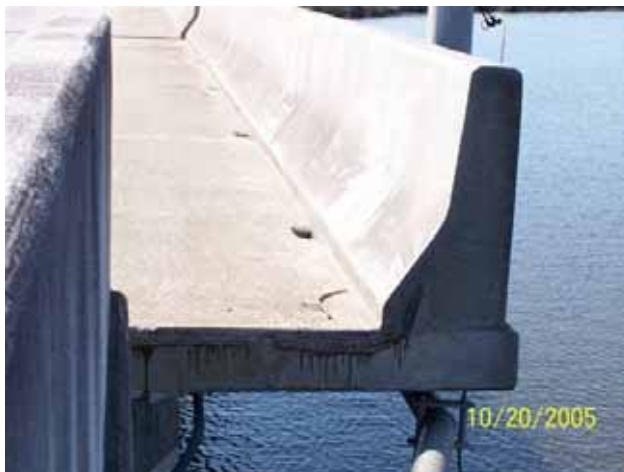
***Popps Ferry bridge.*** The Popps Ferry bridge is a bridge crossing located further west in the Back Bay of Biloxi (see Figure 4-40). It is a concrete bridge with non-continuous, simply supported superstructure spans seated by gravity on concrete piers. Due to the lack of restraint against lateral displacement in the transverse direction, many superstructure spans of the Popps Ferry bridge were laterally displaced by several feet by storm surge and wave actions (Figure 4-46). However, none of the displaced spans was dropped from the supporting piers. In addition to the misalignment of the spans, the lift spans in the middle of the bridge were rendered inoperable, and a section of the fascia and concrete barrier were observed to have been broken up, apparently<sup>15</sup> due to impact of surge-borne debris (Figure 4-47).

**Figure 4-47 Displaced spans of Popps Ferry Bridge (photo credit: J. O'Connor, MCEER)**

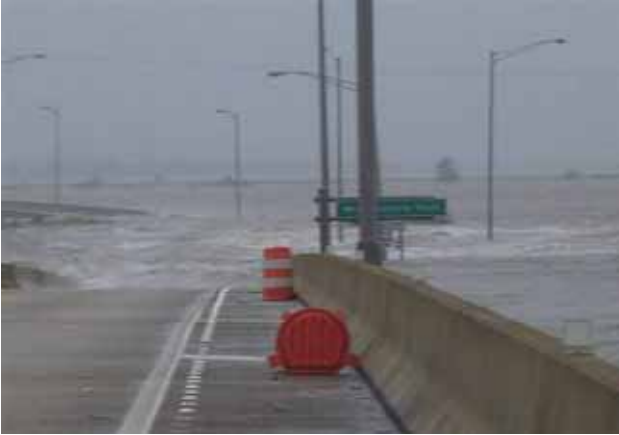
Although Mobile Bay, Alabama was almost 100 miles from the eye of the storm, it saw a rise in water elevation of over 10 feet. At the I-10 bridge over Mobile Bay, storm surge washed out the approach. Where US-90 merges onto I-10 eastbound, the ramp bridge has some spans displaced northward (Figures 4-50 and 4-51). At another site in Mobile, Alabama, a large new cable stay bridge over the Mobile River, the Cochrane-Africatown USA bridge, was hit by a 13,000 ton oil drill rig that had broken free of its moorings. The bridge spans were shifted 4 inches due to the impact (Figure 4-51). This made it necessary to post the bridge with a weight restriction and reduce the number of traffic lanes on it from four to two while a detailed assessment of damage was performed.

**Figure 4-50** Surge waters overtopped US I-10 bridge ramp over Mobile Bay. View is eastbound, taken on the same day Hurricane Katrina hit (8/29/06). (Photo credit: George Conner, MSDOT)

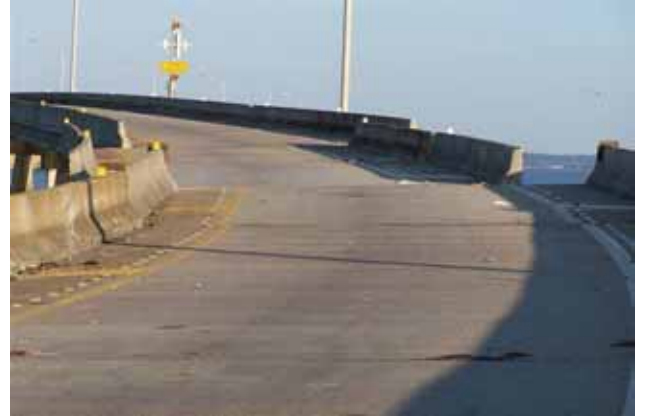
**Figure 4-51** Bridge spans pushed north by the surge (photo credit: LA DOTD, provided by J. O'Connor, MCEER).

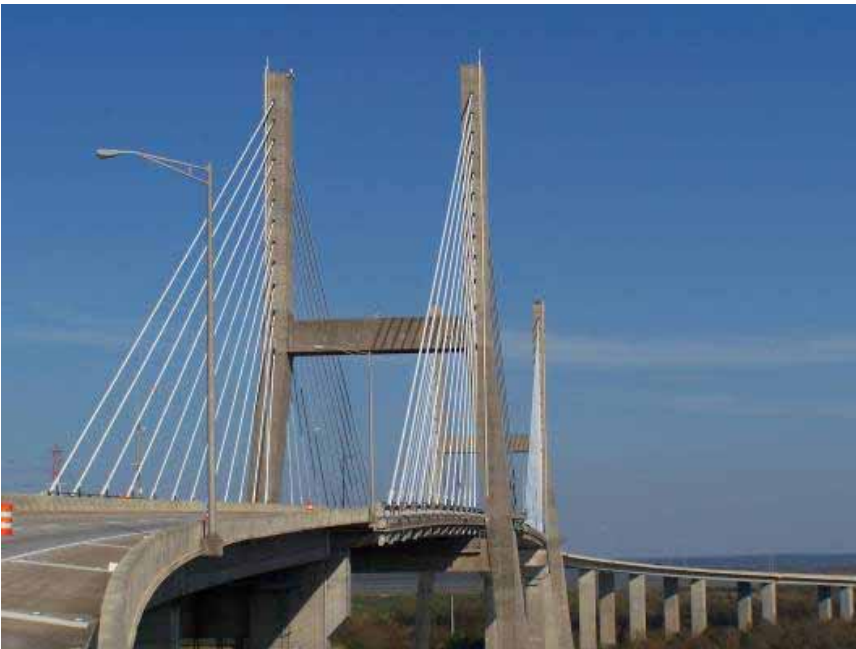
**Figure 4-52** The Cochrane-Africatown USA bridge was hit by an oil rig that had been swept to Mobile Bay by Hurricane Katrina's surge. The impact displaced the bridge spans by four inches, necessitating the restriction of traffic on the bridge (photo credit: LA DOTD, provided by J. O'Connor, MCEER).

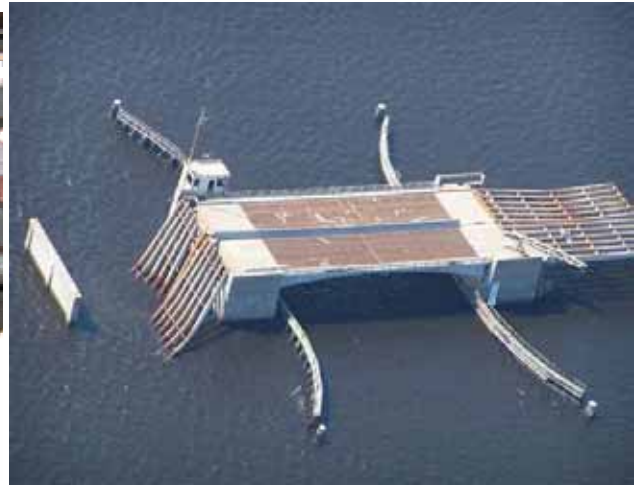
actions. In addition, many of these moveable bridges sustained flood damage to motors and controllers and were rendered inoperable. Flooding of control rooms and/or mechanical rooms caused failure of electrical systems and jamming of gear mechanisms (Figure 4-53). Even when repairs were made quickly, commercial power was typically unavailable for several weeks after the storm. In some cases, auxiliary diesel generators were available to operate the bridges; however, such operations are time-consuming and are undertaken only in emergency situations. Examples of these problems include the Portage Bridge on Hampton Road in Pass Christian and the swing bridge on US-82 at the Texas-Louisiana state line, which was closed due to undermining of the Louisiana approach and damage to the bridge railings. Because these bridges could not be used following the disaster, recovery efforts were delayed. The lift spans carrying US-90 over St. Louis Bay became inoperable, blocking use of the channel by vessels (Figure 4-54).

**Figure 4-54** The lift spans of the US-90 bridge over St. Louis Bay became inoperable, blocking use of the channel by vessels (photo credit: J. O'Connor, MCEER).

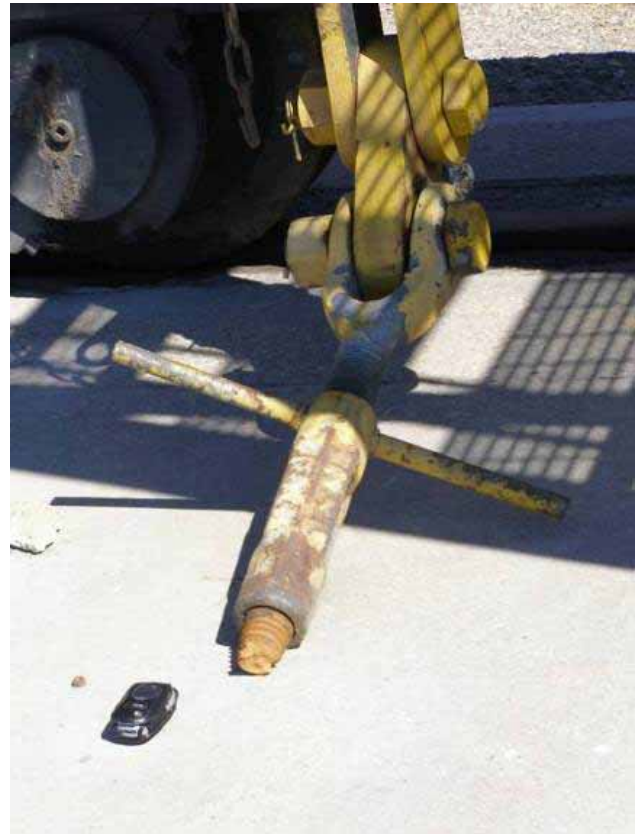
The Port of New Orleans is one of the busiest in the country and, together with the Port of Gulfport, accounts for approximately 25 percent of U.S. shipping. Container cranes are critical to the operation of such facilities, and three container cranes were damaged in Hurricane Katrina. Each was secured with four hurricane tie-down connections designed for hurricane winds (Figures 4-66a and b). The tie-downs were overstressed, resulting in tension failure of several of the 2 in. threaded rods. All three cranes were pushed as far as 50 feet, ending up together at the end of wharf. One crane was also pushed off track and had a wheel carriage broken. Replacement or repair of this equipment can be problematic because it is not easily transported and has long lead times for assembly and delivery.

**Figure 4-66** Damage to crane wheel carriage (a) and restraints (b) (photo credit: NIST)

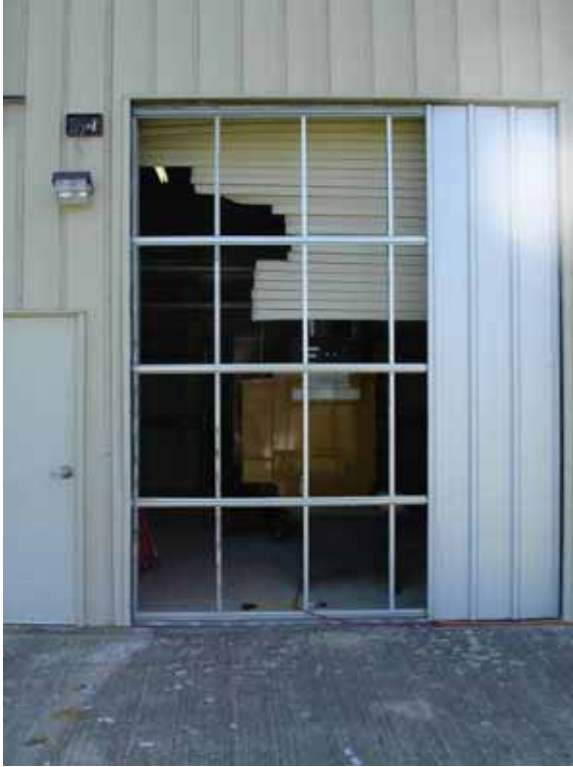
The city of Beaumont, Texas, lost water supply because a roller door on the backup power generator failed (Figure 4-73). The five-year-old Caterpillar backup generators sustained transformer damage, it was difficult to locate spare parts and qualified technicians, and repairs were not completed for nearly 48 hours. Power was not re-connected and consequently communication with outlying pump stations was lost for approximately a week. This meant that water could not be stopped from arriving at the treatment plant, and had to be dumped into the street. Reaching the remote pump stations was very difficult due to extensive tree damage.

**Figure 4-73** Roller door failure (with temporary framing and cladding) that led to auxiliary generator shutdown at Central Water Treatment Plant in Beaumont, Texas (photo credit: Christopher Letchford, Texas Tech University)

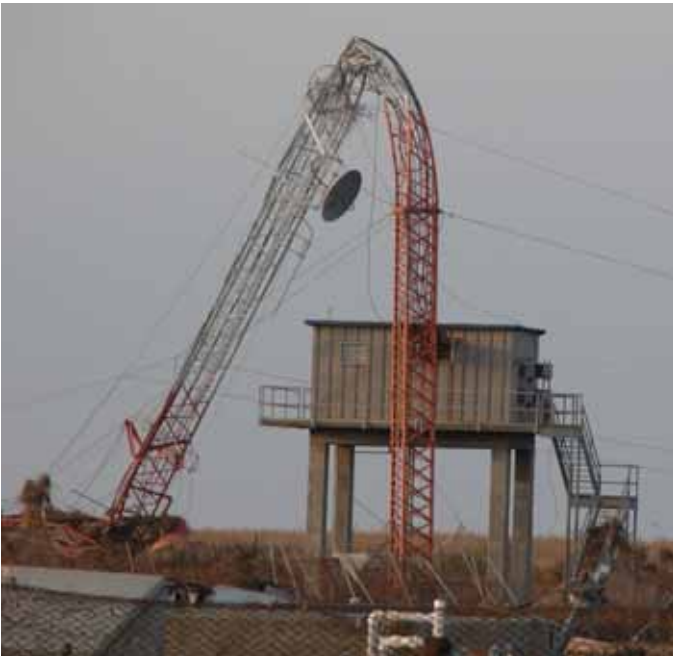
**Figure 4-77** Downed communications tower on US Route 82 near Holly Beach Louisiana following Hurricane Rita (photo credit: Christopher Letchford, Texas Tech University)

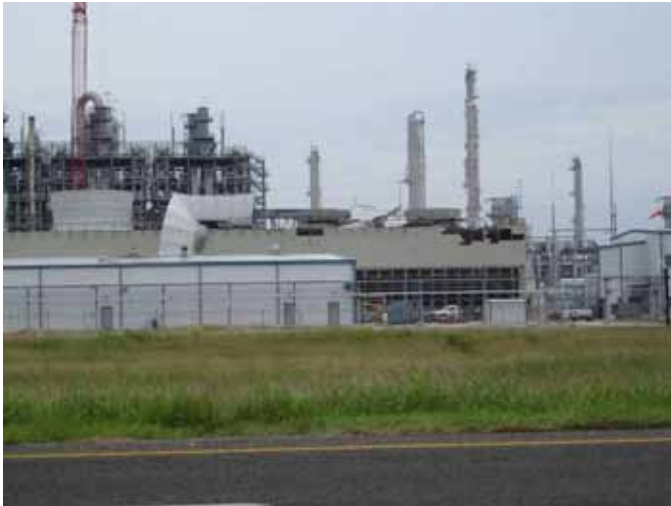
Cooling towers at oil refineries, chemical plants, and power stations were extensively damaged (Figure 4-83). The shrouds, typically constructed of fiberglass, sit atop a timber or metal structure, and many were observed to have failed. Aerial photographs allowed a preliminary statistical survey of cooling tower failures in the region affected by Hurricane Rita, as shown in the table below. Apparently, repair or replacement of these shrouds is not very onerous.

Figure 4-83 Cooling tower failures at the BASF Fina Plant in Port Arthur/Groves, Texas (photo credit: Christopher Letchford, Texas Tech University)

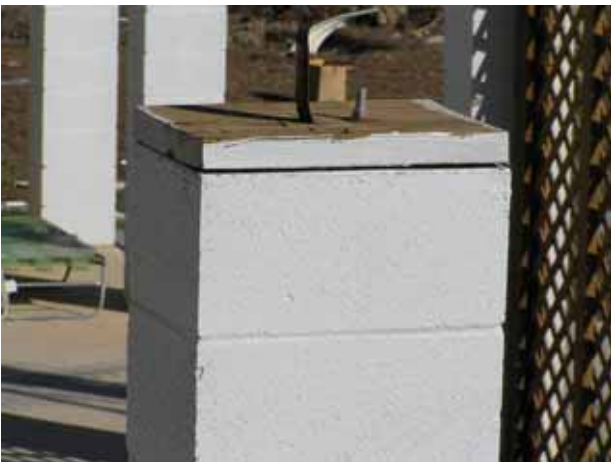
Generally, where the surge height was above the first floor, the super-structure of the single family dwellings was completely destroyed, even for houses on elevated foundations. In most cases, it appeared that the destruction stemmed from the failures of the connections between the building structure and the foundation piers (Figure 5-5) that were not intended to resist storm surge impacts or buoyancy forces. The primary failure mode of the connection was connection pull out or inadequate rebar lap splices at the piers, which allowed the entire structure to be washed off the foundation. In most cases, failures could have been the result of hydrodynamic forces imposed by the storm surge in excess of design loads (mainly design wind loads) on the superstructure. Where residential structures were constructed with appropriately designed and installed connections between the foundation piers and the first floor systems, the superstructure, even though heavily damaged, remained connected to the raised foundations. This was especially the case where precast concrete beams spanned multiple concrete piers (Figure 5-6).

**Figure 5-5 (a) A single-family residential structure near Pass Christian, Mississippi was pushed or floated off its elevated foundation, (b) shows a failed connection between a pier and the super-structure. (Photos credit: NIST)**

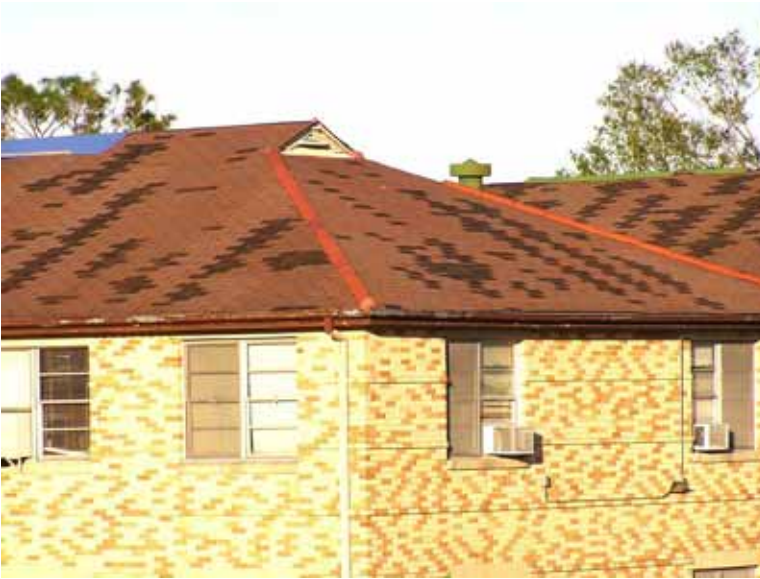
In many cases, the damage appeared to be limited to a small percentage of the roof area (Figure 5-21). However, on some houses, as much as 40 percent to 50 percent of the roof covering had been stripped from the structure (Fig 5-22). In a small number of cases, nearly the entire roof covering was stripped away.

**Figure 5-22** Damage to older three-tab asphalt shingles wherein approximately 40 percent to 50 percent of the shingles were blown off the front side of the home in New Orleans. Note the vertical strips of blown-off shingles. This failure pattern is associated with applying the shingles in a process known as “racking” in which shingle are applied vertically or straight up the roof. Racked–applied shingles are susceptible to blow-off as illustrated here, and the process should not be carried out in regions susceptible to high winds. (Photo credit: Robb Smith, Amtech Roofing Consultants)

In addition to selecting shingles with the appropriate wind resistance rating, installers must ensure that the selected shingles are installed according to manufacturers' recommendations and current design standards. Field observations of failed residential roof coverings provided instances of unacceptable installation, including rack-applied shingles (Figure 5-22). In a racking application, the shingles are applied vertically up the roof instead of diagonally (i.e., across the roof). This method should not be used in high wind areas because it can lead to shingles being installed with less than the recommended number of nails. Consequently the shingles are susceptible to blow-offs as depicted in Figure 5-22.

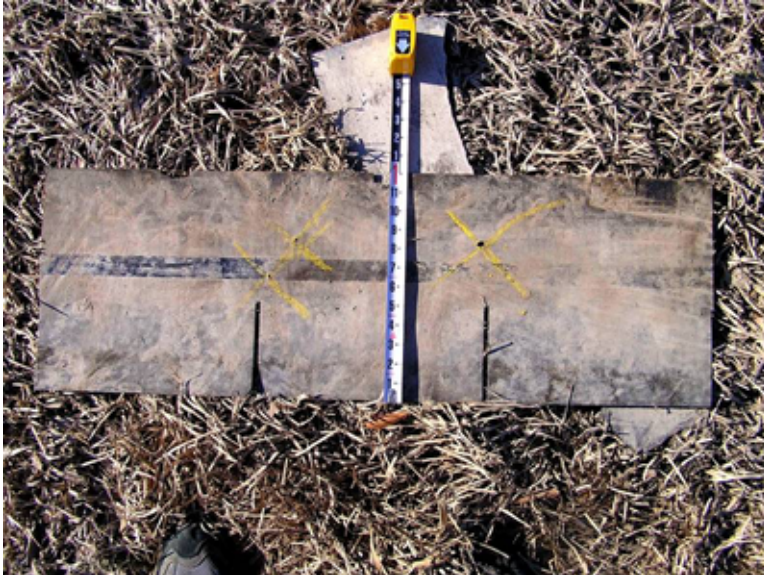
Throughout the study region, the team observed<sup>22</sup> shingles that were nailed high so that the nails penetrated only one shingle layer, which reduces the wind uplift resistance of the shingles. In addition, shingles had been fastened with only four nails, rather than six nails, as has been up to now a long-standing industry recommendation for high wind areas. Figure 5-24 is an example of a three-tab shingle that had been clearly misapplied. This shingle was fastened with four nails (denoted by yellow Xs in Figure 5-24), but no nail was put in place at the left and right ends of the shingle. Three nails were quite high on the shingle, and two were set at essentially the same location.

**Figure 5-24** Example of a blown-off three-tab asphalt shingle that was clearly misapplied. The yellow Xs mark locations where the shingle was nailed in place. (Photo credit: Robb Smith, Amtech Roofing Consultants)

Where repairs were underway, the reconnaissance team also observed contractors replacing asphalt shingles in the same manner as the shingles that had failed, using only four nails. The need to ensure that contractors (and homeowners alike) are educated on proper shingle installation was clearly evident. Mechanisms to ensure education of roofing contractors providing the enormous amount of re-roofing necessary after Hurricanes Katrina and Rita should be put in place as soon as possible, and proper application should be enforced in the field by local building departments. Education activities should include workshops and outreach efforts undertaken in partnership with local building authorities and the roofing industry to help institutionalize sound installation practices. The development of common industry guidelines, including a standardized

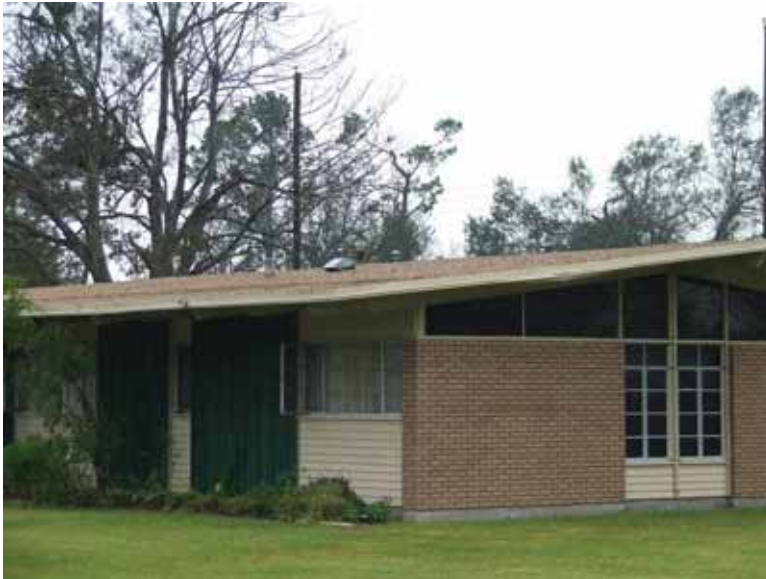
Only a few instances of residential construction with low-sloped membrane roofing systems were observed. For the most part, these buildings were one-story, single-family houses with gravel surfaced built-up membranes (Figure 5-26). In all such cases, no roofing damage was observed, although it was not always possible to have a good view of the entire roof because of the low-slope. At one apartment complex made up of two-story units with low-sloped roofs, piles of smooth-surfaced two-ply modified bituminous membrane debris were lying next to some of the buildings (Figure 5-27). The roofs were inaccessible, so the rooftop condition and the extent of damage were not observed. Examination of the debris piles indicated that 13 mm (1/2 in.) thick wood fiber insulation board had been nailed to the roof decking (presumably wood) along with a fiberglass base sheet, to which an APP (atactic polypropylene) modified bitumen cap sheet had been torch-applied. Wind damage to the system occurred at the interface of the base ply and the insulation board, as the base ply tore from around the center-nailed, thin metal fastening disks (possibly 28 gage to 30 gage with a diameter of about 25 mm (1 in.)). It could not be determined from the debris piles and examination of the buildings from the ground whether wind damage to the metal edge flashing (resulting from peeling up and lifting away from the roof edges) was the initial action that resulted in the membrane blow-offs; the vertical sections of the metal edge flashing (fascia) were not secured to the sides of the buildings.

**Figure 5-26** A small number of single-family, single-story homes having built-up bituminous membrane roofing (BUR) were seen. Those observed were undamaged as was the case for this house in Orange, Texas. (Photo credit: Dominic Sims, International Code Council)
