*NIST Technical Note 1491*

# Performance of Thermal Imaging Cameras In High Temperature Environments

November 2007

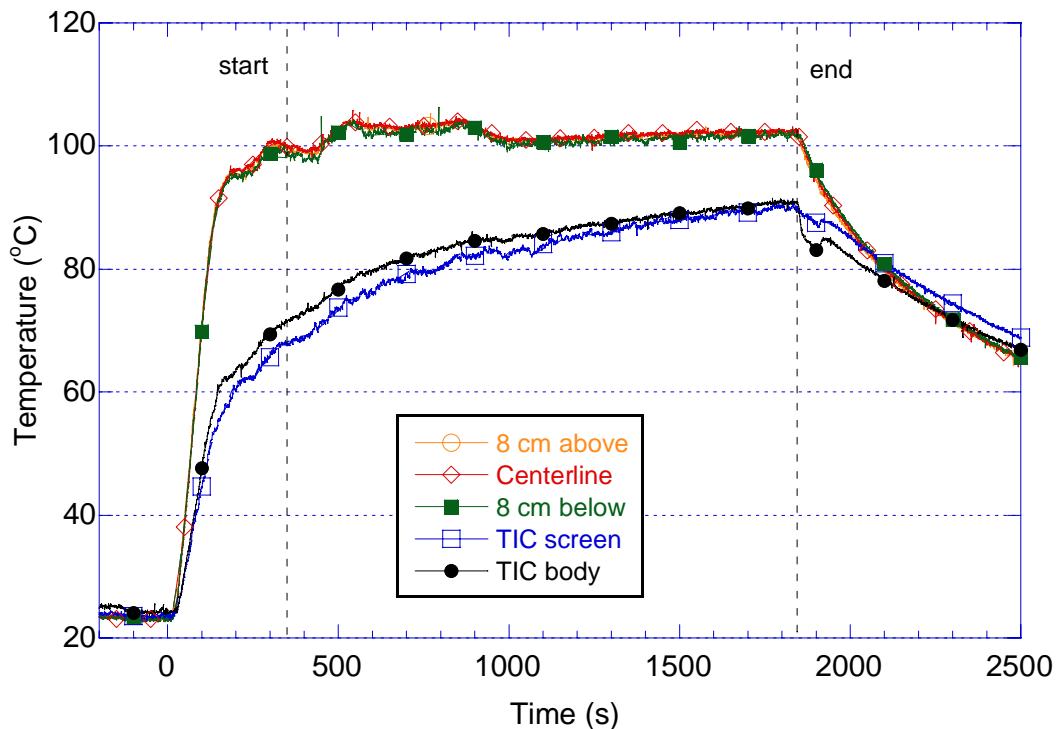
**Figure 5** Temperature measurements at Thermal Class I, 100 °C.

Camera 1 worked properly under the Class I conditions of exposure to an air temperature of 100 °C for 25 min, following the 330 s heat up period. There were no problems with the operation or visible degradation of the screen image. The camera continued to work throughout the heat soak and cool down. Inspection of the camera after the test showed no melting, warping, or damage of any kind to the camera or battery.

Camera 2 worked throughout the Class I conditions of 25 min at 100 °C without visible changes to the image on the display. The camera display remained unchanged during cool down and continued to function after the test. The camera was inspected after cool down, and showed no signs of damage to any parts of the camera or battery. There was one anomaly during this test. The battery indicator dropped quickly, moved back up to nearly full, then dropped quickly again, and repeated this throughout the heating. The up and down inconsistency of the battery indicator had no apparent impact on the camera operation, and the image was not affected. To determine if the abnormal response of the battery indicator was a result of the camera being heated, or a defect in the camera itself, the camera was allowed to cool overnight, and was then operated at ambient temperature for one hour. During this time the battery indicator was observed, and no anomalies were witnessed while operating the camera at ambient temperature.

Camera 3 worked properly throughout the Class I conditions of 100 °C temperatures for 25 min. There were no degradations of the picture during the test. A “high temperature” warning appeared on the camera screen near the end of the thermal exposure, at 22.75 min, but there was no observable change in the camera image as a result of the warning. Inspection of the camera after the test showed no melting, warping or any other observable damage to any parts of the camera. The camera was fully functional after the Class I test.

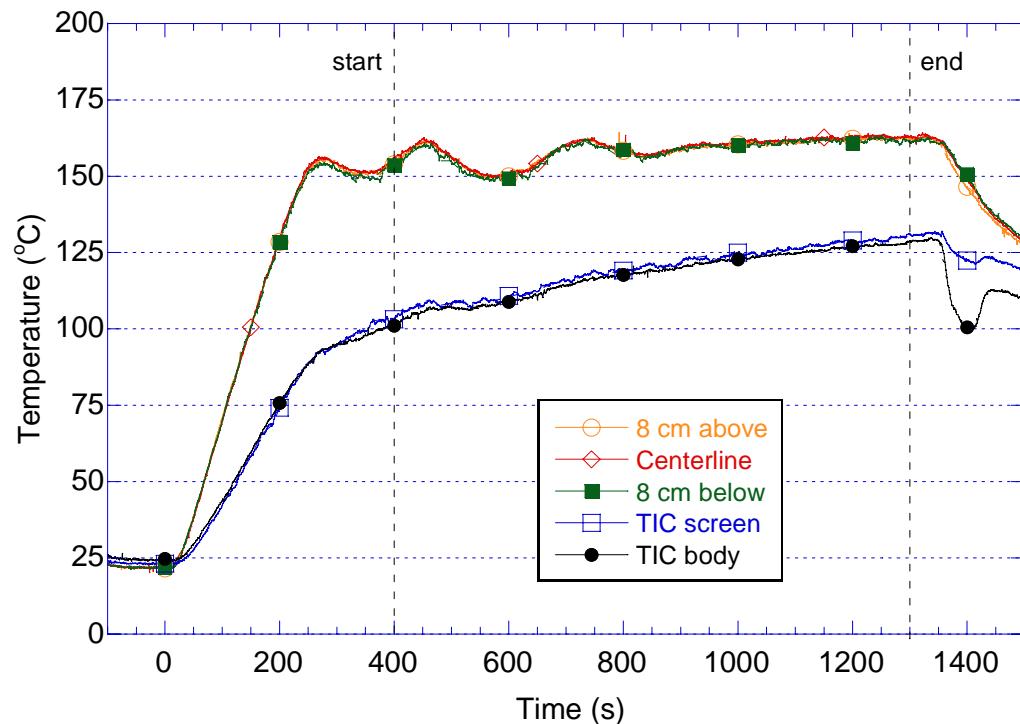
**Figure 6** Temperature measurements at Thermal Class II, 160 °C.

Camera 1 functioned properly throughout the Thermal Class II conditions of exposure to 160 °C for 15 min, following the standard 400 s heat up period. The camera image remained clear, and there were no signs of image degrading during the heat exposure or cool down. After the test, the camera was inspected. There was no observable damage to the camera or battery. Camera operation was normal following this test.

Camera 2 only worked for the first few minutes at the Class II temperature of 160 °C. At a time of 168 s into the thermal exposure, the image suddenly disappeared, and the screen was filled with static. The occurrence was abrupt, and there was no blurring or distorting of the image and no warning from the camera; the screen simply went from showing a clear image to showing only static. The battery indicator was still functioning and indicating a mostly full battery. Other than the picture no longer working, there was no noticeable damage to any other parts of the camera. Camera 2 was allowed to cool overnight, and the battery was replaced; however, operation of the camera was not restored.

Camera 3 functioned normally during the 15 min exposure at the Class II temperature of 160 °C; however, all camera operations failed during the cool down period. Throughout the heated period, the camera image remained clear with no degradation. Near the end of the thermal

exposure, after 12.75 min, the “high temperature” warning appeared on the camera screen. There was no degradation of the image, and the camera continued to operate properly and deliver a clear picture for the last few minutes of the Class II test. The camera was then allowed to cool, and approximately 5 min into the cool down period, the camera stopped working. As with camera 2, there was no degrading of the image; the display just abruptly went dark. During the inspection of the camera after the test, it was noted that the battery remained very warm, while the rest of the camera was at room temperature. The camera was allowed to cool for three days. A new battery was supplied to the camera, but it did not regain operation following this test.

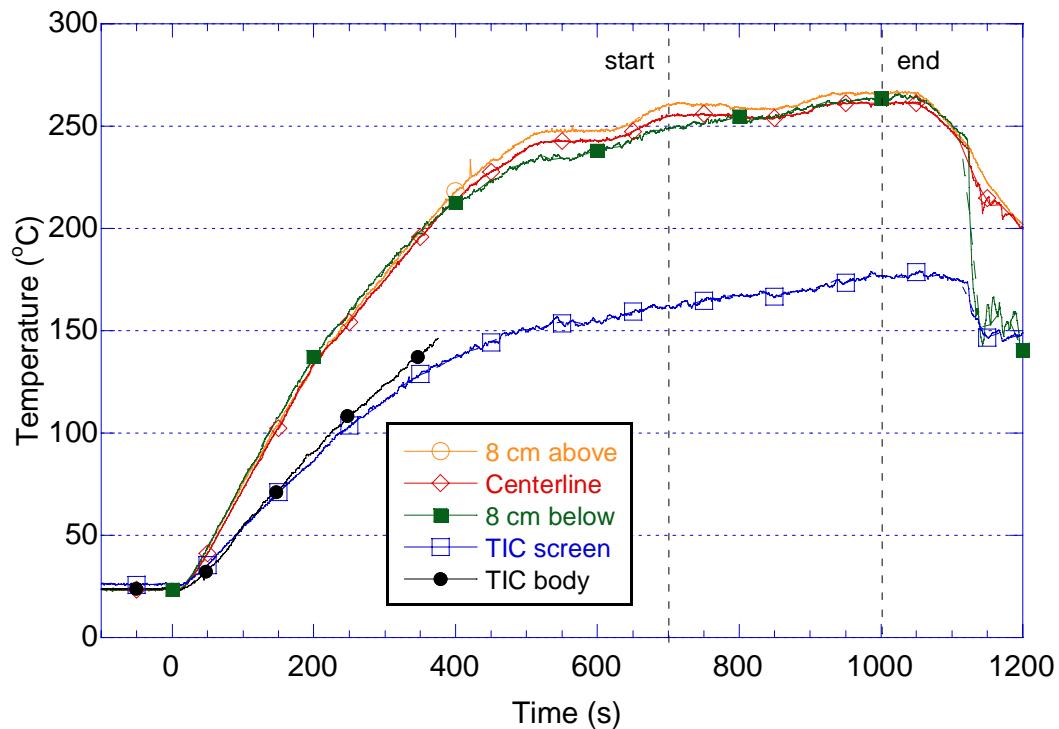
**Figure 7** Temperature measurements at Thermal Class III, 260 °C.

Before testing at the Thermal Class III conditions, an intermediate test was performed on Camera 1 by subjecting it to a 5 min thermal exposure at 210 °C. The camera functioned perfectly throughout this test. The image on the camera display was unchanged throughout the test and the cool down. Following cool down, the camera was inspected, and there was no observable melting, deformation, or any damage to any parts of the camera, except for the battery. The casing of the battery had melted slightly and had become warped. Inspection of the insides of the battery housing area showed no internal damage, including no damage to any of the exposed electronic components in this area. A new battery was supplied to the camera and the camera operated properly with this battery.

Camera 1 was then tested at the Thermal Class III condition of 260 °C exposure for 5 min. This camera survived the 5 min exposure with no changes in the display and no degradation of the picture; however, it failed immediately afterwards during the cool down. Approximately 45 s into the cool down, the top edges of the screen began to darken. The darkening of the screen continued over the next 120 s, working from the edges to the interior until the entire image was gone. Figure 8 shows a picture taken 80 s into the cool down, with darkening of the screen visible in the upper right hand corner (compare with Figure 2). After cool down, an inspection of the camera revealed that the casing of the battery had melted and deformed. Other than the warping of the battery case, there was no other observable melting, deformation, or damage of any kind to any other parts of the camera. The battery housing area was inspected and showed no internal damage. A new, fully charged battery was then supplied to the camera; however, camera operation did not recover.
