NBS TECHNICAL NOTE 558

LUBBOCK TORNADO: A Survey of Building Damage in an Urban Area

N. F. Somes, R. D. Dikkers, and T. H. Boone

Building Research Division
Institute for Applied Technology
National Bureau of Standards
Washington, D.C. 20234

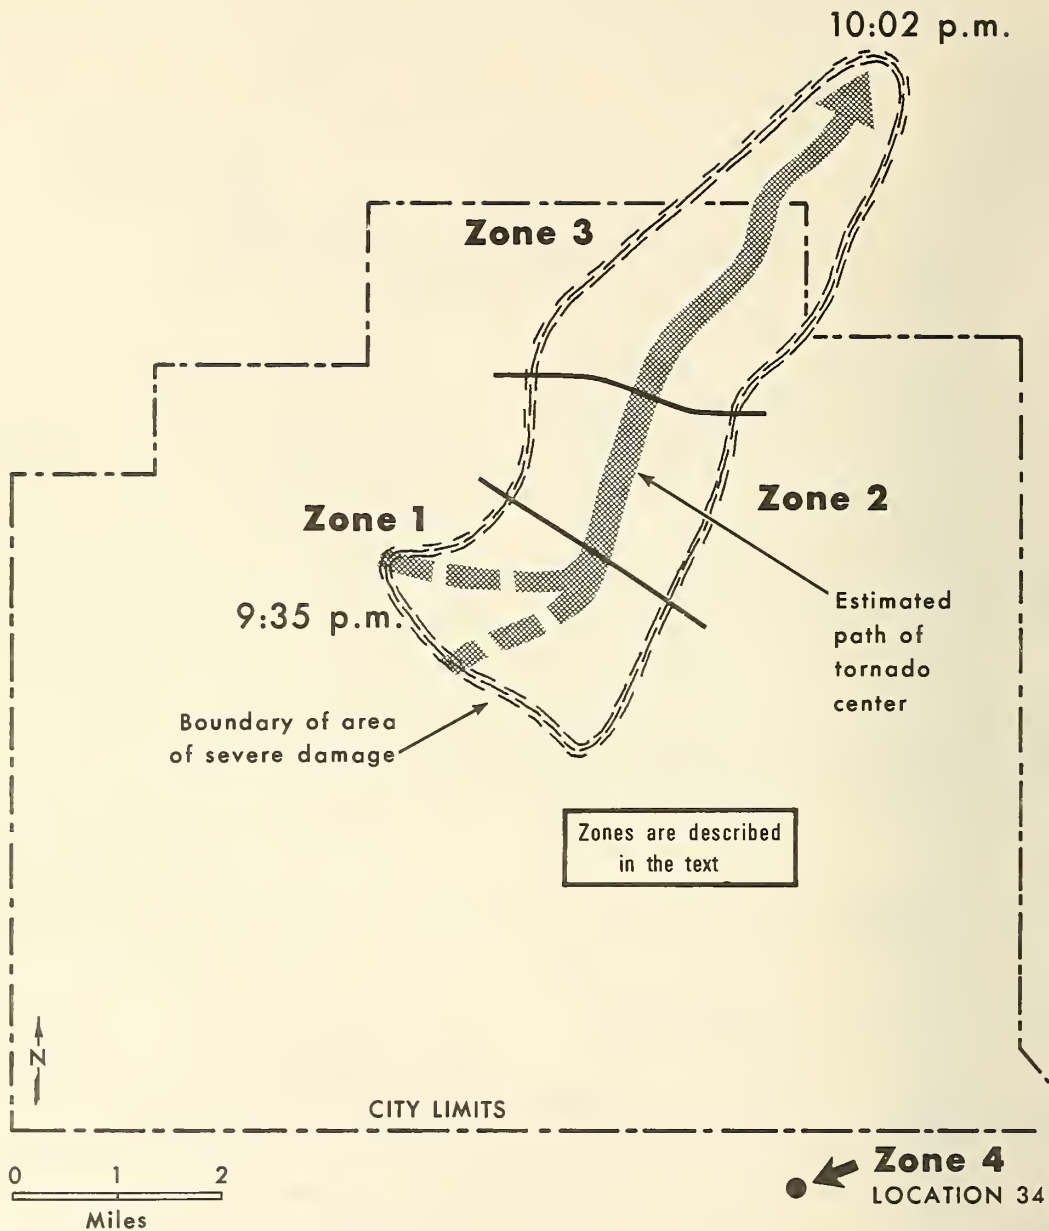
Figure 4 PATH OF TORNADO

Figure 3 shows the main features of the city. Figure 4 shows the area which sustained "severe damage." The term severe damage indicates destruction or damage which the building owner or occupant must seek specialist help in repairing.

Within this overall area there are areas in which all building structures were demolished as well as areas in which the damage was less severe. To avoid overcomplication, the latter areas are not delineated in figure 4.

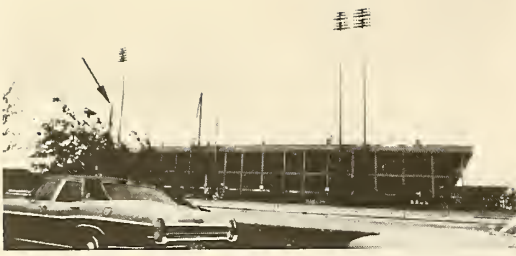
Photograph 3—Jones Stadium of Texas Technological University with bent and collapsed floodlight standards. View looking west. (Location 2)

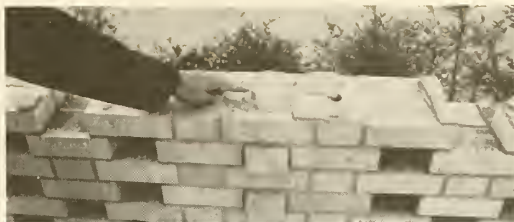
The wall contained vertical reinforcement but unfortunately this reinforcement terminated at mid-height; note photograph 29. Based on the wall dimensions and an assumed bond strength of 20 psi, the minimum wind speed was calculated as 83 miles per hour. Although the type of mortar is not known, the value assumed for the bond strength is conservative and hence the wind speed derived from this calculation is conservative.

Photograph 29—Overturning of wall occurred at level at which vertical reinforcement was terminated. (Location 14)

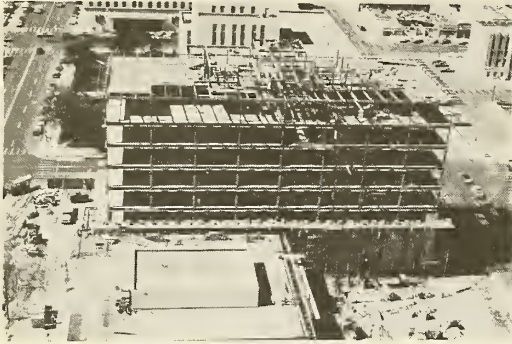
Photograph 32—Federal Office Building under construction. View looking north. (Location 17)

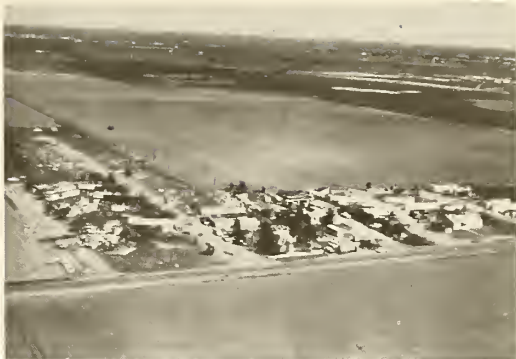
Photograph 50—Mobile home park at Quirt Road, looking east. (Location 30)

few natural windbreaks. Aerial photograph 50 shows the general disruption to the site. Some homes suffered glass breakage and a stripping of their light-gauge aluminum skins; note photograph 51. Others were overturned (photograph 52) and

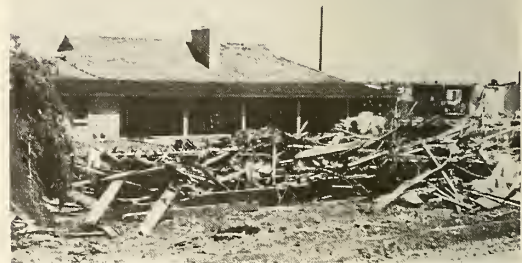
One house in this row escaped damage by some strange chance and is located in the upper part of the photograph 54. This house is shown close up in photograph 55 beyond the wreckage of the neighboring house.

Photograph 55—While houses immediately north and south of this house were severely damaged, this home remained unscathed. (Location 31)

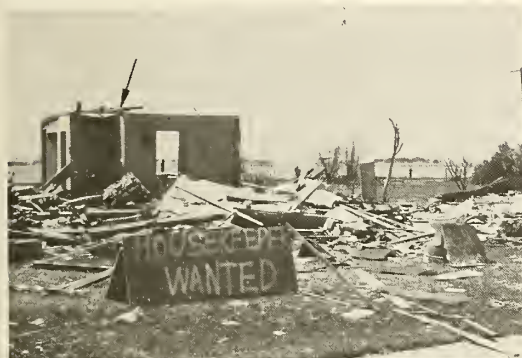
Photograph 57—A loss of everything but a sense of humor. (Location 31)

presumably because of the small dimensions of these rooms giving a closer spacing of cross walls; note photograph 57. Some reinforcement of bathrooms is possibly provided by the presence of plumbing, vent stacks and bathroom fixtures.

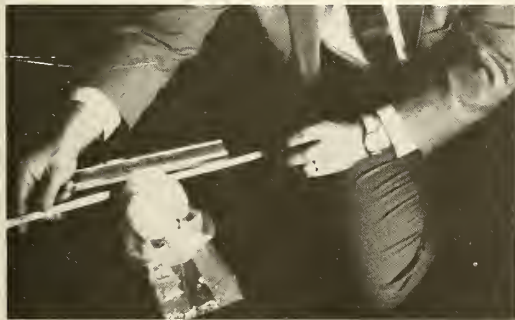
The Town and Country Airport, five miles south of Lubbock, was subjected to hailstones known to have exceeded 3 inches in diameter and reported by others to have reached 6 inches; note photograph 63.

Photograph 63—View of three-inch hailstone preserved by local resident in area five miles south of Lubbock. (Location 34)
