NBS TECHNICAL NOTE 569

Hurricane Camille-August 1969

HURRICANE CAMILLE - AUGUST 1969* A Survey of Structural Damage Along the Mississippi Gulf Coast by Robert D. Dikkers, Richard D. Marshall

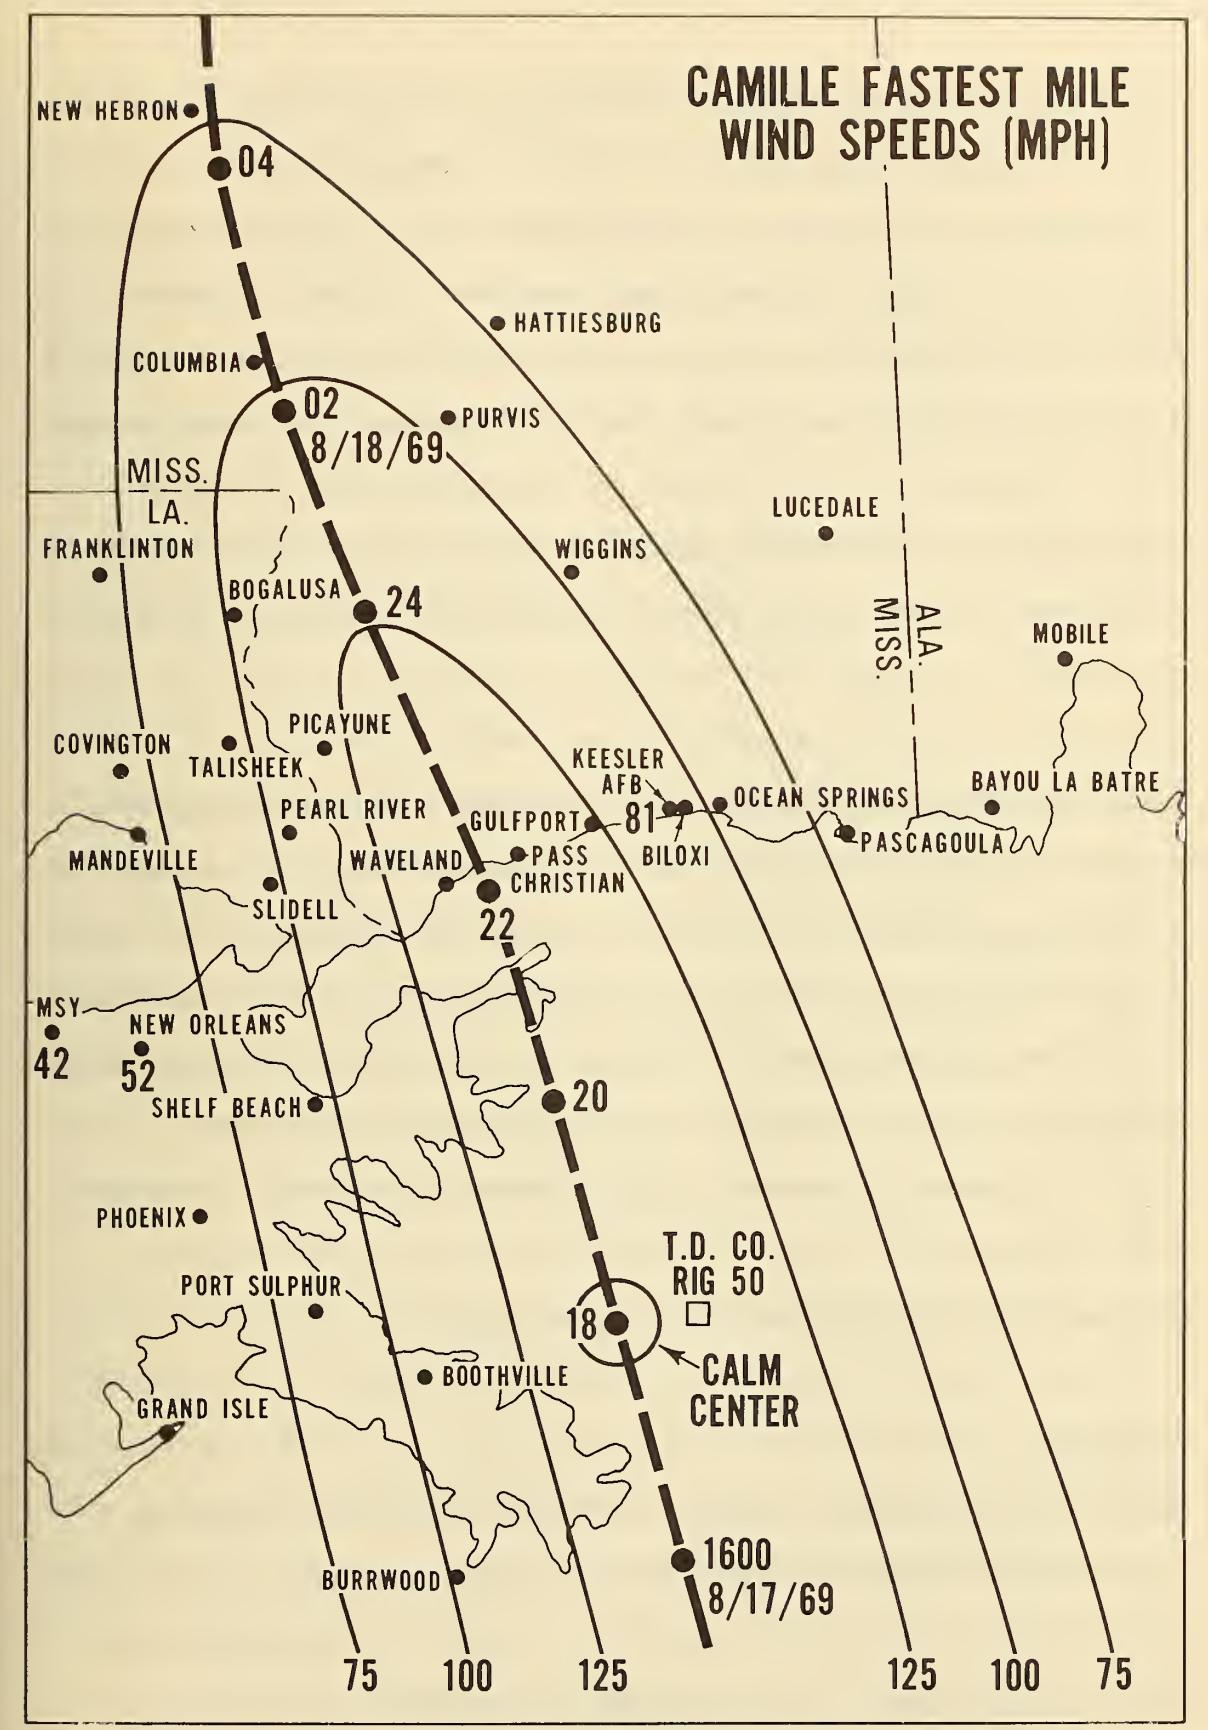
Figure 2. Fastest mile wind speeds (mph) - Hurricane Camille.

Examination of figure 2 shows that the 50-year design winds [6] were exceeded in the area between Slidell, Louisiana, and Ocean Springs, Mississippi. Between Gulfport and Waveland, Mississippi, the 100-year design winds were exceeded by winds corresponding to a mean recurrence interval of perhaps as much as 200 years. Although there were no known official reports of tornadoes, several non-commissioned weather observers reported tornadoes to the northeast of the center where they would be expected to occur. At least one structure (near Wiggins, Mississippi) suggested damage by a tornado [7].

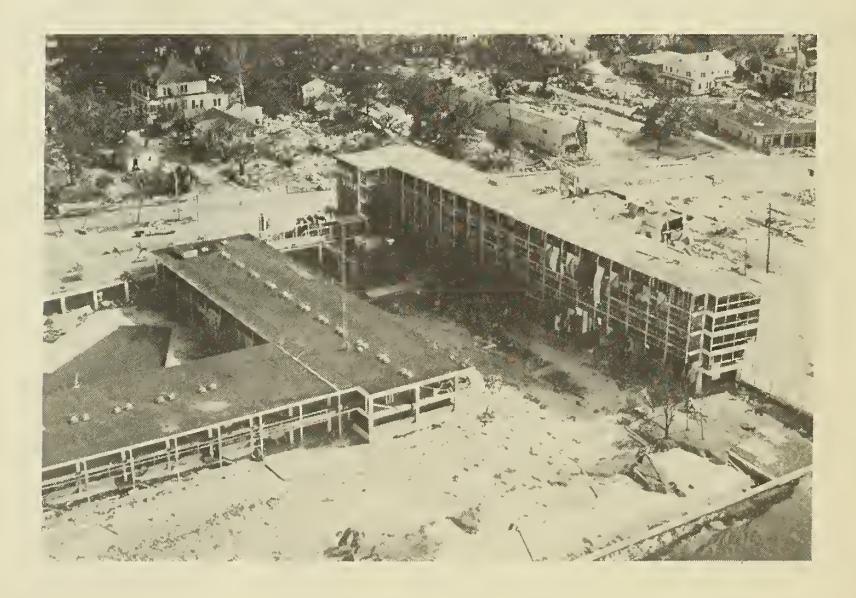
Structures on slightly higher ground fared much better even though their ground floors and basements were flooded (fig. 8). Generally, surge damage was limited to those areas within two blocks of the beach.

Figure 8. Coastal area, Biloxi, Mississippi.

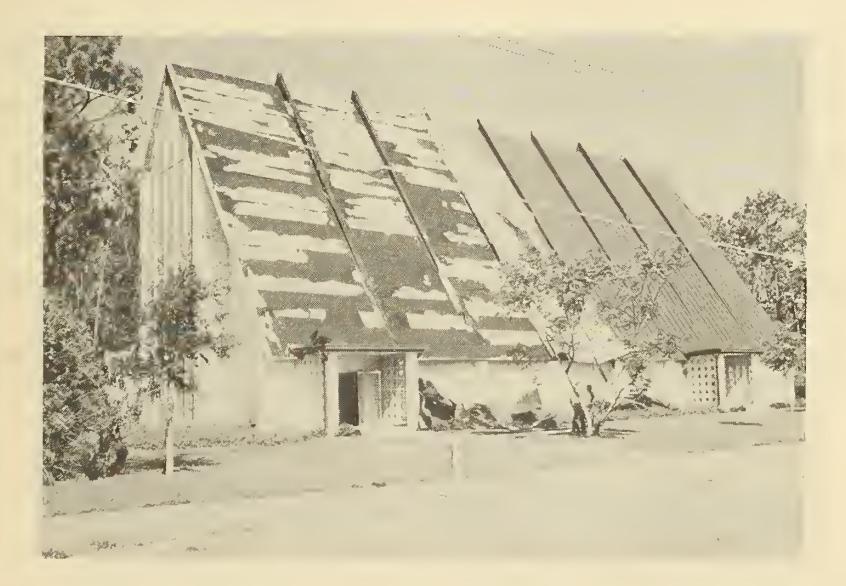
Figure 9. Chapel, Keesler Air Force Base, Biloxi.

Keesler Air Force Base - Damage to buildings was limited to loss of cladding and roofing with some flooding occurring in housing developments located along the back bay. The chapel shown in figure 9 suffered the most serious damage with the loss of copper roofing and subsequent water damage to the interior furnishings. Single-family dwellings with wind-resistant shingles exhibited very little damage (fig. 10).

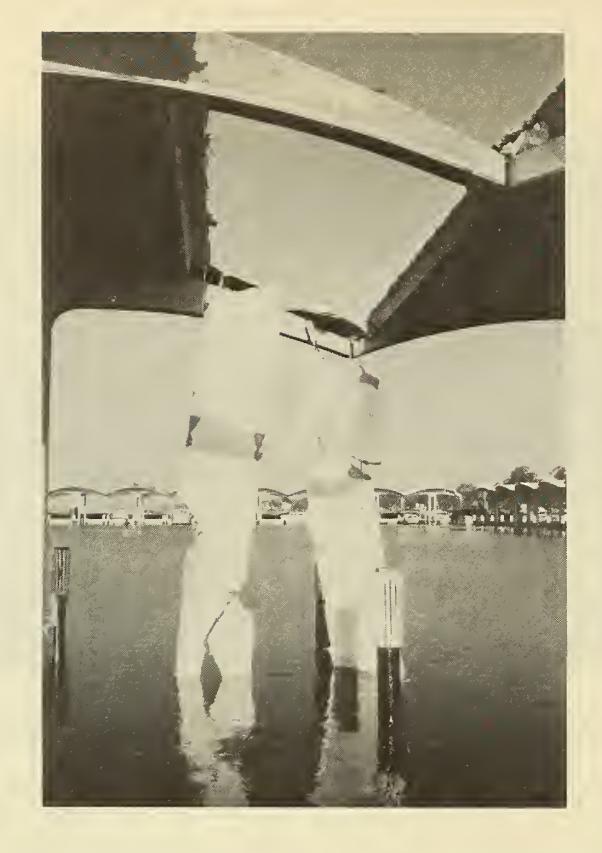
Broadwater Beach Marina - This marina (fig. 11) near Biloxi consists of reinforced concrete columns and double-T roof members over the boat slips. Although some of the roof members were damaged (fig. 12), the overall performance of the structure was very good considering that it was completely inundated by the storm surge. Surge height in this area (approximately half way between Biloxi and Gulfport) was about 20 ft.

Figure 12. Close-up view of damage to Broadwater Beach Marina.

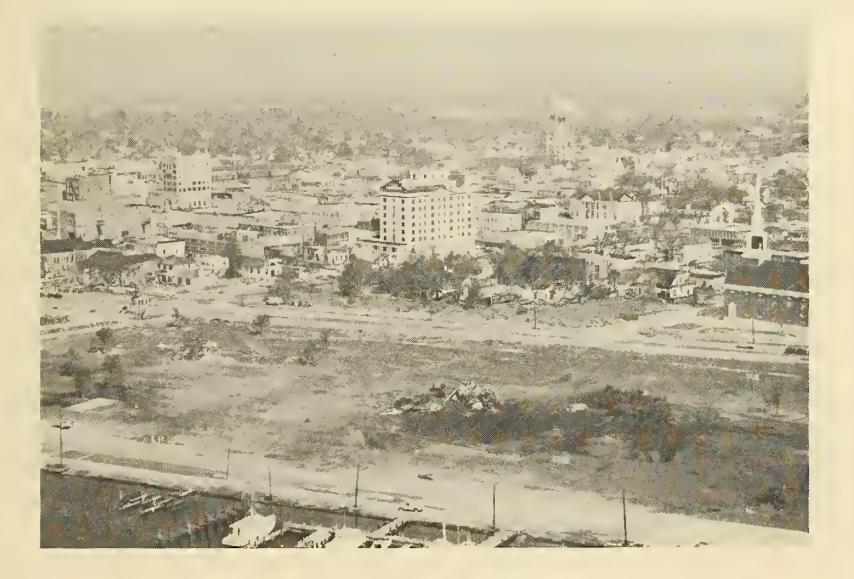
An aerial view showing a portion of the downtown business and commercial area of Gulfport is shown in figure 15. Many small buildings located along this flat coastal area were heavily damaged or destroyed by the

Figure 15. Business and commercial area, Gulfport, Mississippi.

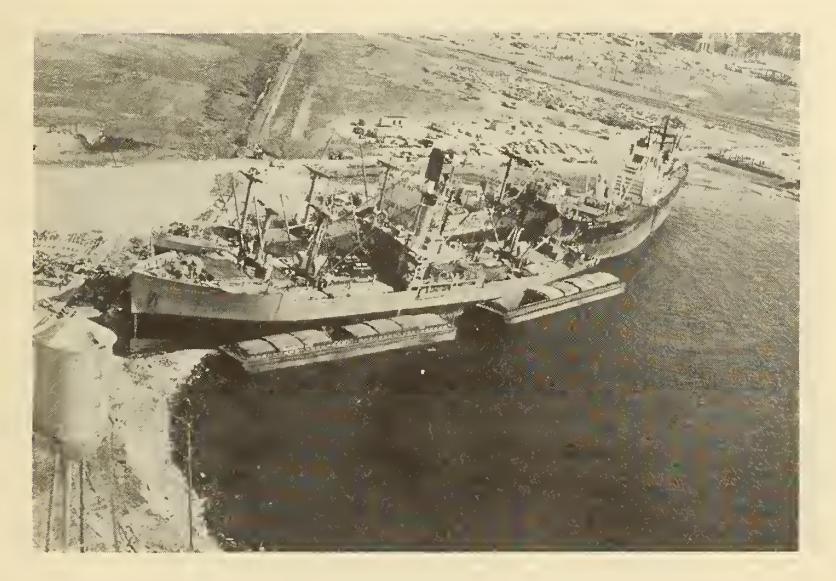
Three large ships, which were driven aground on the Gulfport Coast near the Mississippi Power Company building, are shown in figure 17.

Figure 17. Ships aground at Gulfport, Mississippi.

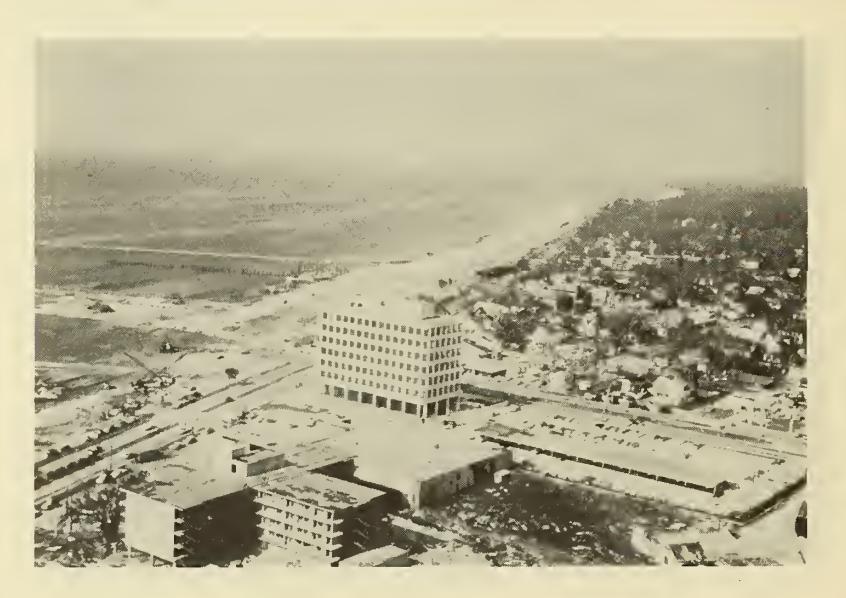
Mississippi Power Company - The new seven-story Mississippi Power Company building is located on U.S. Highway 90 in Gulfport. Figure 19 is an aerial view illustrating the proximity of the building to the coastline. Opened in April, 1969, this \$2.5 million concrete frame building sustained only minor damage. To help protect the building from flooding, it was situated on an elevated, earth-banked plazapodium (about 26 ft above mean sea level).

Figure 19. Seven-story Mississippi Power Company building, Gulfport, Mississippi.

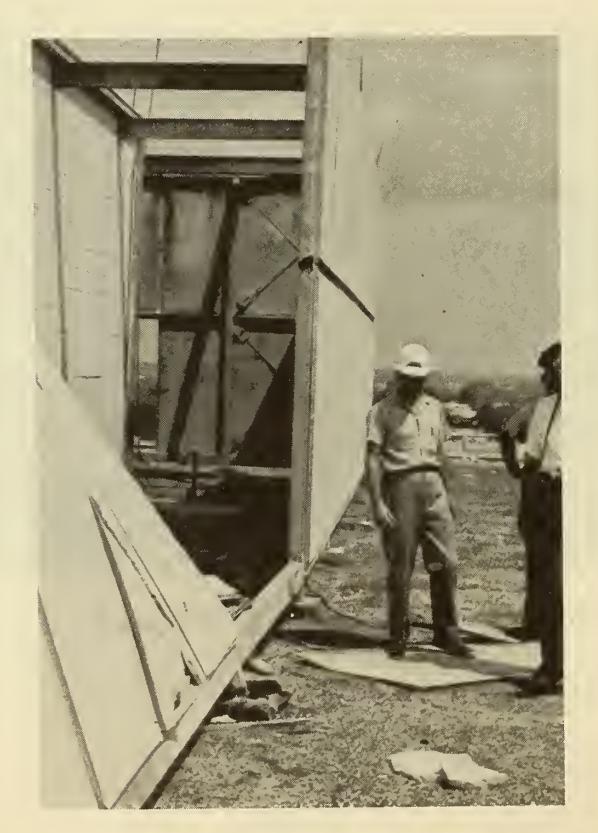
In addition to the window damage, some minor damage occurred to one side of the roof enclosure surrounding the air-conditioning cooling tower (fig. 21). The structure for the enclosure consisted of rectangular structural steel tubing and 2-in thick concrete panels which were reinforced with expanded metal lath.

- Figure 20. Close-up view of Mississippi Power Company building.
 - Figure 21. Enclosure structure on roof of Mississippi Power Company building, Gulfport, MIssissippi.

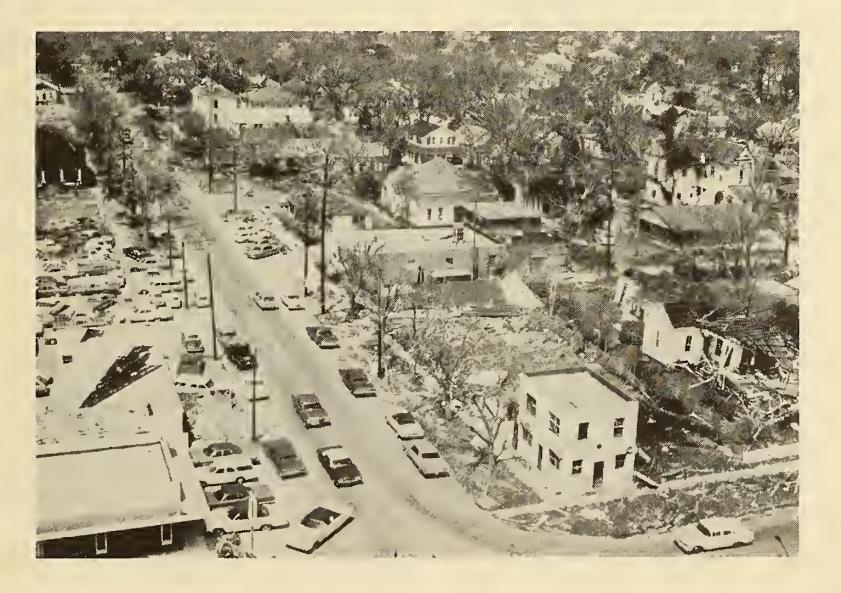
Figures 22 through 24 indicate the general level of damage in the area surrounding the Mississippi Power Company. The prefabricated metal building in figure 22 again points up the importance of local wind effects when designing roof elements. The random distribution of damage shown in figure 23 is typical of the entire area covered by the survey. Failures of roofing are usually progressive as is indicated in figure 24. Gravel from this built-up roof contributed considerably to the flying debris.

Figure 23. Area directly east of Mississippi Power Company building, Gulfport, Mississippi.

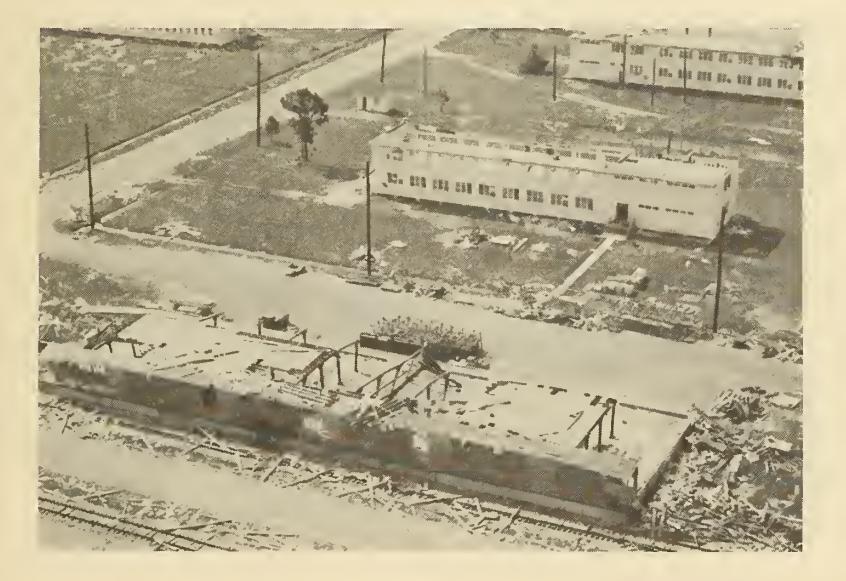
Severely damaged two-story wood-frame barracks and a one-story woodframe warehouse are illustrated in figures 34 and 35. The type of damage observed from both the ground and the air seems to indicate this area was probably struck by tornadoes. Nearby, large pine trees were

Figure 34. Wood-frame barracks, U.S. Naval C. B. Center, Gulfport.

Figure 35. Wood-frame warehouse and barracks, U.S. Naval C. B. Center, Gulfport, Mississippi.

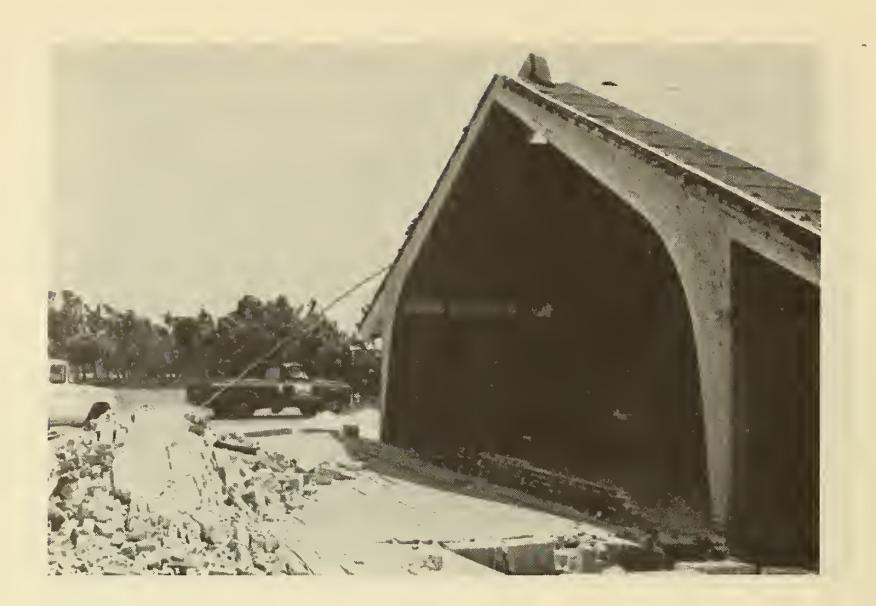
Figure 38. Masonry wall damage, U.S. Naval C. B. Center, Gulfport.

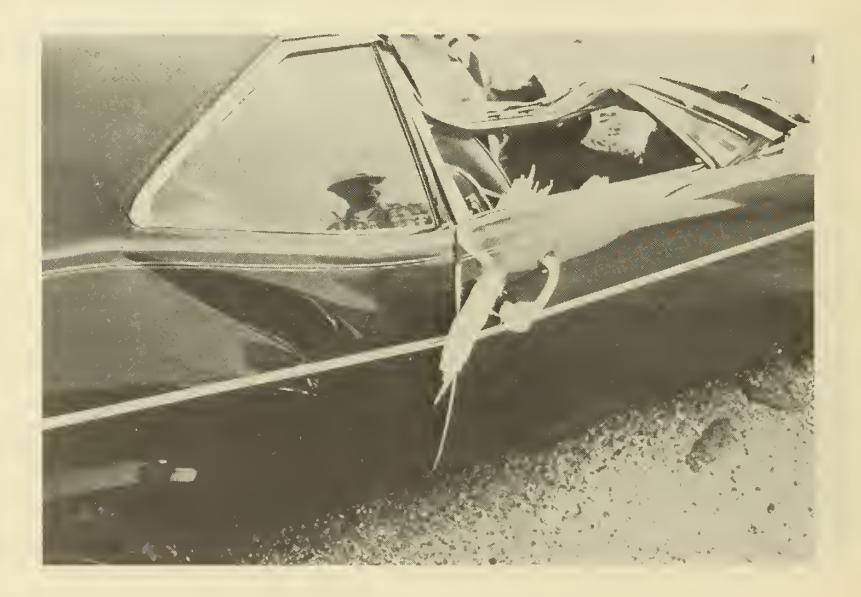
Figure 39. Damaged car, U.S. Naval C. B. Center, Gulfport, Mississippi.

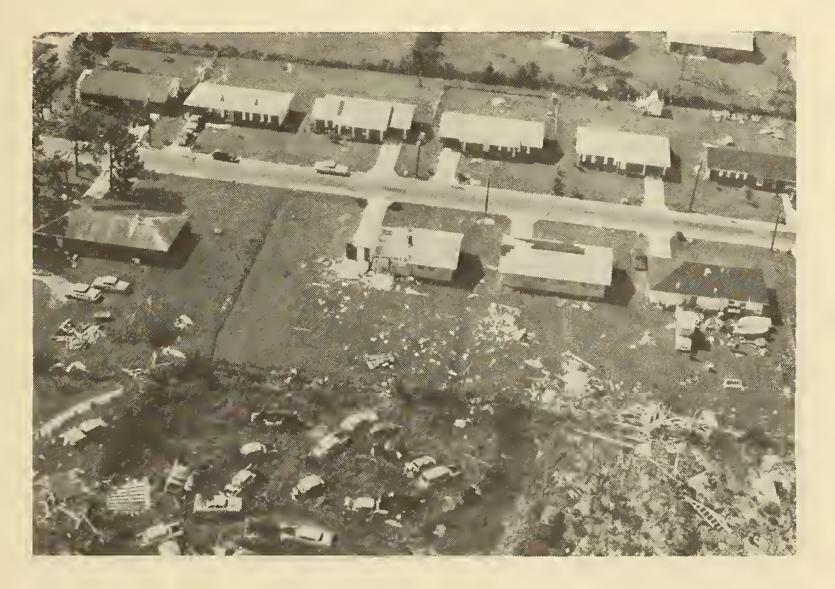
Figures 40 and 41 indicate the sporadic nature of wind damage in the area west of the U.S. Naval Center and north of Long Beach. Failures were usually initiated by loss of carport roofs or large roof overhangs which often led to removal of the complete roof structure.

Figure 40. Residential area west of Gulfport.

Figure 41. Residential area north of Long Beach, Mississippi.

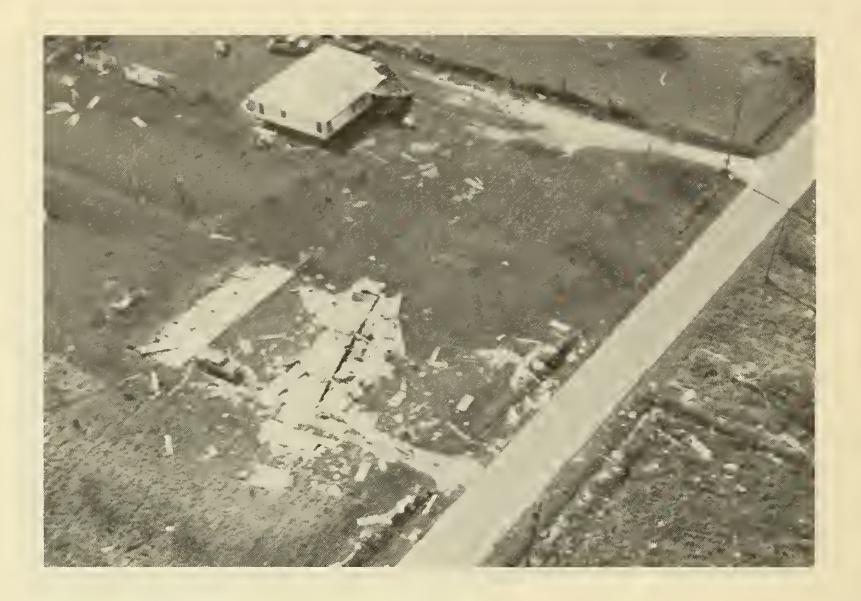
The remains of a mobile home in the same general area are shown in figure 42. The areas shown in the figures 40-42 are relatively clear of large trees, a fact which probably reduced the intensity of damage.

Figure 42. Remains of mobile home, Long Beach.

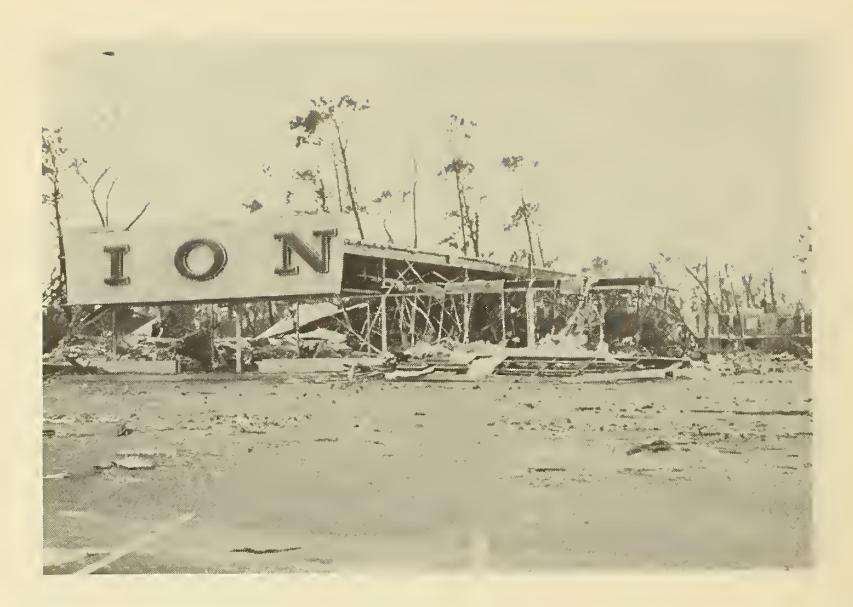
Figure 44. Commercial building, Long Beach. (Building is located across the street from shopping center shown in fig. 45).

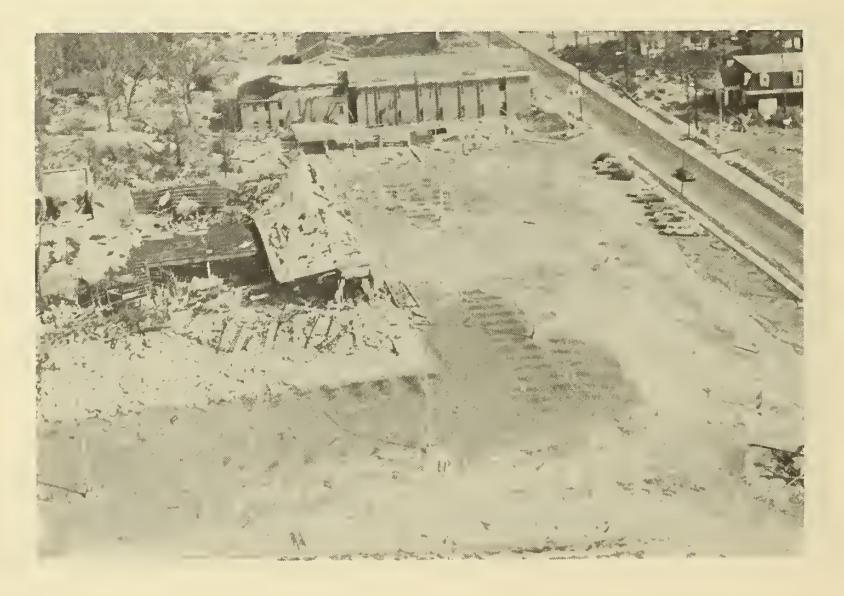
Figure 45. Shopping center, Long Beach, Mississippi.

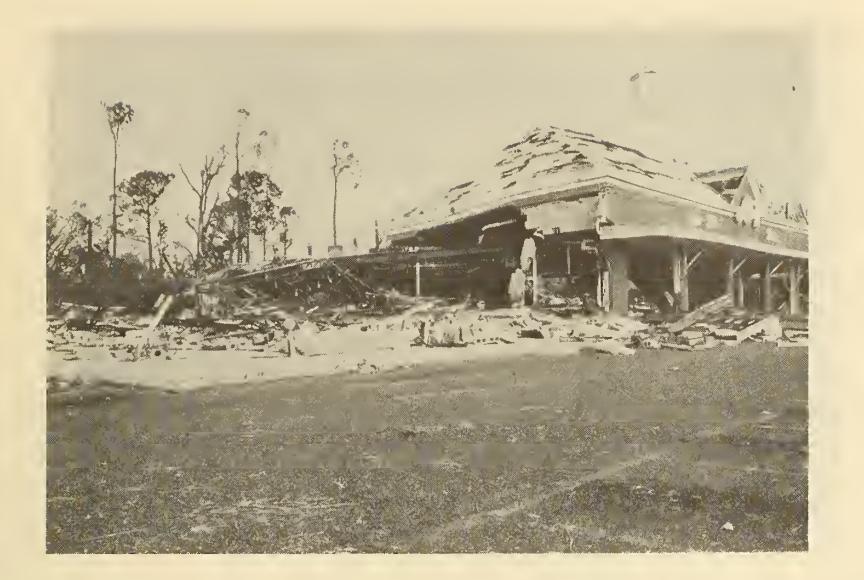
Figure 46. Close-up view of supermarket shown in figure 45.

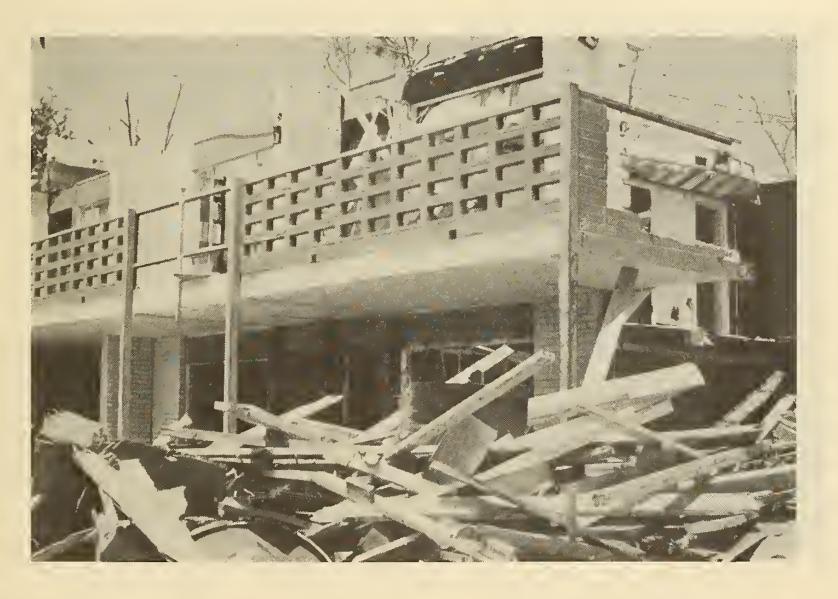
Water-borne debris piled up in front of a damaged masonry veneer wood-frame building (probably a motel) is illustrated in figure 47.

Figure 47. Close-up view of residential building, Long Beach, Mississippi.

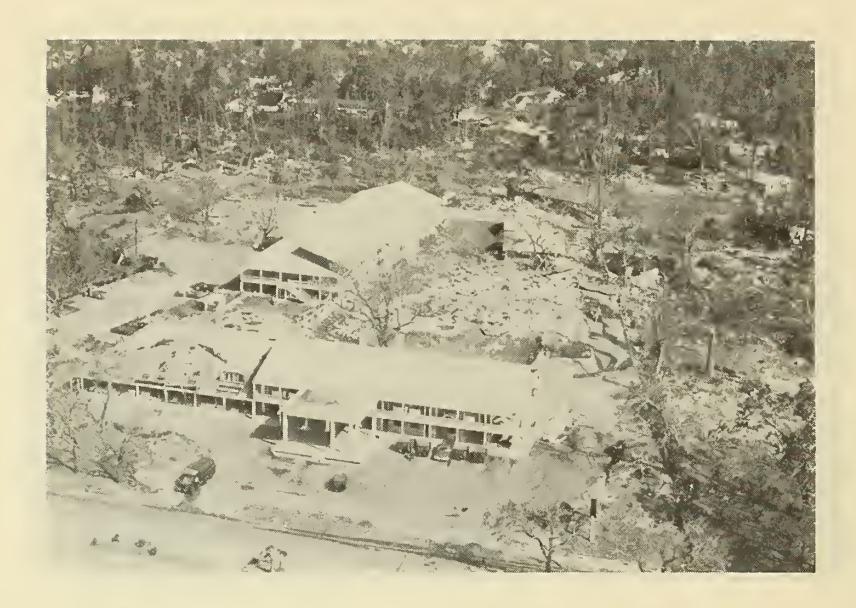
Ramada Inn - This motel (fig. 48) consists of a main building parallel to the highway (U.S. Route 90) plus two wings perpendicular to and behind the main building. As shown in figure 48, the motel wing on the right (east wing) suffered more damage than the other wing, probably because of its clearer exposure to the waves. The main building including

Figure 48. Ramada Inn, Long Beach, Mississippi.

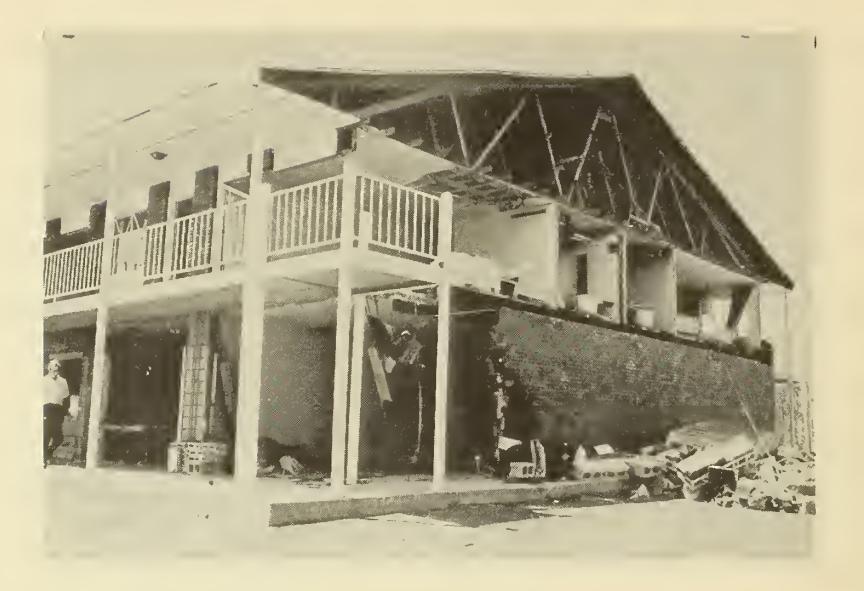
- Figure 50. Damaged masonry wall on east end of main building, Ramada Inn.
- Figure 51. Damaged masonry wall, Ramada Inn; block cells containing vertical reinforcement were not grouted.

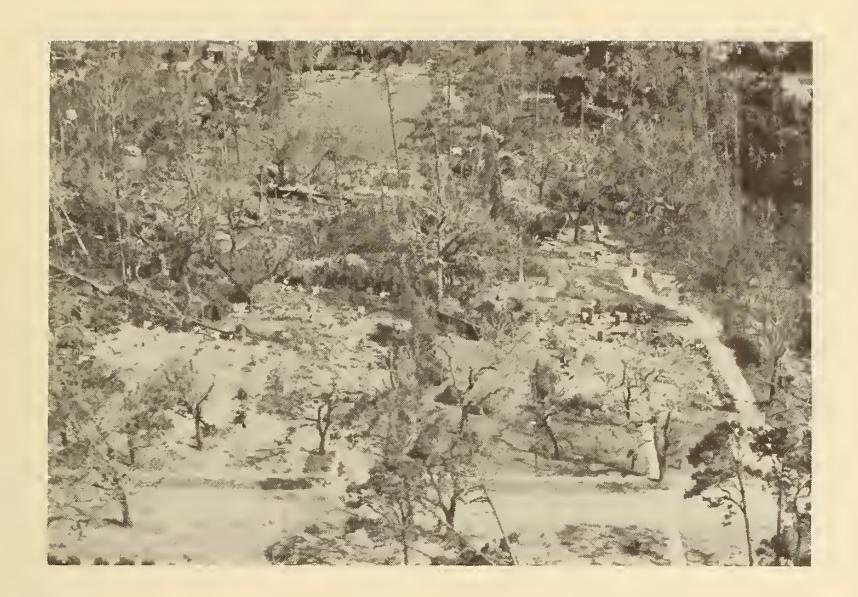
Figure 52. Residential area along coast, Long Beach, Mississippi.

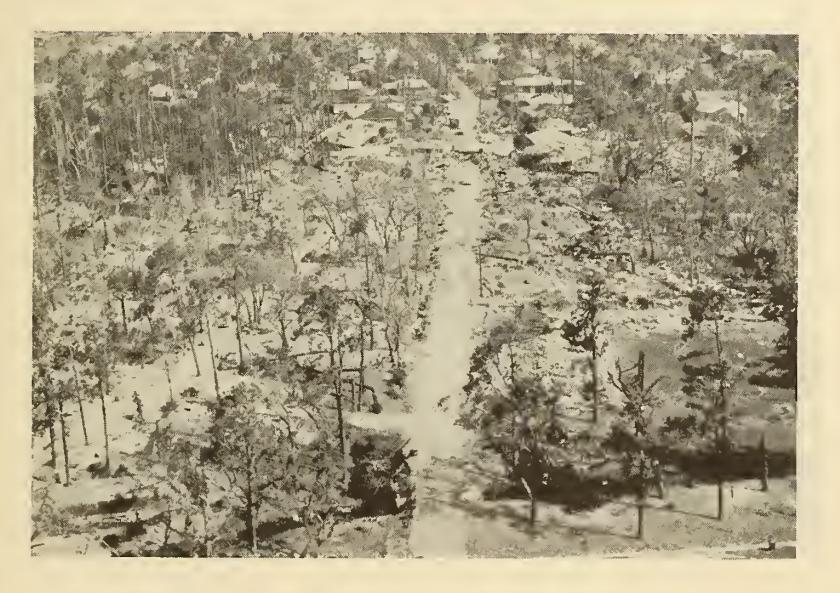
Figure 54. Richelieu Apartments, Pass Christian.

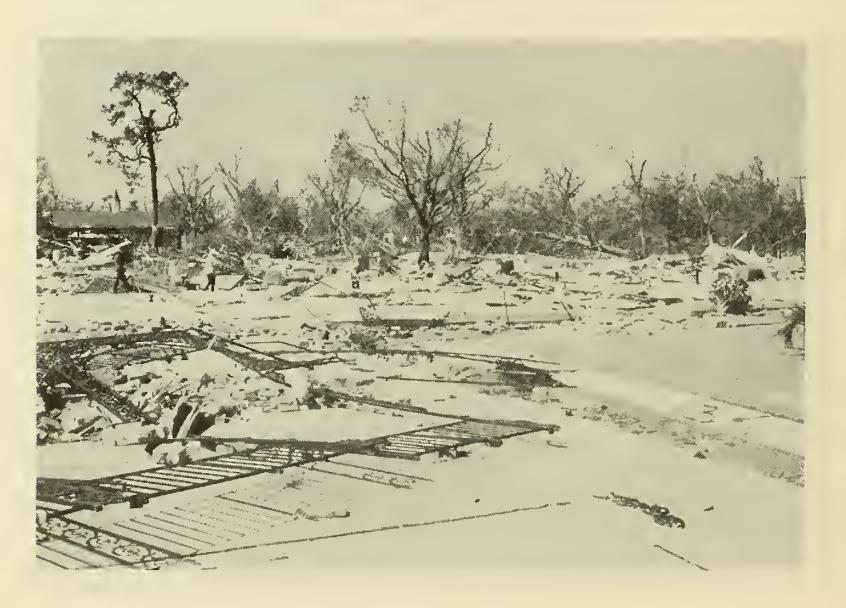
The remains of other demolished apartment buildings are illustrated in figures 56-58. The construction of these buildings was similar - brick veneer and wood frame.

Figure 56. Remains of an apartment building, Pass Christian, Mississippi.

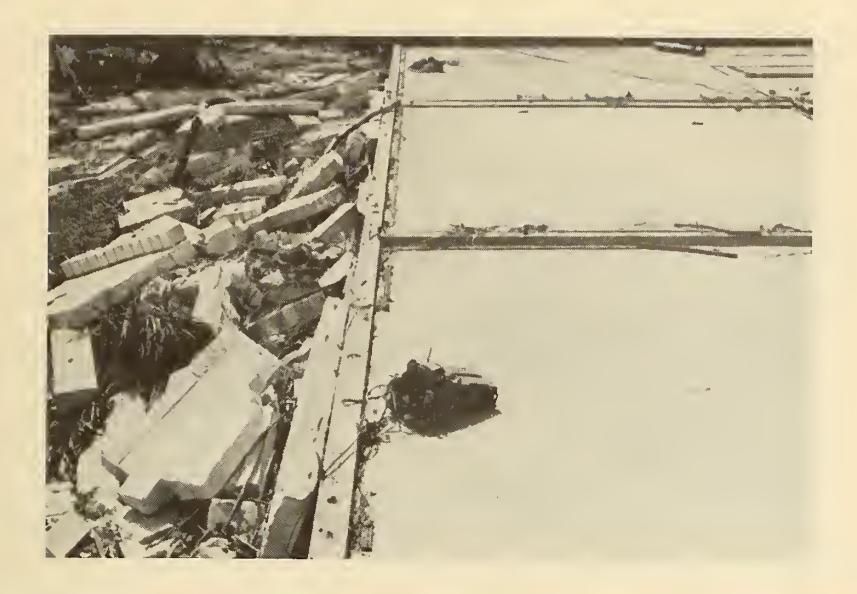
Figure 57. Brick veneer from destroyed apartment building, Pass Christian.

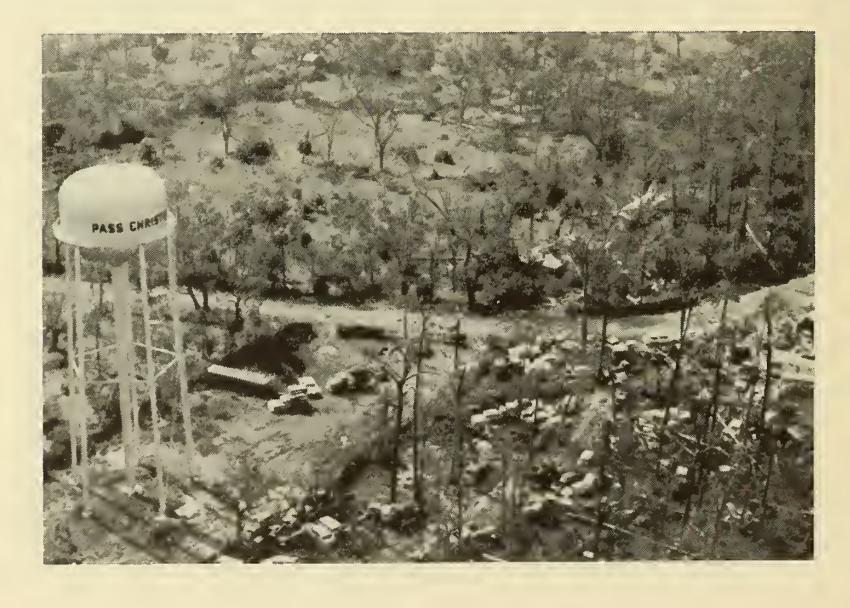
district suffered extensive damage as illustrated in figure 60. The debris in the center of the figure is all that remains of the commercial buildings which were located on the south (near) side of the street. Note U.S. Highway 90 in the foreground. Accumulations of debris were particularly heavy in the back bay areas and along the beaches of Mississippi Sound as indicated in figure 61.

Figure 60. Business area, Pass Christian, Mississippi.

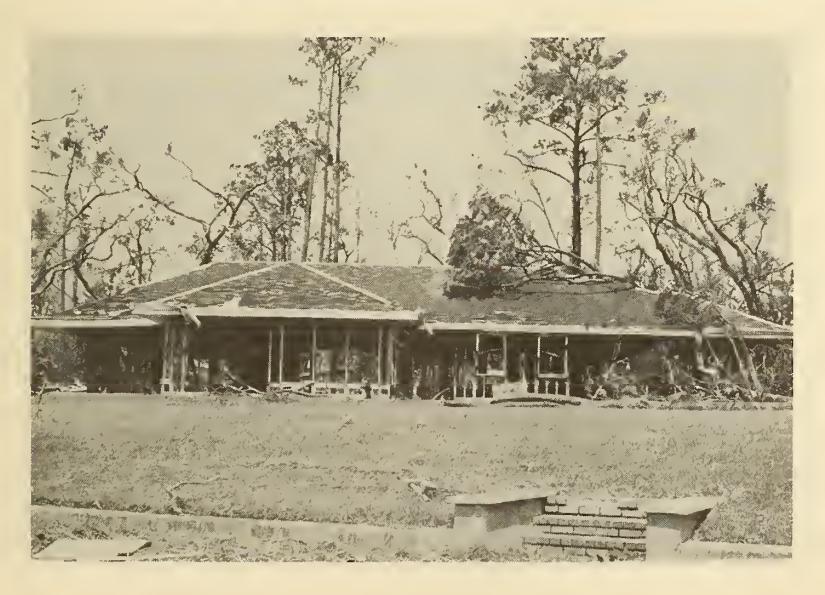
Figure 67. Single-family residence, Waveland, Mississippi.

A residence and a bank building, which were struck by waves, are illustrated in figures 67 and 68. The residential building lost most of its exterior and interior wall coverings but the good anchorage of the woodstud walls to the concrete slab foundation and to the timber roof prevented total destruction. As shown in figure 68, the bank building was completely destroyed except for the reinforced concrete vault and building frame.

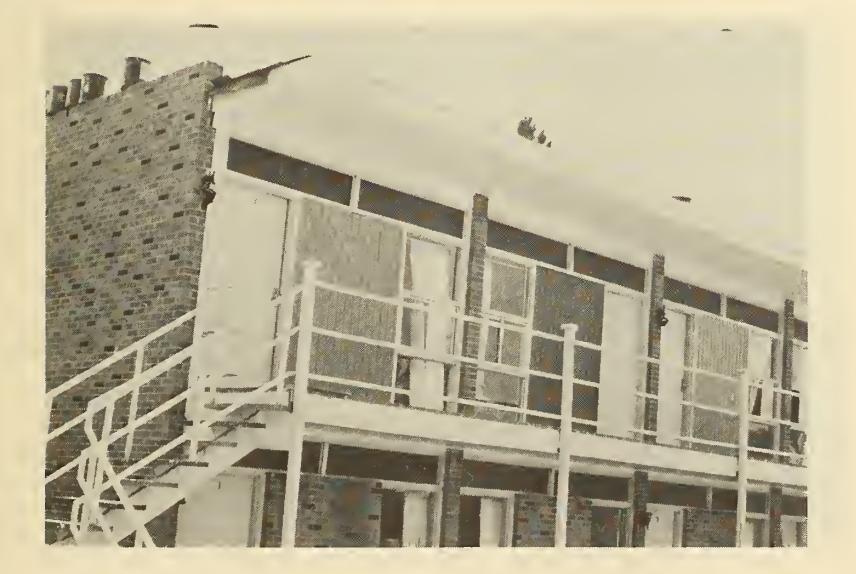
Figure 69. Motel near Waveland, Mississippi.

A small two-story motel located about 3 miles from the coast and on U.S. Route 90 near Waveland, Mississippi, is shown in figure 69. This brick-veneer and wood-frame building was arranged in a U-shaped plan and had a flat roof overhanging the second floor exit balcony. The direction of the wind was such that it resulted in one wing of the motel losing only part of its built-up roofing (fig. 69), while the other motel wing (fig. 70) was stripped of its entire roof structure due to the uplift forces acting on the roof overhang.

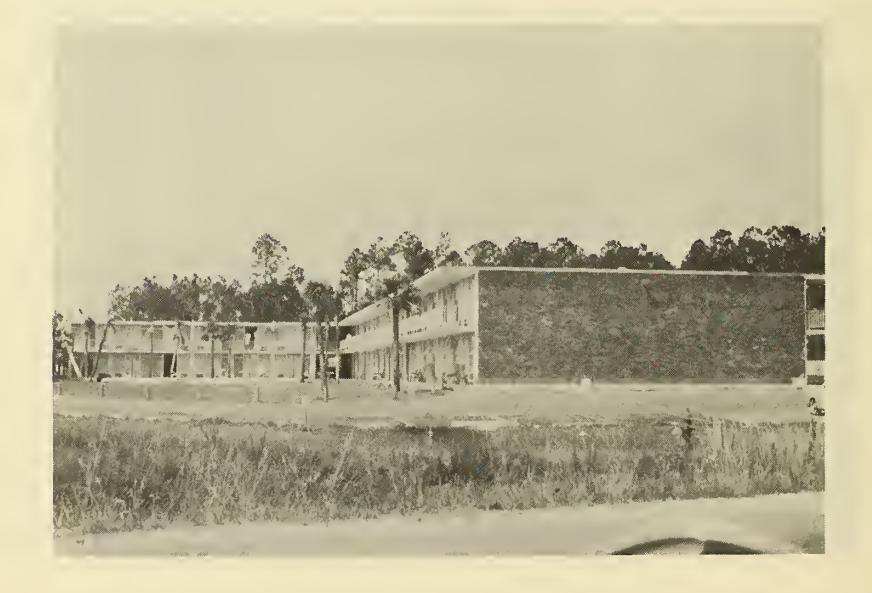
Figure 71. Motel, U.S. Highway 90 near Waveland, Mississippi.

Across the highway from the small motel is a larger two-story motel, which has a flat concrete roof overhanging the second-story balcony (fig. 71). In this building the roof structure was apparently heavy enough and anchored satisfactorily to resist the uplift forces. The only damage observed was to the built-up roofing and underlying insulation.

Current Design Practice - The satisfactory performance of various major buildings and structures (for example, Broadwater Beach Marina, fig. 11; Mississippi Power Company Building, fig. 19; U.S. Naval Center concrete and masonry warehouses, fig. 32; and motel, fig. 71) indicates that the use of current good design and construction practices can greatly minimize property damage resulting from hurricane winds and storm surge.

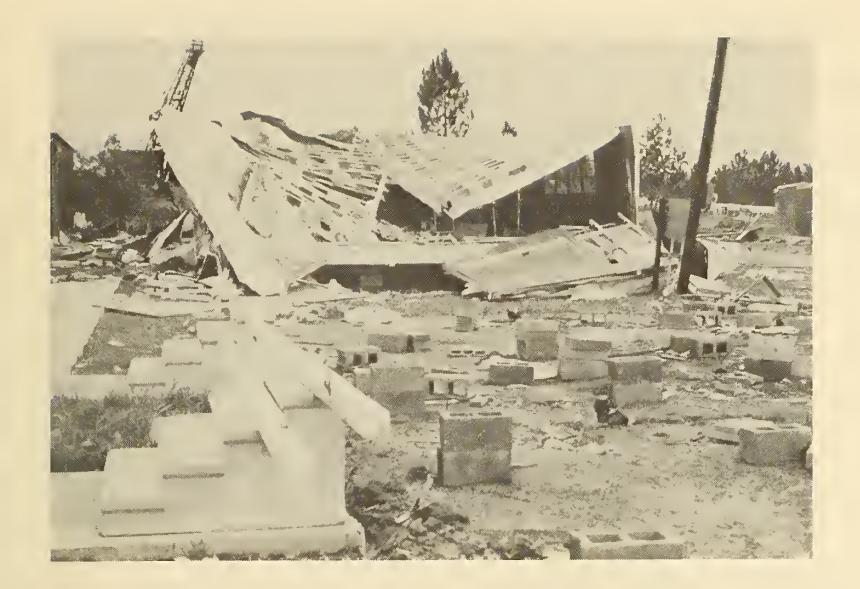
Figure 74. Temporary classrooms, North Central High School.

Two mobile homes adjacent to the main buildings and used as temporary classrooms were totally destroyed (fig. 74).

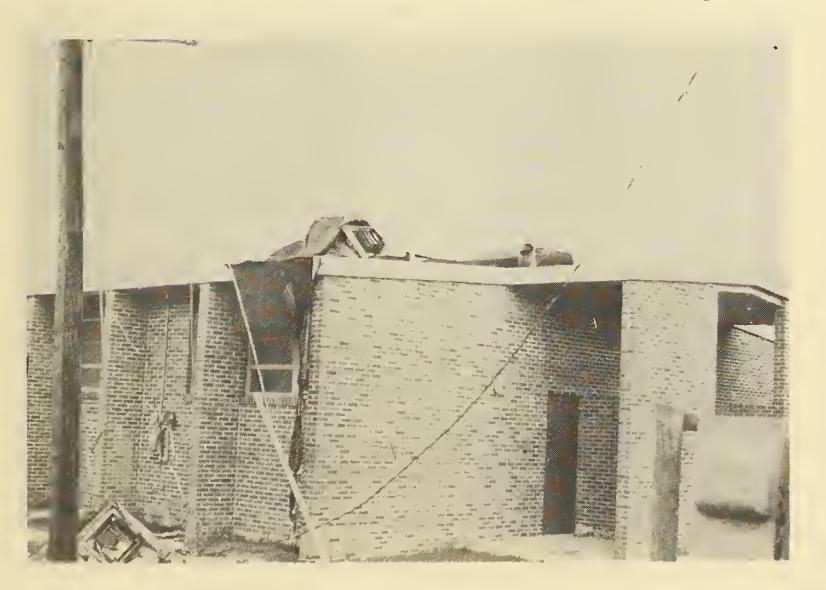
Figure 75. Athletic building, North Central High School.

A smaller masonry building containing athletic locker rooms lost most of its built-up roof covering (fig. 75). It appeared that the wind probably tore off the roof vents first which then made the roof covering more vulnerable to wind action.
