NBS TECHNICAL NOTE 807

Building Performance in the 1972 Managua Earthquake

Following the Managua, Nicaragua, earthquake of December 23, 1972, a team of engineers representing the U.S. Department of Commerce's National Bureau of Standards (NBS) and the National Academy of Engineering (NAE) performed field investigations in Managua, Nicaragua, from December 26, 1972, to January 4, 1973. The objectives were to assist the Nicaraguan government in surveying major buildings to determine whether each was suitable for emergency use, repairable, or appropriate for clearance. The team also viewed the patterns of successful performance and damage to identify needs for improvements in building practices for mitigation of earthquake hazards and opportunities for more detailed investigations which could provide information for future improvements in practices.

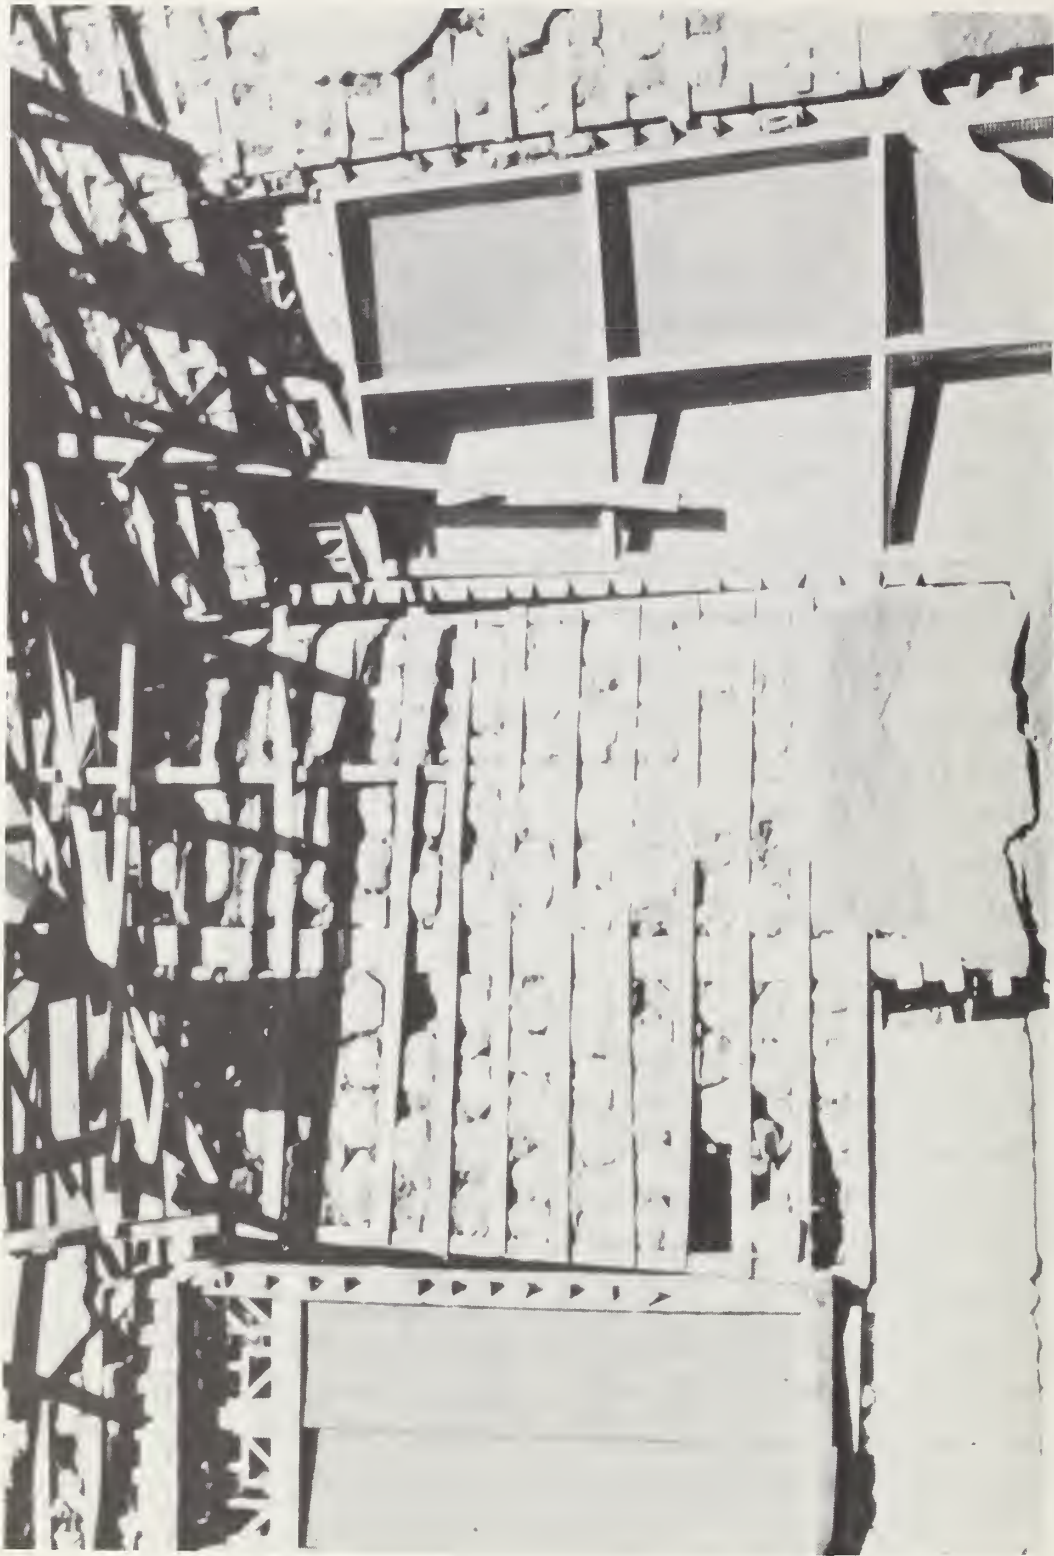
Much of the older residential and commercial construction in Managua was of the type called "taquezal." This is timber framed adobe construction made up of wood posts approximately 4 in square, spaced on approximately 2 ft centers, and connected horizontally by wooden slats which were about 1/2 in by 2 in and spaced at 8 in vertically. The space between the wooden slats was packed with mud, figure 14. These structures usually had timber framed floors and roofs with the roofs often covered by clay tile. The exterior surface would be plastered and painted, figure 15, to form a building of substantial appearance. However, these buildings were inherently quite weak, and heavy enough to generate large lateral forces under ground shaking. In addition, the timber framing was frequently weakened by termites. Over much of the Managua area, these buildings collapsed, figure 16; most of the deaths were suffered in this type of building.

Figure 14 Example of taquezal construction showing interstices between posts and slats filled with mud or stone.

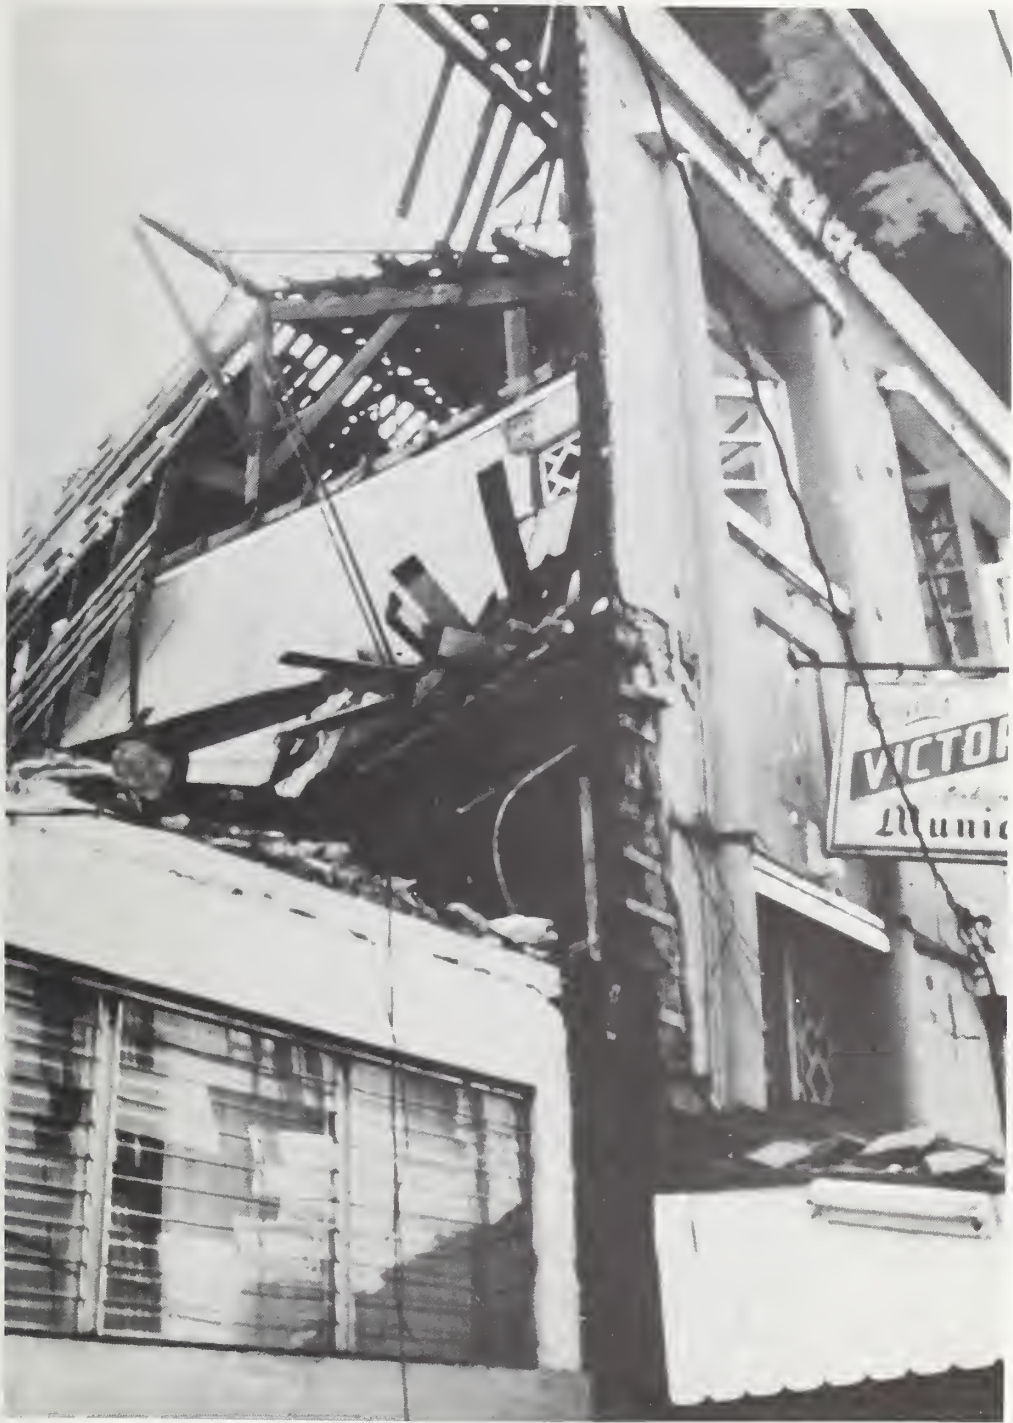
Figure 15 Taquezal construction where the substantial appearance after plastering and painting is belied by the resistance.

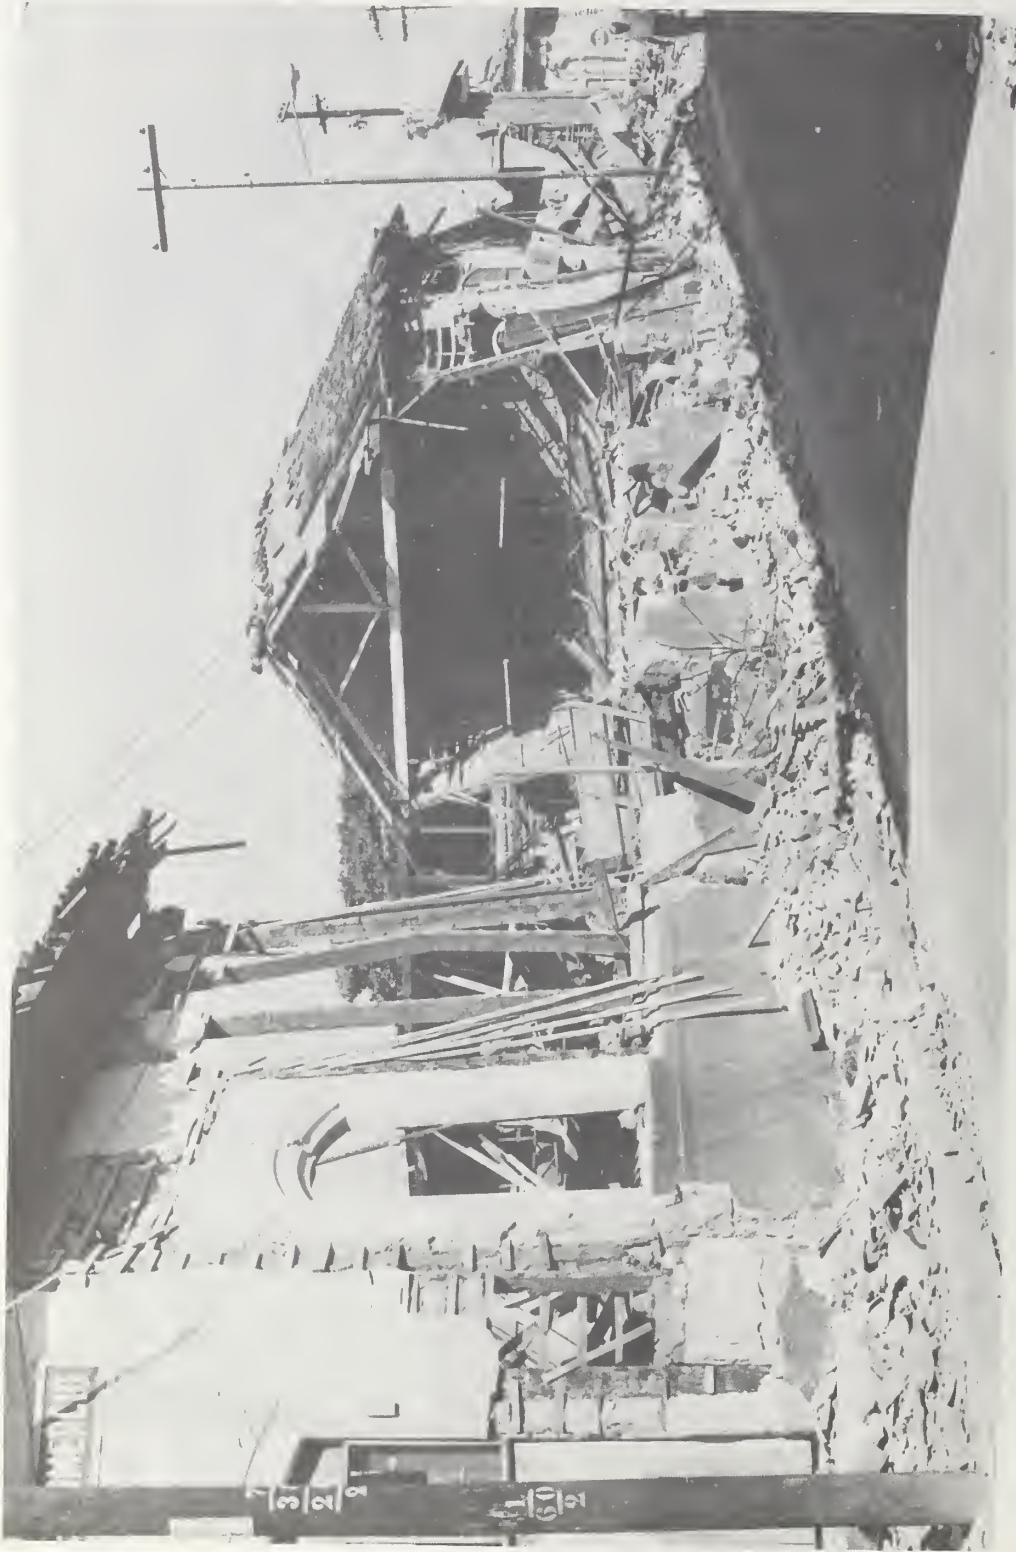
Figure 16 View of the taquezal areas of Managua which were largely collapsed.

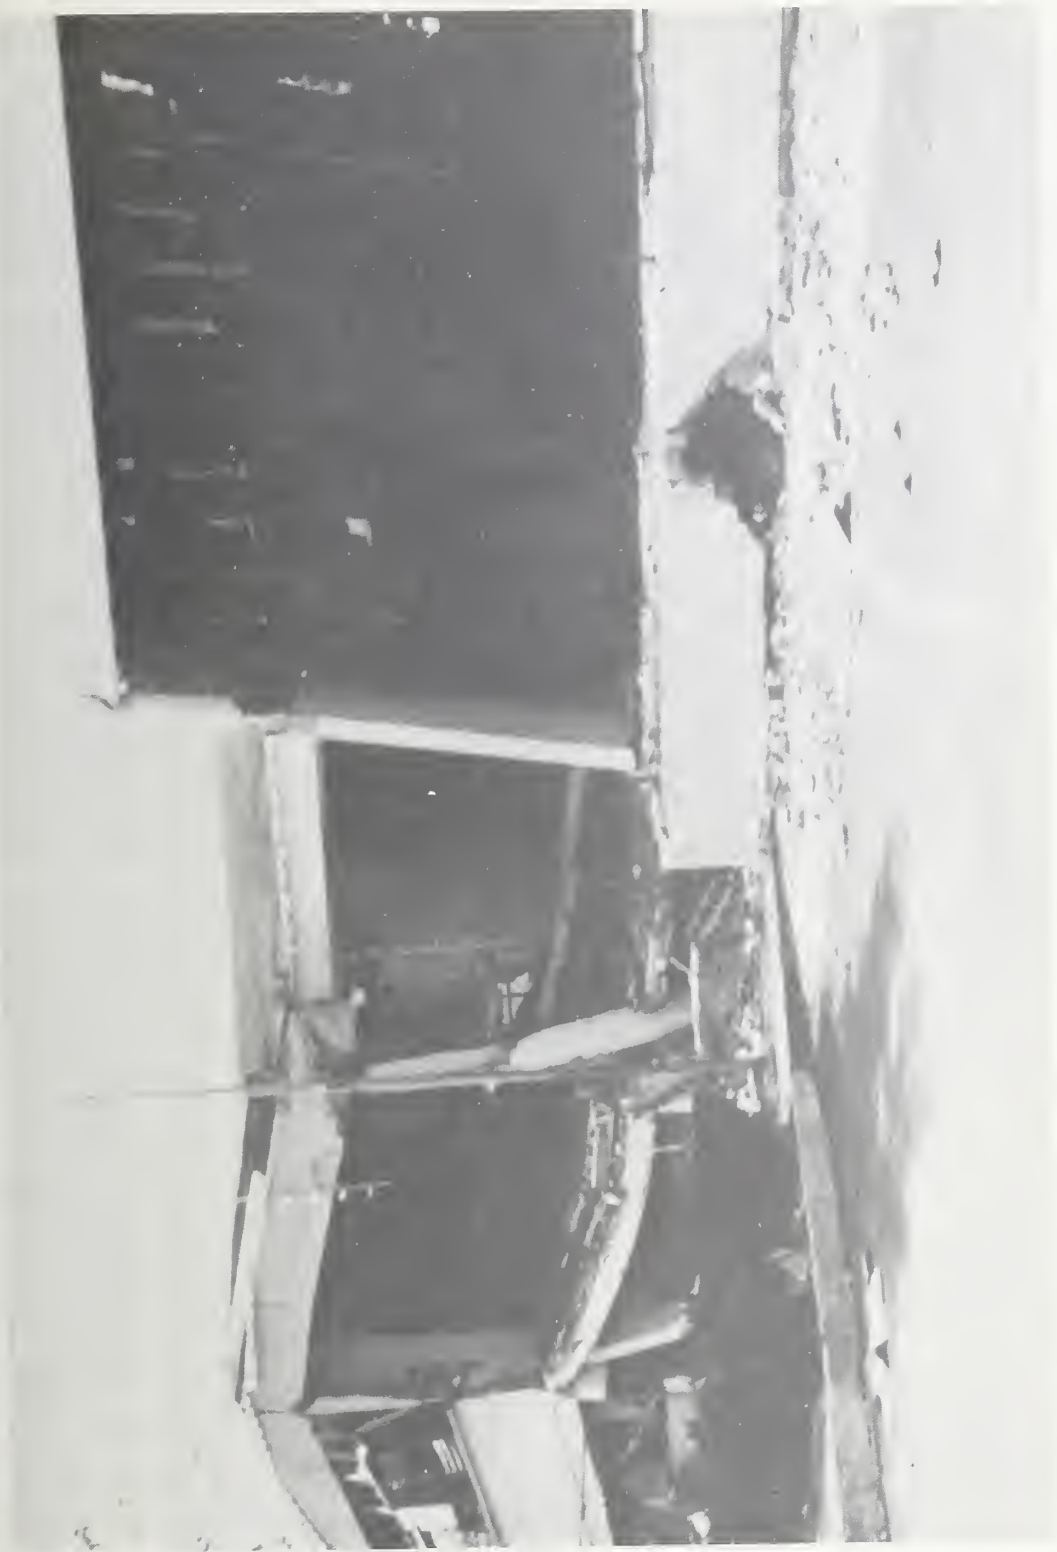
The damage in Managua provides many examples of the need to construct buildings housing critical facilities in a manner such that they will be functional when desperately needed following an earthquake. Most critical facilities in Managua were destroyed. Examples are: the fire station which collapsed upon the fire equipment, figure 17, the Red Cross building, figure 18, which collapsed upon their ambulances and emergency supplies, the INSS Hospital, figure 70-1^{3/}, which suffered severe structural and nonstructural damages making it not just useless, but definitely hazardous to its occupants. The General Hospital, figure 55-2, also suffered

Figure 17 The Fire Station collapsed upon fire equipment.

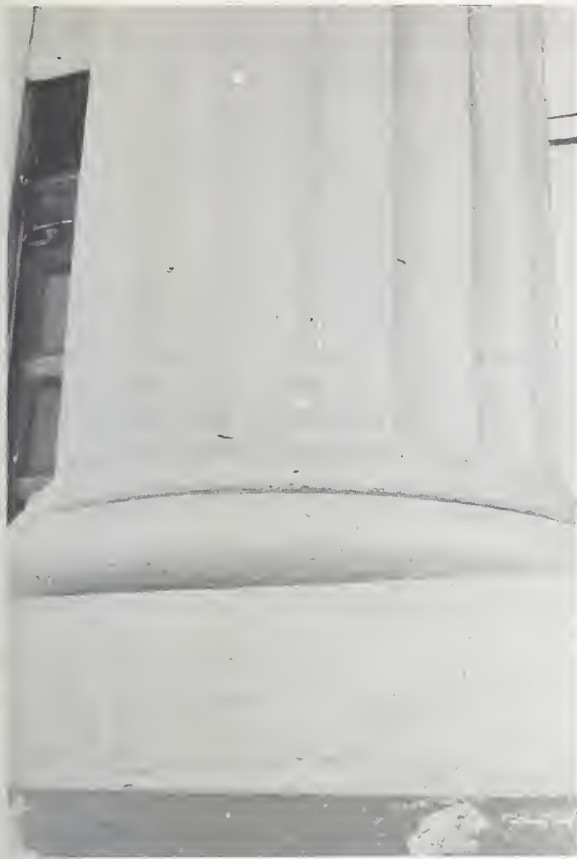
Figure 3-1 Lightly cracked columns in facade, Palacio Nacional.

None of these damages appear to have severely limited the safety of the structure. However, these damages should be repaired so that the structural resistance is returned to its original level and a careful inspection should be conducted to determine whether other damages have occurred. The structure may be cleaned of broken glass and concrete which endanger occupants and returned to function while the major repairs are conducted.

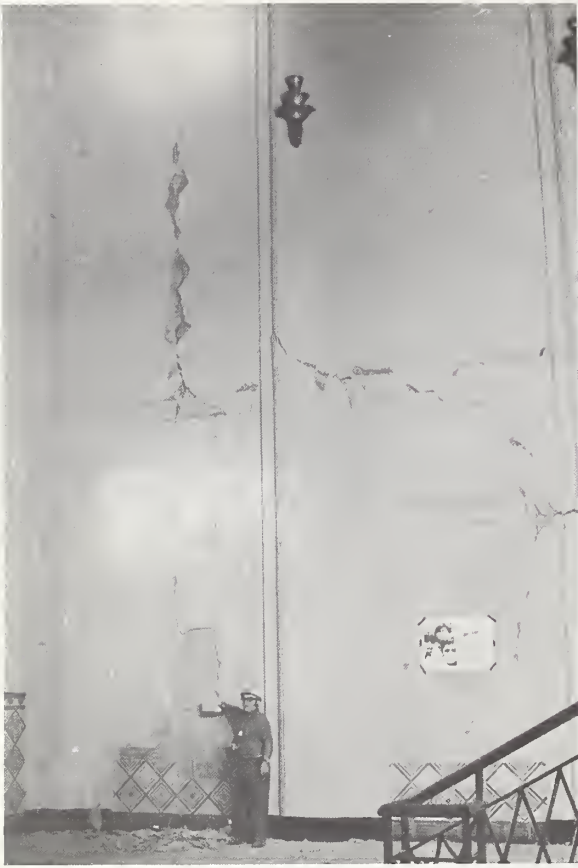
Figure 3-3 Cracking of wall and columns at north entrance to the Palacio Nacional.

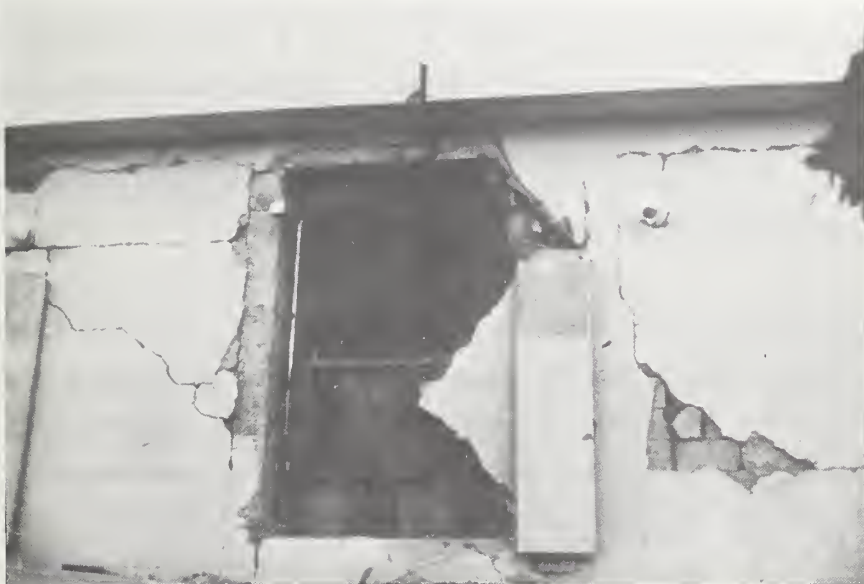
Figure 4-4 Wall and column damage in market building, Mercado Periferico Oriental.

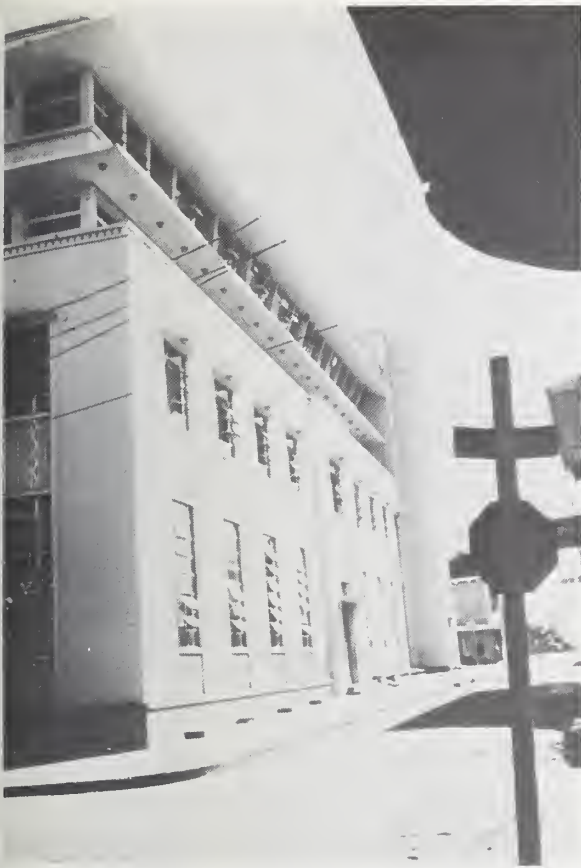
Figure 5-3 Side of the Palacio de Comunicaciones, note the tottering fourth floor walls and roof.

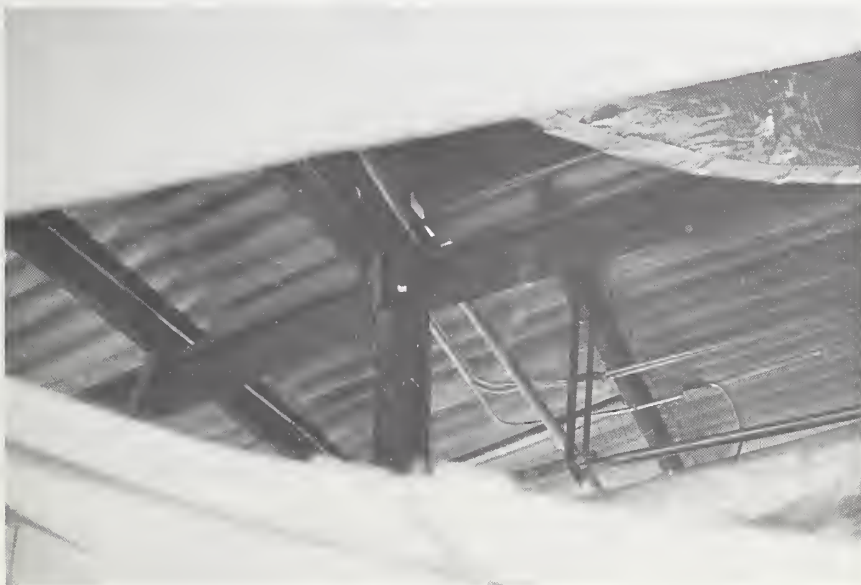
Figure 5-4 Tube column split by pulling of roof framing, Palacio de Comunicaciones.

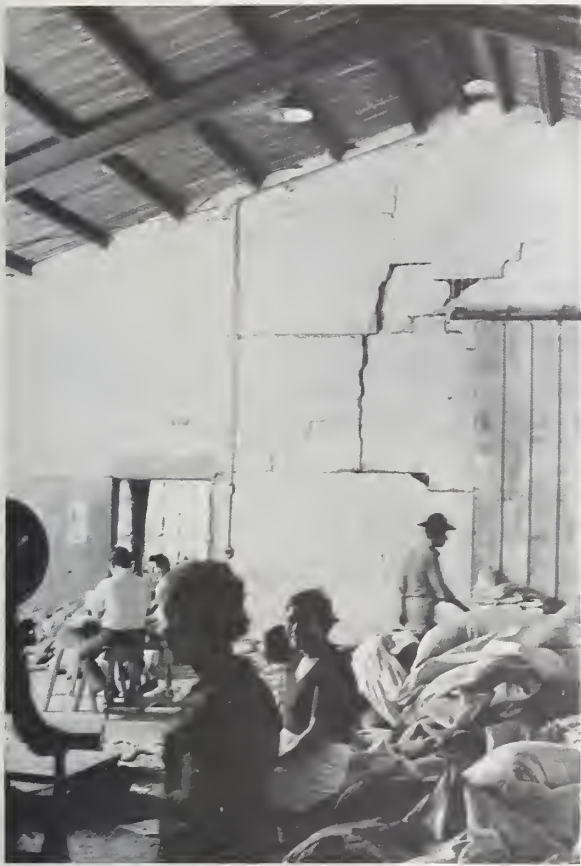
Figure 16-3 Hazardous partition in an undamaged steel industrial building, INCEI shed.

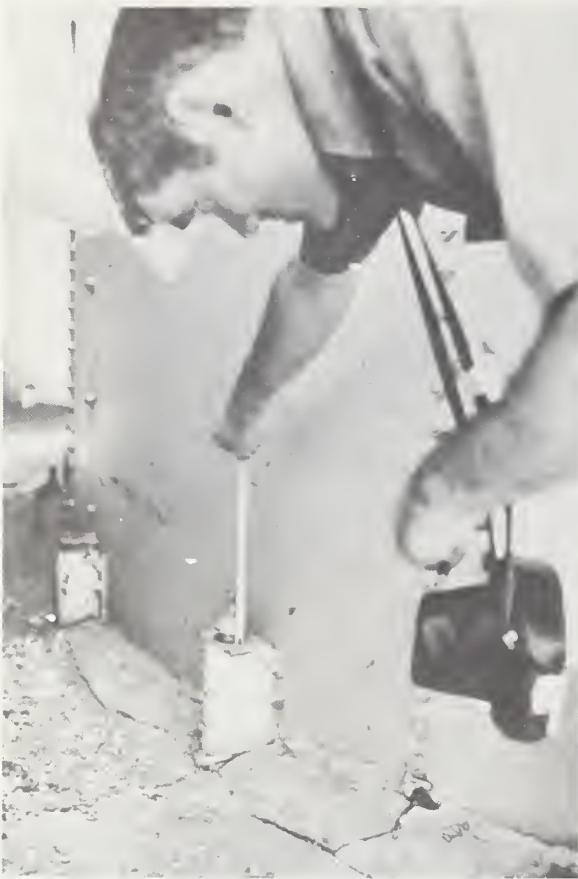
Figure 16-5 Anchor bolts lifted at base of INCEI elevators.

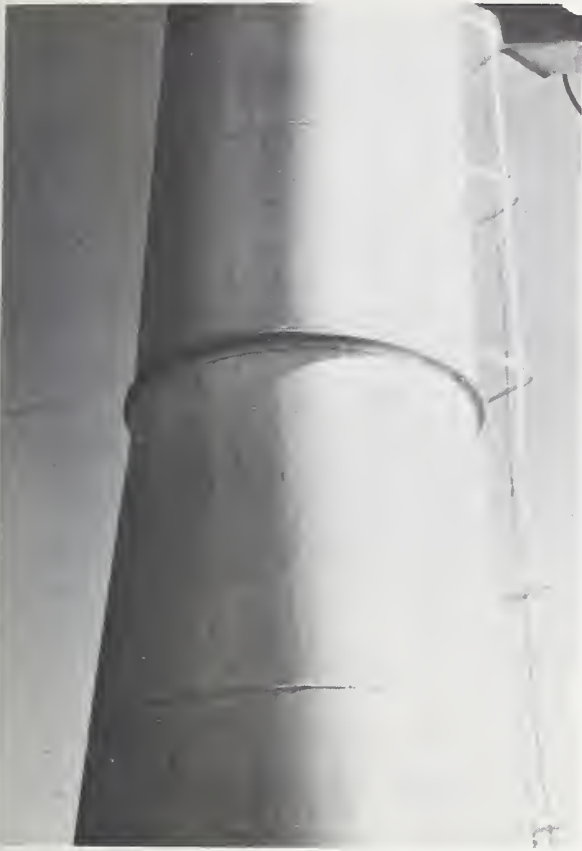
Figure 22-3 Cracked weld in stack,
Planta Electrica ENALUF.

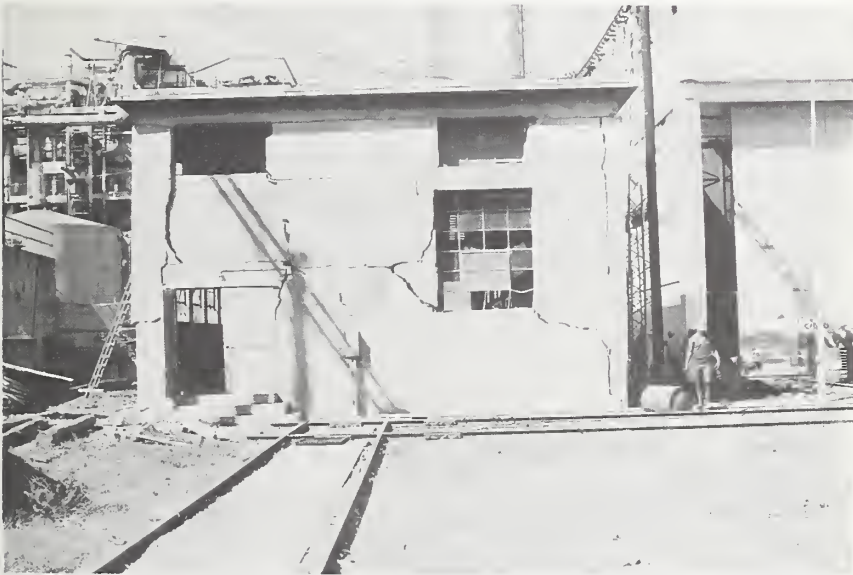
Very severe damage; fortunately, the critical medical supplies stored in a warehouse behind the hospital were on steel shelving, figure 55-8, which supported the building when its walls fell and columns sheared and kept these supplies available for use following the earthquake. Radio communications were dependent on a very feeble building, figure 62-1; however, it was far enough south of town that the collapse was incipient rather than actual. Similarly, the vital switch gear at the power generation plant, figure 22-4, were located in a weak masonry building with a very heavy roof; the building was close to collapse.

Figure 22-4 Severely damaged concrete block bearing
walls of switch gear house at Planta
Electrica ENALUF.

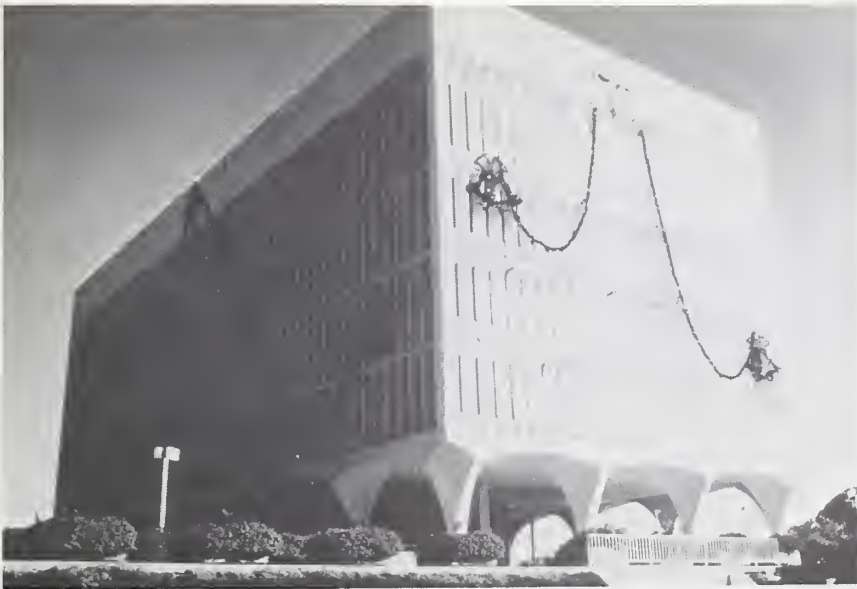
This is a reinforced concrete building with basement, ground floor and six additional floors with a reinforced concrete frame braced by reinforced concrete shear walls around the central core of the building, figure 23-1. In general the exterior of the building and the interior space dividers are in excellent condition, figure 23-2. The shear walls functioned effectively in reducing the earthquake deformations of the building to a level producing little cosmetic damage. However, a substantial amount of cracking was found in the shear wall structure. On the ground floor, local crushing of the shear wall was observed at a splice zone near the floor level where the wall was weakened by a telephone chase, figure 23-3, and at the ceiling level adjacent to a penetration in the shear wall for a duct, figure 23-4. Additional cracking in the shear wall was noted at the basement level. Light cracking in the shear wall was noted from the third through the fifth floors of the building, figure 23-5. The absence of notable cracking on the first and second floors, perhaps was due to an unintended bracing action of the decorative exterior arches. It was noted that the counter weights for the elevators had been displaced by the shock, and other minor cosmetic damage was visible in the building.

Figure 23-1 Shear wall-frame building with little exterior damage, Edificio Administrativo ENALUF.

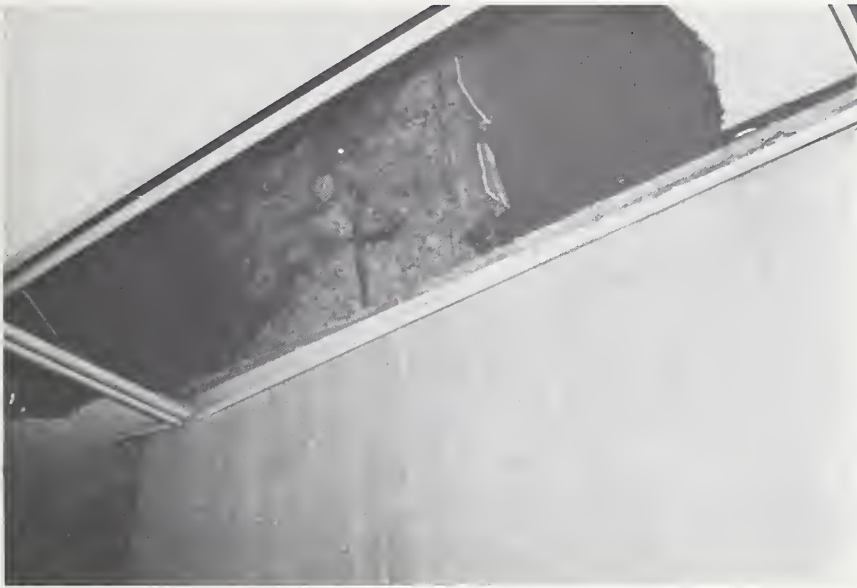
Shear wall-frame buildings were much stiffer; the limited deformations resulted in very little property loss and continuation of functionality. However, some of these buildings showed sufficient structural damage to call into question their safety for an earthquake of similar intensity but longer duration. For instance, the ENALUF (electric utility company) administration building looked sound from the outside, figure 23-1, but exhibited definite structural damage. There was localized crushing of certain shear walls on the ground floor at interruptions for a duct,

Figure 23-4 Shear wall crushing near ceiling on first floor where penetrated by duct, Edificio Administrativo ENALUF.

Since the damages to the shear wall represent a partial failure of the structure, a detailed engineering inspection and repairs of the damages are required before the structure is returned to service.

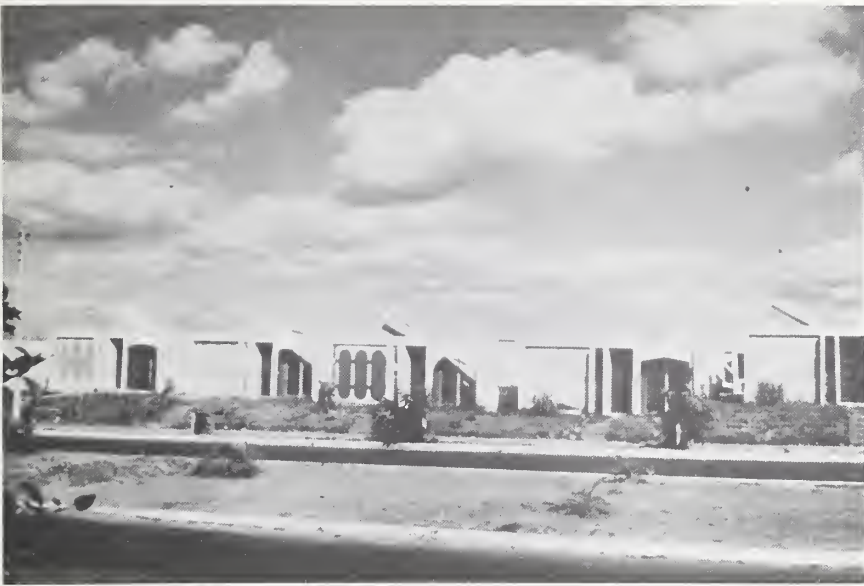
The houses of the subdivision are single and duplex units with cast-in-place reinforced concrete walls and prefabricated roof panels in the form of a channel, figures 24-1 and 24-2. The dwelling units are approximately 20 ft wide by 40 ft deep. The prefabricated roof panels bear on the precast concrete walls which are about 4 in wide. The concrete roof slabs are approximately 3 in thick with the flanges of the channel approximately 12 in high; the panels are about 8 ft wide and 22 ft long. Metal pads at the four corners of the roof slabs are used for connection to similar pads embedded in the walls. The connection is by a 3/16 in fillet weld about 1 in long, figure 24-3. In single houses, the roof slabs overhang the walls at each side by about 8 in. In the duplex units, one wall supports two panels so that the zone of contact is limited to about 2 in and welds may have been omitted.

In most of the dwelling units, the roof slabs were observed to have broken loose from the walls and to have translated, sometimes enough to allow the roof slab to fall into the dwelling unit, particularly for the duplex units which have very little overlap of the roof slab on the wall, figure 24-4. The degree of damage to the walls themselves appears quite small; there were small cracks in the walls near the apertures and sometimes cracking where the connecting pads were anchored in the wall slabs. Most of these buildings appear to be repairable. In the repairs, attention should be given to achieving a stronger connection between the roof slab and the walls to prevent repetition of this damage in a future earthquake.

Figure 24-1 The tilted precast roof channels have slid off walls, Bello Horizonte.

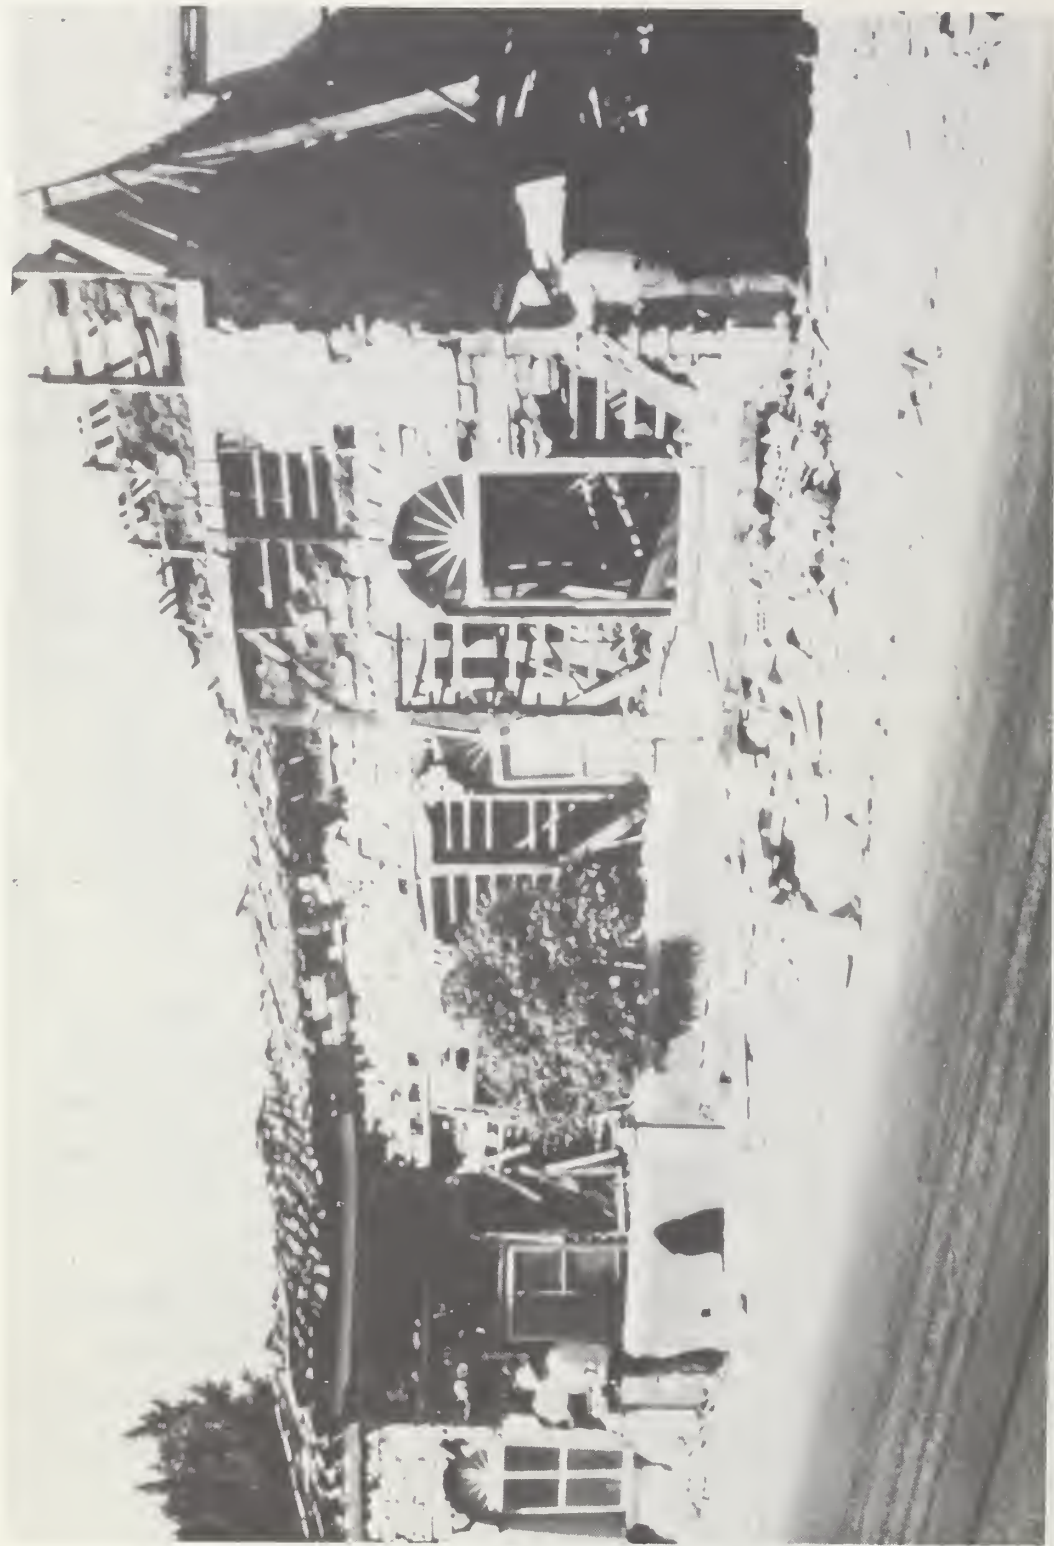
Figure 35-1 Old building of taquezal construction,
Centro Escolar Simon Bolivar.

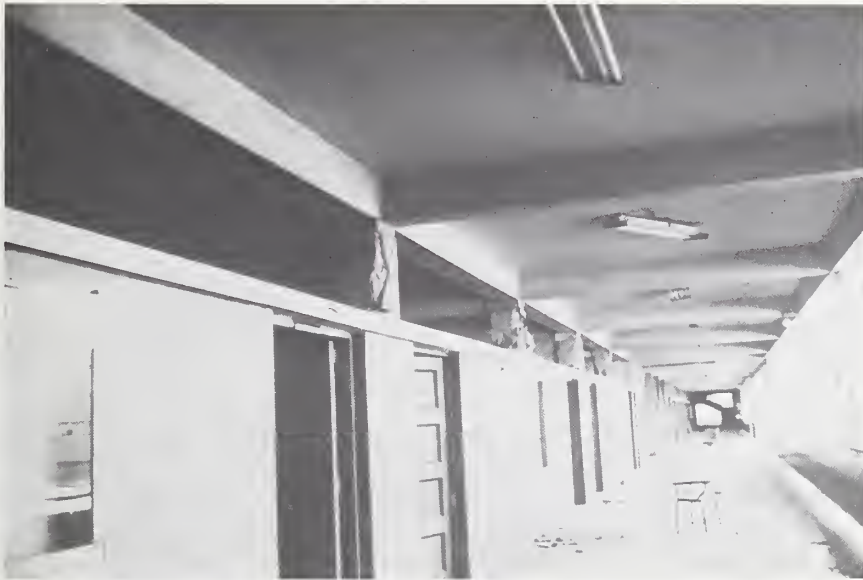
On the second floor of the east wing and on both floors of the south wing, the interior columns are broken and sheared at the top of the partial height infilled wall which separates the rooms from the corridor, figure 38-1. The small section of column subject to deformation at the interior column line is much stiffer than the exterior columns, attracts more load, fails, then the exterior columns must carry the total earthquake and gravity forces.

Figure 38-1 Sheared columns above partial height wall, Instituto Nacional Ramirez Goyena.

The building appears to be in very insecure condition. The portions which have not fallen may fall at any moment. The damages are so severe that repair appears to be impracticable.

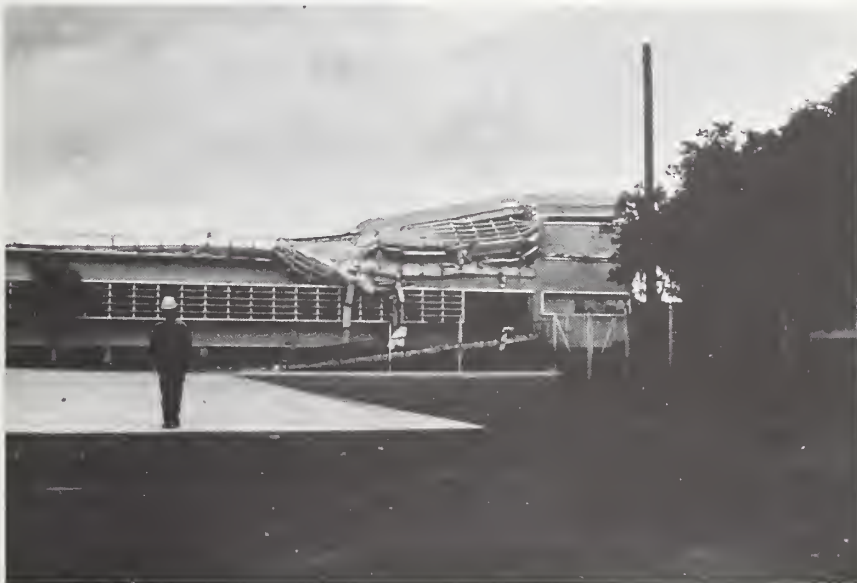
The top two stories of the west wing and the stair tower at its northern end are completely collapsed, very likely from progressive failure after the type of failure of the interior columns observed in the other two wings, figure 38-2 and 38-3. It was apparent that undeformed reinforcing steel had been used in the construction of this building which was completed in 1954.

Figure 38-2 Collapse of upper two stories of the west wing from the courtyard, Instituto Nacional Ramirez Goyena.

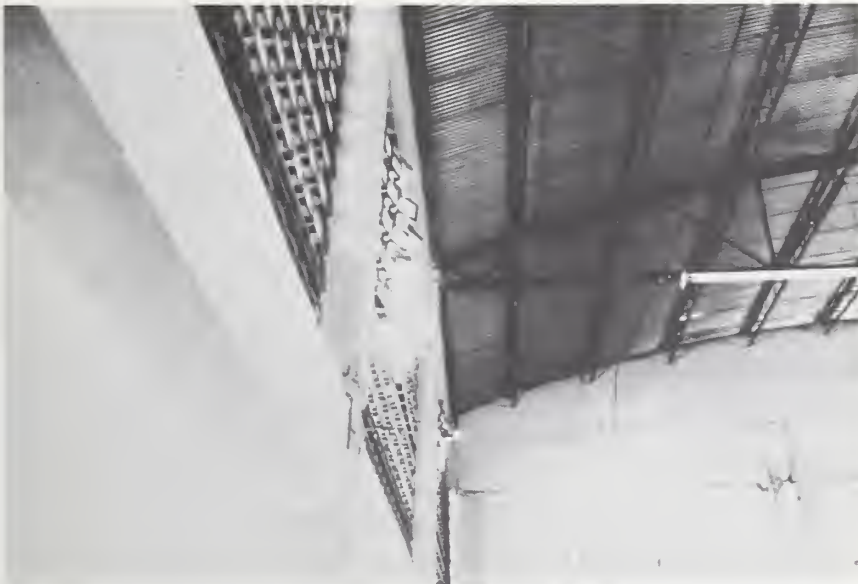
west ends. Therefore, the trusses have shifted north as much as 12 in which fractured the columns and wall on the south side, where connections to the east wing of the building stiffened the supporting columns and wall, and bulged the north wall of the building, figure 38-4. The westerly columns and wall were severely cracked in shear but not strongly displaced, figures 38-5 and 38-6.

Figure 38-5 Lesser damage of south wall of gymnasium at more flexible west end, Instituto Nacional Ramirez Goyena.

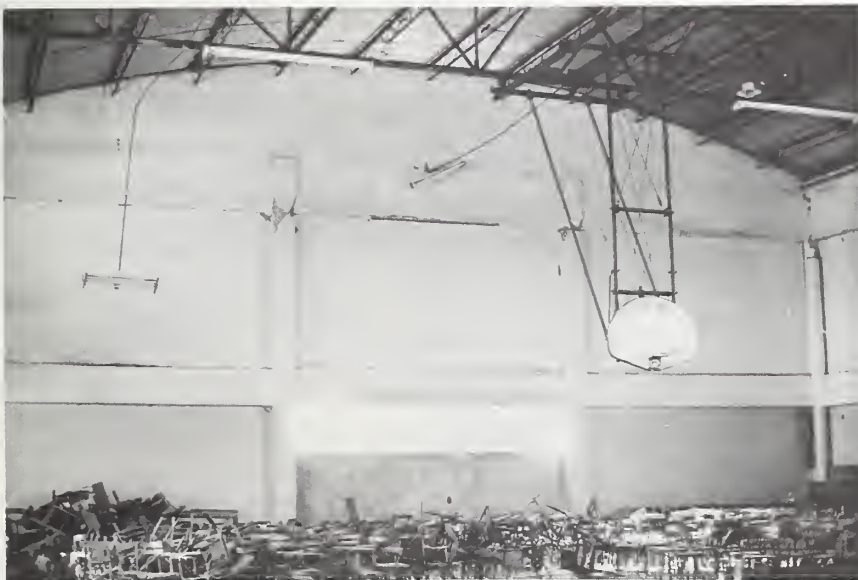
Figure 38-6 Shear of columns at west wall of gymnasium, Instituto Nacional Ramirez Goyena.

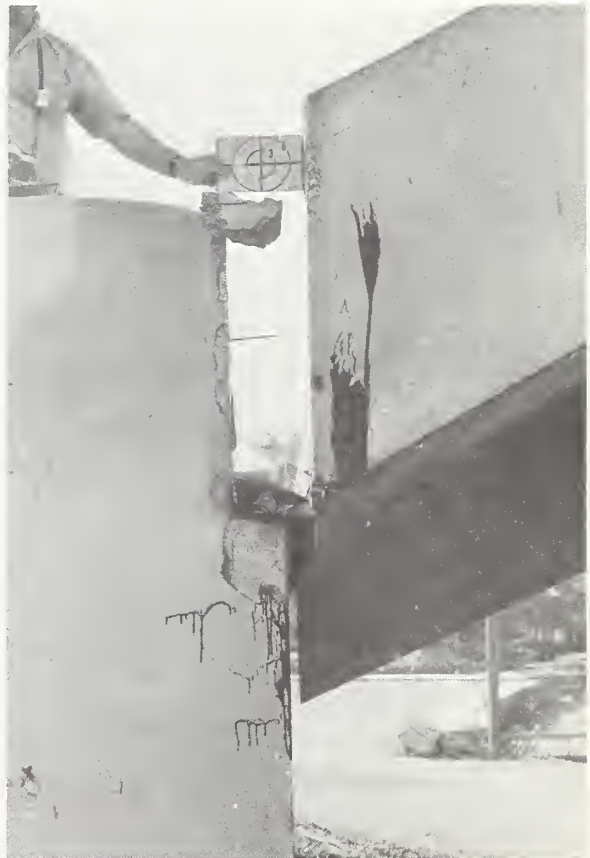
The slabs of the access bridges are in perfect condition. There are minor damages at the abutments of the bridges resulting from hammering out of the expansion joints and perhaps some settlement of the abutments, figure 41-2. The columns which support the slab show light cracking at various elevations. These do not appear to be important but a careful engineering investigation should be carried out as part of the program of repair.

Figure 41-2 Pounding of access pedestrian bridge on abutment knocked out joint material, Teatro Ruben Dario.

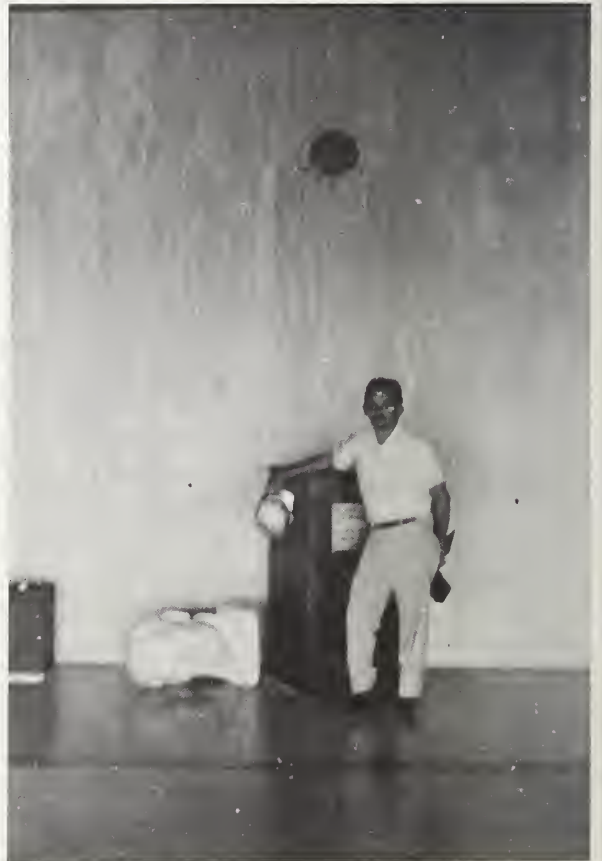
Figure 41-4 Fallen bust of Ruben Dario, Ing. Raul Amador of Nicaraguan Ministry of Public Works, Teatro Ruben Dario.

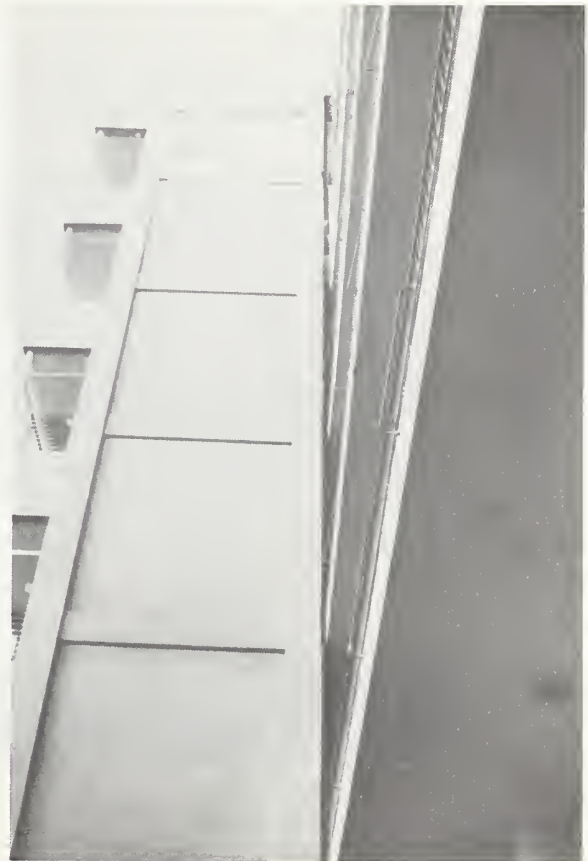
This "Reticular" flat plate building has a permanent deformation of approximately 15 cm toward the west at the top floor, figure 46-2. Cracks exist at bottoms of slabs along column lines where bottom reinforcement was stopped or lapped, figure 46-3. Flexural cracks appear in columns, figure 46-4. The structure is still intact and the building may be restored by adding reinforced concrete shear walls after an appropriate analysis. It should be closed until repaired.

Figure 46-2 Displacement of building and cracking of slabs, Instituto Pedagógico.

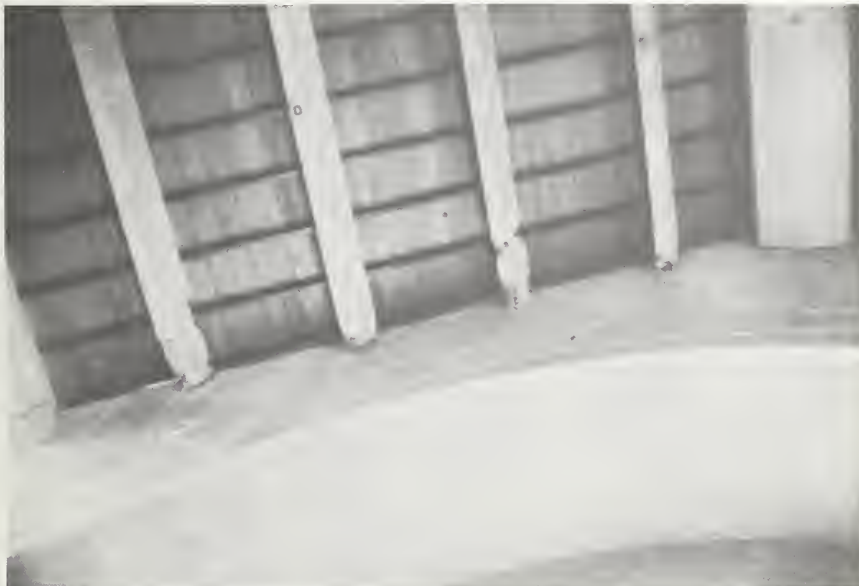
Several arches were structurally damaged by transverse motion, as well as the structure near the east end, figures 46-5 and 46-6. The building is not in danger of collapse but should be repaired (after an appropriate analysis) as soon as possible. It should be closed until repaired.

Figure 46-6 Damages at ends of beams at connections to arch, Instituto Pedagógico.

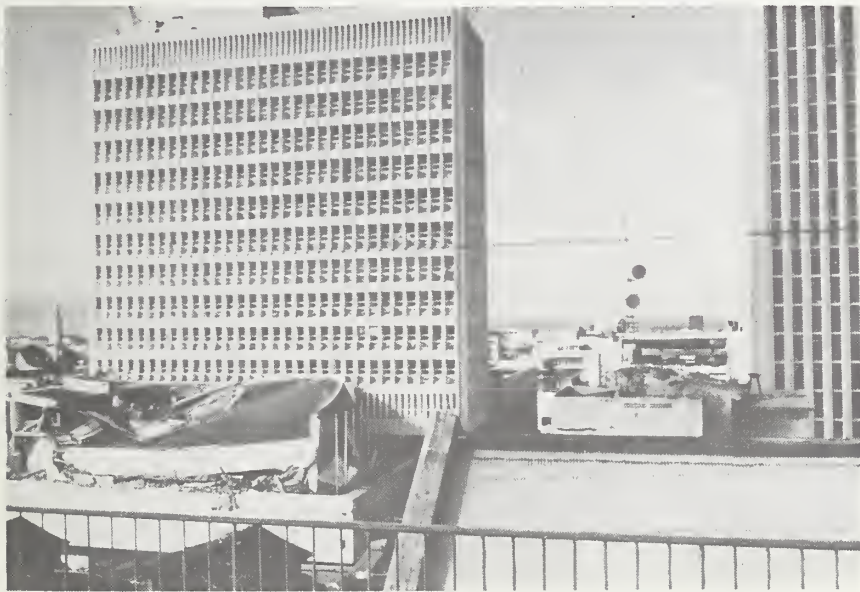
Figure 52-2 Collapsed auditorium and cracked infill walls on framed tube tower.

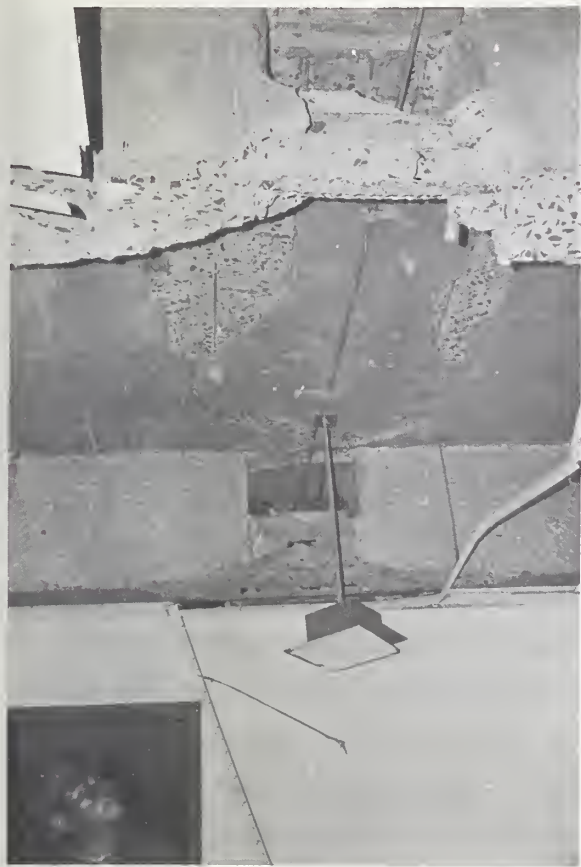
Figure 54-1 Failures of beams connecting shear wall towers, Banco de America.

1. Analyze the structure (in the form it is to be completed for a base motion input at least 50 percent more intense than the one measured at the Esso Refinery on December 23, 1972, or according to the results of a complete site study).
2. Check shear walls for alignment in the vertical direction.
3. Check connections between slab and edge of columns and shear walls at levels above the seventh floor.
4. Check slab between shear walls at levels above the 12th floor.
