NBS TECHNICAL NOTE 807

Building Performance in the 1972 Managua Earthquake

Following the Managua, Nicaragua, earthquake of December 23, 1972, a team of engineers representing the U.S. Department of Commerce's National Bureau of Standards (NBS) and the National Academy of Engineering (NAE) performed field investigations in Managua, Nicaragua, from December 26, 1972, to January 4, 1973. The objectives were to assist the Nicaraguan government in surveying major buildings to determine whether each was suitable for emergency use, repairable, or appropriate for clearance. The team also viewed the patterns of successful performance and damage to identify needs for improvements in building practices for mitigation of earthquake hazards and opportunities for more detailed investigations which could provide information for future improvements in practices.

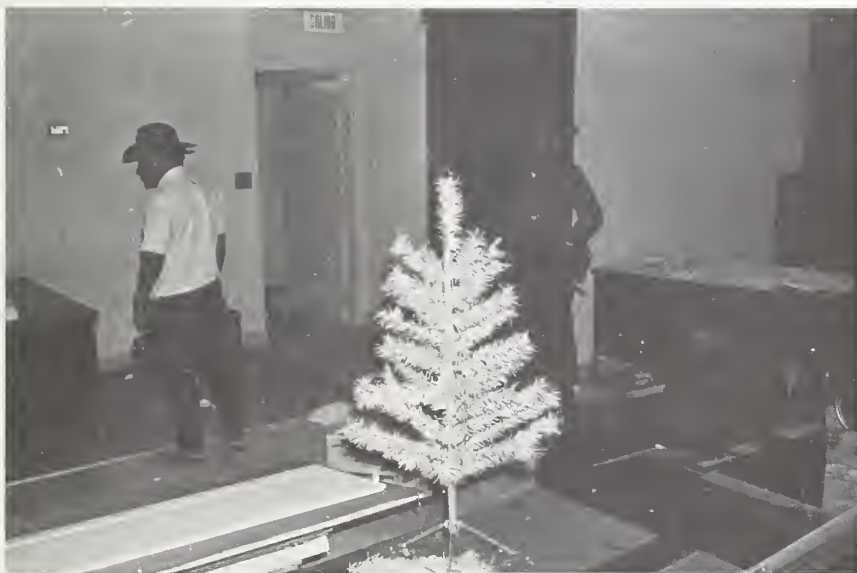
The good condition of the interior shows the advantages of the drift restraint provided by shear walls, figure 54-2.

Figure 54-2 Good condition of interior due to control of drift, Banco de America.

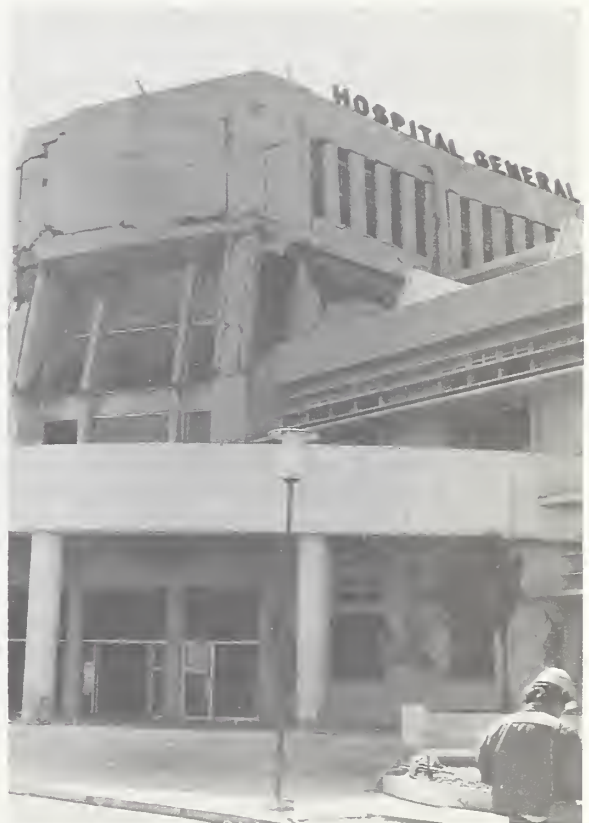
This building with four, three-story wings on a semi-basement and a four-story central portion was completed in 1962, figure 55-1. It appears to be a reinforced concrete frame without shear walls. Damage at the north front of the building is substantial, figures 55-2, 55-3, and 55-4. Exterior columns in the walls of the wings are extensively broken by cracks originating in the infill walls which caused concentration of deformations in the columns, figure 55-5. Interior columns in the wings show little distress, figure 55-6. The four story building at the intersection of the wings shows severe damage to columns and partial collapse at the south of the third floor, figure 55-7. The damaged columns appear to be reinforced with undeformed steel which is very lightly tied.

Figure 55-2 Damage at north facade of Hospita General El Retiro

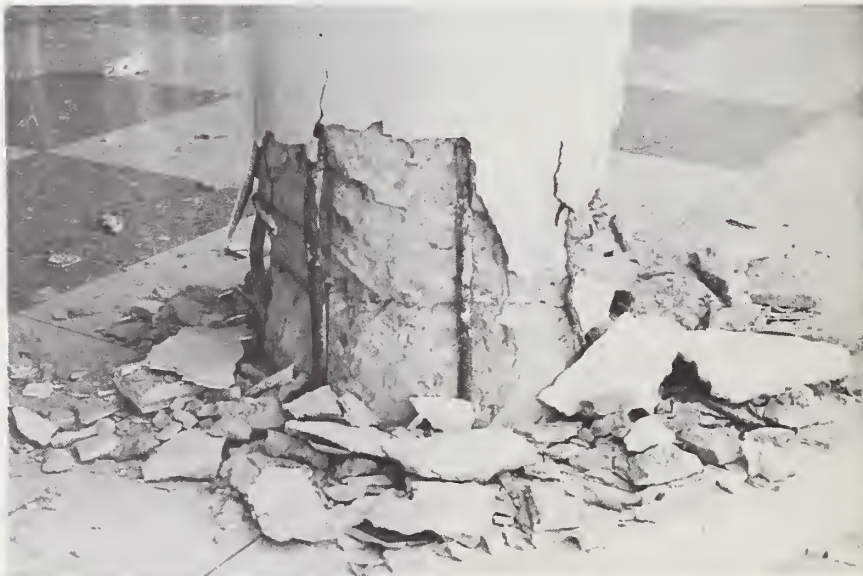
Figure 55-4 Damage at base of canopy columns, undeformed reinforcing, Hospital General El Retiro.

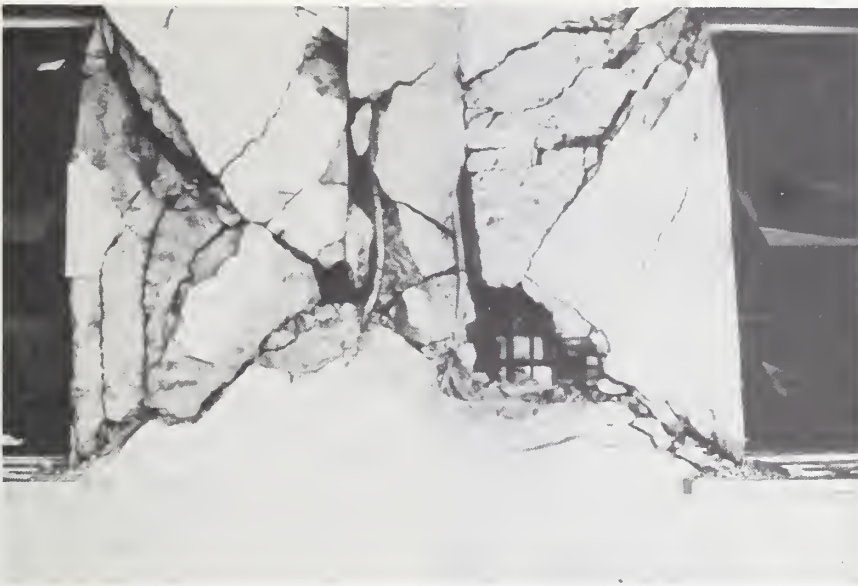
Figure 55-5 Detail of column and wall damage in north facade, undeformed reinforcing, Hospital El Retiro.

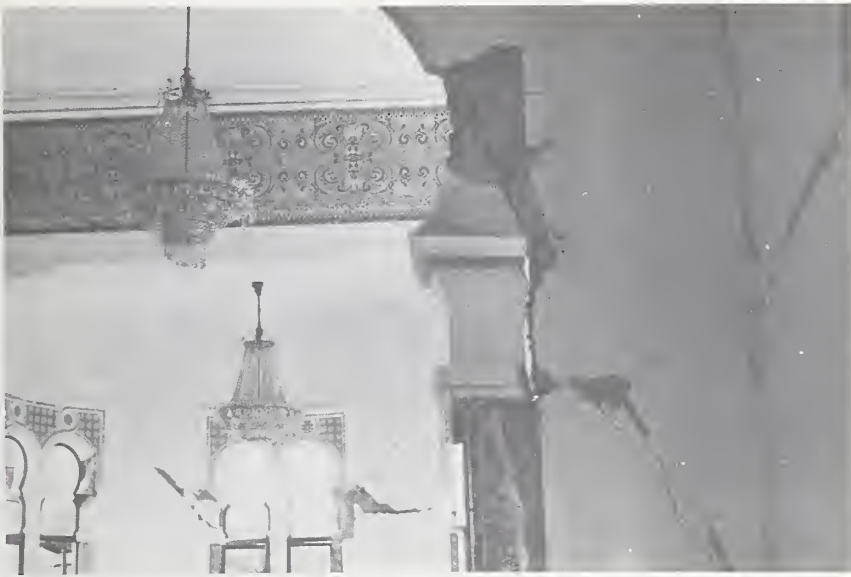
Figure 60-3 Details of interior damage, Casa Presidencial.

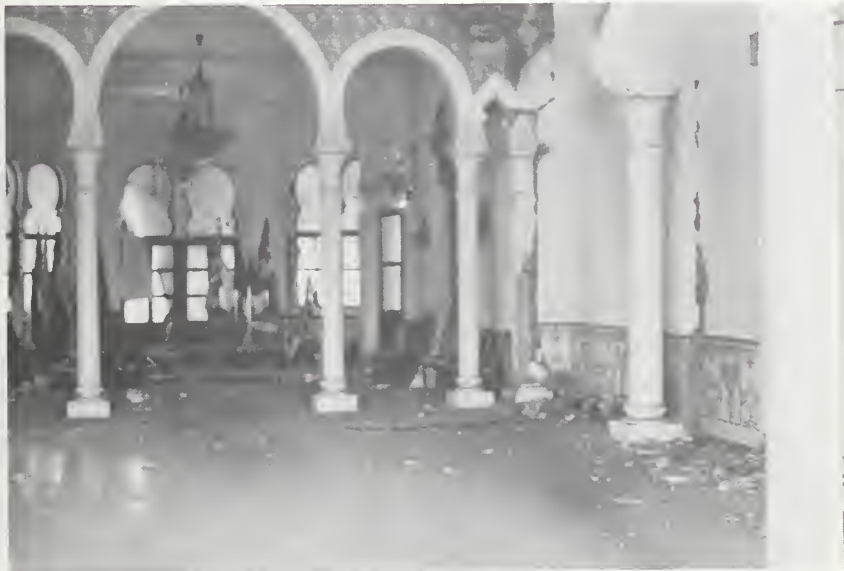
Figure 60-4 Interior damage in main lobby, Casa Presidencial.

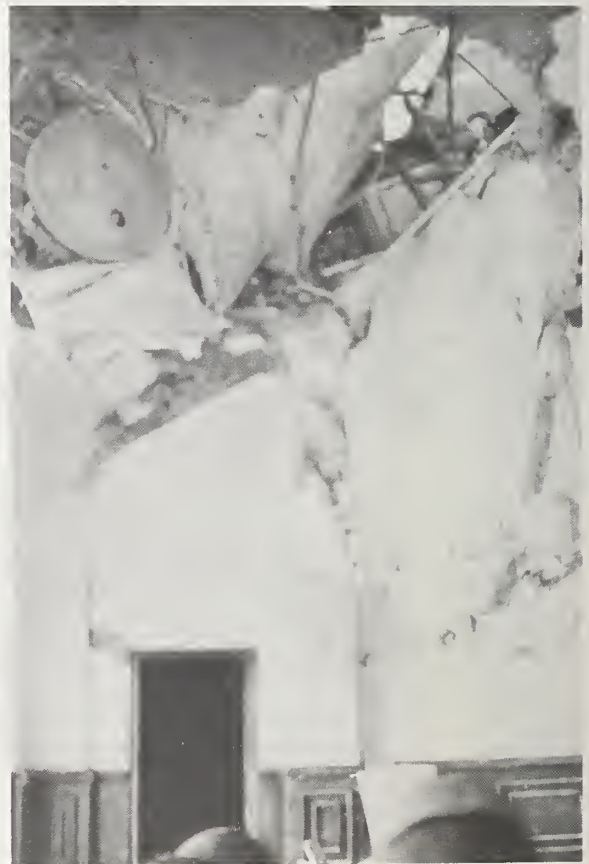
One of the two roof towers has fallen and penetrated the ceiling of the lobby at the entrance of the first floor, figures 61-1 and 61-2. The other tower is sheared and ready to fall. There is extensive wall, beam, and column cracking in the first floor of the building. In the basement of the building there is heavy cracking of the walls, light cracking of some columns, and heaving of the floor or penetration of the wall footings. At the west end of the basement, the east wall is heavily cracked, a west end column is crushed at mid height, figure 61-3, and many columns are lightly cracked.

Figure 61-2 Tower fallen through ceiling of entrance lobby, Residencia Jefe Director.

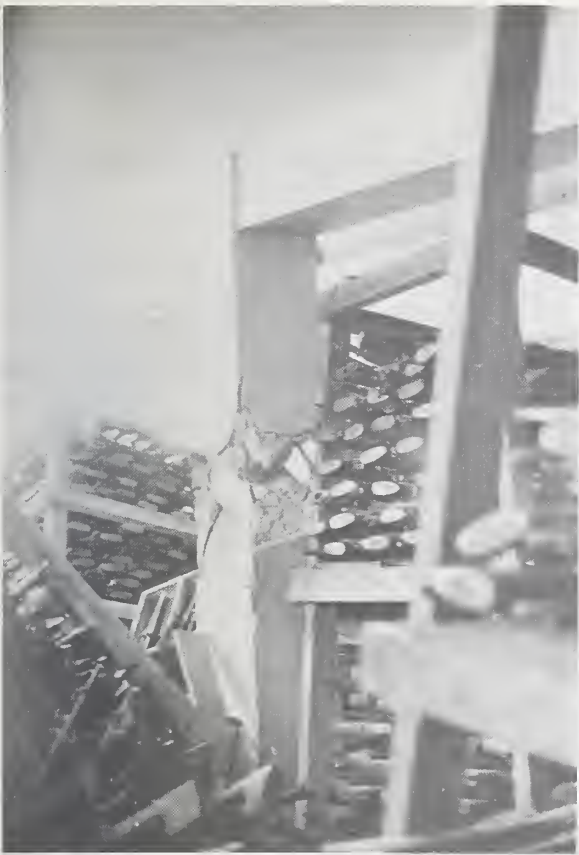
Figure 61-3 Column crushed in basement, Residencia Jefe Director.

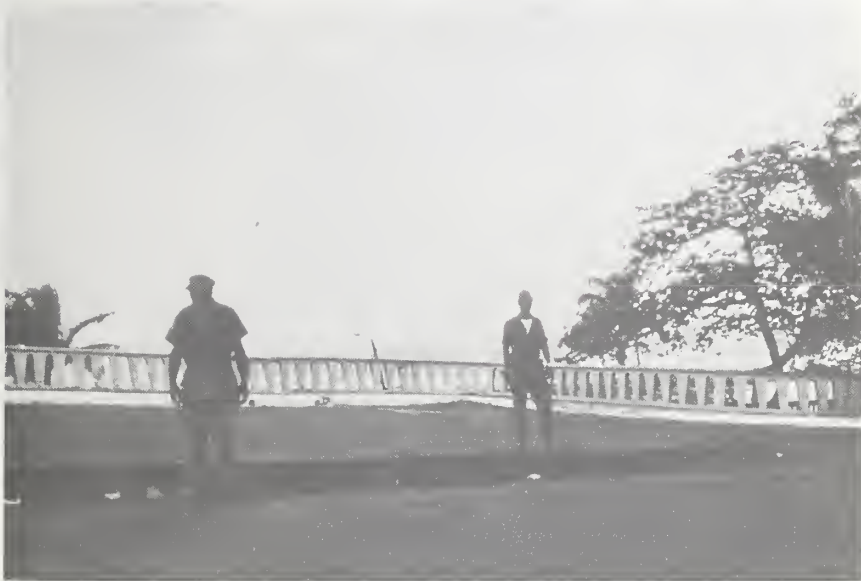
The foundations of the building and the site in general show evidence of instability, figure 61-4. In this area, the movement of the building appears to be down and south into the crater lake. Repair of the building would be an extensive and expensive operation. It should not be undertaken unless stability of the foundations can be assured.

Figure 61-4 Slide movement in front of Residencia Jefe Director.

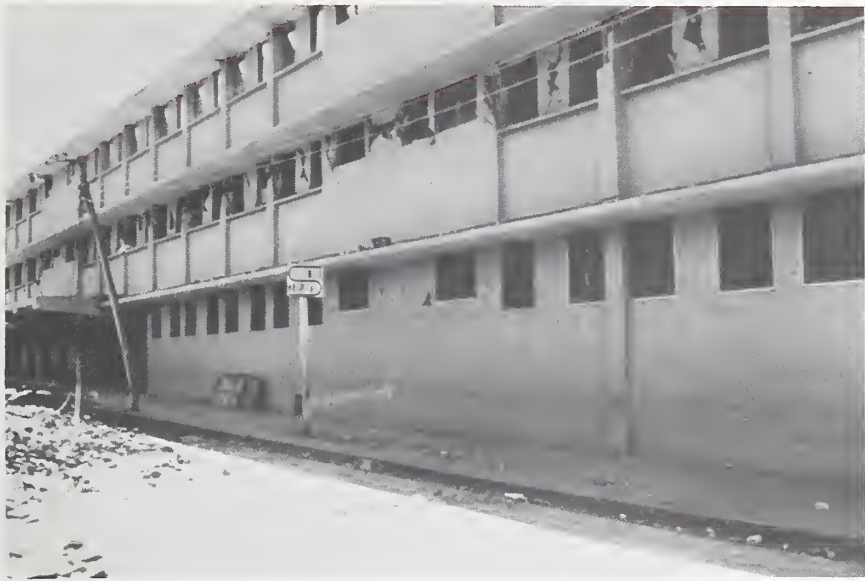
The second floor facades on the north and east sides shows severe column damage above the breast high infilled walls. The columns are approximately 14 by 12 in reinforced with four number eight bars. The corresponding columns on the west facade are much more lightly cracked. There was fire on the third floor of the building which burned the wood frame supporting the corrugated metal roof leading to collapse of portions of the roof. The first floor structure on the east side of the building is in reasonably good condition. Concrete block and heavy brick partitions appear to have braced the frame. Second floor columns on the east side are destroyed as noted above due to the concentration of deformations caused by partial height walls, figure 70-3. The structural system on the third floor of this east side appears to be in good condition in spite of the fire. On the west side of the building, there is major damage to some columns and beams on the second floor. In this region, there is severe cracking and falling of partitions. The first floor shows some shear cracking in stub girders where column spacings change between floors.

Figure 70-1 East facade of the Hospital del INSS, extensive second floor damage, note roof collapse through third floor windows.

The repair of this building is possible but will be very expensive. It may be more economical to build a new hospital when the advantages of a modern building plan are considered. The present building cannot be considered for any use prior to major reconstruction.

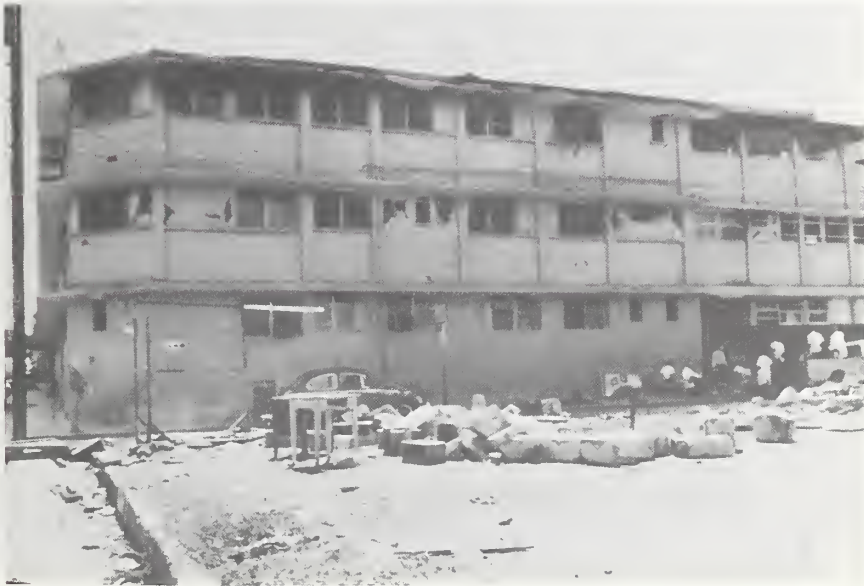
Figure 70-2 North facade Hospital del INSS, much wall and column damage.

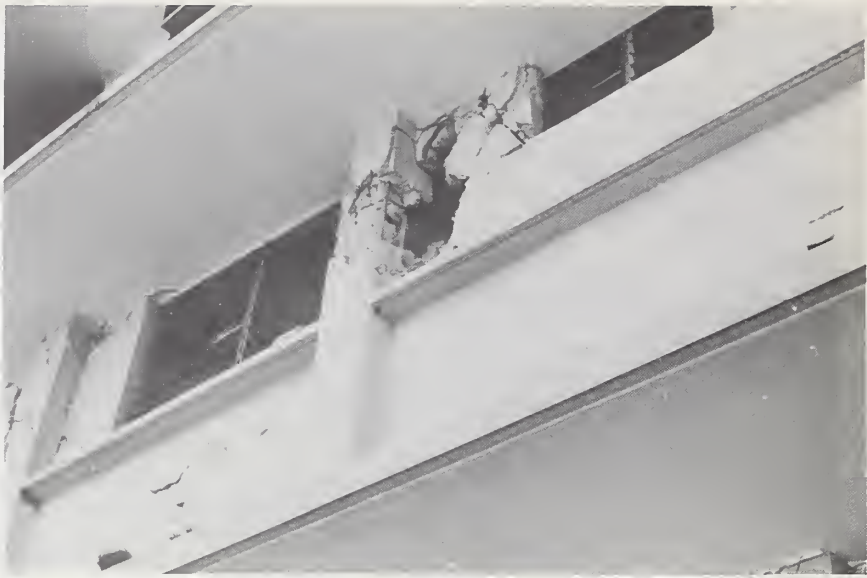
Figure 70-3 Detail of wall and column damage on north facade, Hospital del INSS.

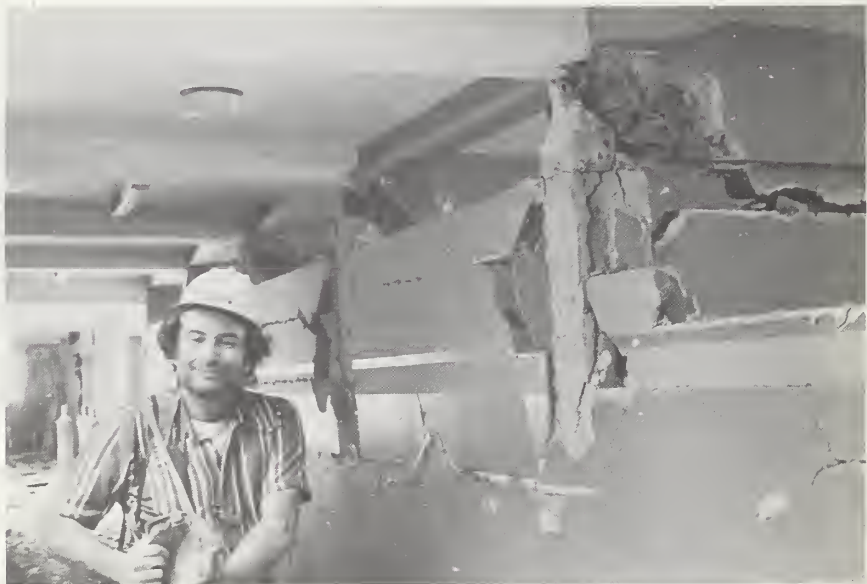
Although the structure did not collapse, extensive damage to unreinforced masonry partitions and infill walls made the building dysfunctional and hazardous to occupants, figures 70-4 and 70-5.

Figure 70-4 Structural and nonstructural damage on east wing, first floor, Hospital del INSS.

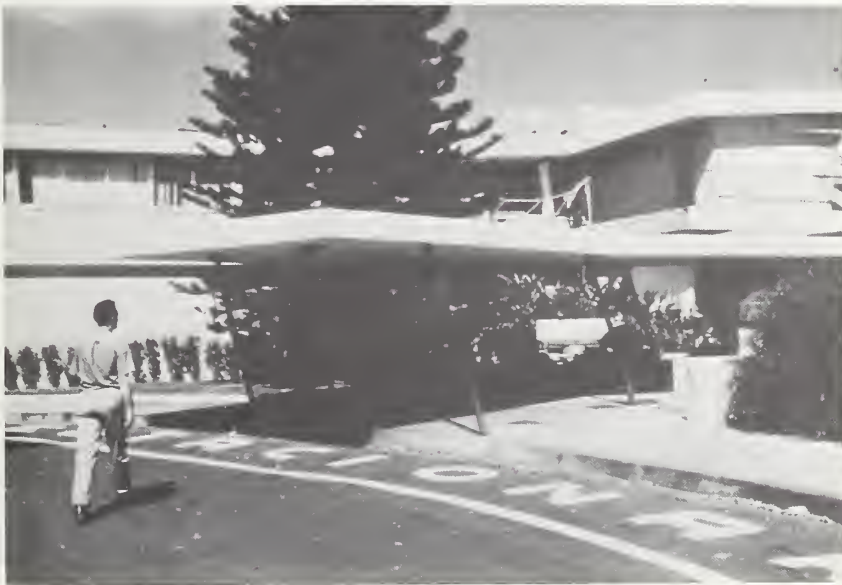
The main wing is severely damaged and partially collapsed, figure 73-1. The eight in thick canopy slab has swayed more than two ft on its steel pipe columns, figure 73-2. An attendant reported that the partial collapse of the reinforced concrete main wing occurred on the first shock of the earthquake. Although it was not closely inspected, the two story wing at the southeast showed no evident damage from the outside. It was pointed out, that new cracking appeared in the entry drive in front of the club at the time of the earthquake. This may be part of the fault breaking in the earthquake since there are no strong slopes in the vicinity suggesting sliding action.

Figure 73-2 Sway deformation of heavy canopy slab, Country Club Tejapa.

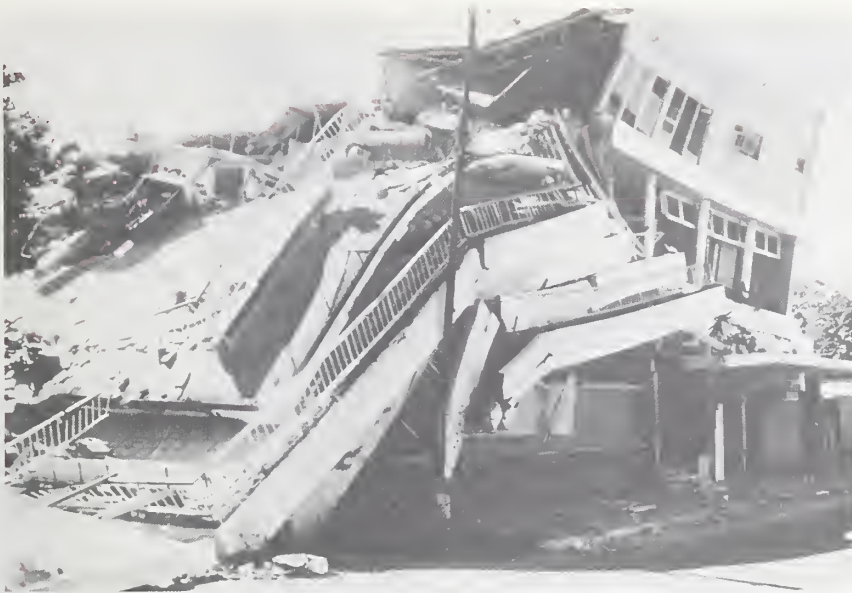
This was a five story reinforced concrete frame building at the corner of Calle 27 de Mayo, one block from Bolivar Avenue. One column observed was reinforced with six No. 8 plain bars. A large portion of the building has collapsed, figures 74-1 and 74-2. In the remaining part of the building, it is evident that partial height infill walls contributed to failures of the columns.

Figure 74-1 Four of five stories collapsed, Edificio Guerrero Pineda.

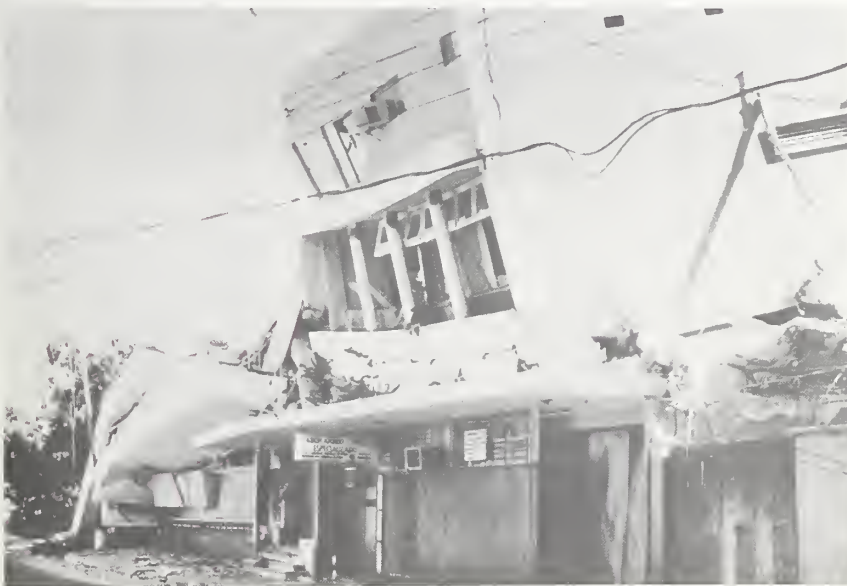
Figure 74-2 Three of five stories of the Edificio Guerrero Pineda standing at this end.

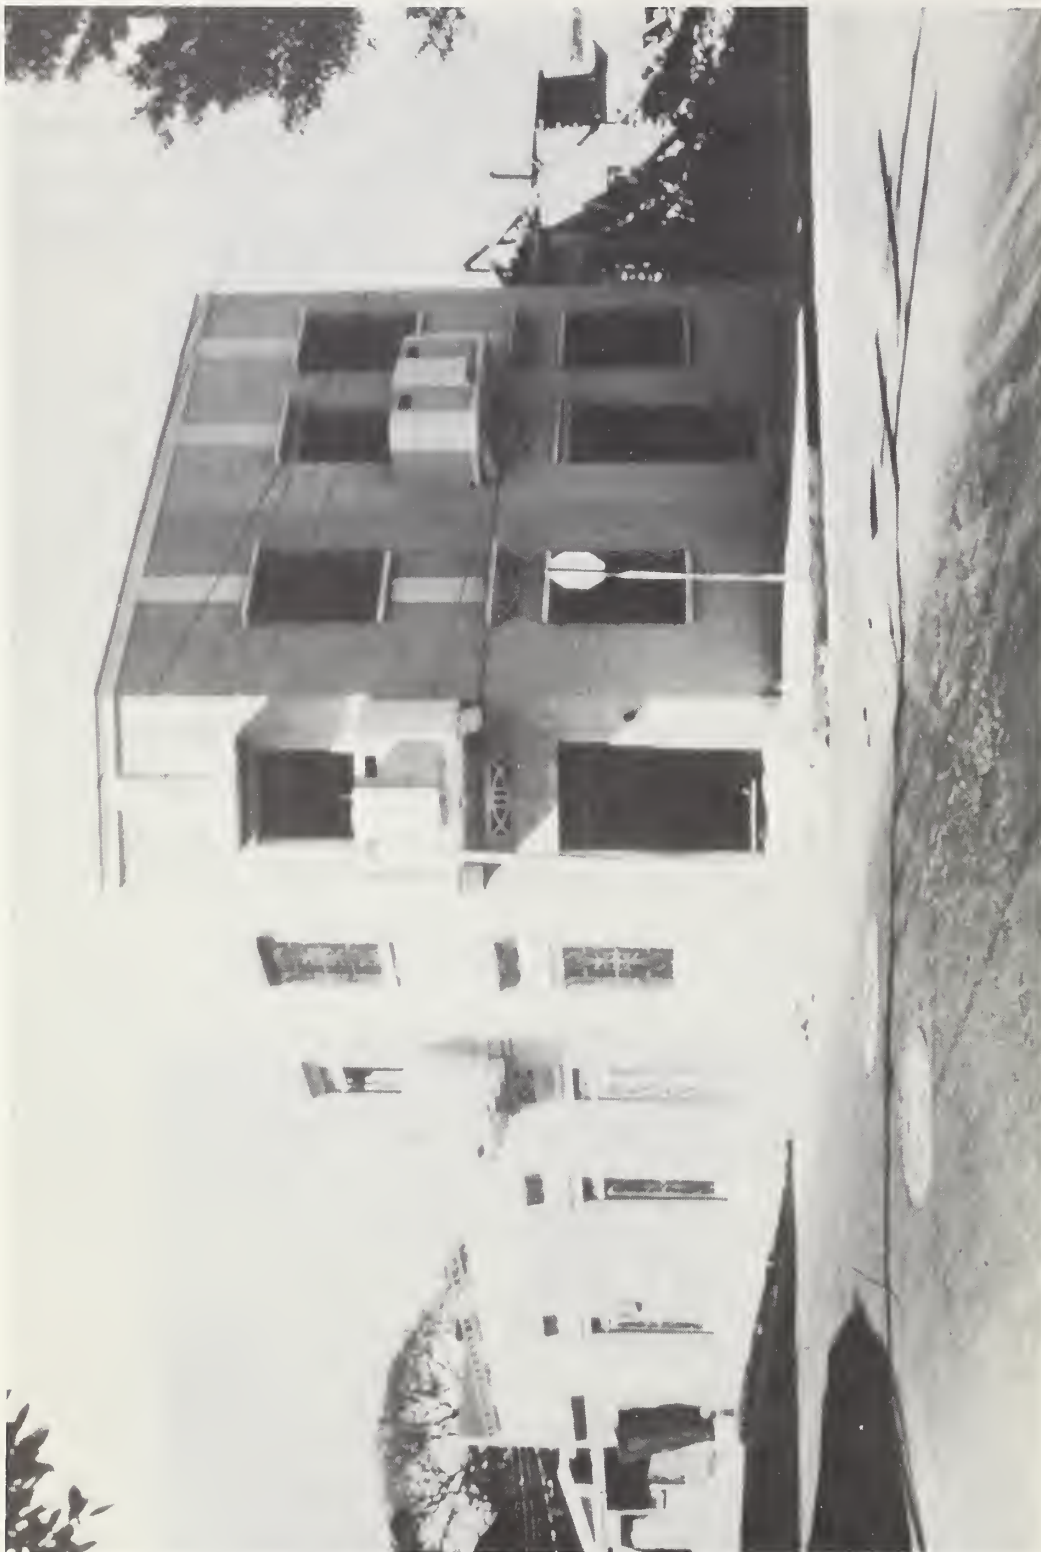
It is interesting to note the contrasting lack of damage to a building across the street, figure 74-3.

Figure 74-3 Building across from Guerrero Pineda shows little damage.

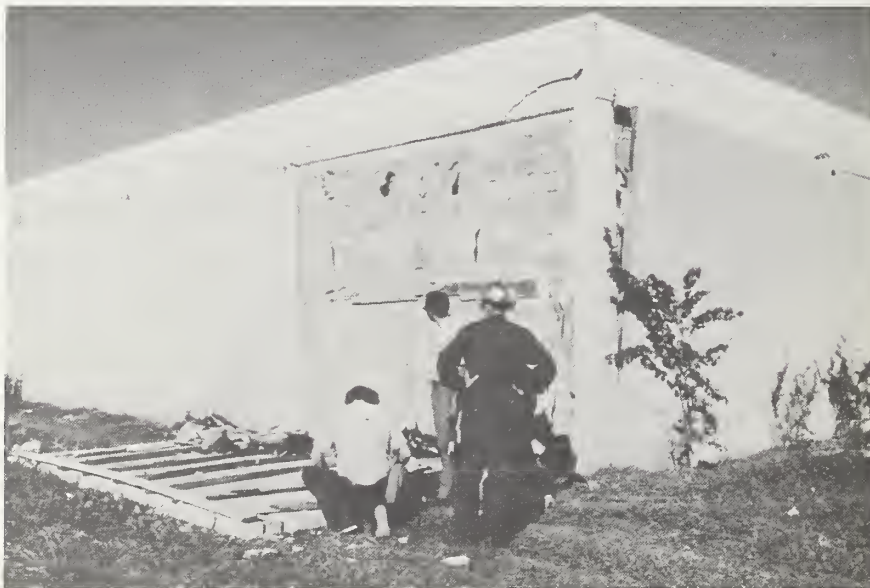
The building is extensively damaged. The cavity walls which were not tied together across the cavity or tied to the columns or beams have suffered a number of failures, some leaning out, some completely fallen, figure 75-2. Exterior columns are sheared at the top. Much of the suspended ceiling has fallen inside the building.

Figure 75-2 Falling of cavity walls and shearing of
frame columns, Instituto Geografico
Nacional.

The building should be evacuated and repaired before further use. Special attention is required to repair and reforce the exterior walls and columns. It may be desirable to provide a shear wall in place of the present curtain walls.
