NBS TECHNICAL NOTE 909

Investigation of Wind Damage in the Metropolitan Washington, D.C. Area, April 3-4, 1975

A limited investigation was conducted of wind damage that occurred on April 3 and 4, 1975 in the Metropolitan Washington, D.C. area.

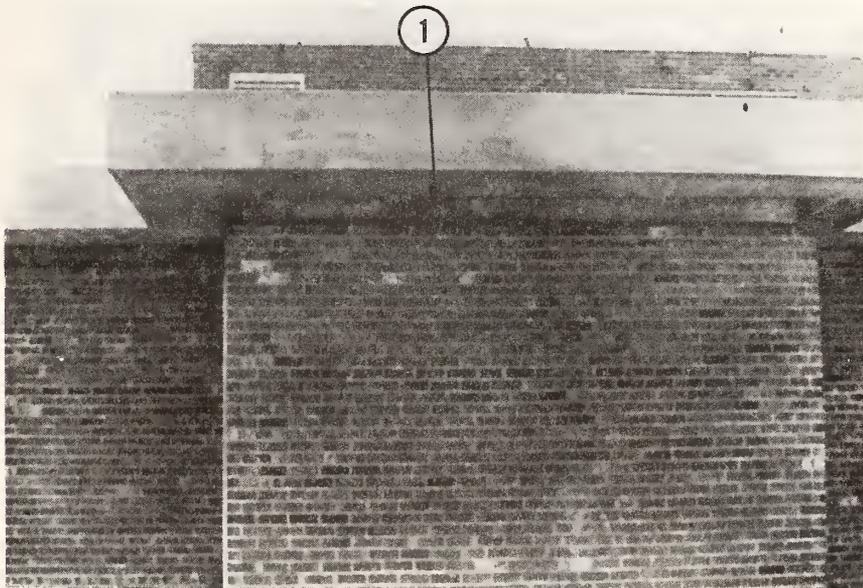
Figure 5 - Front elevation of similar wall located in undamaged building. Looking west.

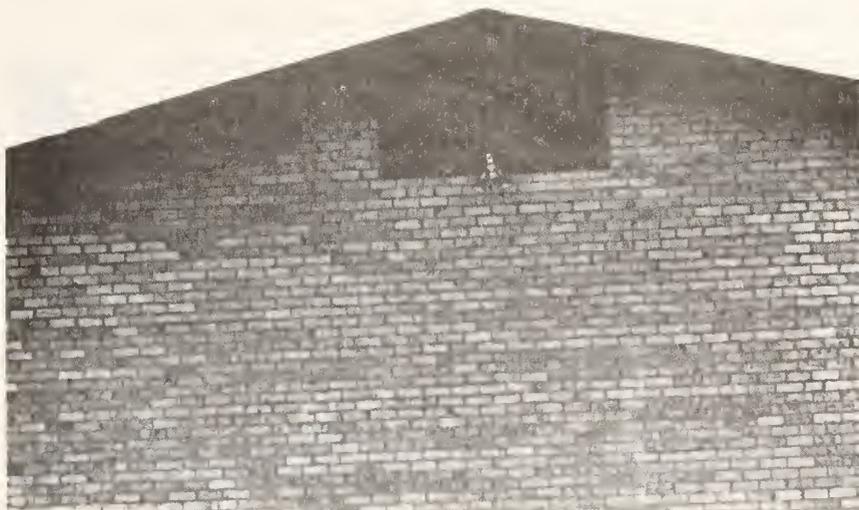
An overall view of the damaged building under repair is shown in figure 18. Figure 19 shows a closer view of the damaged wall and roof overhang. Figure 20 shows a similar undamaged wall in an adjacent building.

Figure 20 - Elevation view of an undamaged gable wall.

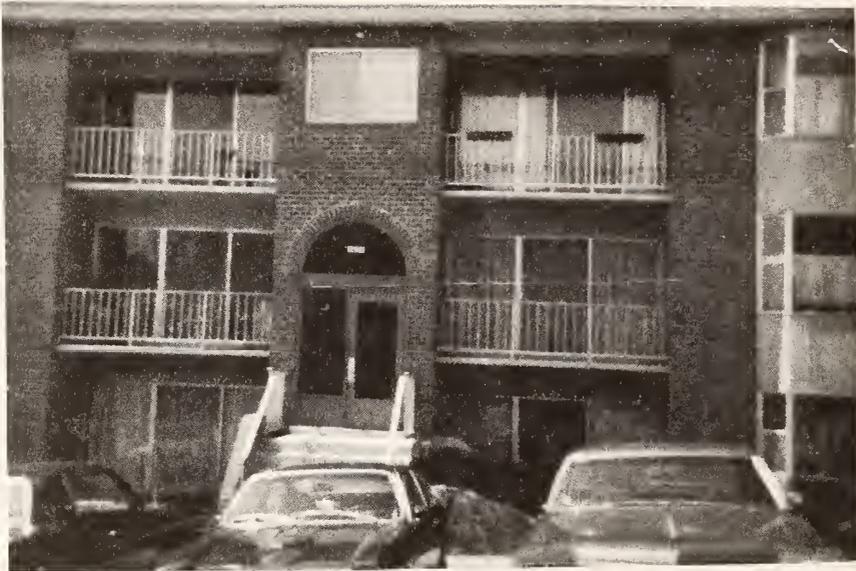
Figure 27 shows a front elevation of a typical three-story unit of a garden apartment complex with flat mineral surface built-up roofs. Figures 28 -31 show overall views of the roof damage suffered by the apartment complex. The prevailing wind direction is shown in figure 28. The figure also shows that the roofs overhanging the balconies were ripped off by the wind. The view through the window on the upper left of figure 29 shows that part of the roof and ceiling over the living unit is removed. Another front view of the damage is given in figure 30 and a side view in figure 31. Figure 32 shows some of the debris of the collapsed roof. The roof construction consisted of 2 x 8 (5 x 20 cm nominal) wooden joists 24 inches (61.0 cm) on centers with plywood on both sides of the joists. This flat roof was then covered with a composite roofing. No information was available on the anchorage between the joists of the roof structure and the masonry walls of the building and no evidence of anchorage could be found in the field examination. Apparently, the wind exerted substantial uplift on the overhanging portions of the roof and in particular on sections of the roof covering the balconies. Evidence of this uplift can be seen in Figure 33. Note the separation between the roof (which is in this case still in place) and the masonry wall. Figure 34 shows that the portion of the roof overhanging the balcony was supported by a beam which in this case stayed in place while the roof was demolished. In figure 35 a case is shown where the beam was also pulled out from its bearing socket. An overall view of the roof under repair is shown in figure 36. The areas under repair in this figure give an indication of the extent of the damage suffered.

Figure 27 - Front elevation of a typical three-story apartment building.

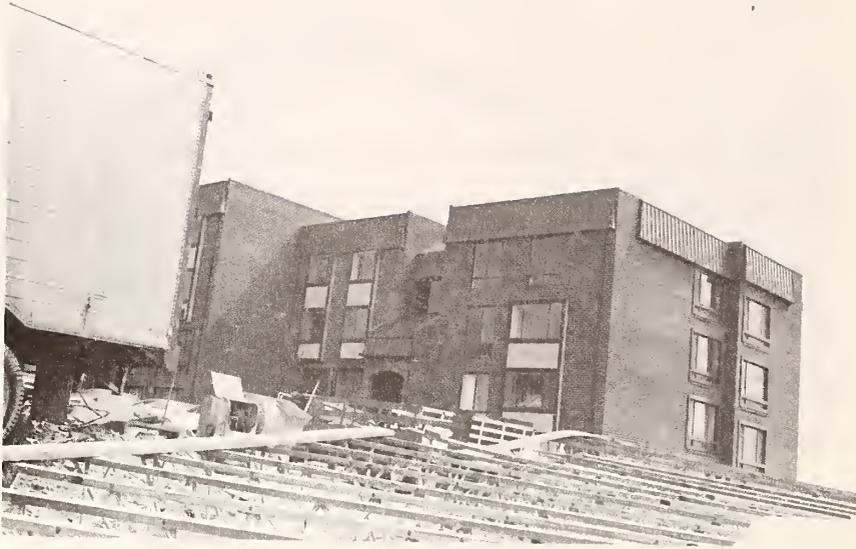
Figure 37 shows a three-story garden apartment building. This is one of the completed units which suffered no damage. Figure 38 shows a row of the same type of units under construction. The prevailing wind direction is indicated by the arrow. Note that in the completed unit (figure 37) the truss structures which support the roofs are closed by siding, giving the appearance of a mansard. Figure 38 shows part of the roofs which were removed by the wind and deposited in front of the buildings under construction. A closer look at an undisturbed roof assembly in place is shown in figure 39. Figures 40 and 41 show details of the roof assemblies which were lifted up, overturned and deposited on the ground. The truss structure had wooden top and bottom chords and galvanized steel tubing as diagonal truss members. The top of the roof was covered by 1/2 in (1.3 cm) thick plywood sheathing. Although this plywood sheathing was in place, the built-up roofing had not yet been installed. The span length of the trusses was 49 ft (14.9m) and spacing between trusses was 24 in (61.0 cm). Connections of the roof trusses to the masonry walls are shown in figures 42, 43 and 44. Figure 44 shows that not only was the roof truss structure removed, but also a steel beam which served as a lintel over a window opening. One of these lintels, in place, is marked by the arrow in figure 45. Two of the displaced lintels are seen, still attached to the trusses in figure 38. The failure of these roofs is probably attributable to two causes: 1. the sides of the trusses were open and the windows were not completed, thus providing openings which caused pressure buildup on the underside of the roof sheathing; this pressure, together with suction acting on the top of roof surface exerted a considerable upward force; 2. the built-up roofing was not yet in place to add weight which could have contributed to the resistance to uplift pressure. Figure 45 shows the details of roof trusses on units which were under construction and which were not damaged by the wind.

Figure 37 - A completed three-story garden apartment building.

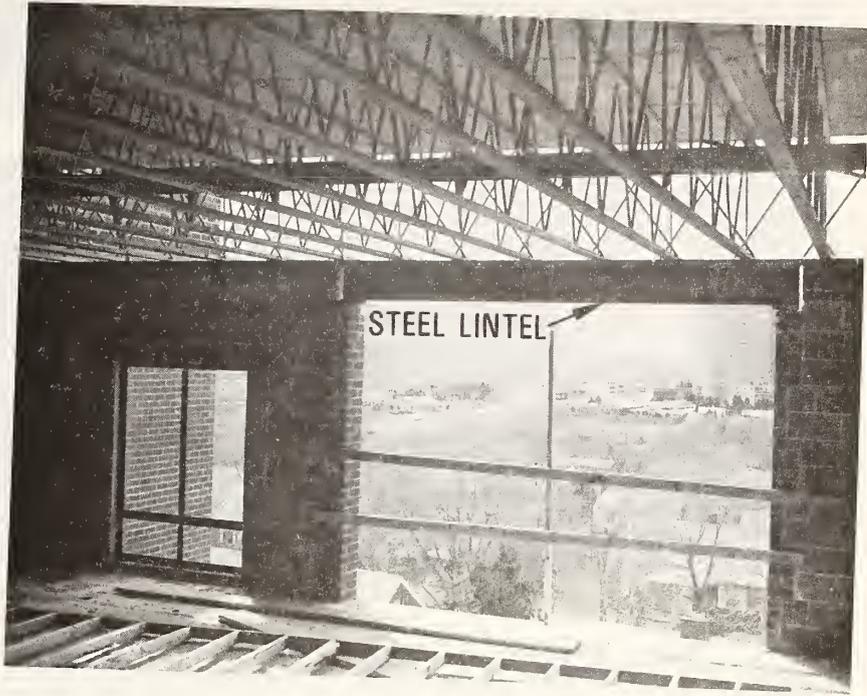
Figure 39 - Closeup view of the underside of a typical roof assembly.

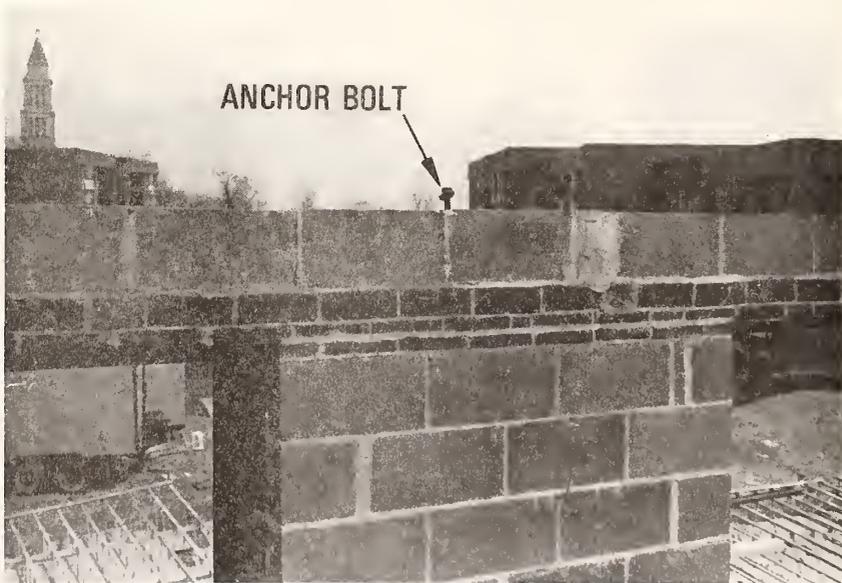
Figure 42 - A front masonry wall with projecting bolt for anchoring the roof assembly.

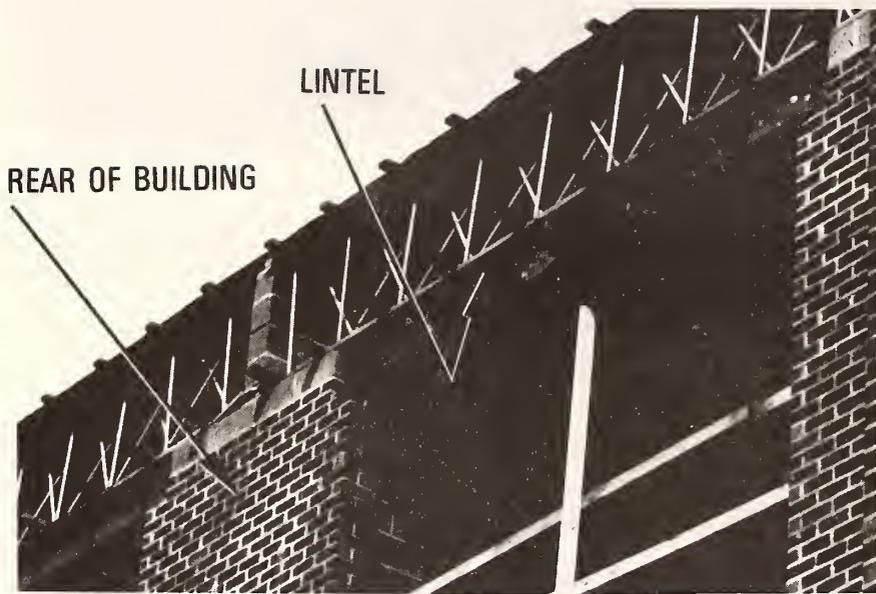
Figure 45 - Rear view of roof truss support in an undamaged building. Looking east.

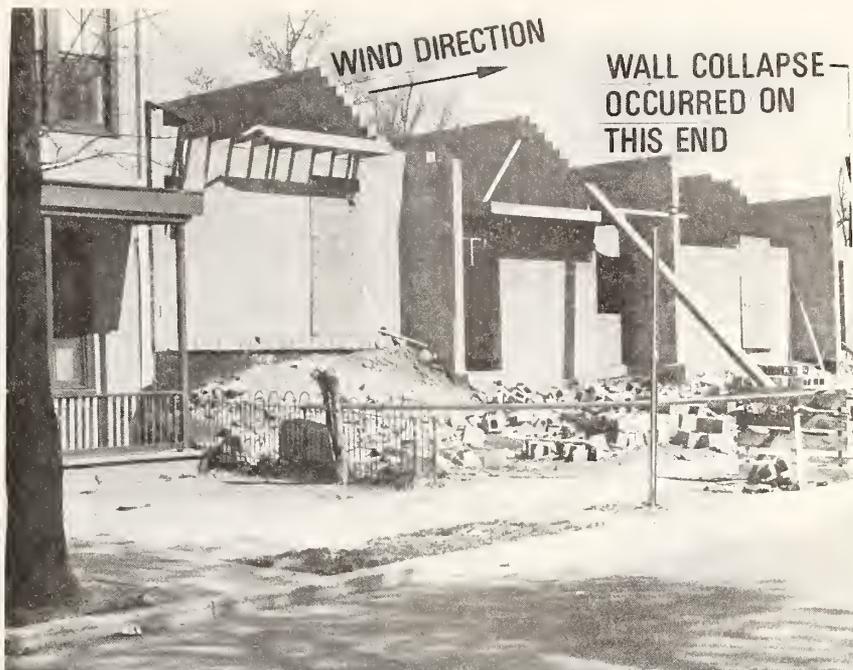
Figure 46 shows the end unit of a four-unit concrete masonry row house under construction. The exterior side wall of this unit collapsed and fell into the street causing two fatalities. (See the debris in the foreground of the photograph). Figures 47 and 48 are other views of the same structure taken from another street at right angles to the one into which the wall collapsed. The direction of the prevailing wind is shown by the arrow in figure 47. Note the partial collapse (figure 48) of cross-walls in other portions of the structure which were parallel to the exterior wall that collapsed. Details of the pulled-out joint reinforcement in one of the damaged cross-walls is shown in figure 49. The construction was 8 in (20 cm) unreinforced hollow concrete block with joint reinforcement. The incident illustrates the vulnerability of masonry walls in the construction stage before they are fully braced at their tops.

Figure 47 - Front elevation of three of the living units in row house complex.
